# Inspection Photos

API: 043-06122

Operator: JAVERNICK OIL

Inspection Date: 5/22/2023

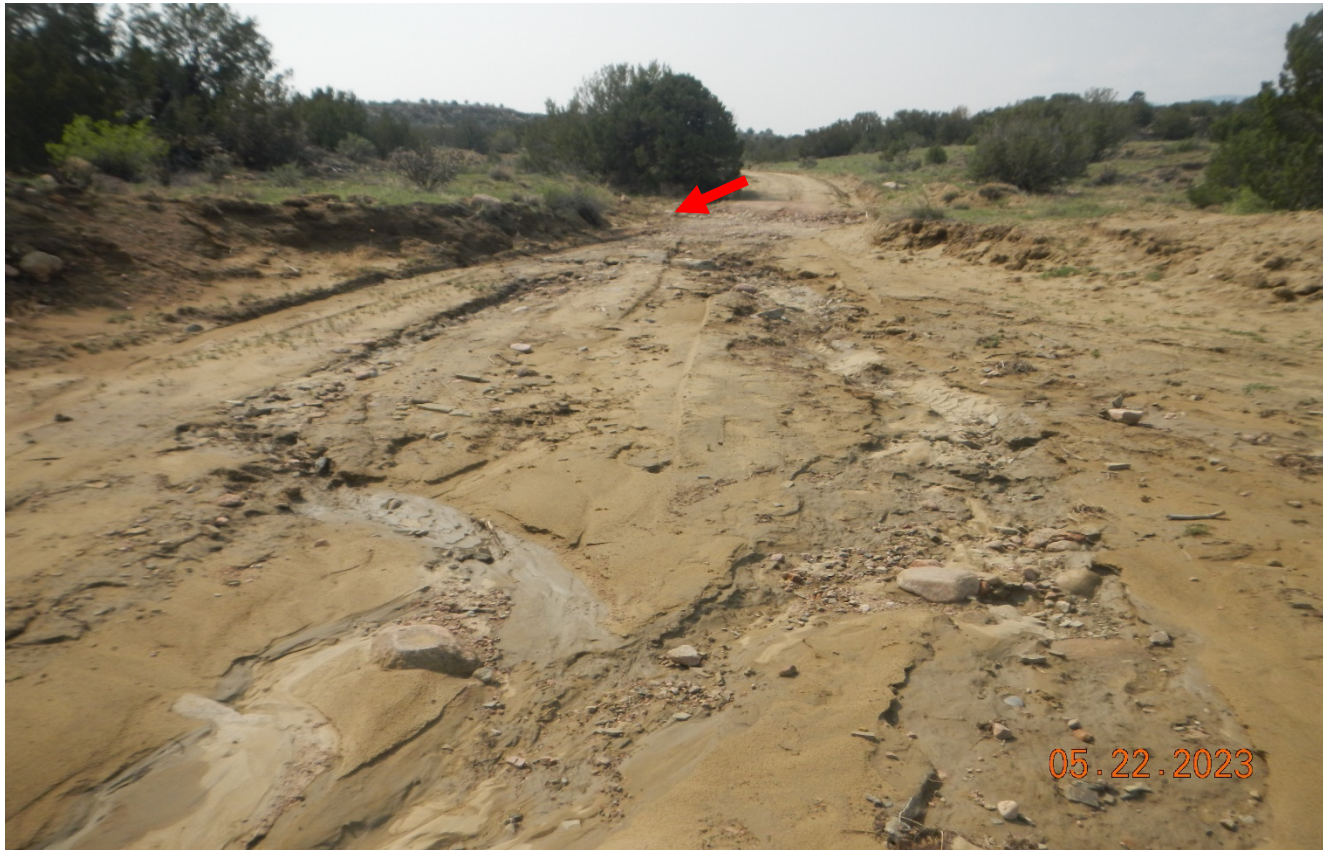
**Photo 1.** Facing southeast long the access road. Erosion has occurred from a recent storm event which washed down from the drainage at red arrow. Previous corrective action required culvert or other BMP to be placed at the drainage which may have prevent erosion of the road. Previous corrective action was not completed.

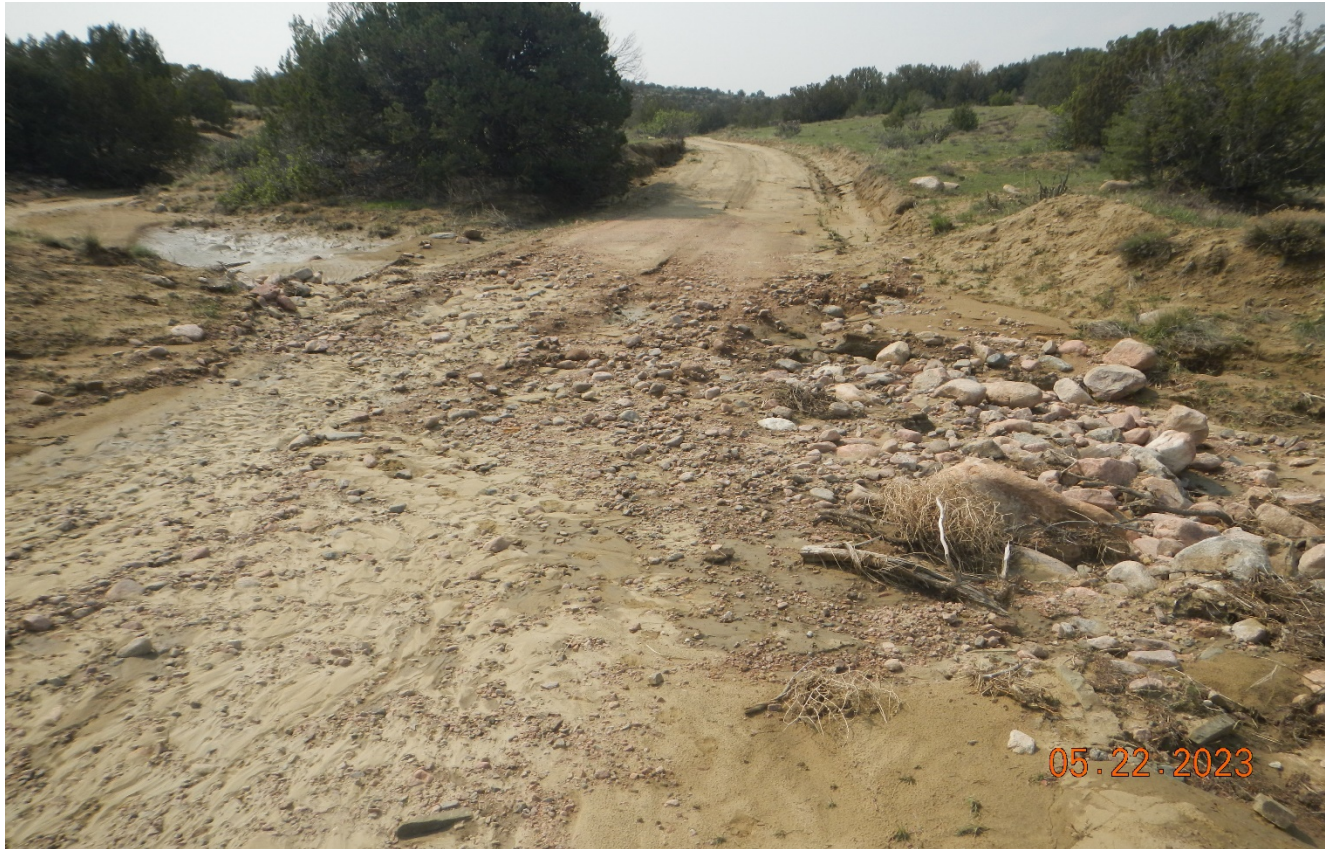
**Photo 2.** Facing southeast long the access road. This drainage crossing must have BMP's installed to accommodate seasonal storm event to prevent material from washing out. BMP may include culvert, rip/rap, ect. Previous corrective action not completed. Recent storm event has caused significant erosion of the road since previous inspection.

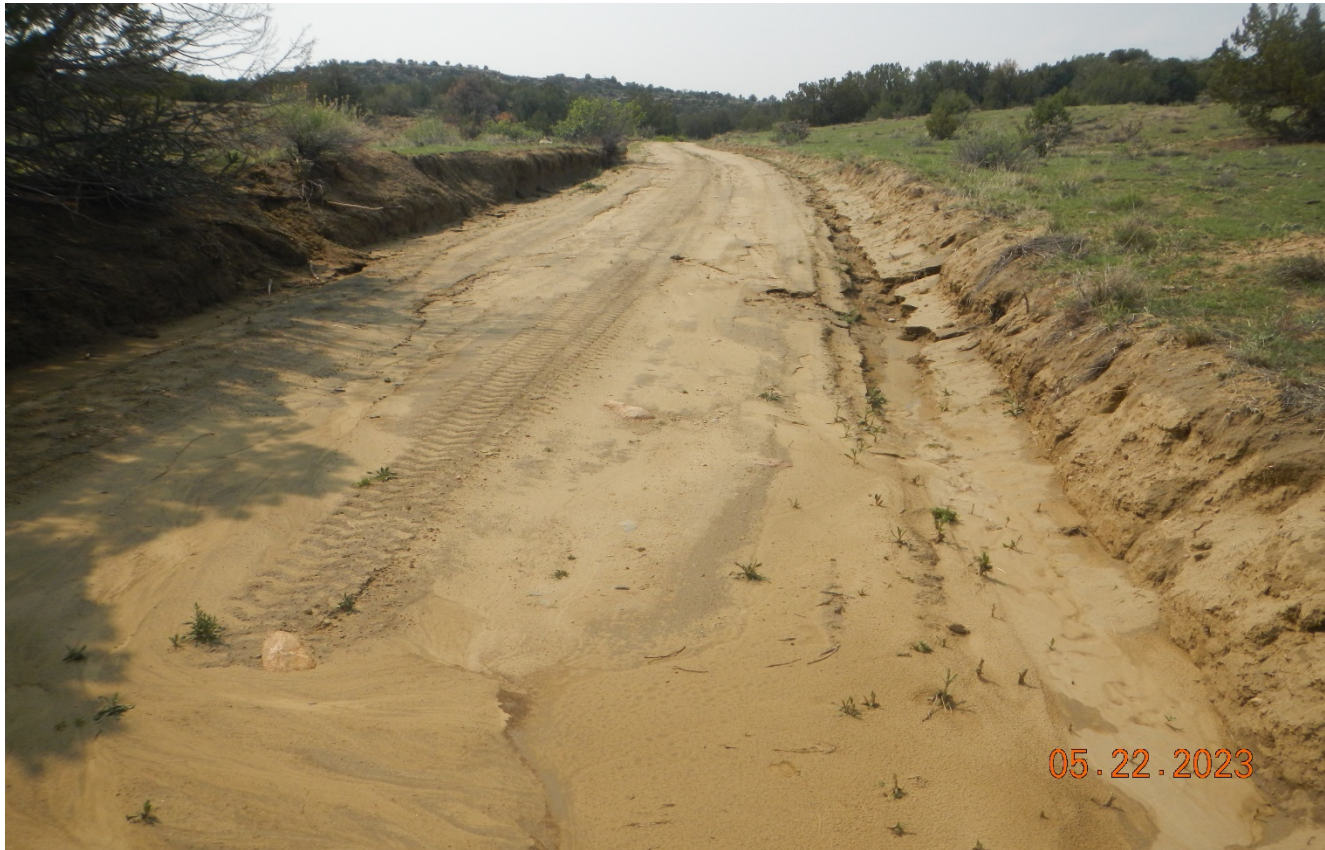
**Photo 3.** Facing southeast long the access road. There is erosion along the access road which is not stabilized and no BMP's have been installed.

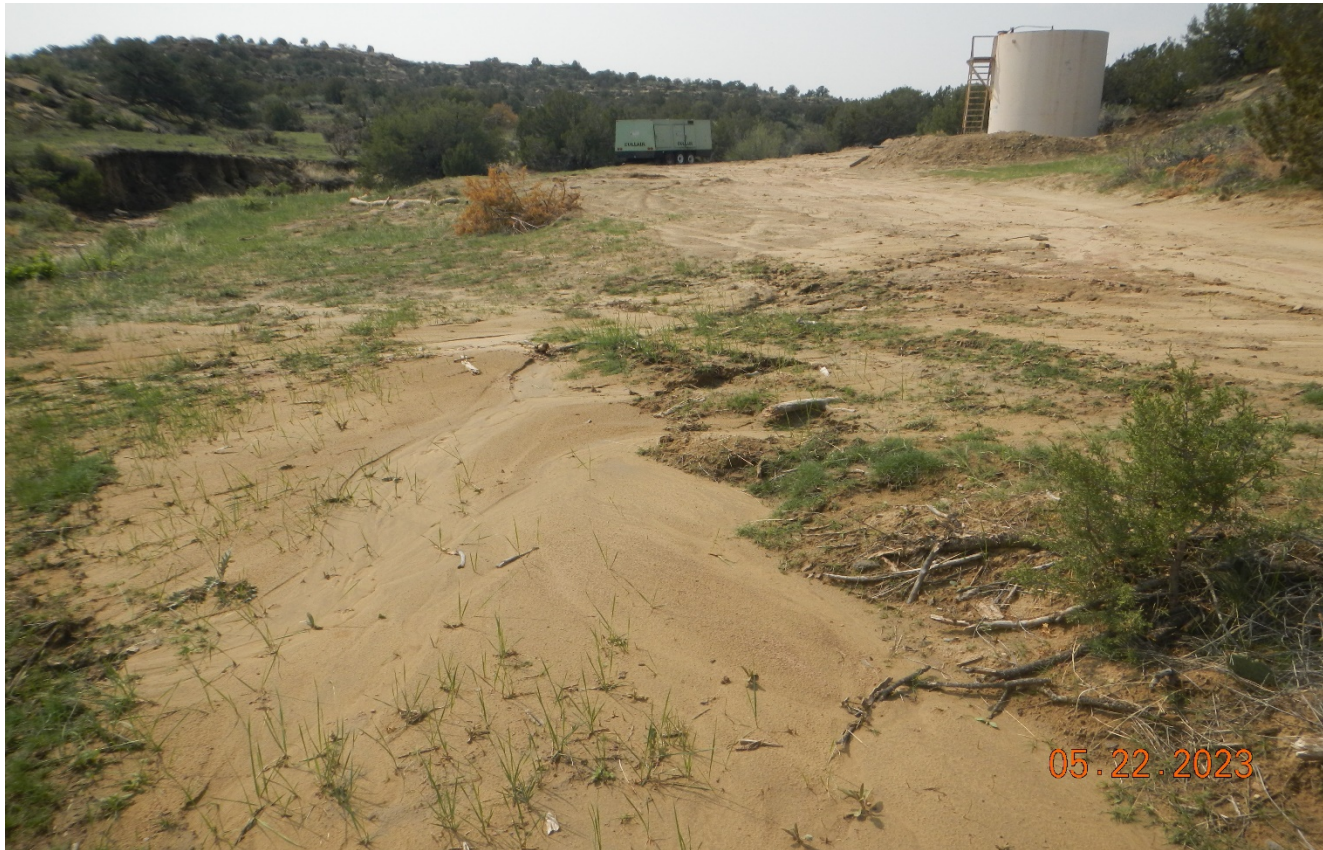
**Photo 4.** Facing southeast long the access road near the tank battery site. Recent storm event has washed sediment down the road and offsite into the stream drainage

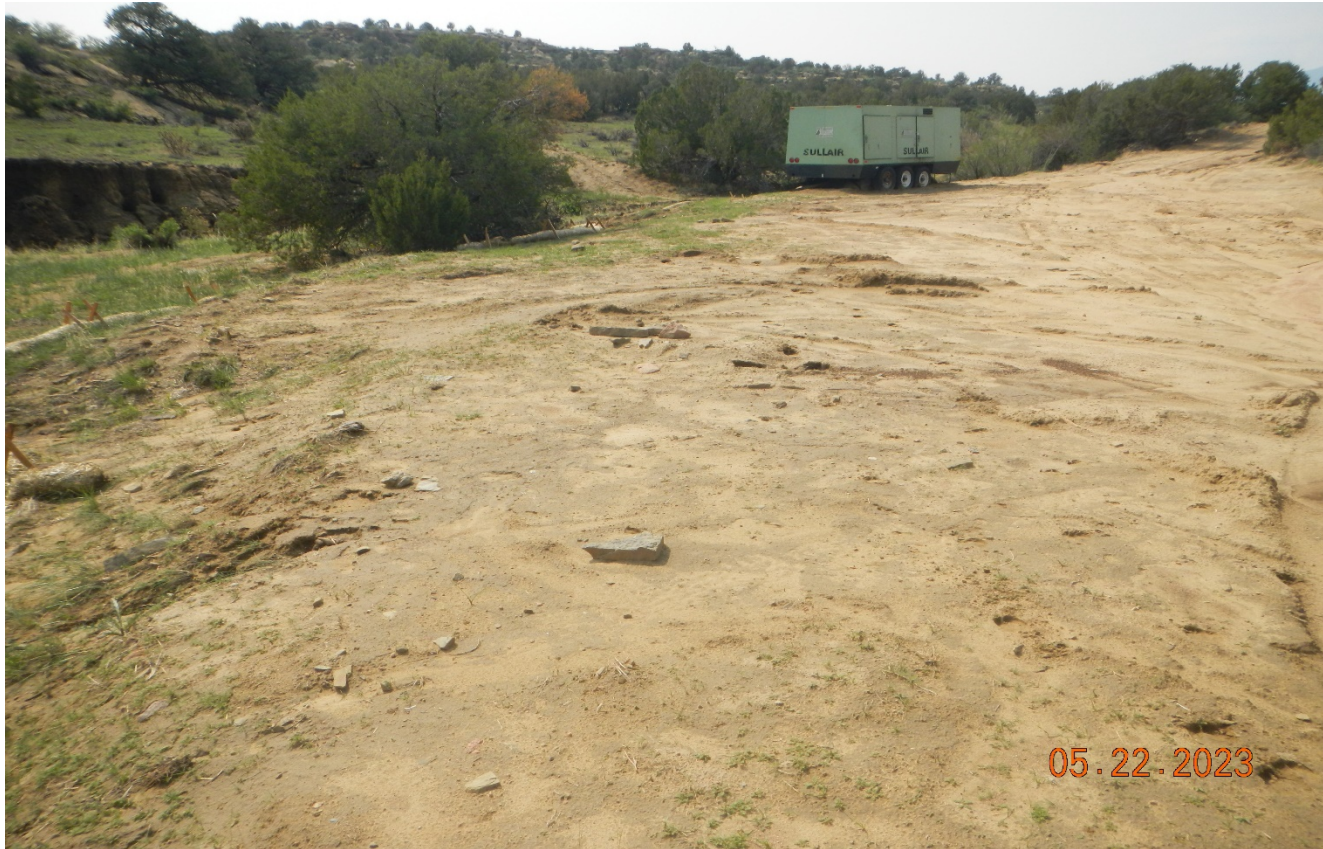
**Photo 5.** Facing southeast at the tank battery site. Most of the equipment has been removed since previous inspection. There is still 1 equipment trailer that needs to be removed. This disturbed area needs to be reclaimed and stabilized.

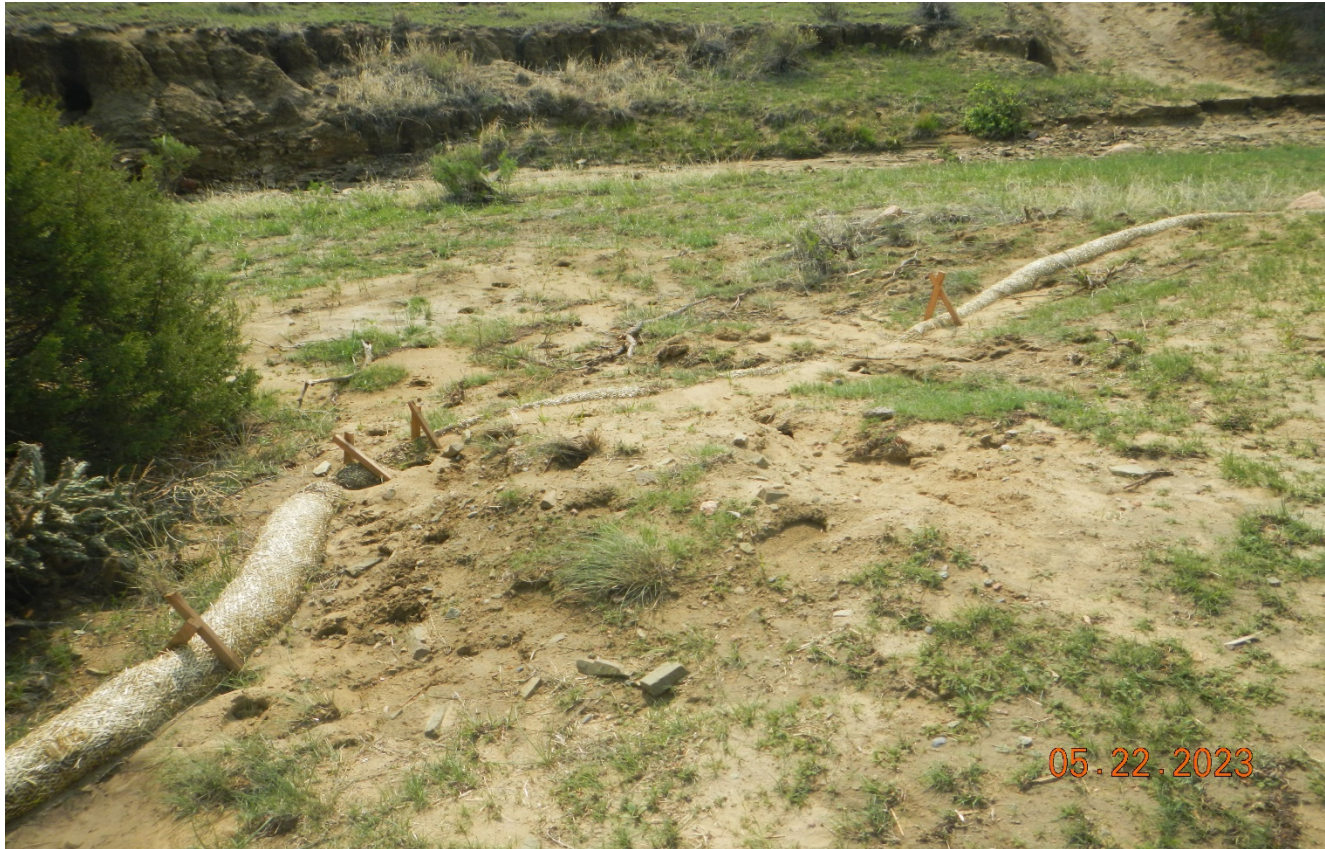
**Photo 6.** Facing southeast at the perimeter of the disturbance at the east side of tank battery. Stormwater controls were installed since previous inspection but were not sufficient and sediment overtopped the wattles in this area. The wattles are not maintained and are filled in with sediment.

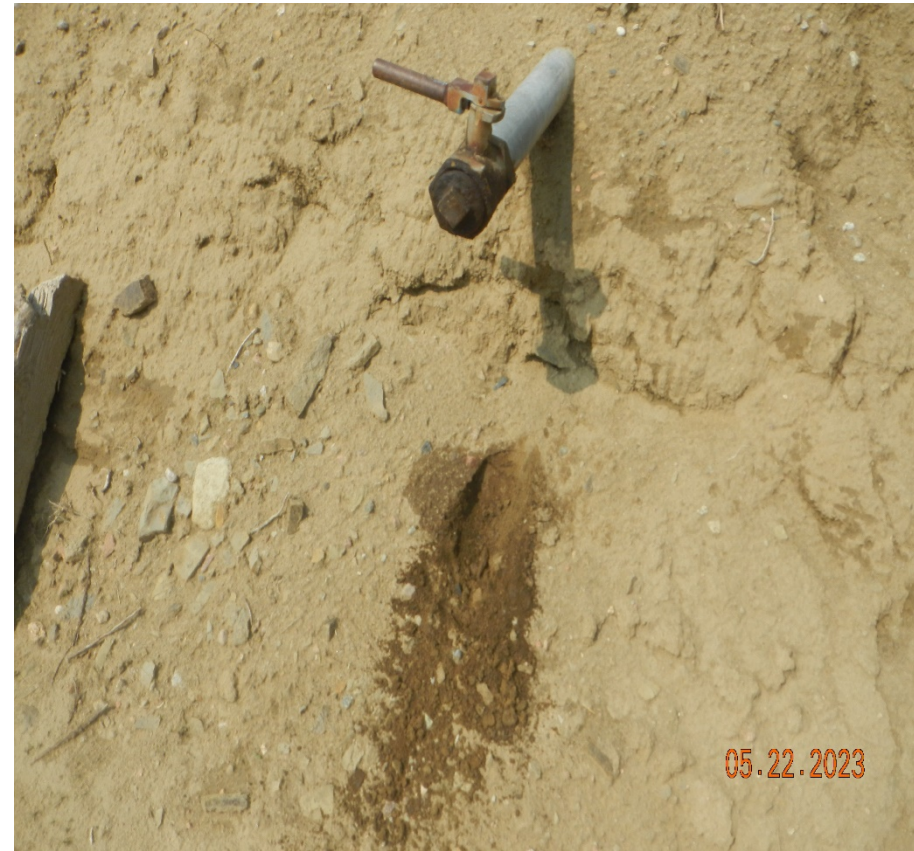
**Photo 8.** There is still oil stained soils at the tank pipe outlet. Previous corrective action to clean up impacted soils is not completed.

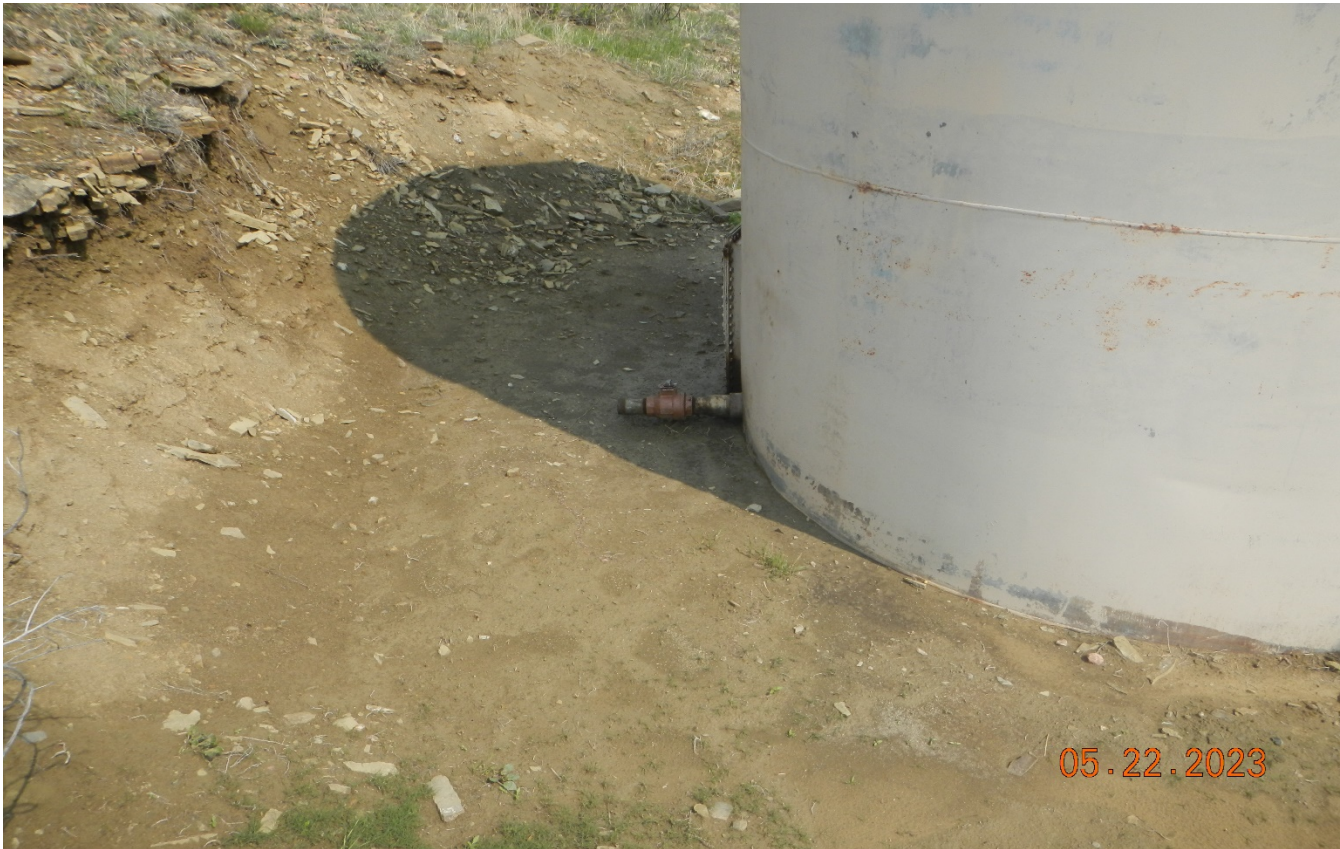
**Photo 9.** The dripping leak appears to have been fixed or fluids have been drained from the tank. The excavated area at the pipe outlet was filled back in.

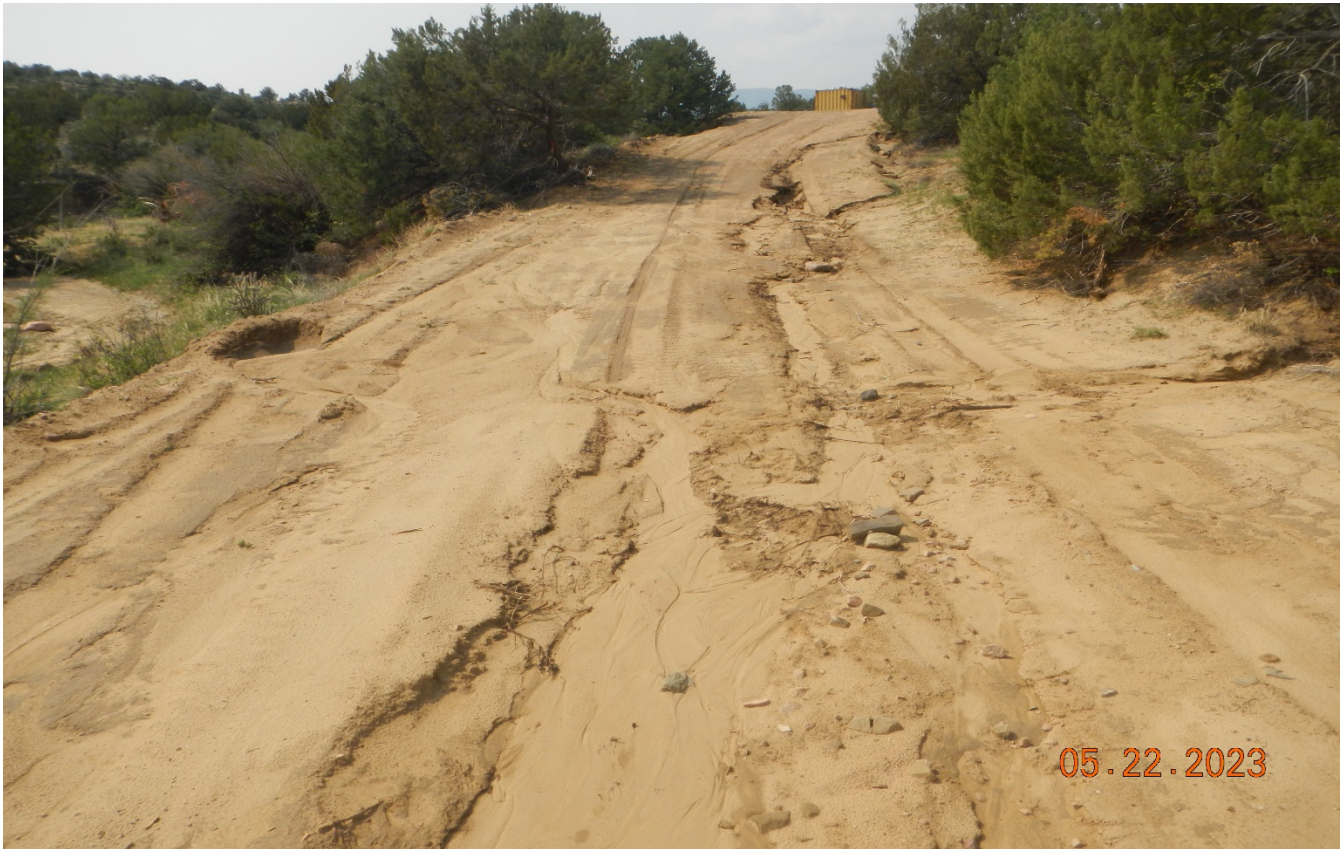
**Photo 10.** Facing south along the access road to the wellsite location. The road was never stabilized with BMP's and has eroded since previous inspection.

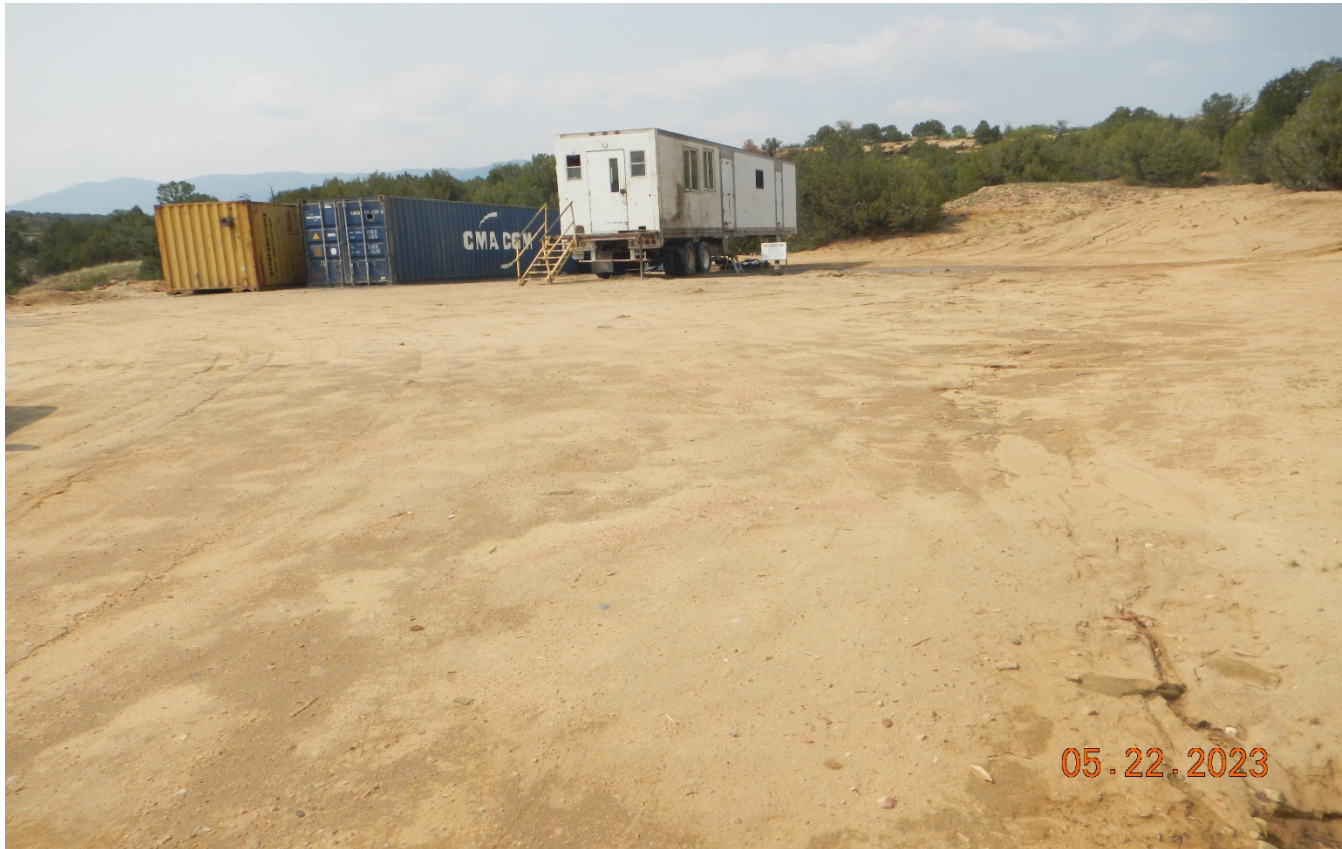
**Photo 11.** Facing southwest toward the well site. The drill rig has been removed since previous inspection however there is still equipment trailers that need to be removed.

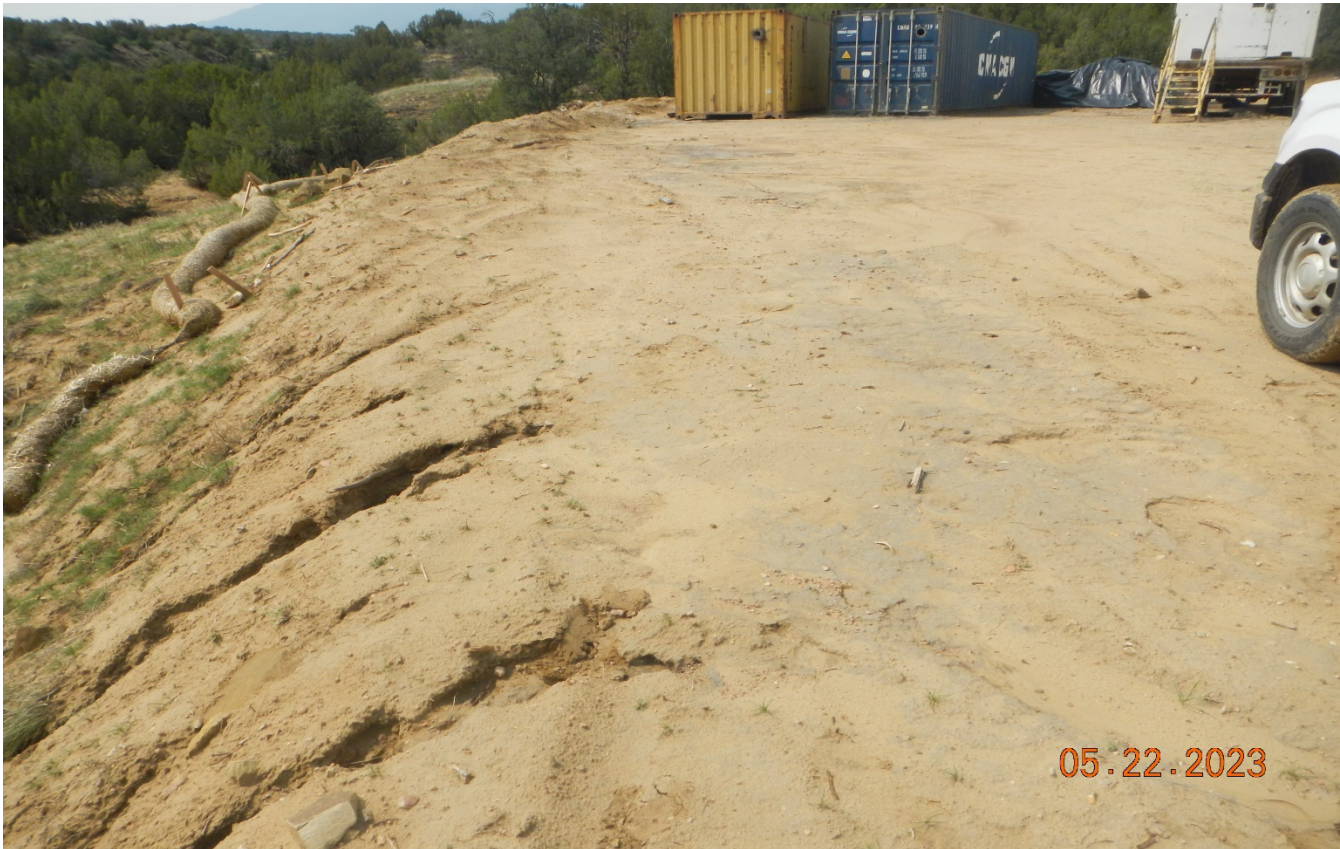
**Photo 12.** Facing southeast along the fill slope of the pad. There is erosion that has occurred off the fill slope which is not stabilized. BMP's were not properly installed.

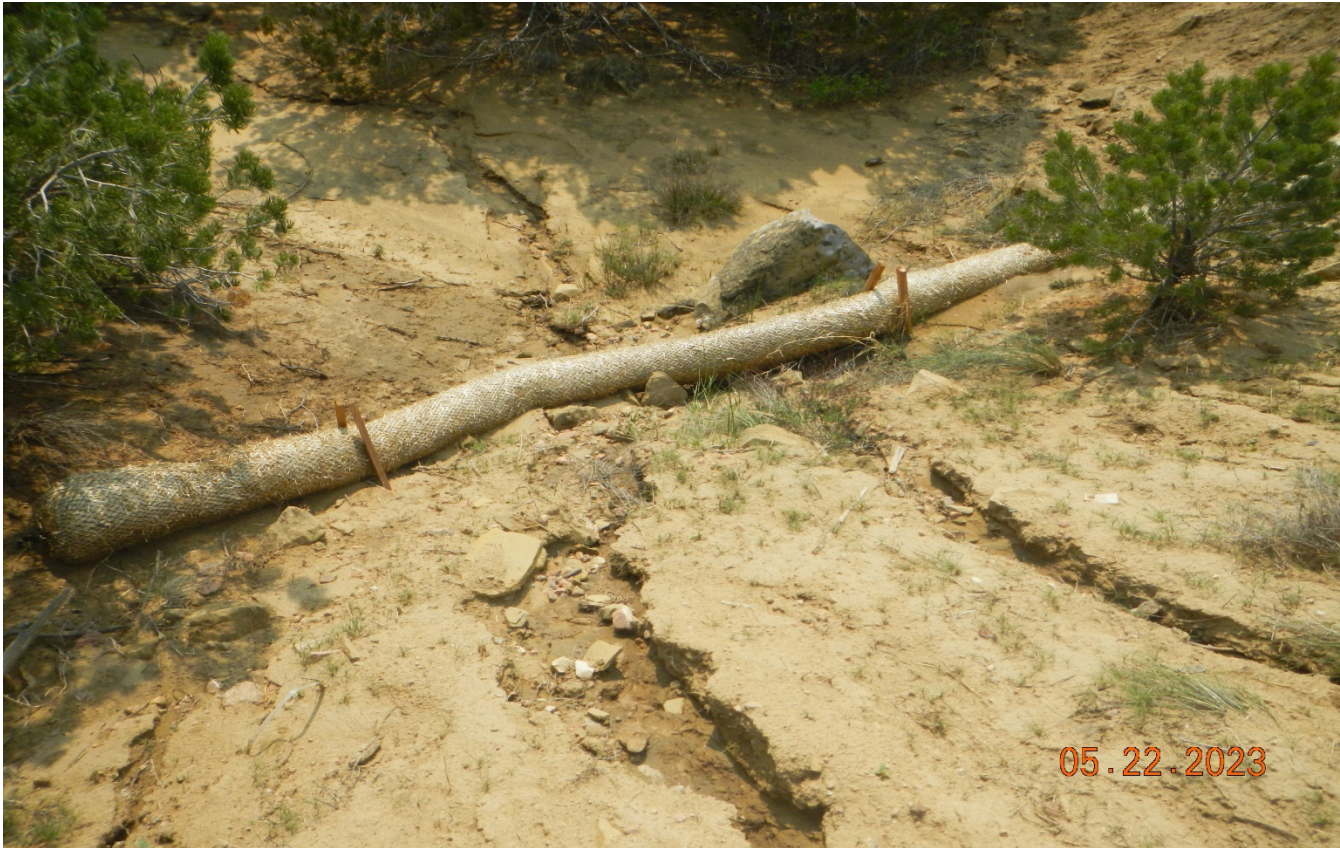
**Photo 13.** The wattles at the east perimeter were not properly installed and stormwater eroded underneath the wattles transporting sediment offsite.

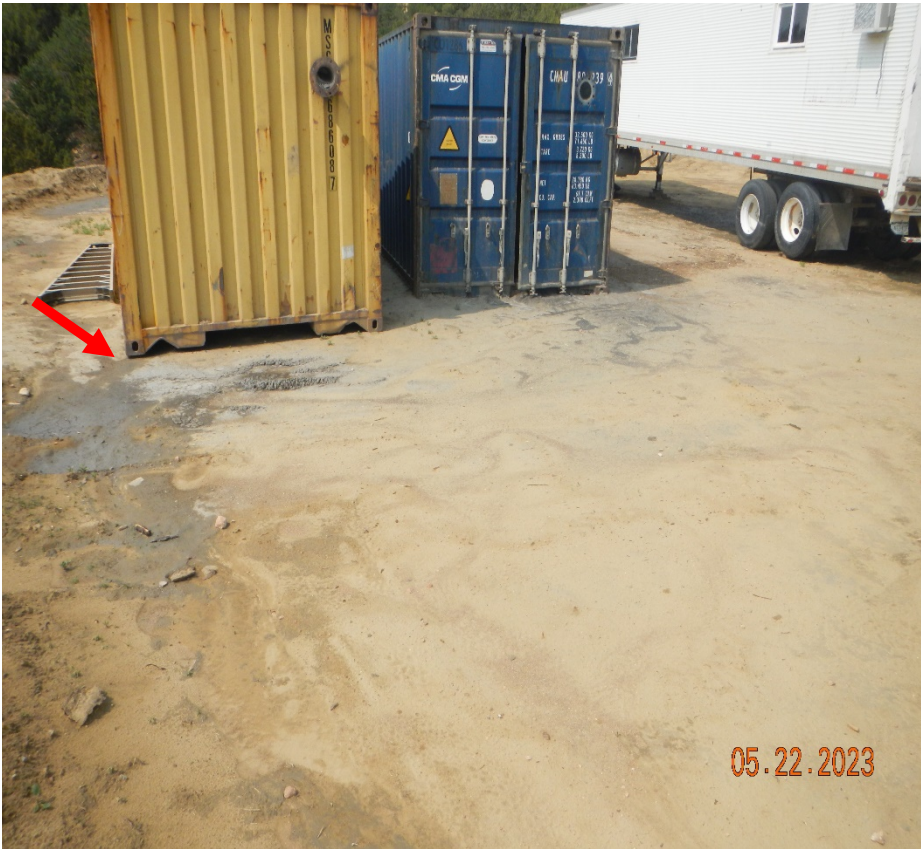
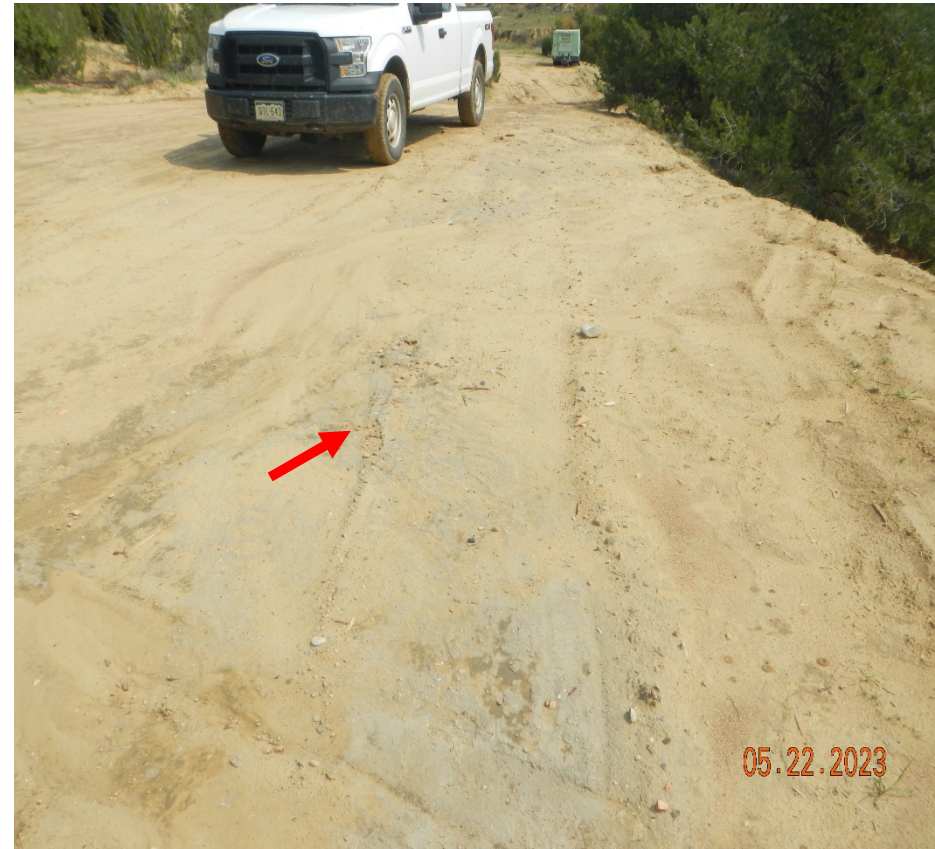
**Photo14&15.** There is gray cuttings material at the conex shown at the left photo which appears to have washed northeast along the pad shown at the right photo.

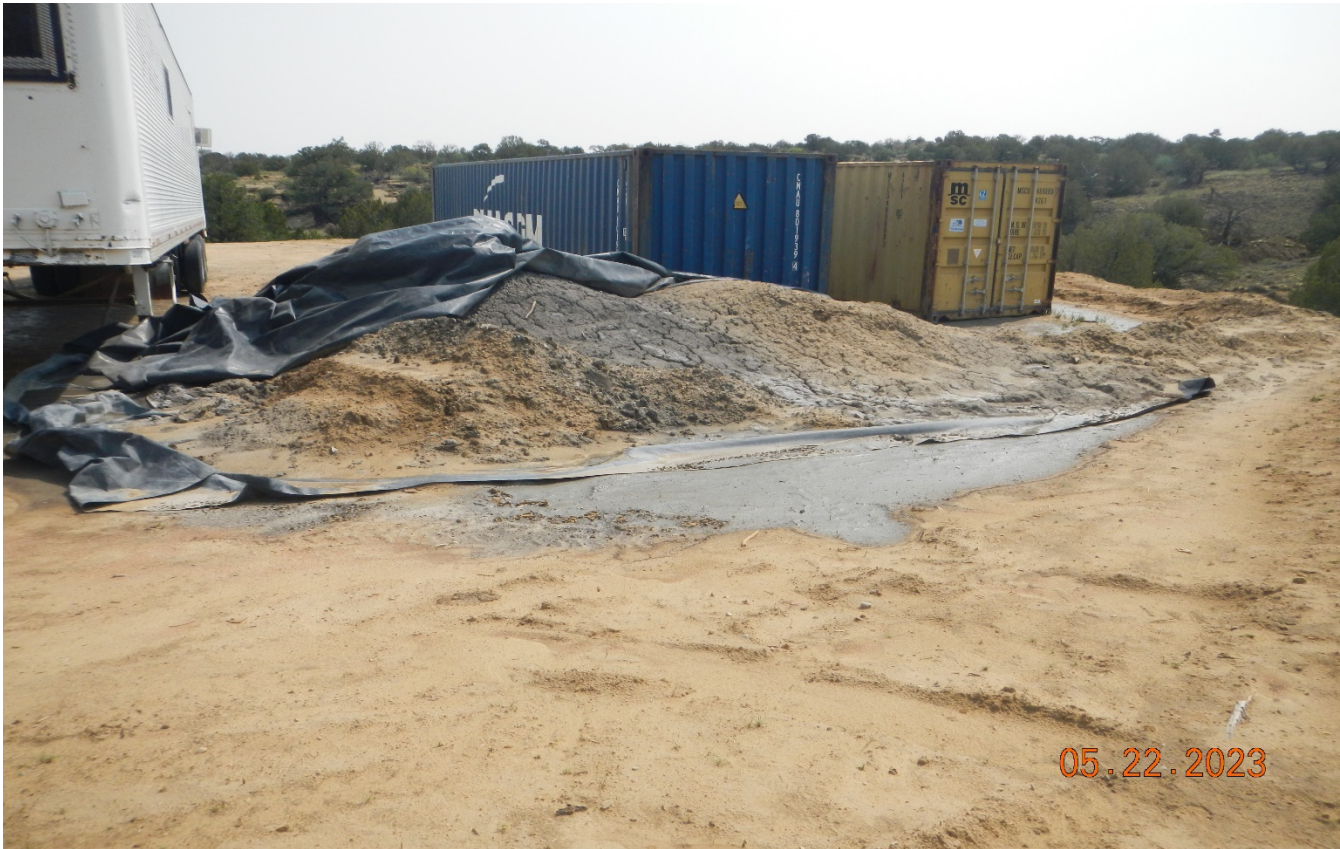
**Photo 15.** There is drill cuttings on the surface not properly stored and contained which is piled up behind the storage containers. The plastic liner does not contain the drill cutting and stormwater has transported the cutting off the liner toward the area shown in previous photos. Previous corrective action was not completed.

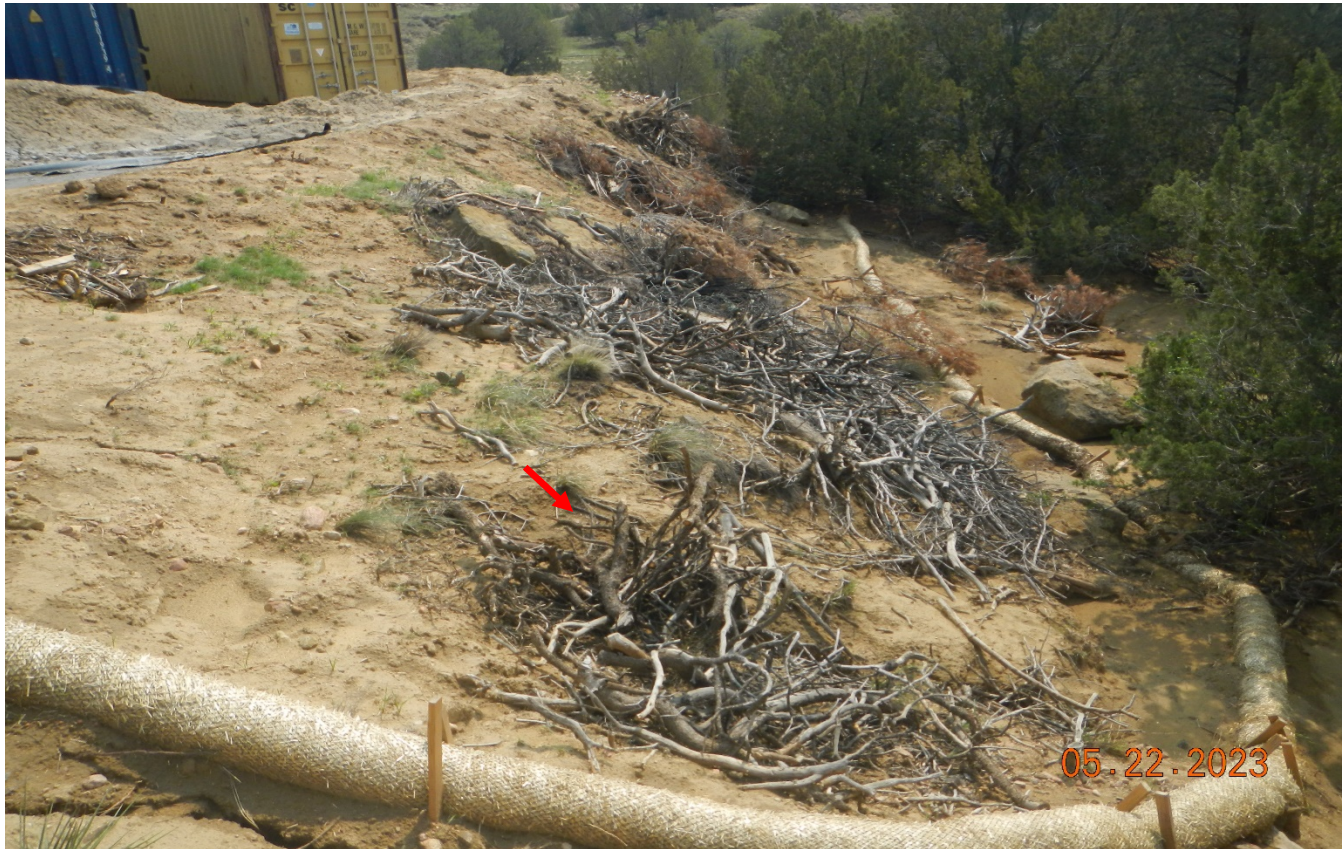
**Photo 16.** The wattles were repositioned since previous inspection but do not appear to be properly installed and have filled with sediment. The piles of wood debris along the fill slope need to be removed and the fill slope need to be seeded and stabilized.

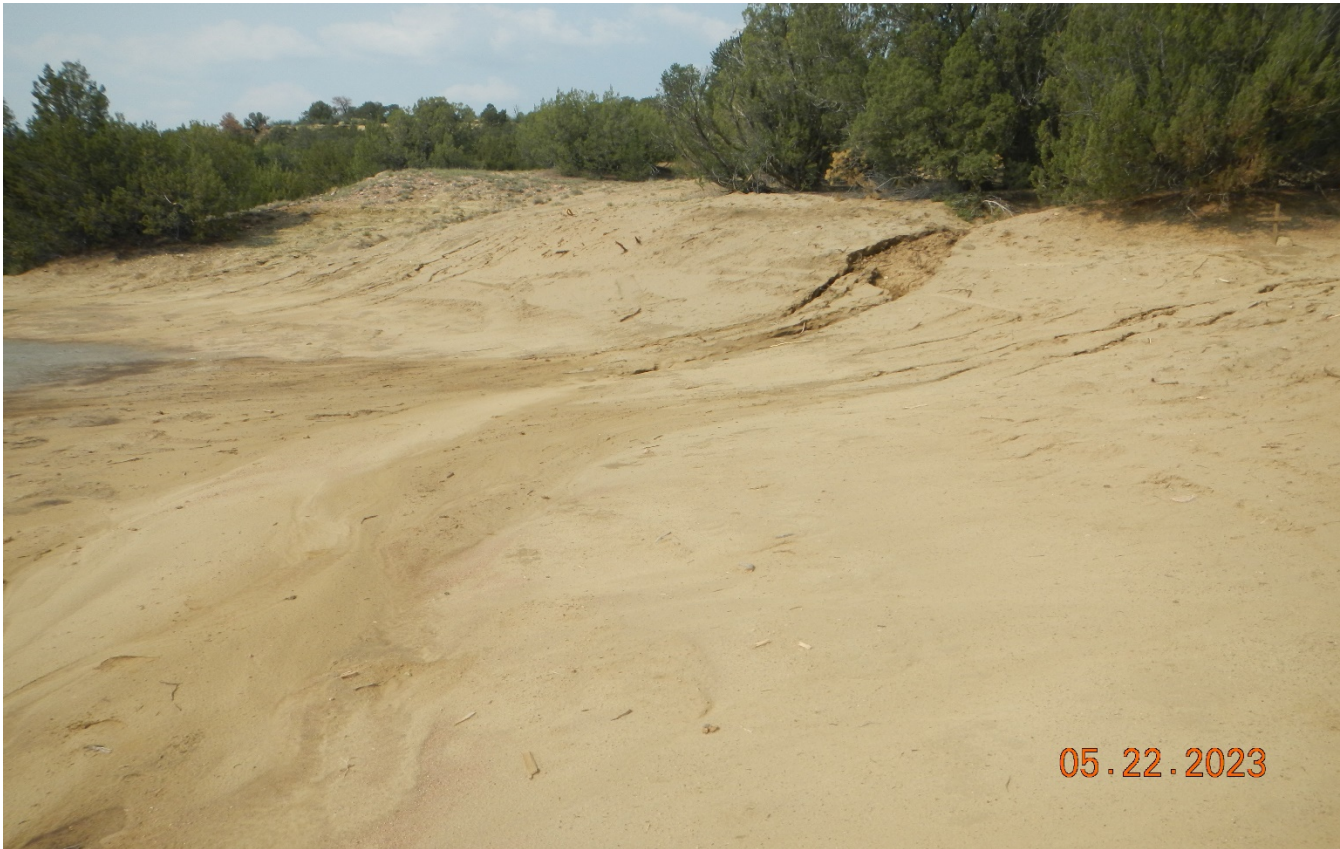
**Photo 18.** Facing southwest at the location. There are no stormwater run-on controls along the west side of the location. Recent storm event has caused erosion of the cut slope and stormwater was directed down the access road causing further erosion. Previous corrective action was not completed to install stormwater run-on controls.

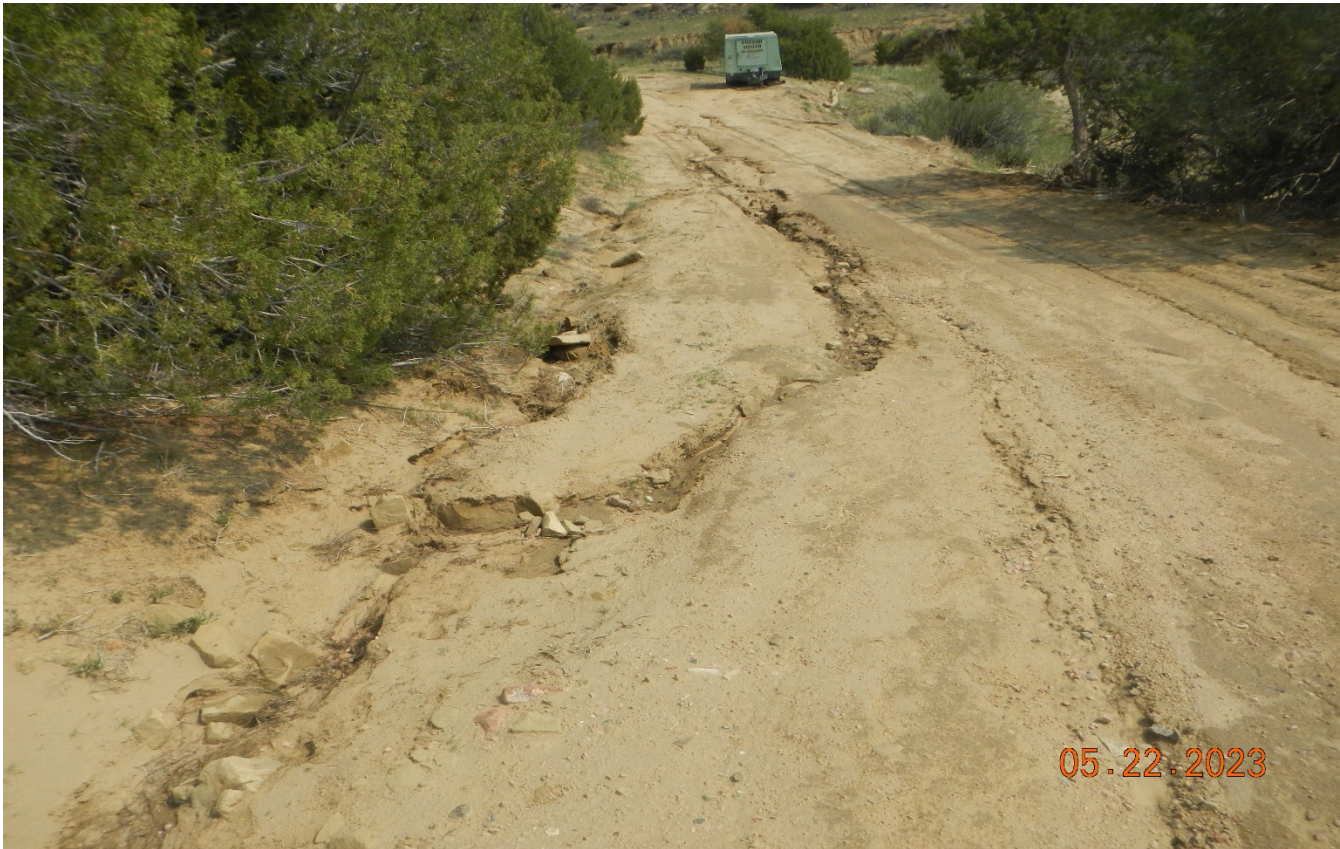
**Photo 19.** Facing back to the northeast toward the access road. Stormwater directed from the location shown in previous photo caused erosion of the access road which transported sediment off site.
