Inspection Photos

API: 043-40000

Operator: JAVERNICK OIL

Inspection Date: 5/22/2023

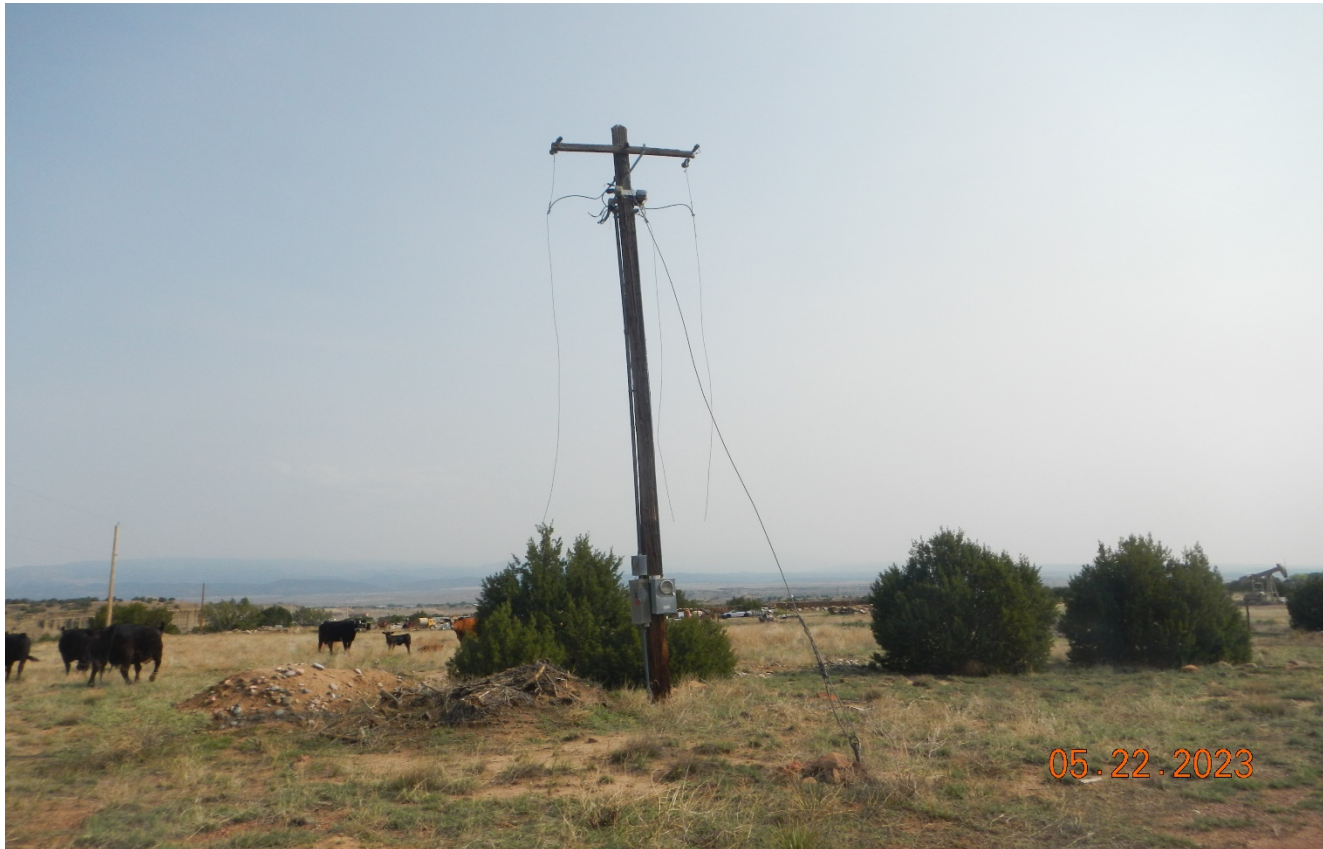
Photo 1. Facing east at the abandoned well site. There is an abandoned powerpole that remains which needs to be removed.

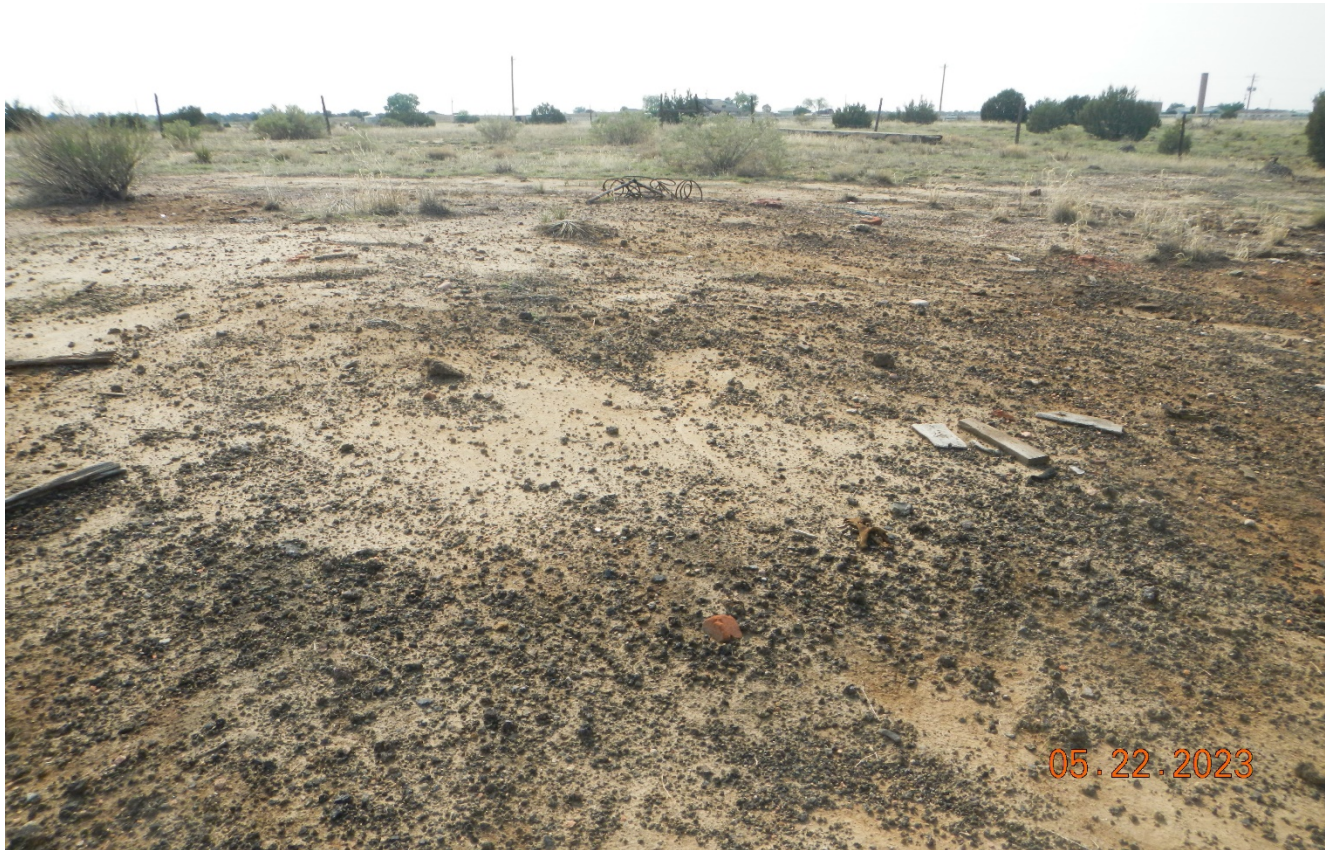
Photo 2. Facing east toward the location. There is gravelly soils and debris that remain and the location is not reclaimed. There is no vegetation growth in this area of the location.

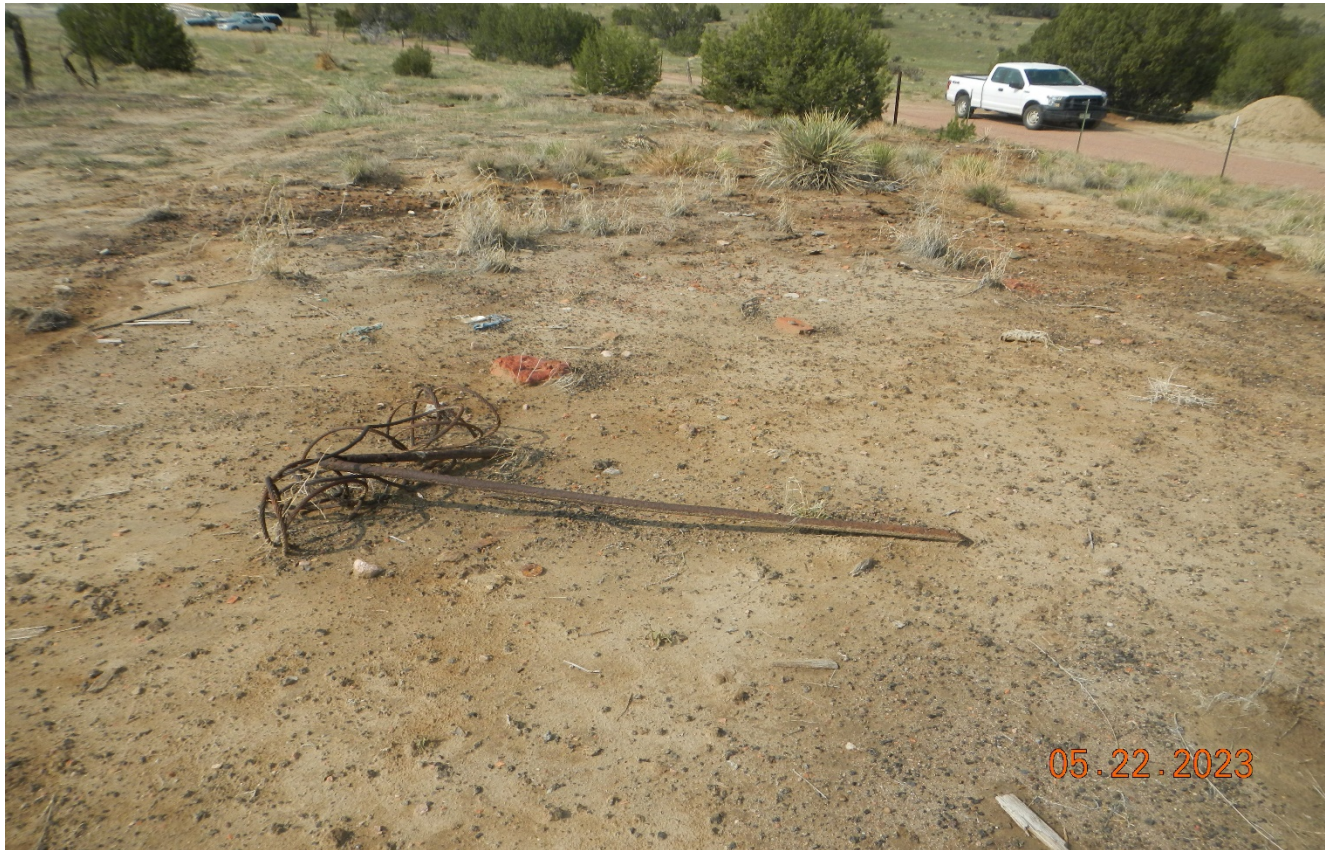
Photo 3. There is cable and various debris that remains.

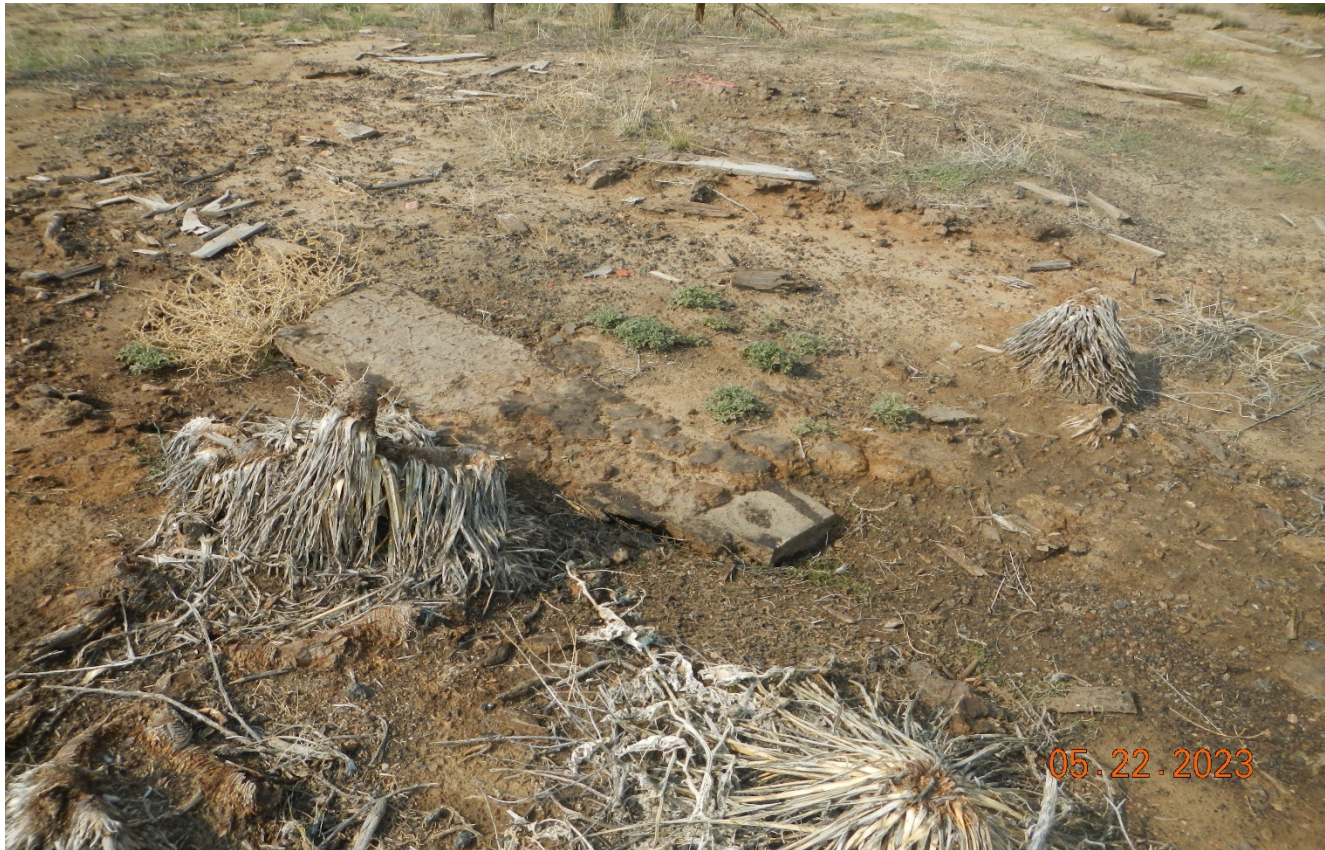
Photo 4. Facing north toward the location. There wood plank debris and oily soils that were never cleaned up.

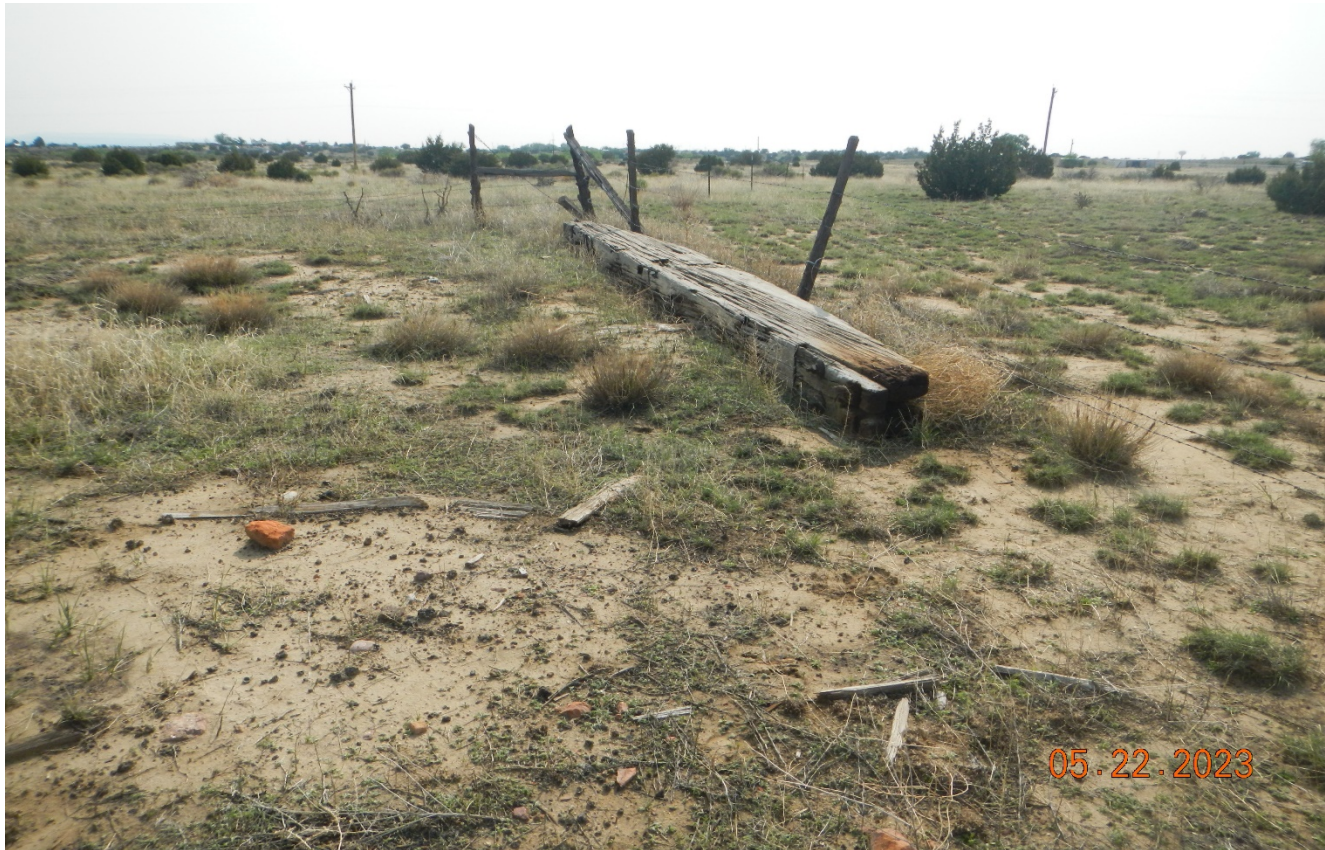
Photo 5. There is a bridge timber used for the pumpjack base that needs to be removed.

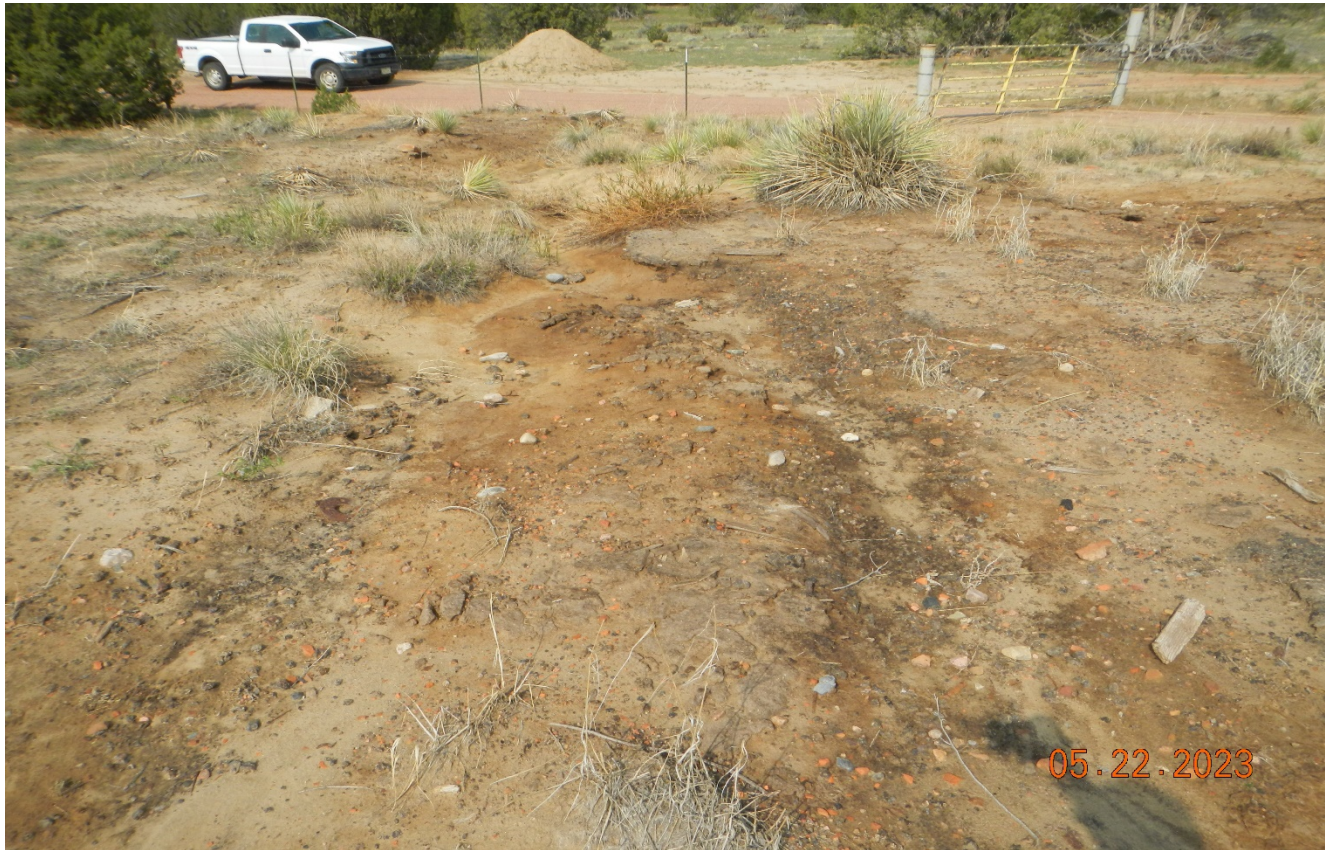
Photo 6. There are signs of erosion and soils are not stabilized.

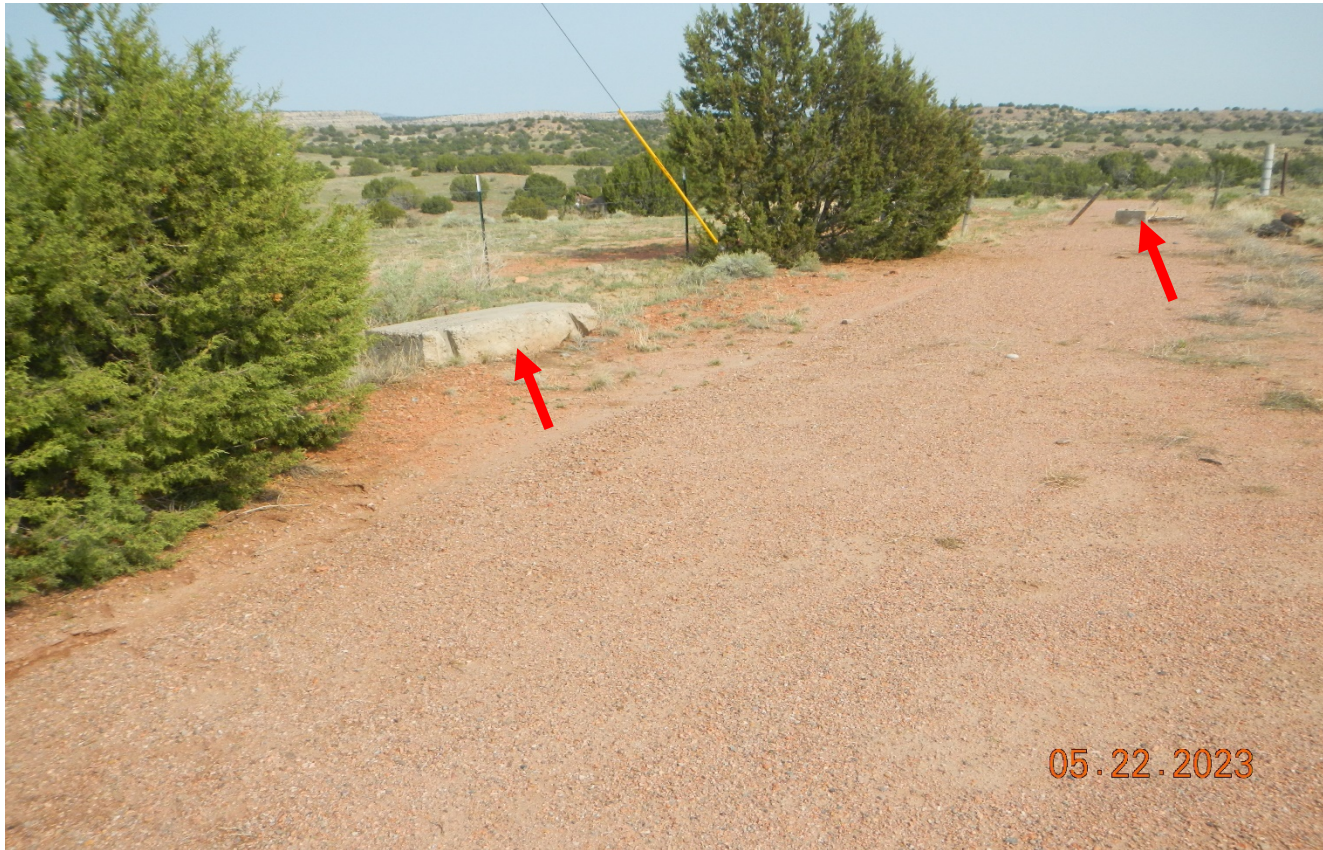
Photo 7. There are cement blocks that remain which need to be removed.
