Interim Reclamation and Stormwater Inspection

Operator: VERDAD RESOURCES LLC - 10651

Location ID: 456879

Inspection Document #: 708200267

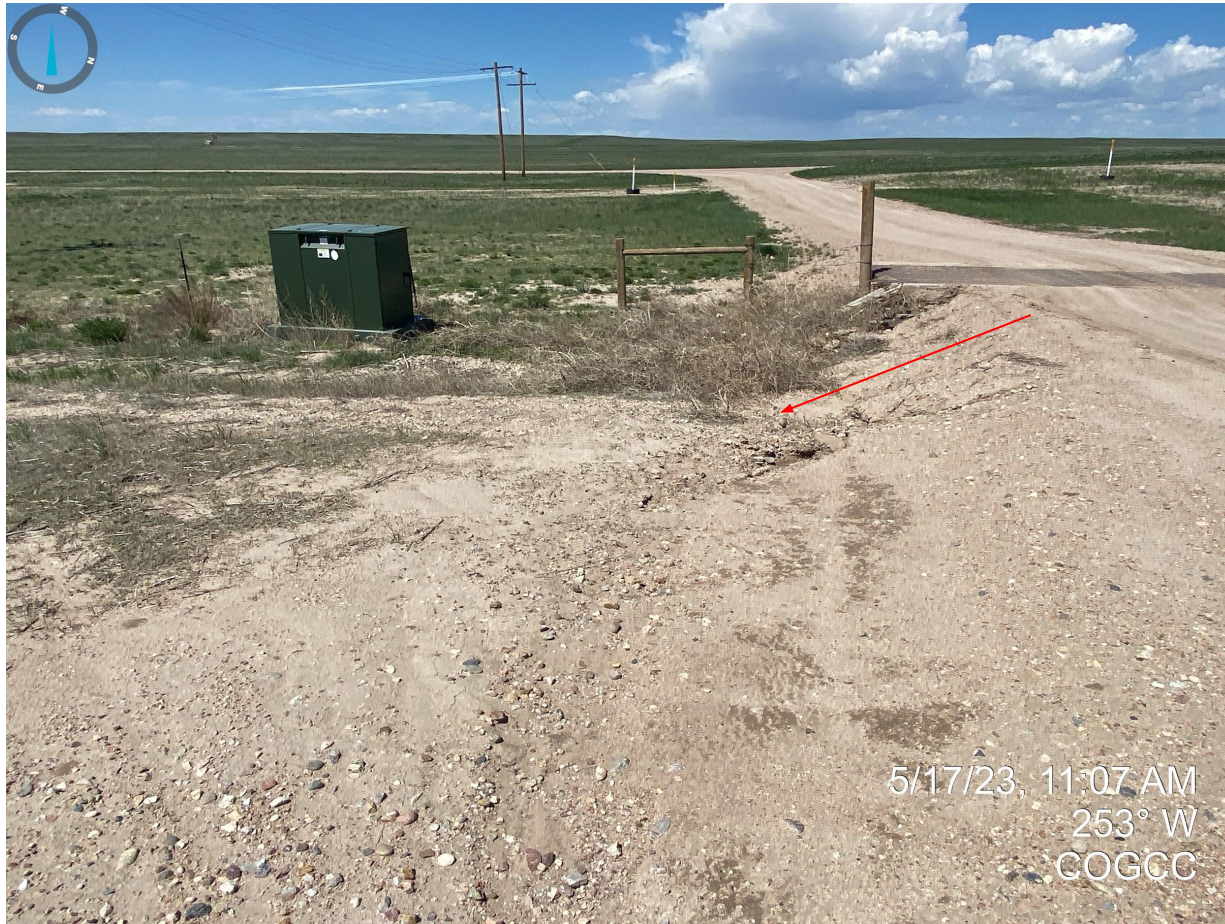
Photo 1. Taken near the entrance. Photo illustrates that the production areas don't appear to be stabilized with evidence of rill erosion occurring.

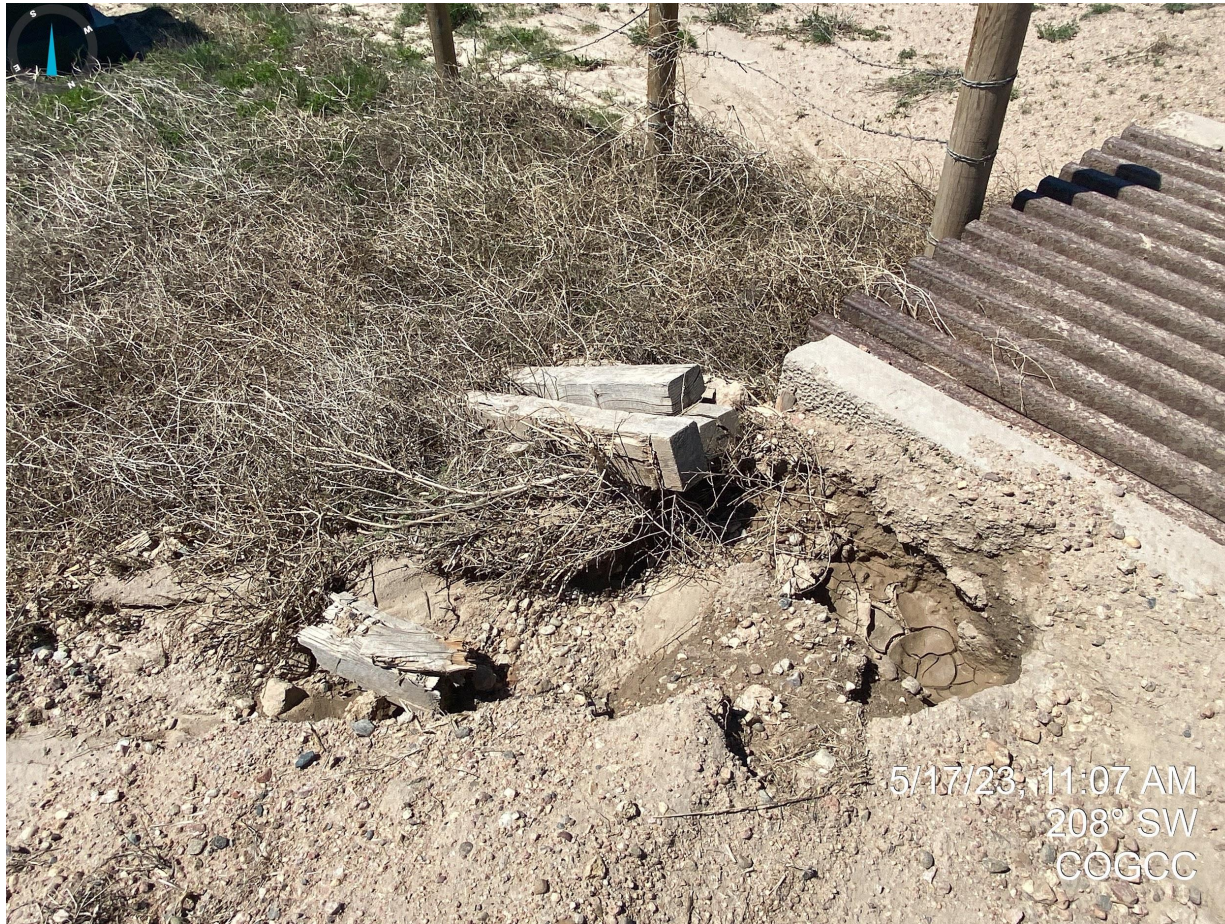
Photo 2. Area around cattle guard has gully erosion and appeared to be under cutting the concrete stem walls.

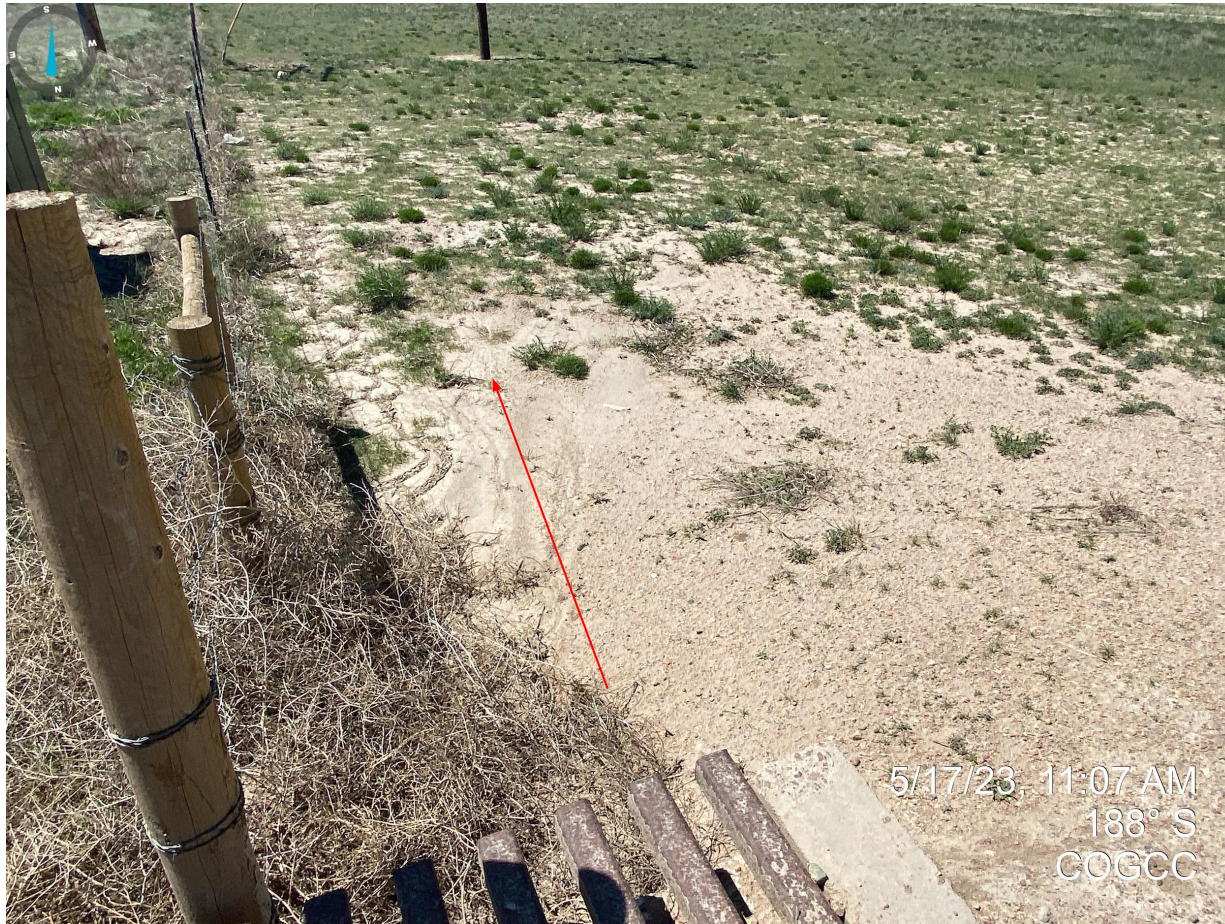
Photo 3. Evidence of sediment deposition from around the cattle guard area

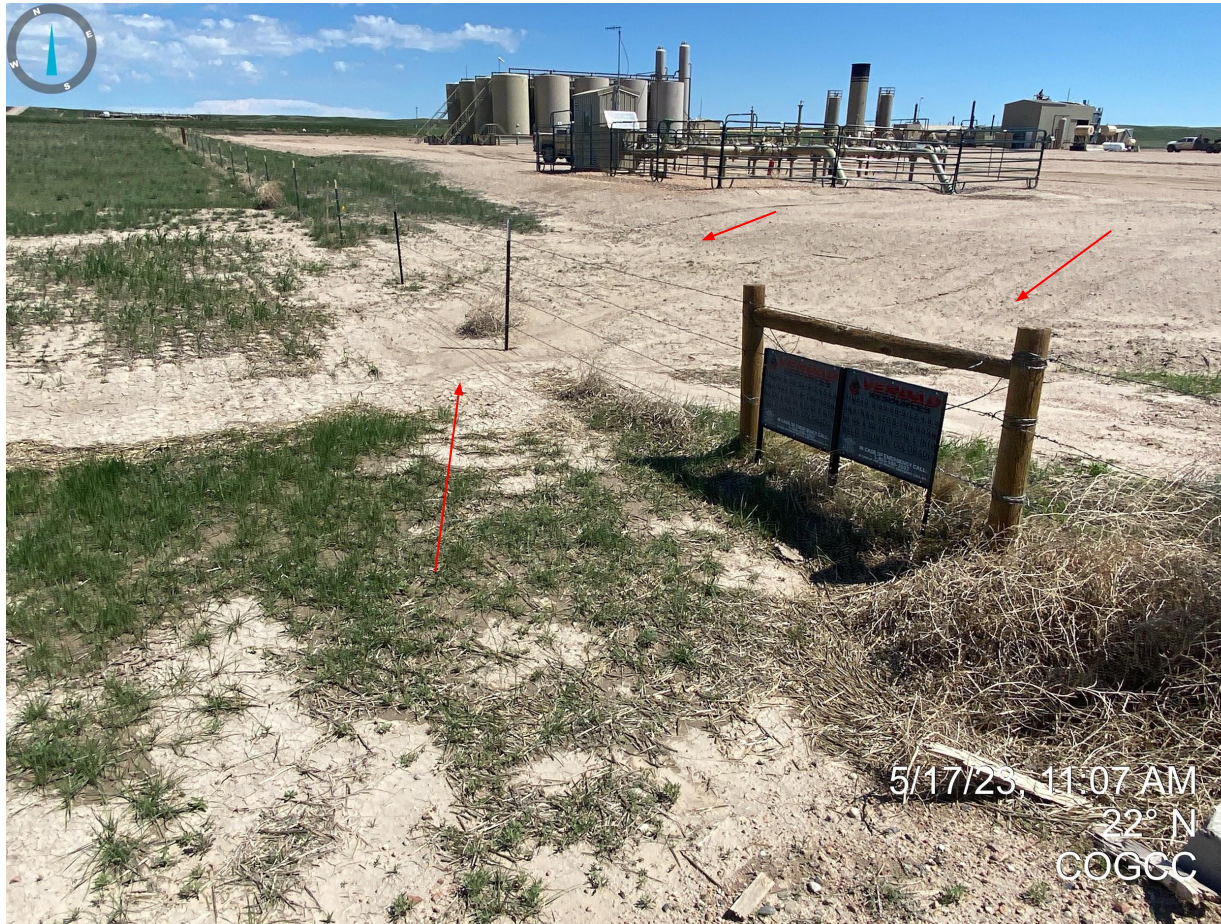
Photo 4. Rill erosion pictured on the production areas and evidence of sediment transport outside of the fenced area. Additional BMPs should be implemented to manage sediment deposition from the location.

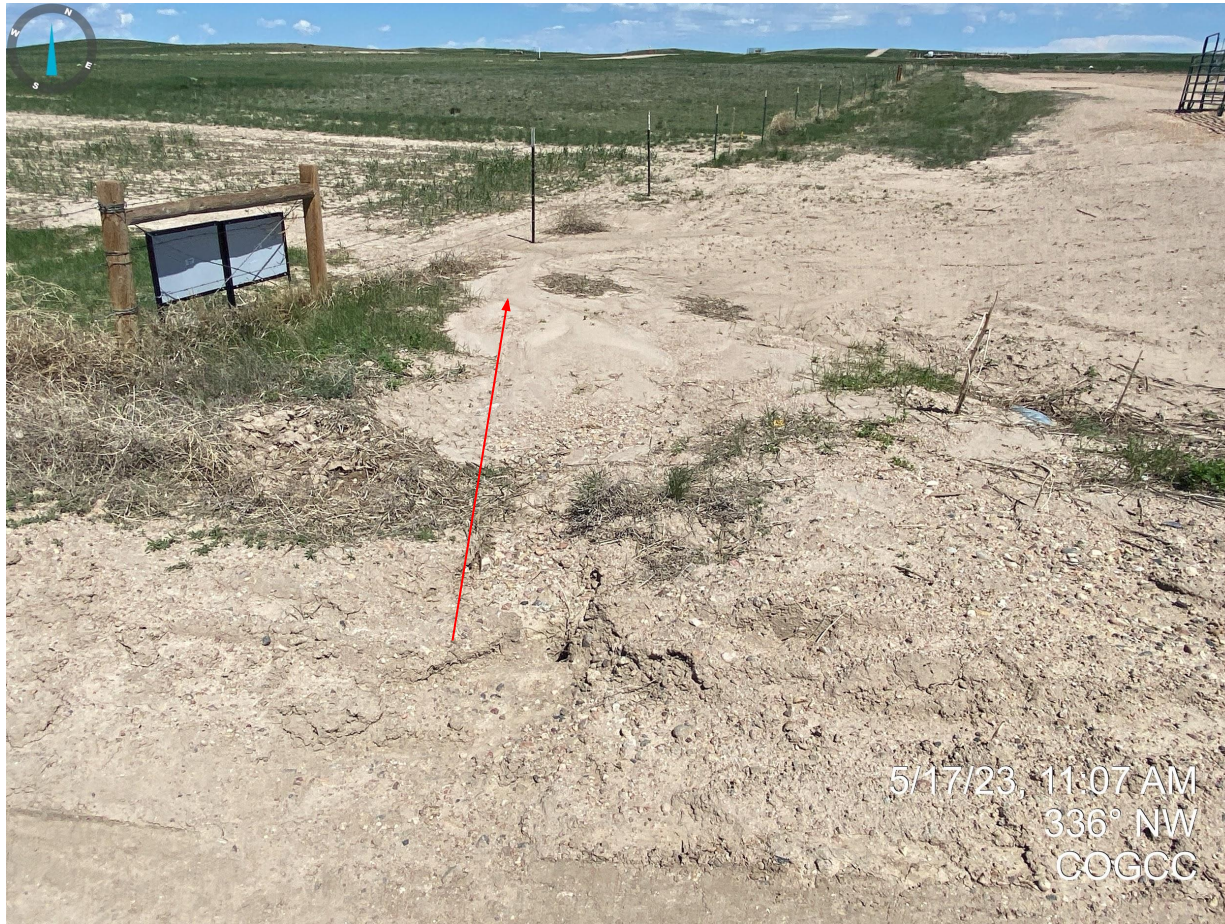
Photo 5. Rill erosion and sediment deposition.

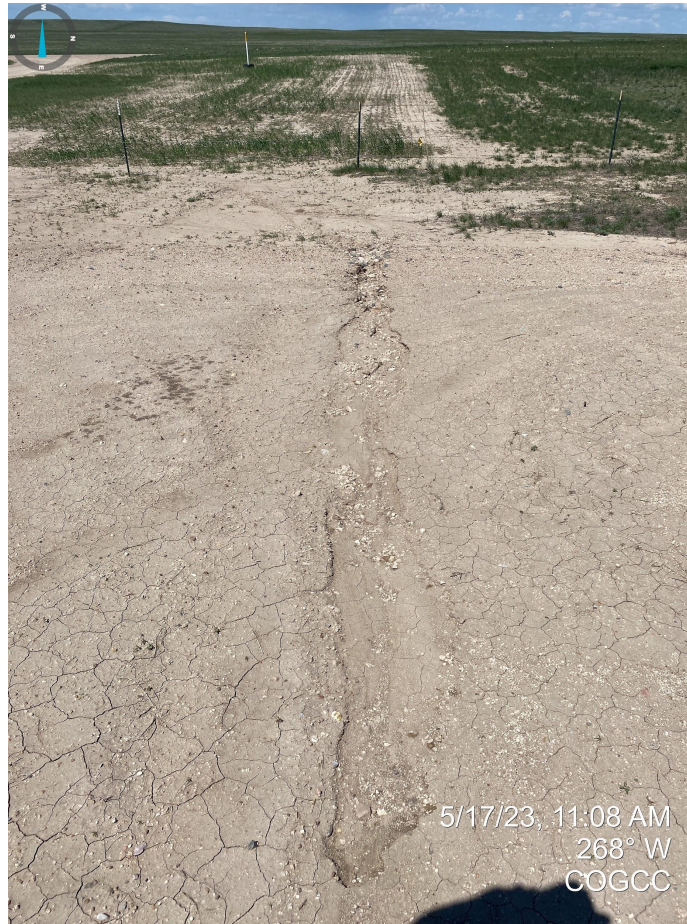
Photo 6. Rill erosion occurring on banks; no BMPs identified in this area to prevent sediment laden stormwater from exiting off location.

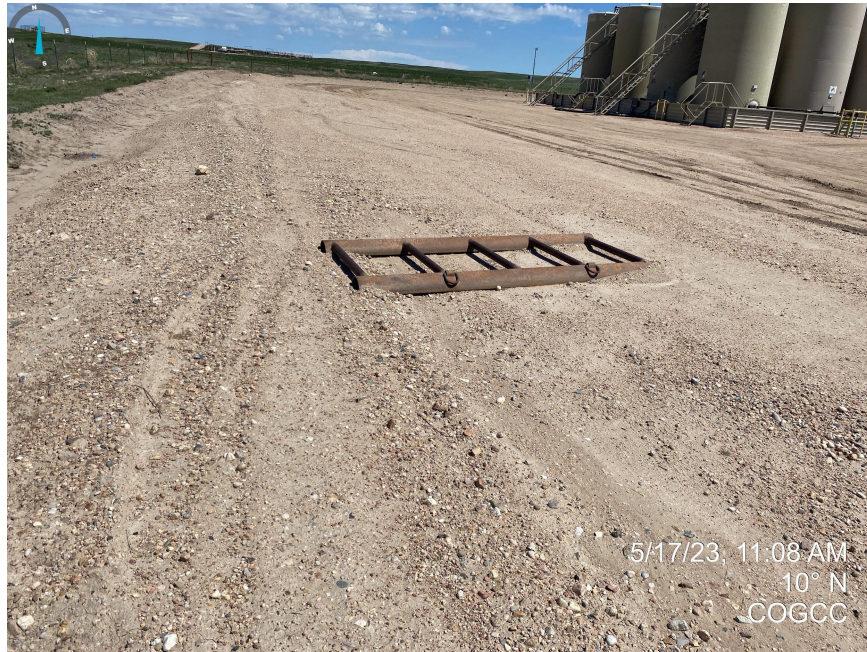
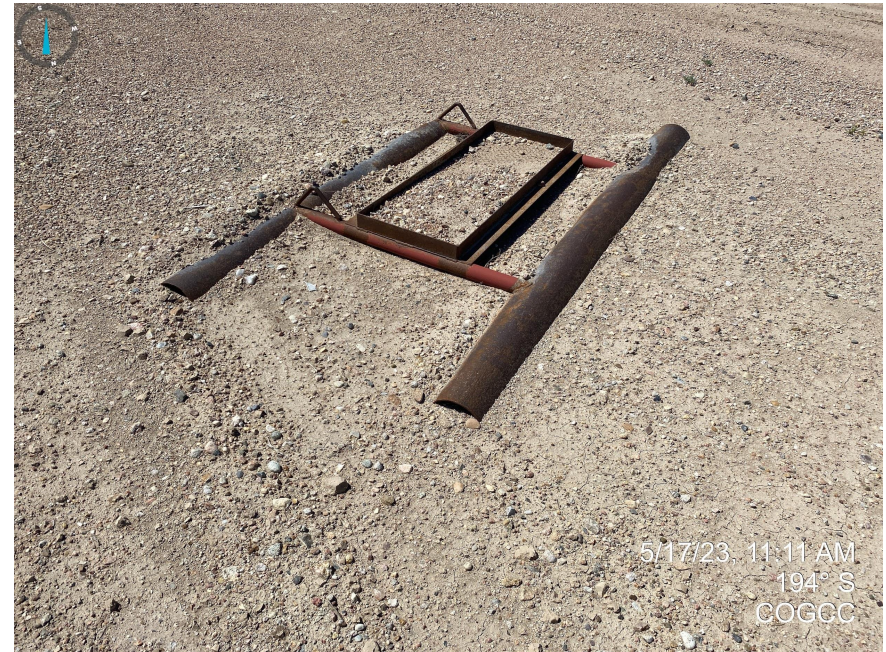
Photos 7 & 8 . Storage of equipment, supplies, etc on location is prohibited.

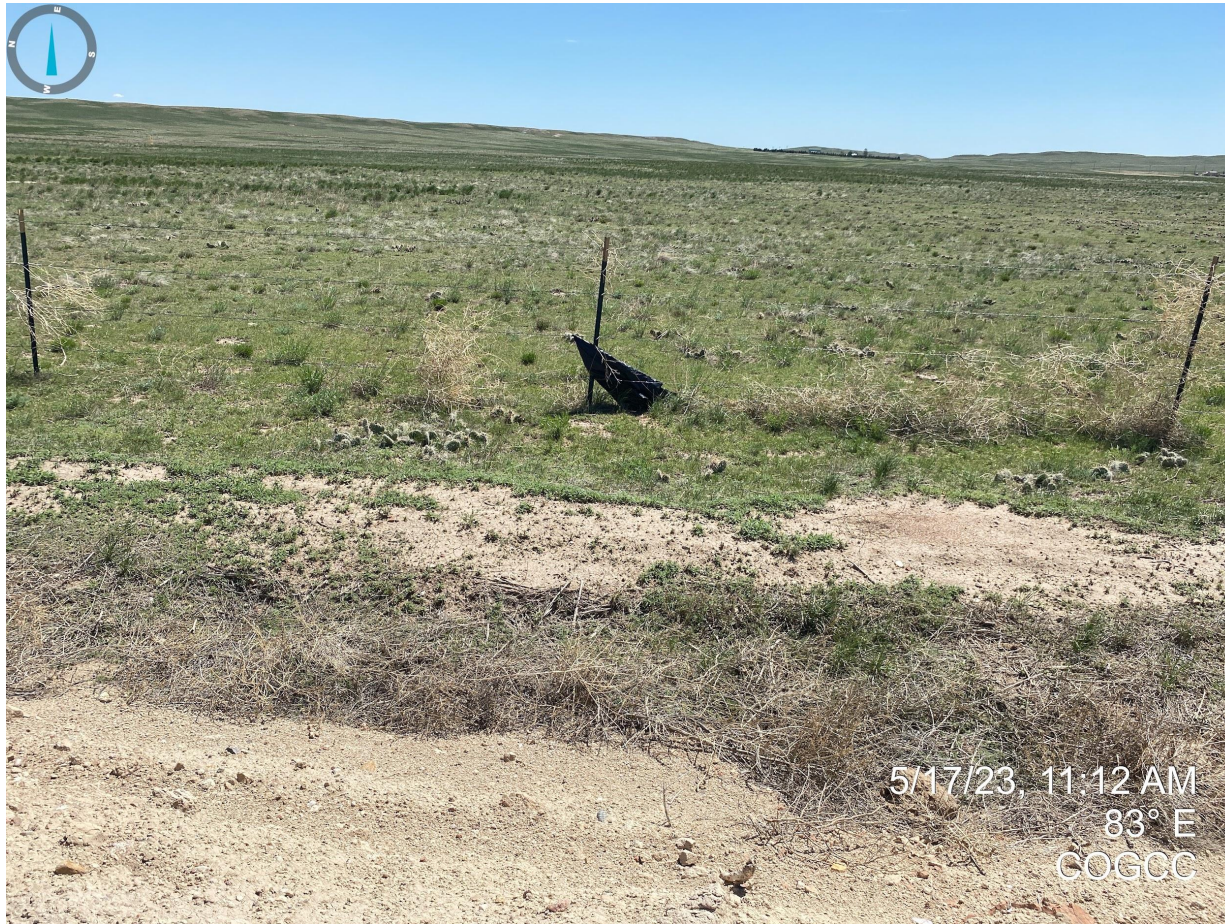
Photo 9. Debris/trash observed on location will need to be picked up and disposed of.

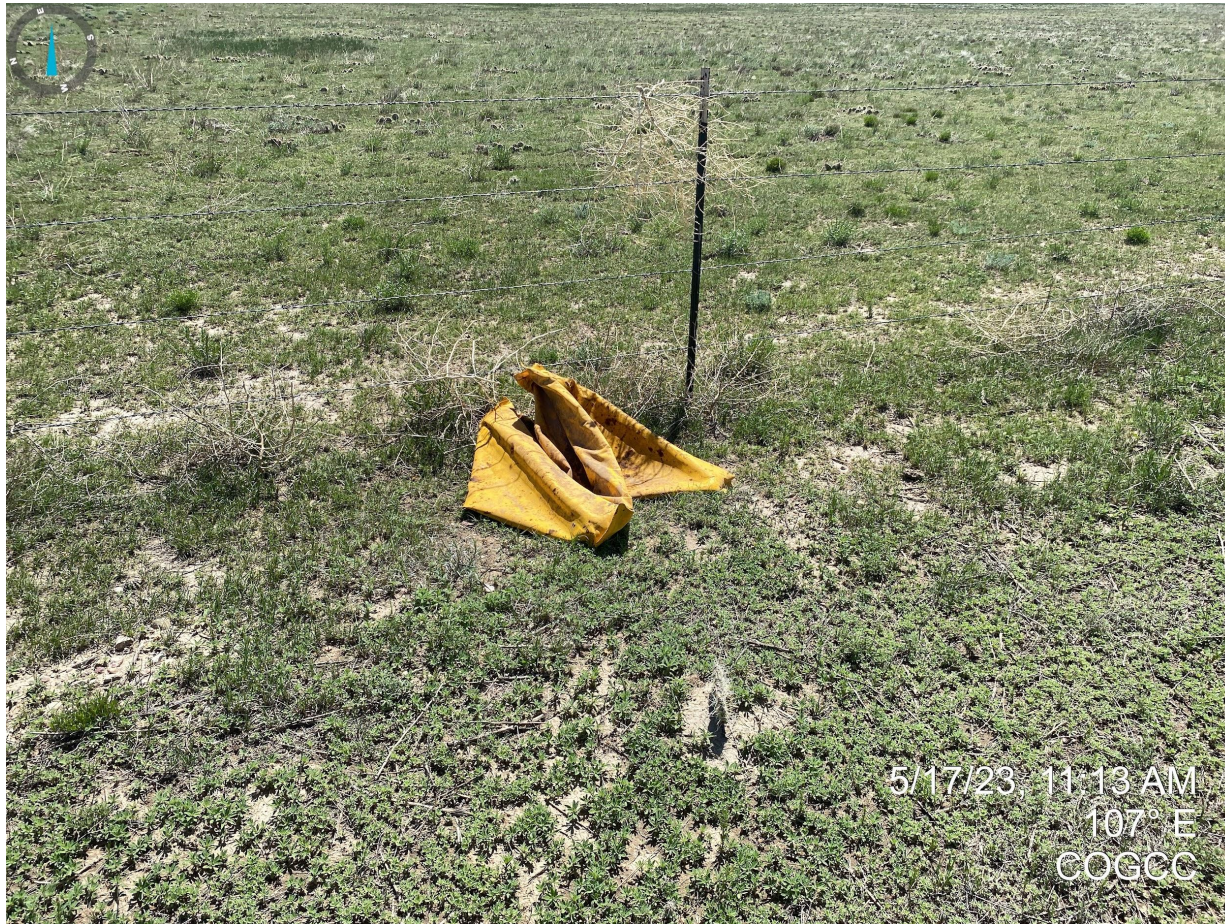
Photo 10. See comments in Photo 9.

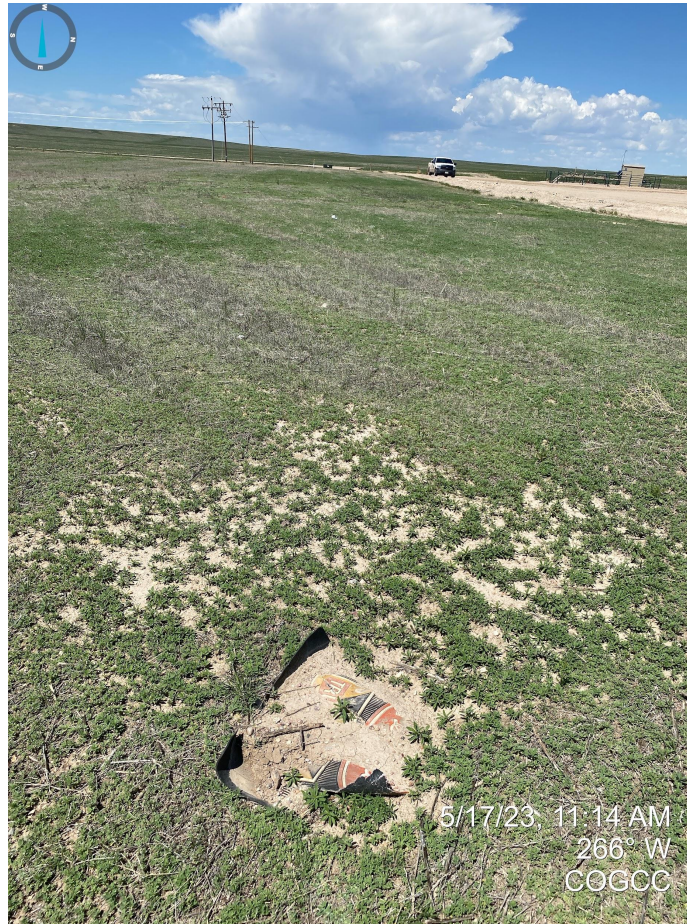
Photo 11. See comments in Photo 9.

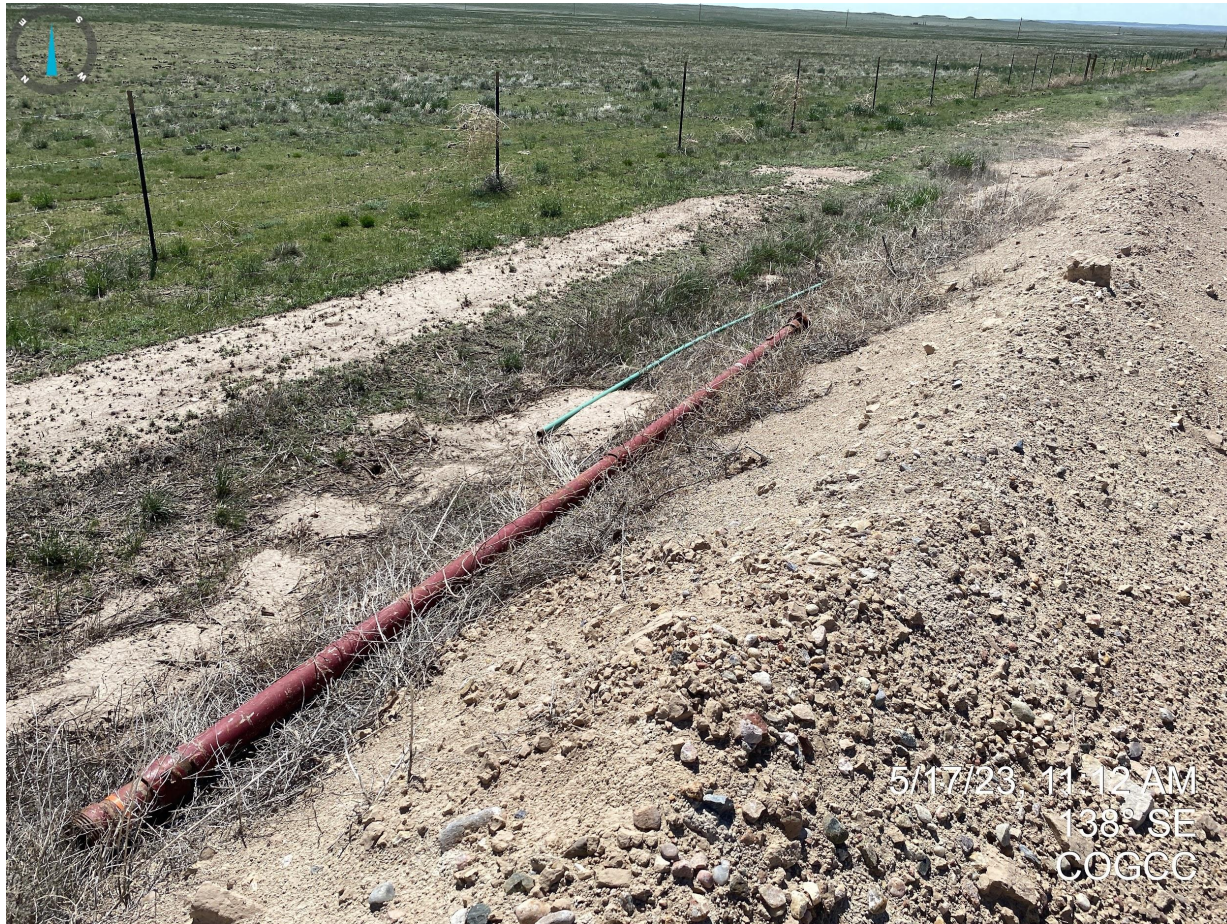
Photo 12. Unused equipment observed in the stormwater ditch.

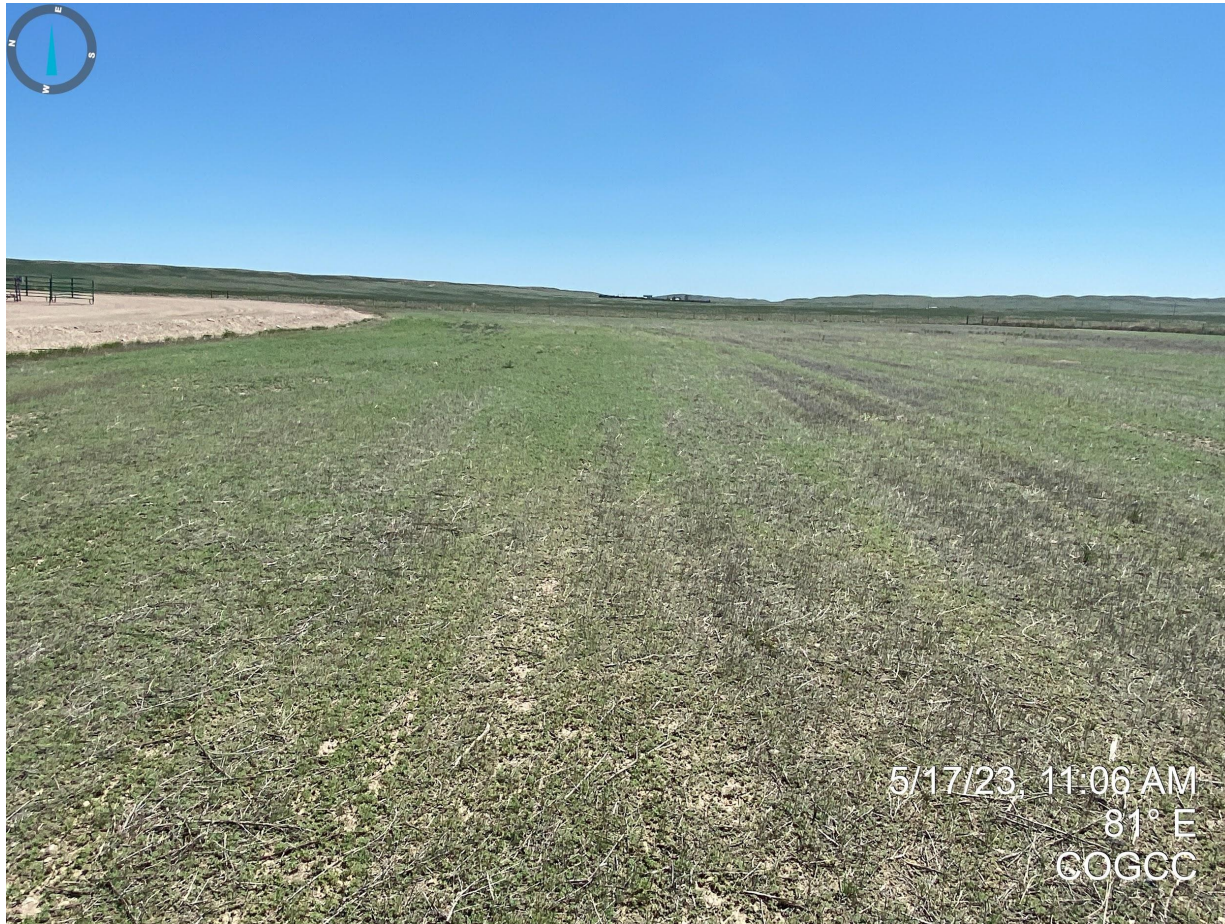
Photo 13. Interim reclamation areas are predominantly undesirable vegetation (e.g. kochia).

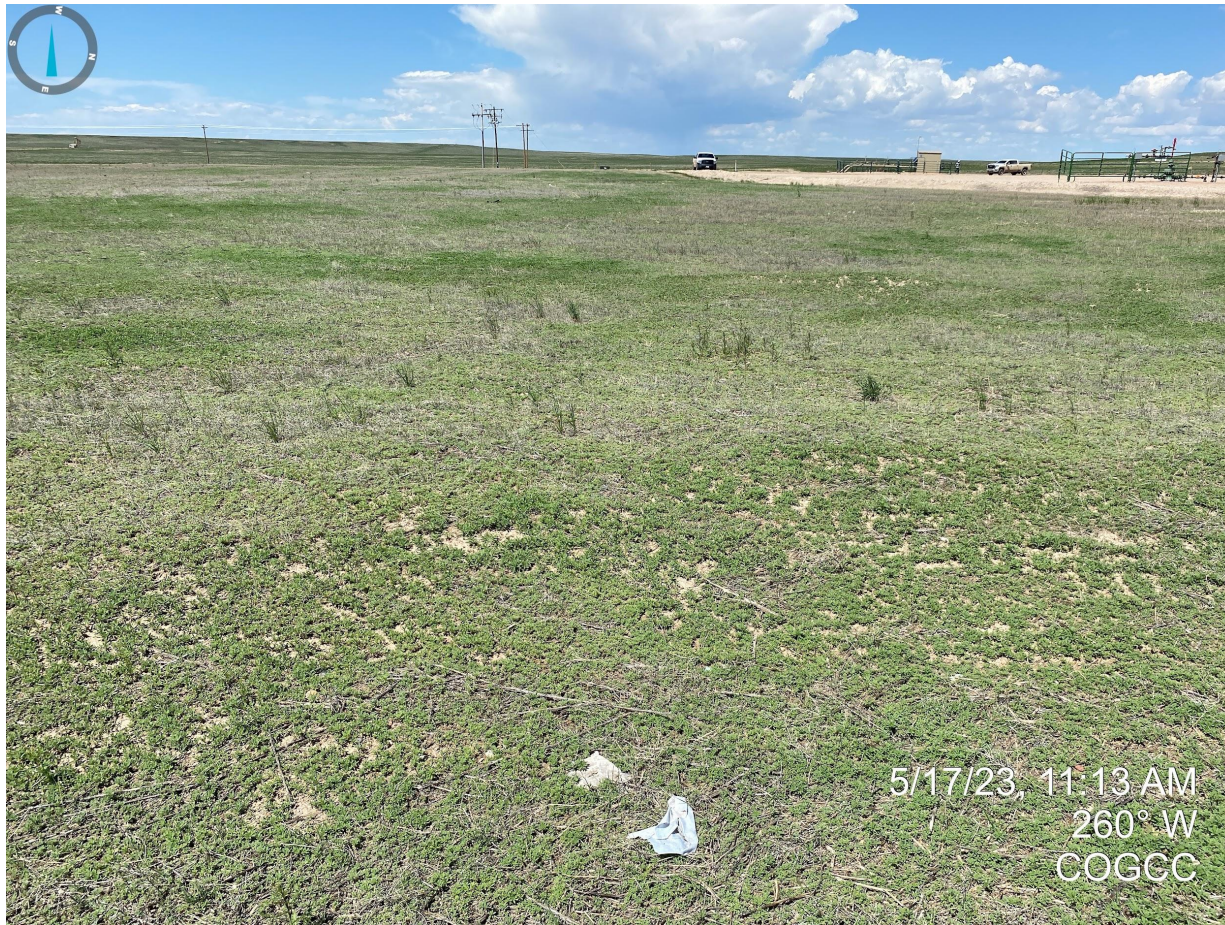
Photo 14. See comments in Photo 13.
