Inspection Photos

Location Name: TEP ROCKY MOUNTAIN LLC MDP 2 Pad

Location ID: 414794

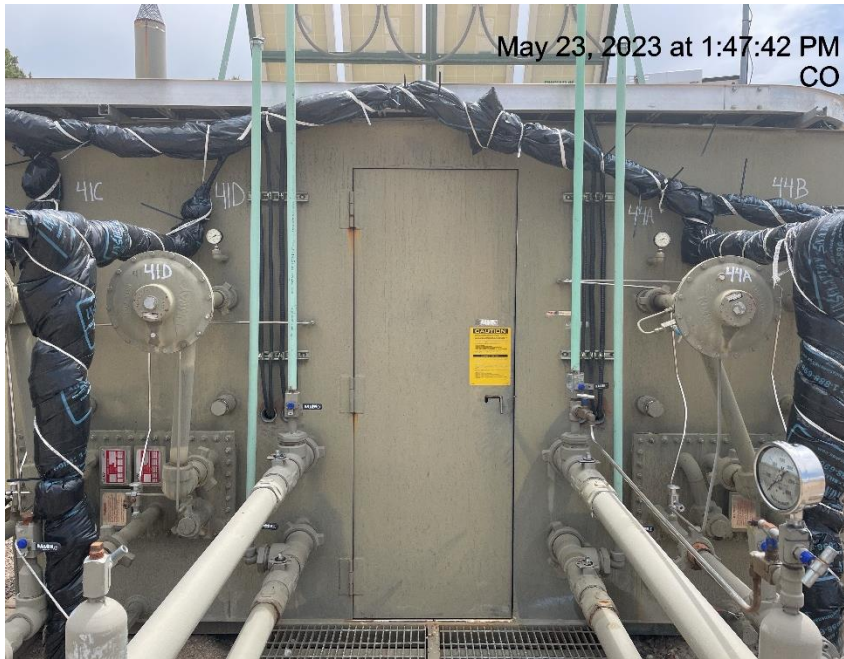
Photo # 8471 Meter calibration info not conspicuously posted

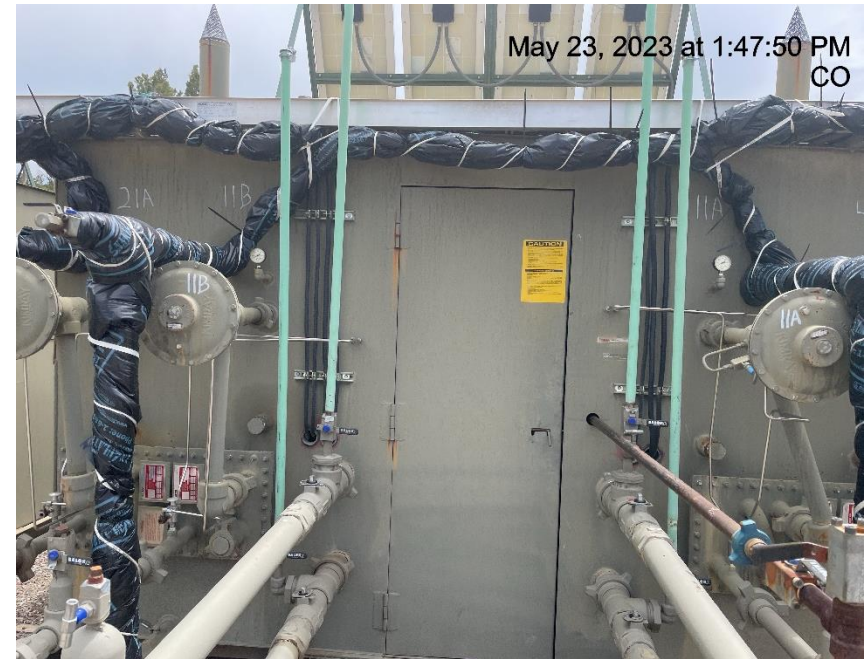
Photo # 8472 Meter calibration info not conspicuously posted

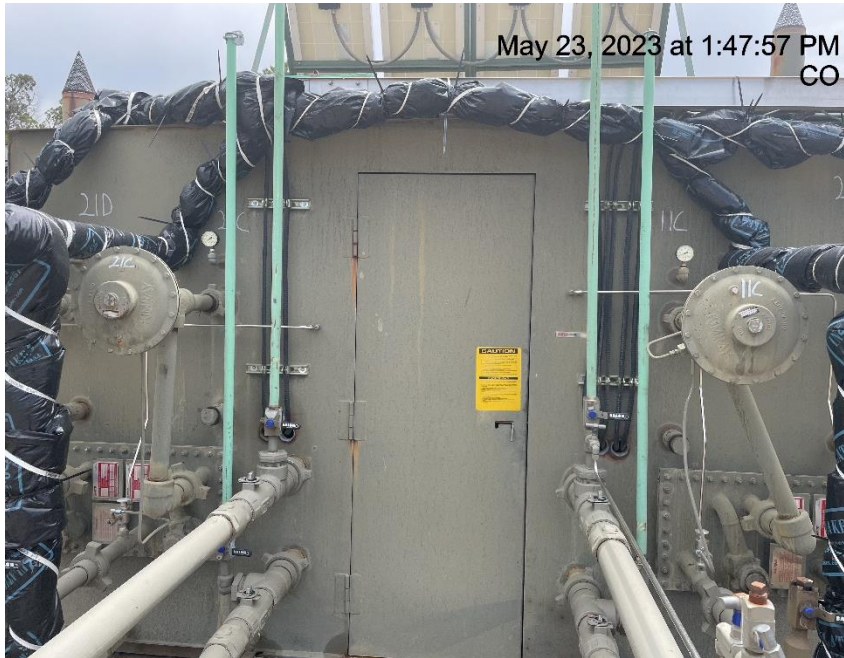
Photo # 8473 Meter calibration info not conspicuously posted

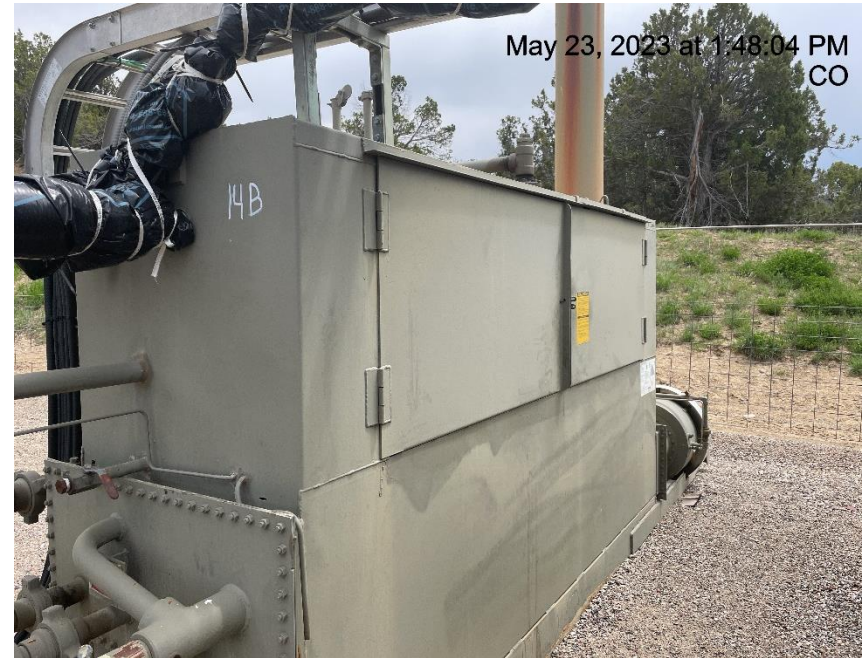
Photo # 8474 Meter calibration info not conspicuously posted

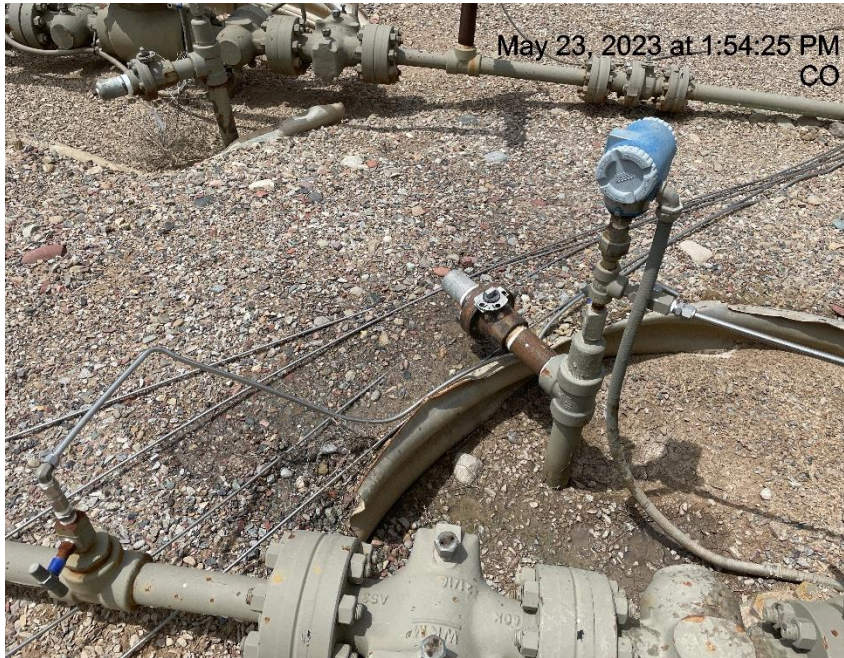
Photo # 8481 Valve on bradenhead leaking fluid onto ground

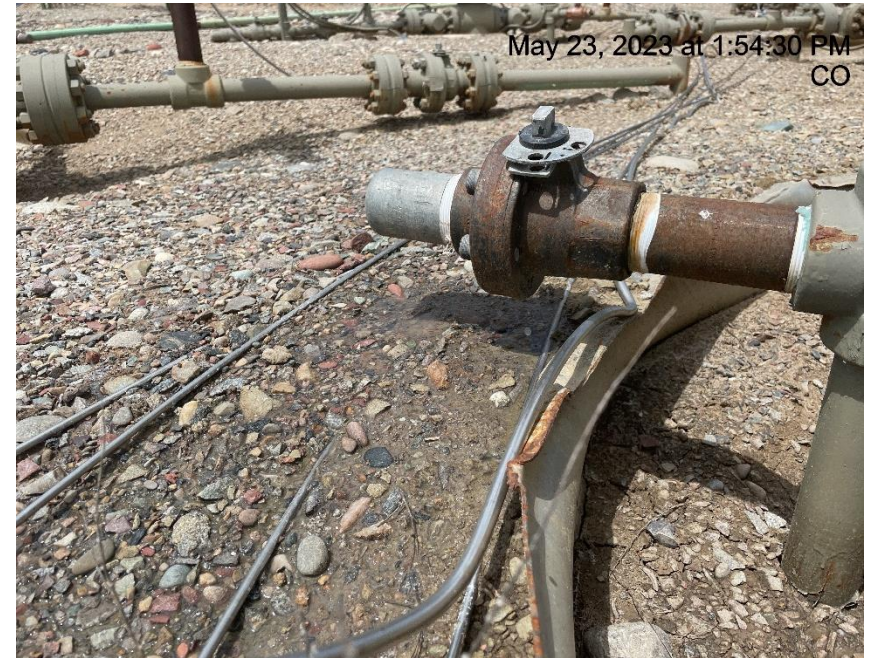
Photo # 8483 Valve on bradenhead leaking fluid onto ground

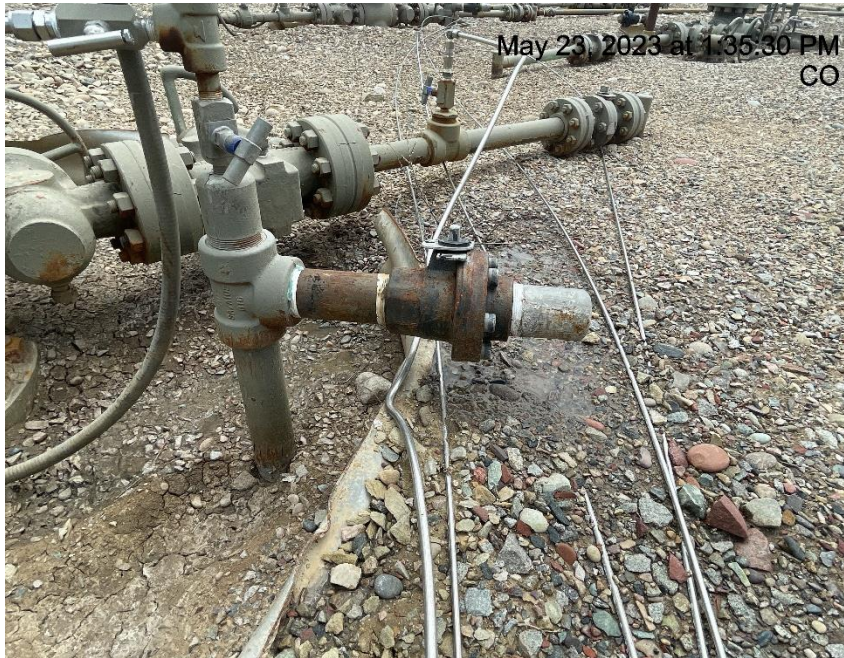
Photo # 8433 Valve on bradenhead leaking fluid onto ground

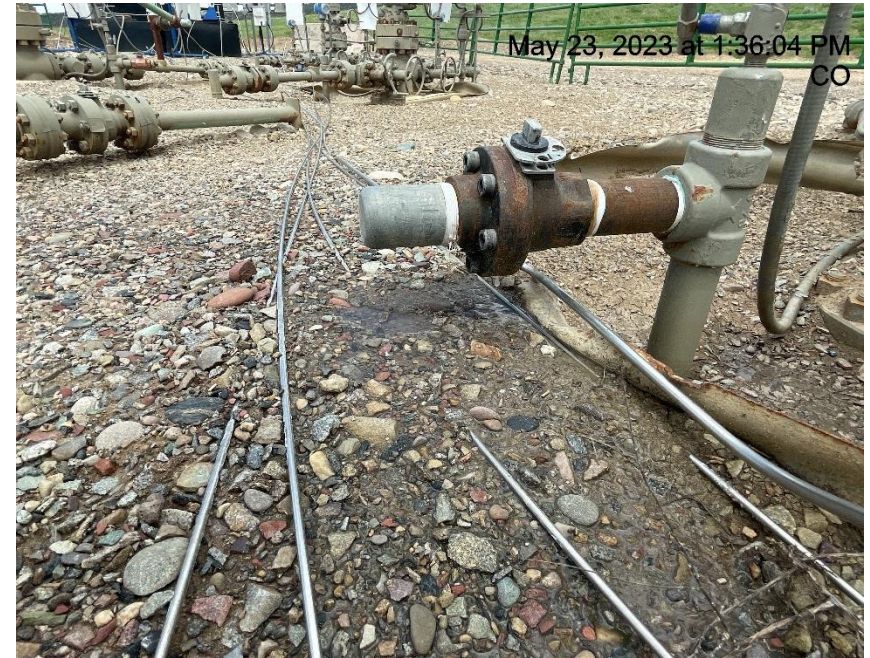
Photo # 8436 Valve on bradenhead leaking fluid onto ground

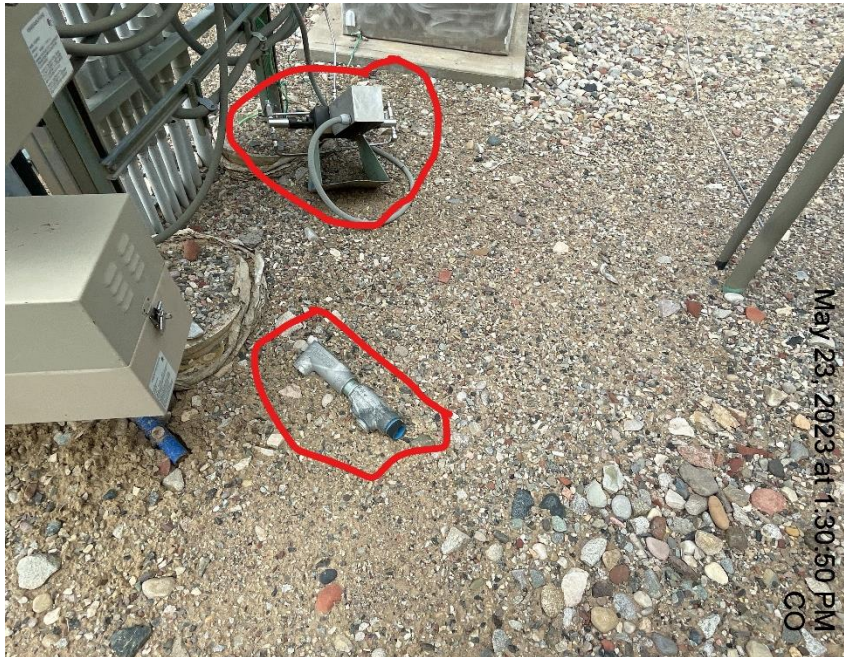
Photo # 8426 Unused equipment

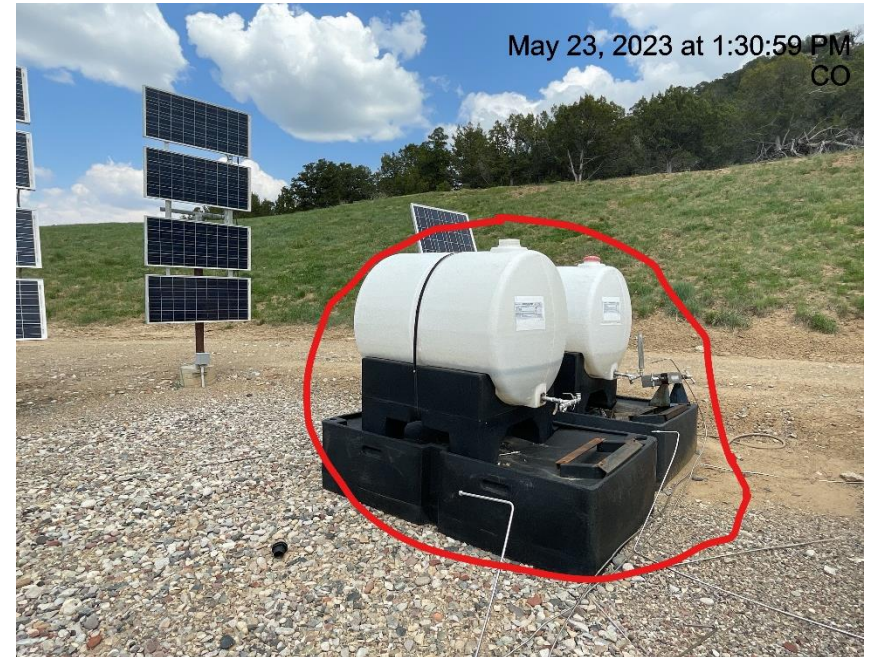
Photo # 8427 Unused equipment

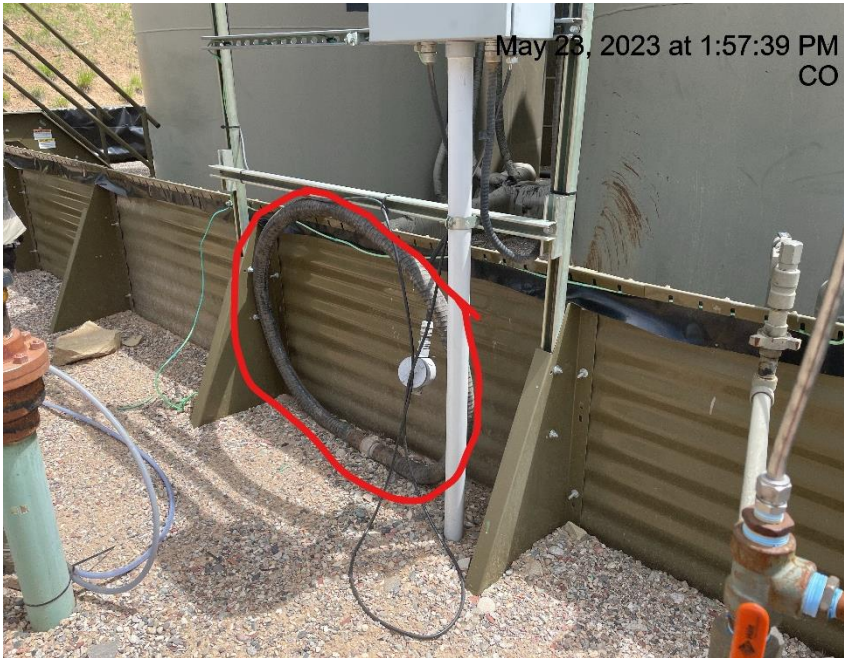
Photo # 8490 Unused equipment

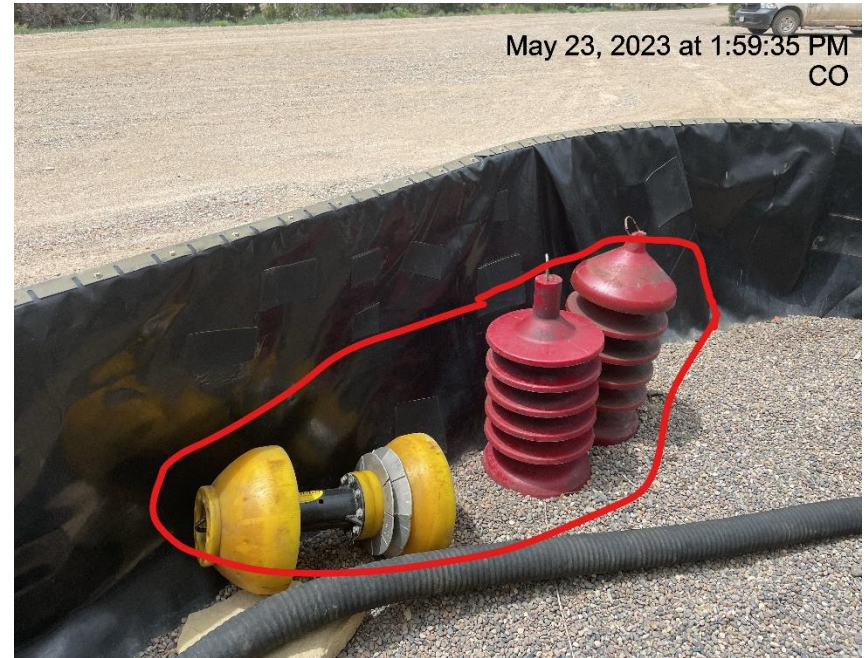
Photo # 8495 Unused equipment

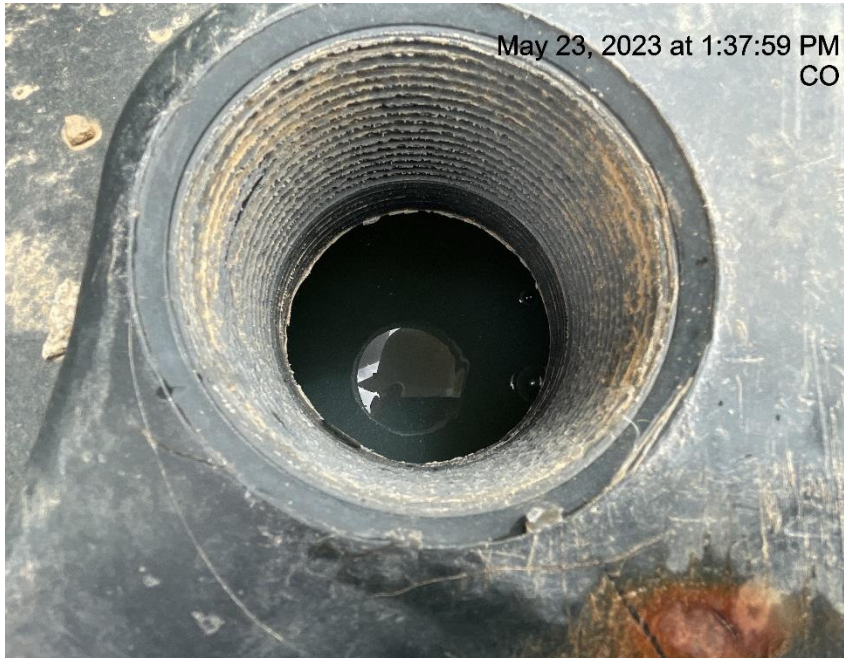
Photo # 8442 Chemical tank containment 1 full of fluid/failure to maintain chemical BMP's

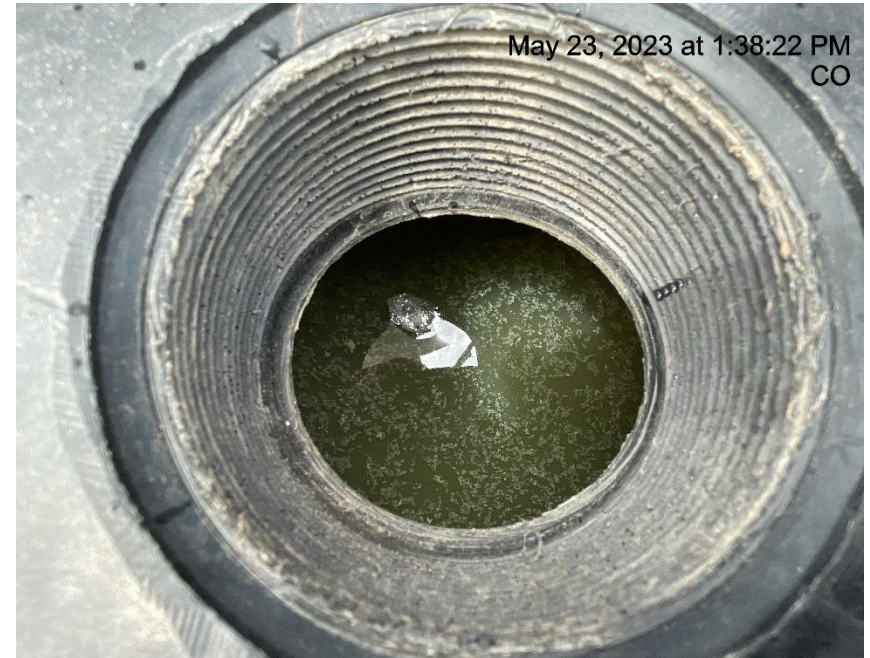
Photo # 8447 Chemical tank containment 2 full of fluid/failure to maintain chemical BMP's

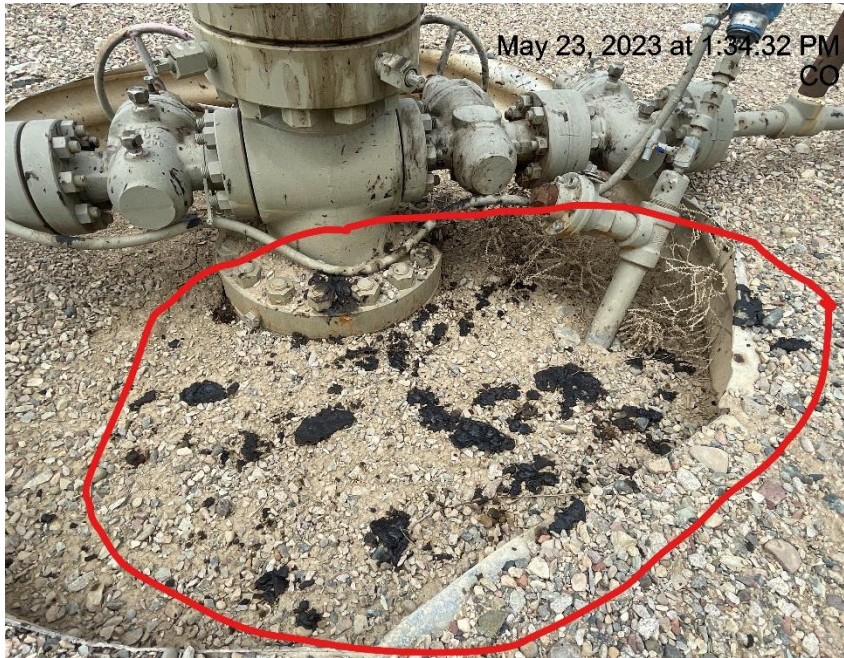
Photo # 8430 Stained soils & gravel

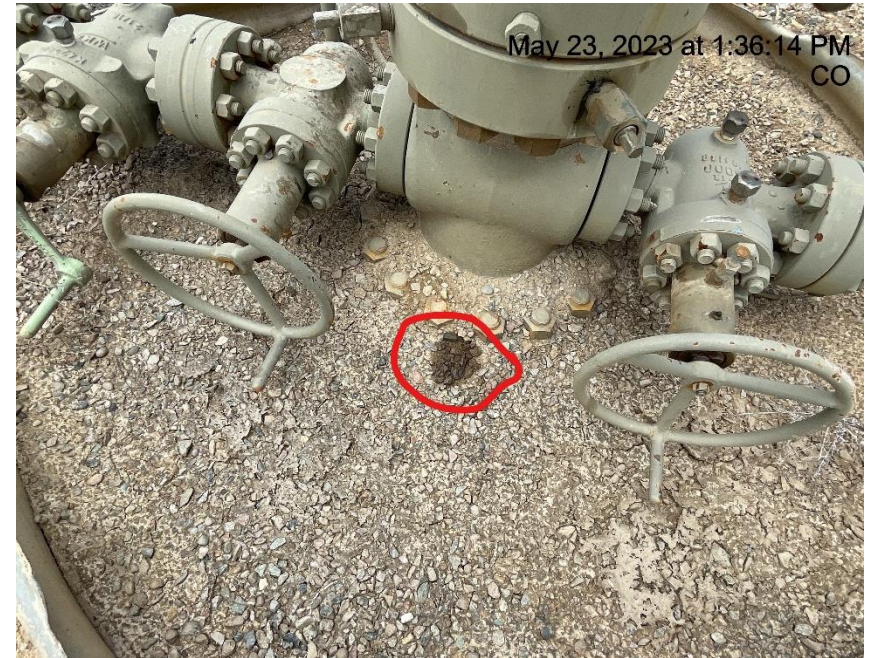
Photo # 8437 Stained soils & gravel

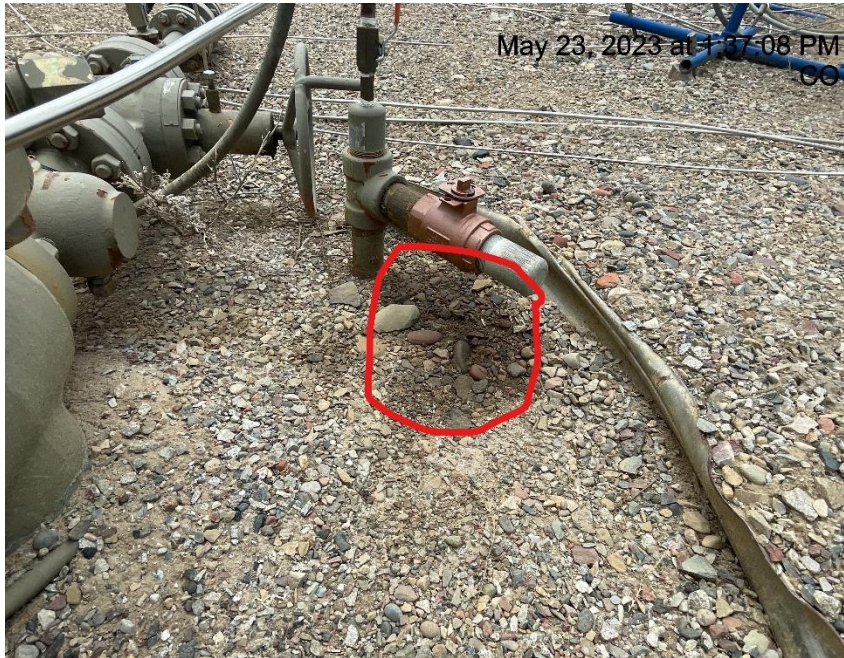
Photo # 8439 Stained soils & gravel

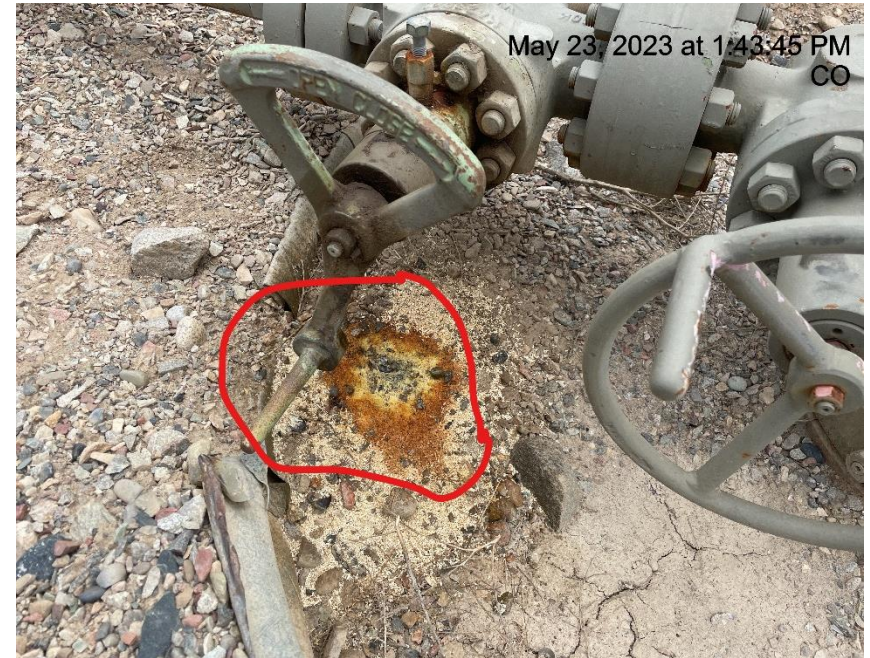
Photo # 8465 Stained soils & gravel

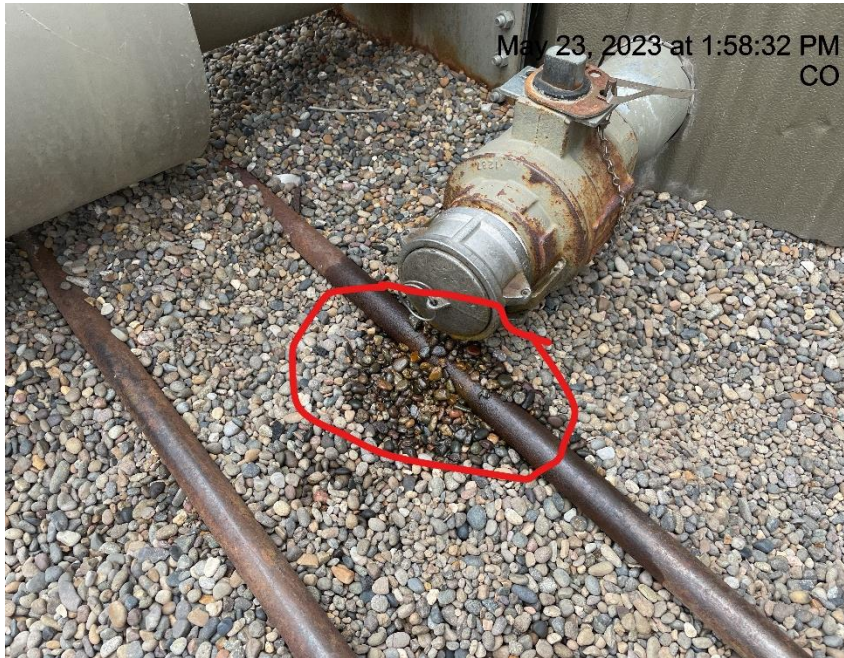
Photo # 8491 Stained gravel

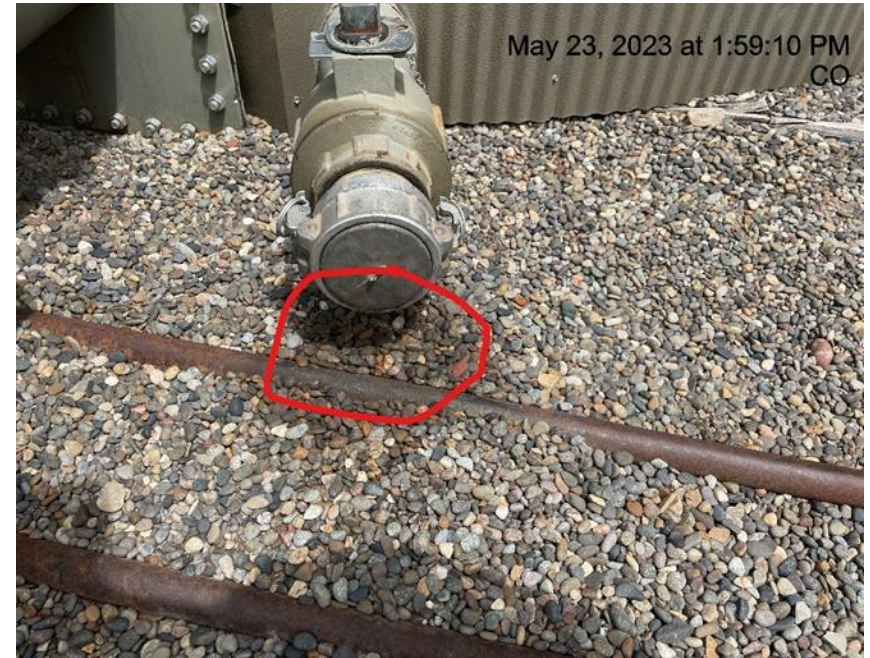
Photo # 8492 Stained gravel

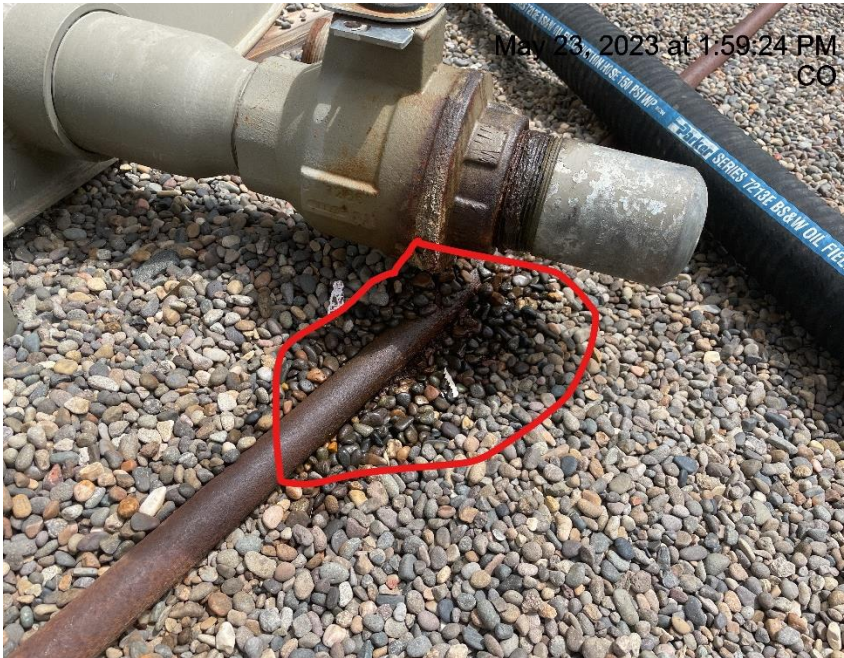
Photo # 8493 Stained gravel

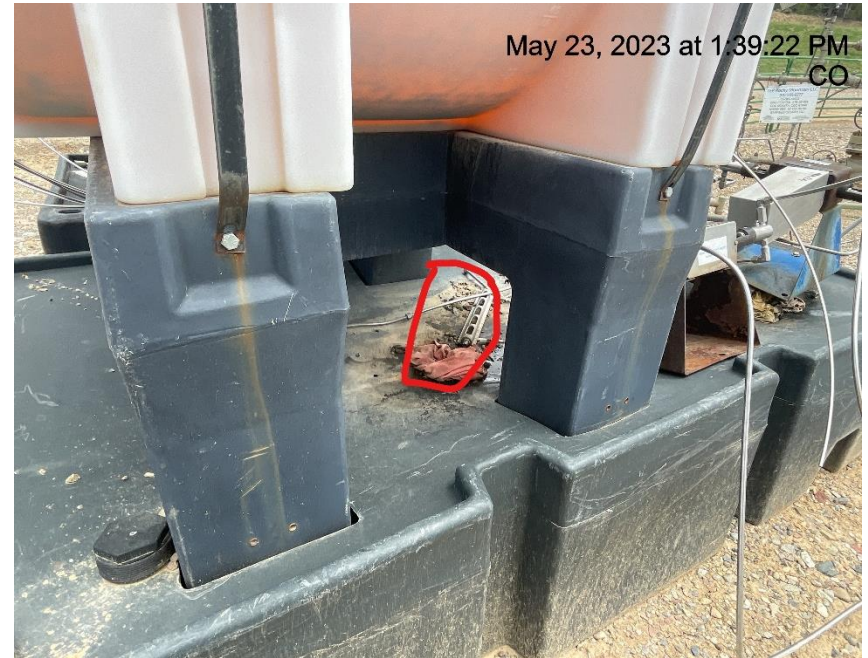
Photo # 8449 Debris

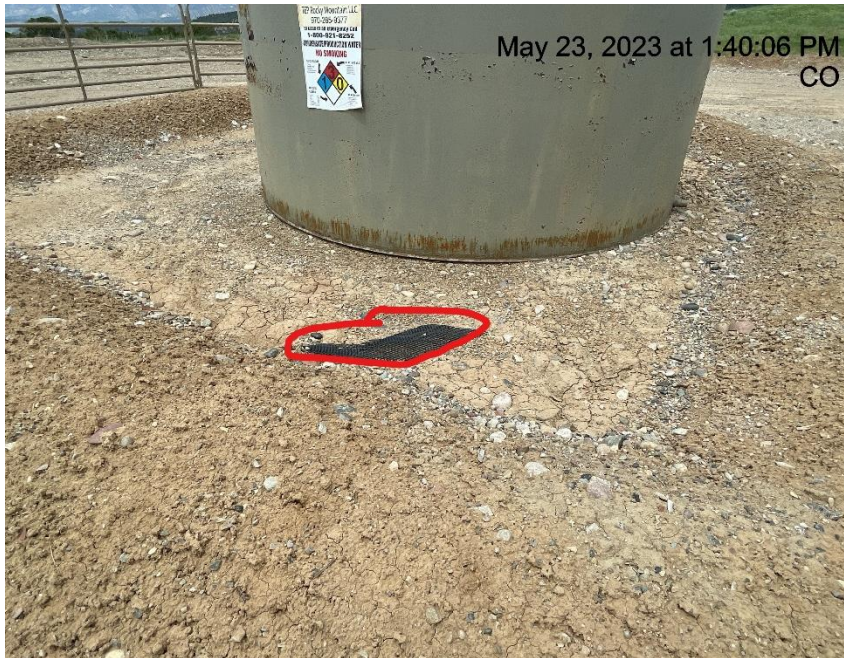
Photo # 8450 Debris

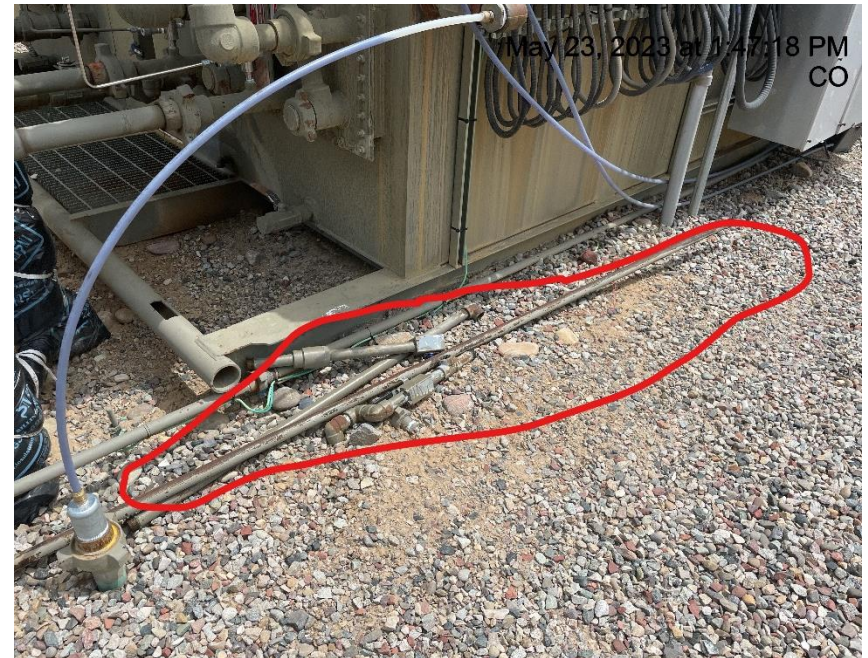
Photo # 8470 Debris

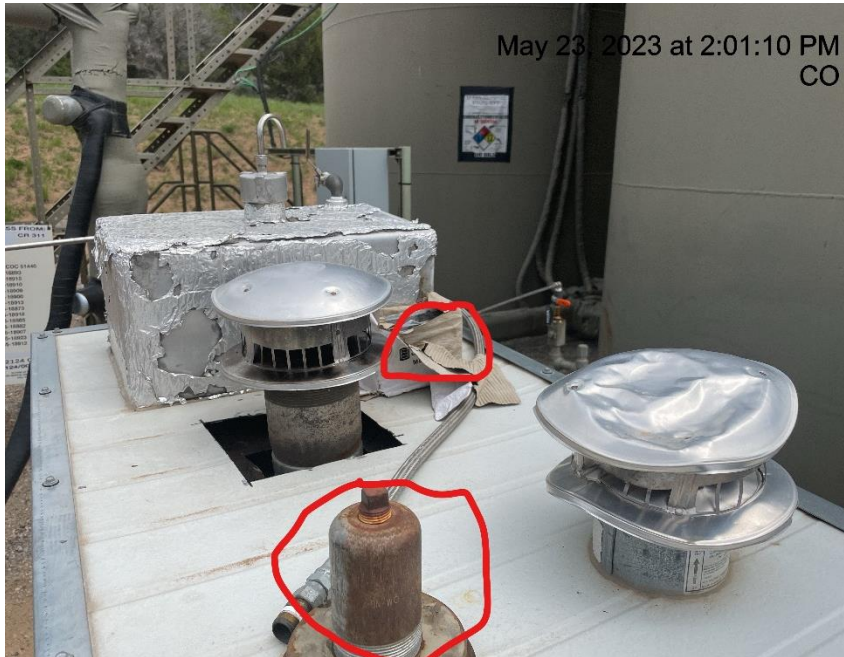
Photo # 8497 Debris
