**Inspection Photos**  
**Location Name: Fabrizius 33-34**  
**Location ID: 302848**

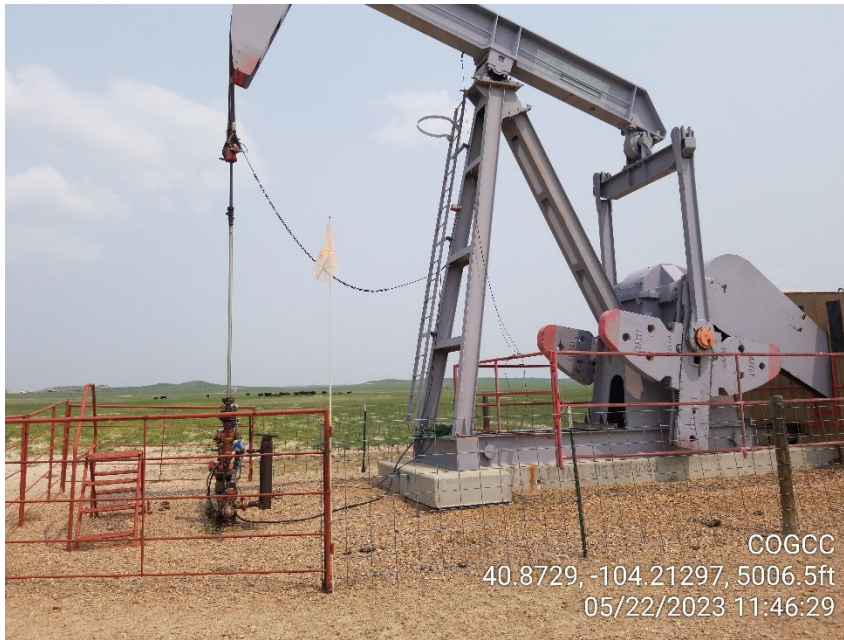
**Photo 1 – Pumping Unit**

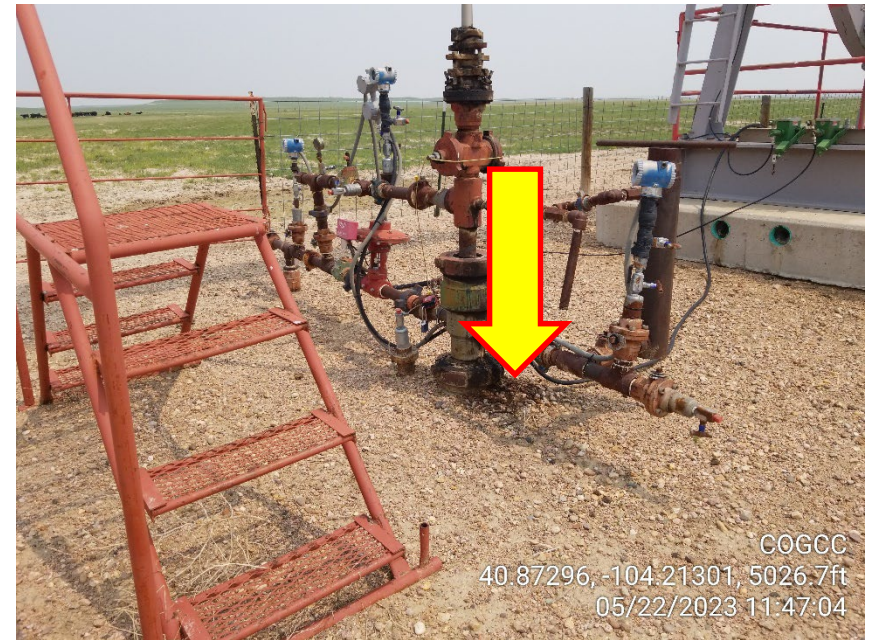
**Photo 2 – Wellhead – Stained Soil**

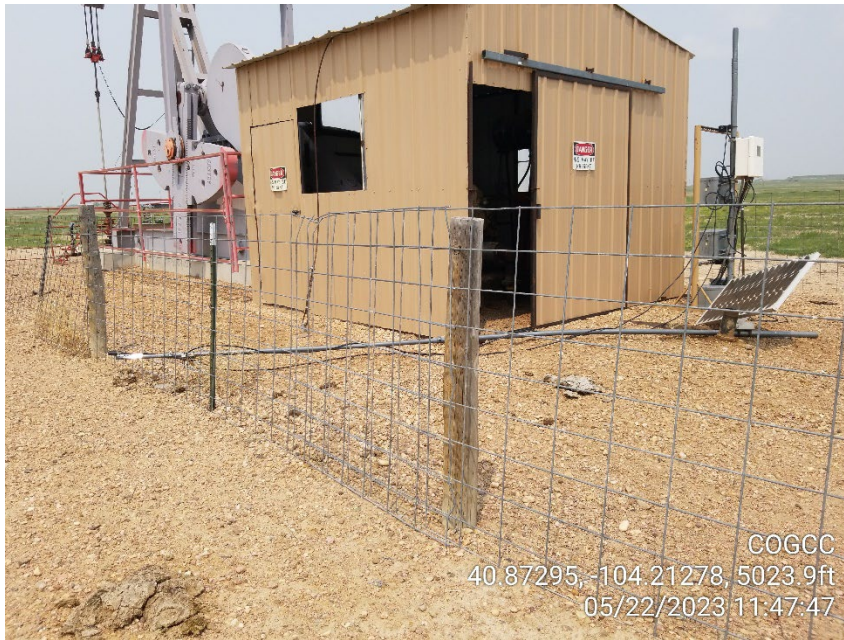
**Photo 3 – Engine House**

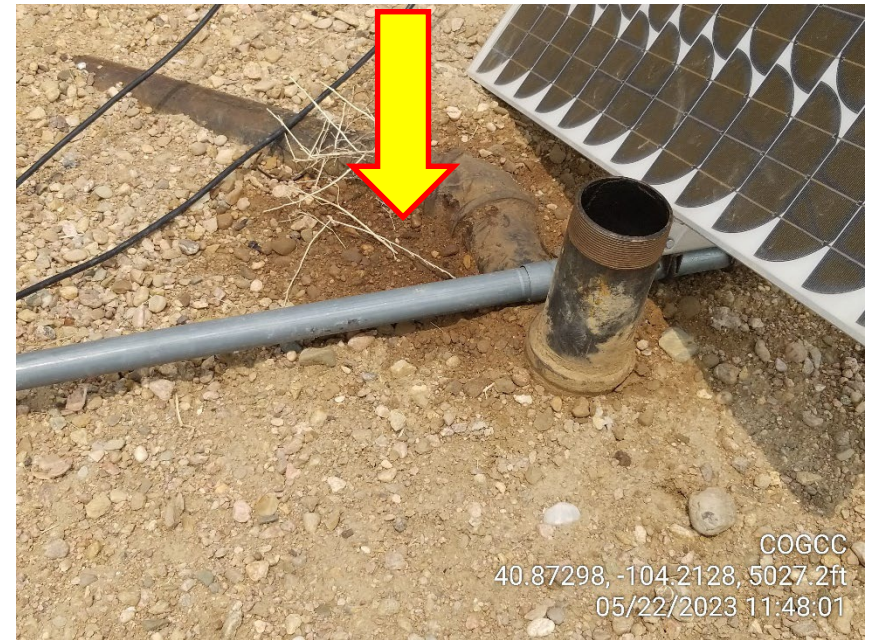
**Photo 4 – Stained Soil**

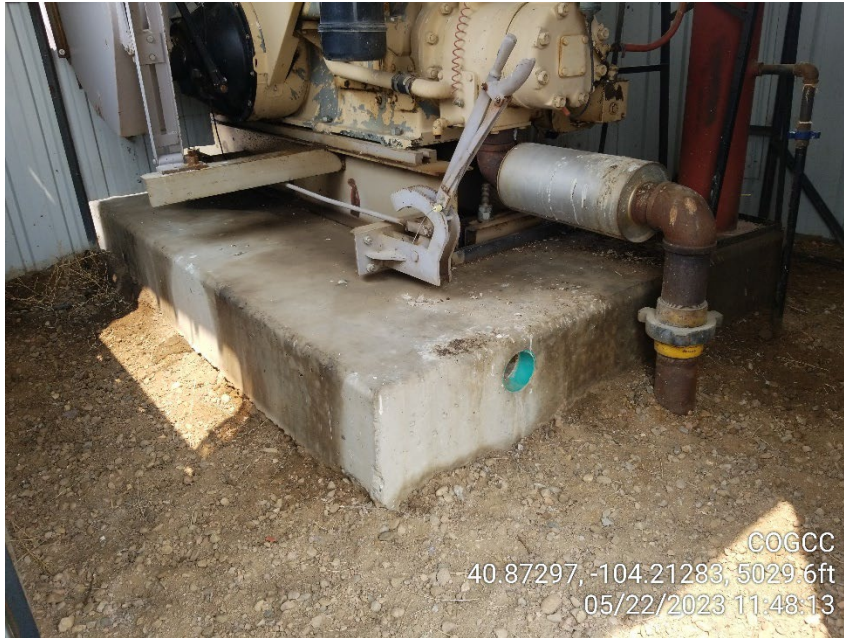
**Photo 5 – Gas Engine**

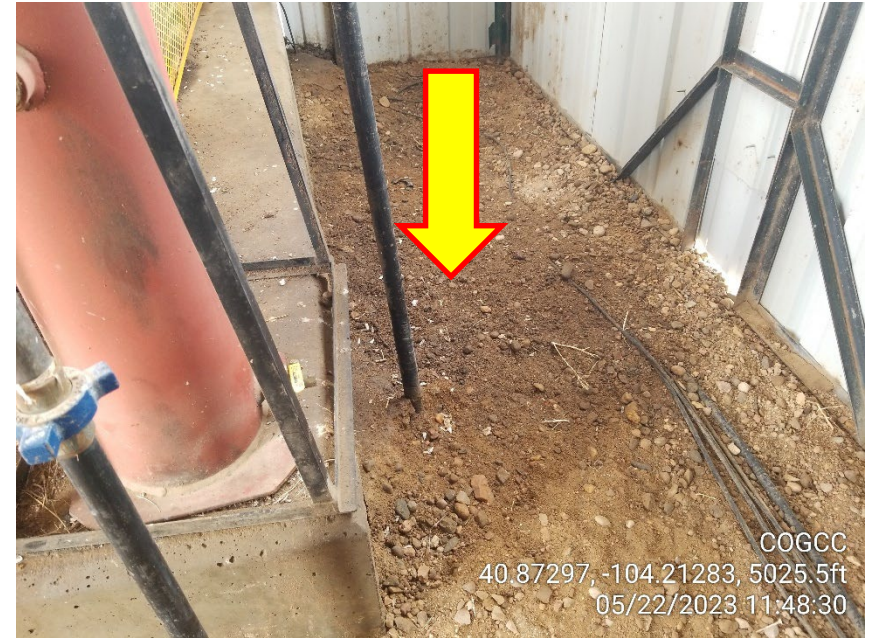
**Photo 6 – Stained Soil**

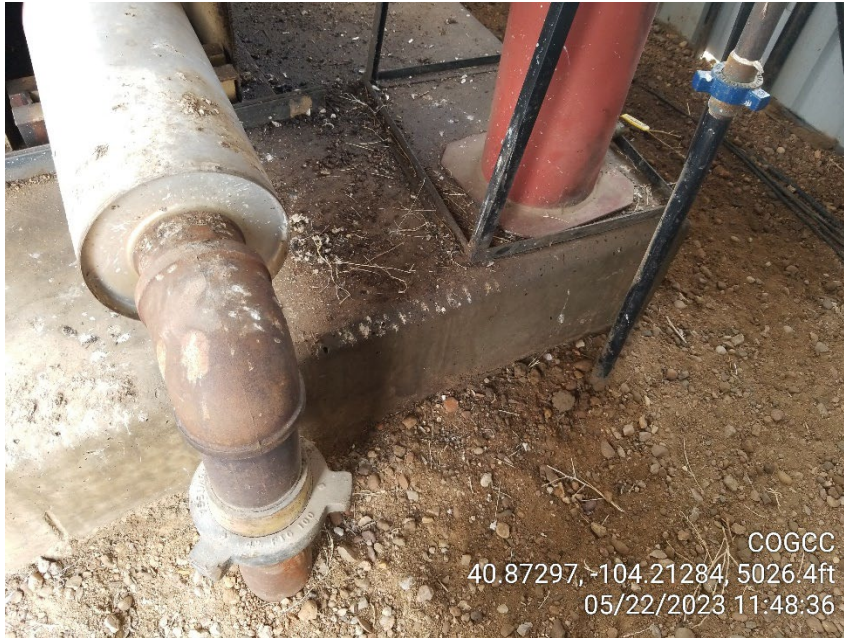
**Photo 7 – Stained Soil**

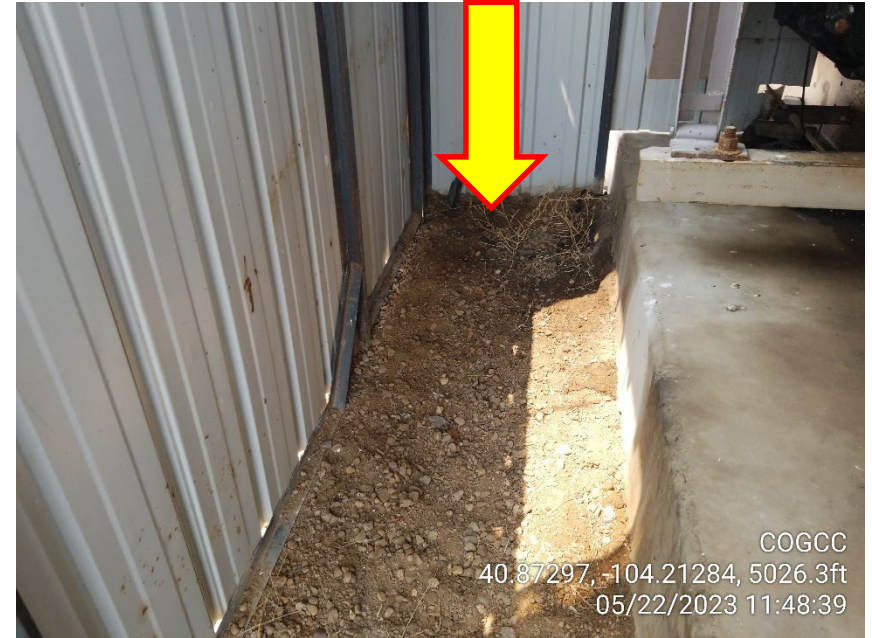
**Photo 8 – Stained Soil**

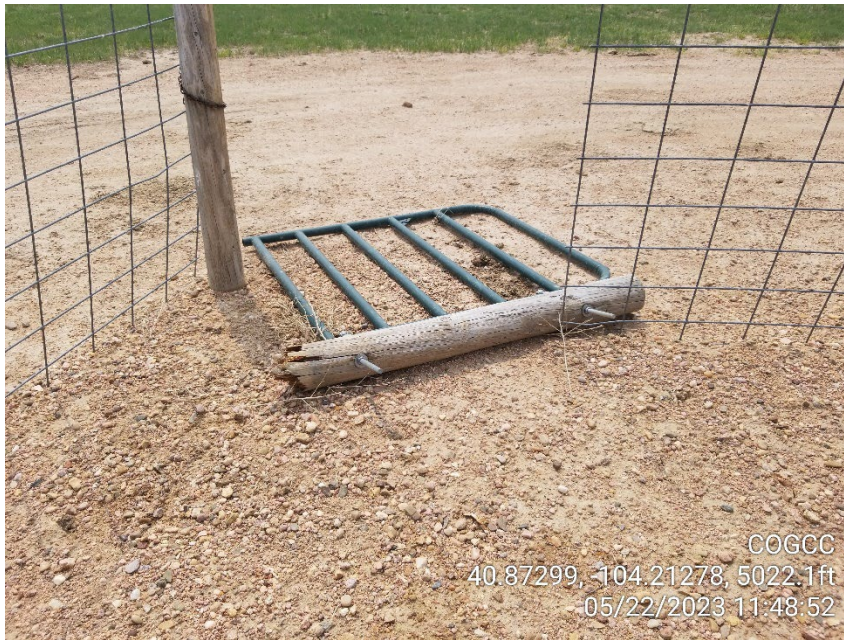
**Photo 9 – Gate in disrepair**

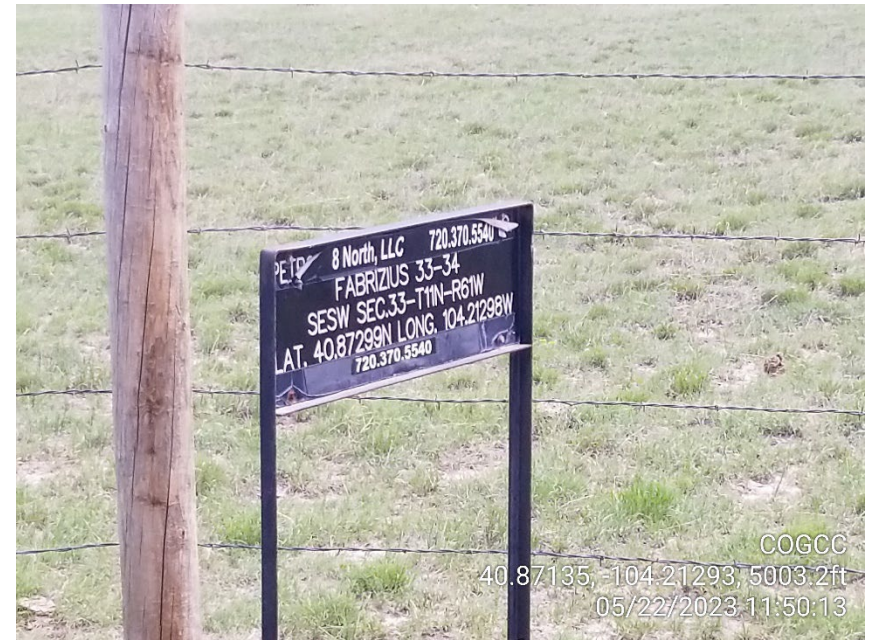
**Photo 10 – Sign at Entrance**
