Interim Reclamation and Stormwater Inspection

Date: 05/26/2023

Operator: FUNDARE RESOURCES OPERATING
COMPANY LLC - 10773

Inspection Photos
Location Name: Razor 271 Pad
Location ID: 433999

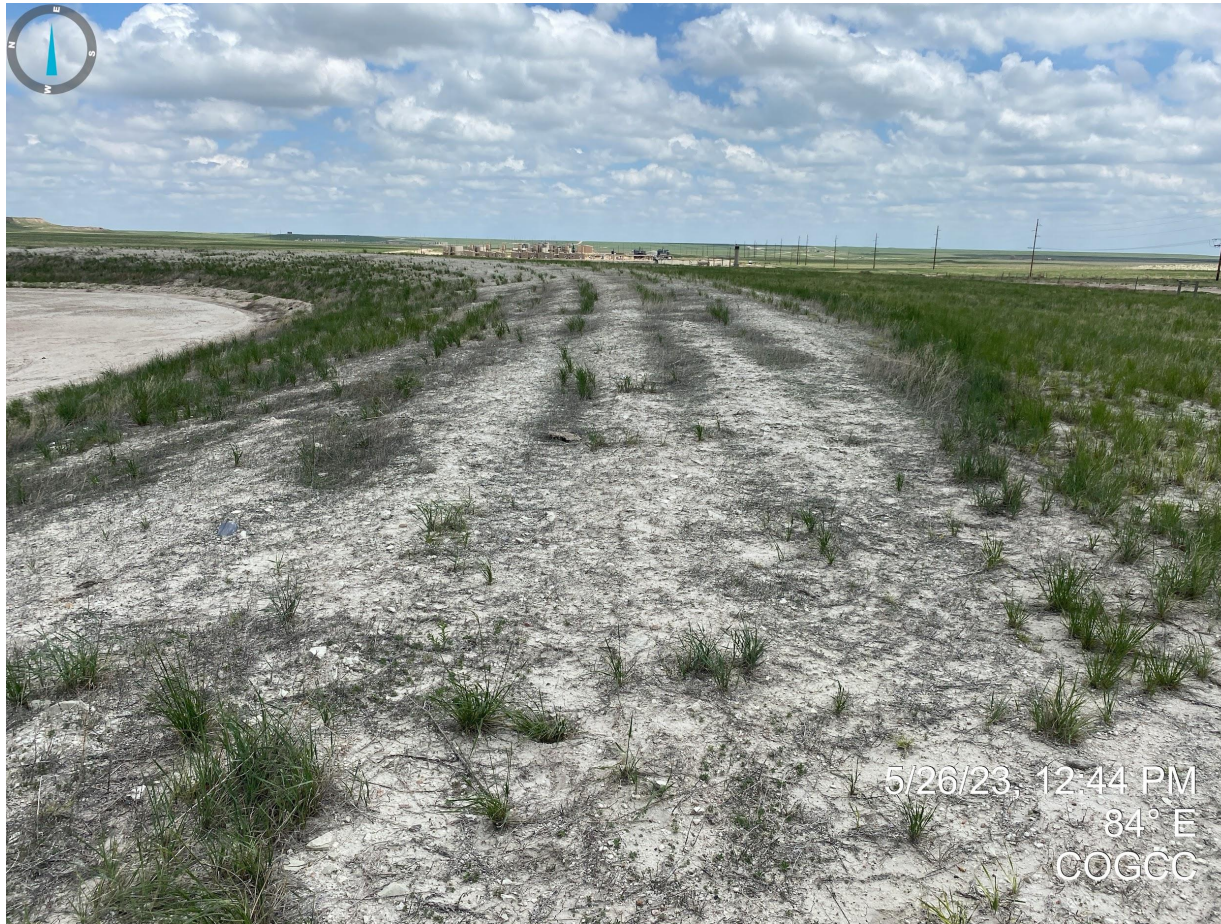
Photo 1. Southern interim/topsoil stockpile. During this inspection Staff observed that the interim areas are not progressing towards reclamation standards with evidence of non-uniform vegetation cover resulting in areas of bare soil and undesirable vegetation (e.g. kochia) was observed growing throughout. Additional reclamation activities are required in order to meet Rule 1003 standards.

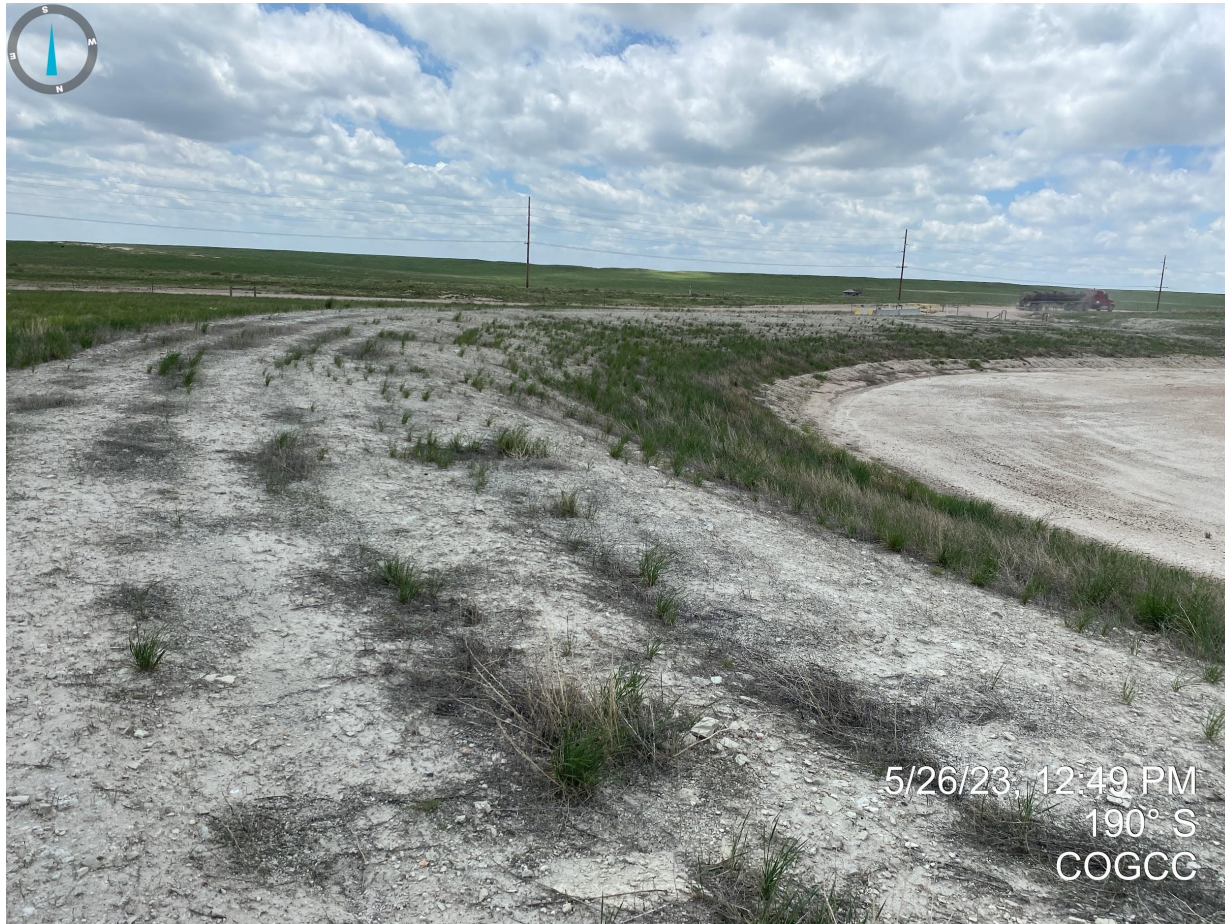
Photo 2. Topsoil stockpile. See comments in Photo 1.

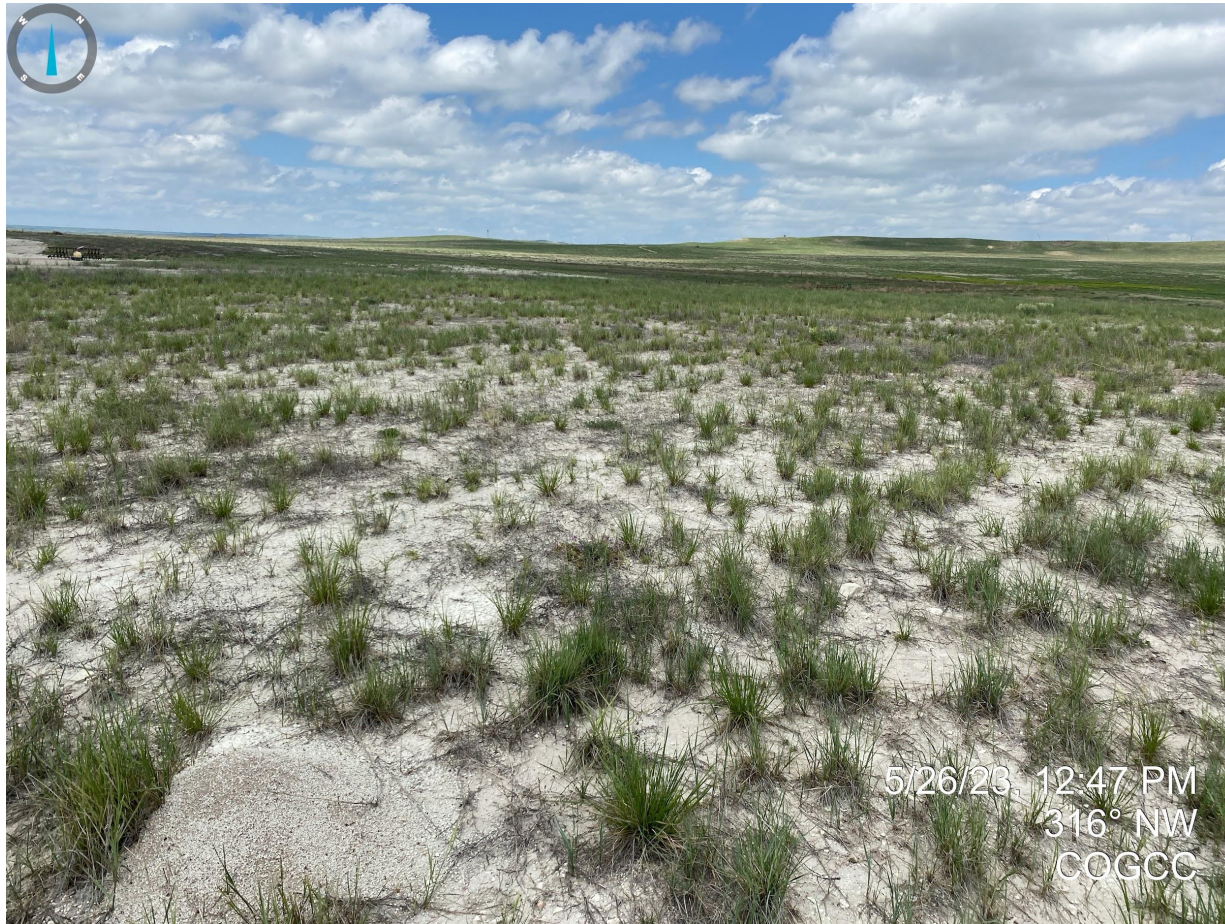
Photo 3. Eastern interim area. See comments in Photo 1.

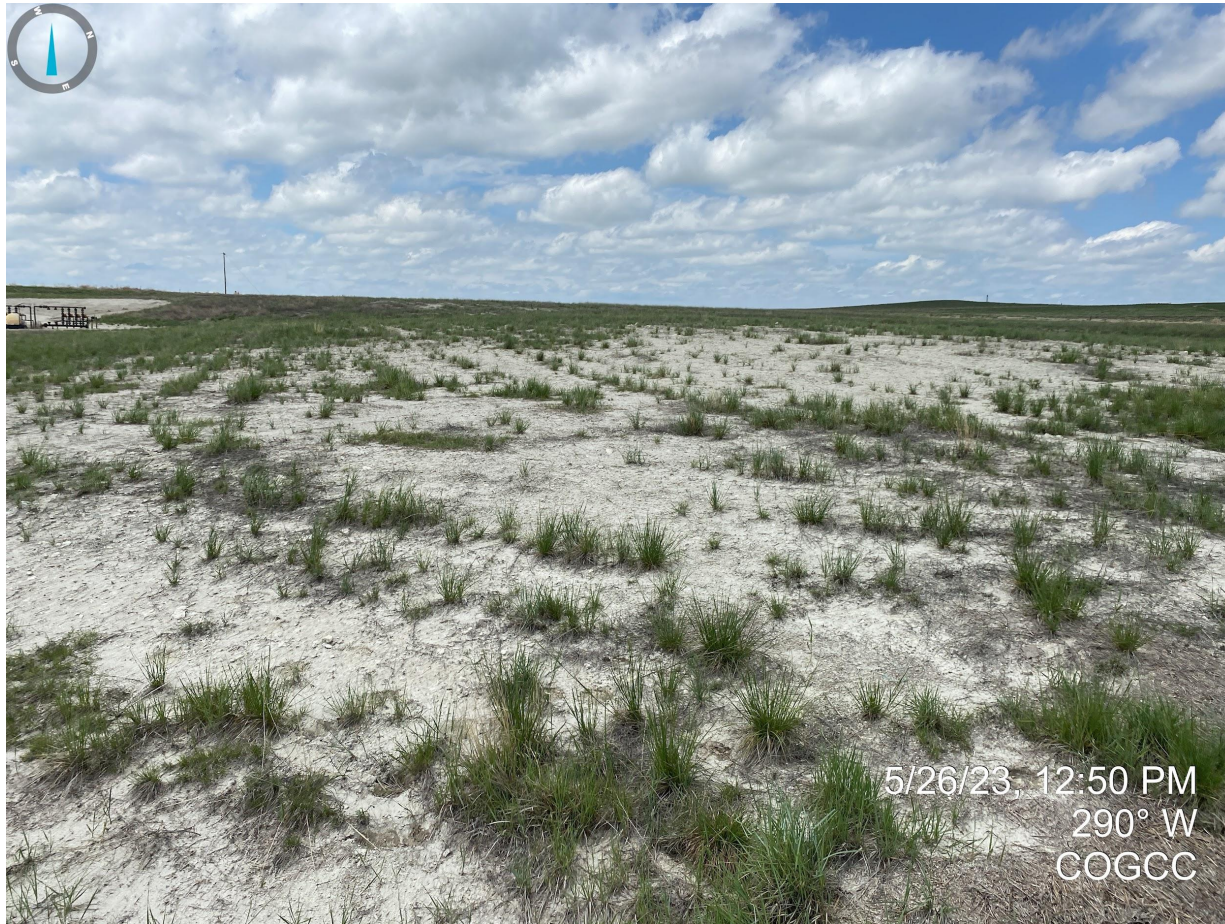
Photo 4. Northern interim area. See comments in Photo 1.

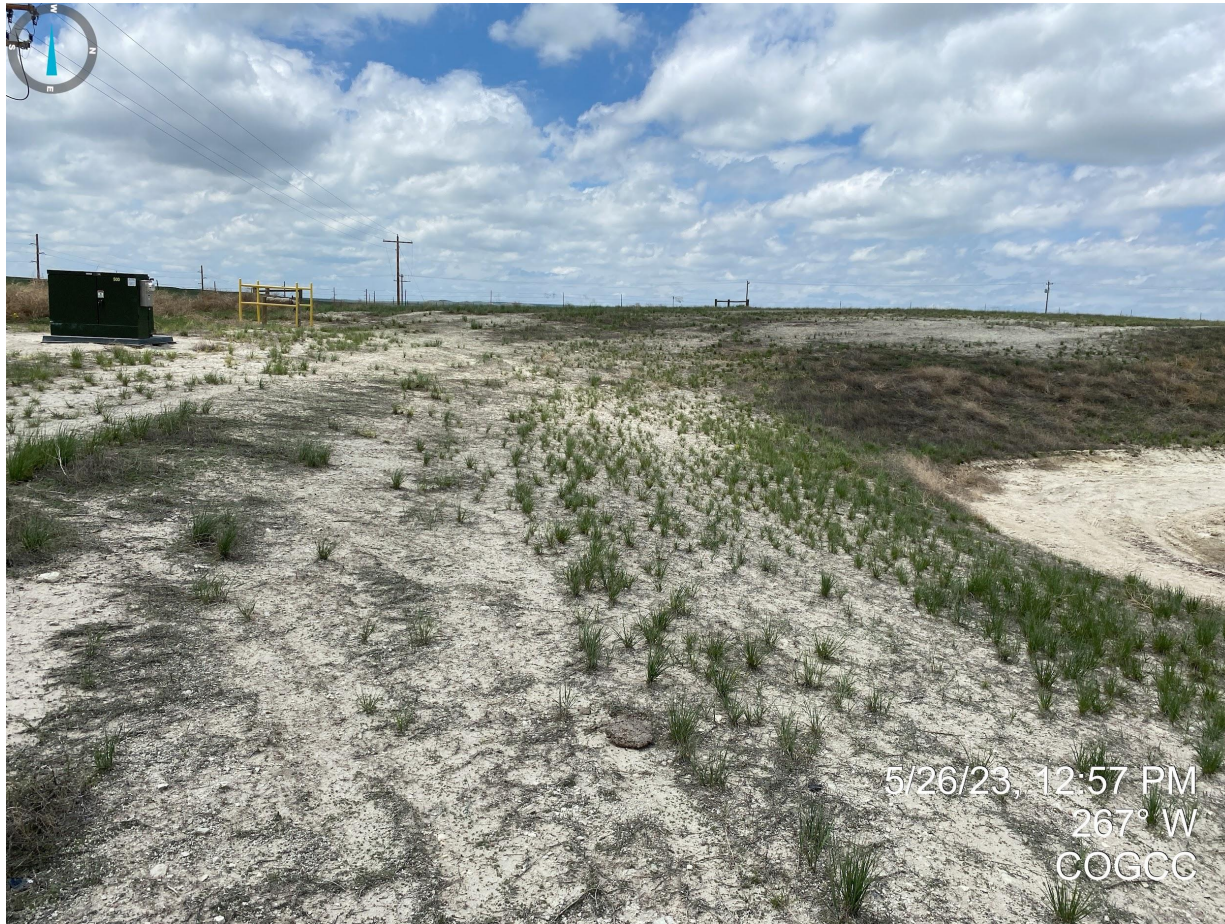
Photo 5. Southern Interim areas. See comments in Photo 1.

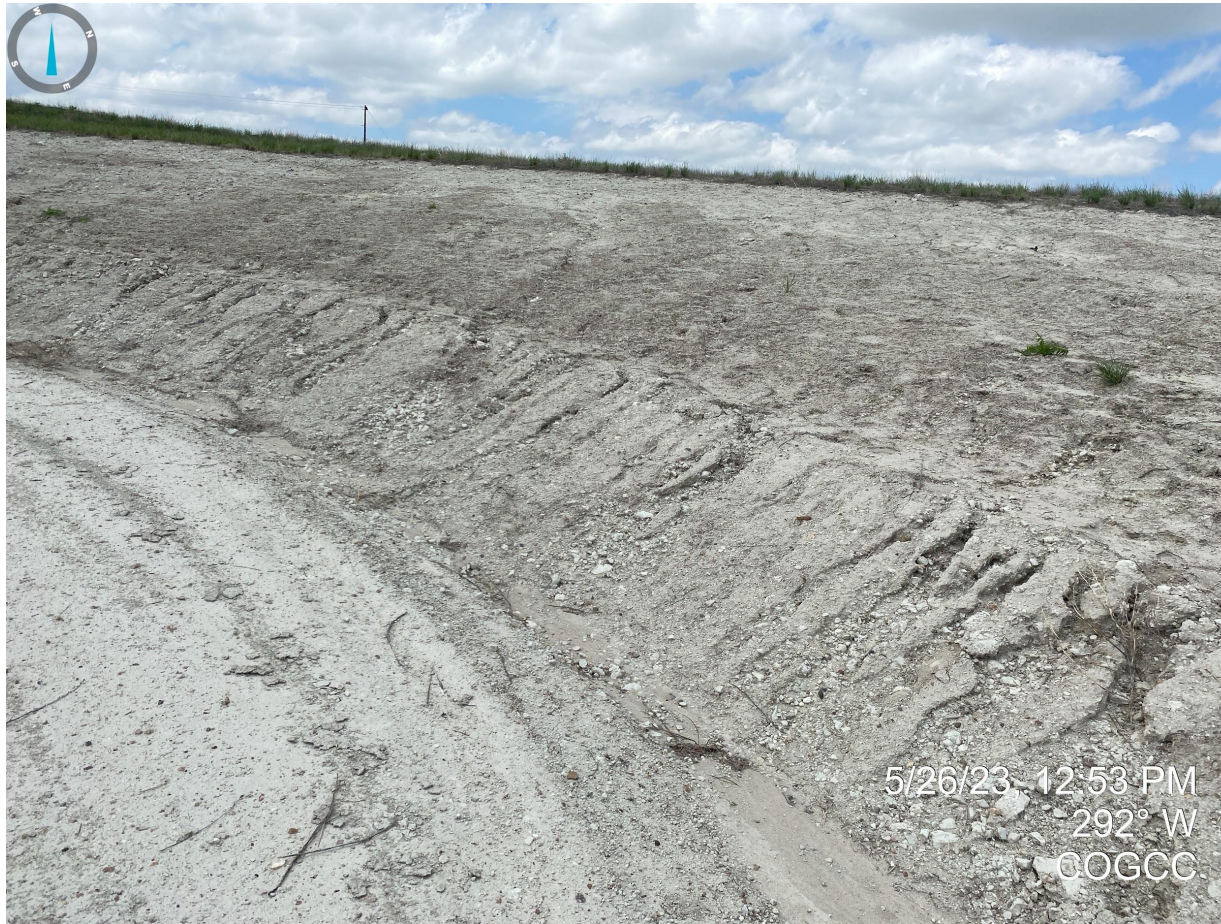
Photo 6. During this inspection, Staff observed that cut banks towards the northwest corner of the location are experiencing rill erosion and do not appear to be properly stabilized. Repair/maintenance of stormwater BMPs should be implemented to stabilize the areas experiencing erosion.

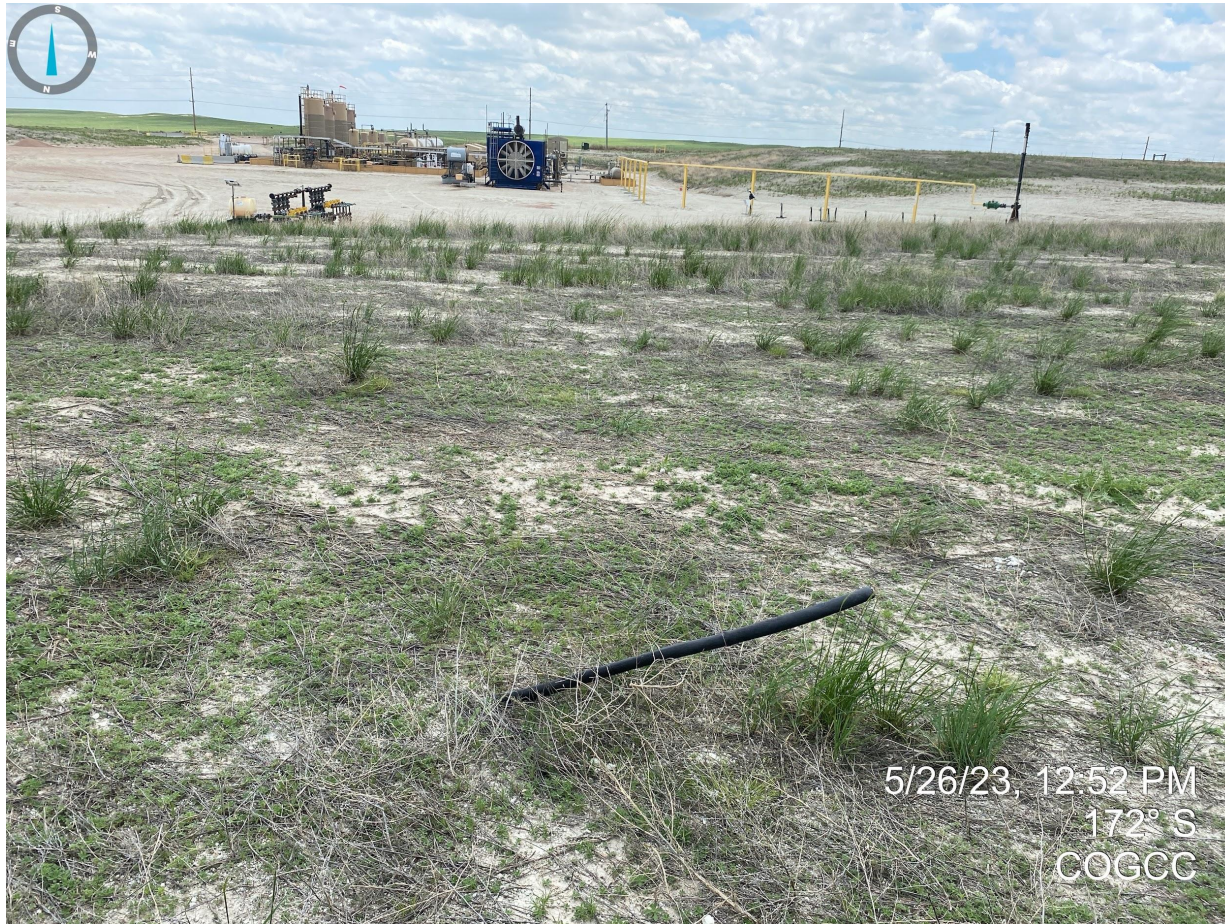
Photo 7. Northern end of location. Debris observed during this inspection will need to be removed. Unmarked hose/tubing coming from ground.

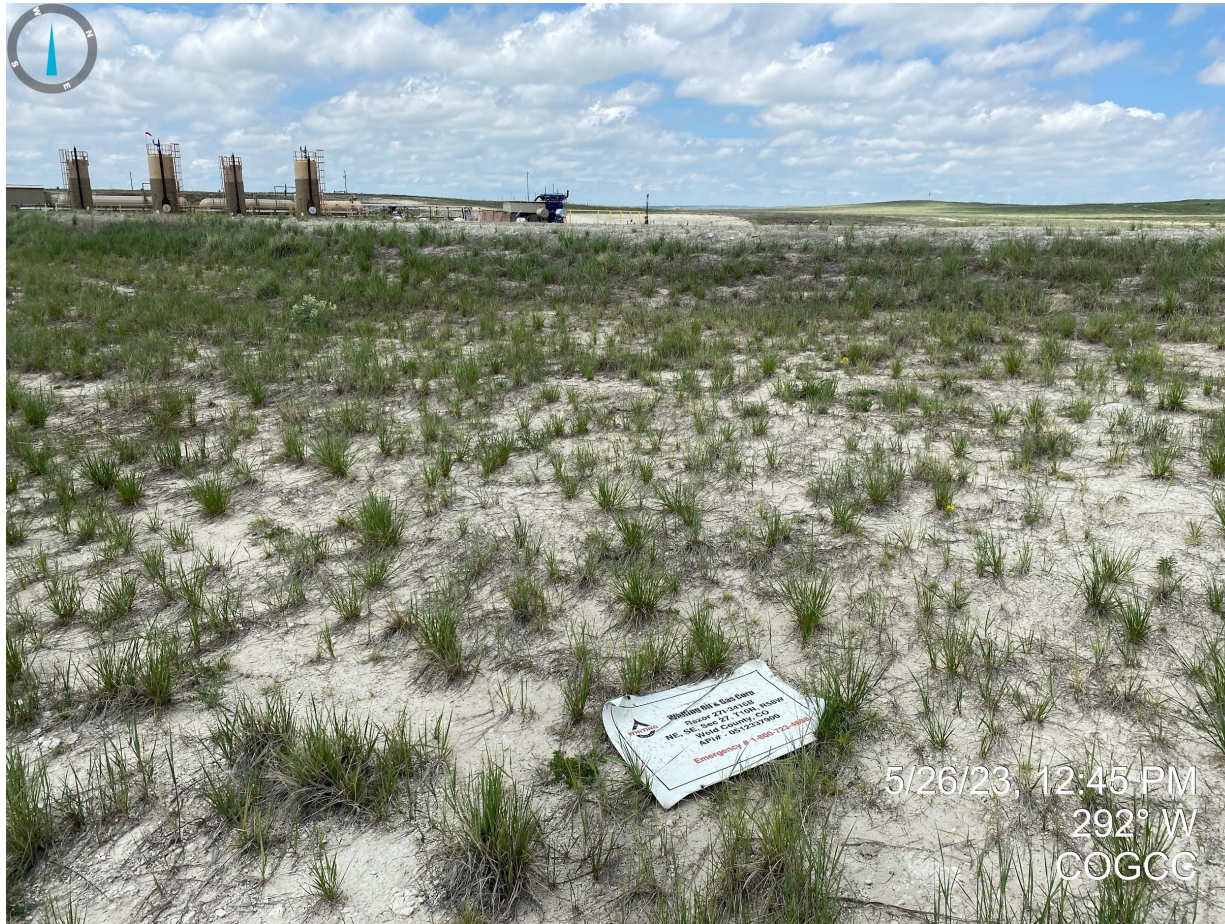
Photo 8. Eastern side of location. See comments in Photo 7.

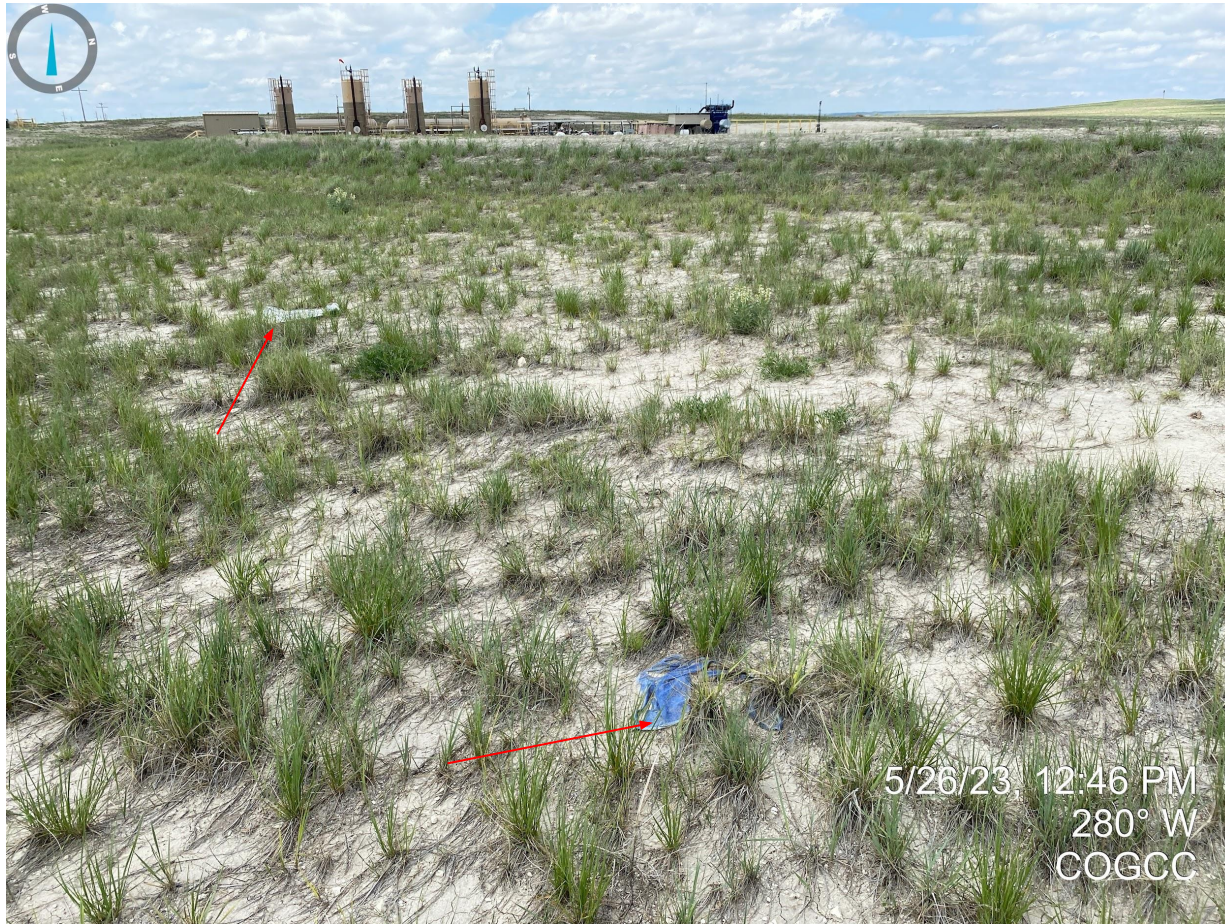
Photo 9. Eastern side of location. See comments in Photo 7.

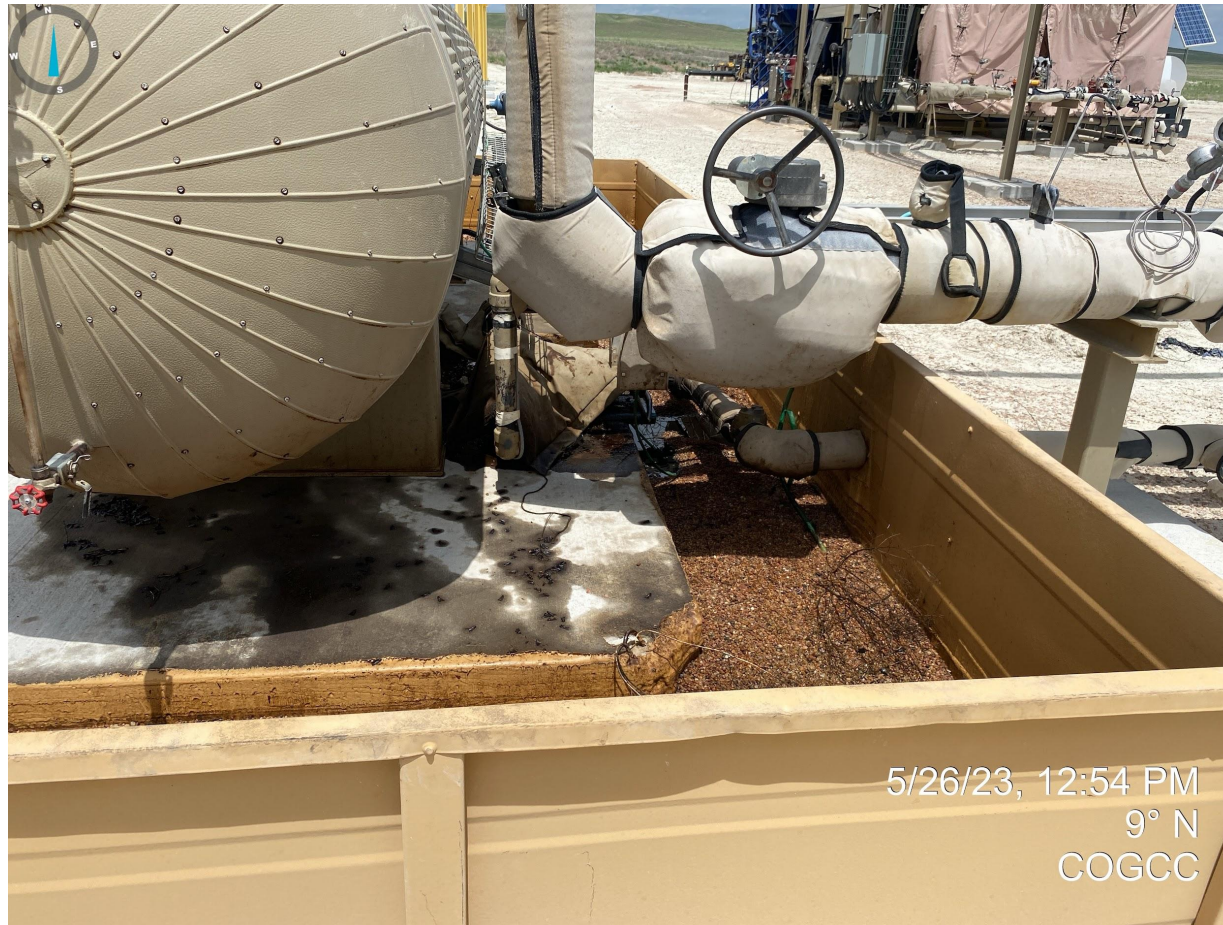
Photo 10. Apparent hydrocarbon leak observed within secondary containment on the west side of the location. Properly dispose of oily waste in accordance with 905.e. Additionally, Securely fasten all valves, pipes, fittings, and Production Facilities to ensure good mechanical condition, inspect at regular intervals and maintain in good mechanical condition per Rule 608.e.

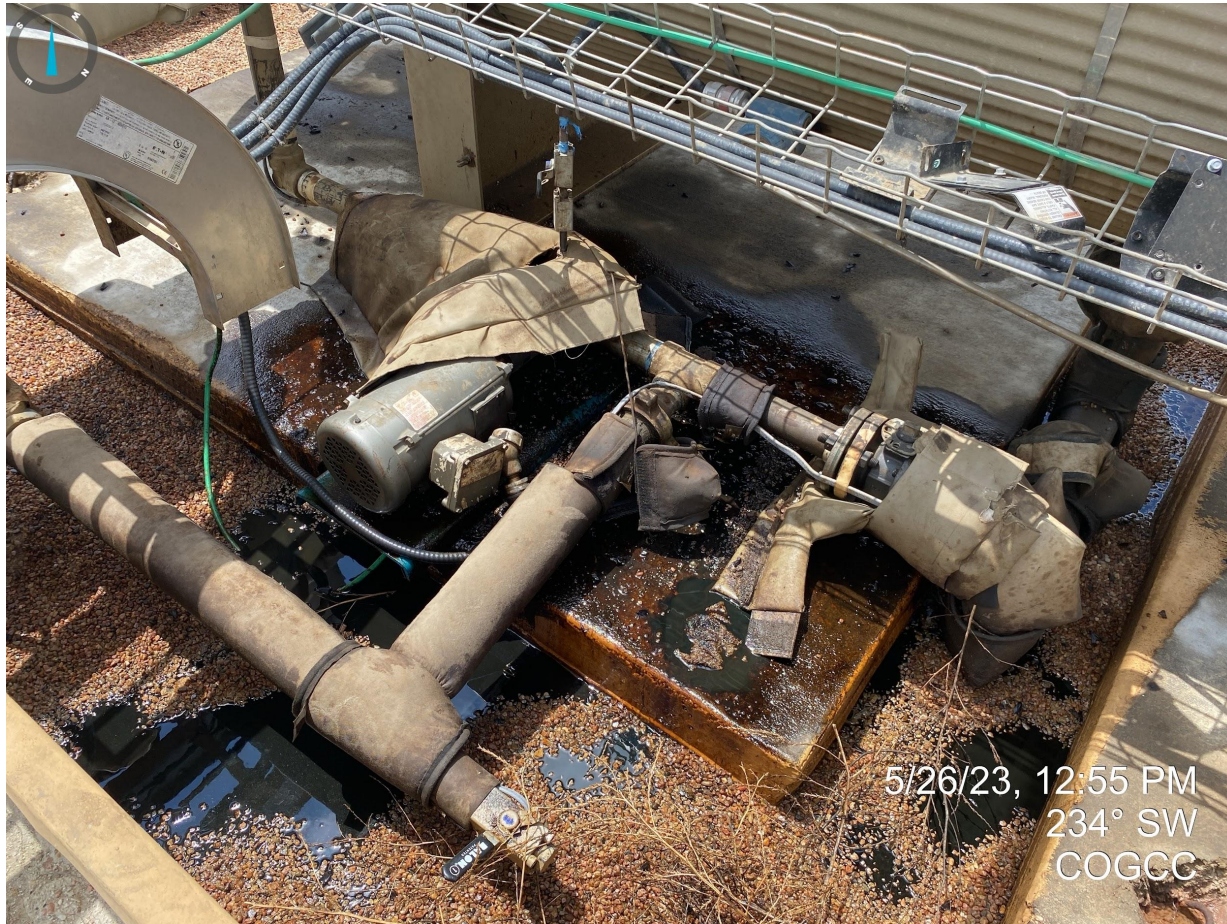
Photo 11. See comments in Photo 10.
