Construction and Stormwater Inspection

May 31, 2023

Operator: BISON IV OPERATING LLC- 10670

Location ID: 477204

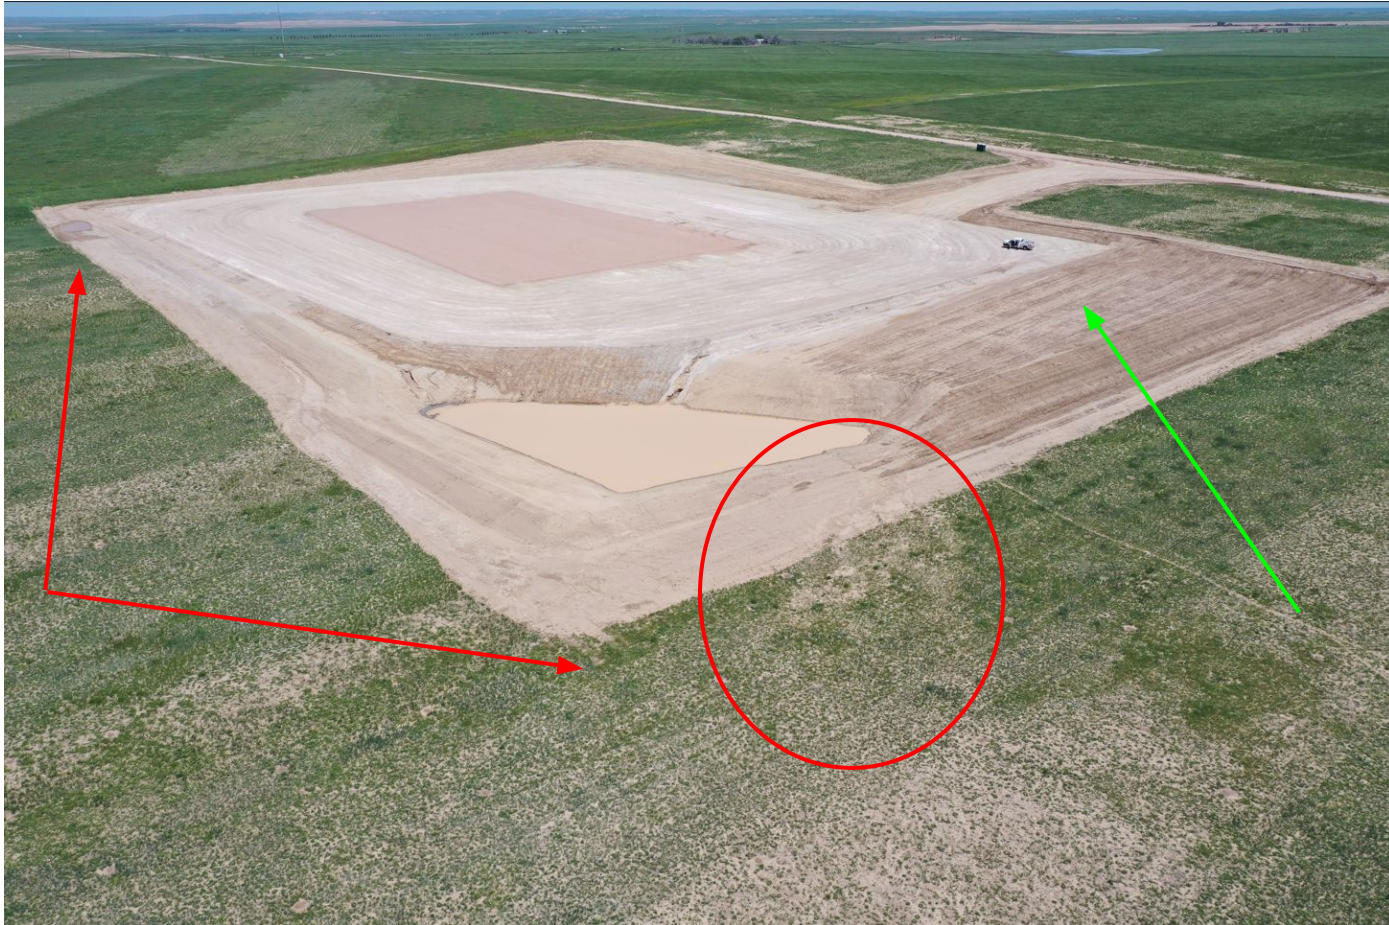
Photo 1. Drone imagery illustrates the location, facing Northeast. At the time of this inspection, there were no perimeter stormwater BMPs along the southern and western perimeter. The sediment basin overflowed and sediment laden stormwater discharged along the southwestern perimeter (red circle). Areas of sediment laden stormwater also discharged along the western perimeter (red arrows). Topsoil has been stockpiled along the southern location- green arrow.

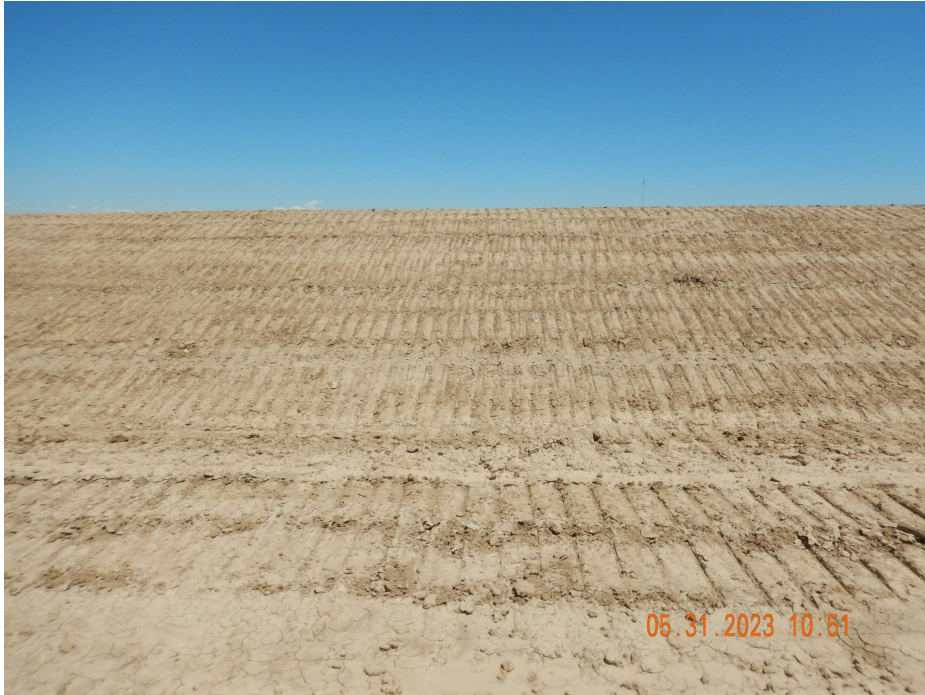
Photo 2. Photo taken from the southern location on the topsoil stockpile, facing North. Photo illustrates the stockpile has been temporarily stabilized; however, the equipment tracking was not conducted perpendicular to the slope.

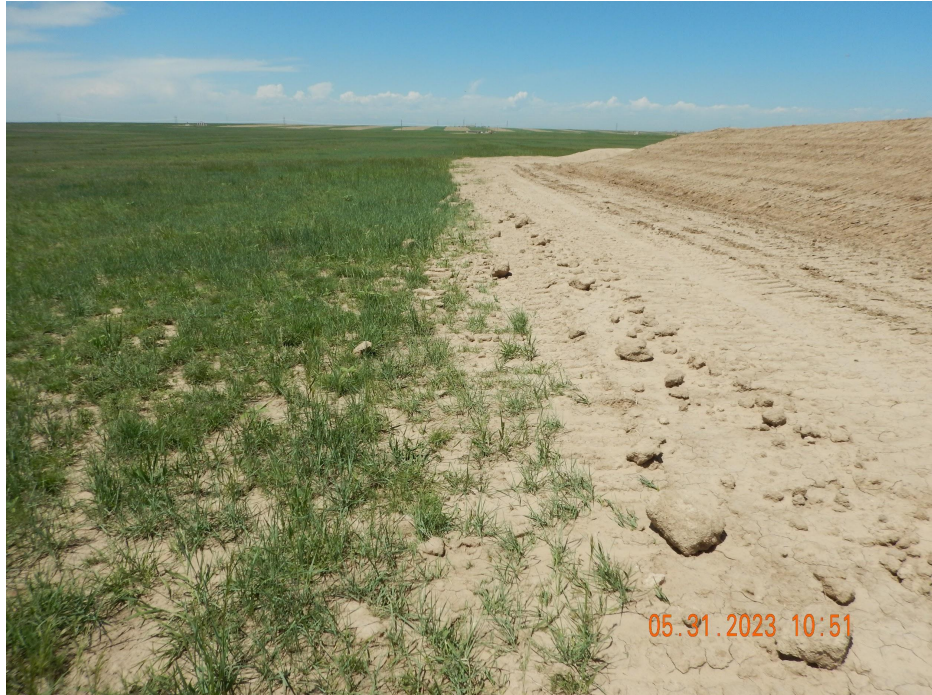
Photo 3. Photo taken from the southern perimeter of location, facing West. Photo illustrates there is no perimeter stormwater BMP.

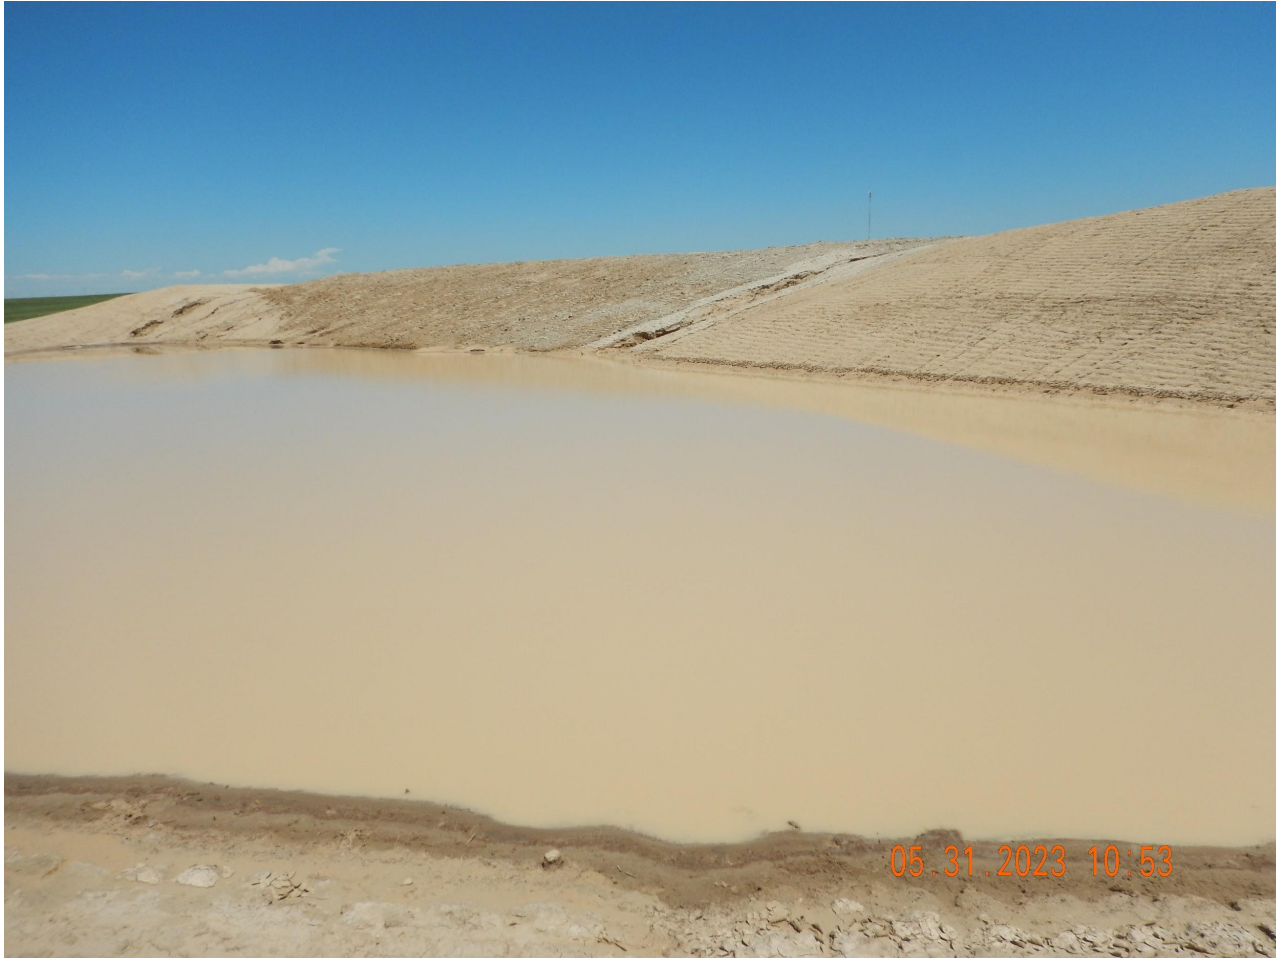
Photo 4. Photo taken from the sediment basin, facing North. Photo illustrates gully erosion is evident and in need of repair.

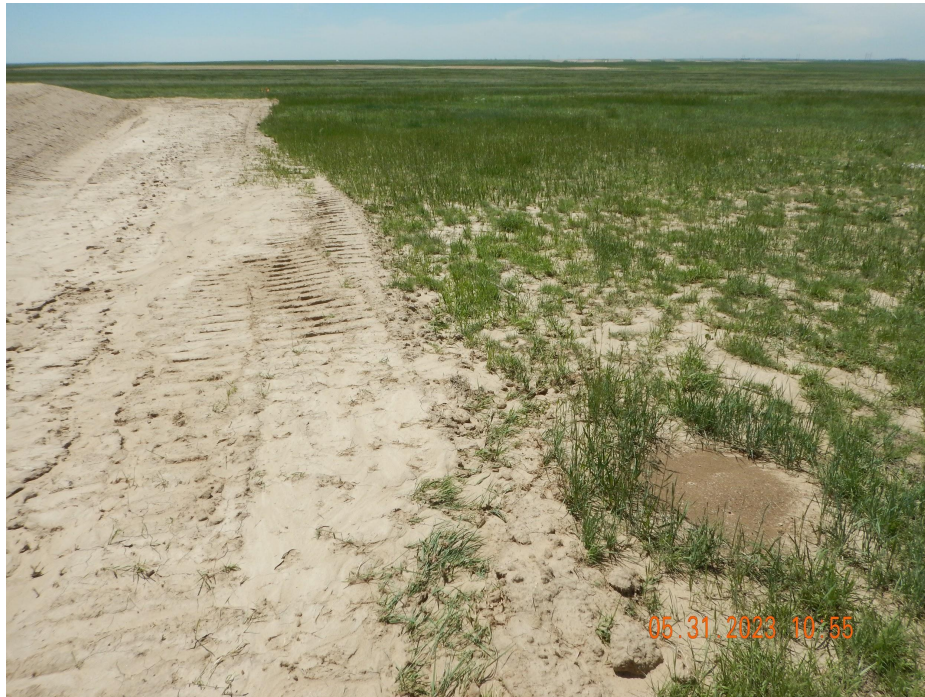
Photo 5. Photo taken from the southwestern perimeter of location, facing South. See comments under Photo 3.

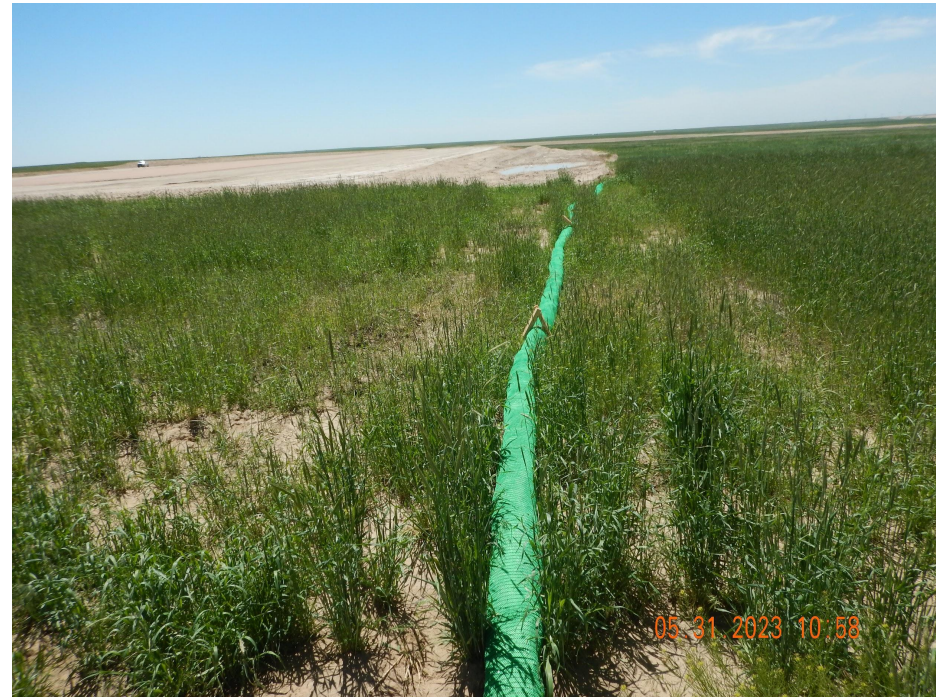
Photo 6. Photo taken from the northwestern perimeter of location, facing South. Photo illustrates a perimeter stormwater BMP that extends along the northern perimeter where there has been no oil and gas disturbance.

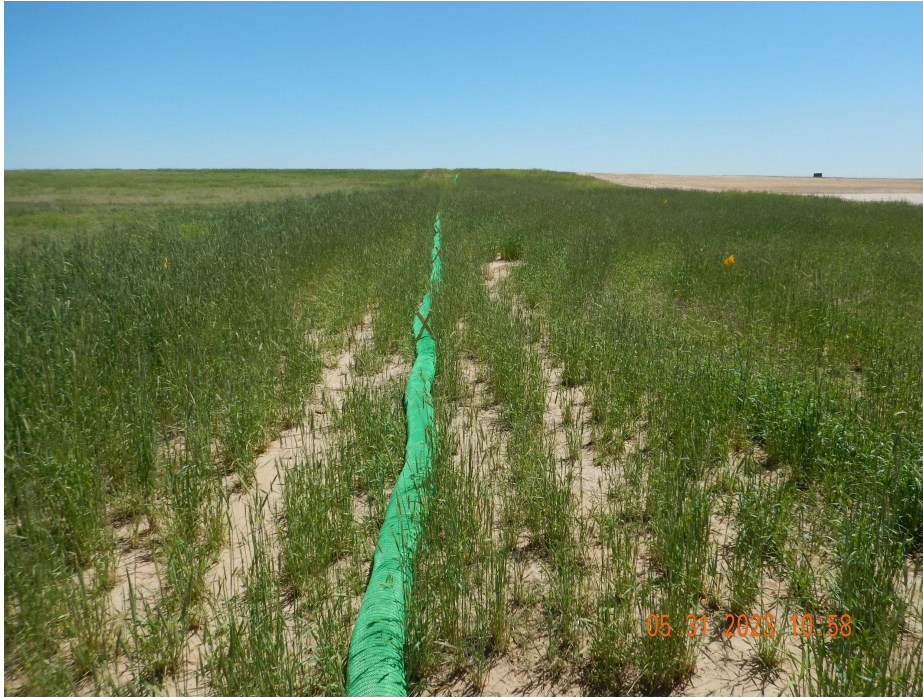
Photo 7. Photo taken from the northwestern perimeter of location, facing East. See comments under Photo 6.

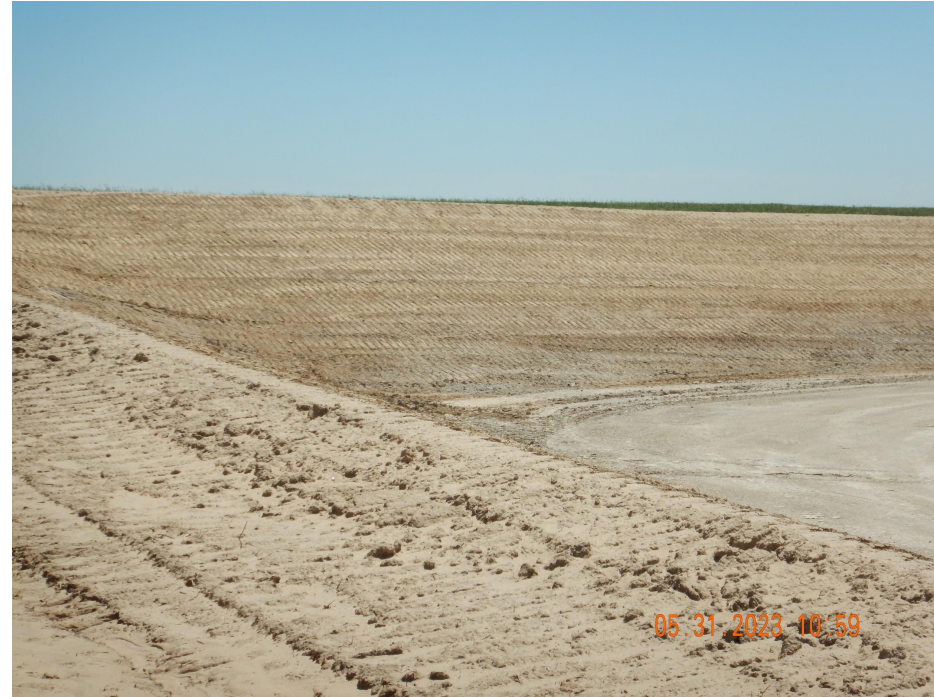
Photo 8. Photo taken from the northern perimeter of location, facing East. Photo illustrates the cut slope has temporarily stabilized; however, the equipment tracking was not conducted perpendicular to the slope.
