Inspection Photos

Operator: TEP Rocky Mountain- #96850

Location Name: South Leverich /13-09 Pad

Inspection Document #: 702801561

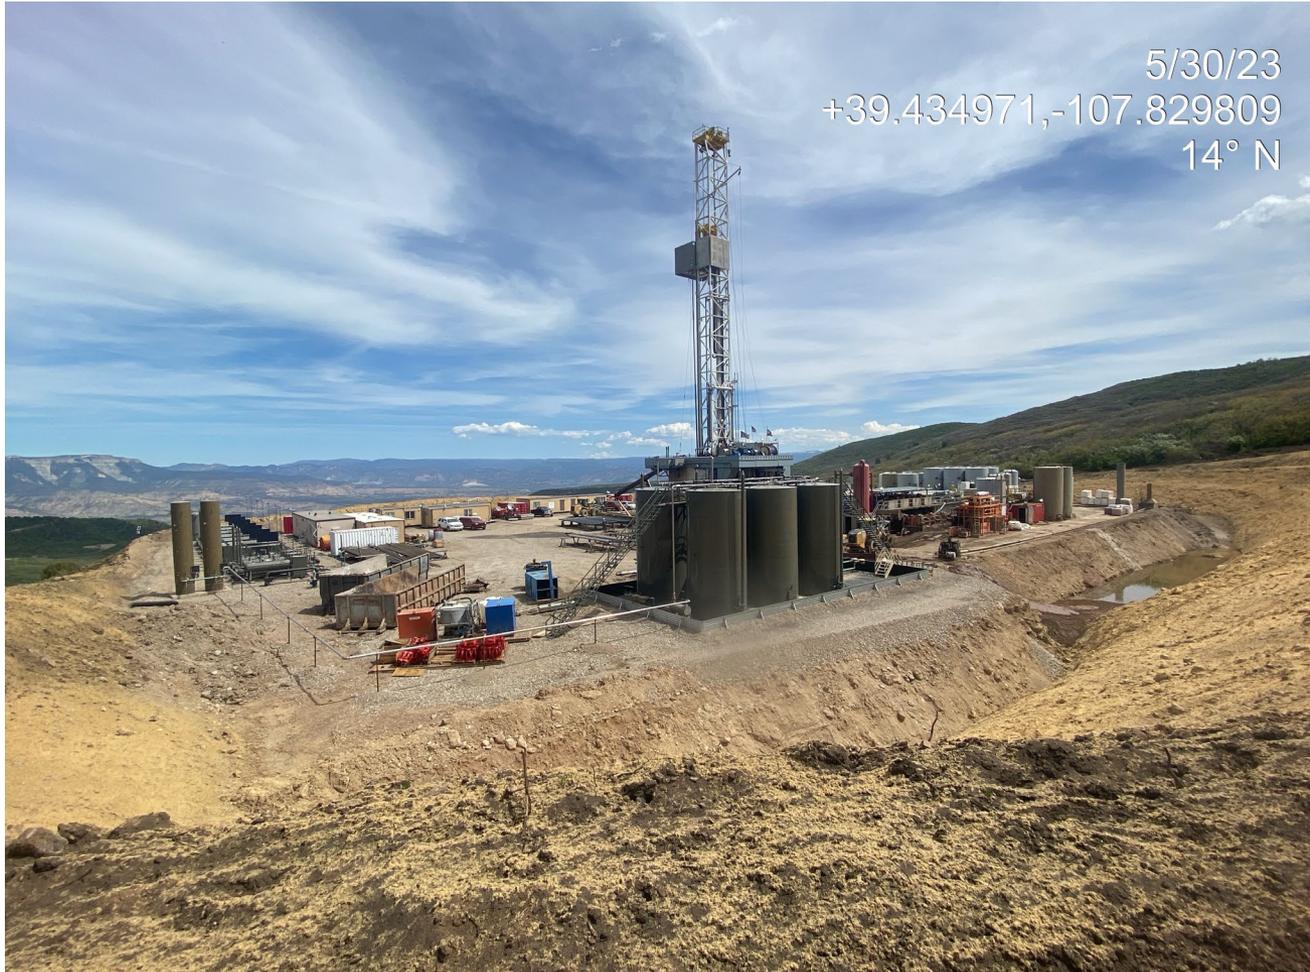
Photo 1. Photo taken from the southwest shows an overview of the working pad area.

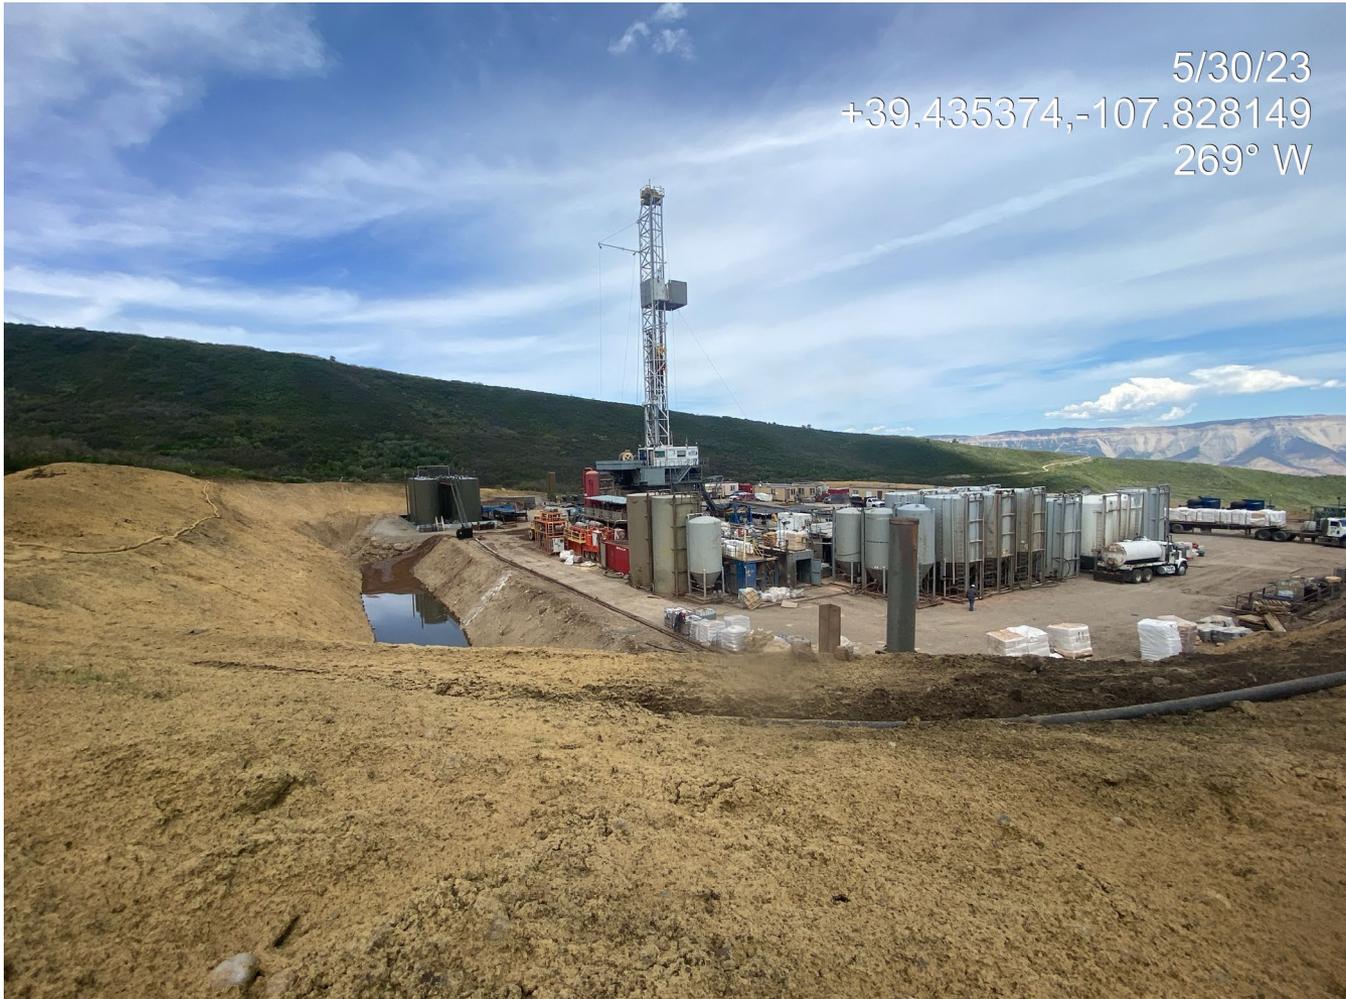
Photo 2. Photo taken from the southeast shows an overview of the working pad area.

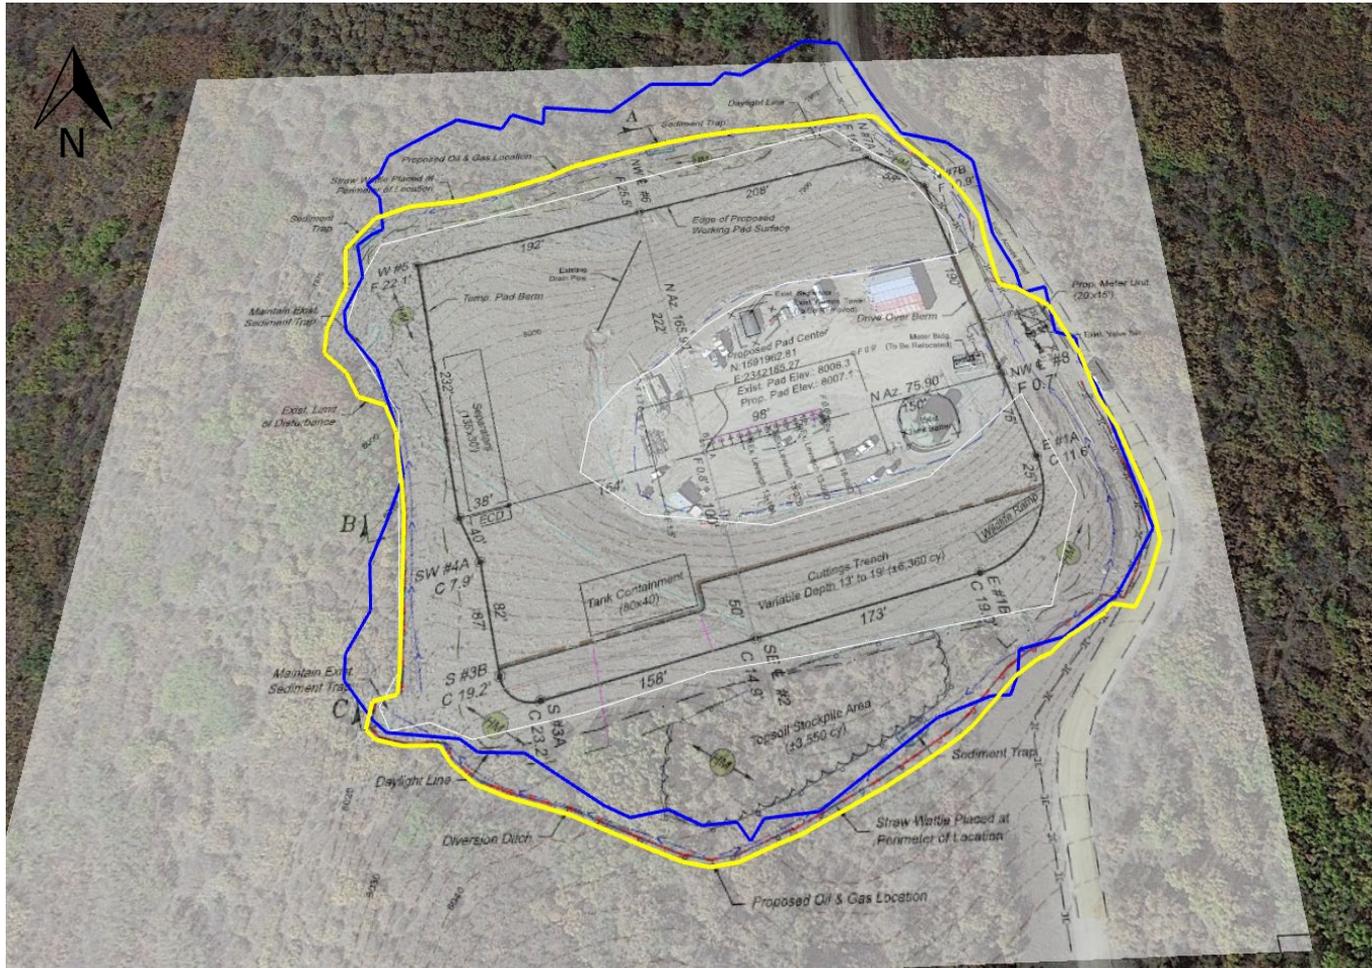
Photo 3. Photo shows the construction layout drawing overlaid on Google Earth imagery with the 2A location (yellow). The actual location disturbance extends approximately 70 feet beyond the permitted location to the north (blue).

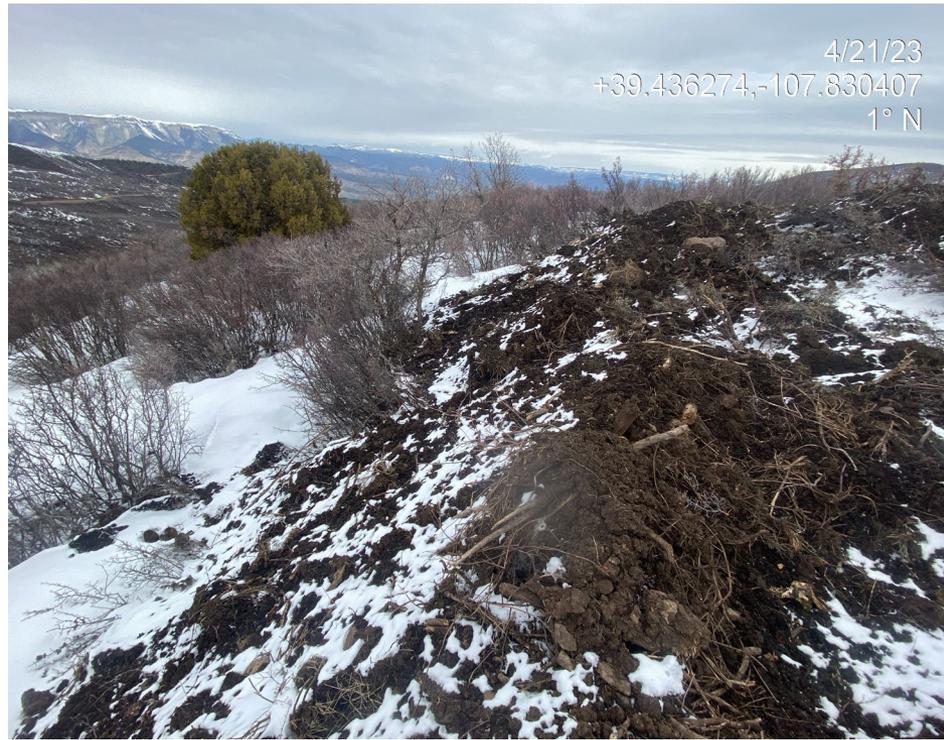
Photo 4. Photo taken from the northwestern edge of the location during the previous inspection shows lack of erosion protections for unconsolidated topsoil.

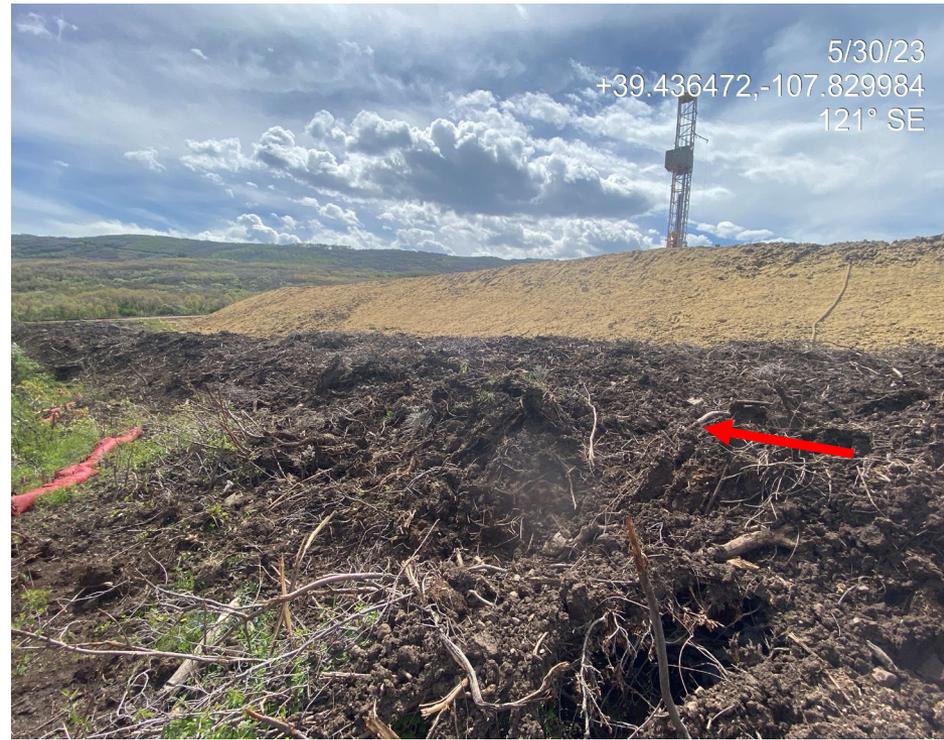
Photo 5. Photo taken from the northern edge of the location during the 5/30/23 inspection shows lack of erosion protections for unconsolidated topsoil.

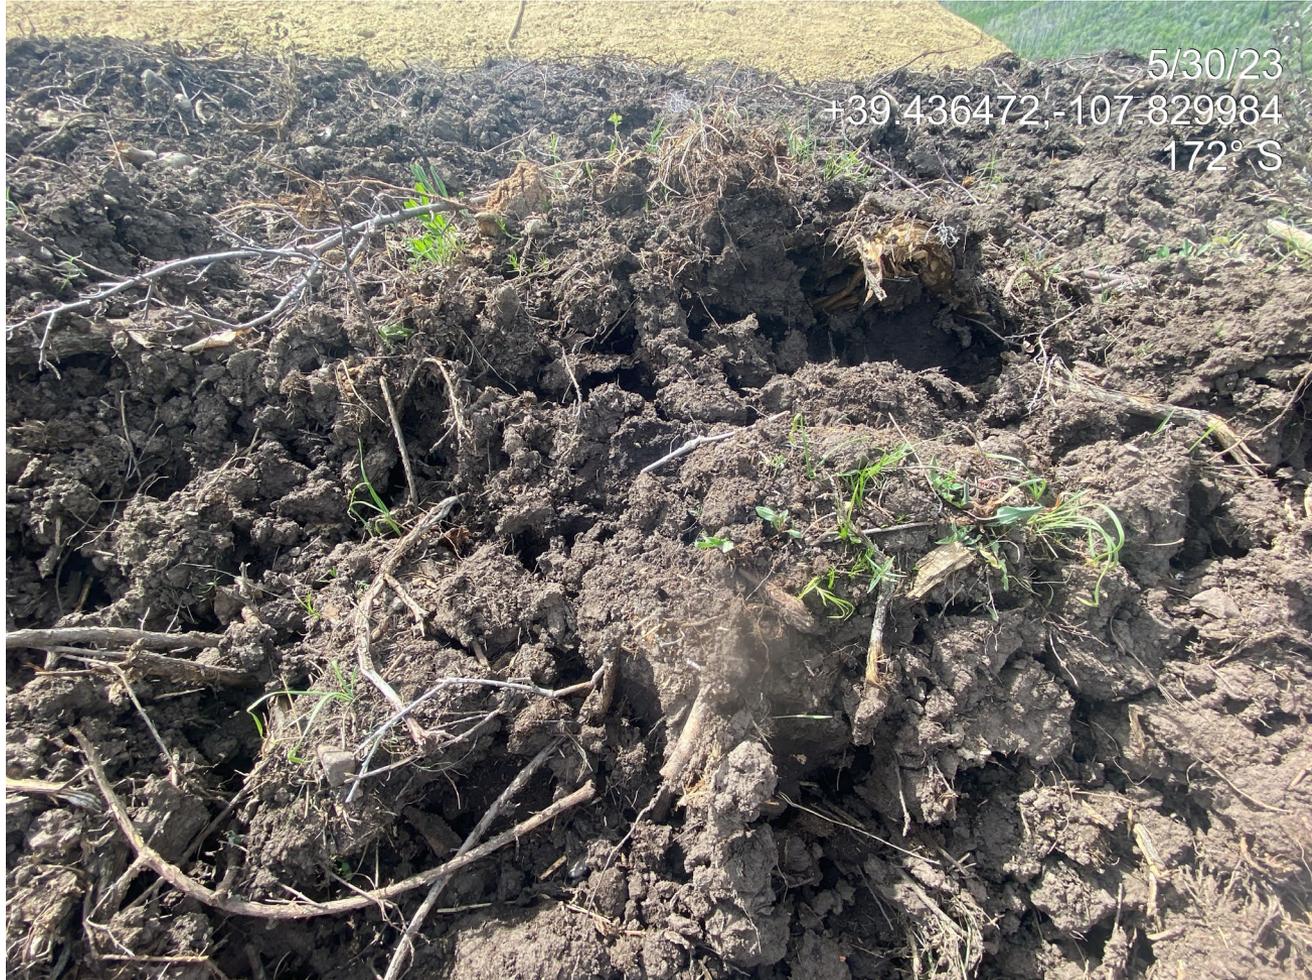
Photo 6. Photo taken from the north shows a close-up of the soil in Photos 4 and 5. The pile appears to contain topsoil. BMPs to protect topsoil from erosion degradation are missing/insufficient.

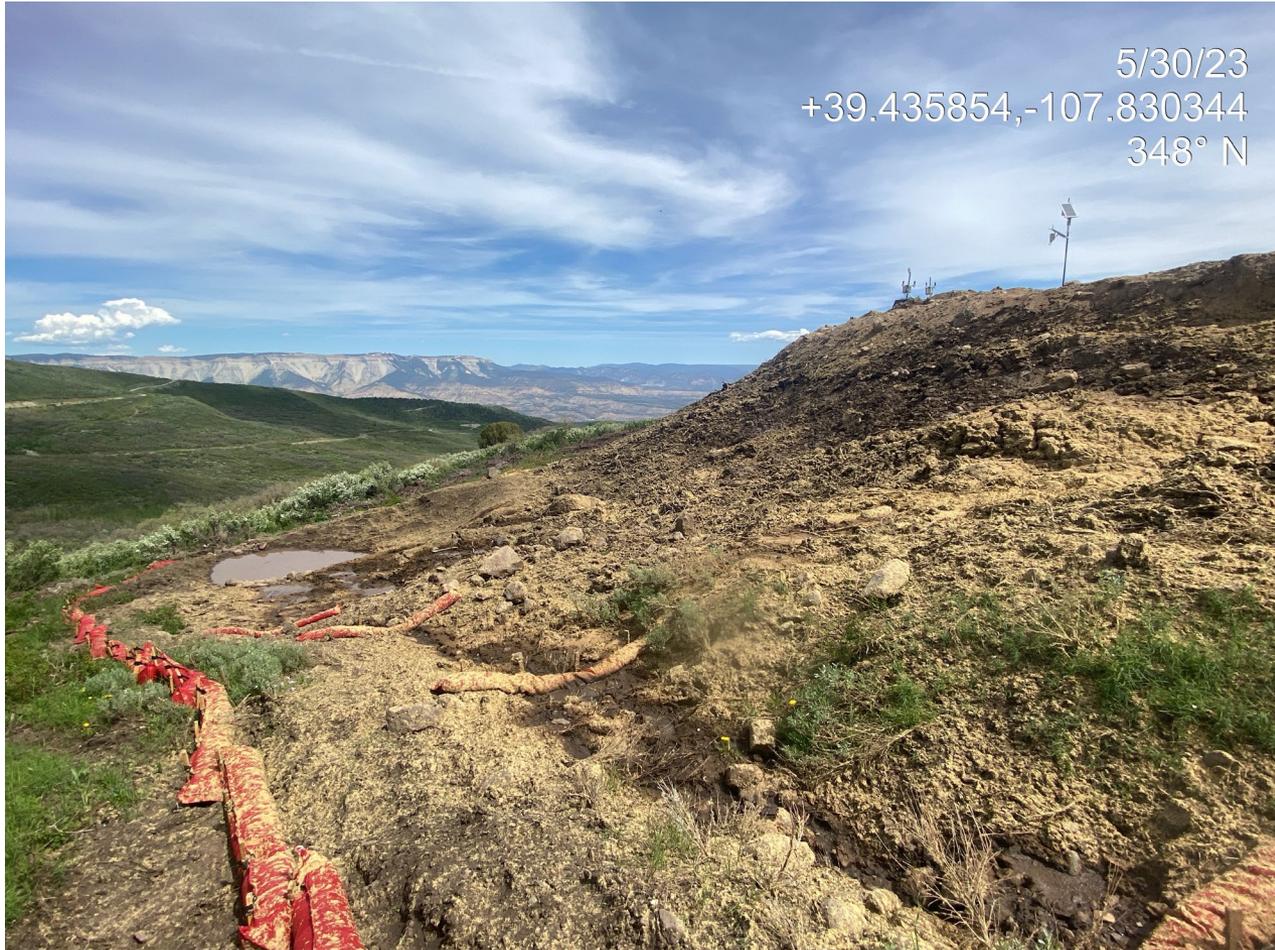
Photo 7. Photo taken from the northwest. Topsoil does not appear to have been salvaged at stormwater BMPs (note presence of intact vegetation).

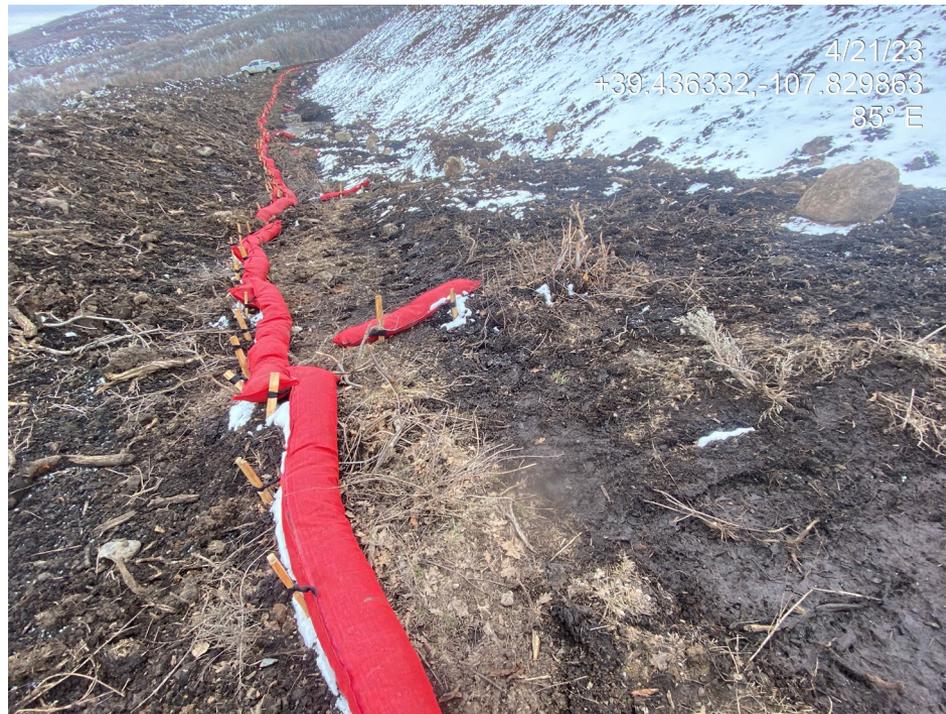
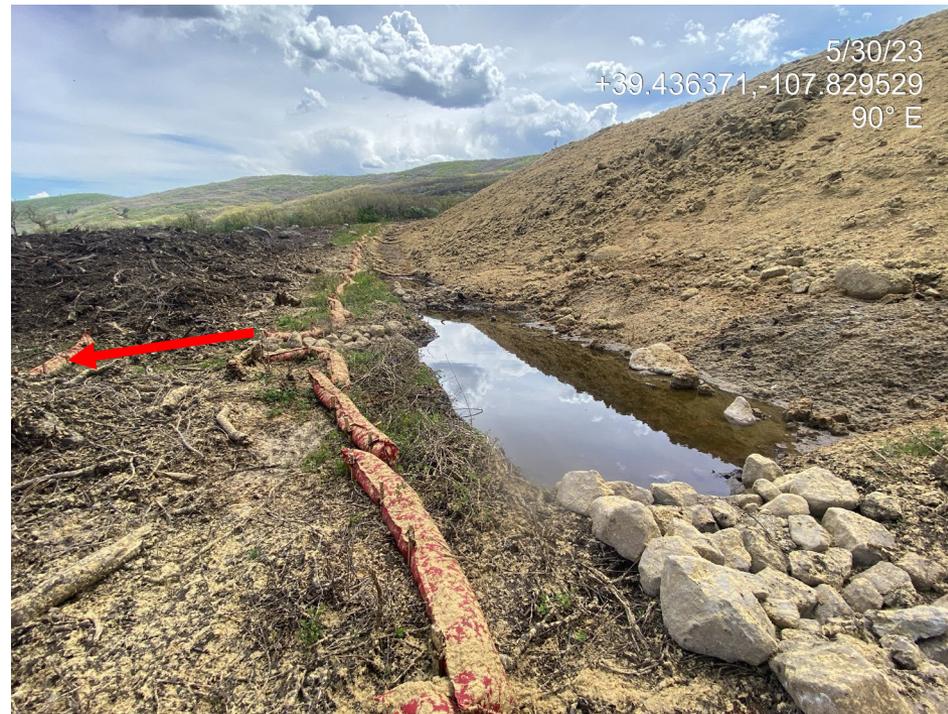
Photo 8. Photos taken from the north during the previous inspection (left) and current inspection (right). Topsoil does not appear to have been salvaged at stormwater BMPs (note presence of intact vegetation). Note also stormwater discharges from a sediment trap into stockpiles which appear to contain topsoil (arrow).

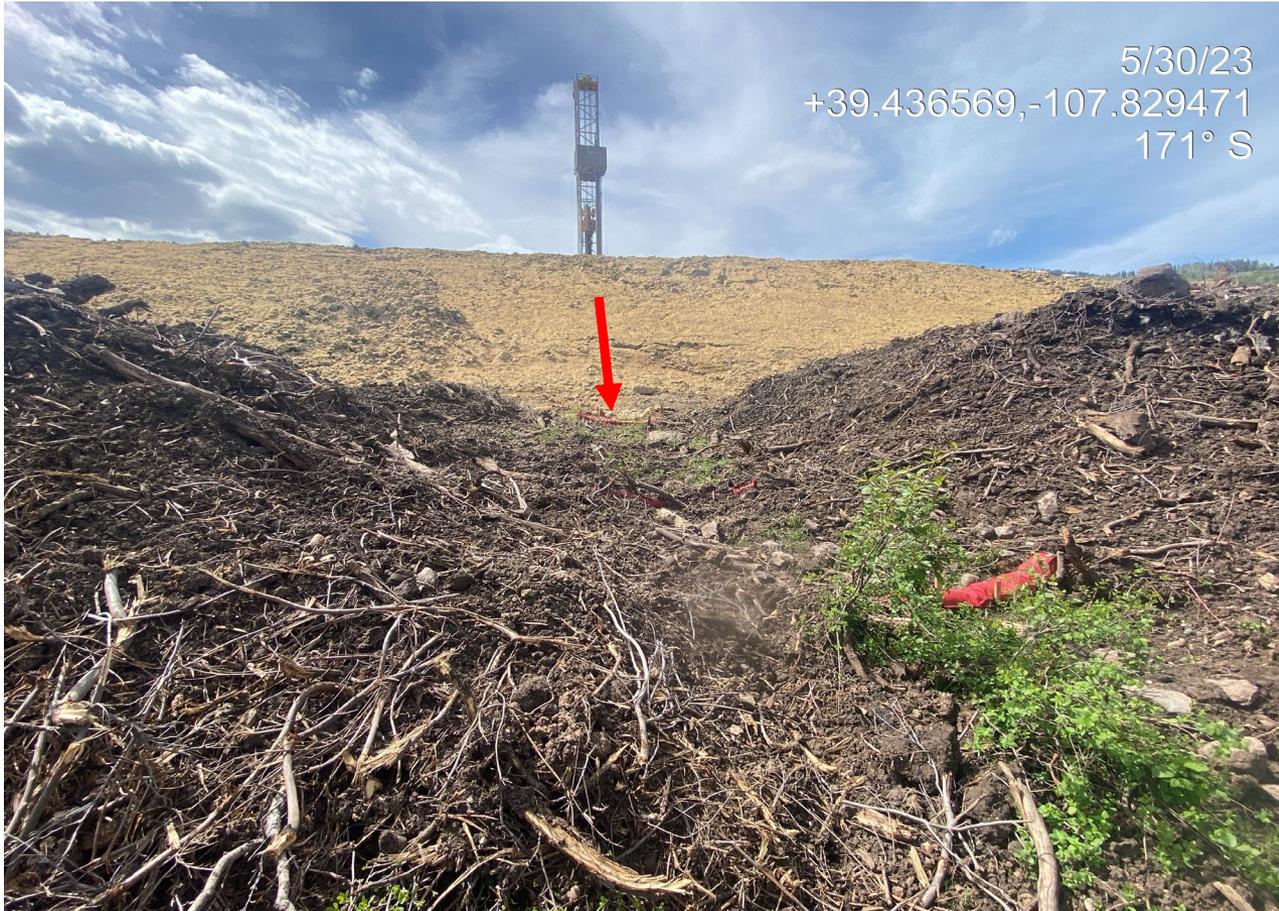
Photo 9. Photo shows where stormwater from a sediment trap (indicated by arrow and shown on previous slide) discharges into a ditch between two stockpiles which appear to contain topsoil. No BMPs present to protect unconsolidated topsoil from concentrated stormwater flows.

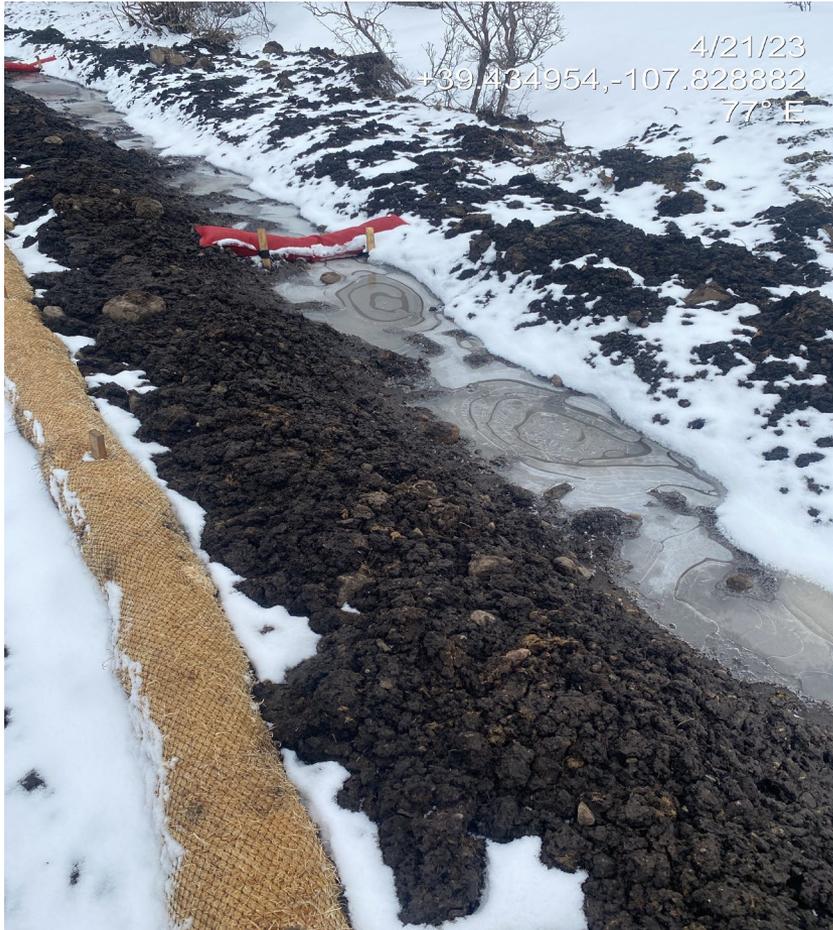
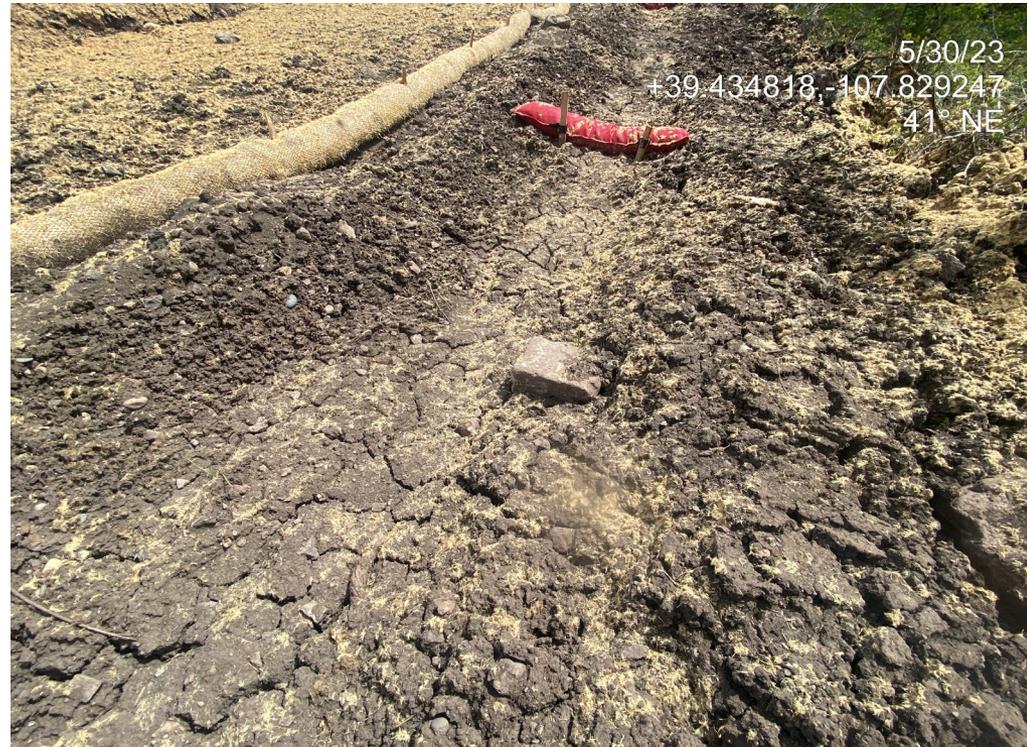
Photo 10. Photo taken from the south during the previous (left) and current (right) inspection. Topsoil does not appear to have been salvaged. Stormwater BMPs appear to be constructed from topsoil. Additionally, the ditch is constructed from loose, unconsolidated material susceptible to erosion from concentrated flows.

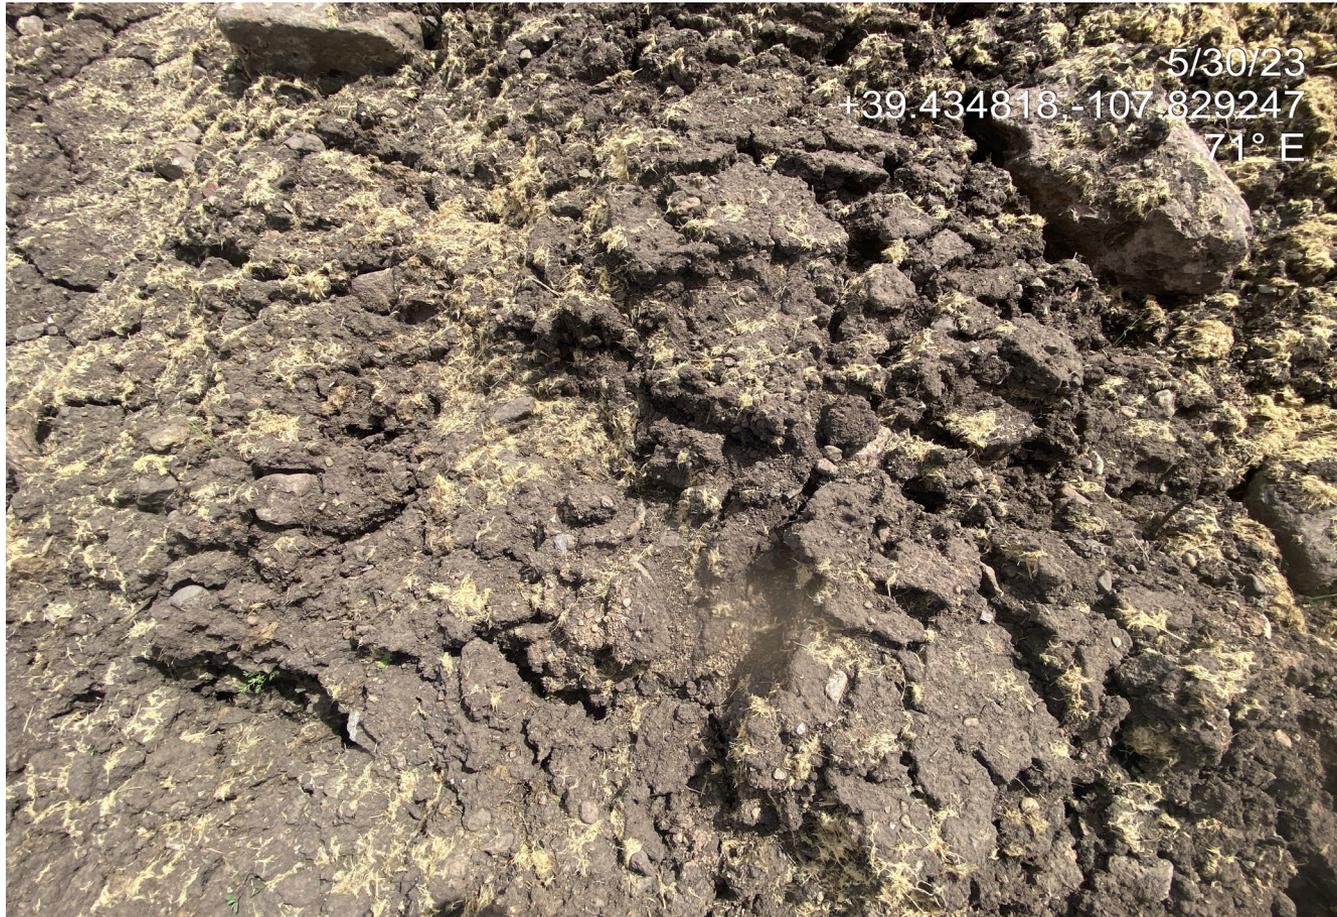
Photo 11. Photo shows a close-up of the ditch pictured on the previous slide. The ditch has not been stabilized and constructed per good engineering practices; soils are loose and unconsolidated and susceptible to erosion from concentrated flows.

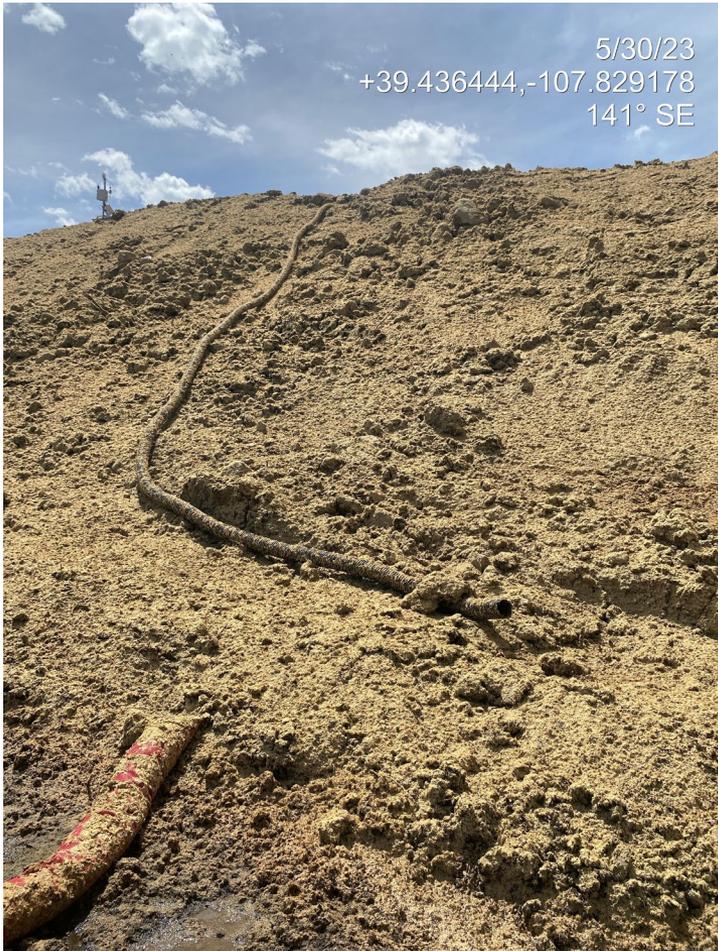
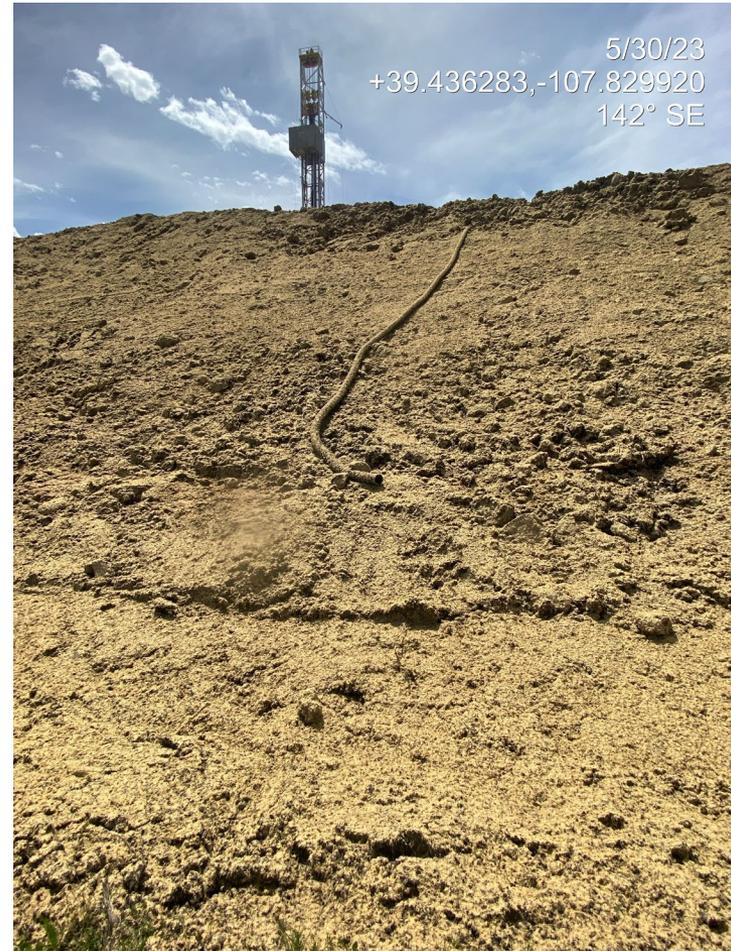
Photo 12. Photos show examples of two (2) slope drains which have not been installed per good engineering practices; the pipe is not properly anchored, the pipe is discharging mid-slope/does not extend beyond the toe of the slope and lacks proper outlet protections.

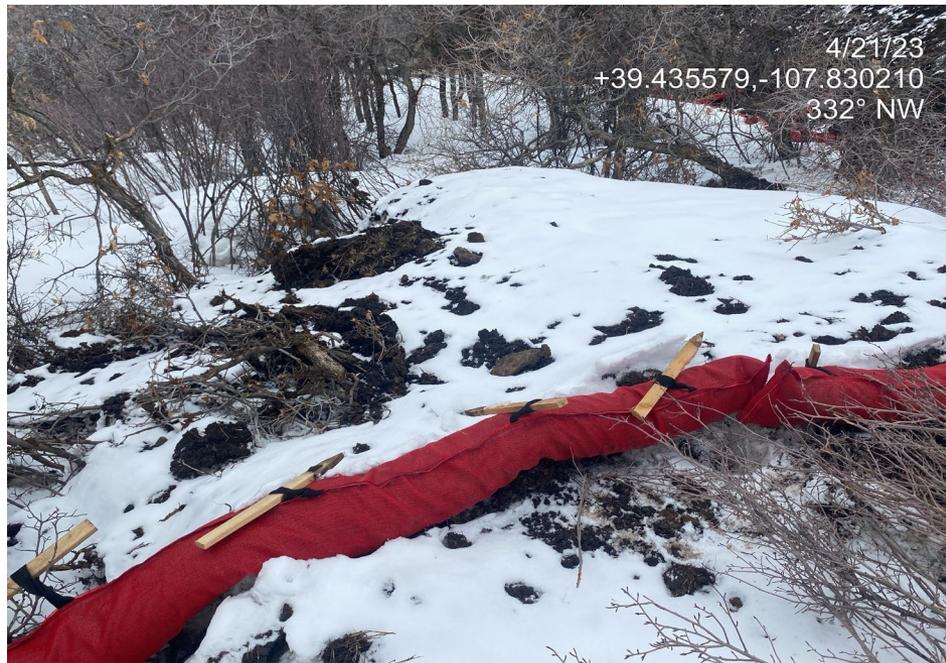
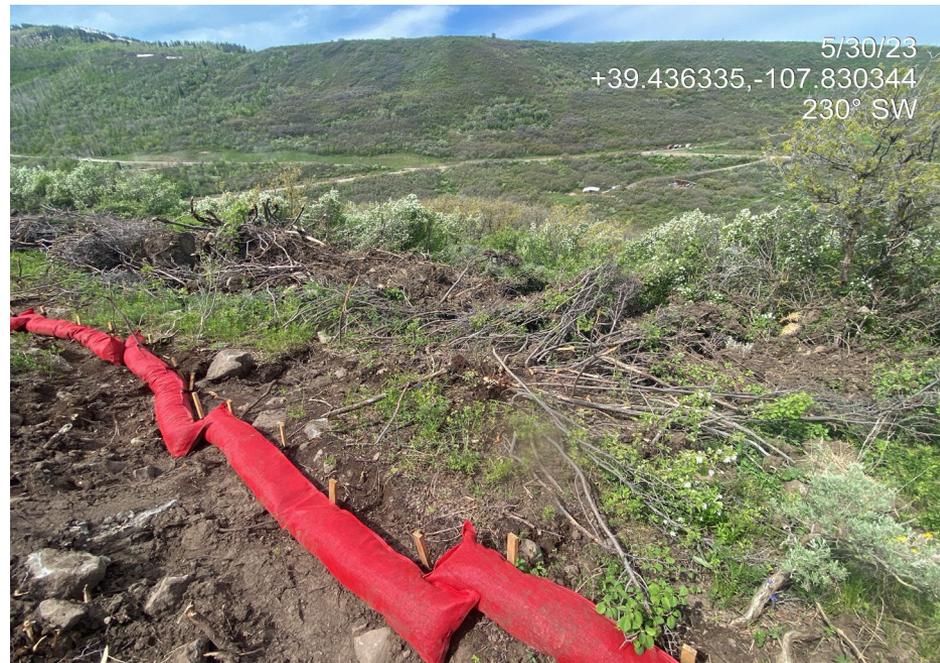
Photo 13. Photo shows perimeter stormwater BMPs at the west of the location previously in disrepair (left) have been properly installed and are in proper functioning condition during the current inspection (right).

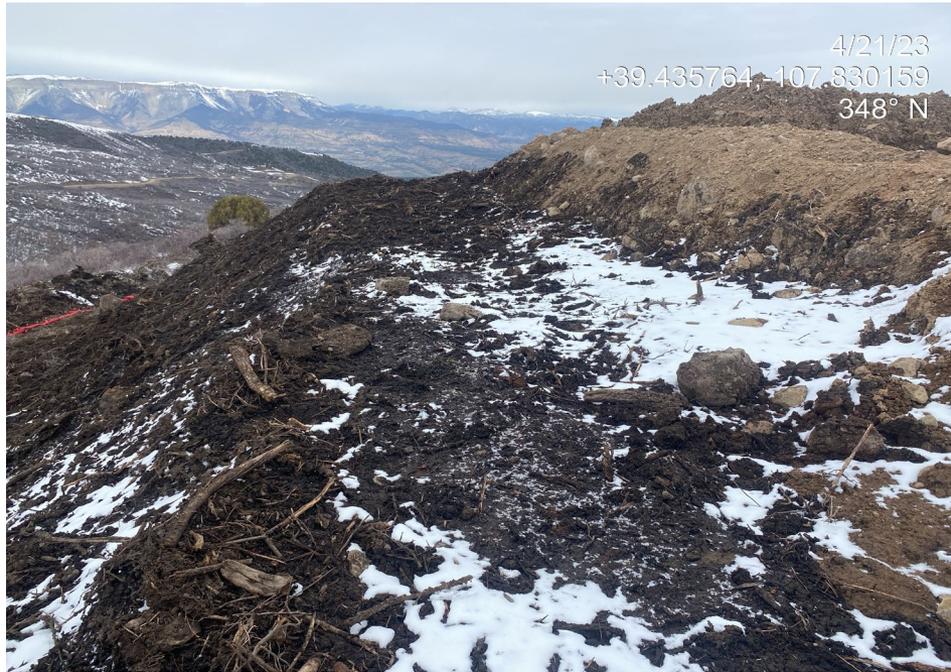
Photo 14. Photo shows the western fill slope during the previous inspection. BMPs to segregate and protect topsoil from mixing with the lighter colored subsoil berm are missing/insufficient. Additionally, topsoil is bare, loose and unconsolidated and susceptible to erosion.

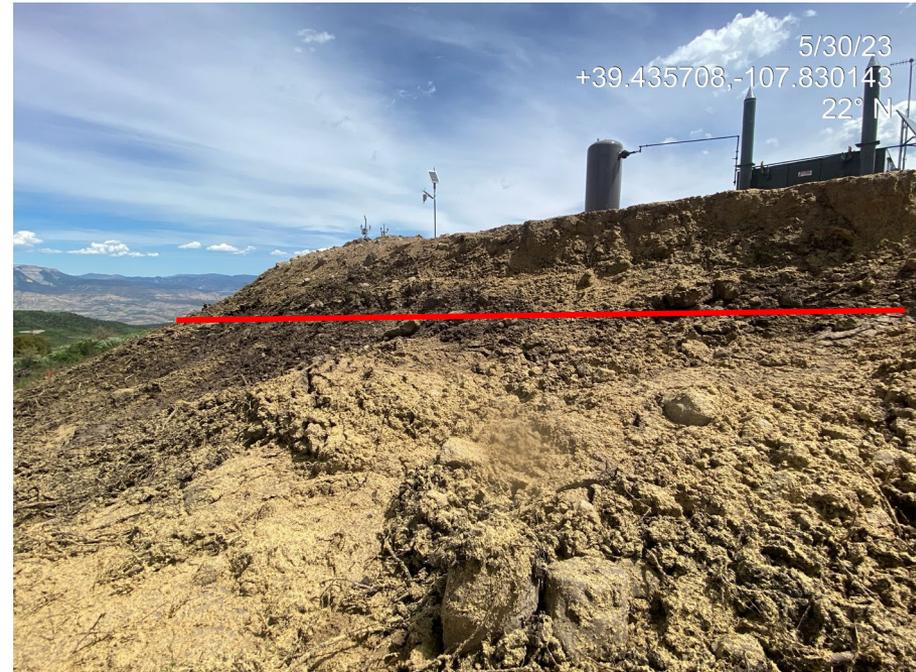
Photo 15. Photo shows the western fill slope during the current inspection. Although Hydromulch has been applied to stabilize topsoil (approximately below the line) BMPs to segregate and protect topsoil from mixing/contamination with the subsoil berm (approximately above the line) are missing/insufficient.

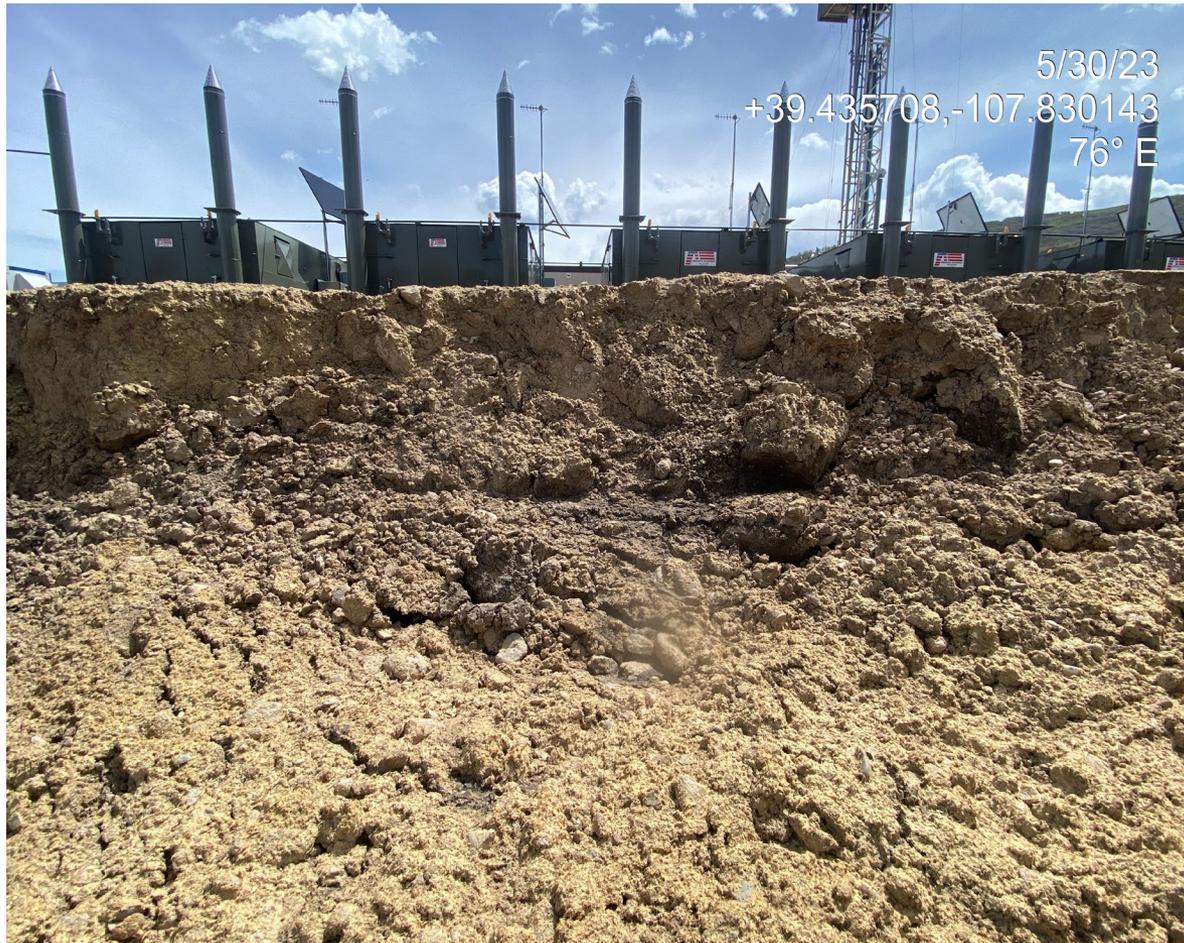
Photo 16. Photo taken from the northwest shows the location perimeter berm is not constructed in accordance with good engineering practice. The berm is loose, unconsolidated, and portions are vertical.

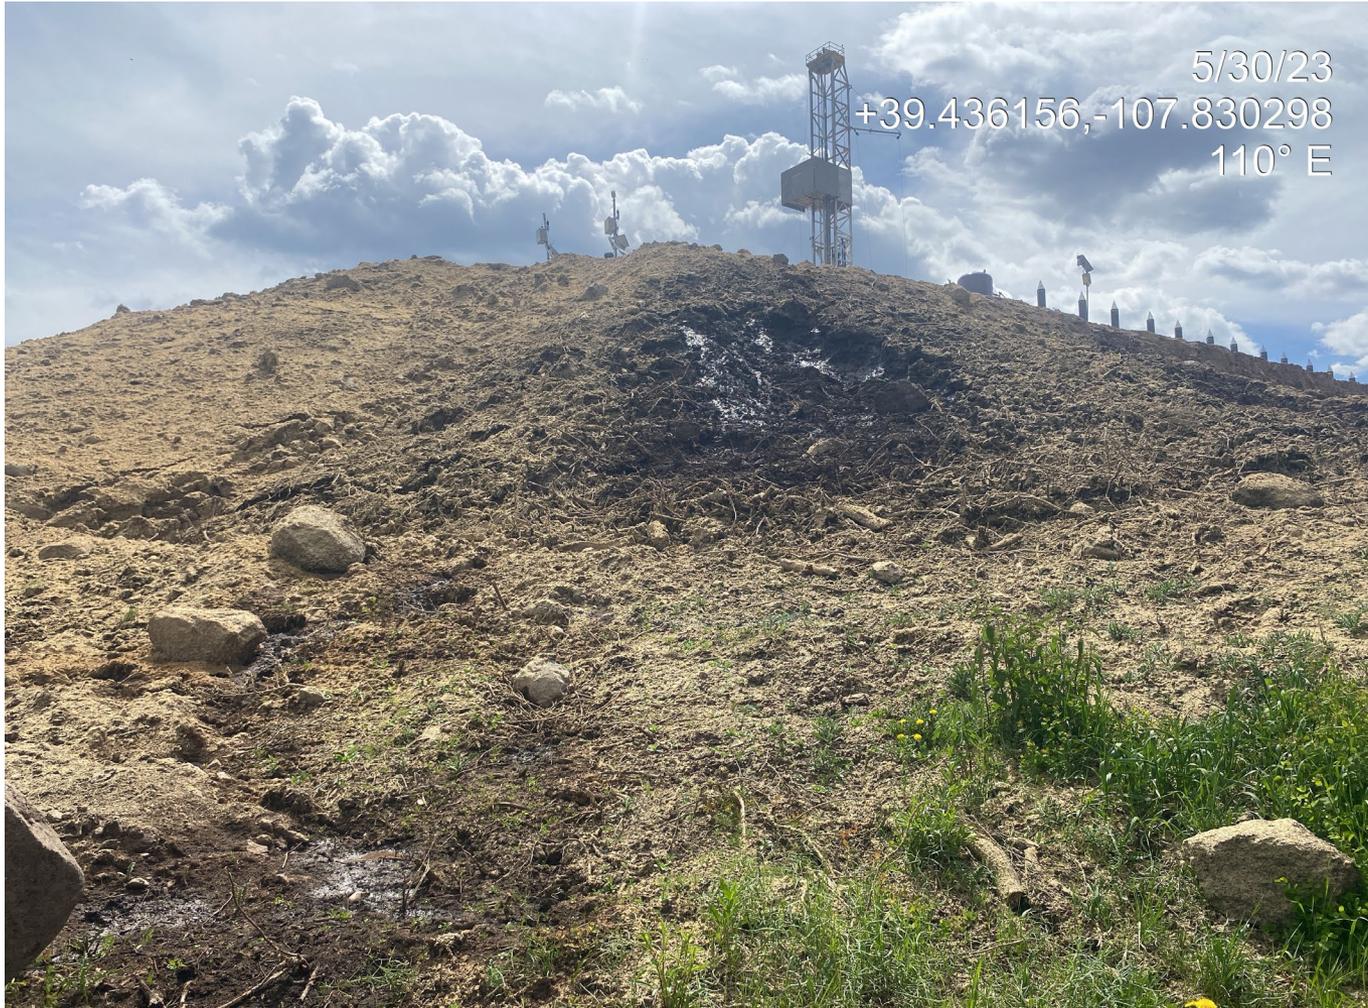
Photo 17. Photo shows a slump that has occurred in the northwest fill slope of the location.

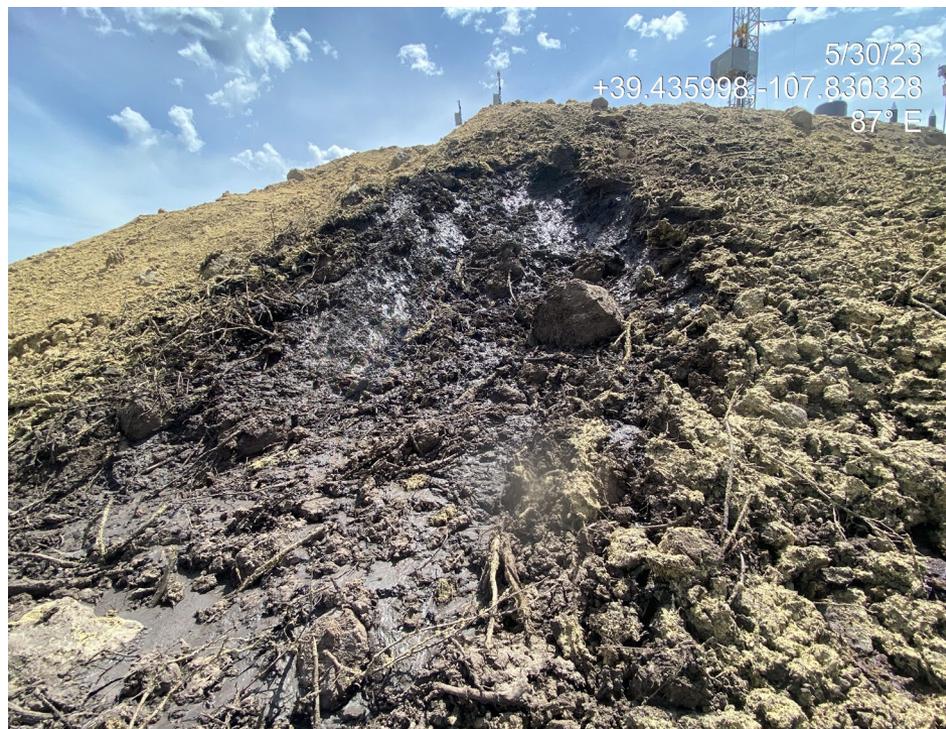
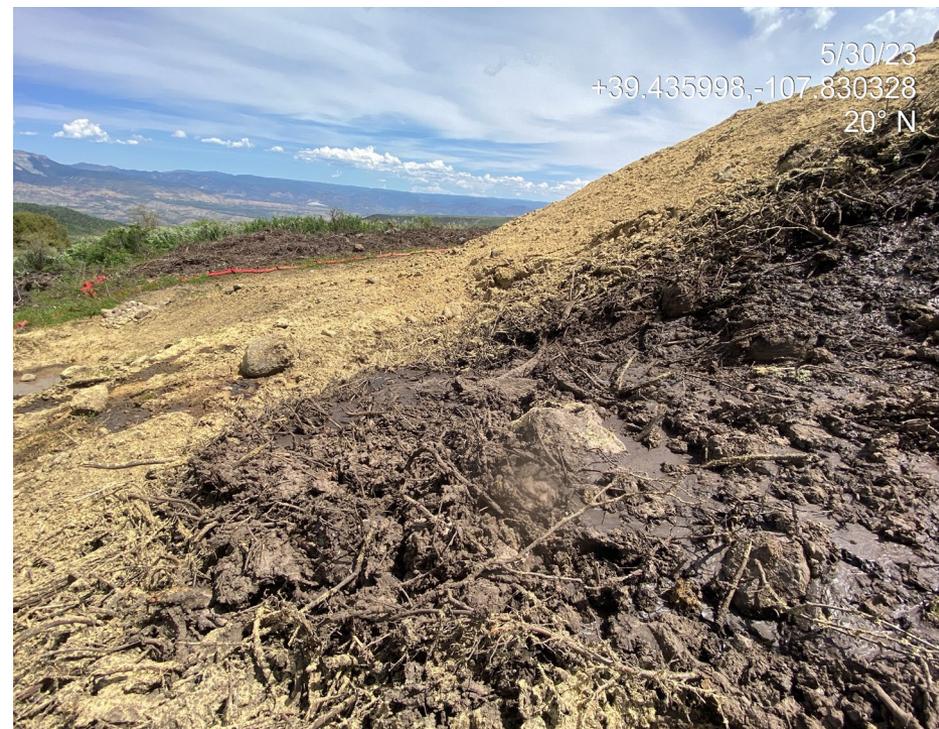
Photo 18. Photos show the top (left) and base (right) of a slump that has occurred in the northwest fill slope of the location.
