Inspection Photos

Operator: TEP Rocky Mountain- #96850

Location Name: South Leverich /13-09 Pad

Inspection Document #: 702801561

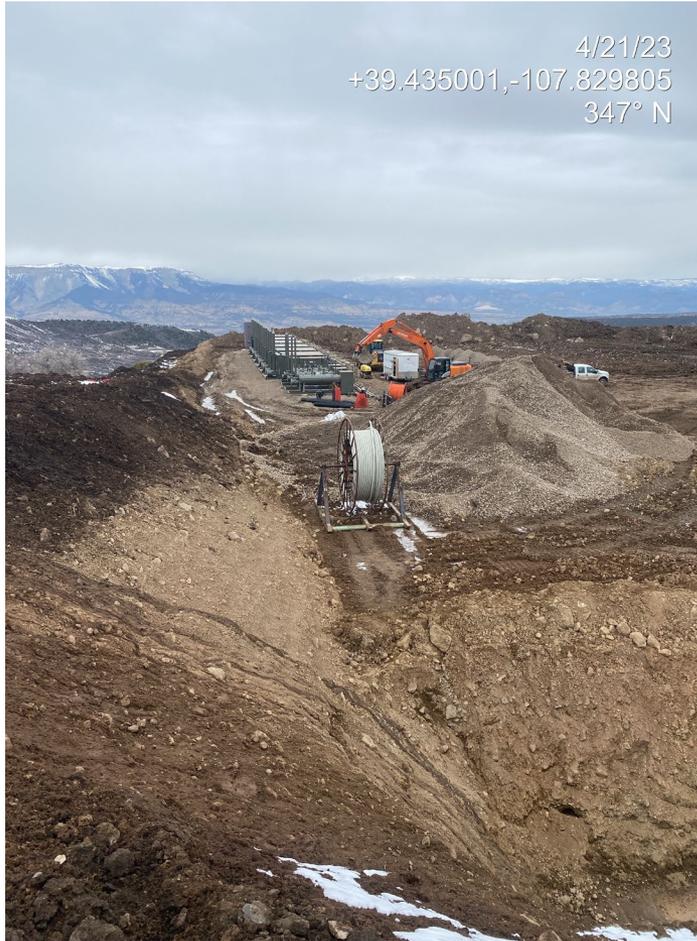
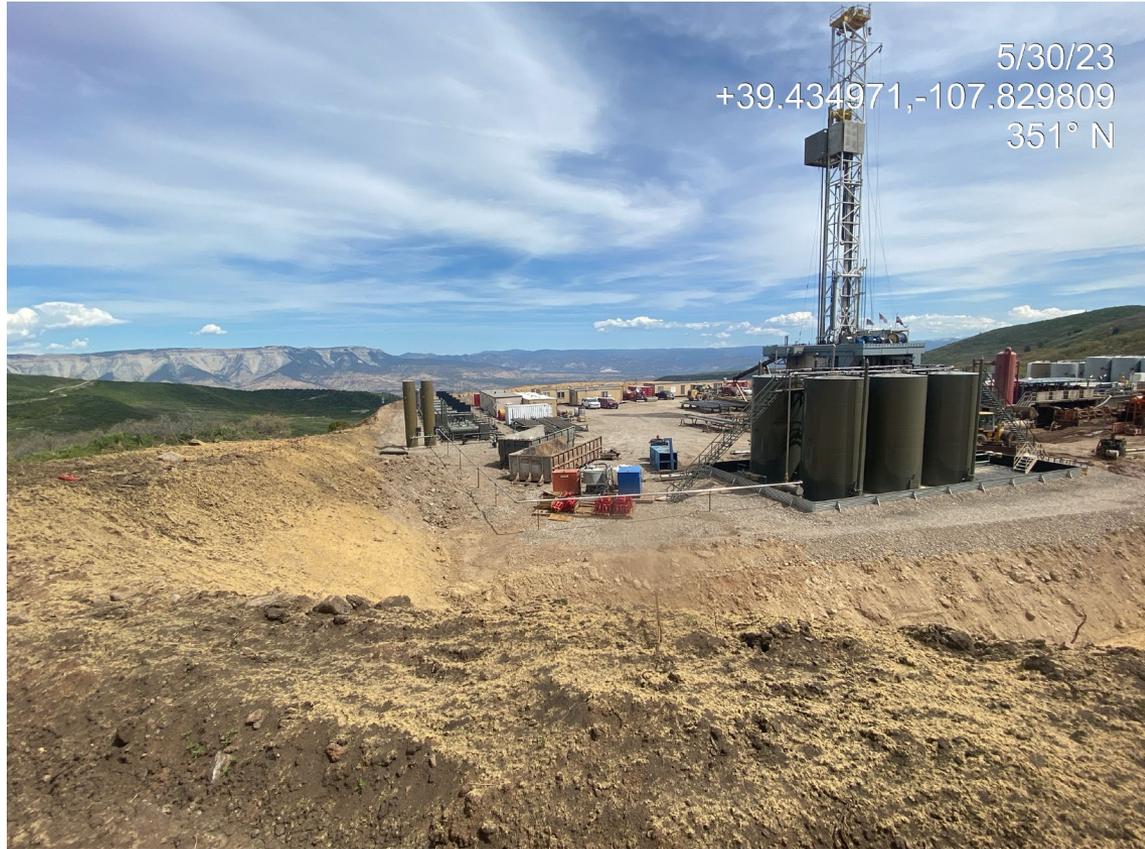
Photo 19. Photo taken from the southwest shows unstabilized and eroding slopes during the previous inspection (left) have been stabilized with Hydromulch (right).

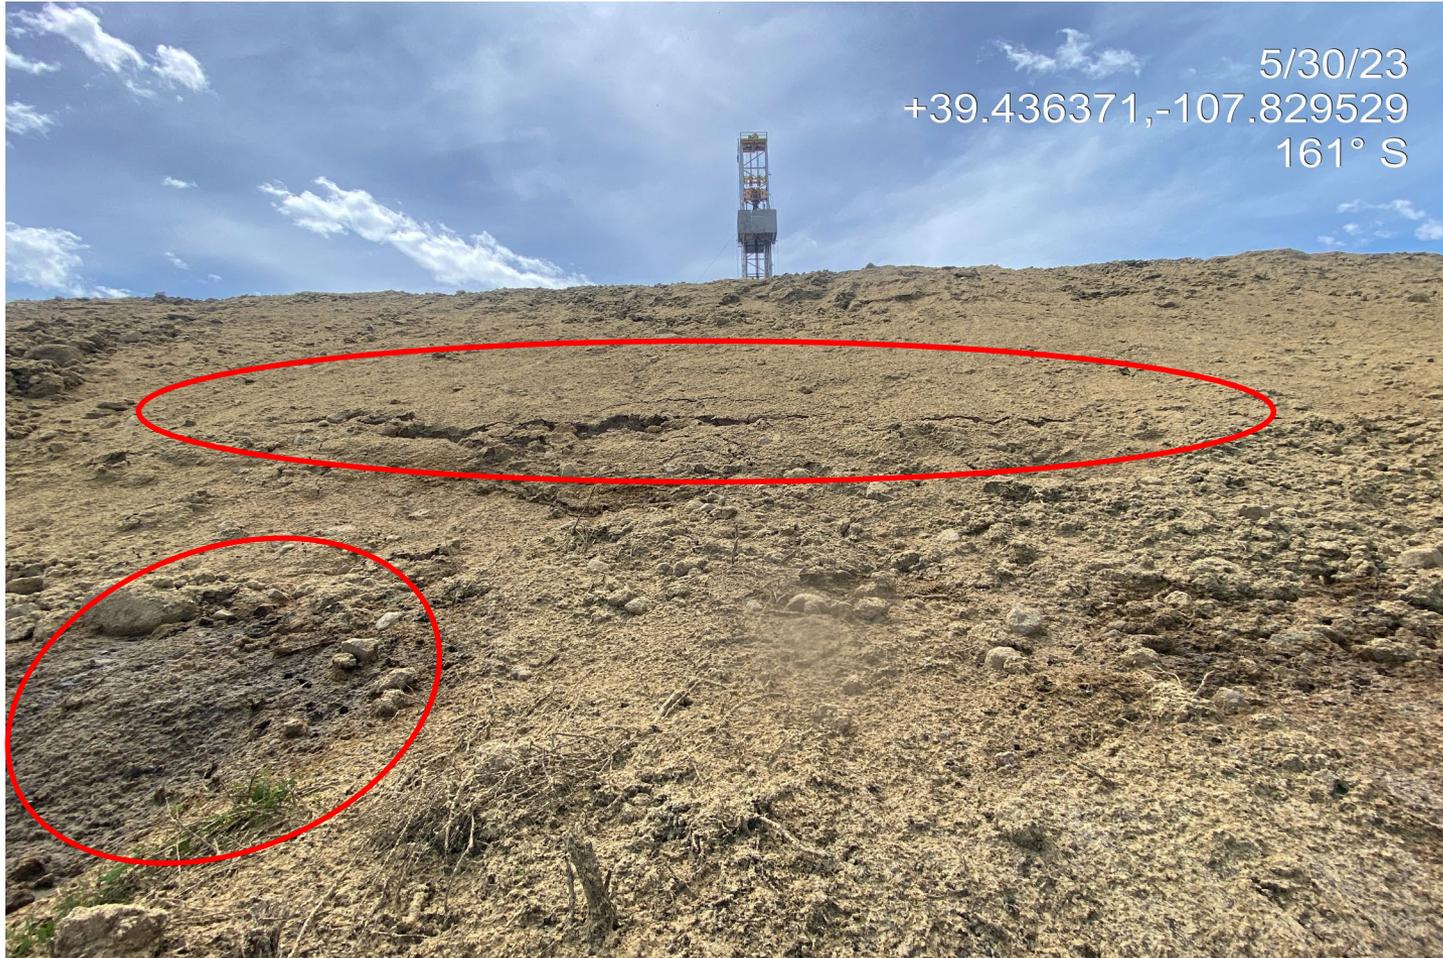
Photo 20. Photo shows fill slopes have been stabilized with Hydromulch. However, slumping of slopes is occurring indicating a lack of stabilization and degrading the Hydromulch coverage.

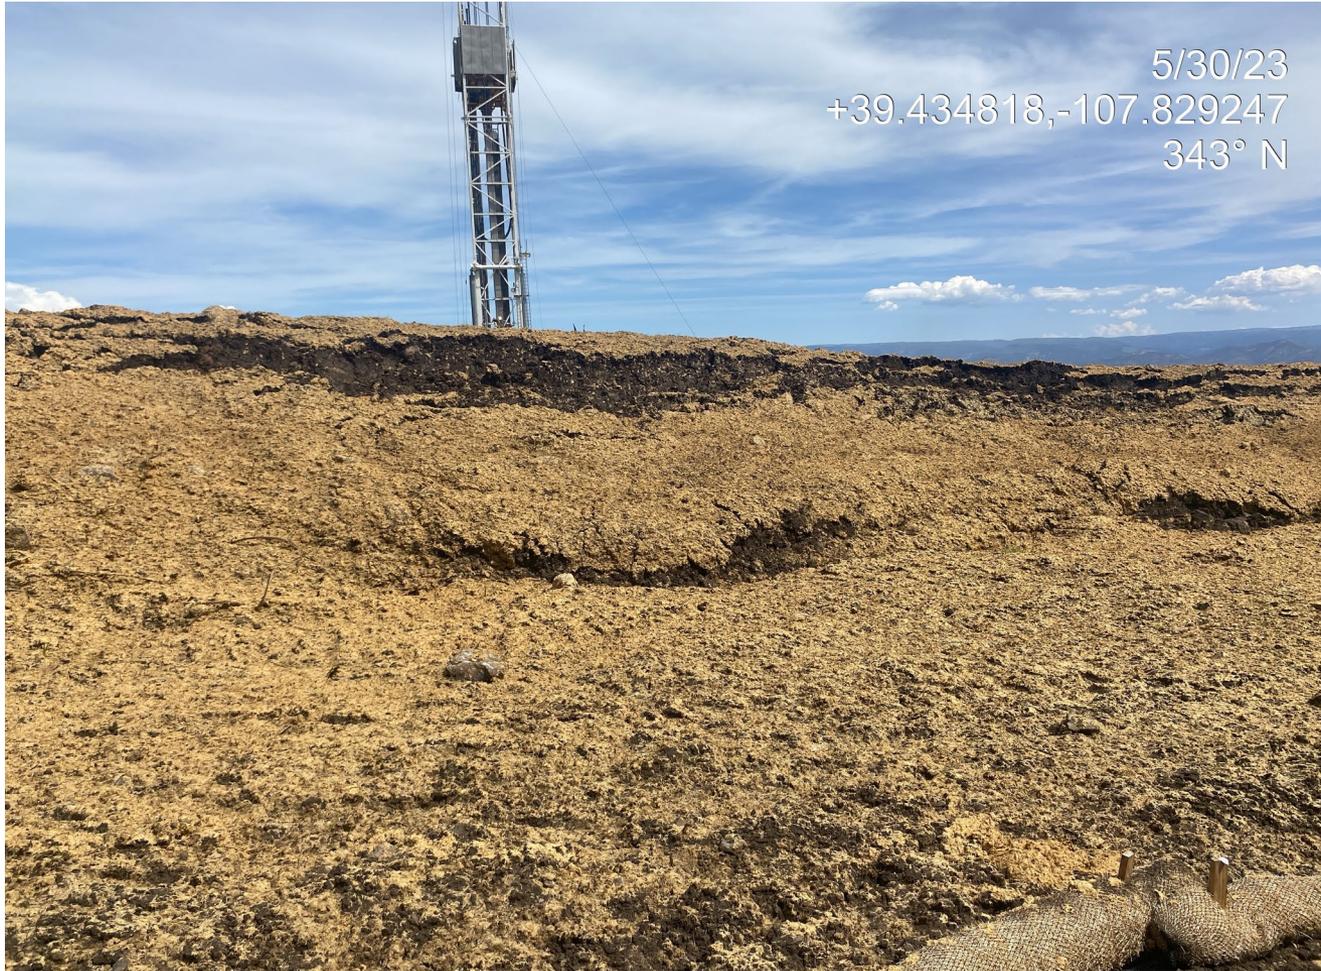
Photo 21. Photo shows degradation of the Hydromulch on a portion of the topsoil stockpile at the south of the location. The Hydromulch is evenly and thoroughly applied to the rest of the topsoil pile.

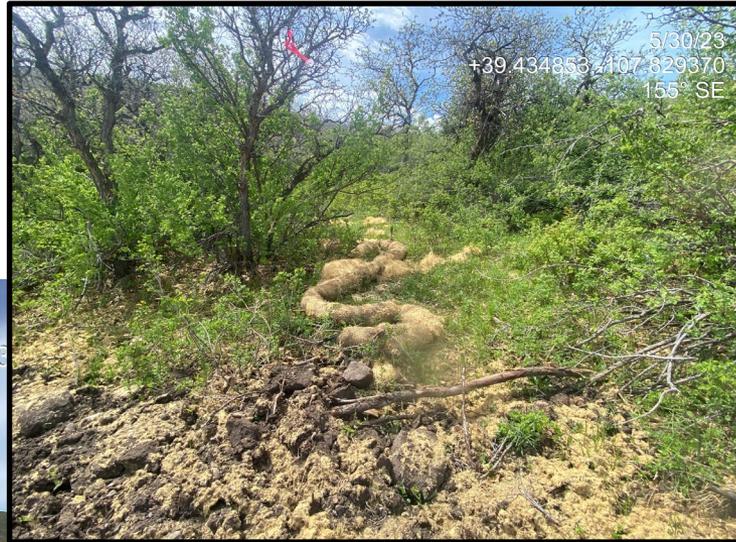
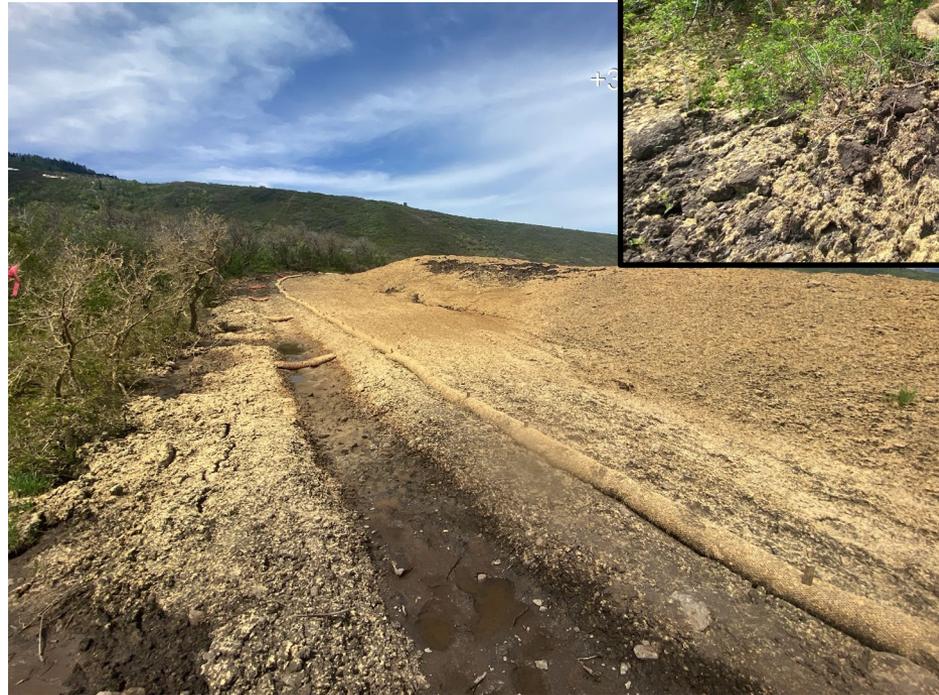
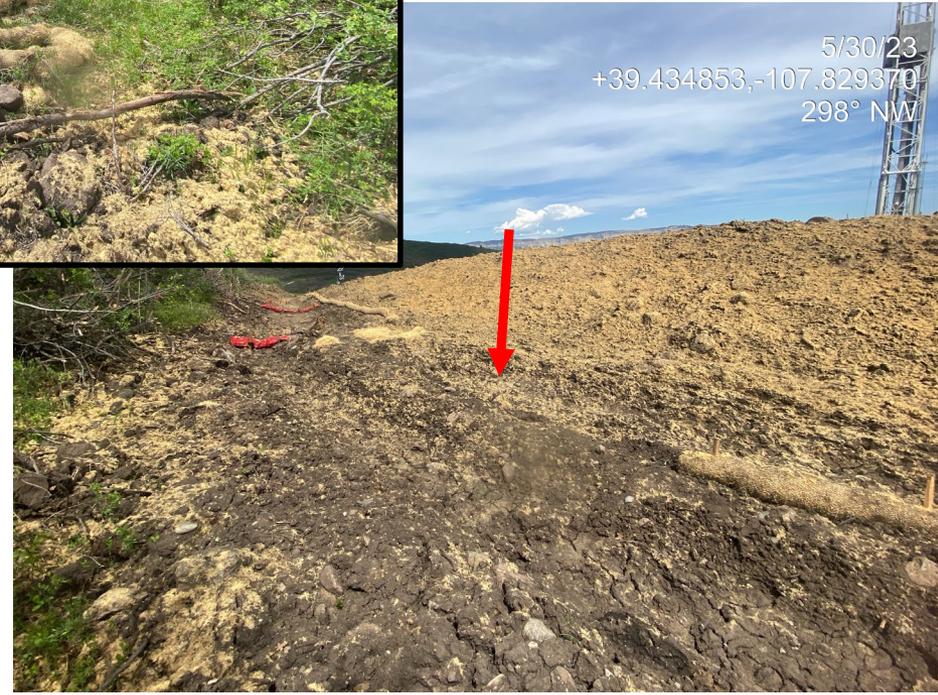
Photo 22. Photos show the topsoil stockpile at the south of the location. Wattles are trenched and backfilled (left). However one wattle is in disrepair and no longer functioning (center, right).

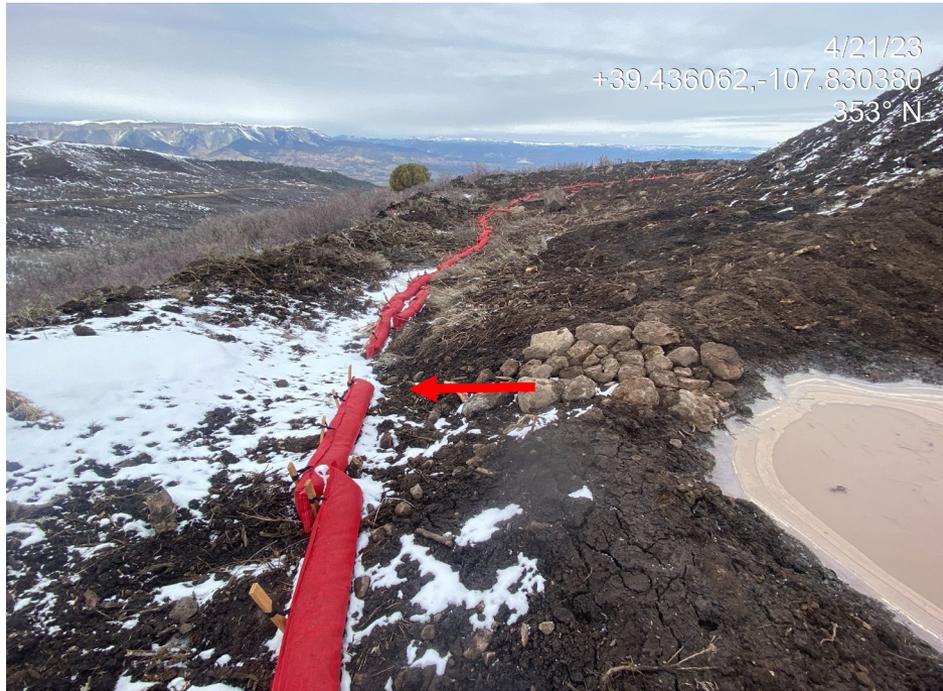
Photo 23. Photo taken during the previous inspection shows a sediment trap to the northwest was designed to discharge stormwater directly into an unvegetated, unstabilized topsoil berm.

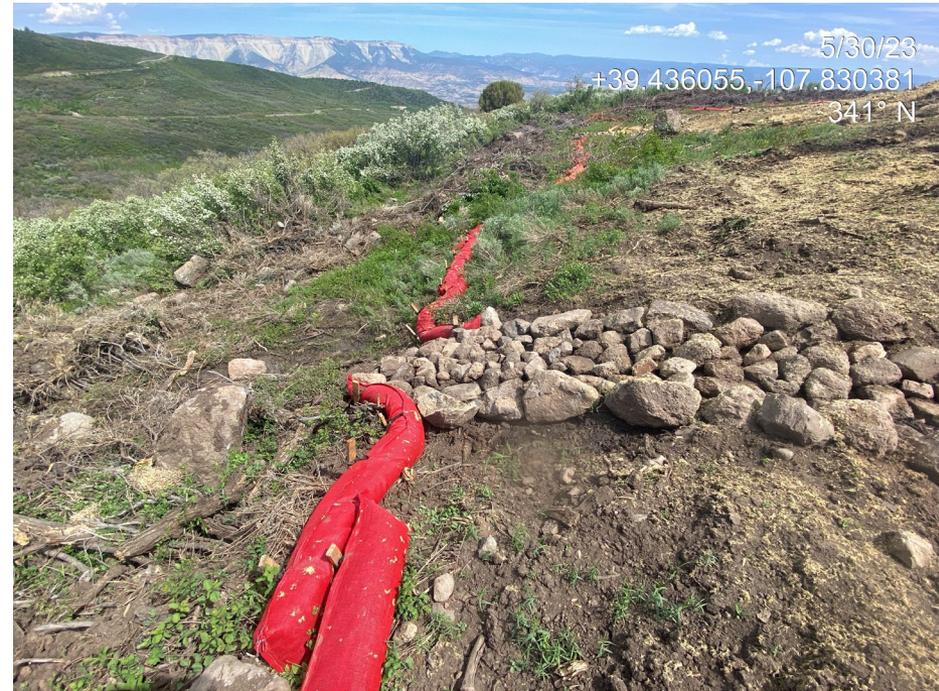
Photo 24. Photo taken during the current inspection shows the sediment trap is now discharging stormwater offsite into a vegetated, stabilized area.

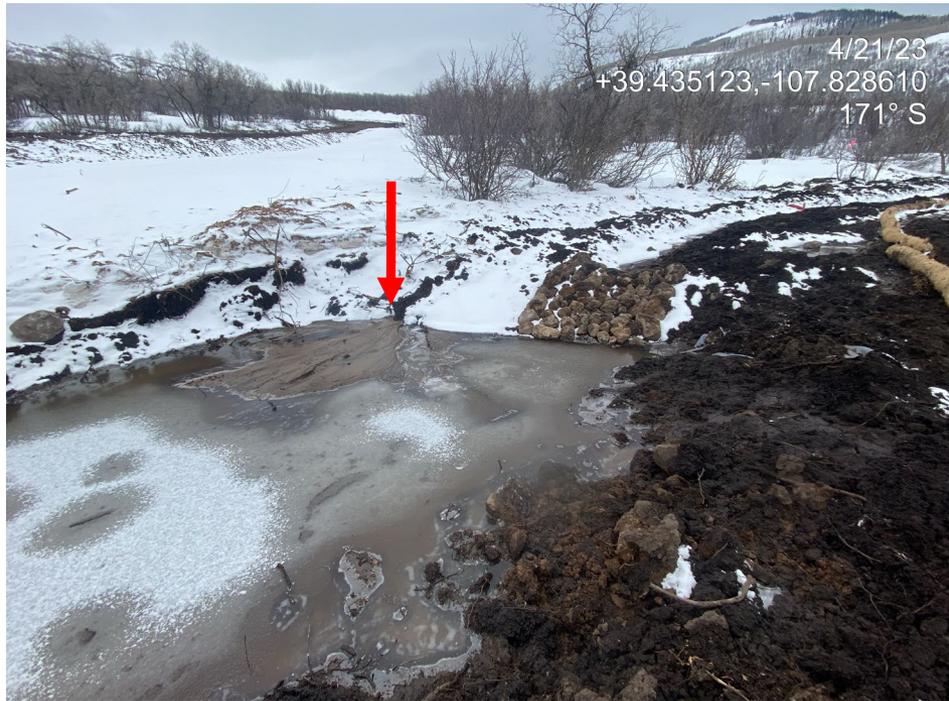
Photo 25. Photo taken from the southeast during the previous inspection shows degradation where stormwater was bypassing an armored inlet to a sediment trap.

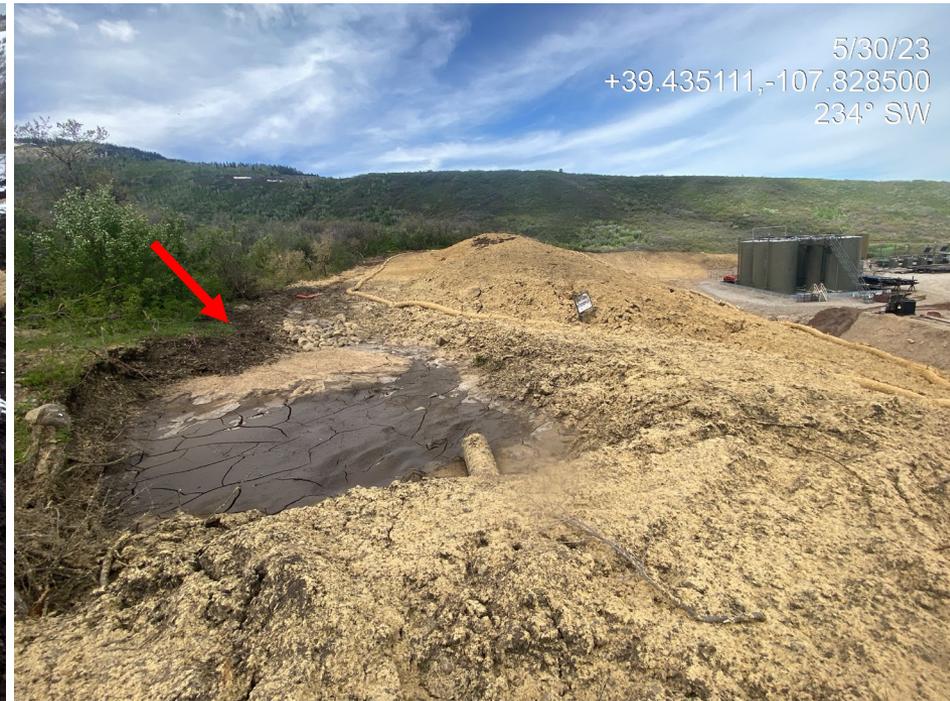
Photo 26. Photo shows the sediment trap pictured in Photo 25 during the current inspection. No controls present to manage run-on which is bypassing an armored inlet to the sediment trap.

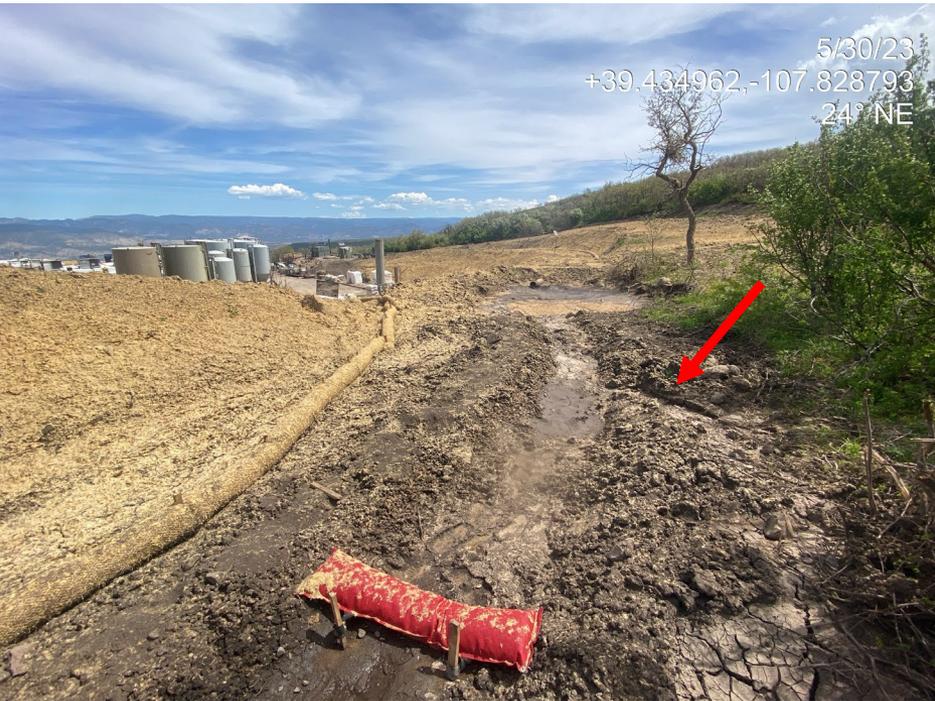
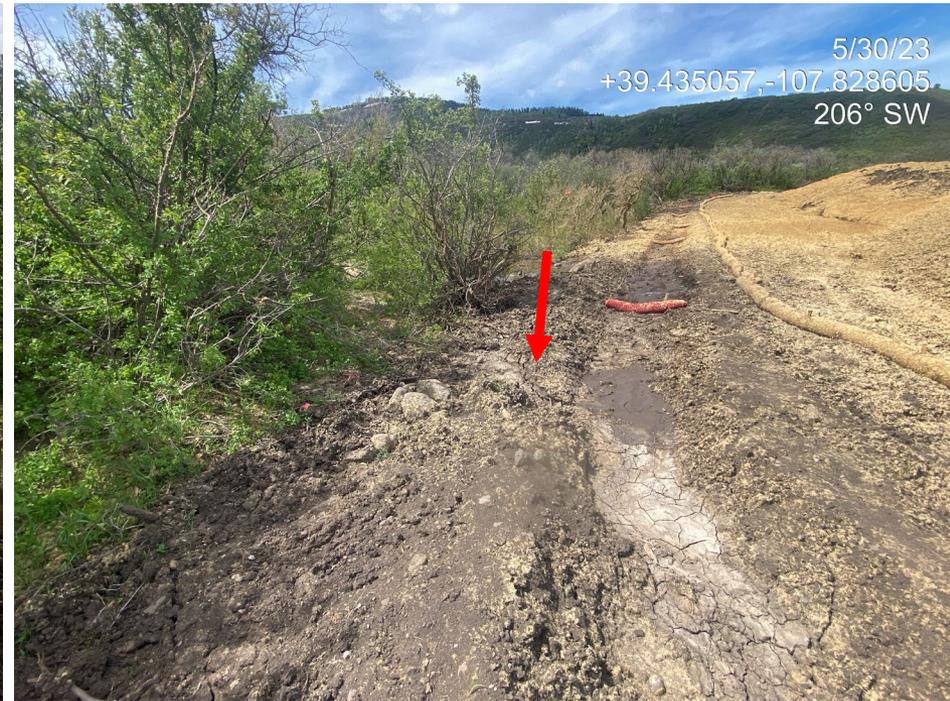
Photo 27. Photos taken from the southeast shows where run-on is breaking through a berm into the perimeter run-on diversion ditch causing degradation to the ditch and berm BMPs. Note also the ditch appears to be constructed from topsoil and is built from loose, unconsolidated martial which is susceptible to erosion from concentrated flows in the ditch.

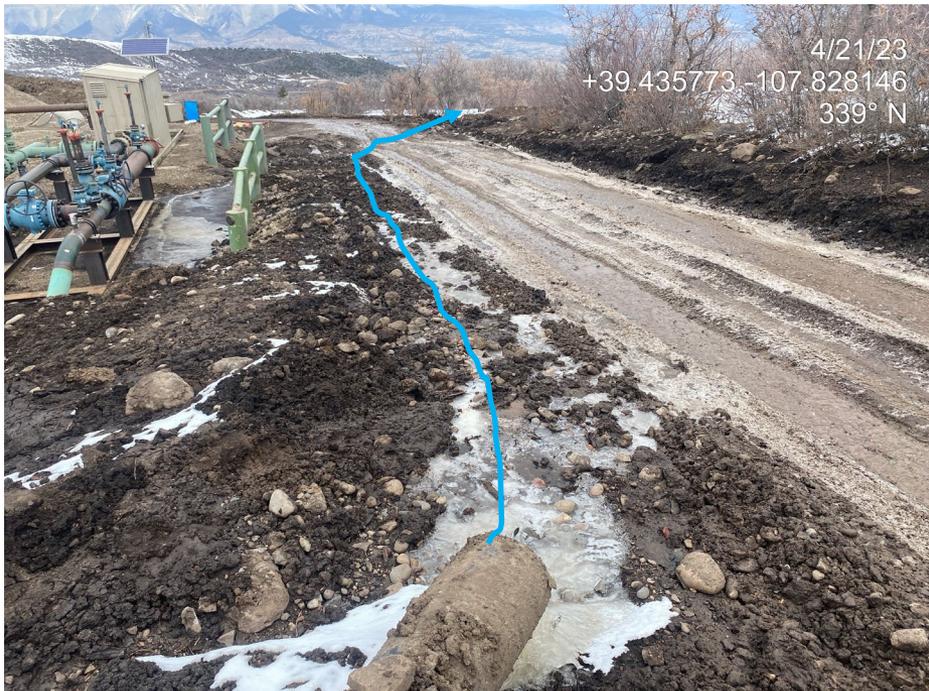
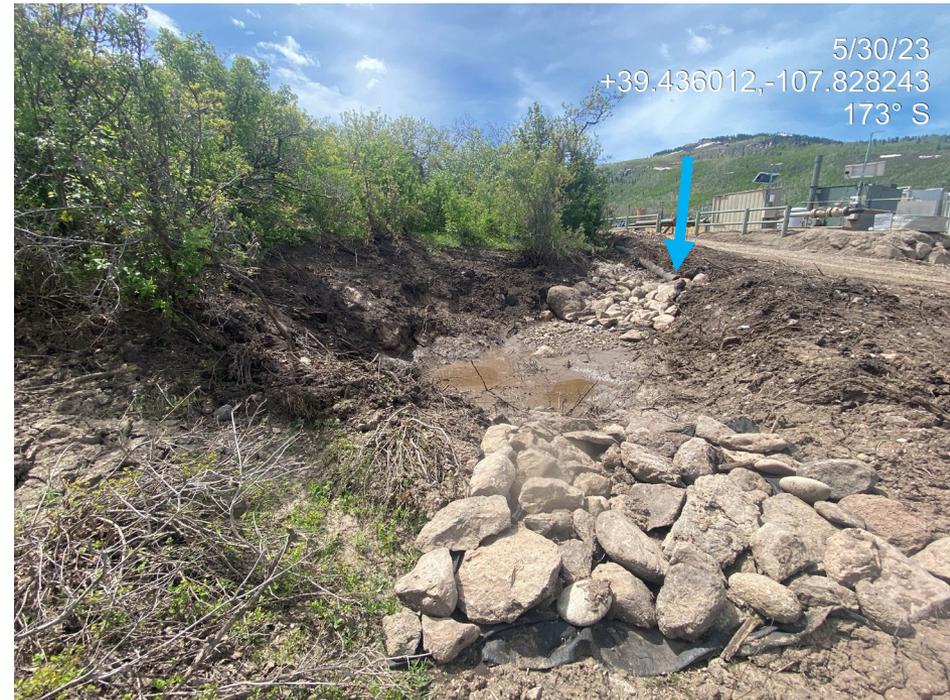
Photo 28. Photo taken from the east shows a drain discharging concentrated stormwater flows without outlet protections during the previous inspection (left). During the current inspection, flows are diverted under the road and discharged to the east of the road at an armored outlet into a sediment trap (right). Note also sediment trap walls appear to be constructed from topsoil and are loose and unconsolidated and susceptible to erosion. This pipe diversion, and sediment trap on the east of the road appears to be outside the permitted disturbance area for the location.

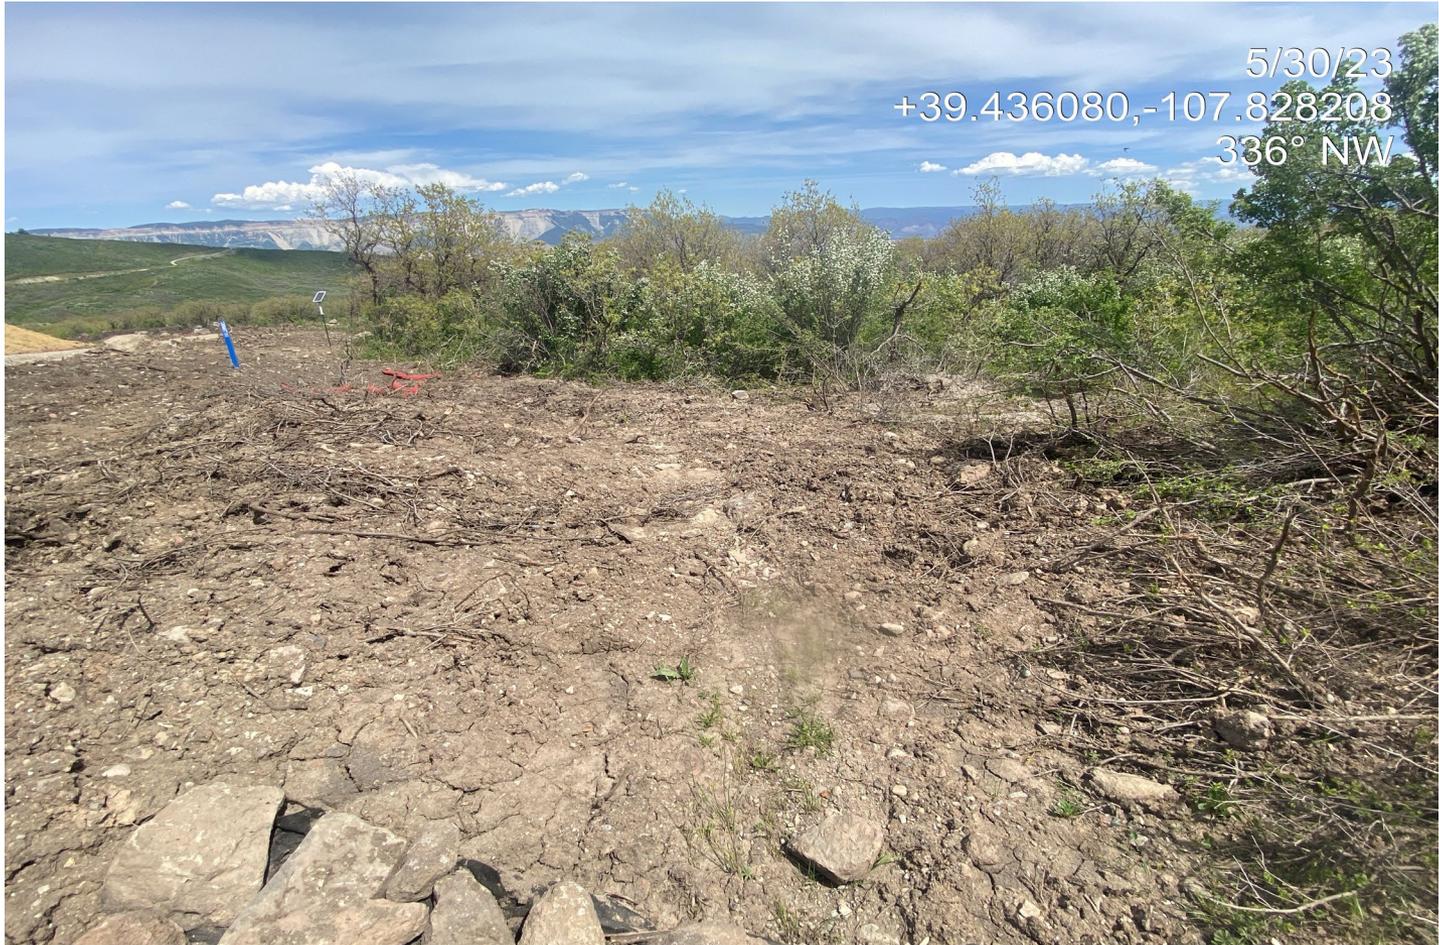
Photo 29. Photo shows the outlet for the sediment trap pictured on the previous slide is discharging stormwater into loose, unconsolidated soil subject to erosion. Photo also shows what appears to be an unpermitted area of disturbance to the east of the access road.

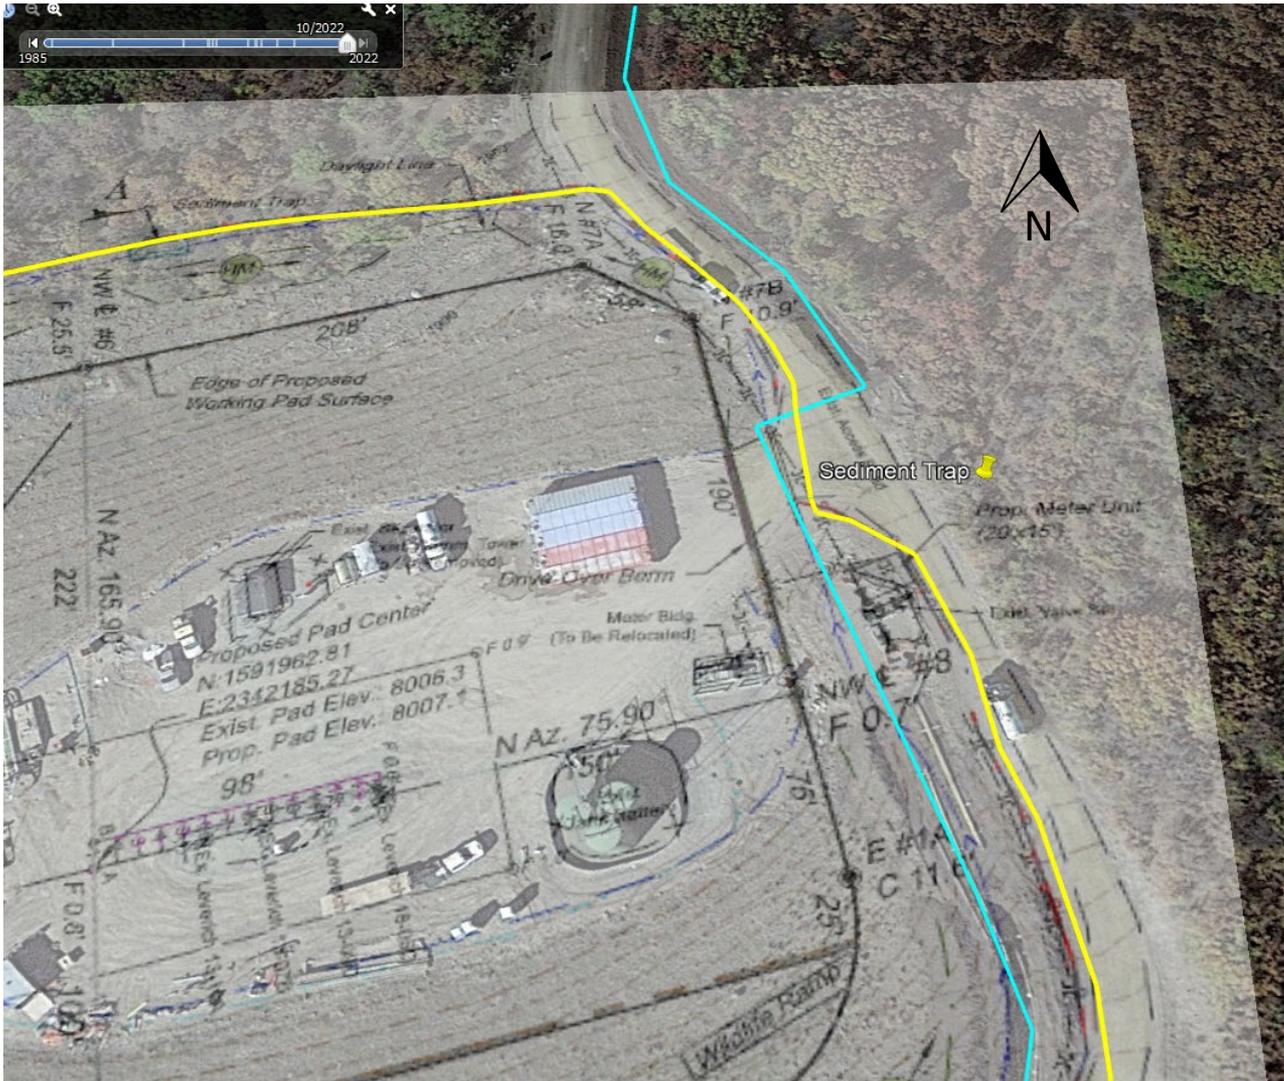
Photo 30. Photo shows the sediment trap area pictured on the previous two slides. Disturbance to the east of the road in the area of the sediment trap appears to be outside the permitted disturbance (yellow line). The blue line indicates a mapped produced water pipeline disturbance. Note also the layout drawing shows the stormwater ditch continuing to the north around the perimeter of the location, not to the east of the road.

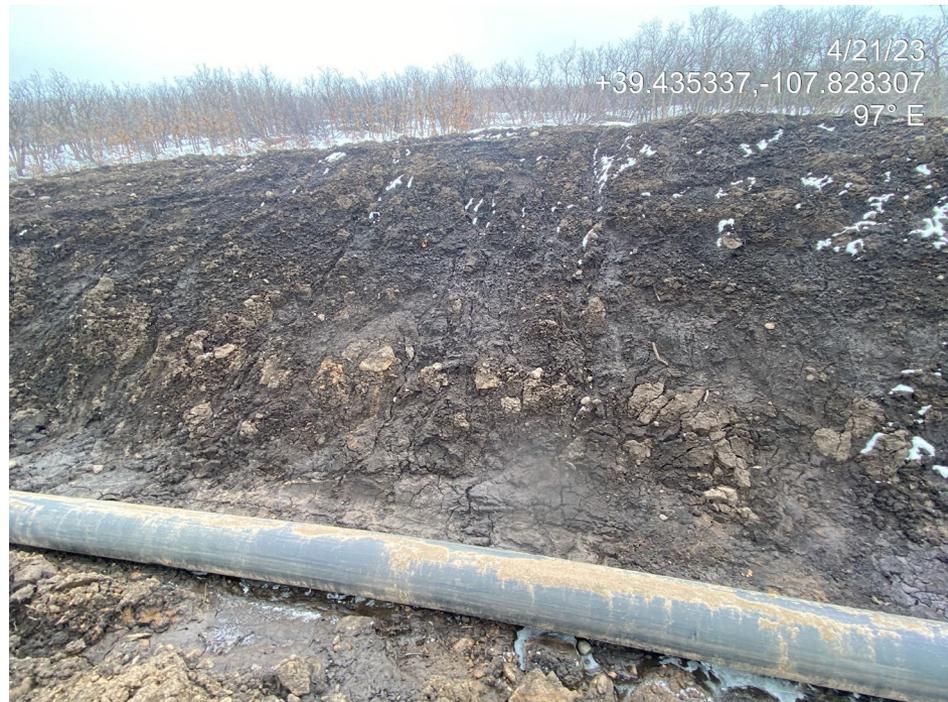
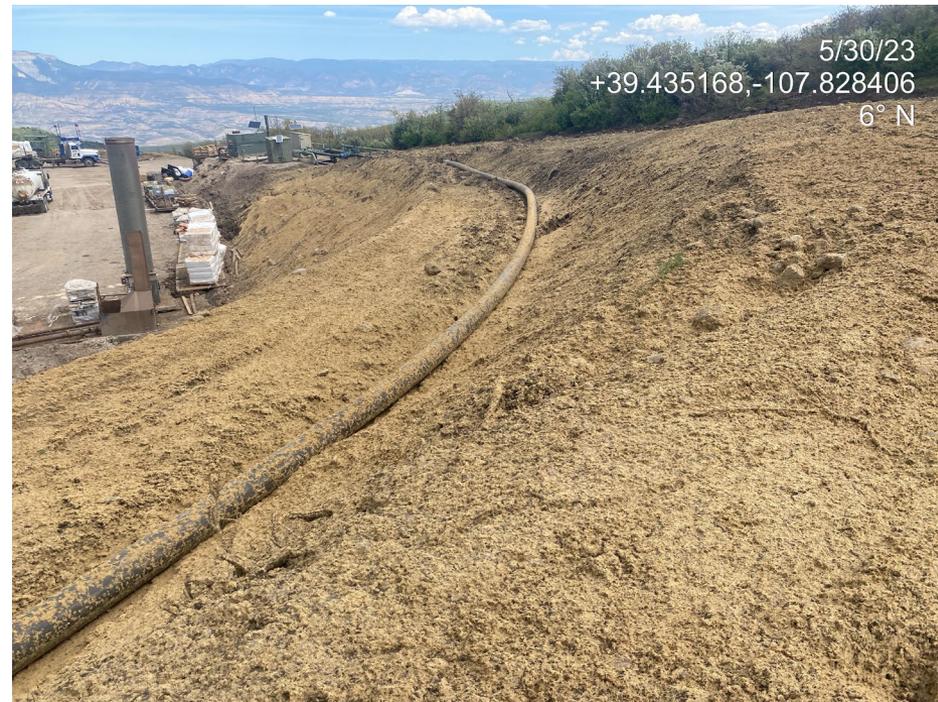
Photo 31. Photos taken from the south shows rill erosion occurring on bare, unprotected, unstabilized slopes in the previous inspection (left) have been stabilized with Hydromulch (right).

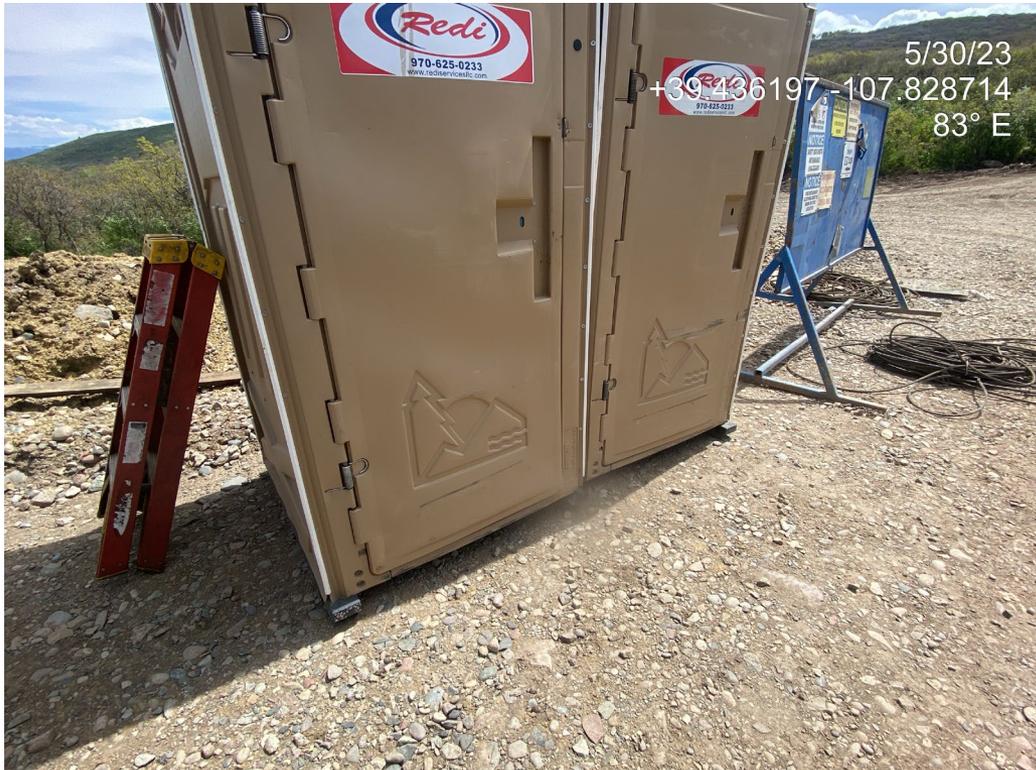
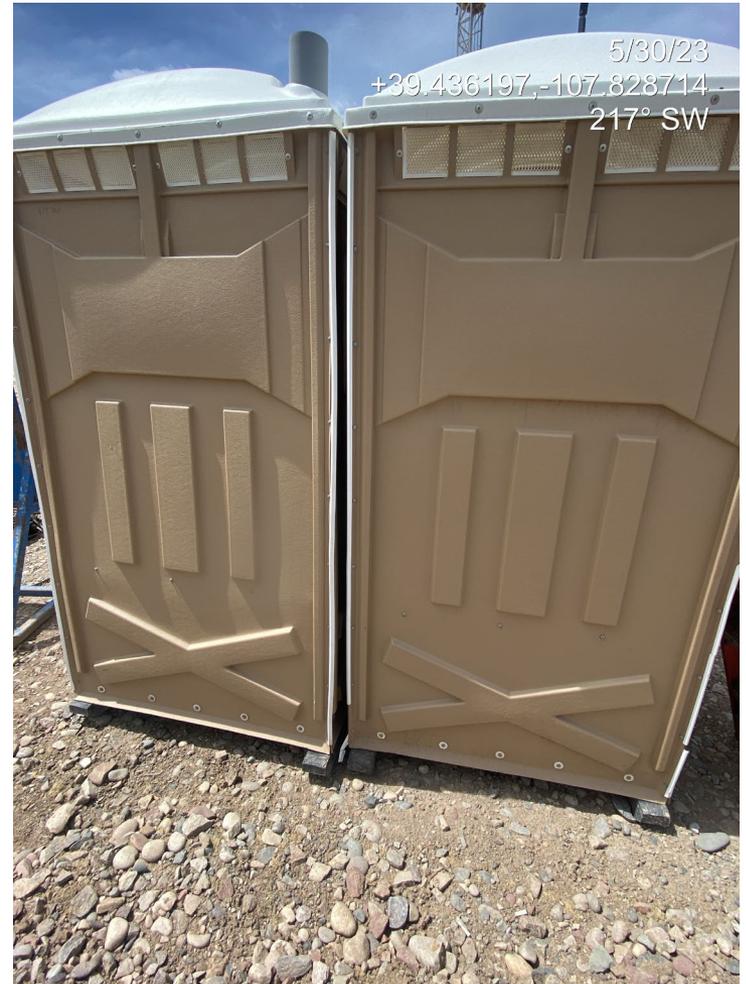
Photo 32. Photos taken from the Location entrance show portable toilets have not been secured to prevent a spill.

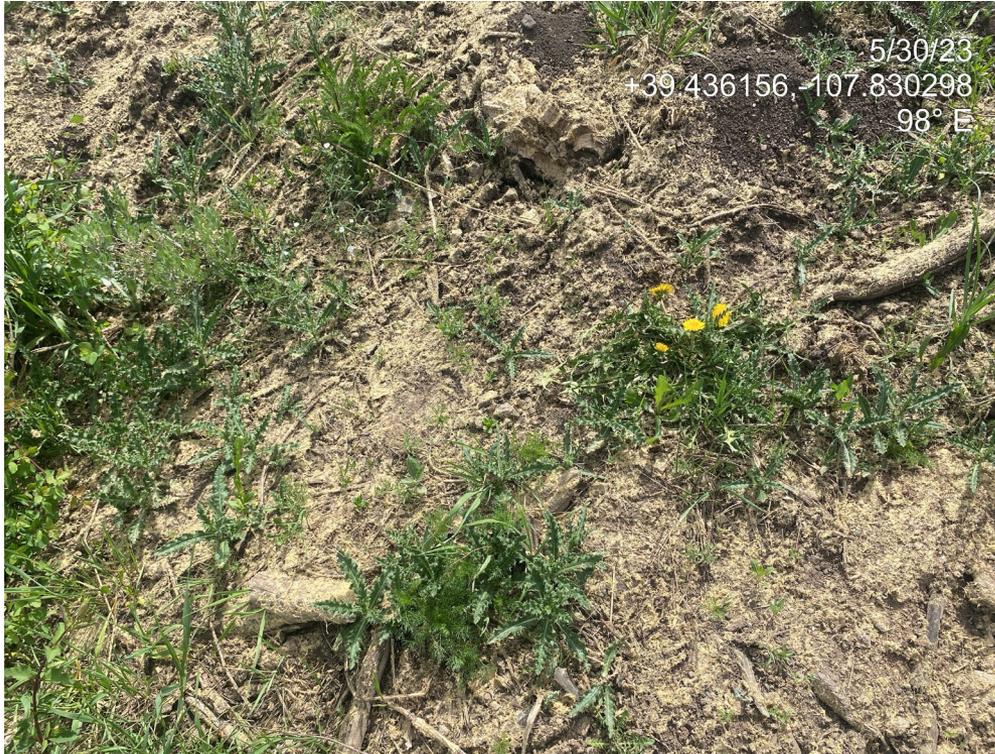
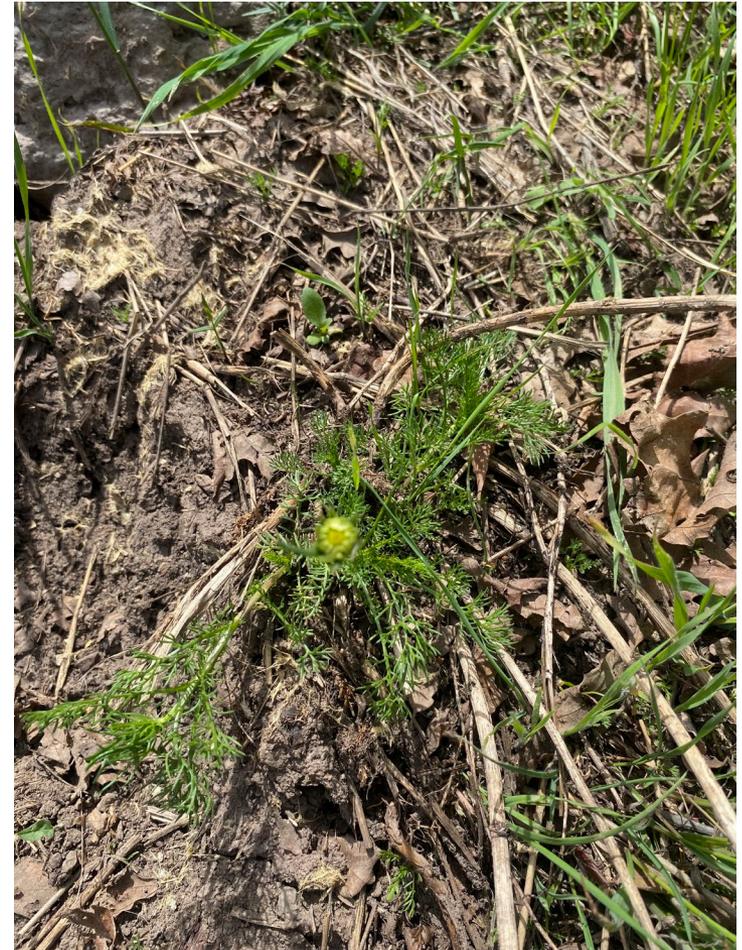
Photo 33. Photos show List B Noxious Weeds Canada thistle (left) and scentless chamomile (right) at the northwest of the location.

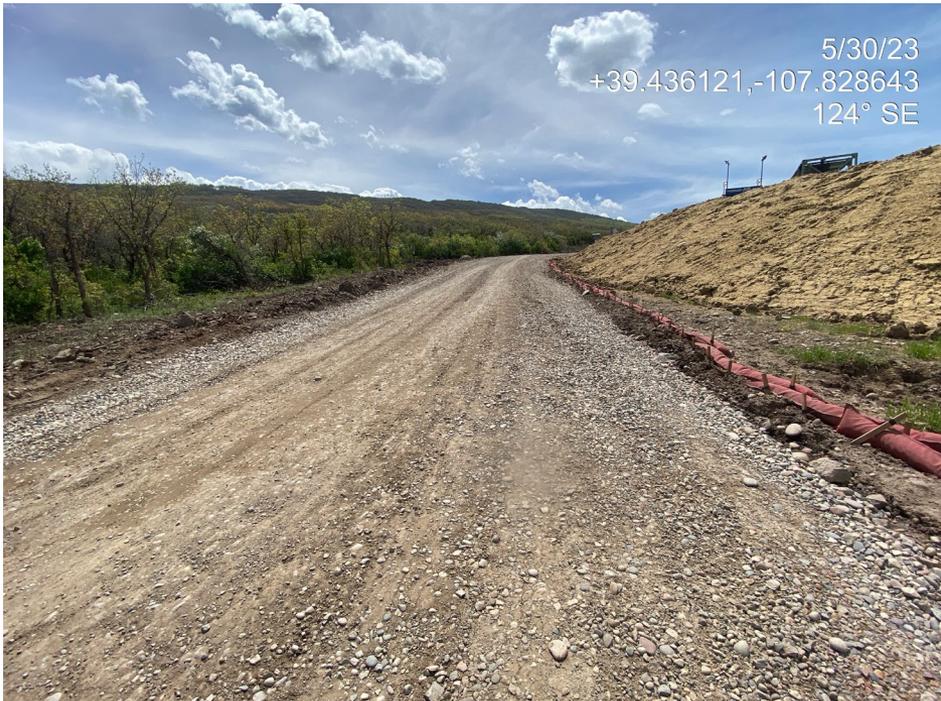
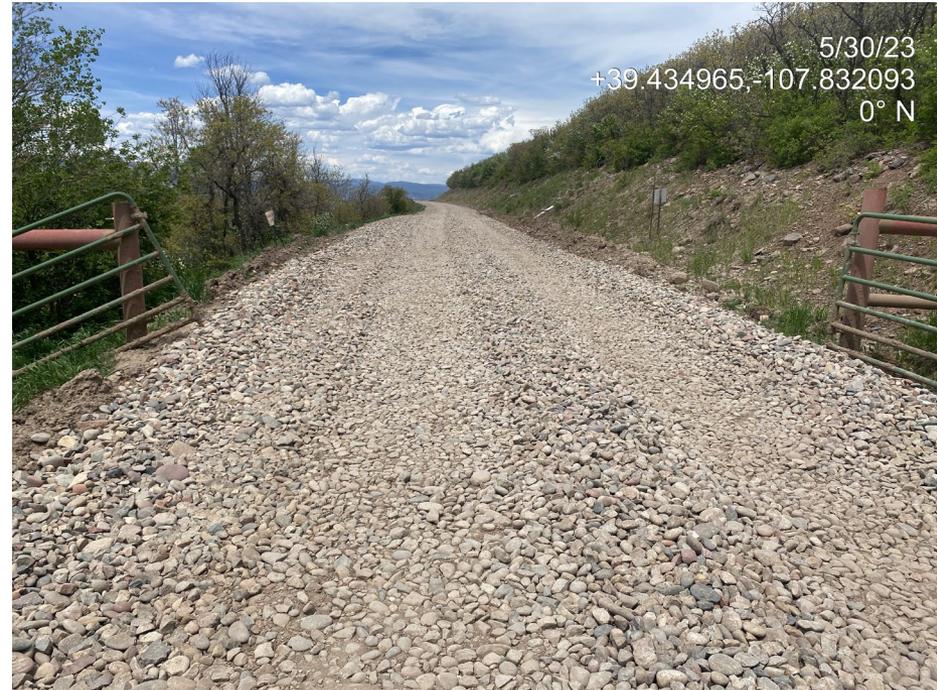
Photo 34. Photos show the location access road directly north of the pad (left) and before it merges with county road 317 (right). Surfaces are stabilized. There is no evidence of sediment tracking.
