Inspection Photos

API: 055-06314

Operator: OXY USA INC

Inspection Date: 6/1/2023

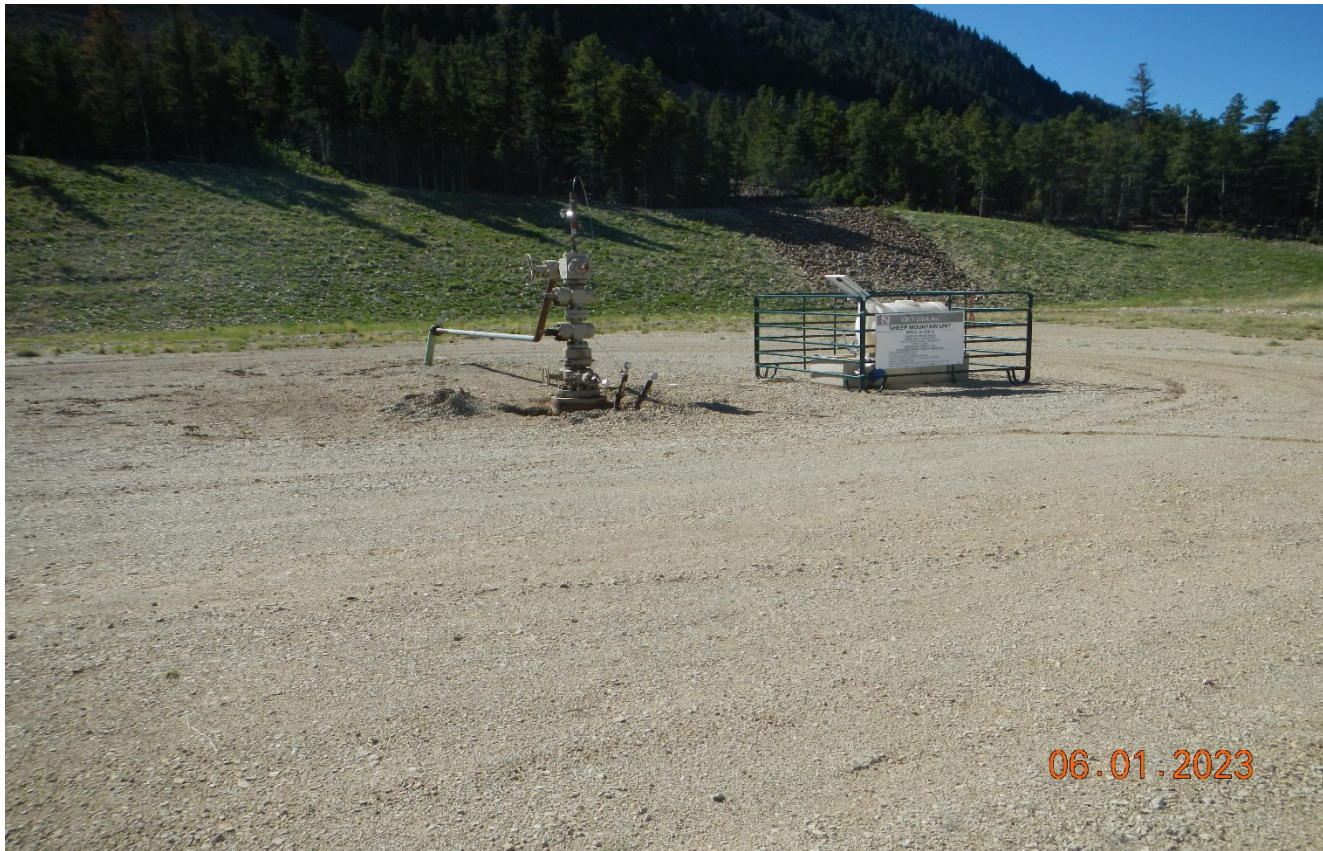
Photo 1. Facing toward the SMU 4-23 well.

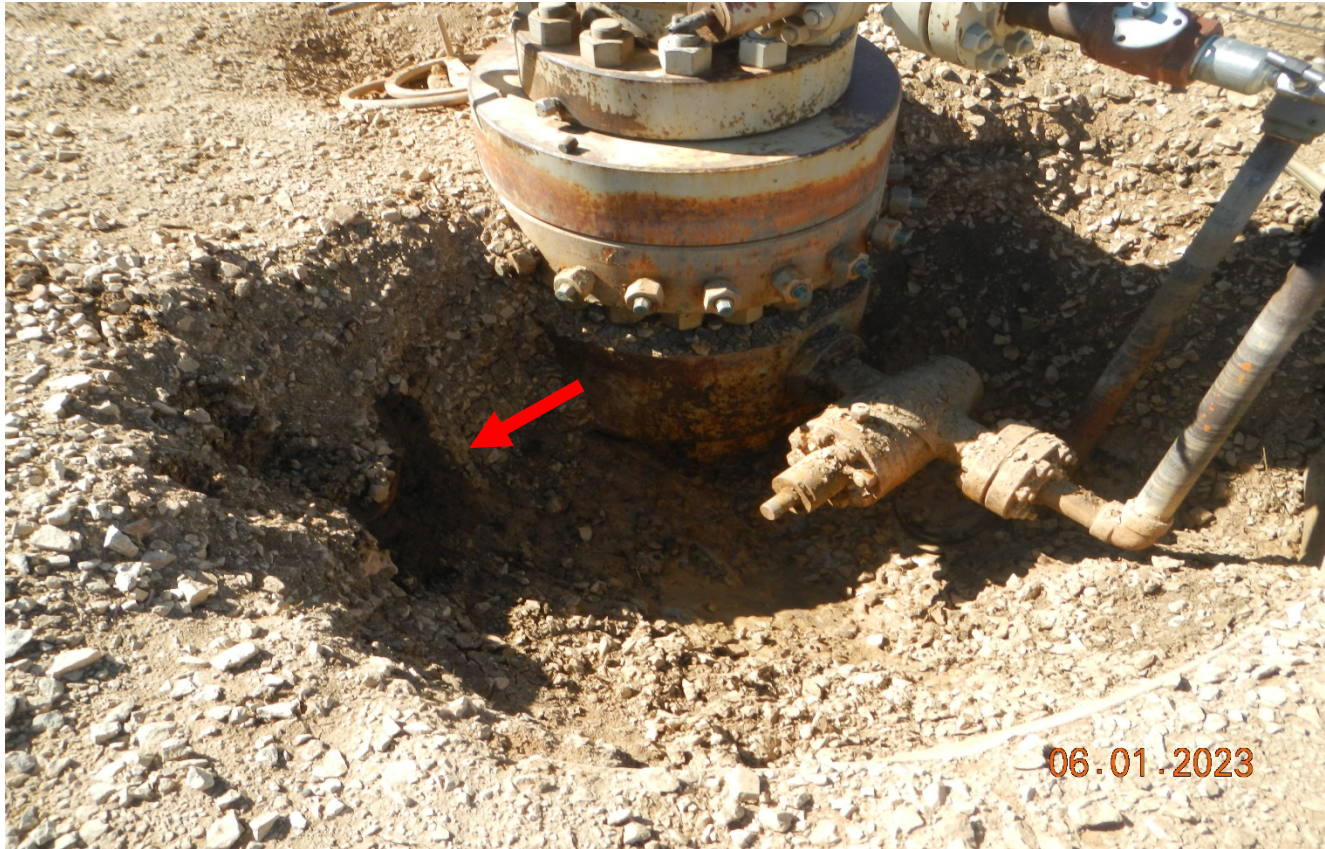
Photo 2. The wellhead is partially excavated and there is oil stained soils at red arrow that needs to be cleaned up.

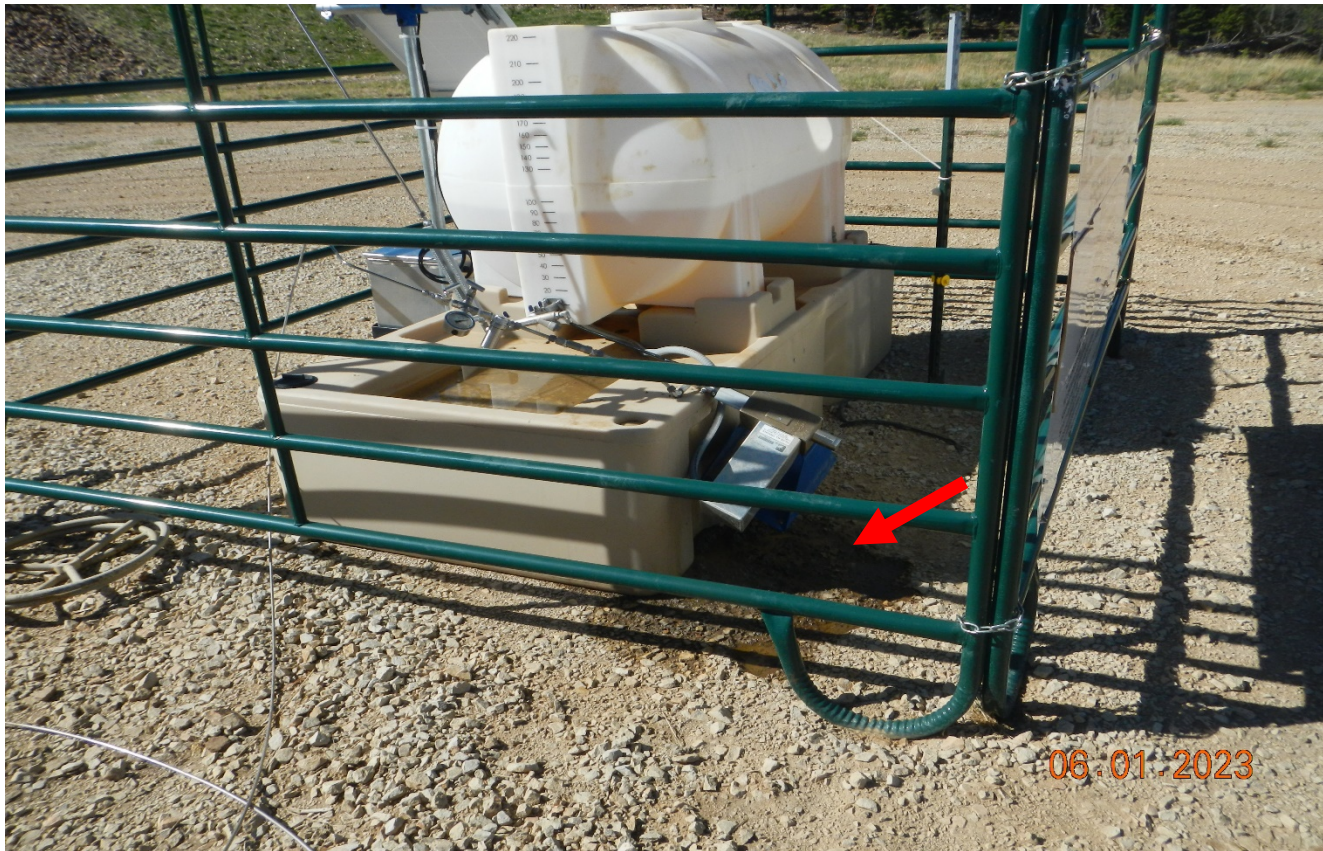
Photo 3. There is a dripping leak coming from the chemical tank line.

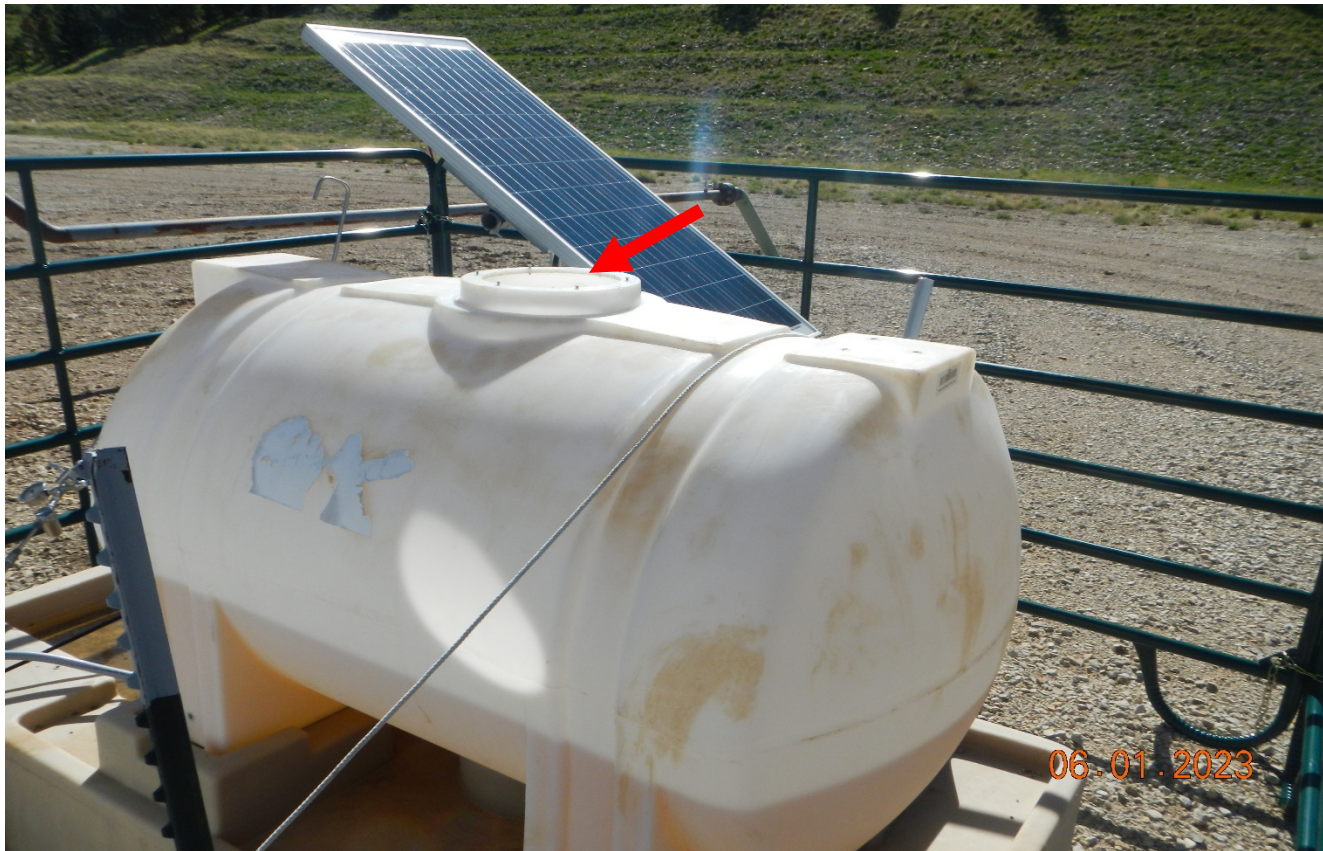
Photo 4. There is no labeling at the tank and there is no lid on the tank
