Inspection Photos

Loc: 333348

Operator: OXY USA INC

Inspection Date: 6/1/2023

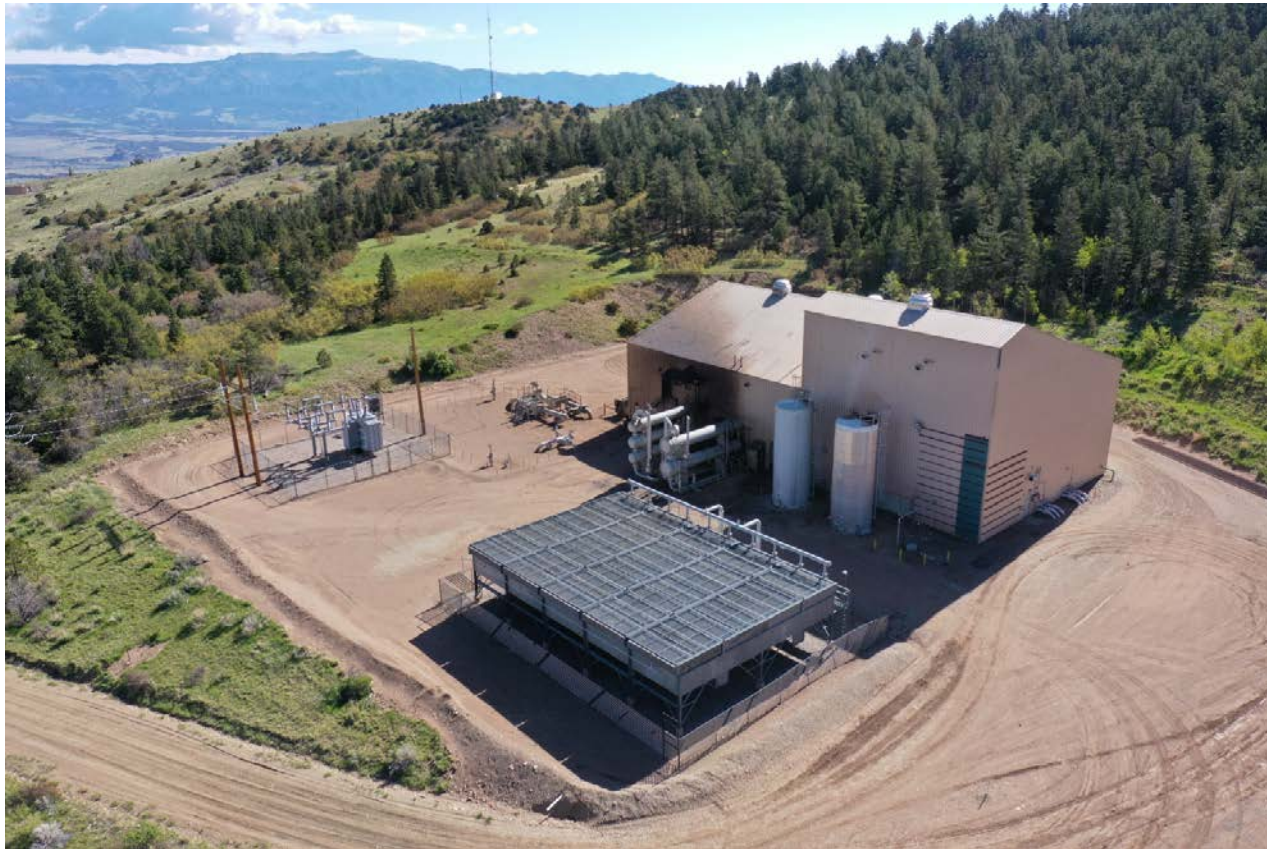
Photo 1. Drone aerial photo facing northeast at the Drill site 3 compressor.

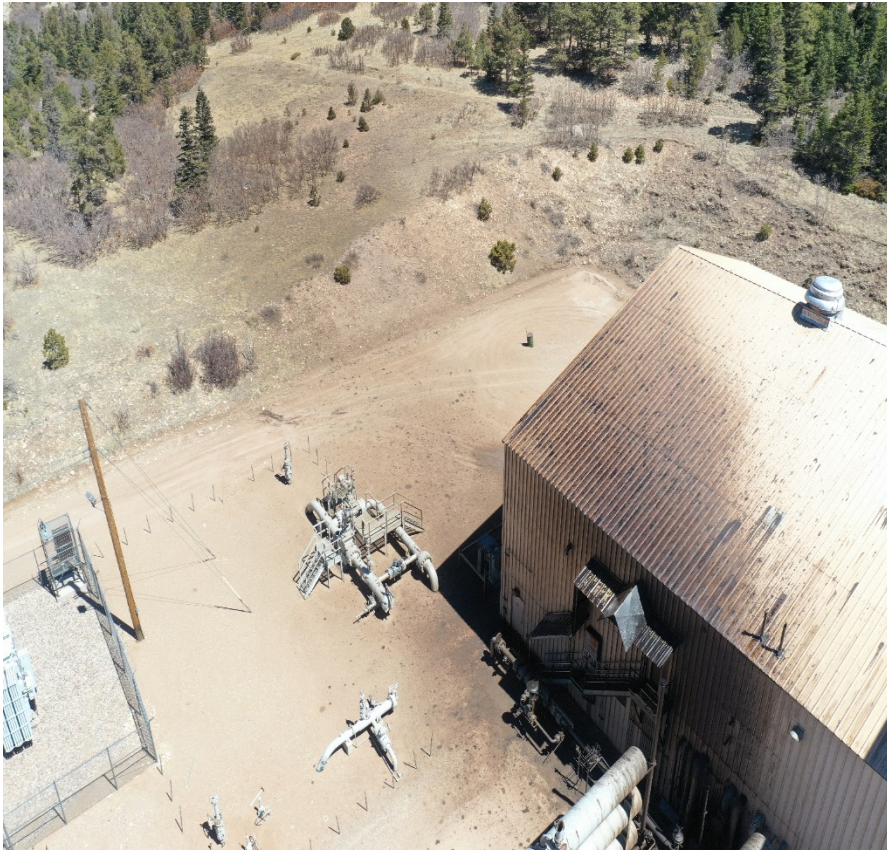
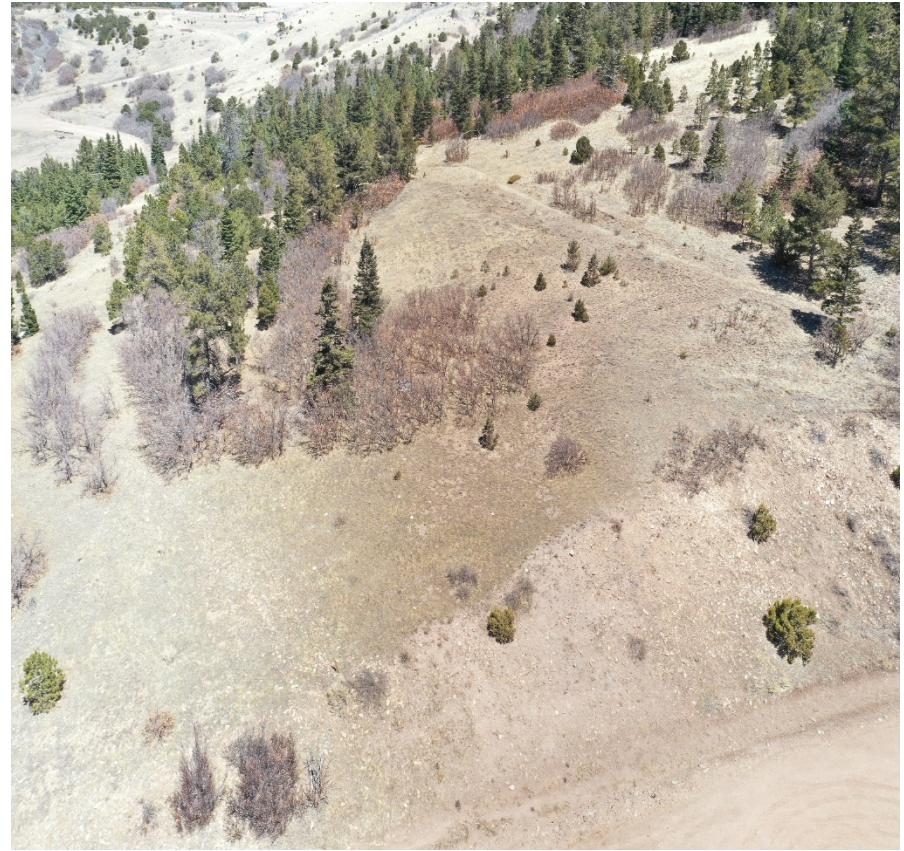
Photo 2. Previous Drone aerial photos taken on 4/10/2023. Facing northeast at the Drill site 3 compressor. There was a leak that has blackened the facility and areas of the ground and sprayed out to the northeast off the location.

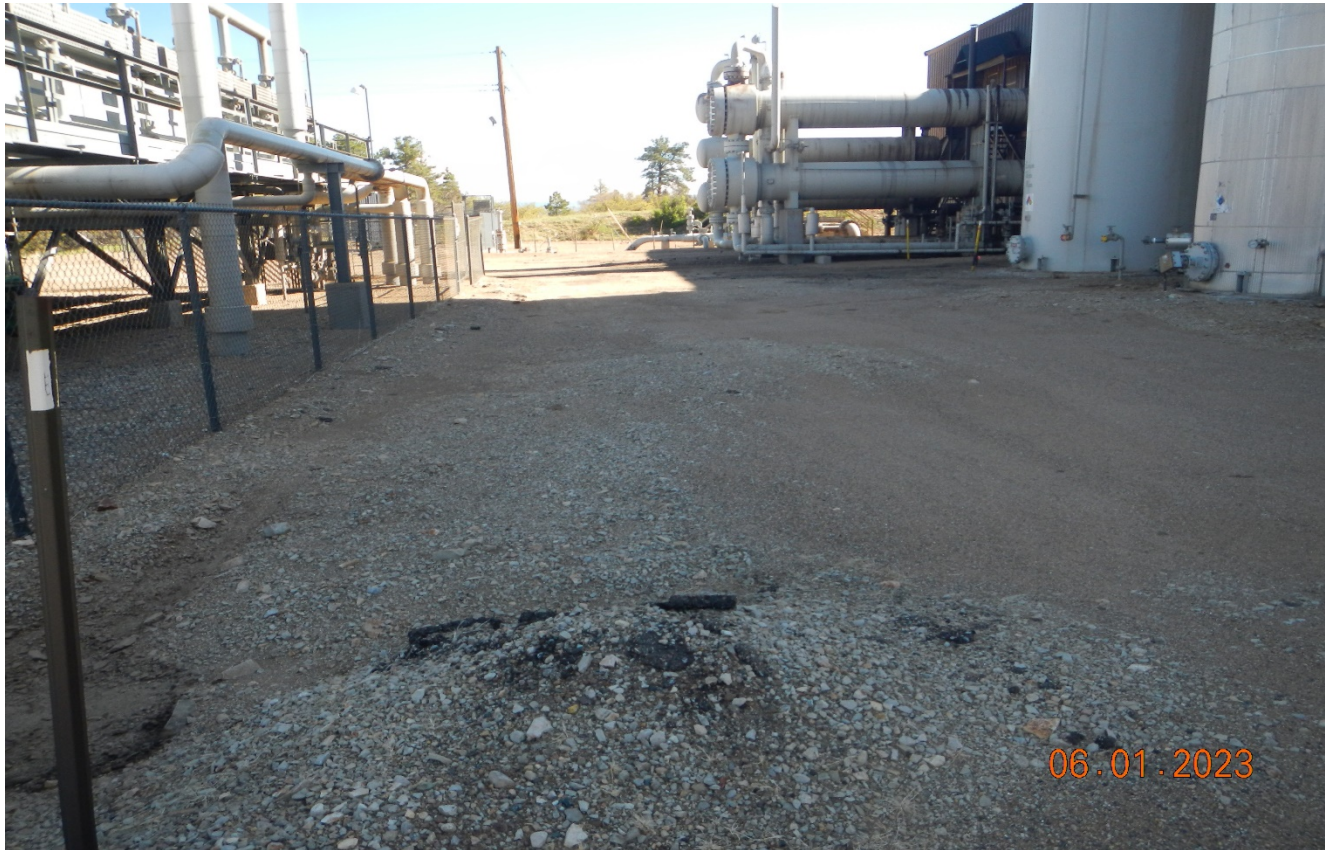
Photo 3. Facing north at the Drill site 3 compressor.

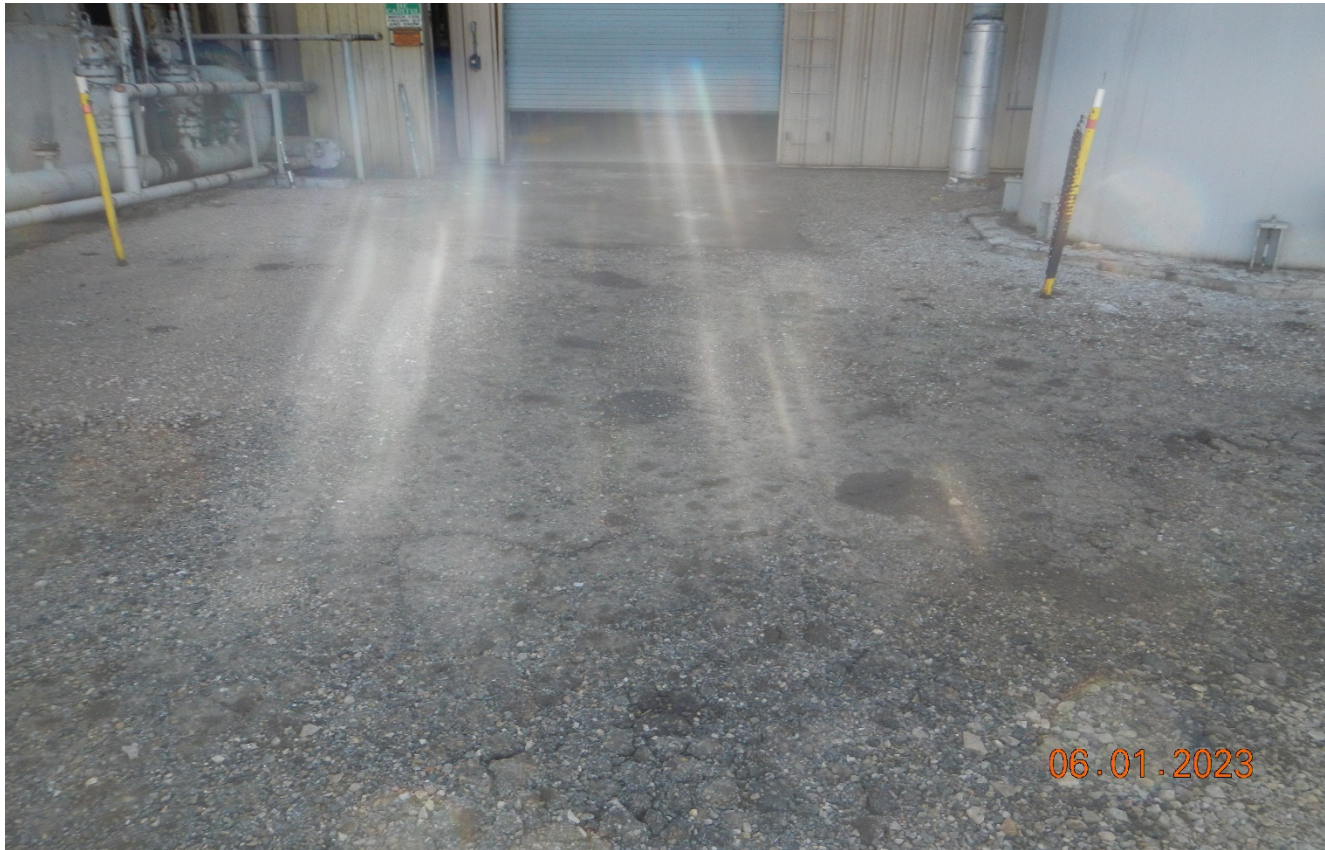
Photo 4. The is still stained soils along the east side of the compressor.

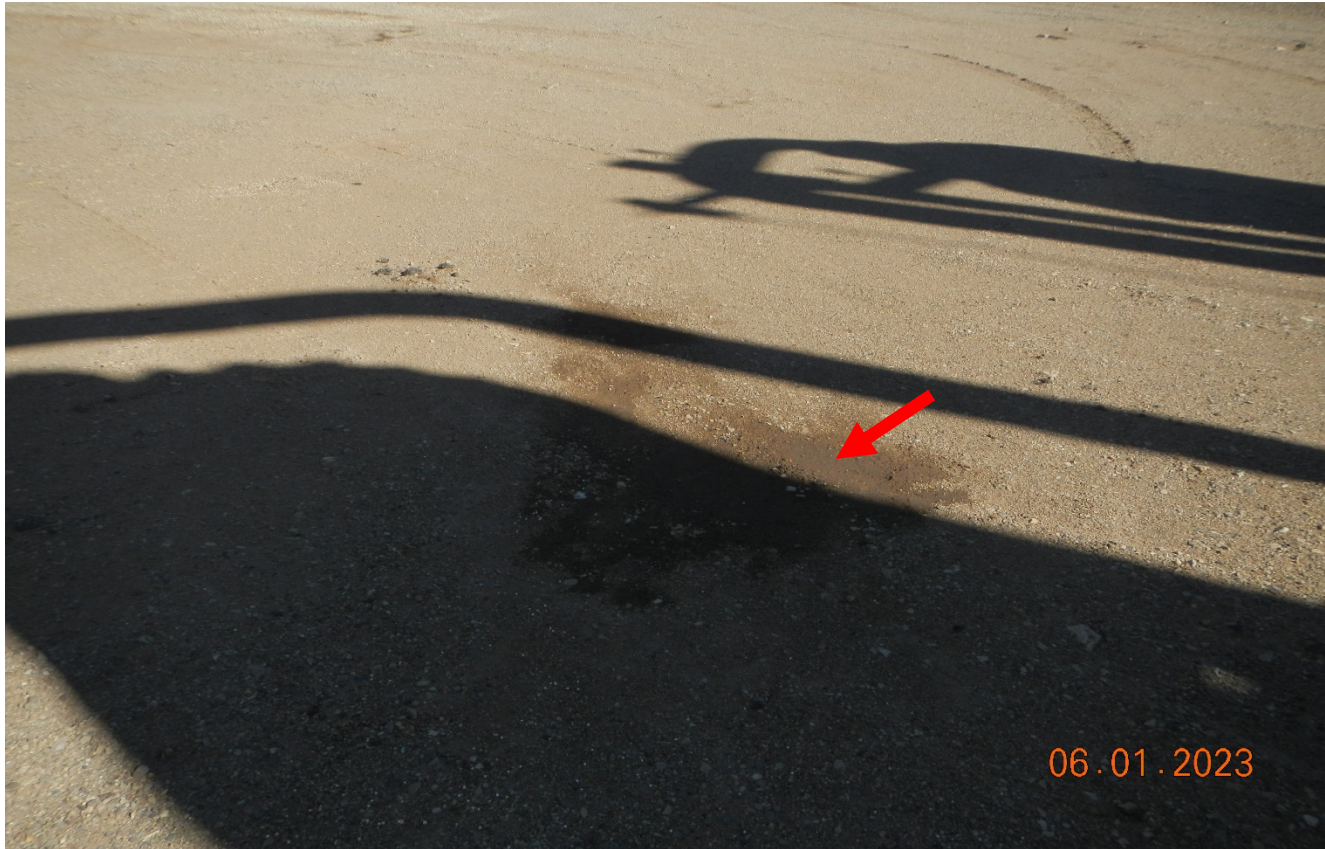
Photo 5. There are still numerous areas of impacted soil from the spill that have not been cleaned up.

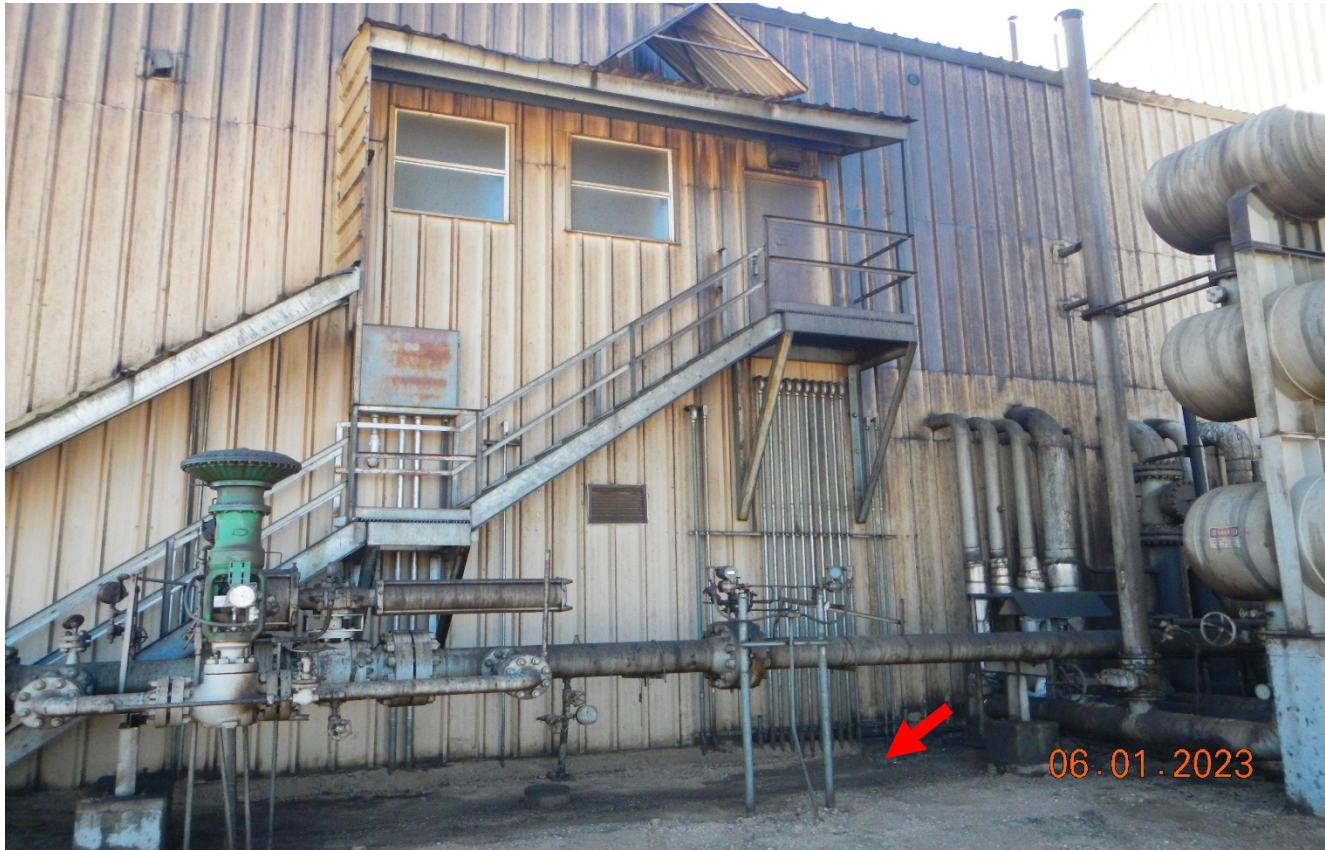
Photo 6. Facing toward the facility where leak occurred. The facility still remains blackened from the spil. There is still oil stained soils at the base of the facility shown at red arrow.

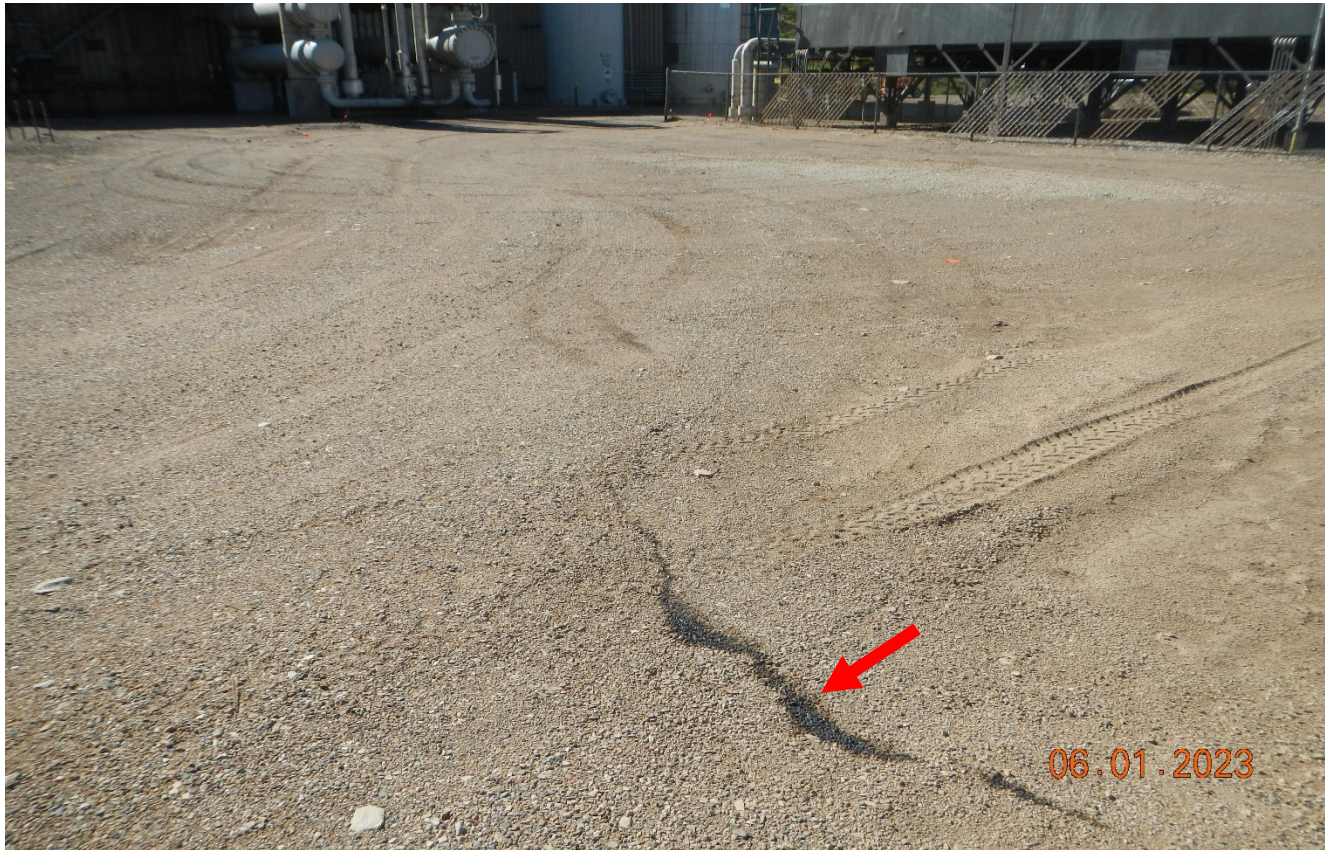
Photo 6. Facing toward the west side of the facility. It appears stormwater has moved impacted material down gradient. There is a line of oil staining at red arrow.

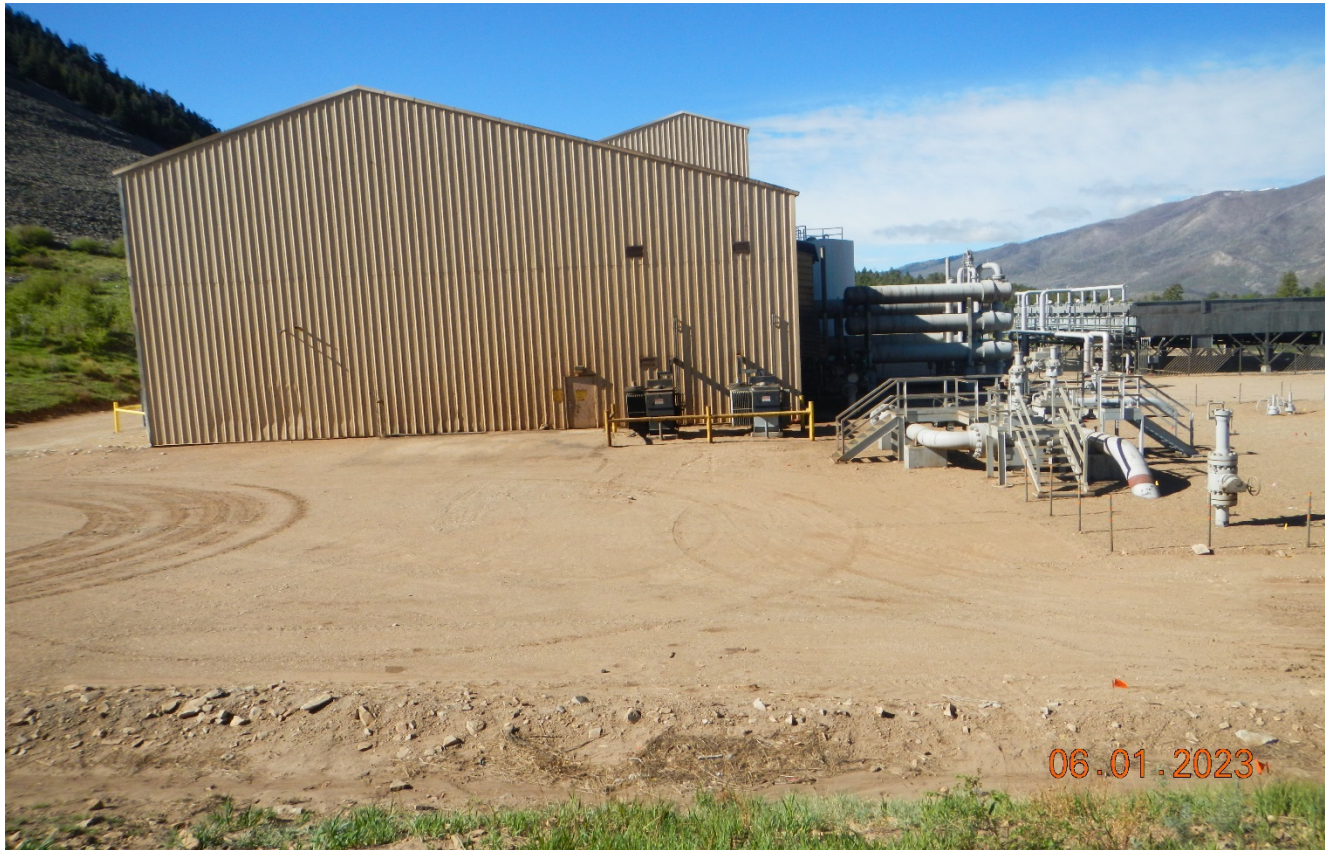
Photo 6. Facing back south toward the facility where spill occurred.

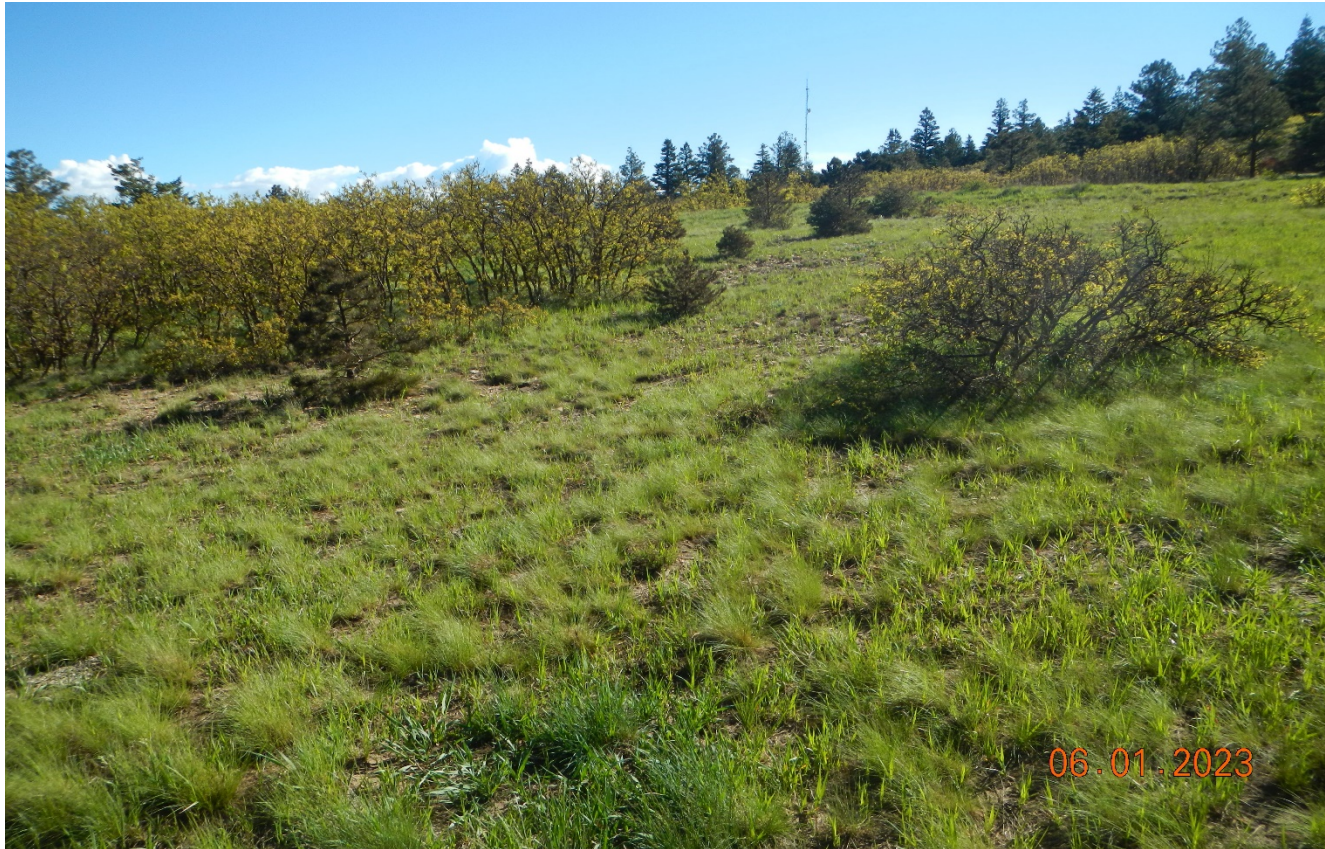
Photo 9. Facing northeast off the location where spill had drifted off the location. There are no perimeter stormwater controls around the area of the spill. The vegetation is growing in this area however, soils and vegetation remain blackened from the spill.

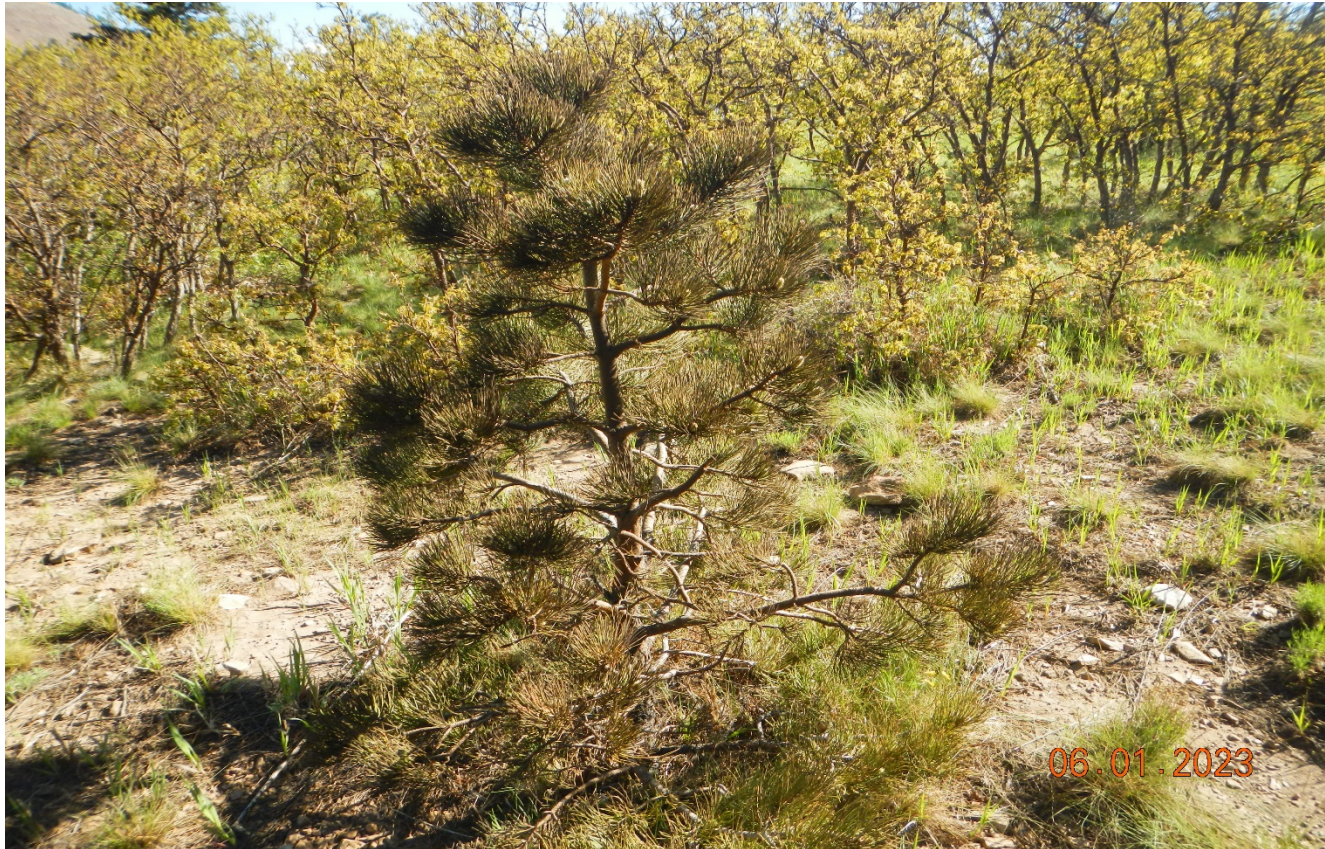
Photo 10. The vegetation, brush, trees, still remain blackened from the spill.
