Gulley #1-D Off-Location Flowline Removal
PADCO, LLC
Remediation Project #28912

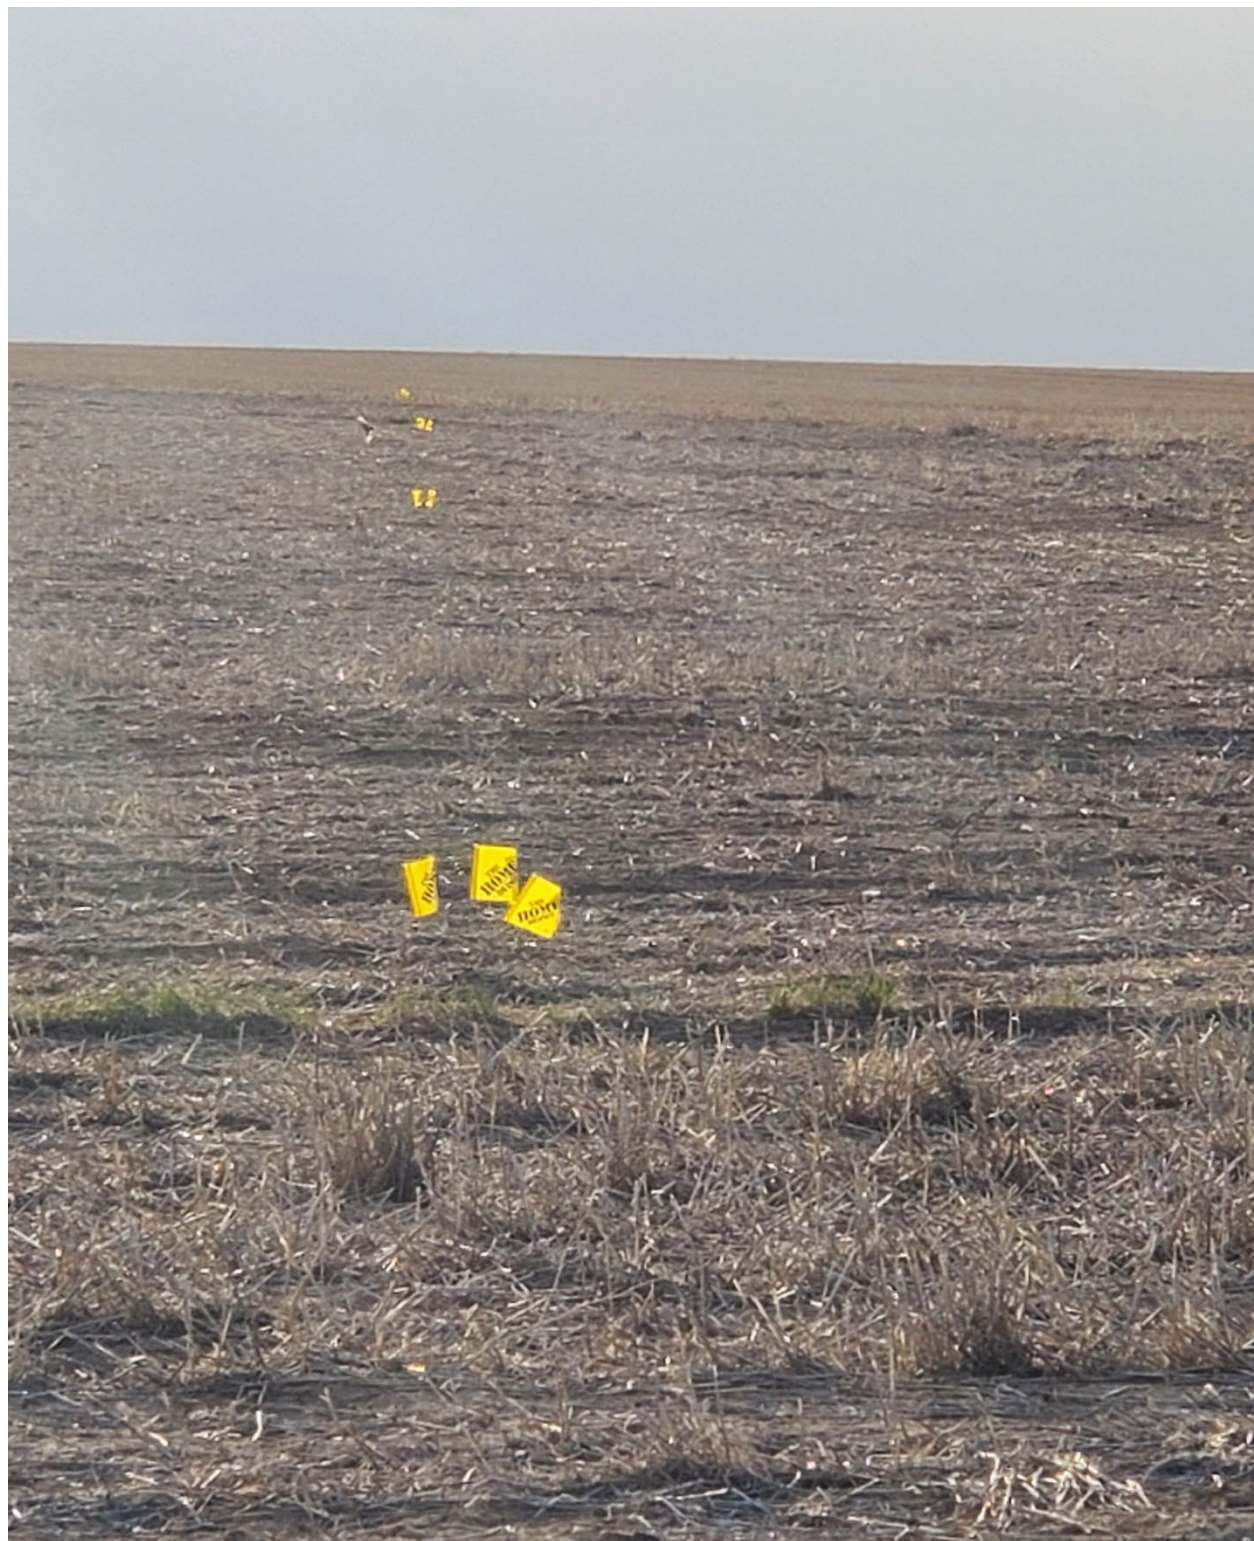
Photo 1

Location of the Gulley #1-D Off0-location Flowline

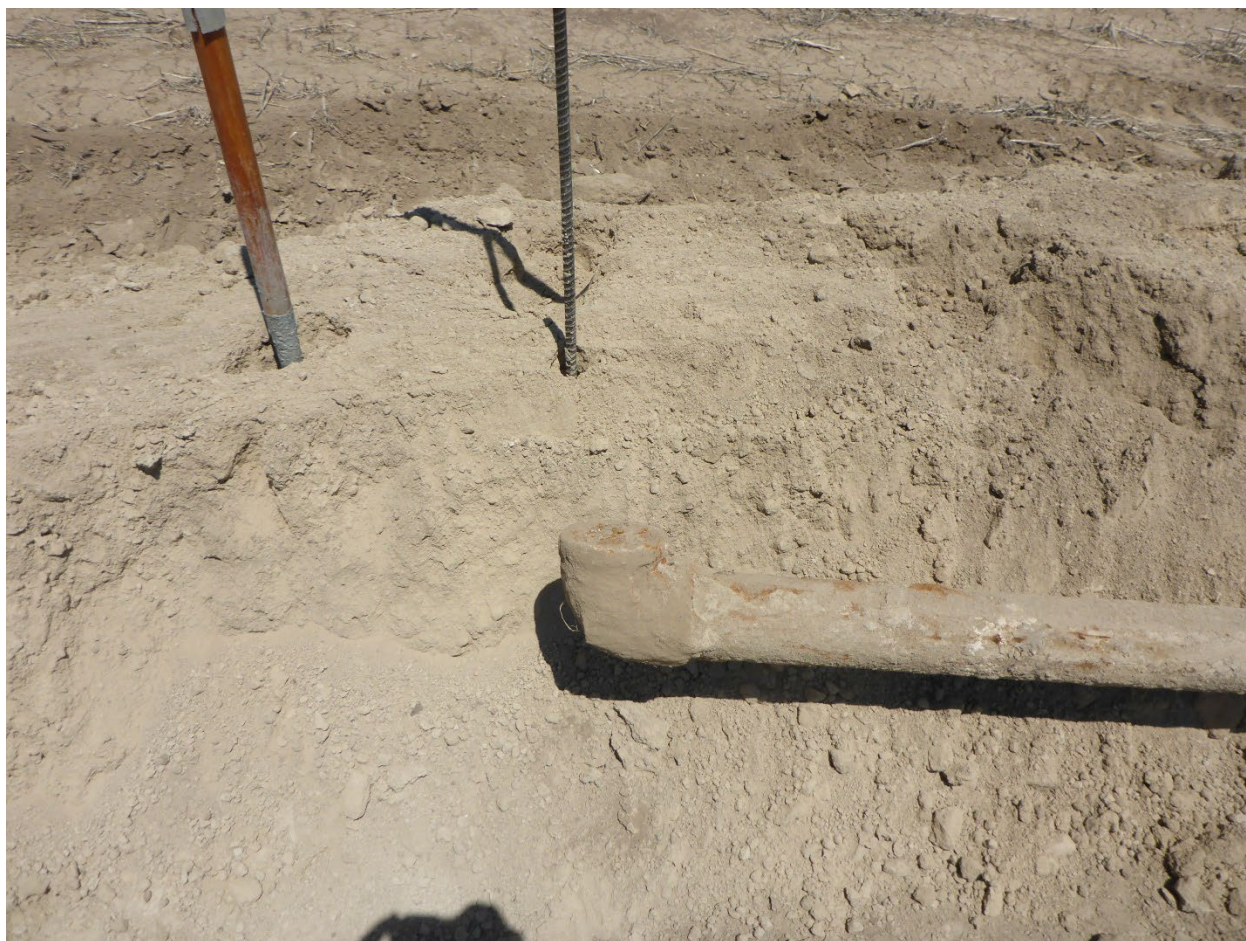
Photo 2

Gulley #1-D flowline riser point

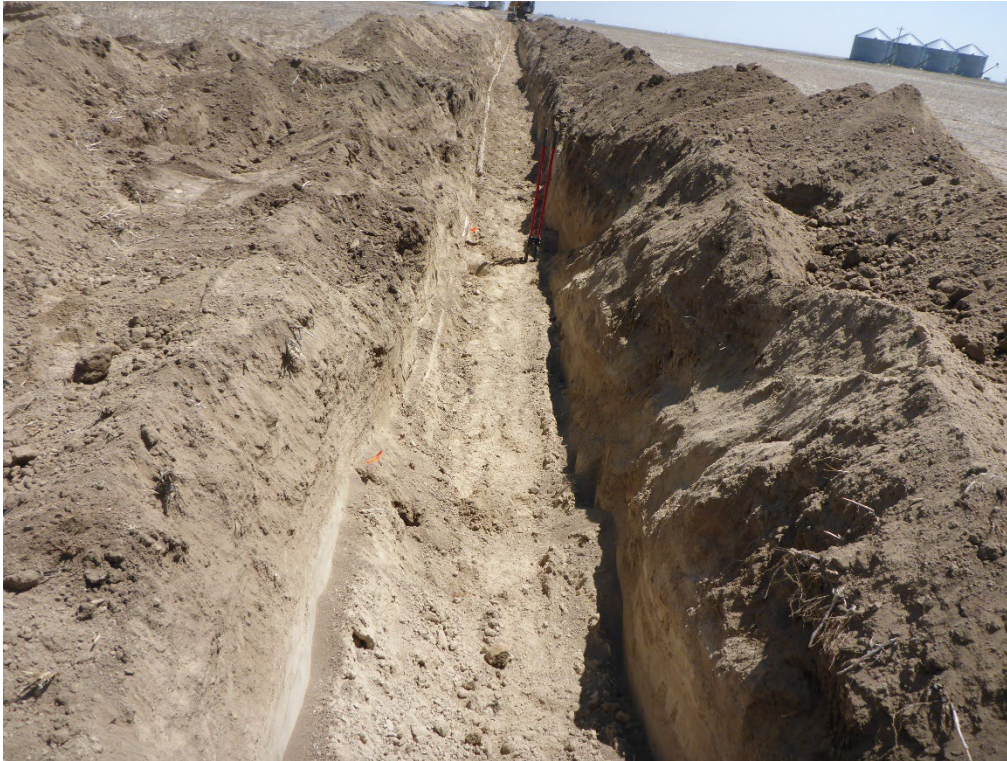
Photo 3

Gulley #1-D Flowline Excavation

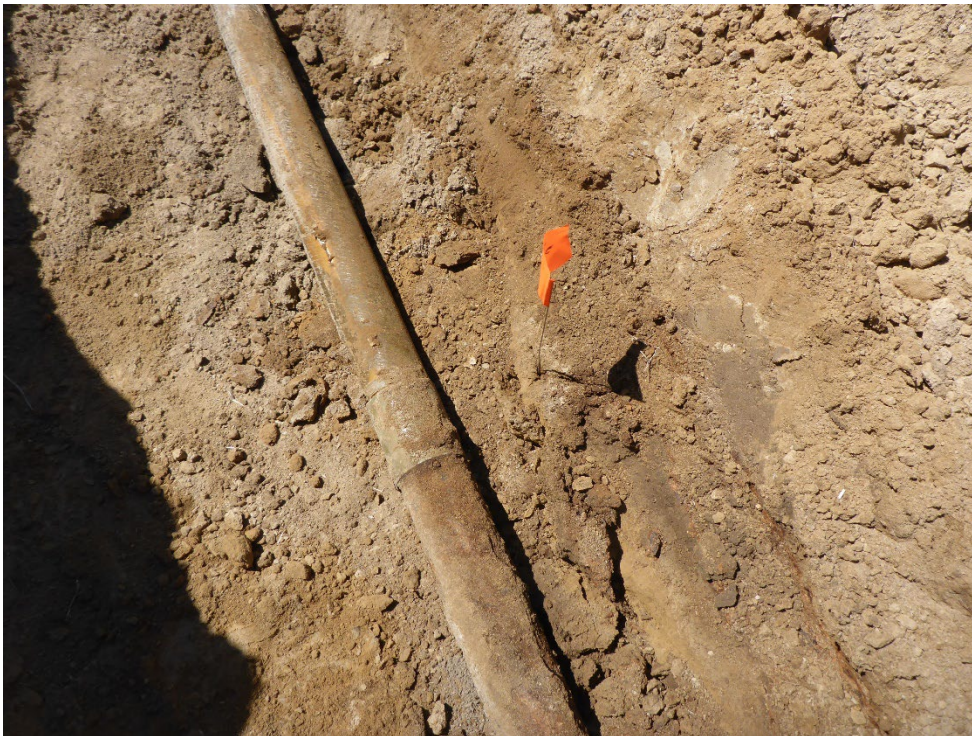
Photo 4

Sample Point G1b (observed stained soil around fiberglass flowline collar)

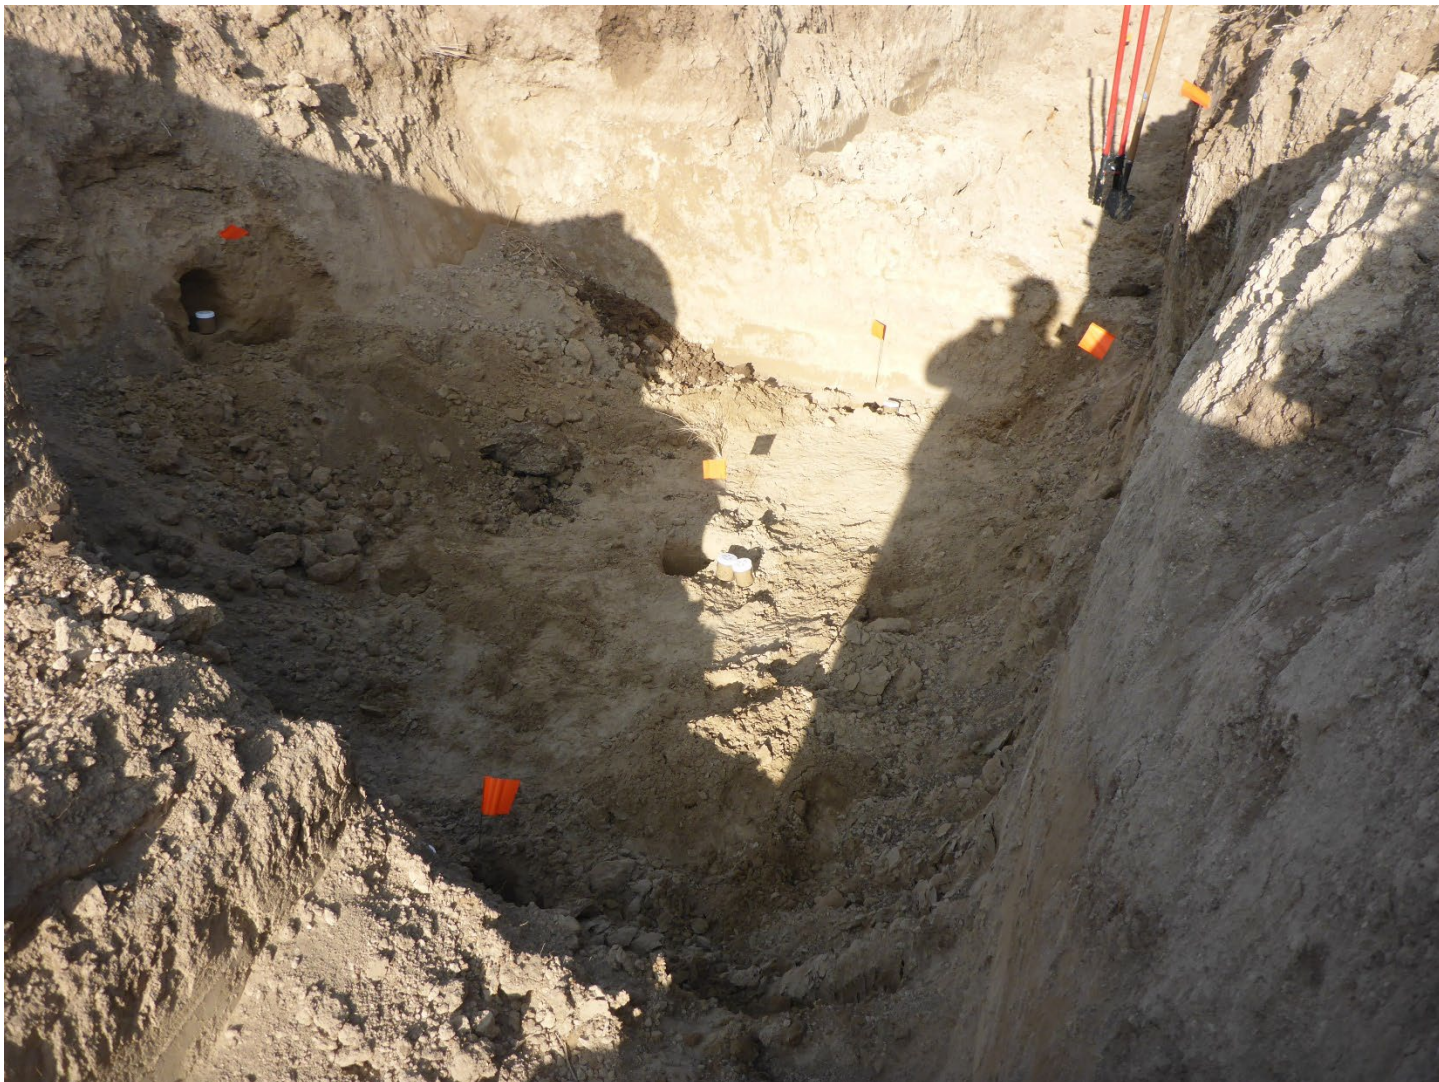
Photo 5

Sample point G1b (excavation of contaminated soil and samples G1b2 for closure)
