# Inspection Photos

API: 055-06316

Operator: OXY USA INC

Inspection Date: 6/1/2023

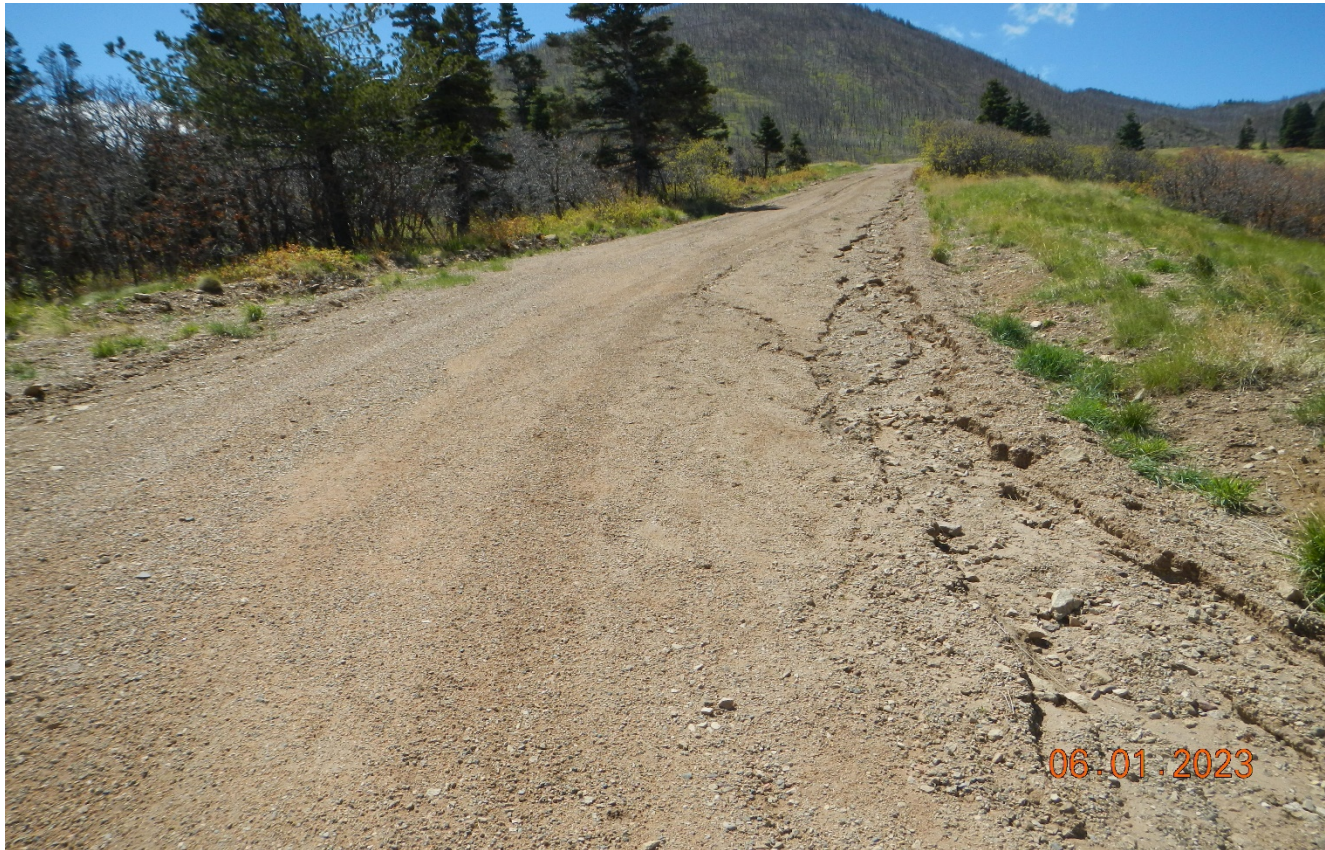
**Photo 1.** Facing south along the access road. There are signs of erosion along the steep grade of the road. Stormwater should be diverted off the road to reduce erosion. Previous corrective action is not completed.

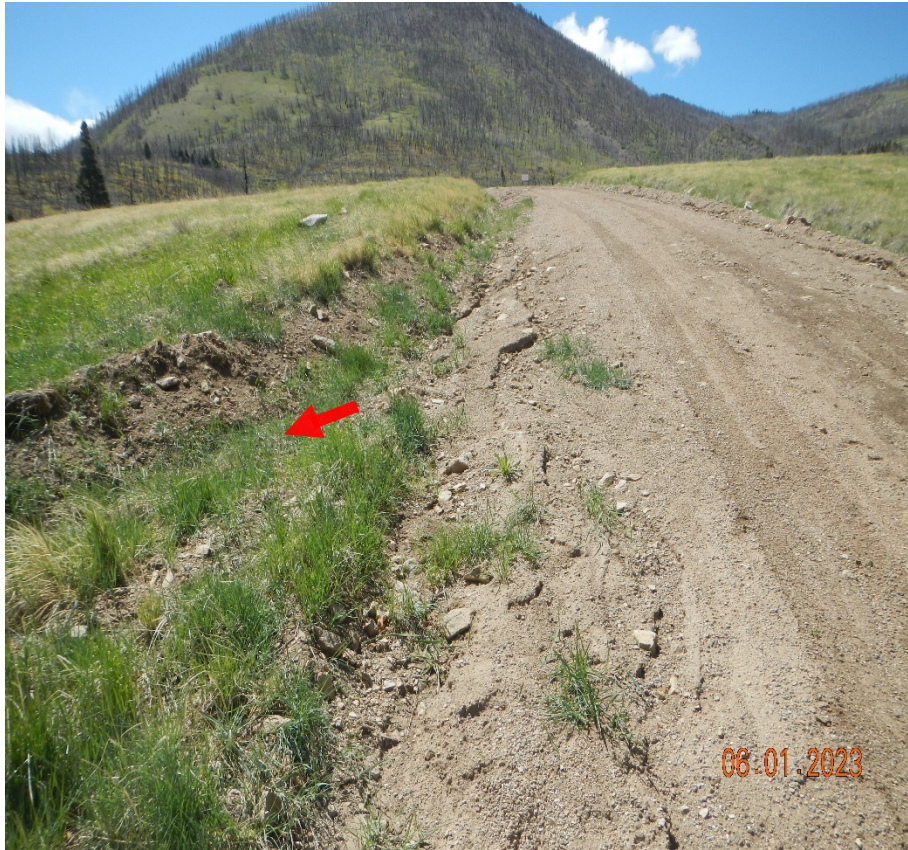
**Photo 2.** Facing back north the steep grade of access road. Stormwater is not being diverted off the road which is causing erosion of the road. Stormwater should be diverted toward red arrow and into a sediment trap.

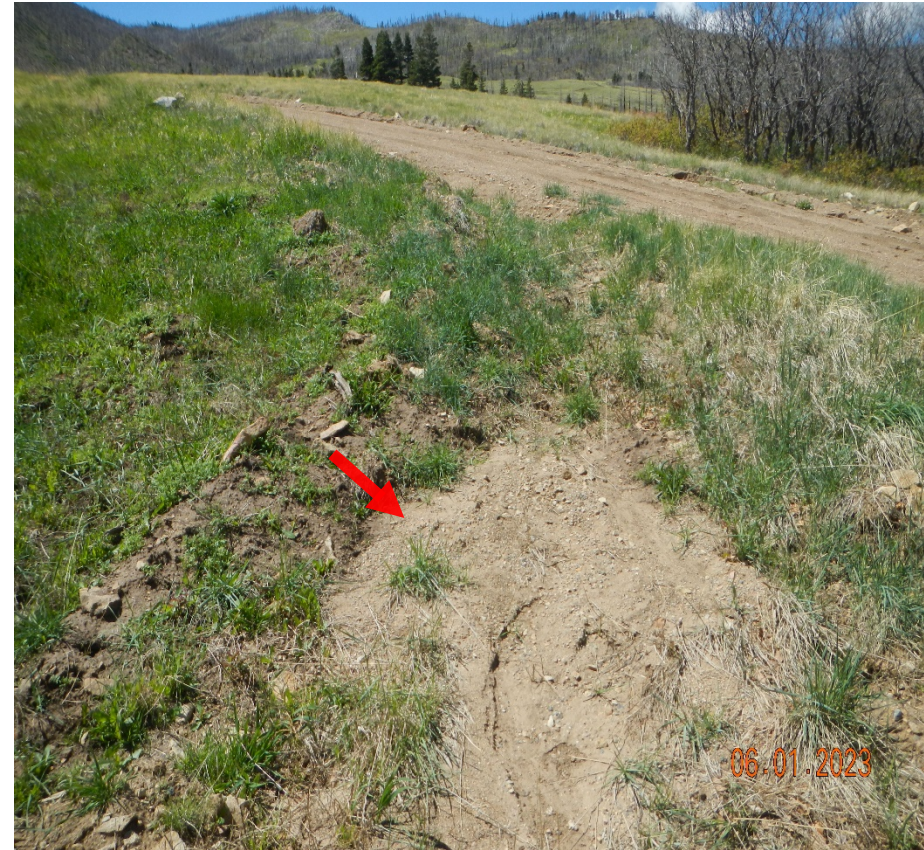
**Photo 3.** This sediment trap is completely full sediment and needs to be maintained.

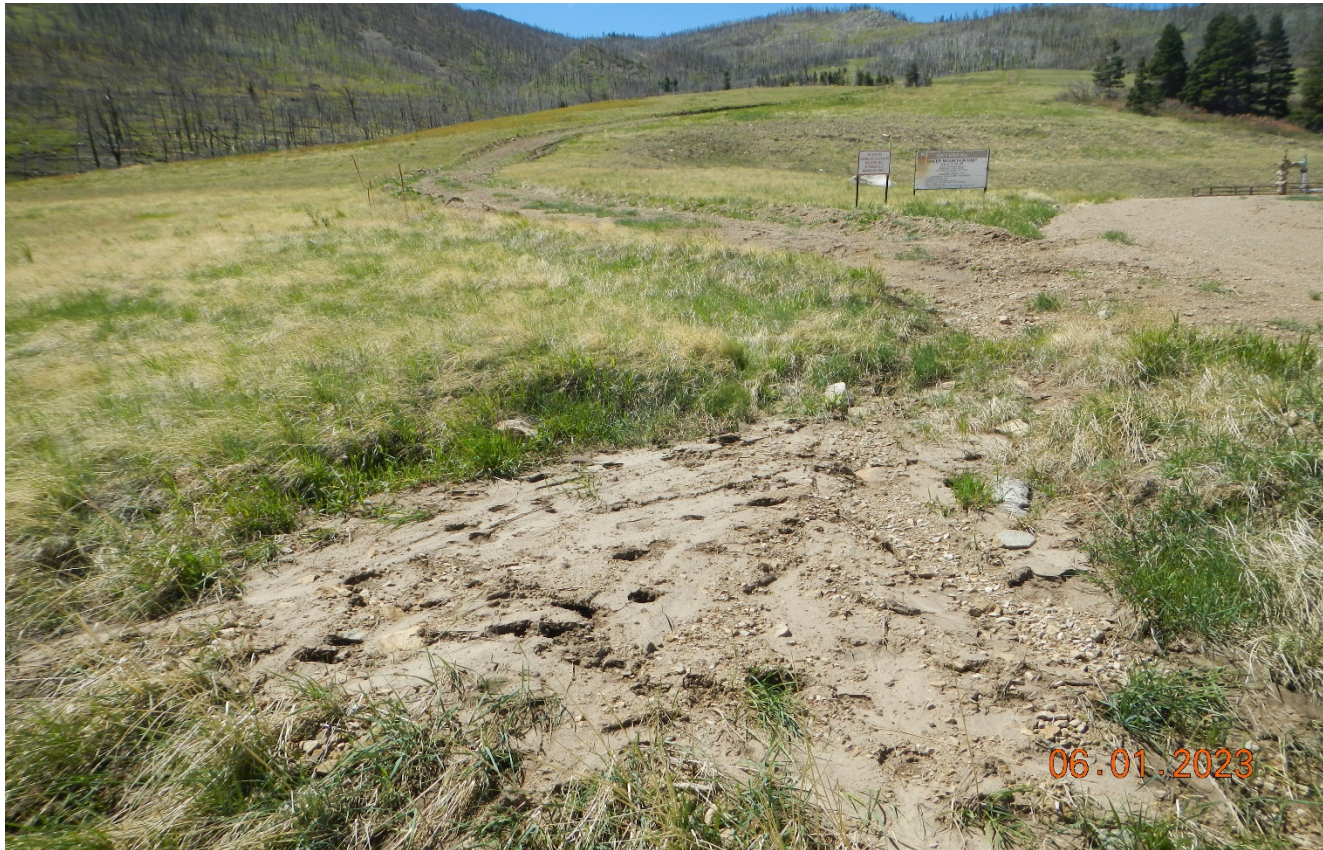
**Photo 4.** Facing southwest near the location. Sediment is being deposited offsite in this area from erosion of the road. This sediment trap is completely full sediment and needs to be maintained.

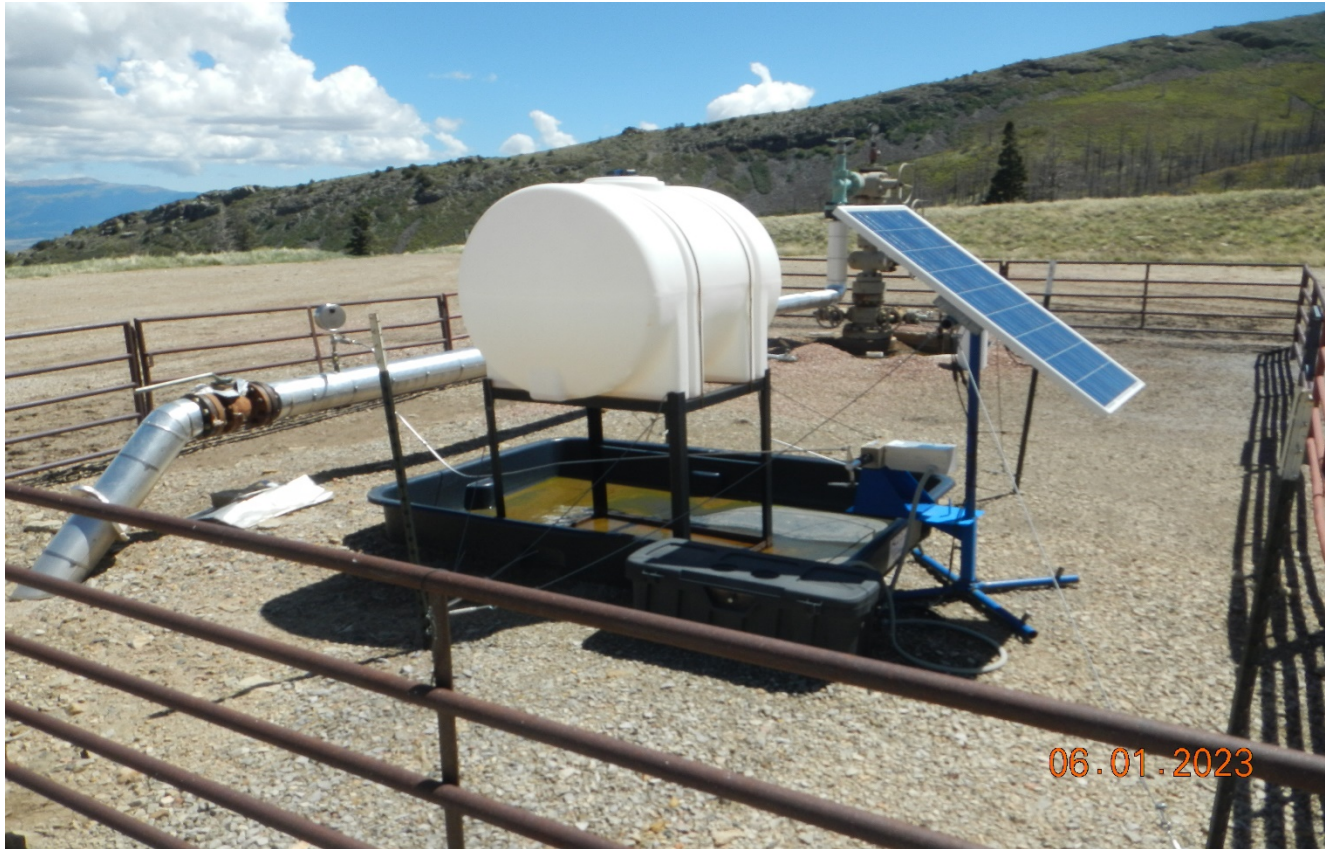
**Photo 5.** There is no labeling of the white chemical container.
