Inspection Photos

Location Name: CAERUS PICEANCE LLC PITMAN E13W Pad

Location #: 334900

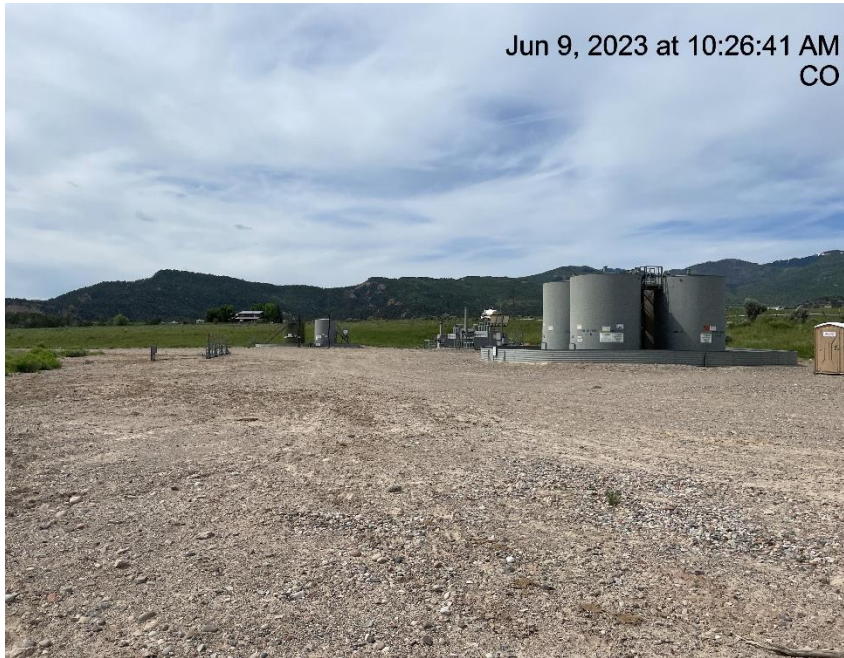
Photo # 9965 From entrance to location

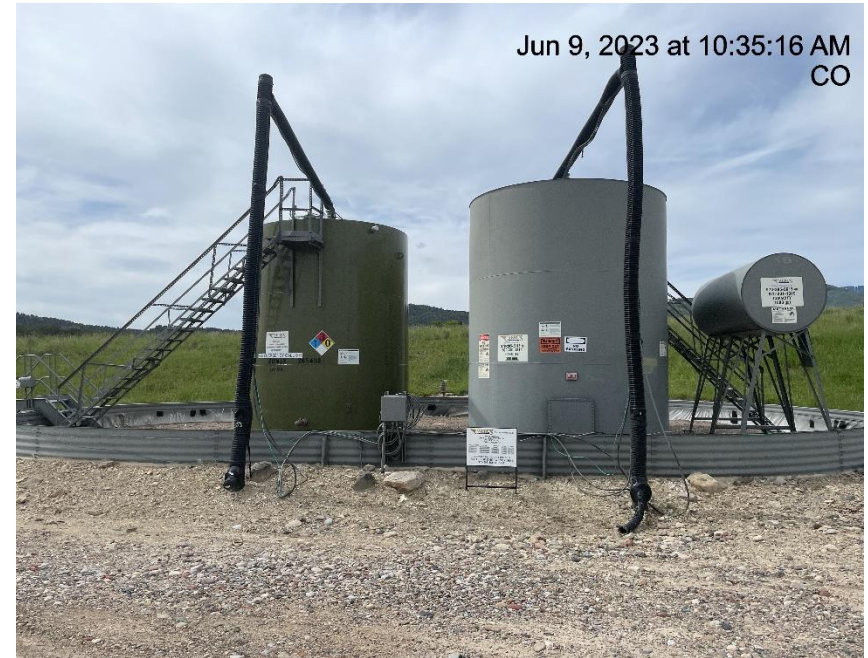
Photo # 9971 Location

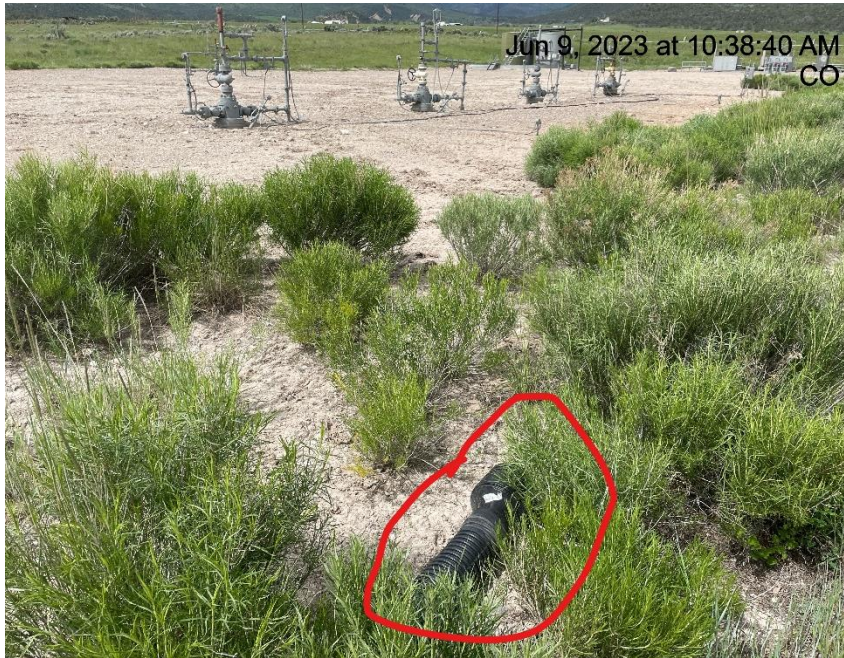
Photo # 9976 Debris

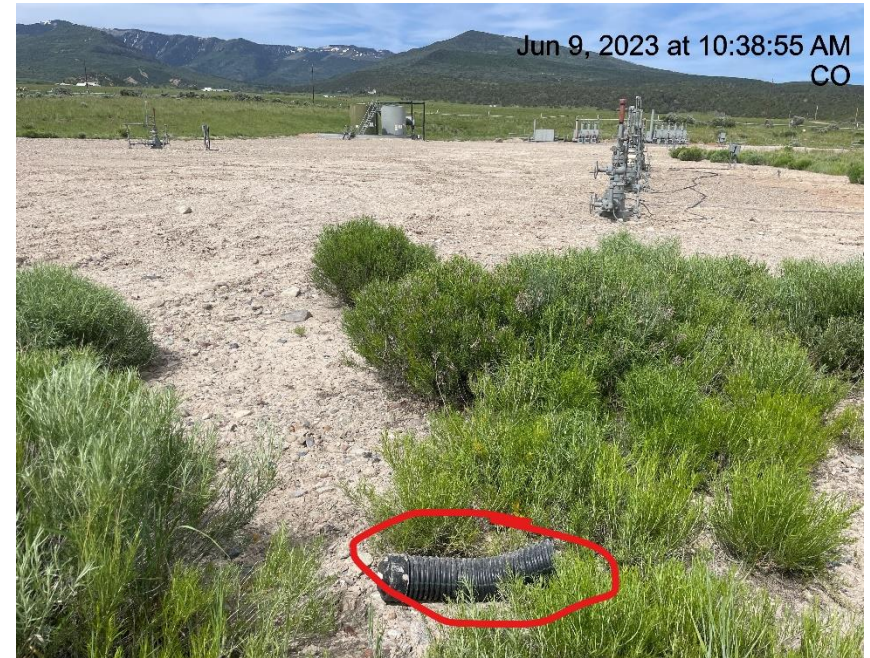
Photo # 9977 Debris

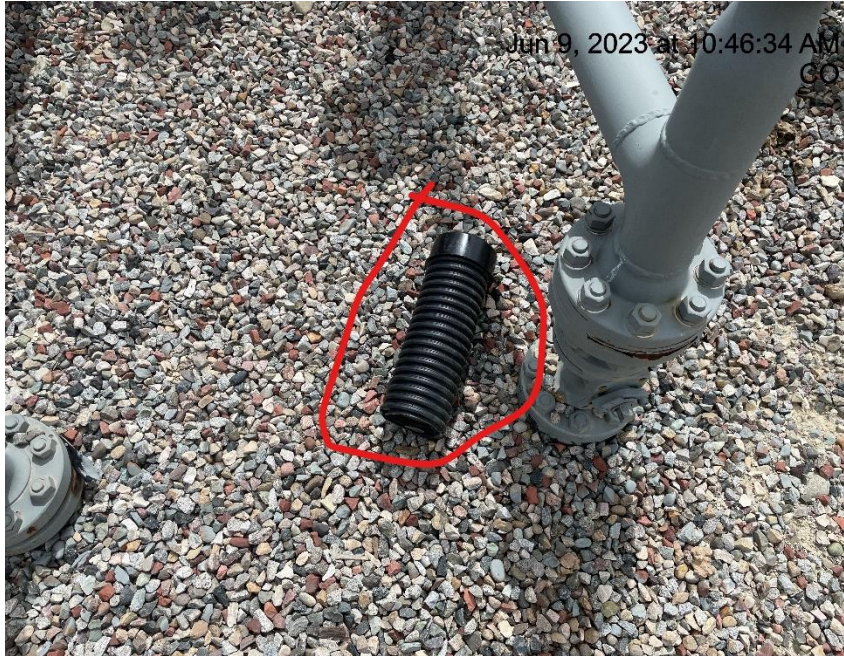
Photo # 9988 Debris

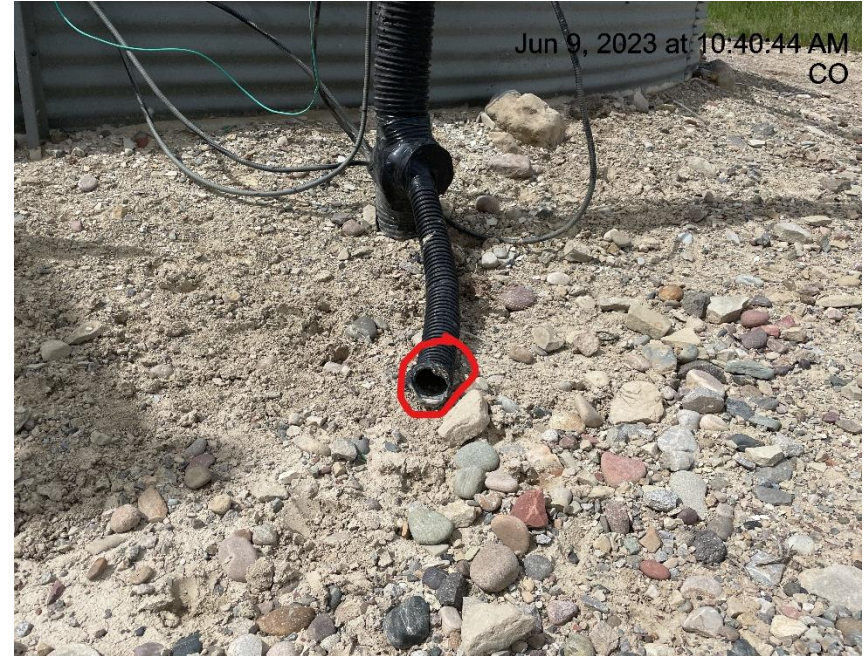
Photo # 9978 Flowline heating insulation open ended

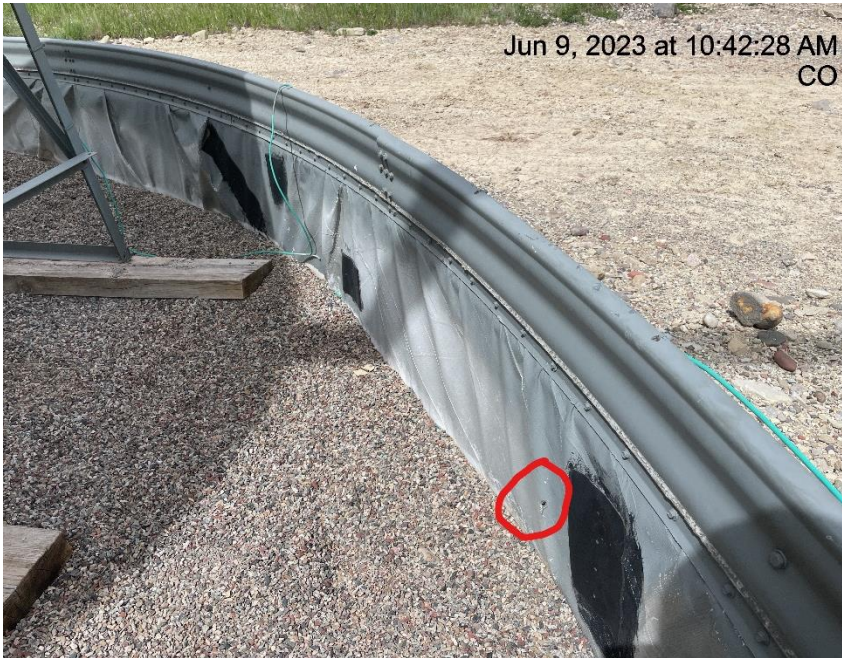
Photo # 9980 Containment liner needs maintenance

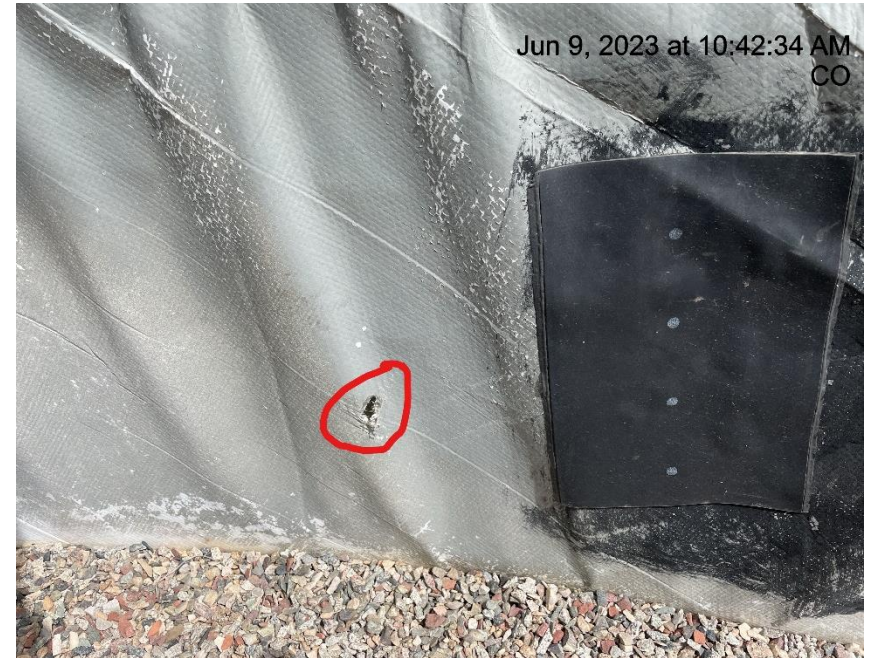
Photo # 9981 Containment liner needs maintenance

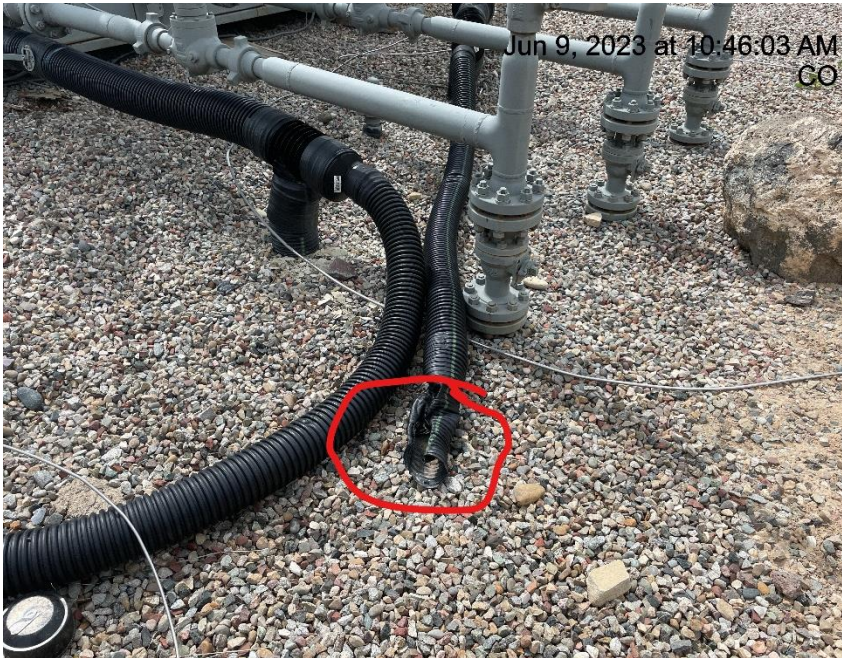
Photo # 9985 Flowline heating insulation open ended

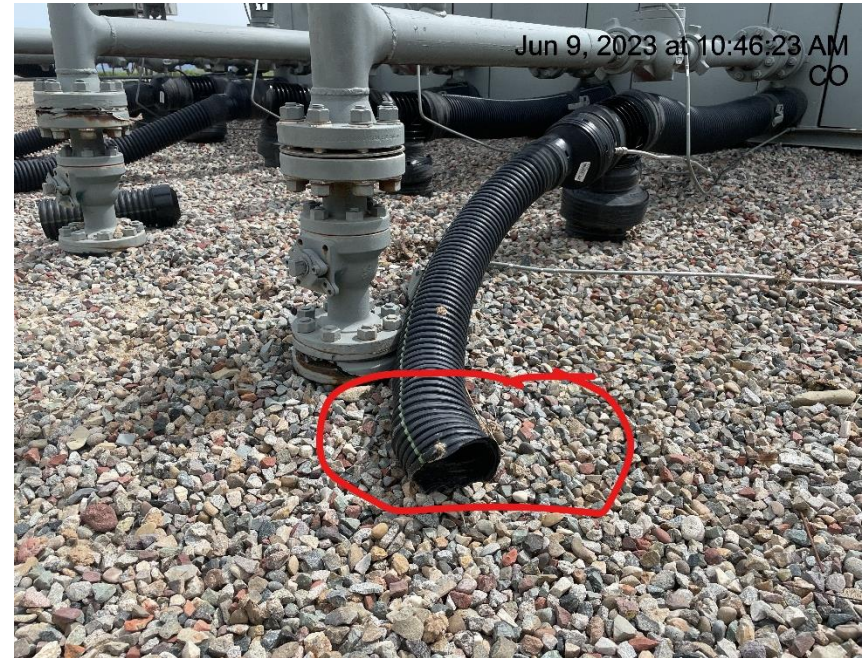
Photo # 9986 Flowline heating insulation open ended

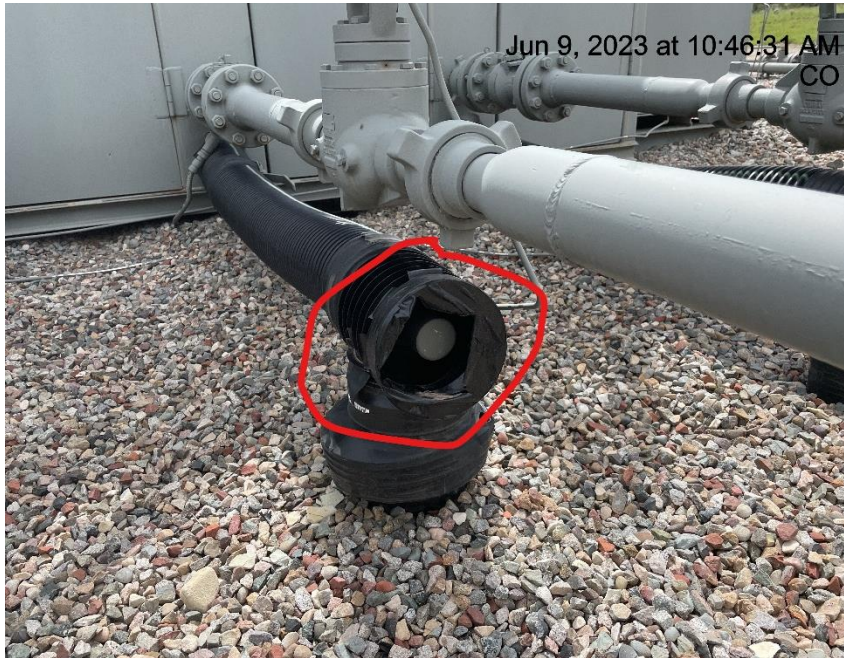
Photo # 9987 Flowline heating insulation open ended

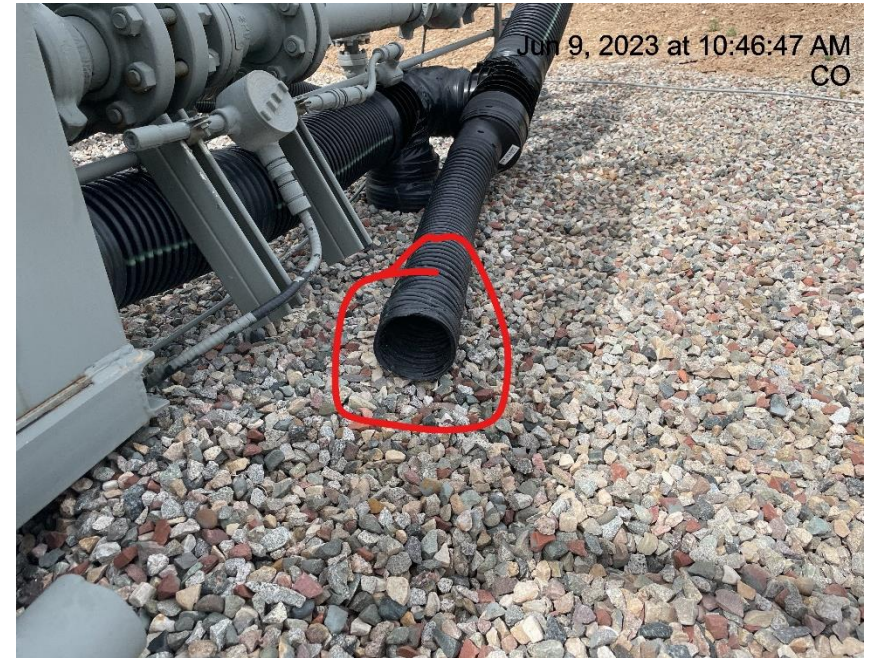
Photo # 9989 Flowline heating insulation open ended
