Storm Water Management and Erosion control
Location Name: TEP ROCKY MOUNTAIN LLC CLOUGH 104 Pad
Location ID: 322416

Location Overview:
Section/Township/Range: 16 6S94W

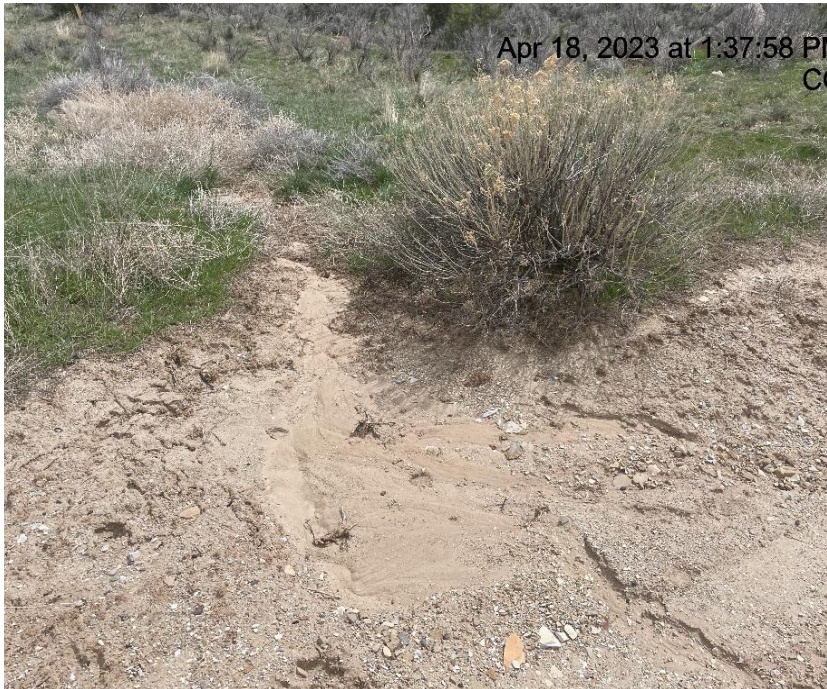
**Photo # 5694 From Inspection 708900299
conducted on 04/18/2023 Erosion & transport of
sediment off location**

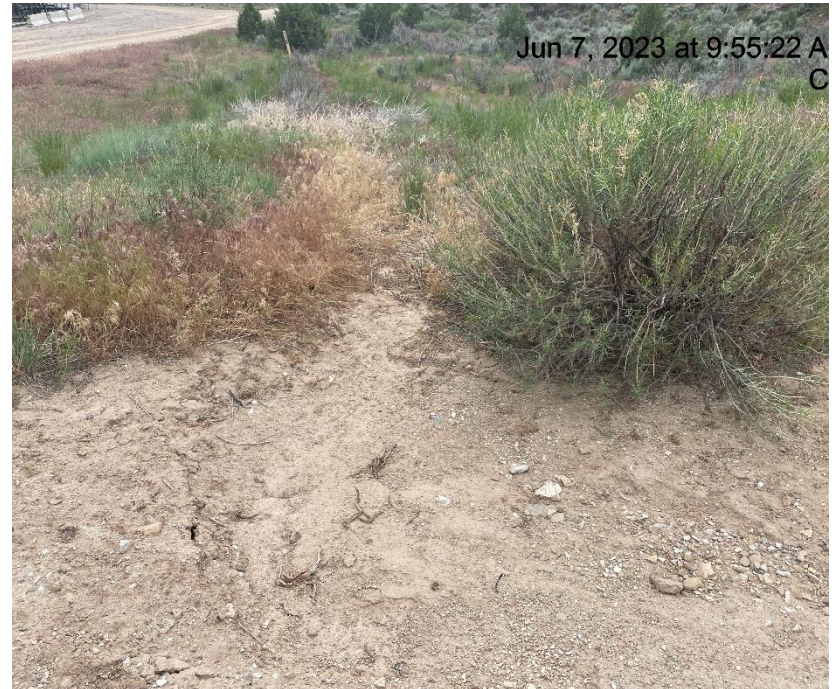
**Photo # 9685 Erosion & transport of sediment off
location**

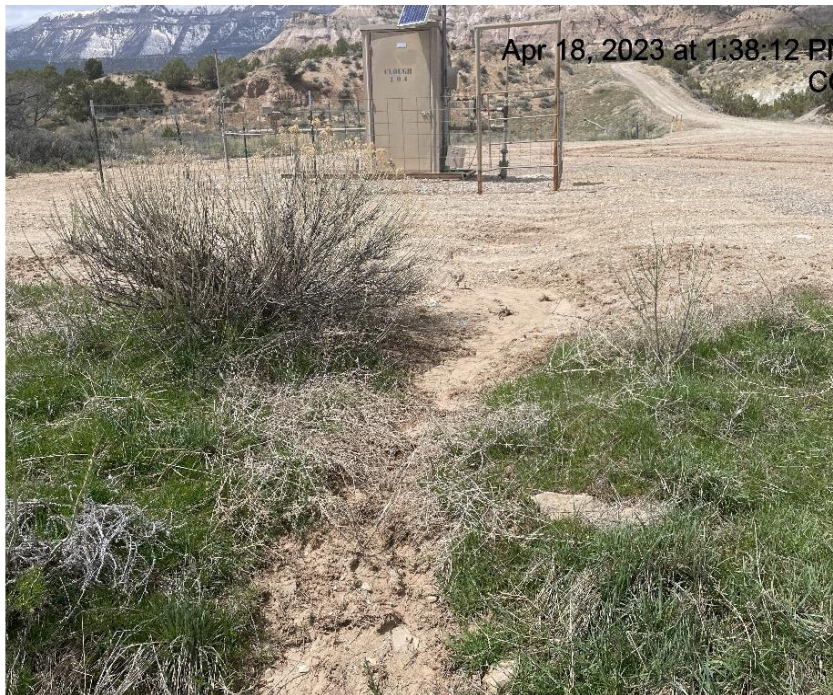
Photo # 5695 From Inspection 708900299 conducted on 04/18/2023 Erosion & transport of sediment off location

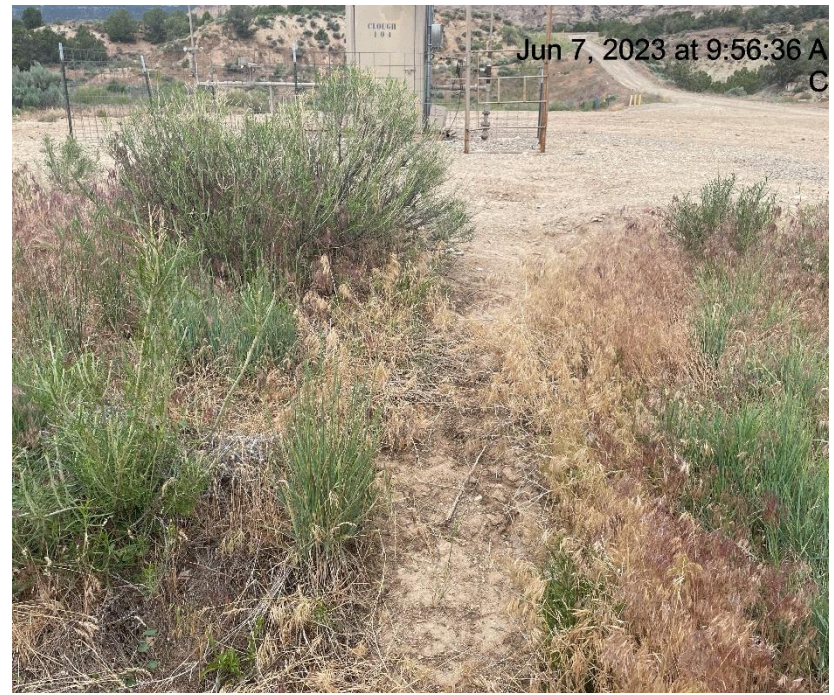
Photo # 9692 Erosion & transport of sediment off location

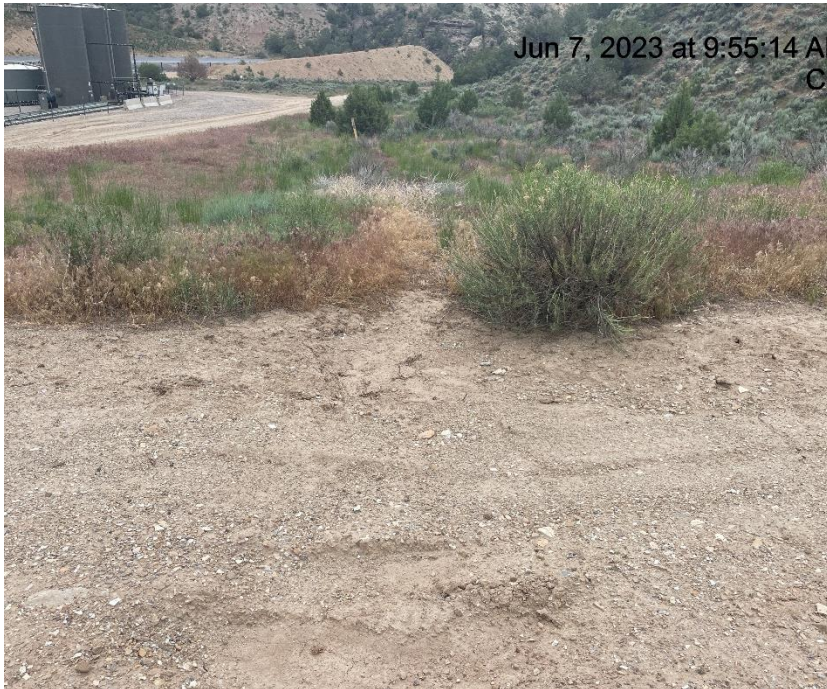
Photo # 9684 Erosion & transport of sediment off location

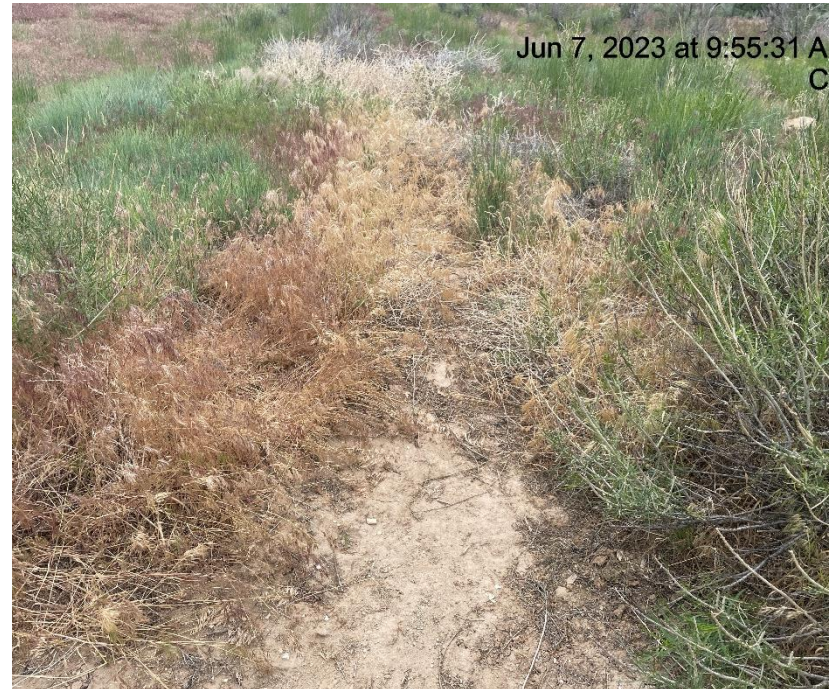
Photo # 9686 Erosion & transport of sediment off location

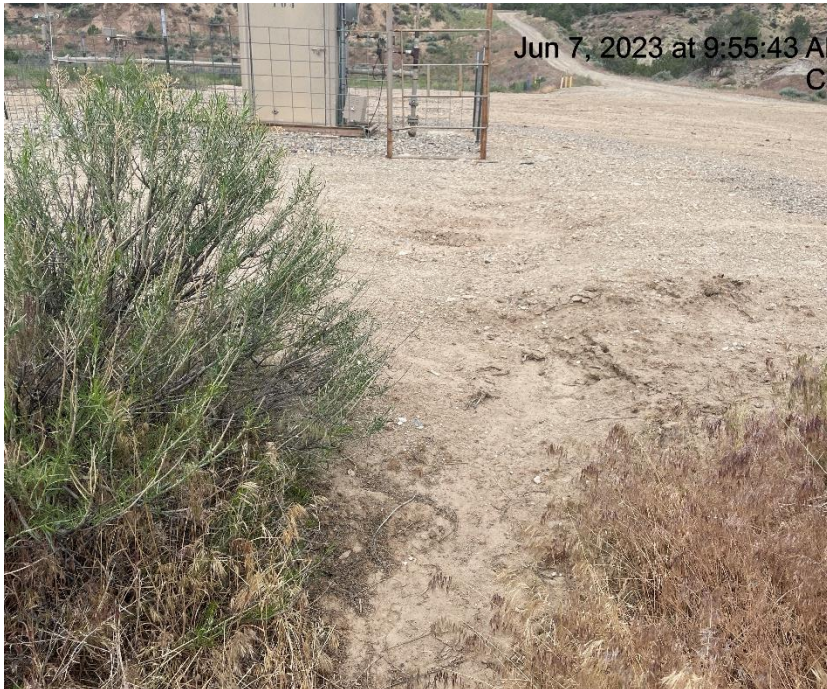
Photo # 9687 Erosion & transport of sediment off location

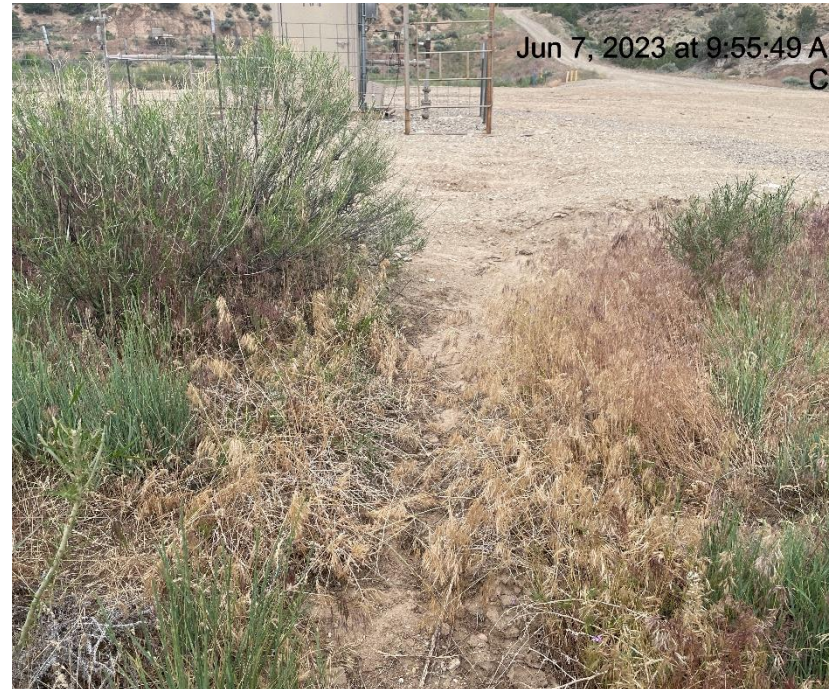
Photo # 9688 Erosion & transport of sediment off location

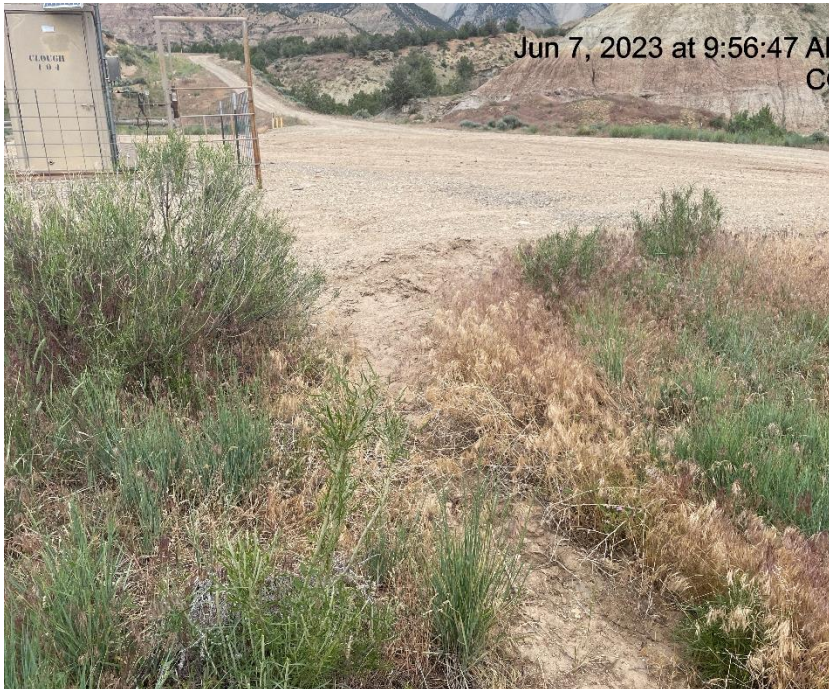
Photo # 9693 Erosion & transport of sediment off location
