Inspection Photos

API: 067-05521

Operator: LOGOS OPERATING LLC

Inspection Date: 6/15/2023

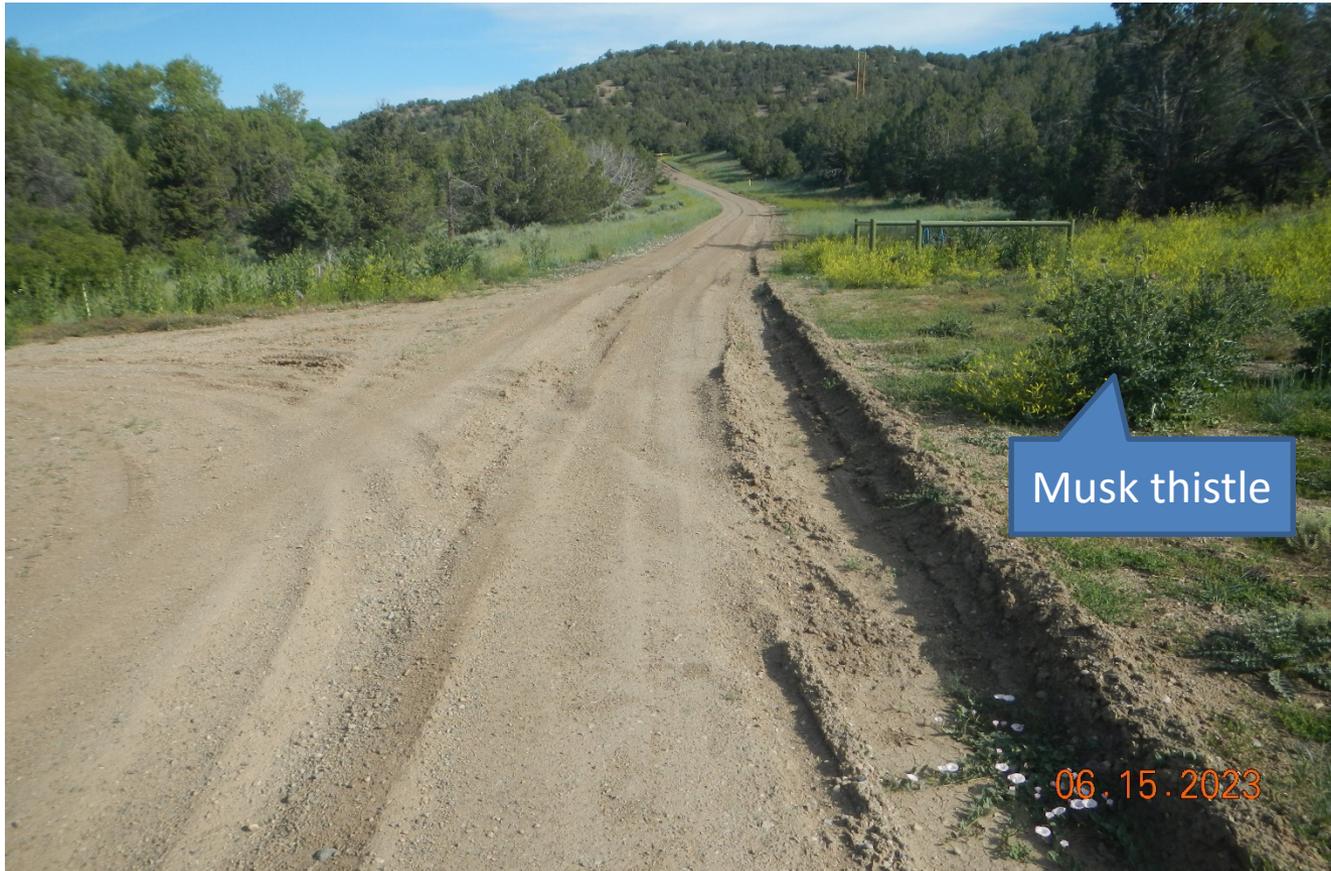
Photo 1. Facing northwest along the access road. There is vehicle rutting and tracking along the road that needs to be repaired and stabilized. There are also noxious weeds along the roadside that need to be controlled.

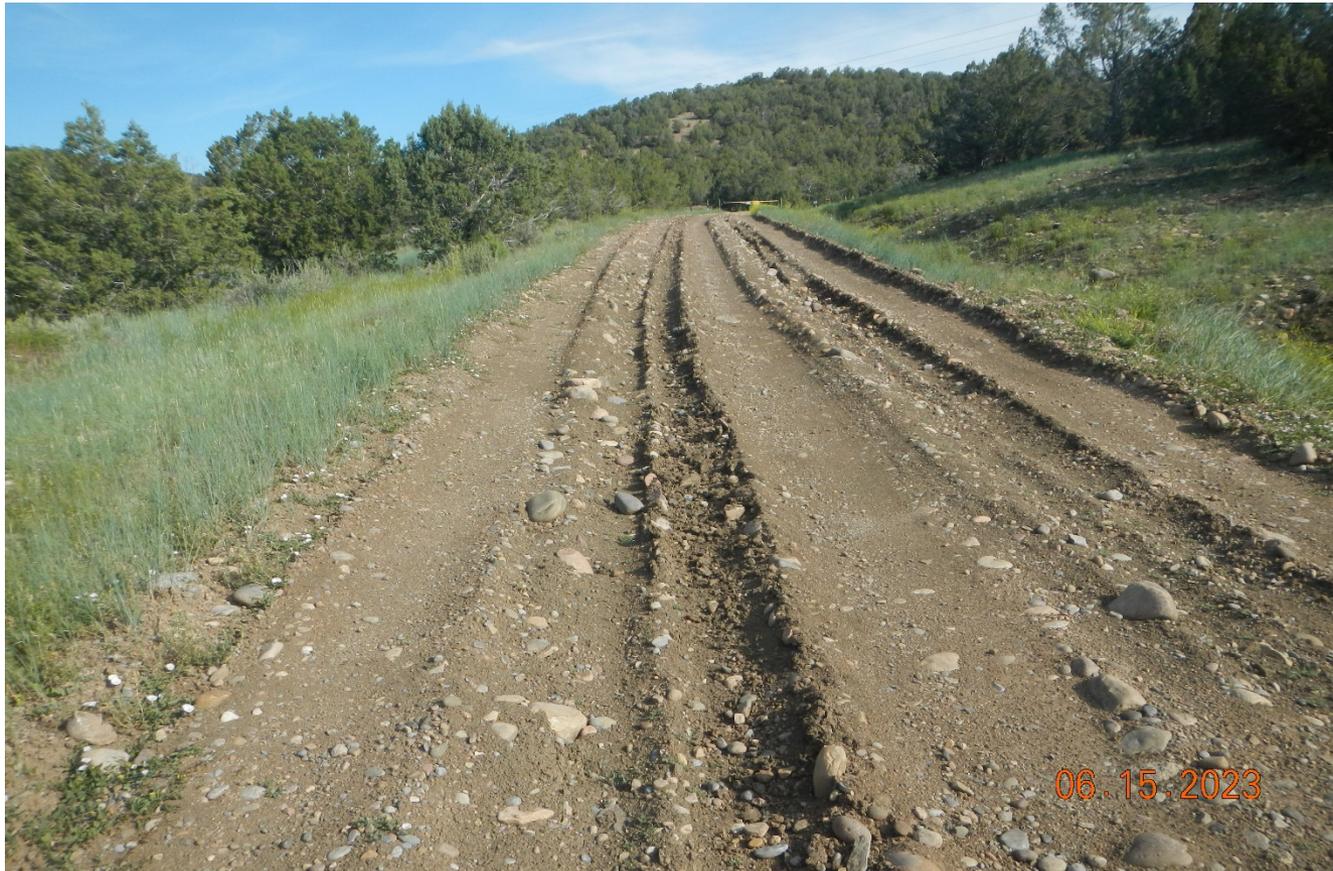
Photo 2. Facing northwest along the access road. There is vehicle rutting and tracking along the road that needs to be repaired and stabilized. Previous corrective action was not completed.

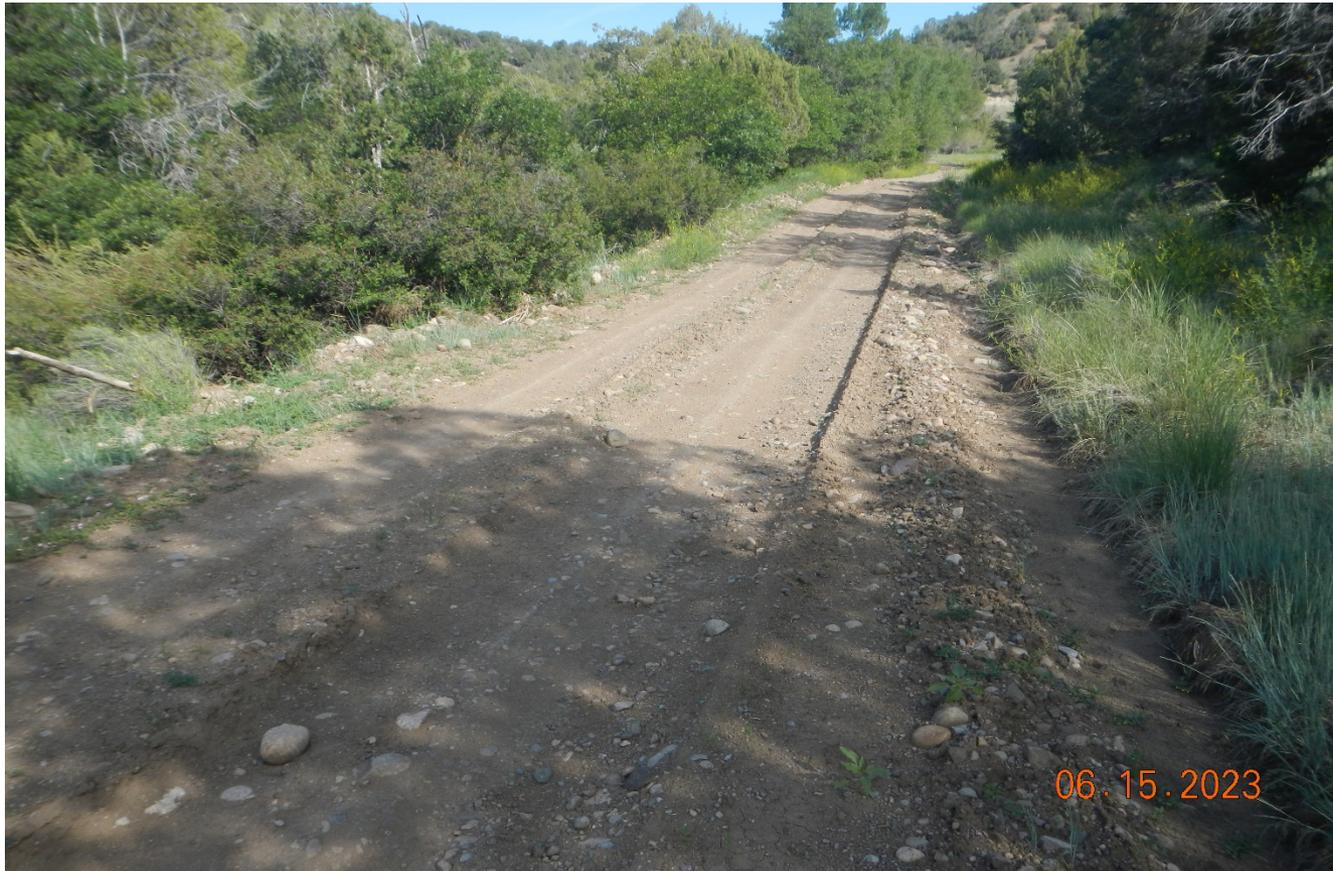
Photo 3. Facing northwest along the access road. This area had previously washed out and was repaired however, stormwater is directed down this area and there are no BMP's to divert off the road e.g. culvert water bar ect.

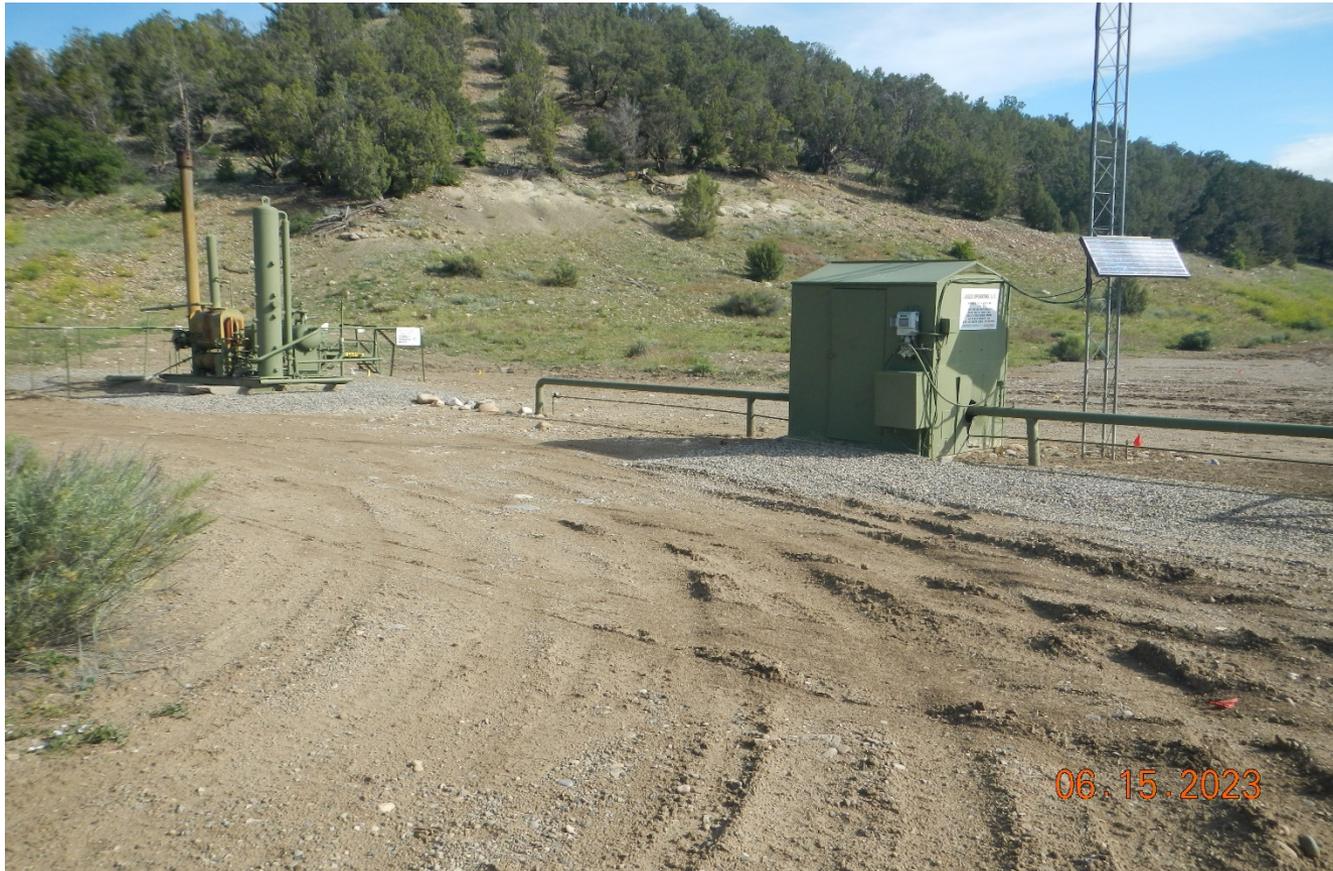
Photo 4. Facing northeast toward the wellsite.

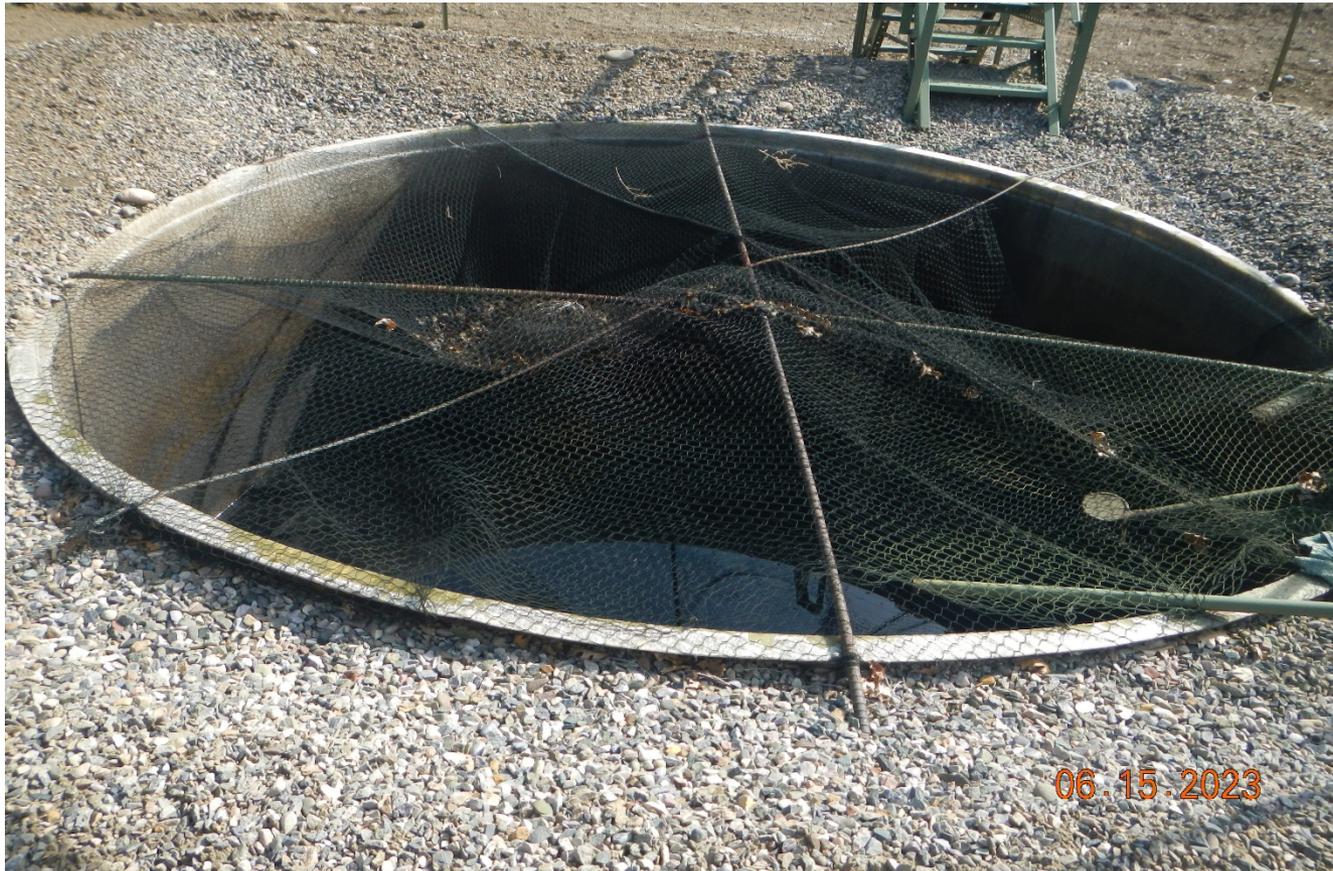
Photo 5. The netting on the buried tank is not maintained to prevent wildlife entry.

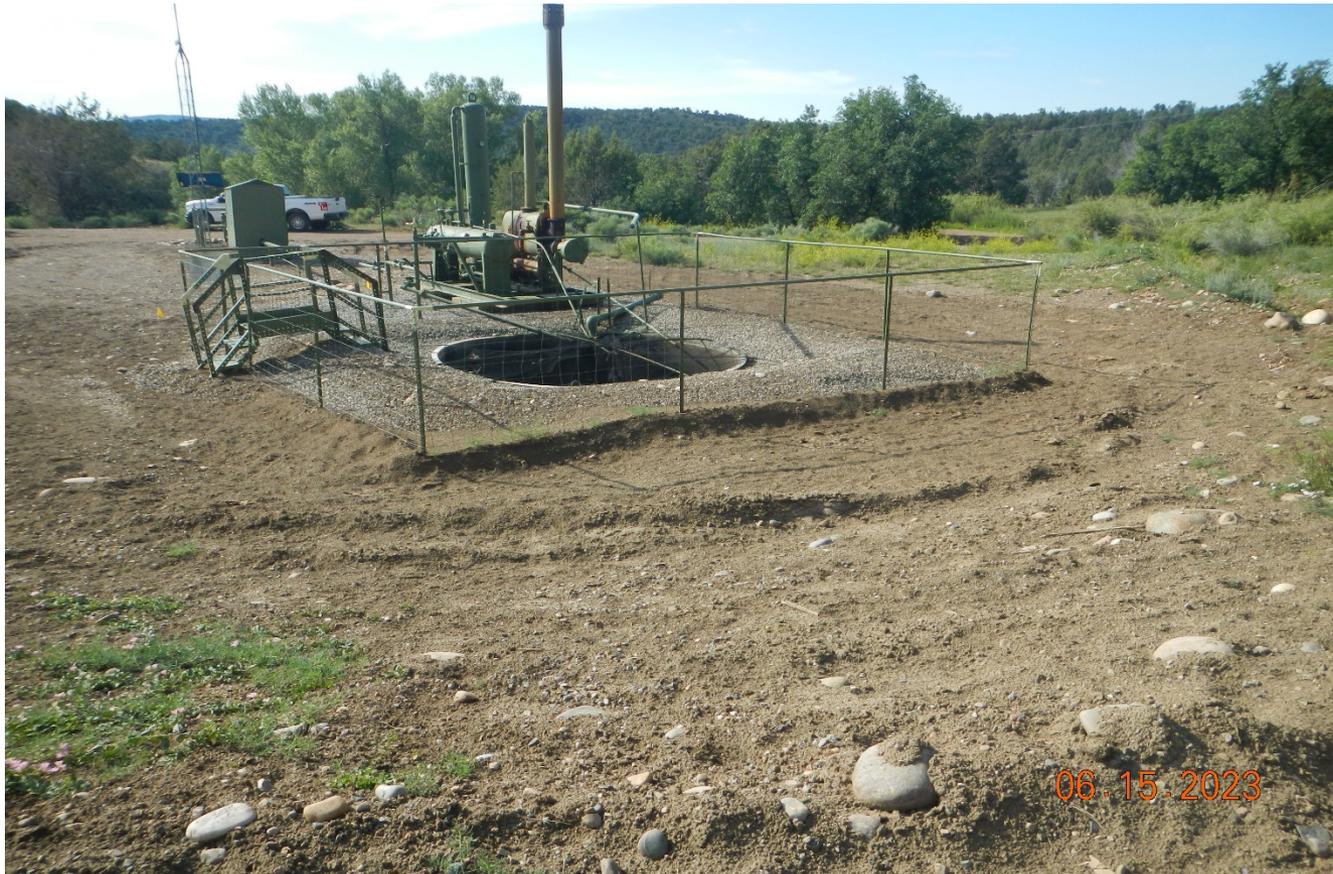
Photo 6. Facing back to the southwest.

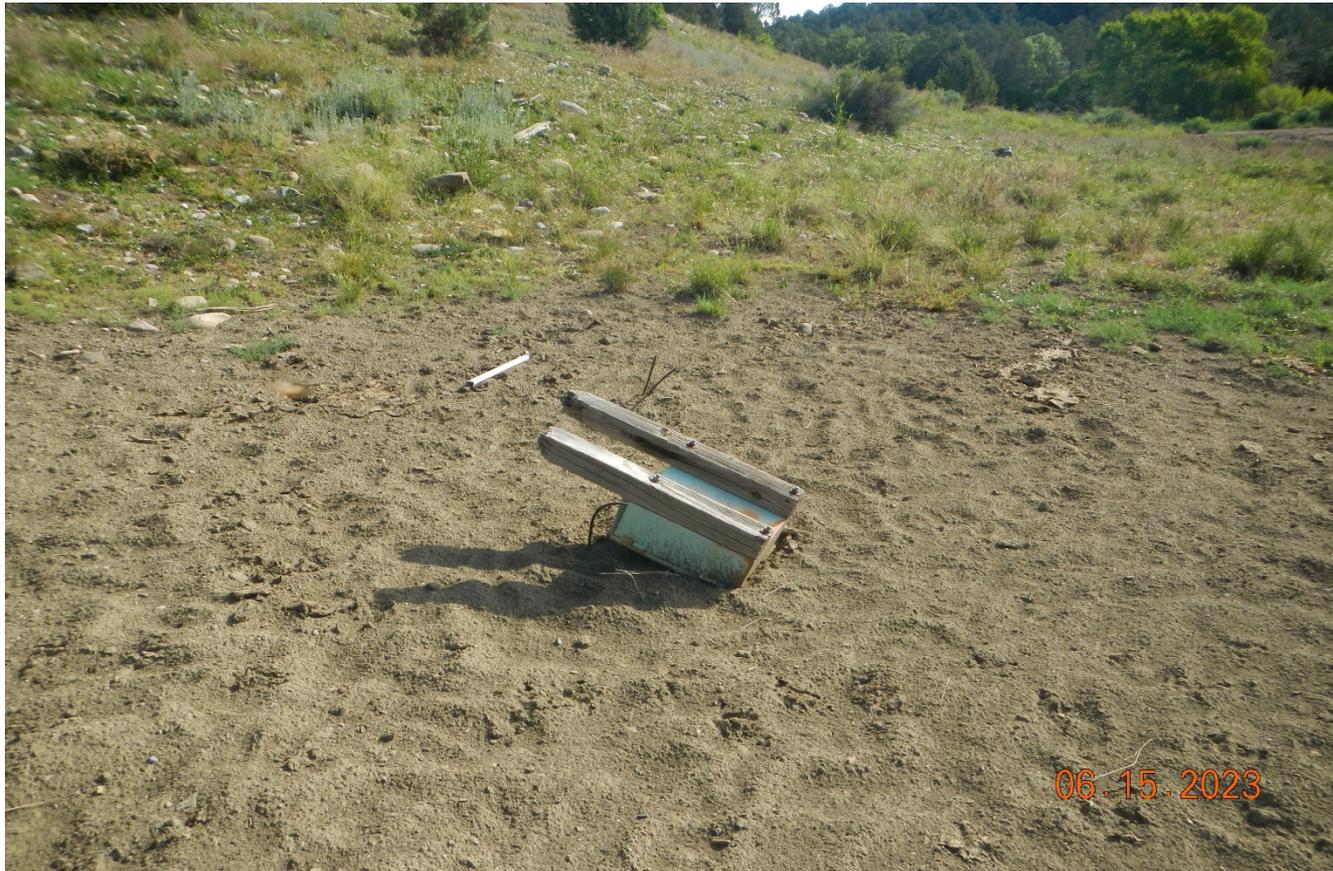
Photo 7. There is an electric utility that has fallen over at the northside of the location and needs to be removed or repaired.
