Inspection Photos

Location Name: TEP ROCKY MOUNTAIN LLC FURR /22-07 (F1) PAD

Location ID: 334778

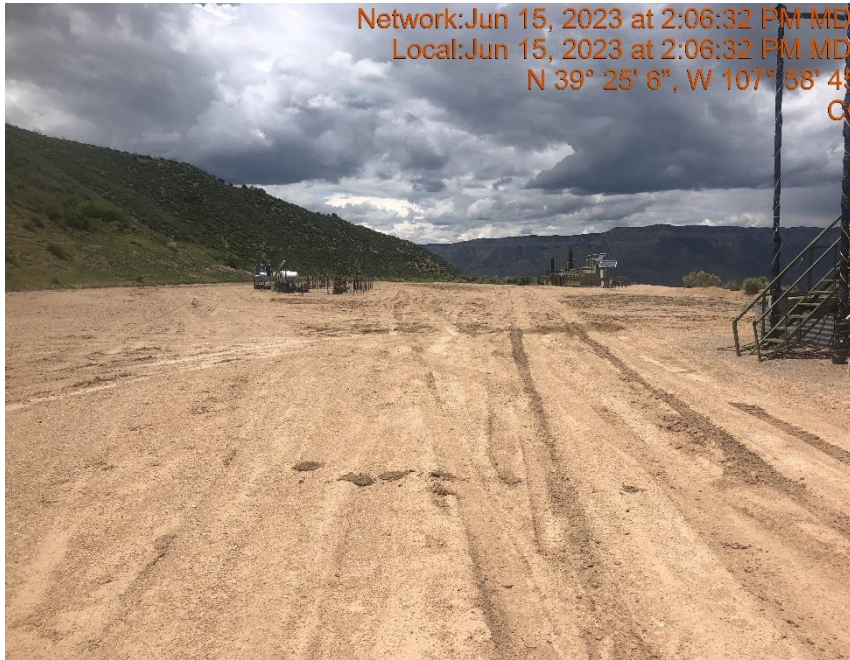
Photo #380 From entrance to location.

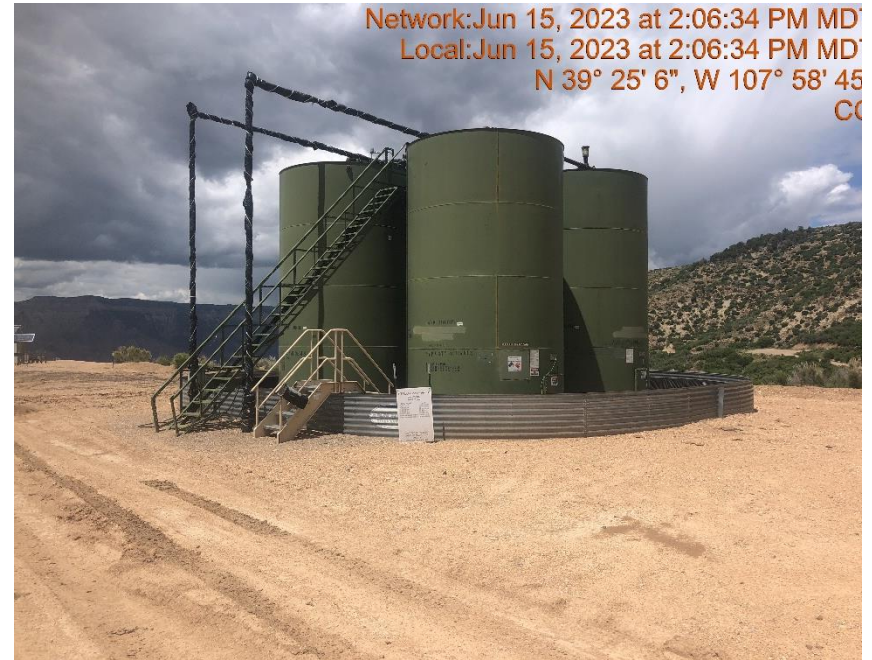
Photo #381 From entrance to location

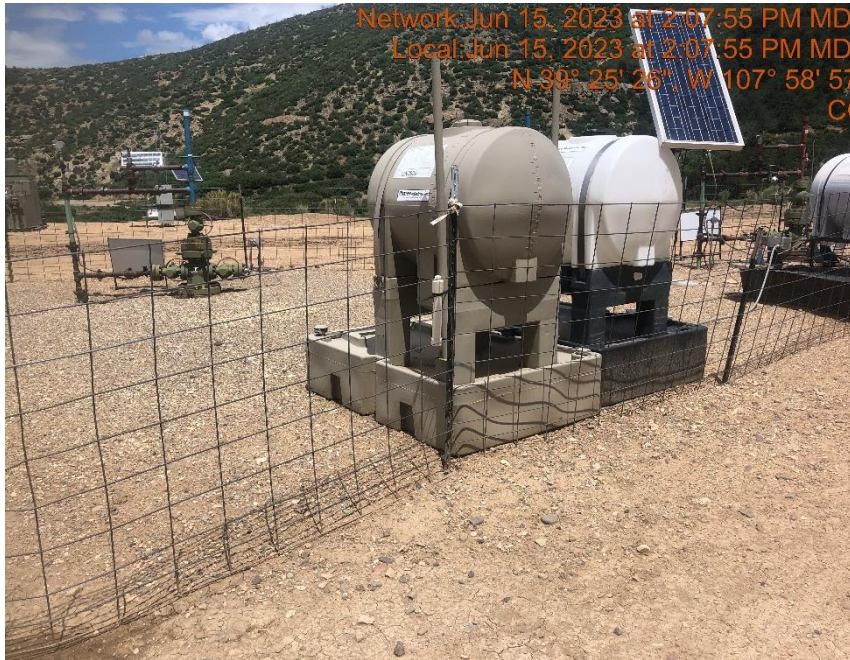
Photo #386 Unused equipment.

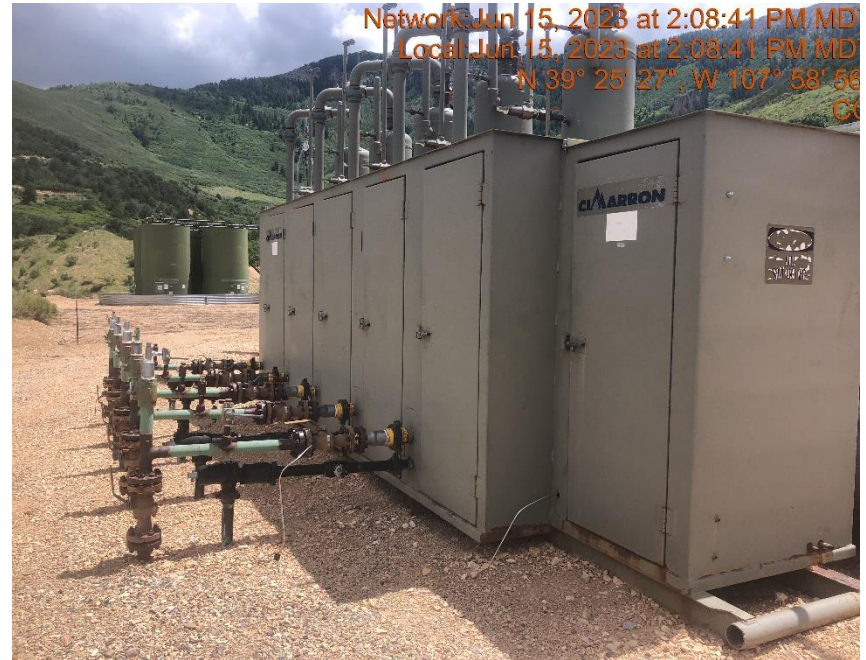
Photo #389 Calibration cards not conspicuously posted.

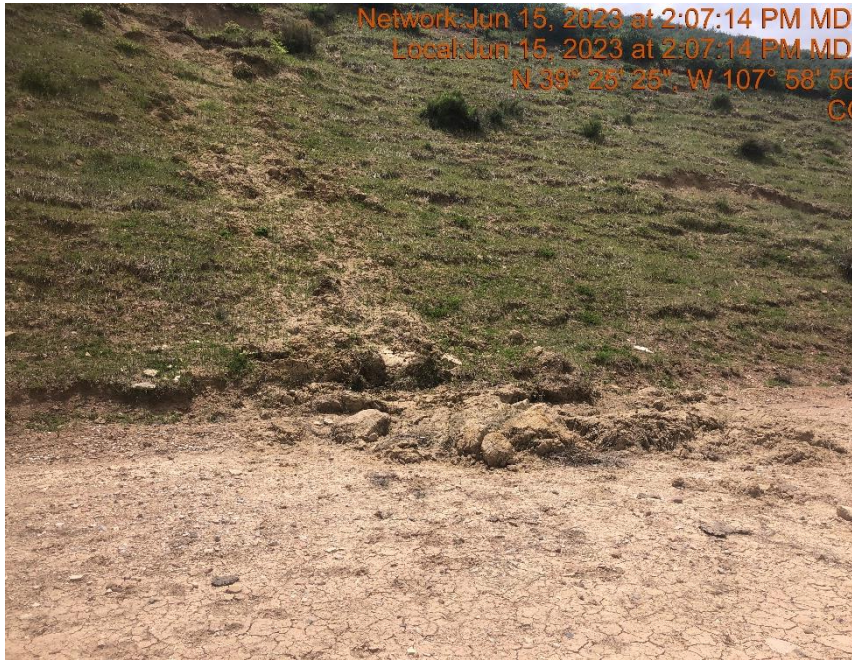
Photo #382 Run on to location not being controlled.

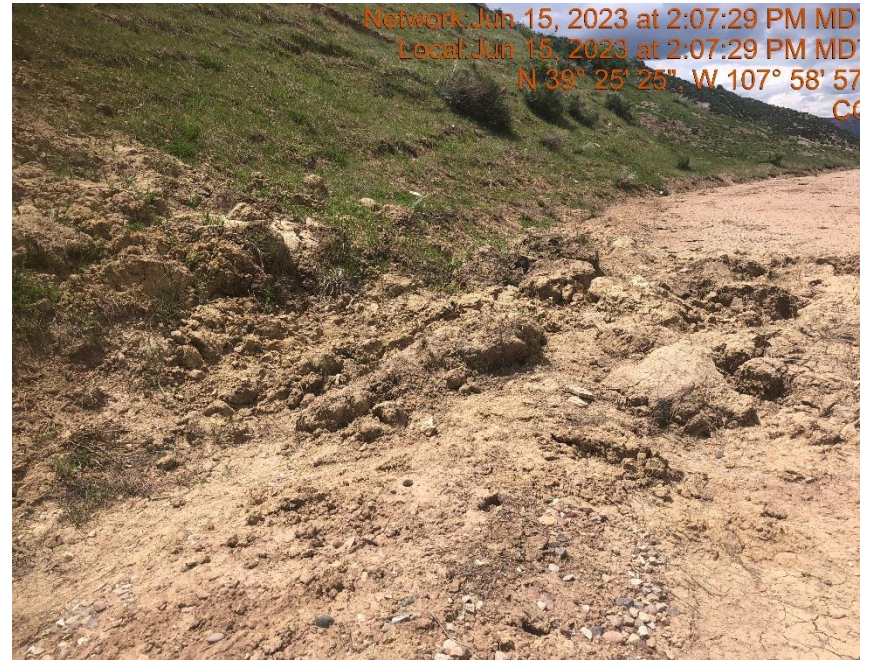
Photo #384 Run on to location not being controlled.

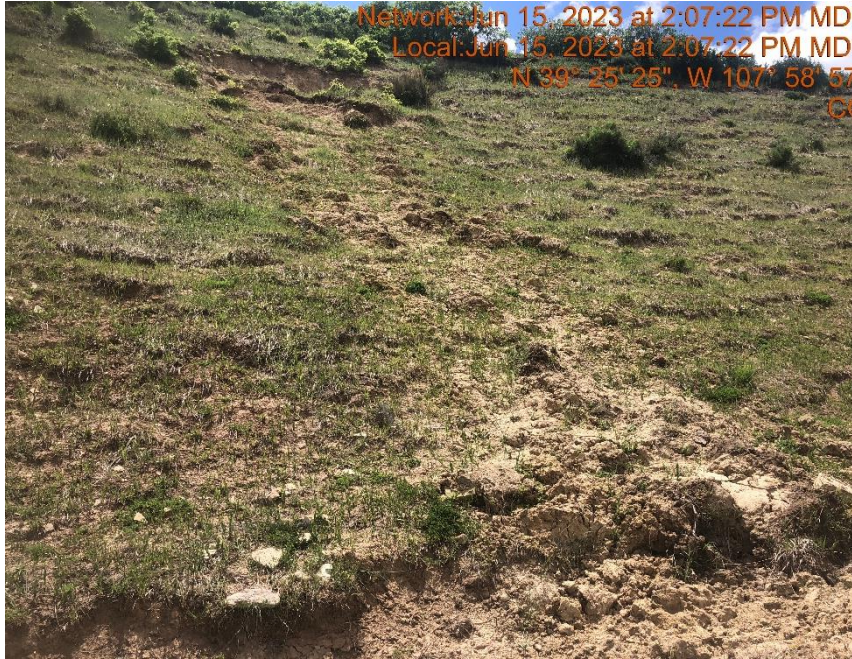
Photo #383 Cut slope lacks stabilization.

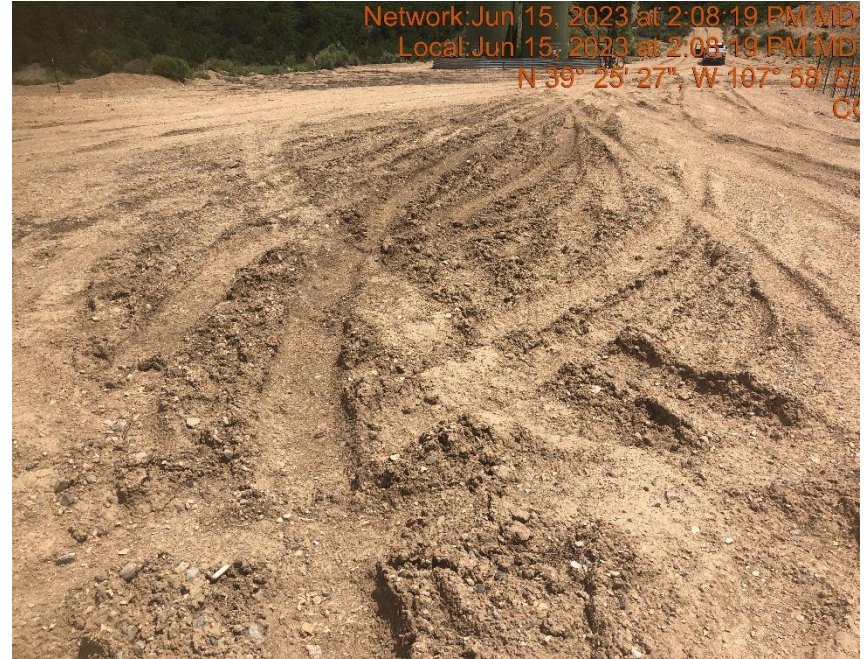
Photo #387 Location lacks stabilization.

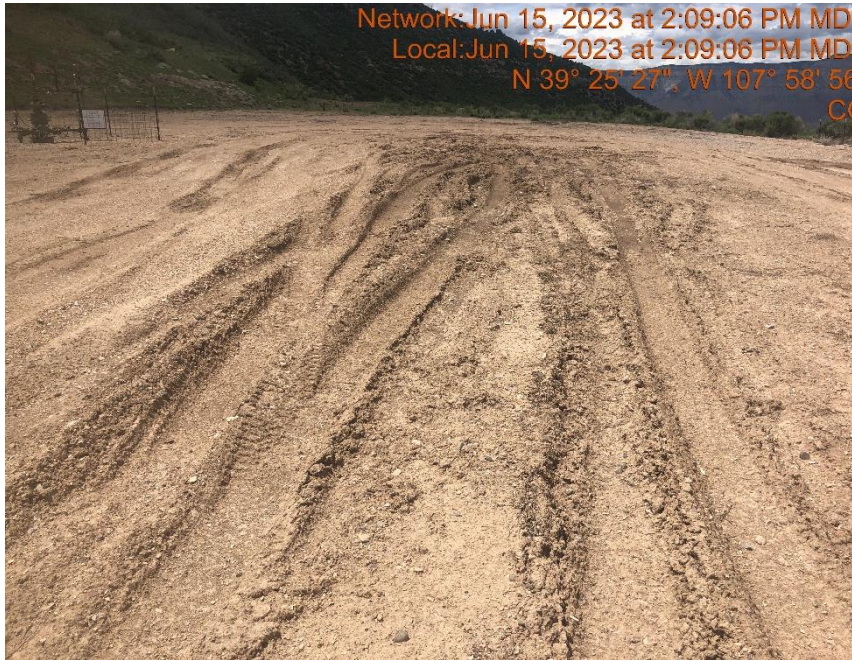
Photo #390 Location lacks stabilization.

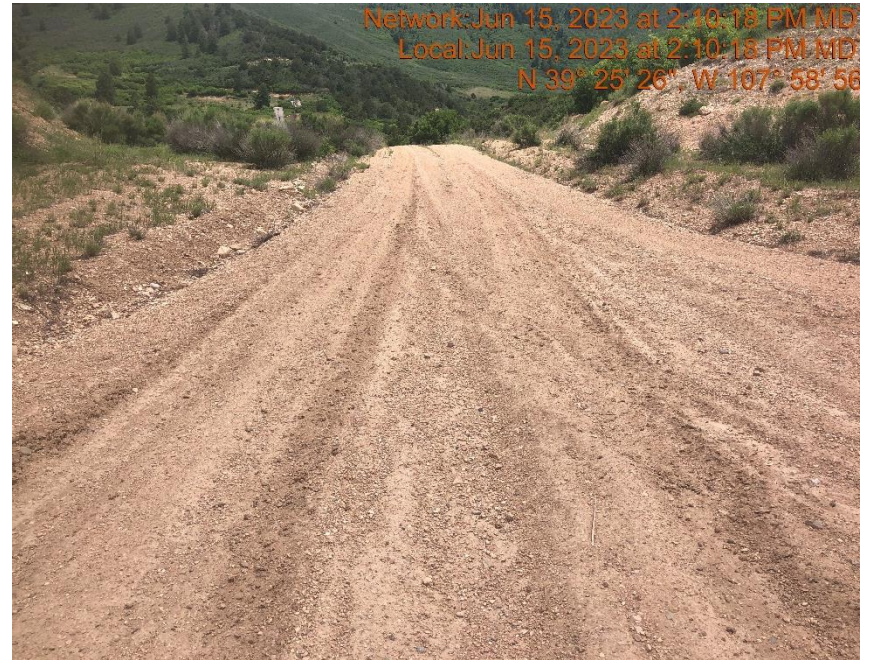
Photo #395 Insufficient tracking BMP at entrance to location to minimize the transport of sediment.
