Inspection Photos

Loc: 484496

Operator: NUEVIDA RESOURCES LLC

Inspection Date: 6/15/2023

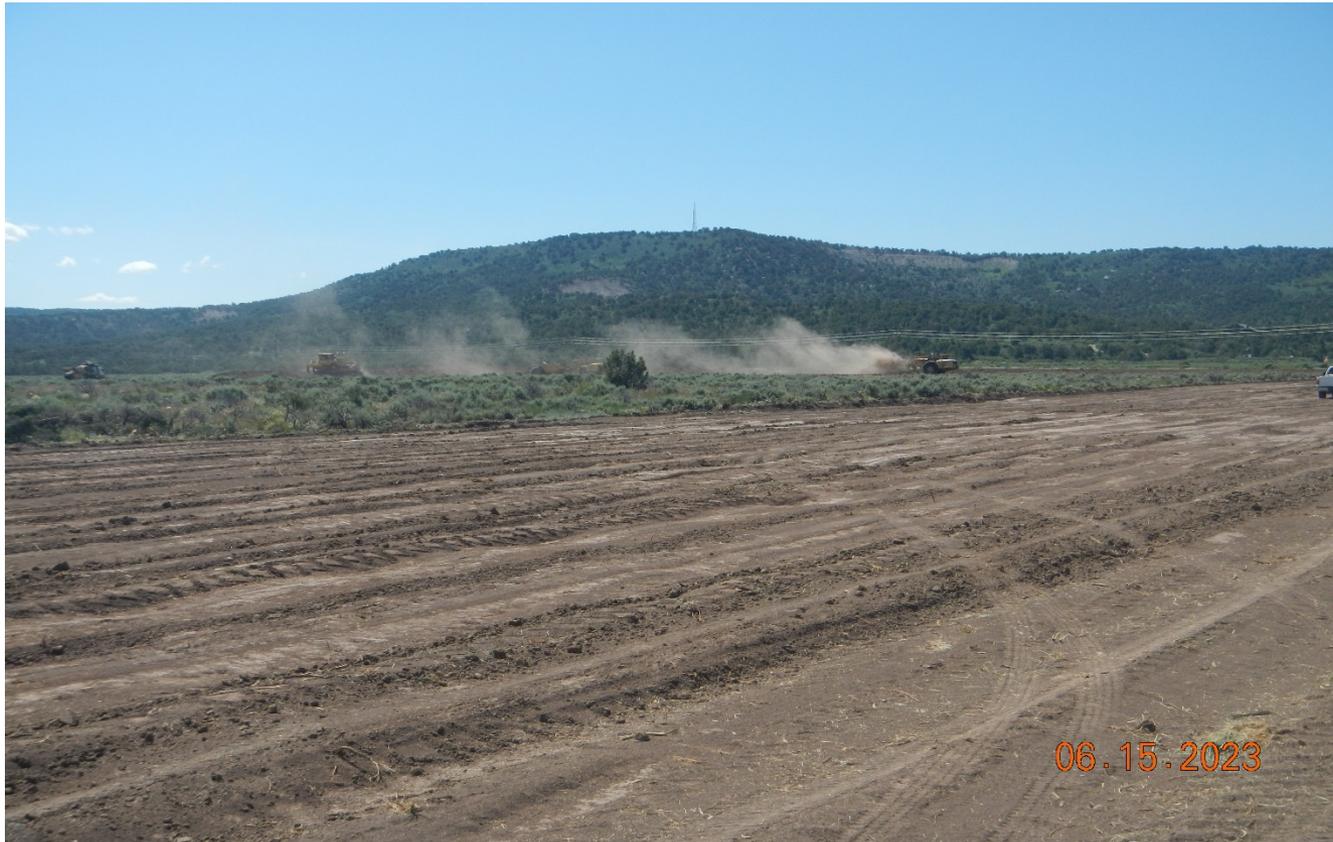
Photo 1. Facing southwest toward the tank pad location which is being constructed. It was slightly windy and dust from equipment was observed.

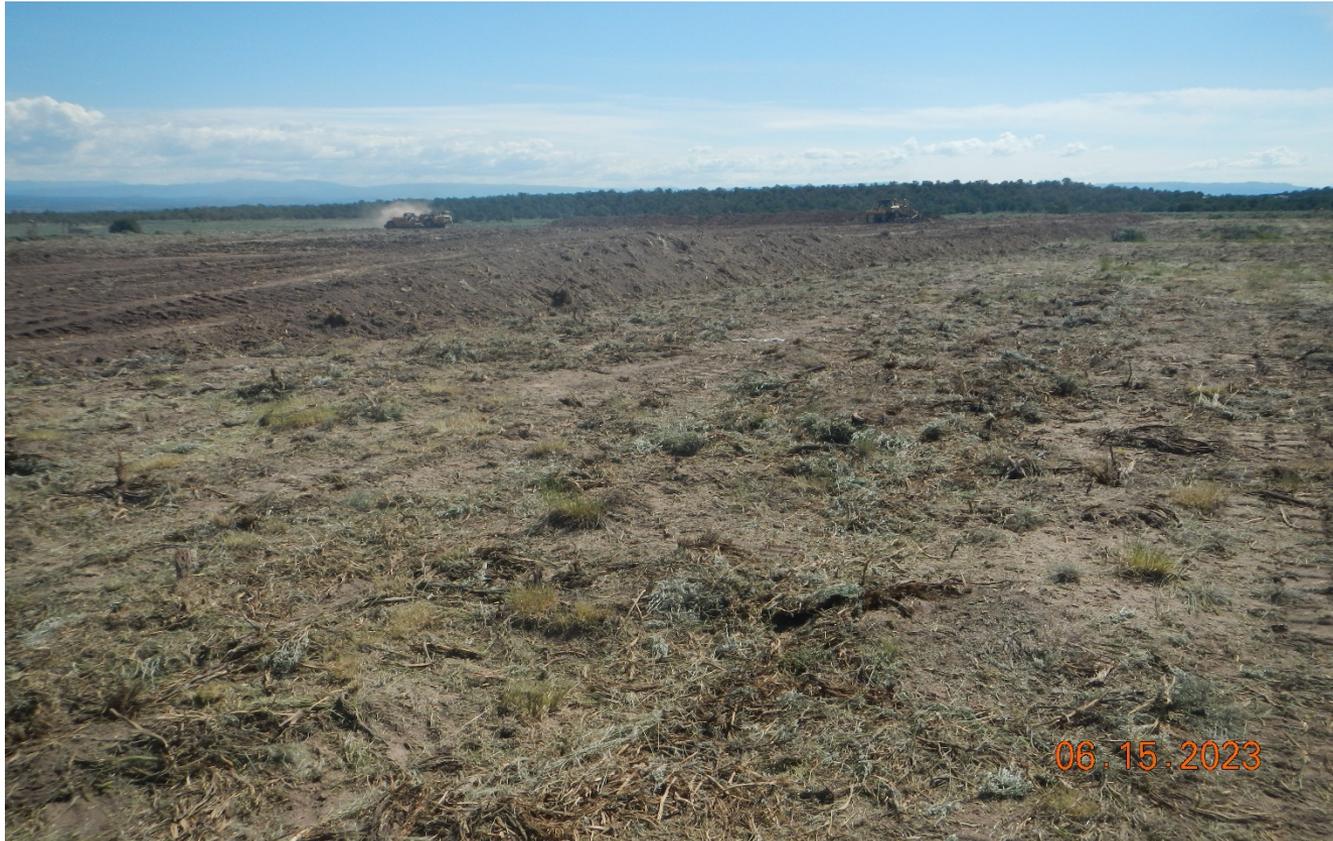
Photo 2. Standing at the southwest corner of the tank pad location facing northeast. Topsoil was in process of being stripped and stockpiled at the south and east side of the location.

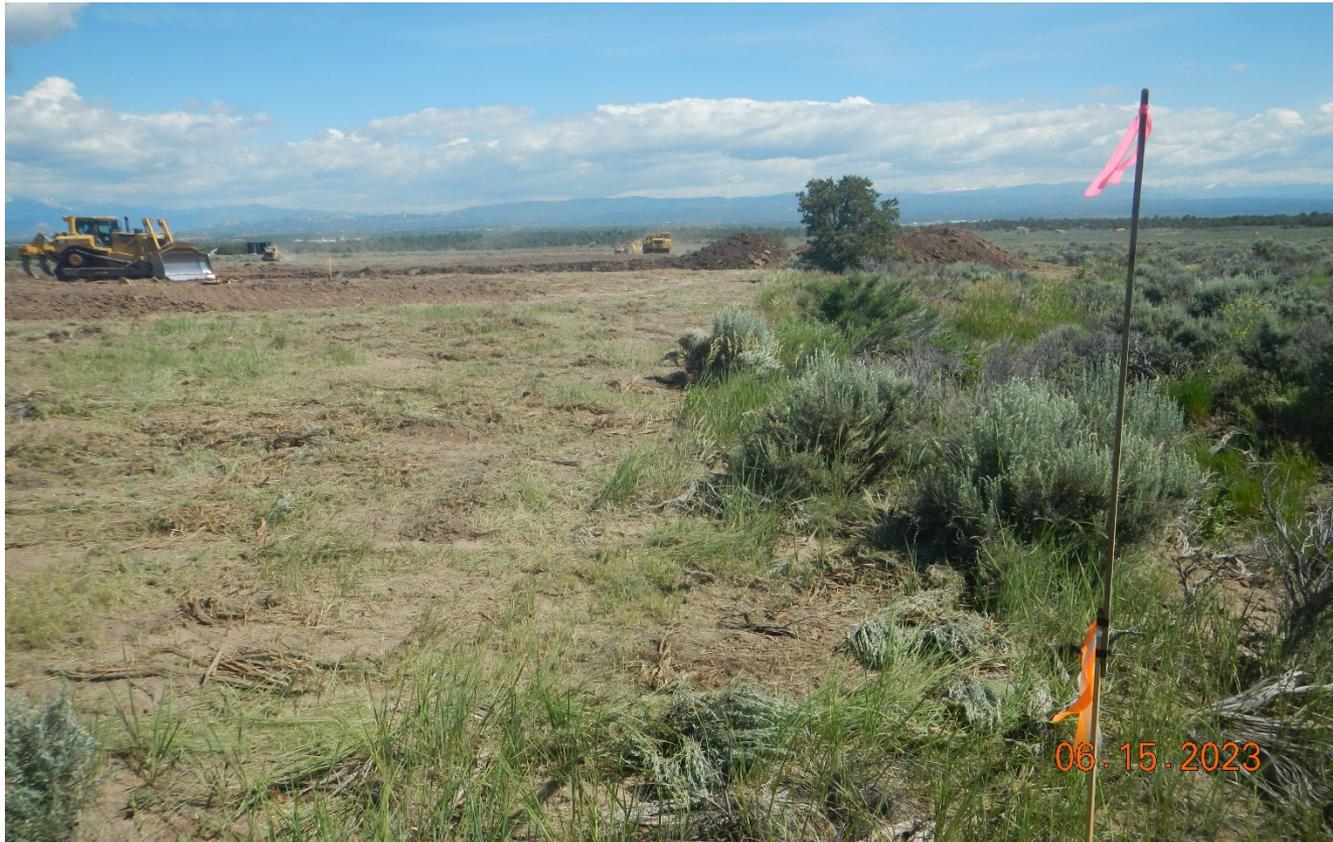
Photo 3. Standing at the southeast corner of the tank pad location facing north.

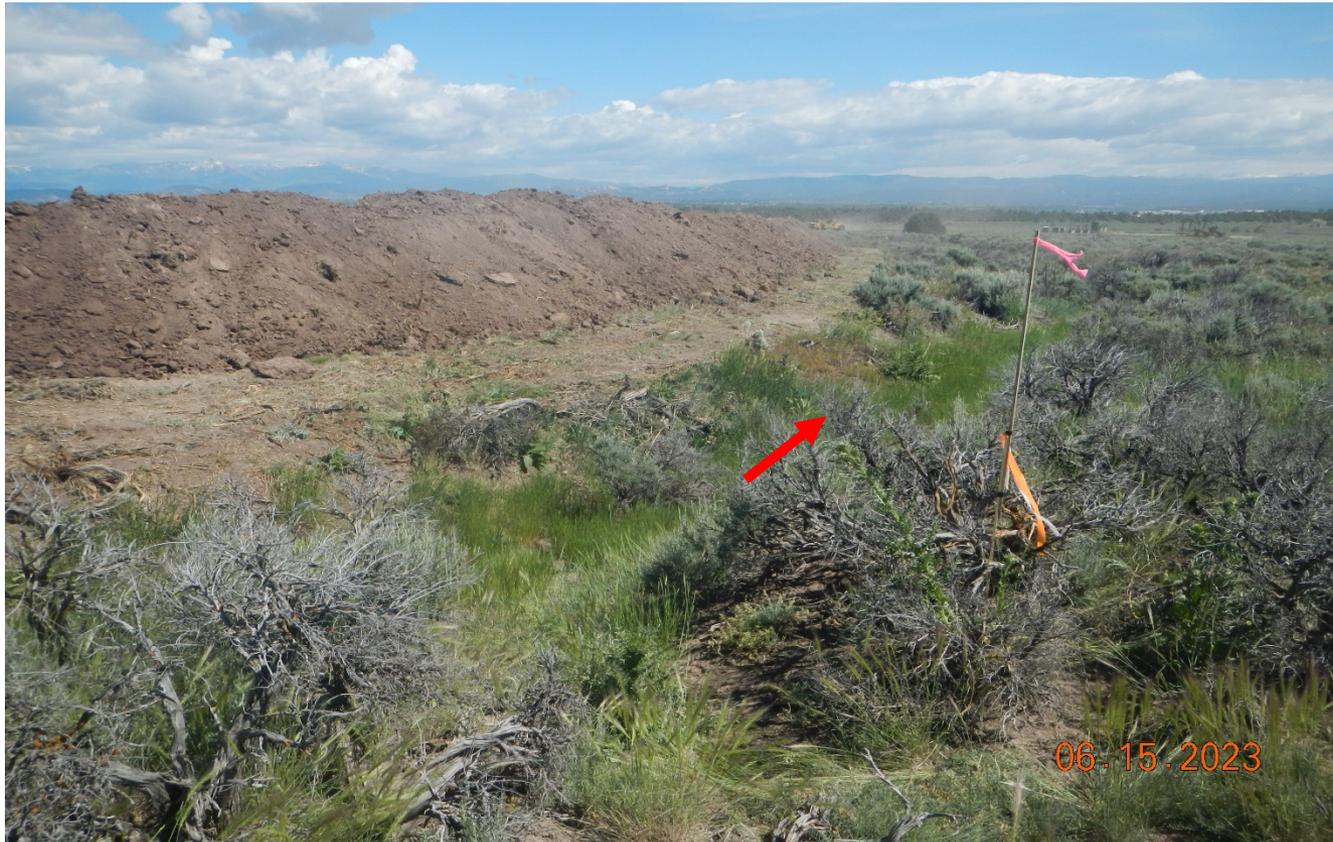
Photo 4. Southeast side of the location facing north. There are no perimeter stormwater controls installed. Topsoil is being paced near the drainage swale shown at red arrow which runs along the edge of the disturbance.

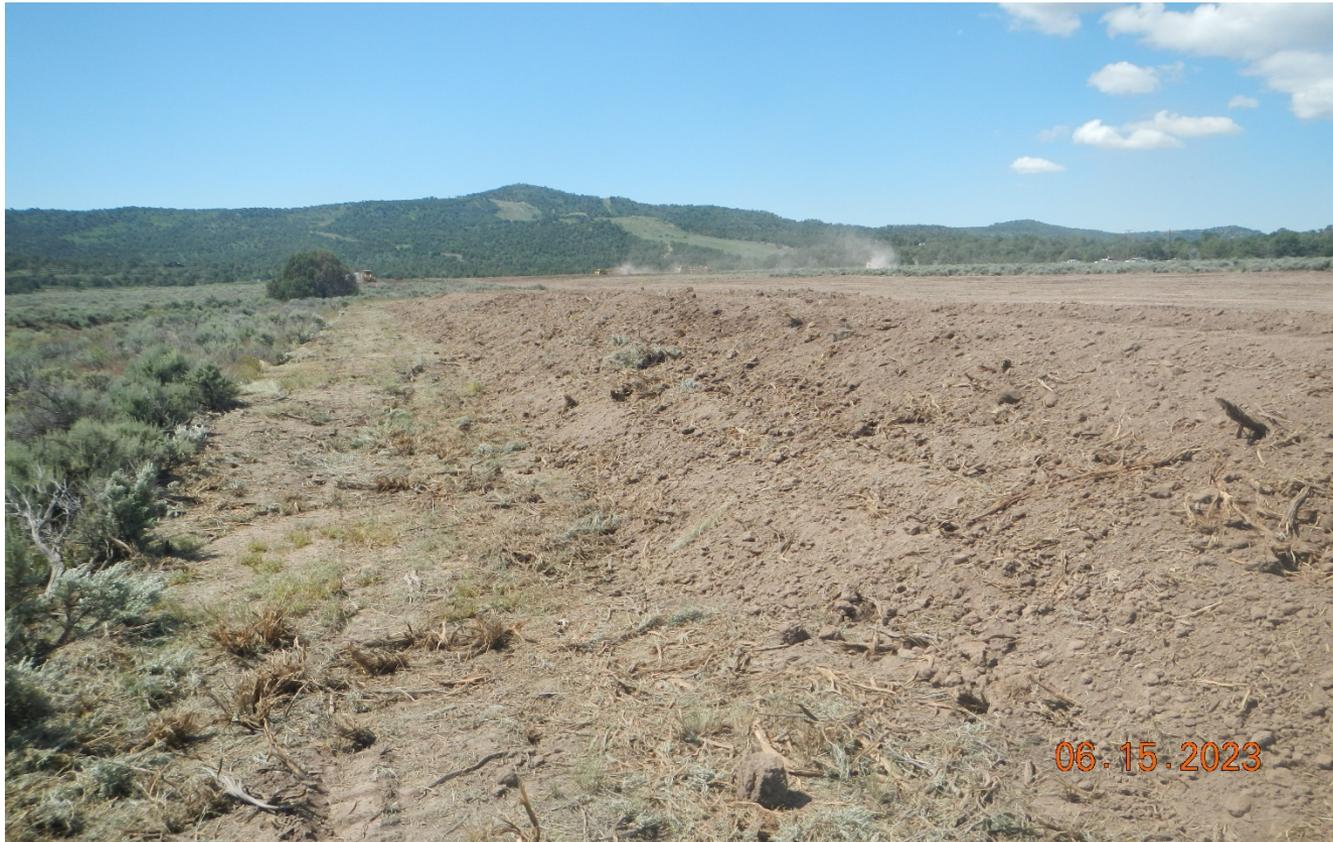
Photo 5. Northeast side of the location facing south. There are no perimeter stormwater controls installed. Stormwater controls should have been installed prior to construction. Topsoil is being stripped and stockpiled along the east side of the location.

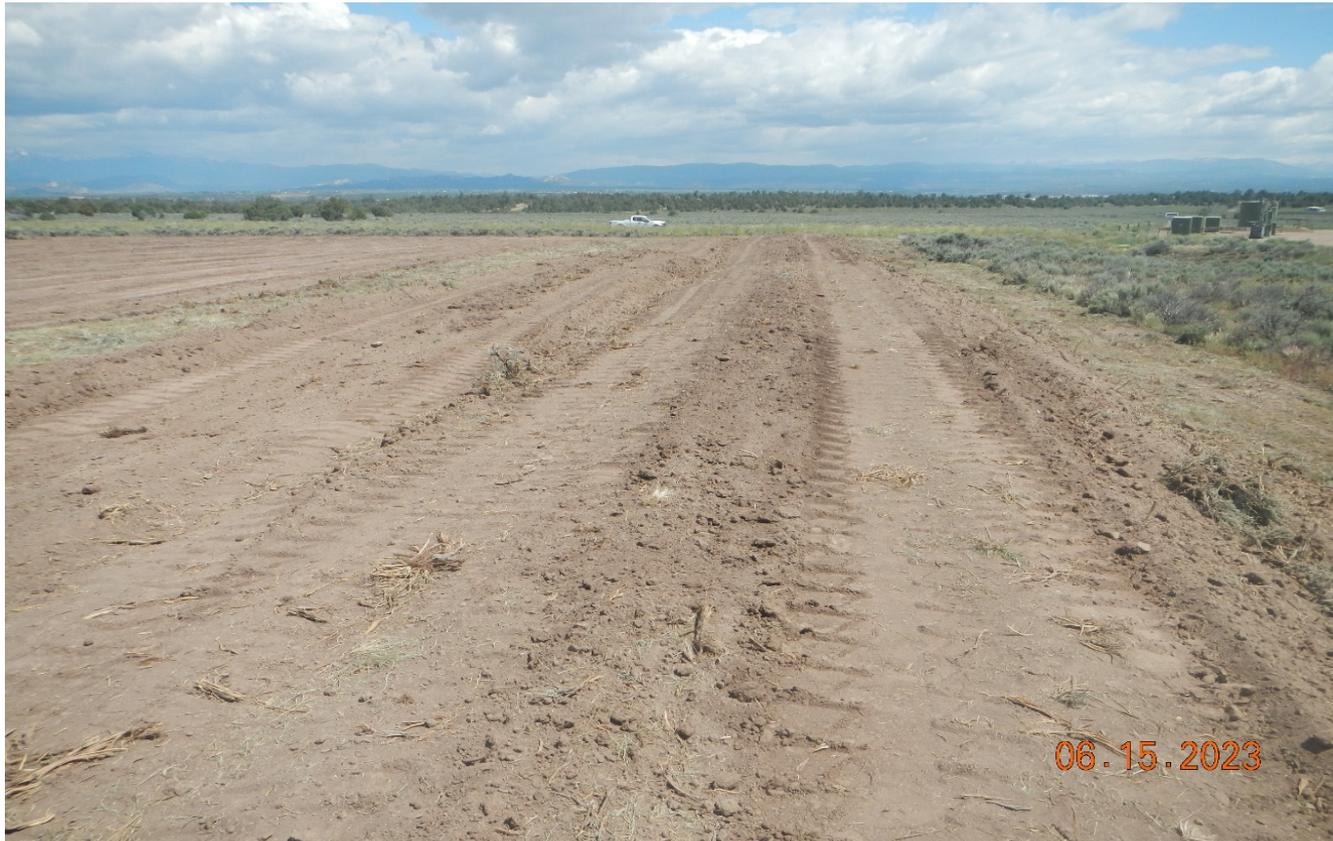
Photo 6. Standing on the topsoil pile facing north. There are no perimeter stormwater controls installed. Stormwater controls should have been installed prior to construction.

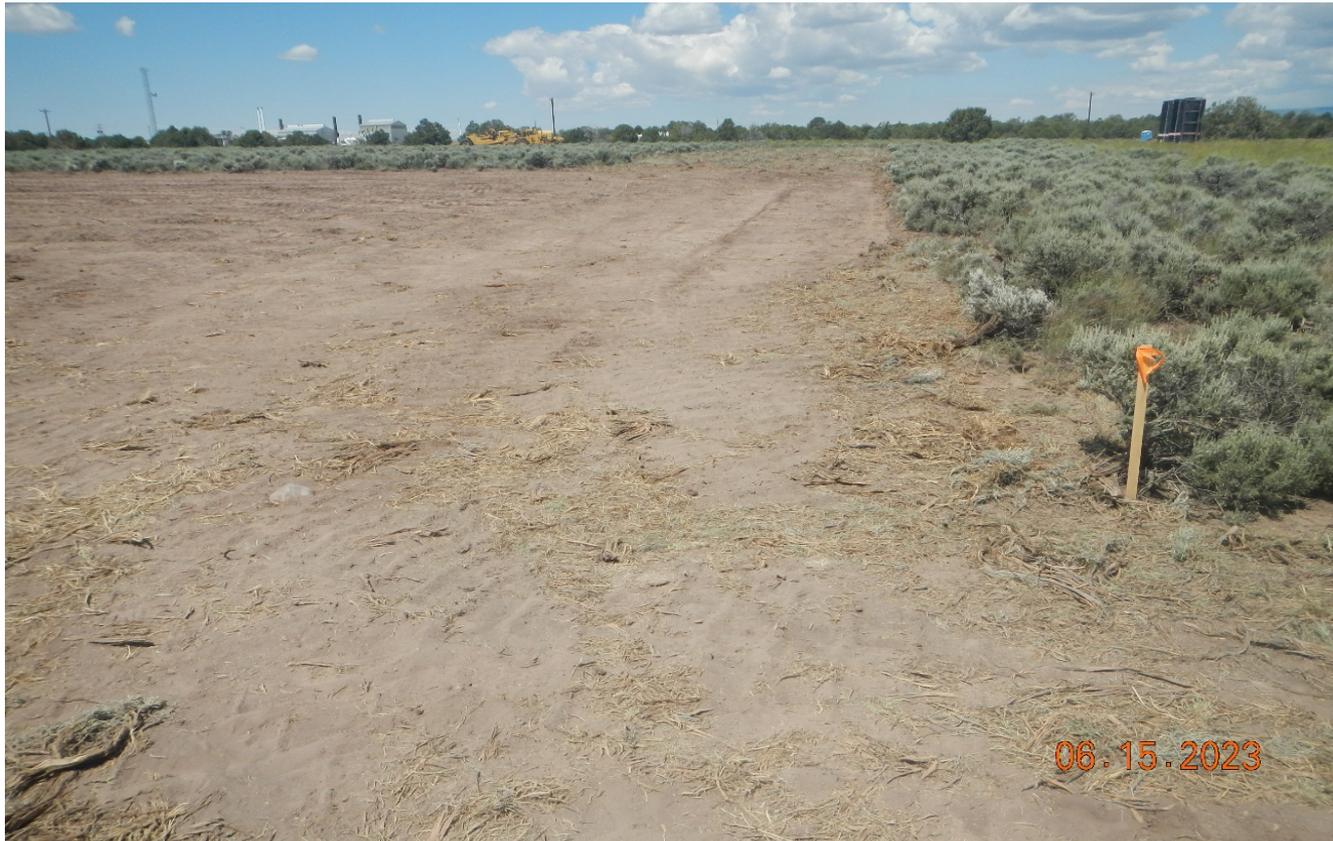
Photo 7. Northeast side of the location facing west. There are no perimeter stormwater controls installed. Stormwater controls should have been installed prior to construction. This is the downhill gradient slope of the location.

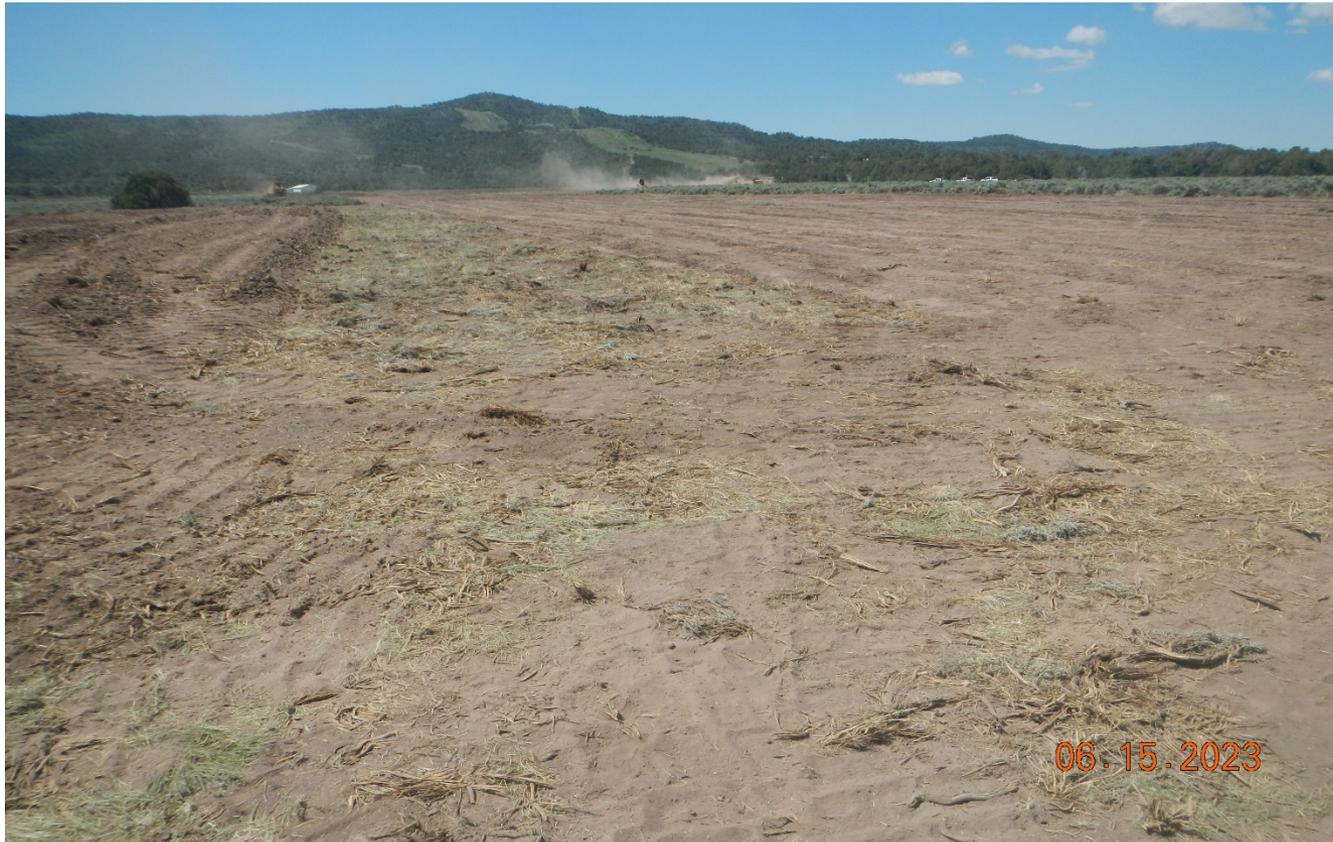
Photo 8. Northeast corner of the location facing southwest.

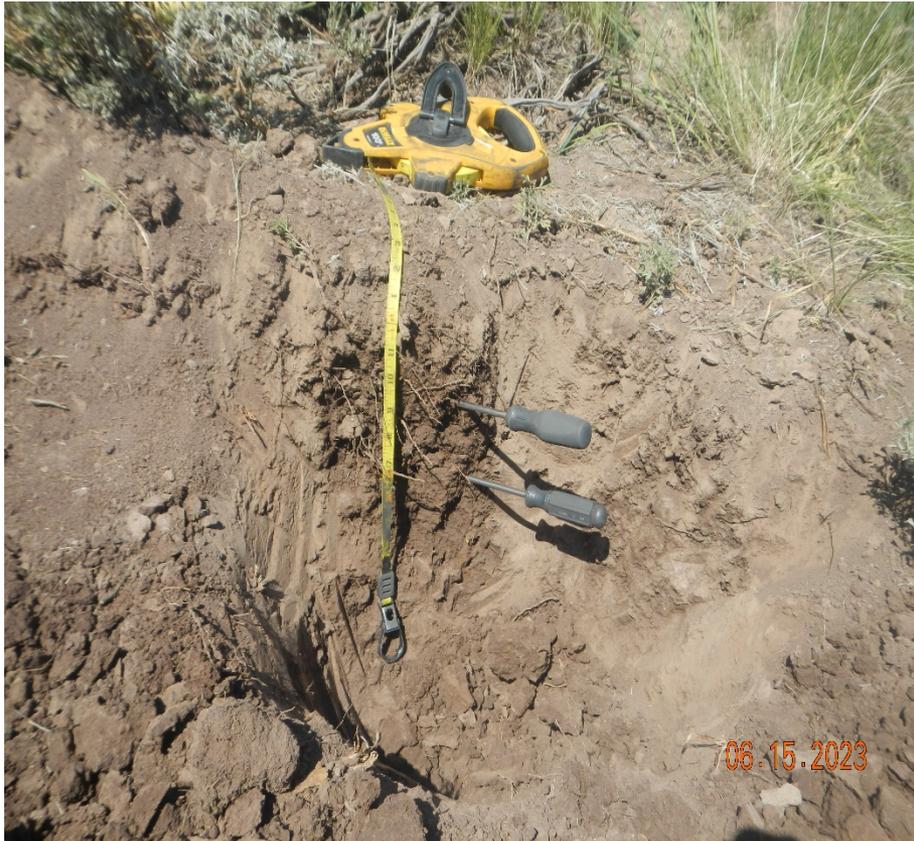
Photo 9. View of test hole for topsoil evaluation.

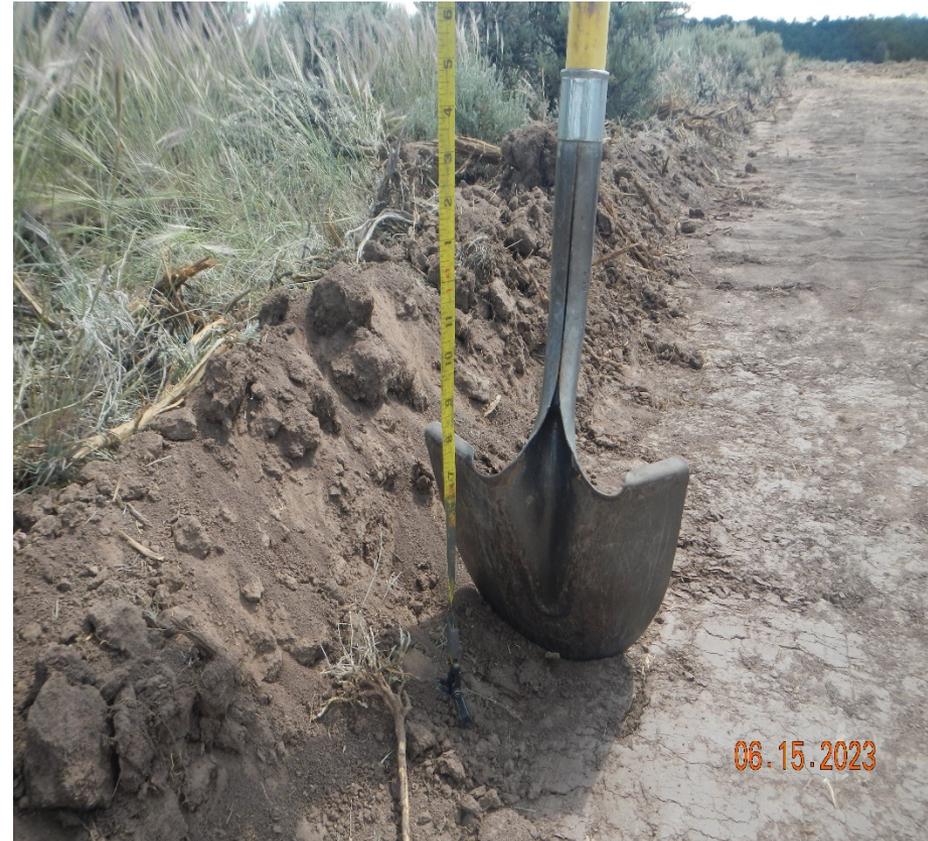
Photo 10. Northeast corner of the location facing southwest. It appears topsoil was being salvaged around 6-8" in some areas and less in other areas but salvaging was still ongoing.

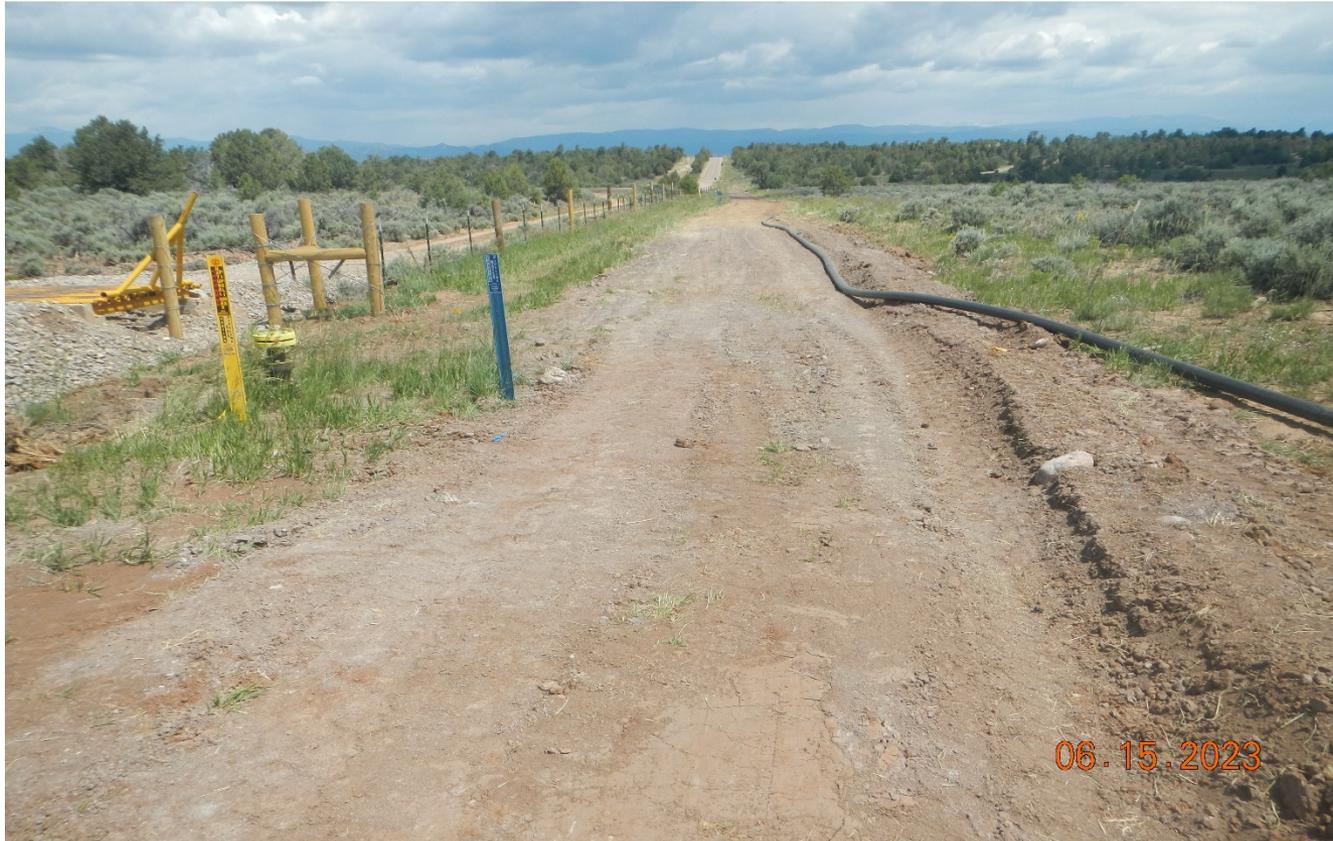
Photo 11. Facing north along the flowline disturbance. BMPs need to be installed along the flowline disturbance.
