# Final Reclamation and Stormwater Inspection

Operator: TIMKA RESOURCES LTD - 88370

Location ID: 312278

Inspection Photos  
Location Name: Barnhart ET AL 1  
Location ID: 312278

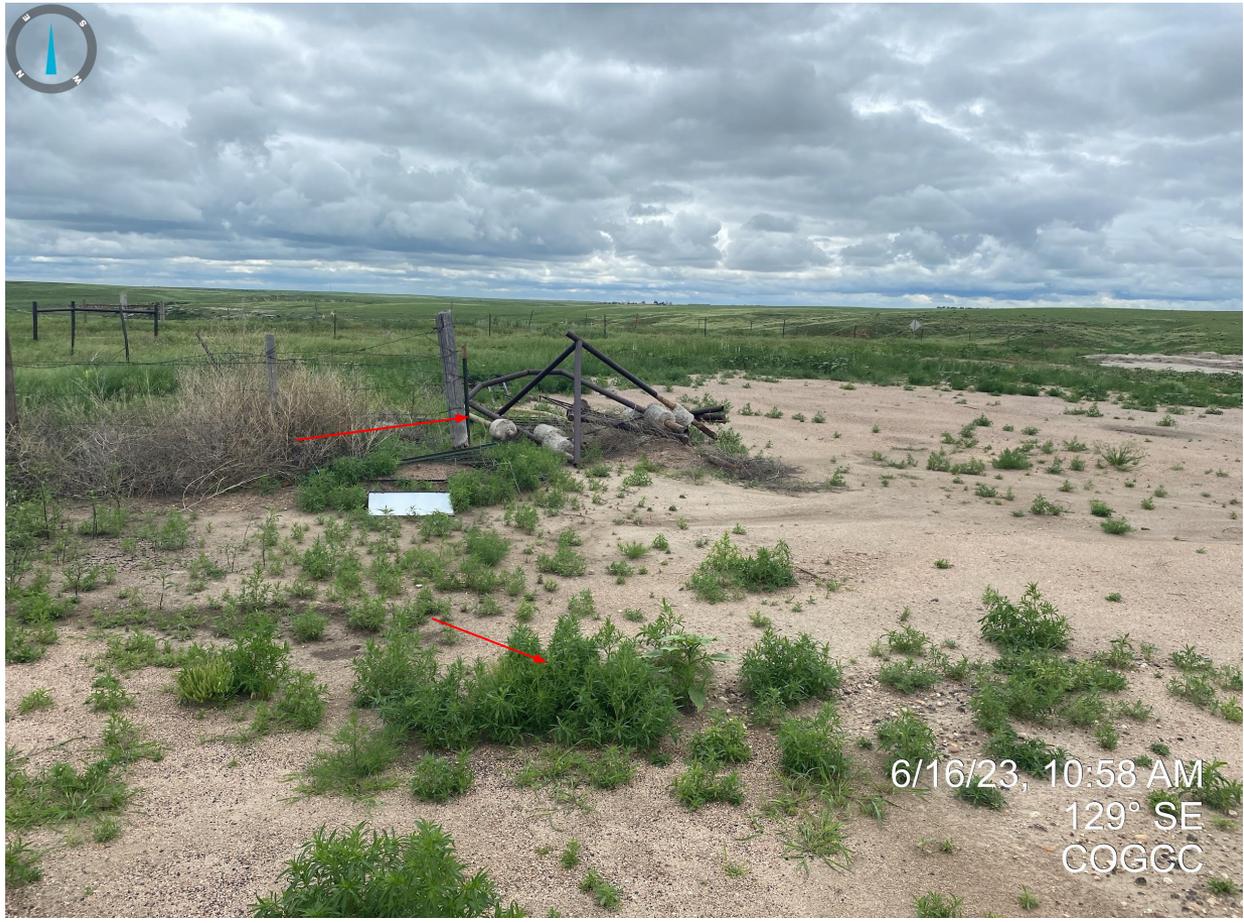
**Photo 1.** Debris and equipment observed on location. This equipment should have been removed 3 months after plugging date in accordance with Rule 1004. Also pictured, undesirable vegetation (e.g. kochia) throughout the former production areas.

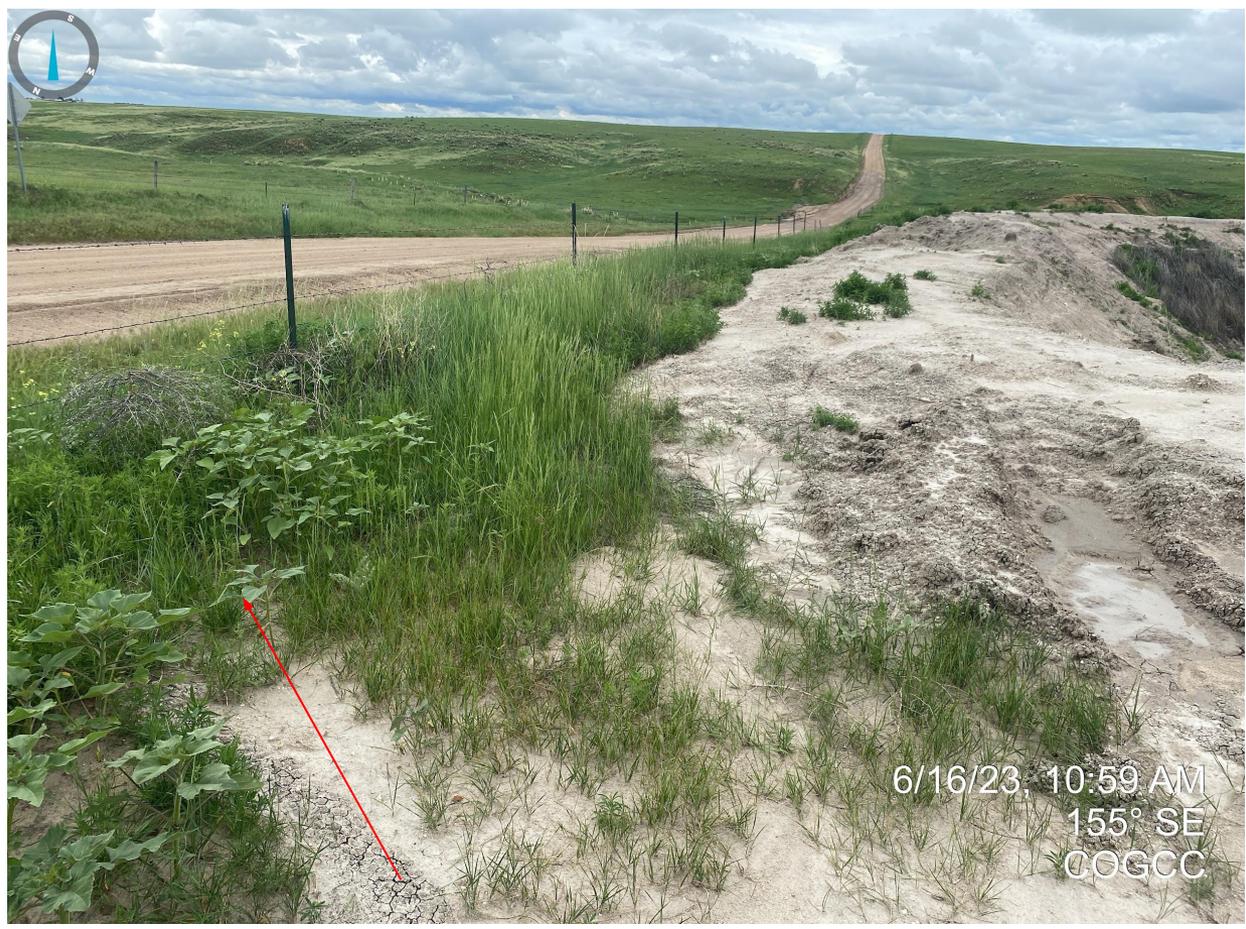
**Photo 2.** Berm material (possibly impacted) does not appear stabilized with evidence of sediment transport and unconsolidated material. Additional stormwater BMPs will be required to prevent sediment from leaving location.

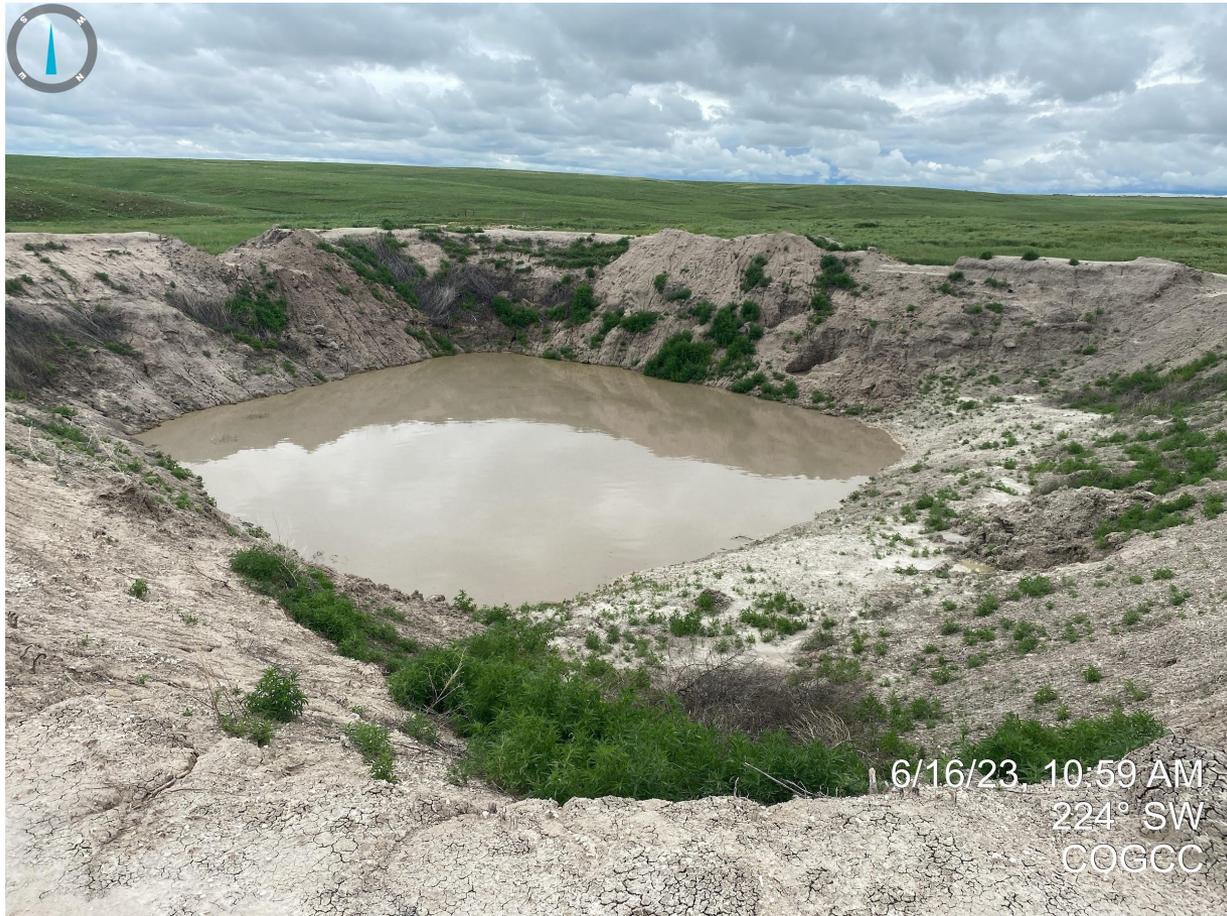
**Photo 3.** Pit walls do not appear to be properly stabilized with evidence of unconsolidated material. Kochia was also observed to be growing within the pit walls and will need to be managed for.

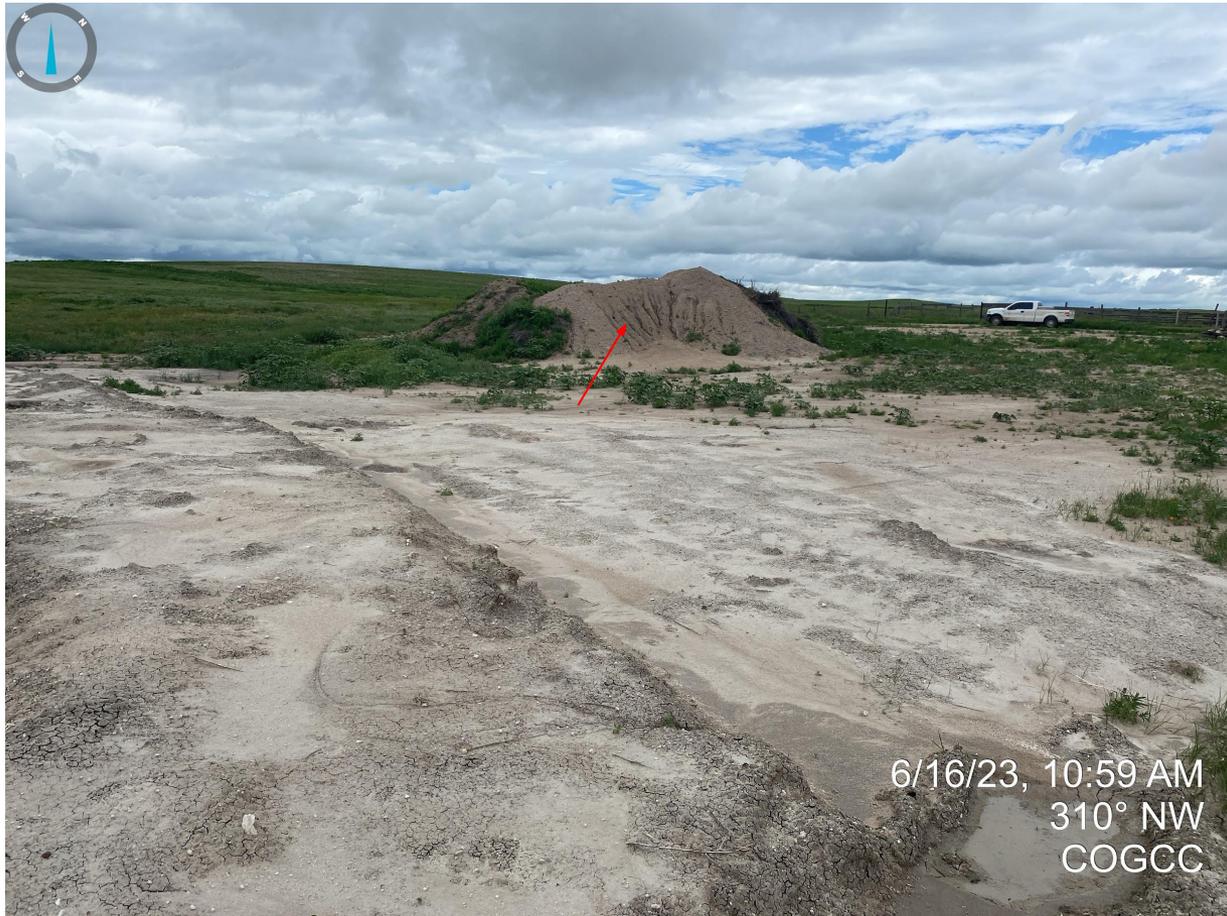
**Photo 4.** Stockpiled material north of the pit is not marked or signed to indicate if material is impacted or not. Rill erosion and sediment transport is observed on the stockpile and no evident stormwater controls/BMPs observed to contain the soils.

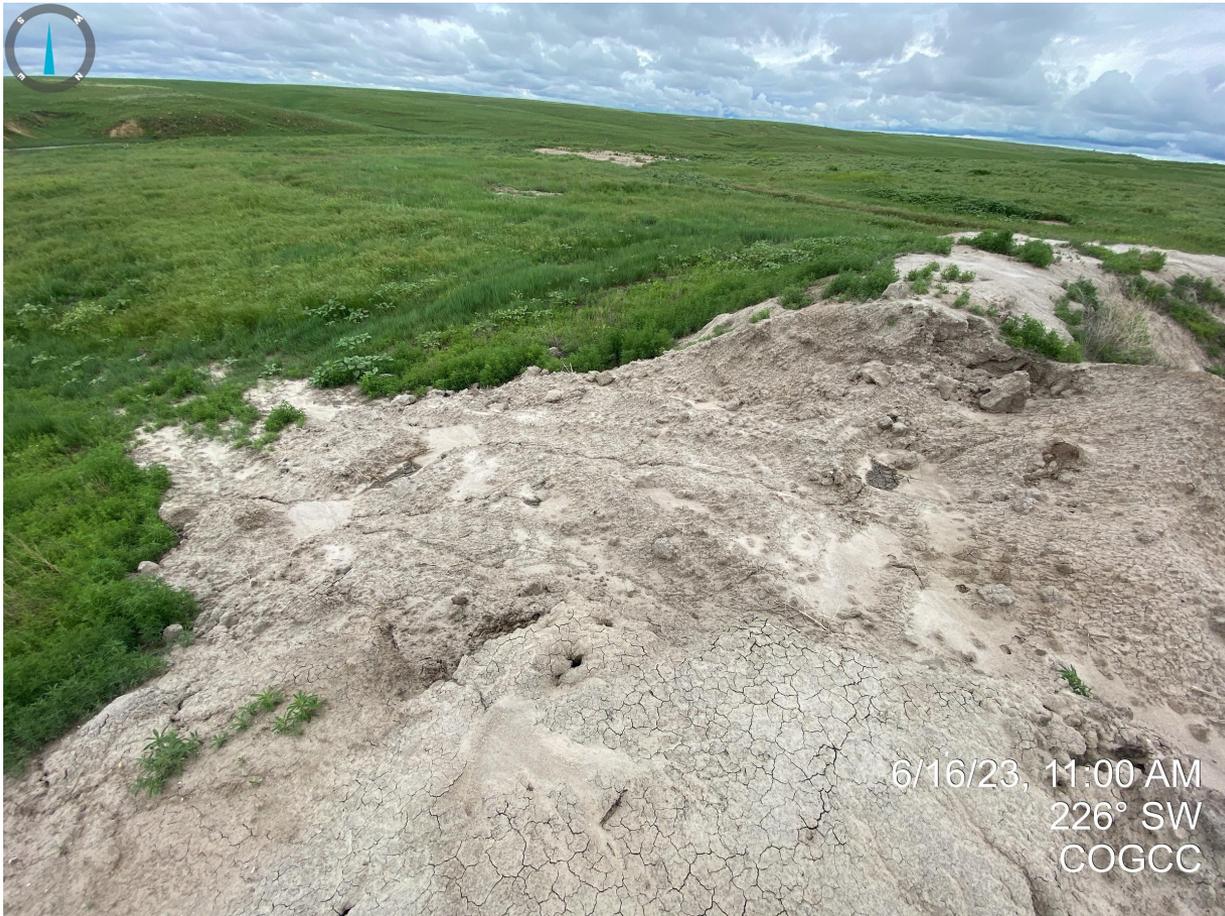
**Photo 5.** Southern pit wall, There is evidence of recent equipment tracking on the outside of the berm; the material has been left unconsolidated and is beginning to migrate into the surrounding areas. Additional stormwater BMPs are required to stabilize and contain the material from migrating into adjacent areas, especially if the material is impacted.

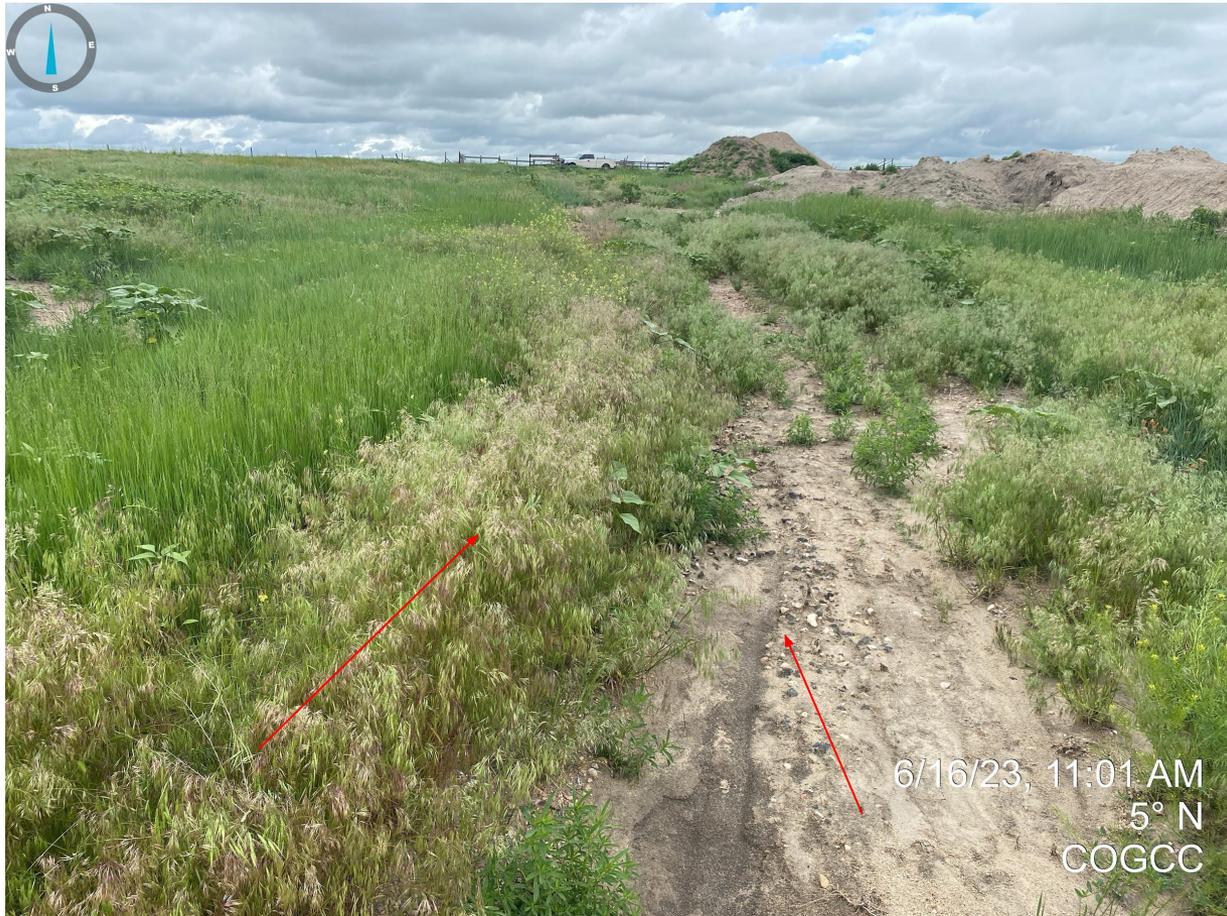
**Photo 6.** Taken from the access road. Evidence of rill erosion and CO List C Noxious Weed (cheatgrass) observed.

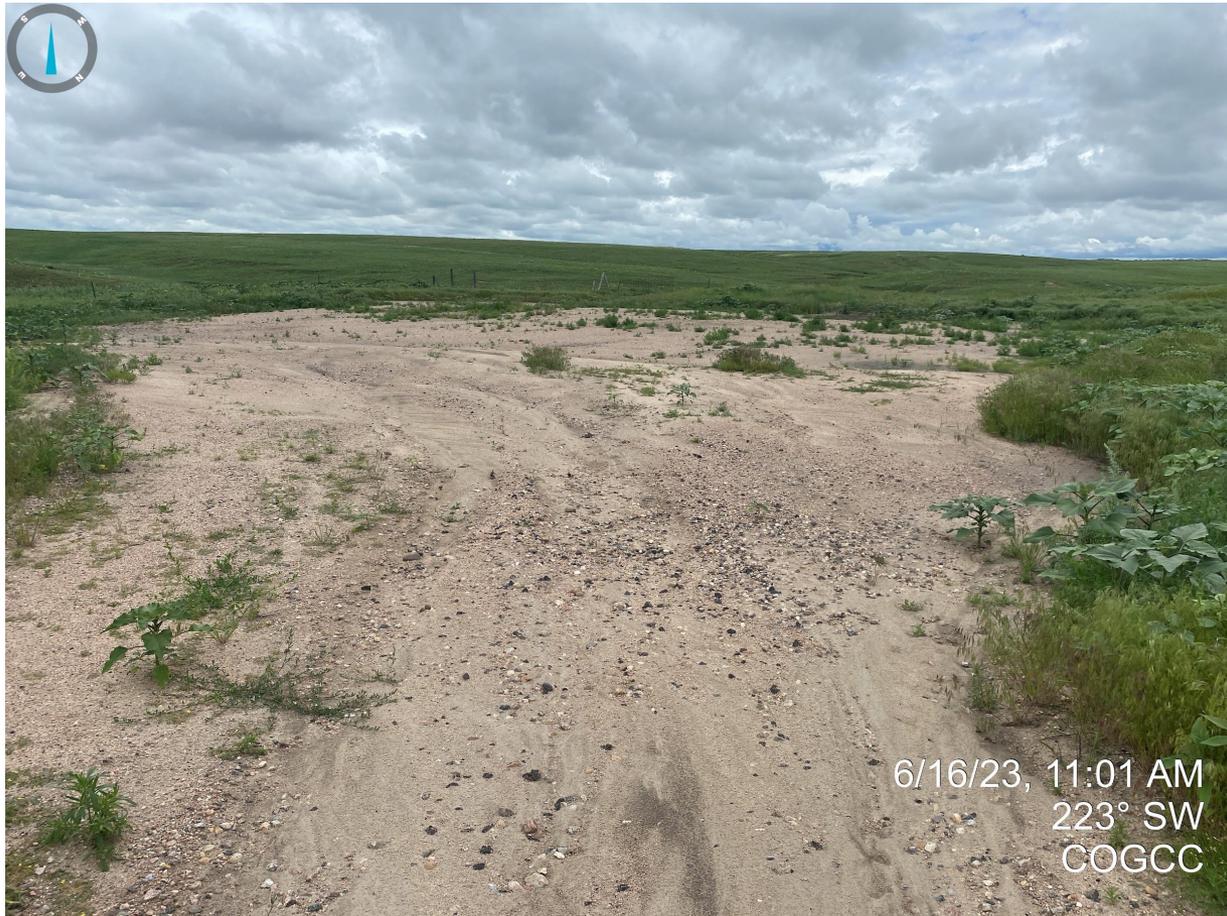
**Photo 7.** Former well location does not appear to have been reclaimed. Active remediation projects should not preclude the commencement of final reclamation activities.

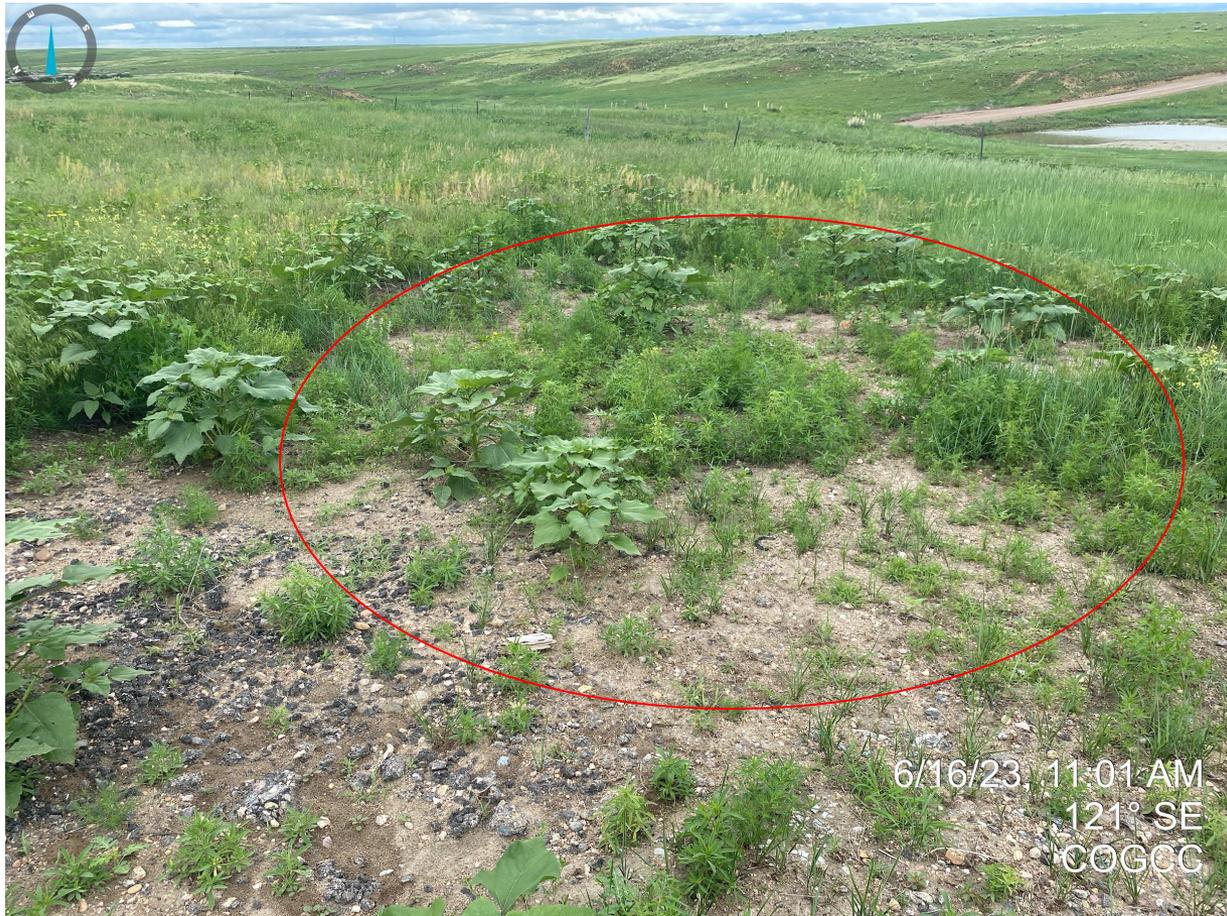
**Photo 8.** Southeastern corner of the former well location. Evidence of unstabilized production areas and sediment transport into adjacent areas.

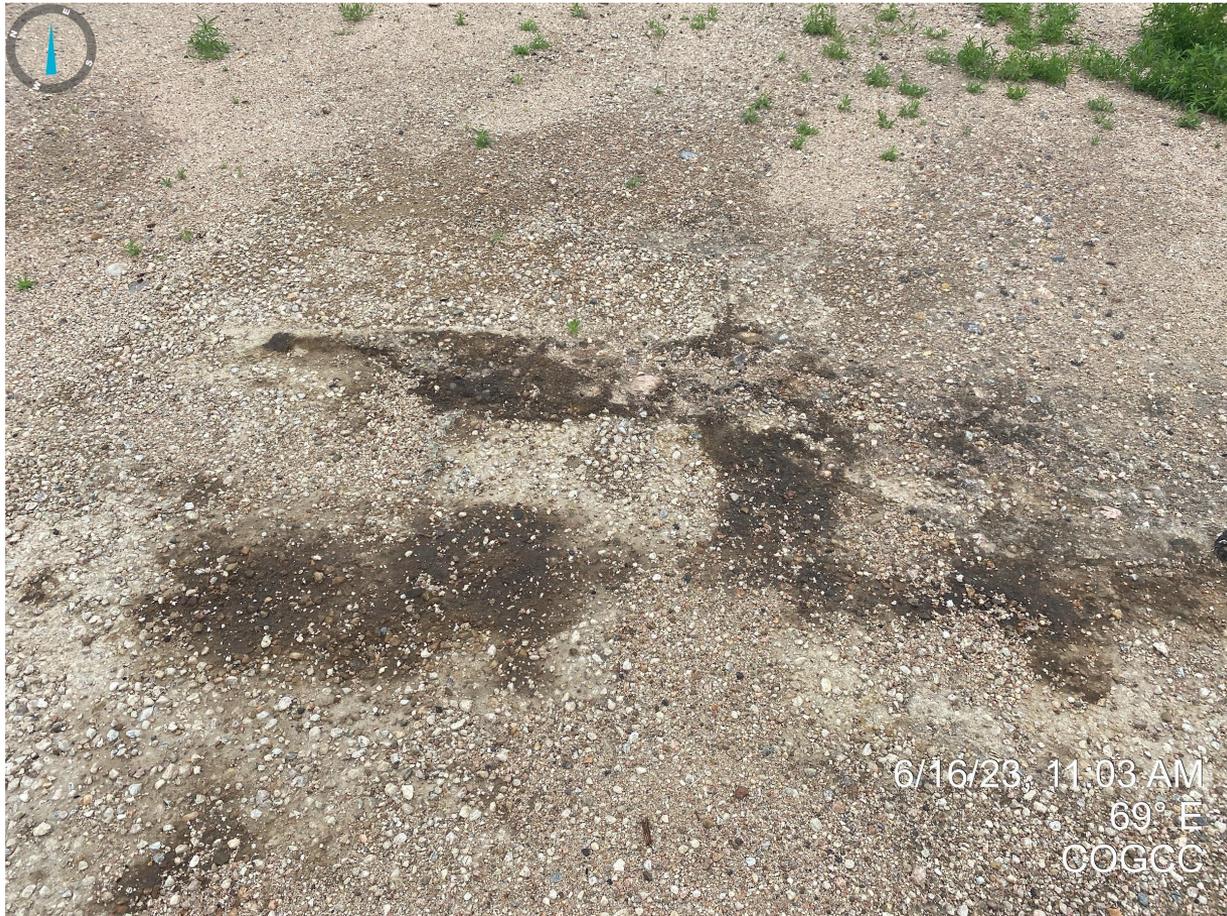
**Photo 9.** Stained soils near the access road and former well location will need to be properly cleaned and disposed of.

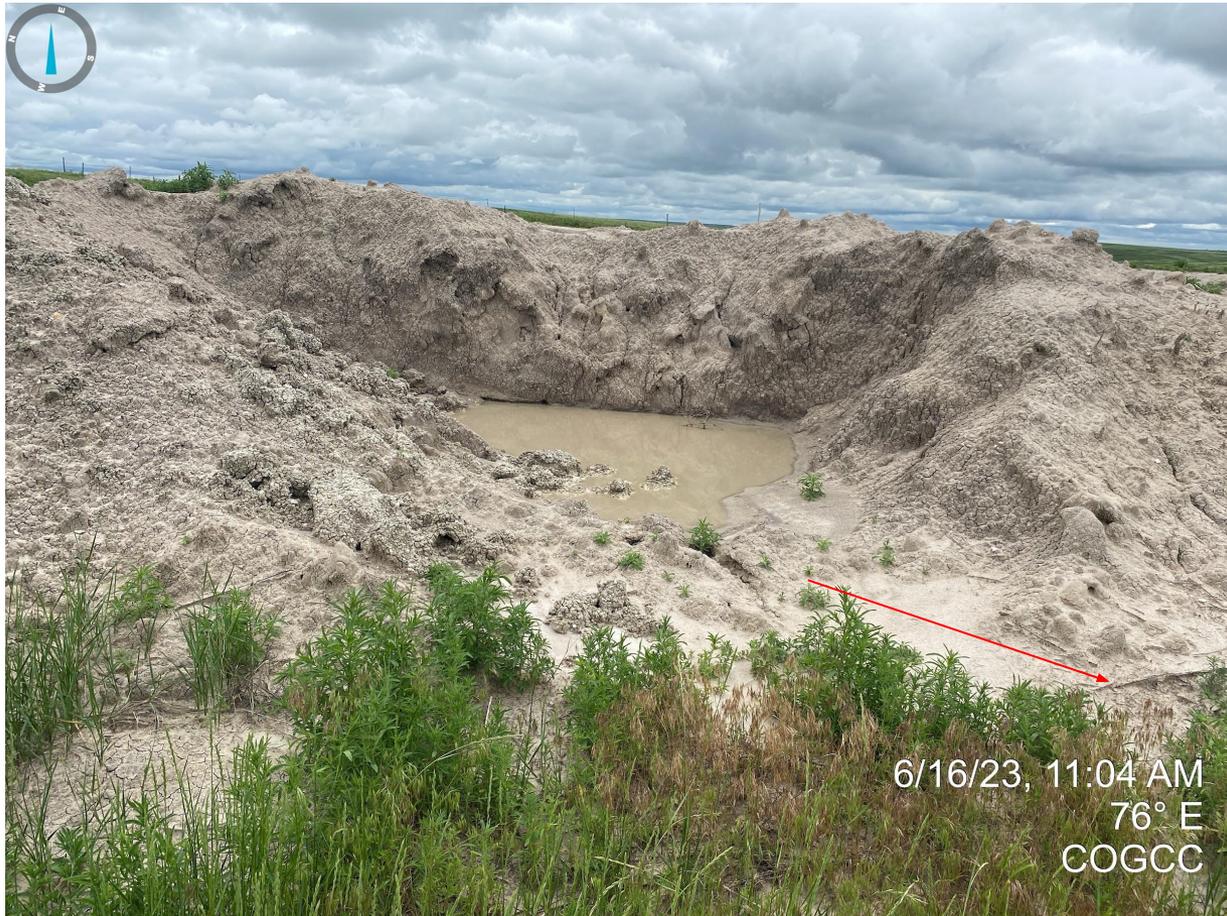
**Photo 10.** Western portion of the pit. It appears a recent excavation has occurred and stormwater has collected in the void. No apparent stormwater BMPs were observed to prevent any stormwater from coming in contact with impacted material and preventing sediment transport (observed at the base of the excavation).

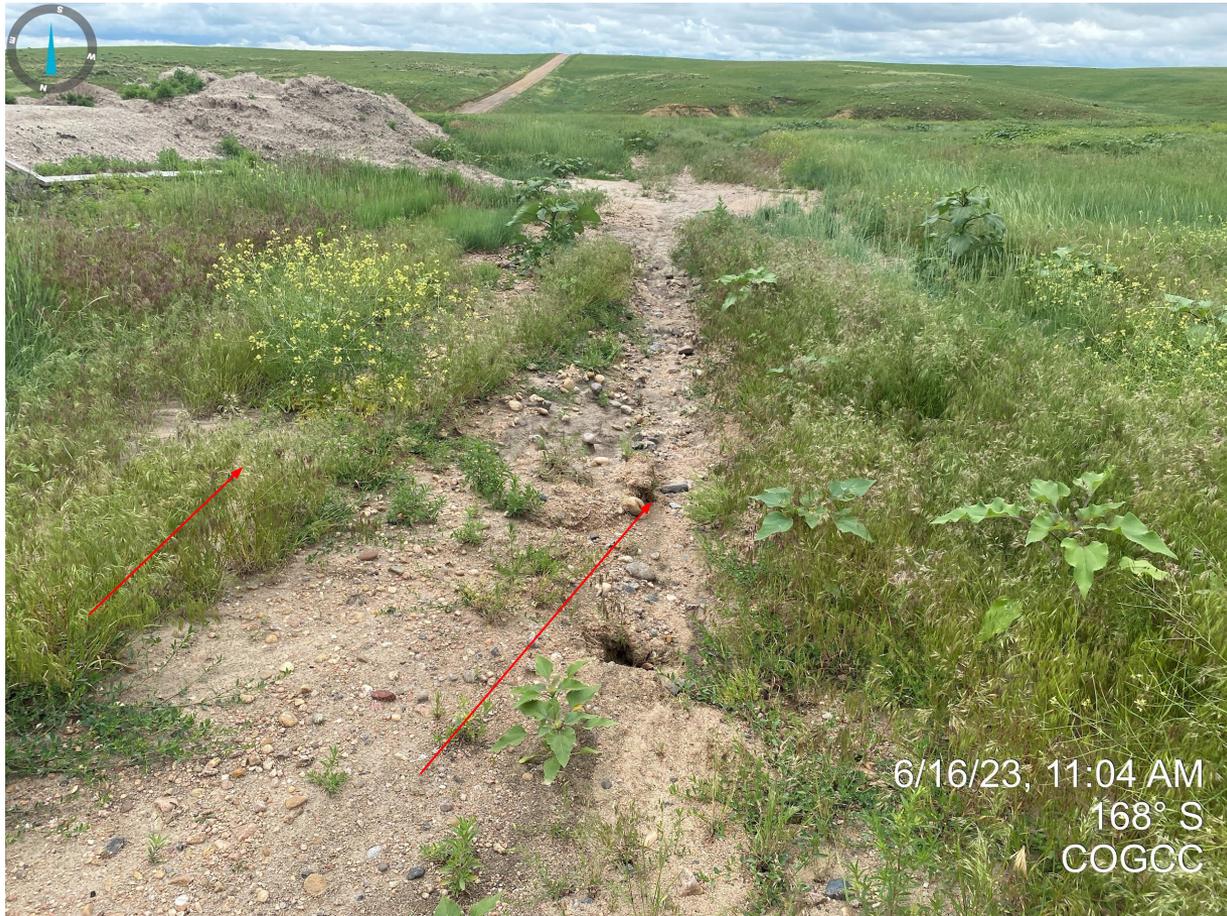
**Photo 11.** Rill erosion and Noxious Weeds (cheatgrass) observed on the access road.
