# Inspection Photos

6/21/2023

Operator: PRE RESOURCES INC - 10241

Location Number: 322302

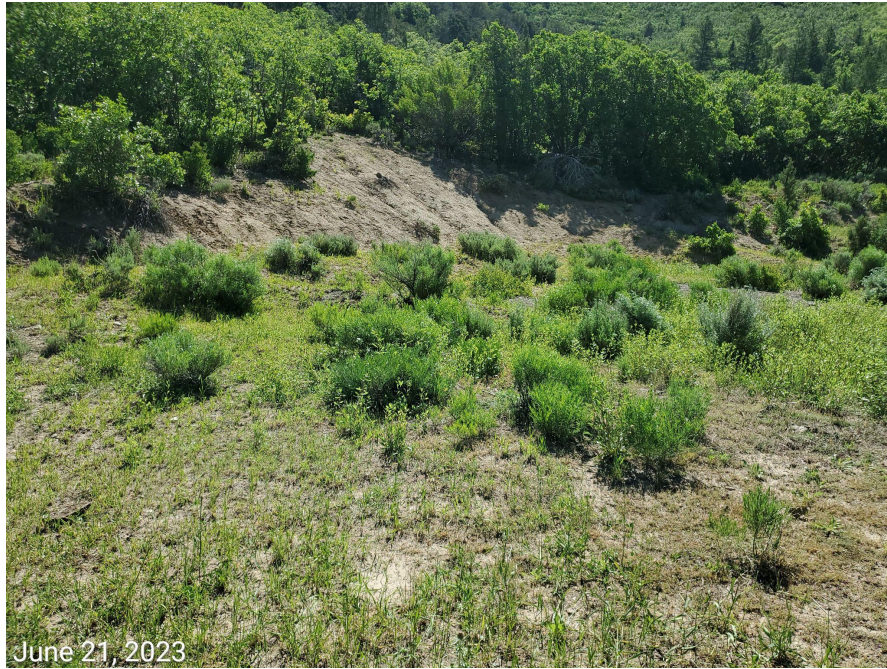
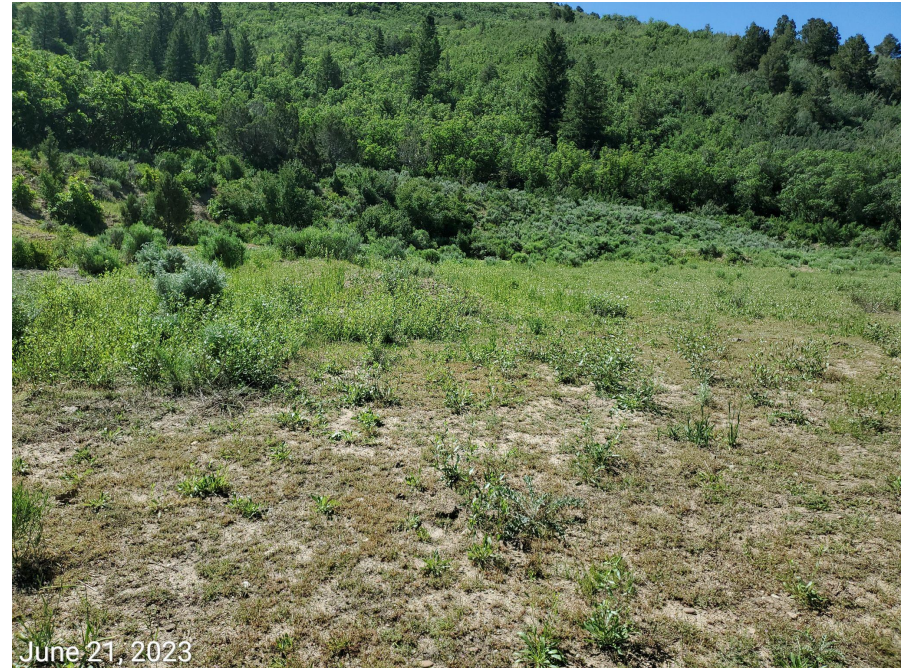
**Photo 1:** Photos 1-2 taken from the north end of the Location. Photos provide an overview of the Location from east, southeast, southwest to west. Photos show final reclamation of the Location, including compaction alleviation, recontouring/regrading and reclaiming, has not been performed. NOTE: Vegetation observed within photo is predominantly Undesirable and Noxious Plant species such as Redstem filaree, Field Bindweed, Hoary Cress, Curly cup Gumweed, etc...

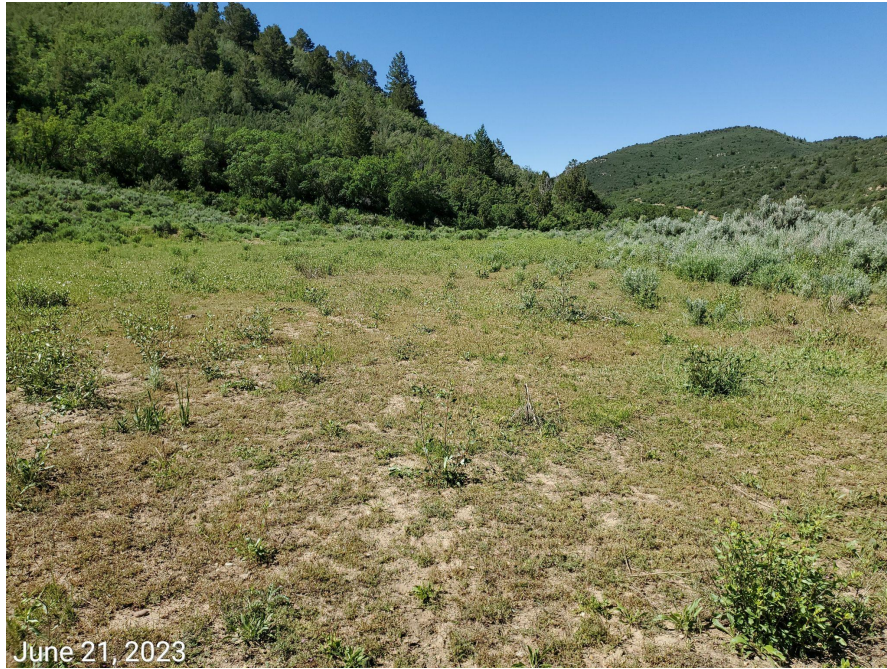
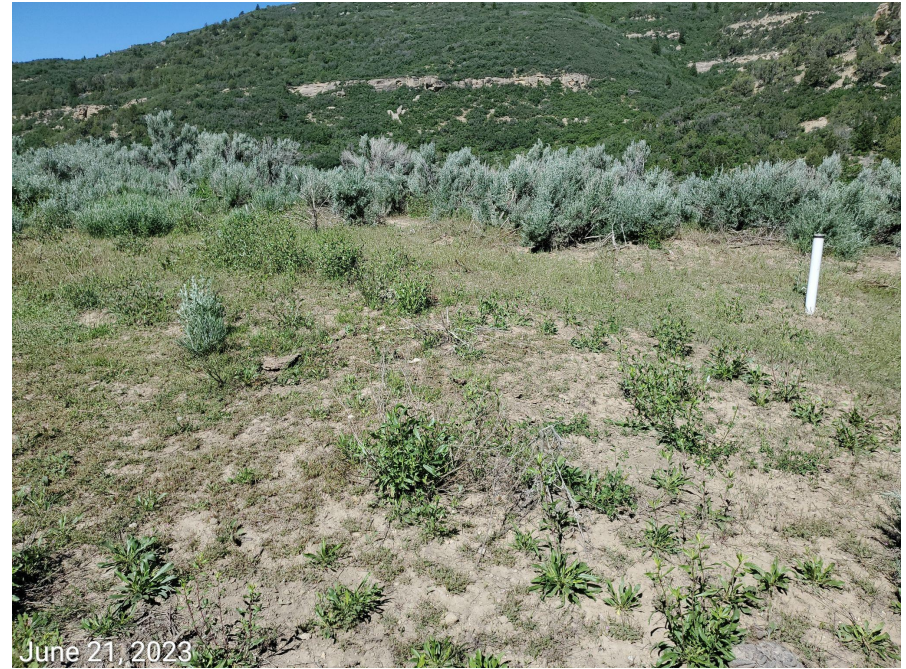
**Photo 2:** See comments under photo 1.

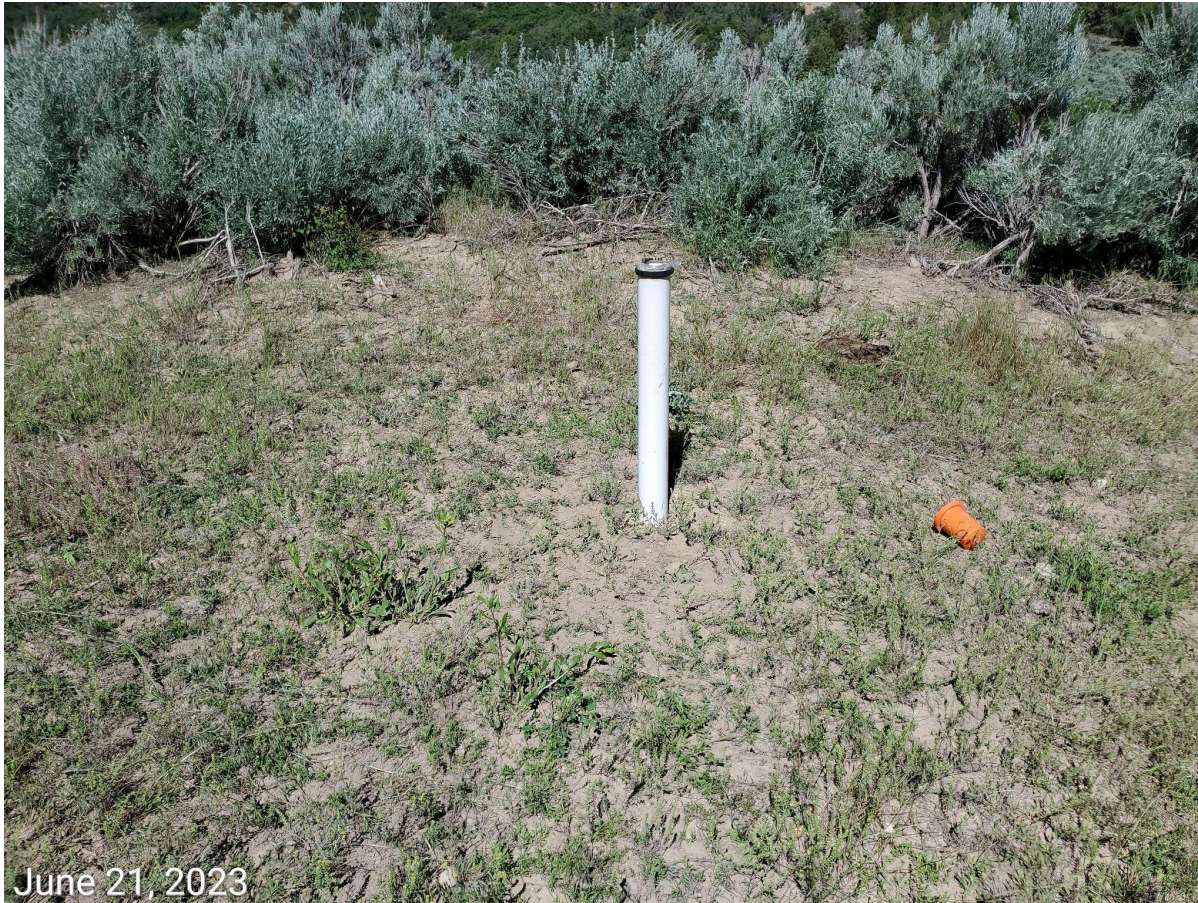
**Photo 3:** Unused pipe equipment remaining on the Location.

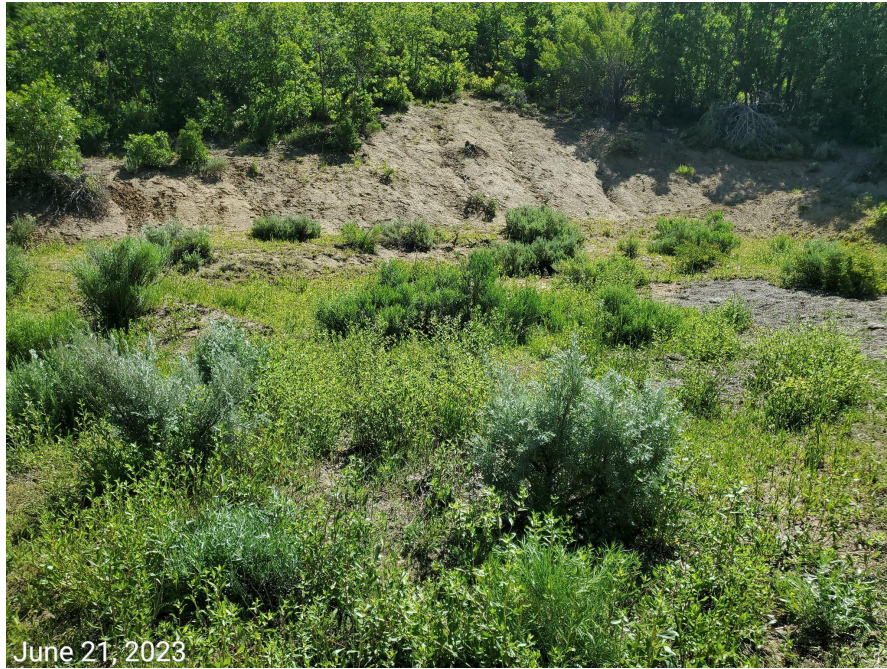
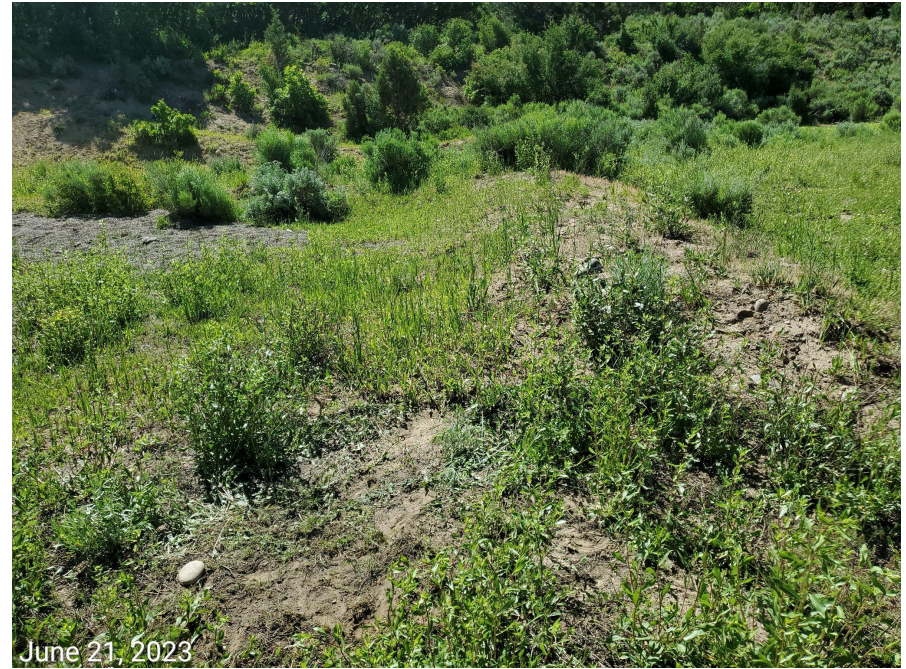
**Photo 4:** Photos show cut slope remaining, as well as gravel and secondary containment berms associated with the former tank battery facility. Location has not been recontoured/regraded/reclaimed. Vegetation observed within photo is predominantly Undesirable and Noxious Plant species such as Redstem filaree, Field Bindweed, Hoary Cress, Curly cup Gumweed, etc...

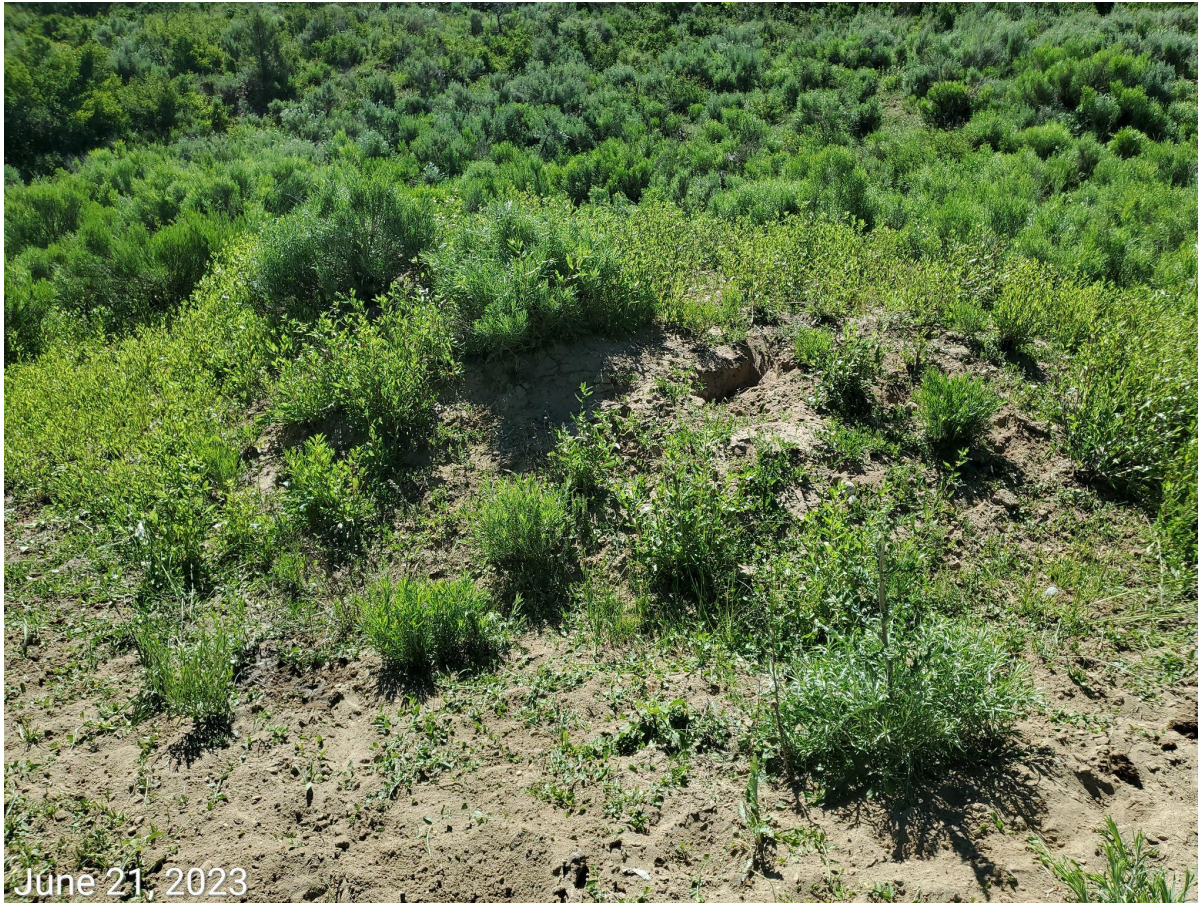
**Photo 5:** Photo shows a soil stockpile remaining on the southeast end of the Location. Vegetation observed within photo is predominantly Undesirable and Noxious Plant species such as Redstem filaree, Field Bindweed, Hoary Cress, Curly cup Gumweed, etc...

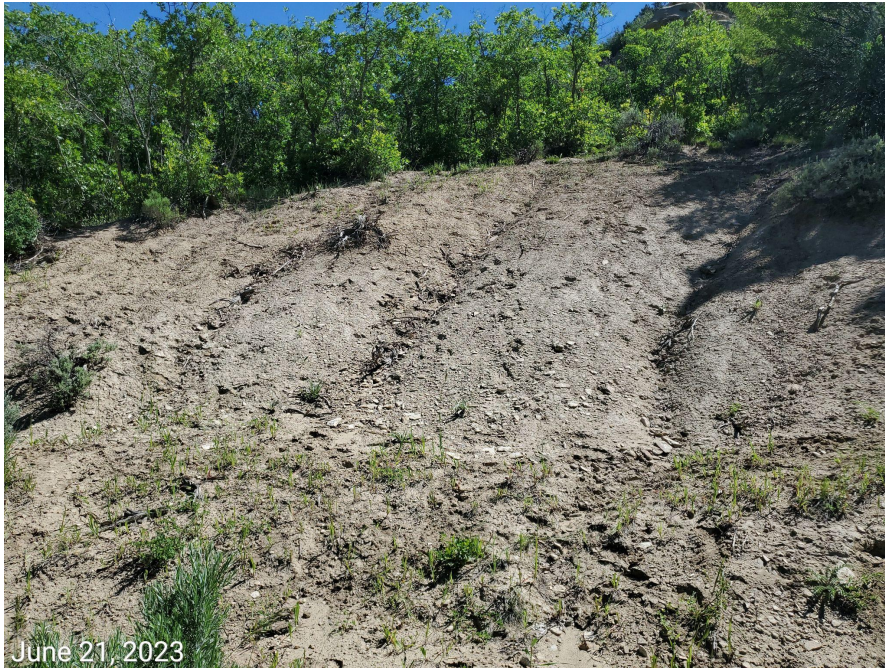
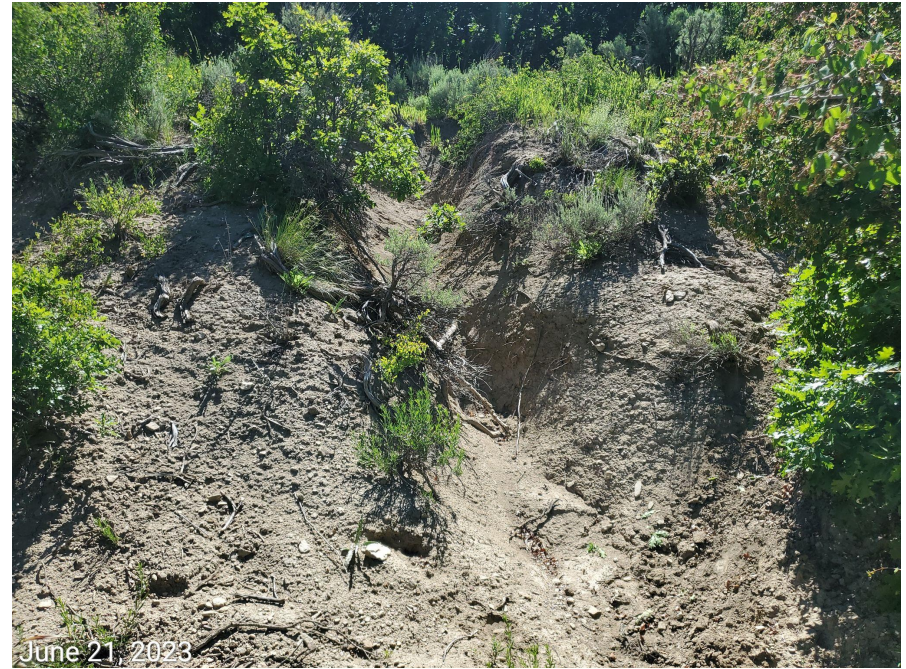
**Photo 6:** Photos taken from the cut slopes on the east end of the Location. Photo shows Location has not been recontoured/regraded and reclaimed. Photos also example showing slopes lack stabilization; stormwater and erosion control BMPs remain missing or insufficient to stabilize slopes, and to manage runoff; erosion degradation has persisted.

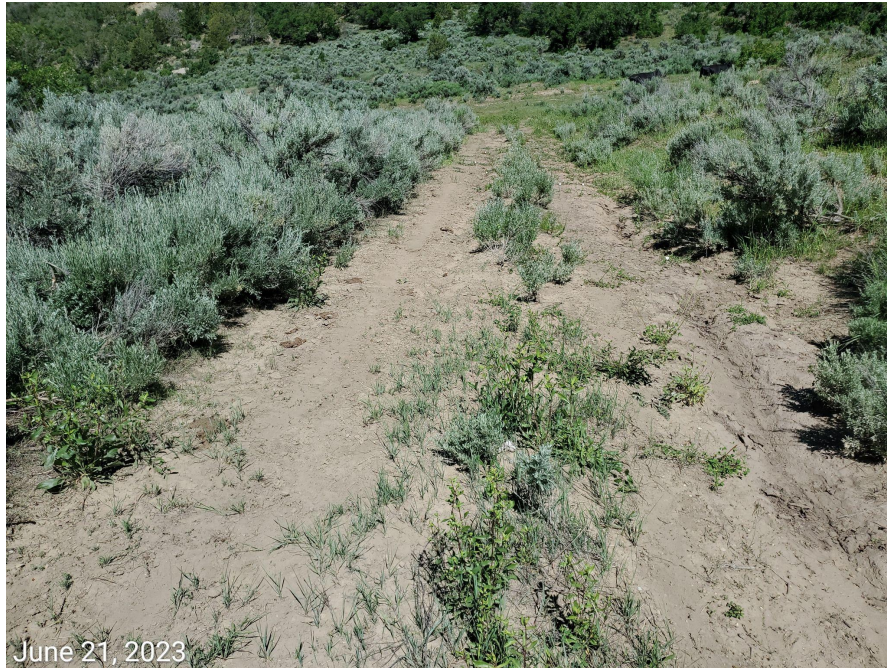
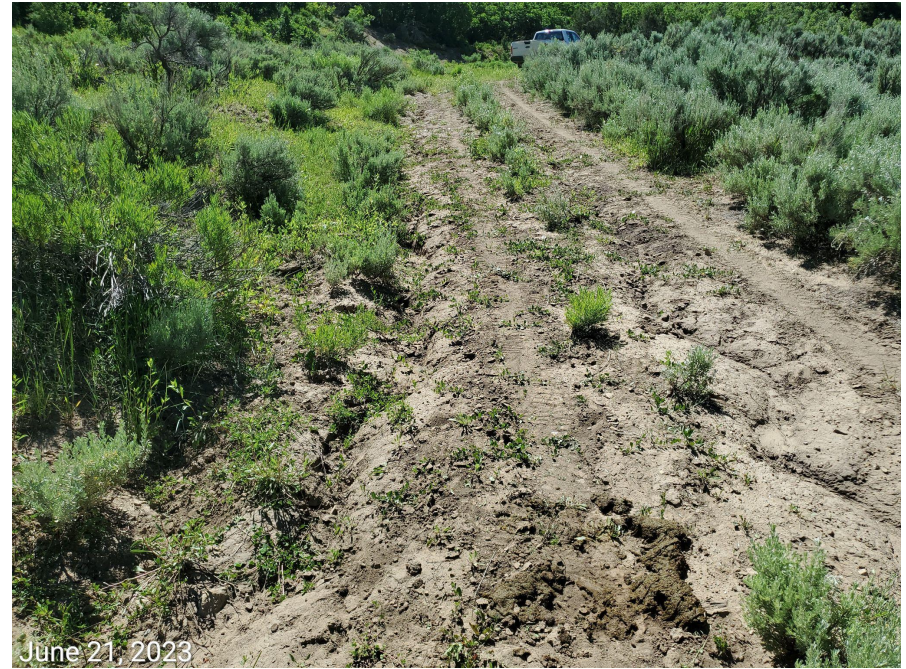
**Photo 7:** Photos taken from the access road. Photo shows road has not been reclaimed. Photo also shows stormwater and erosion control BMPs remain missing or insufficient at road; erosion degradation has persisted.

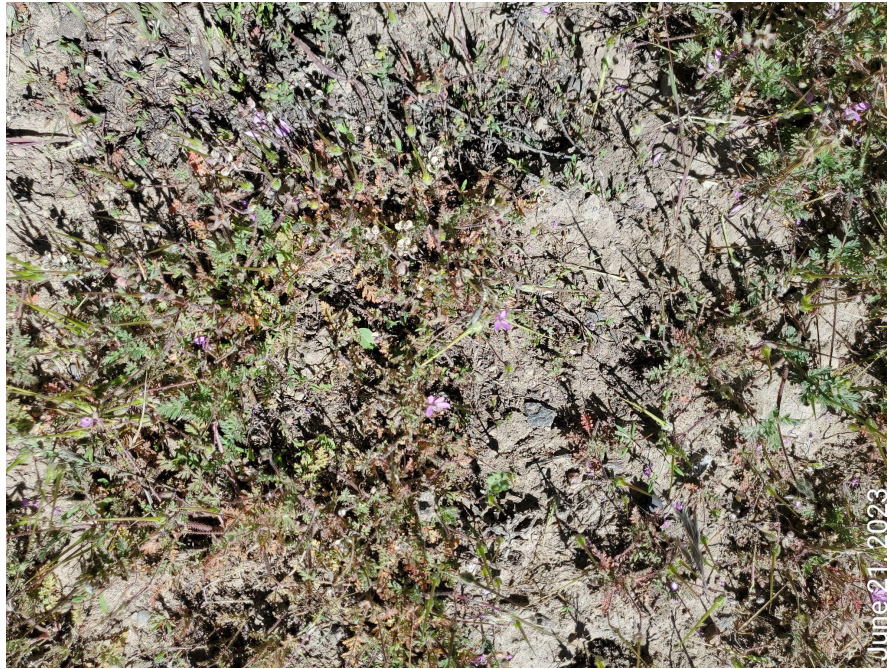
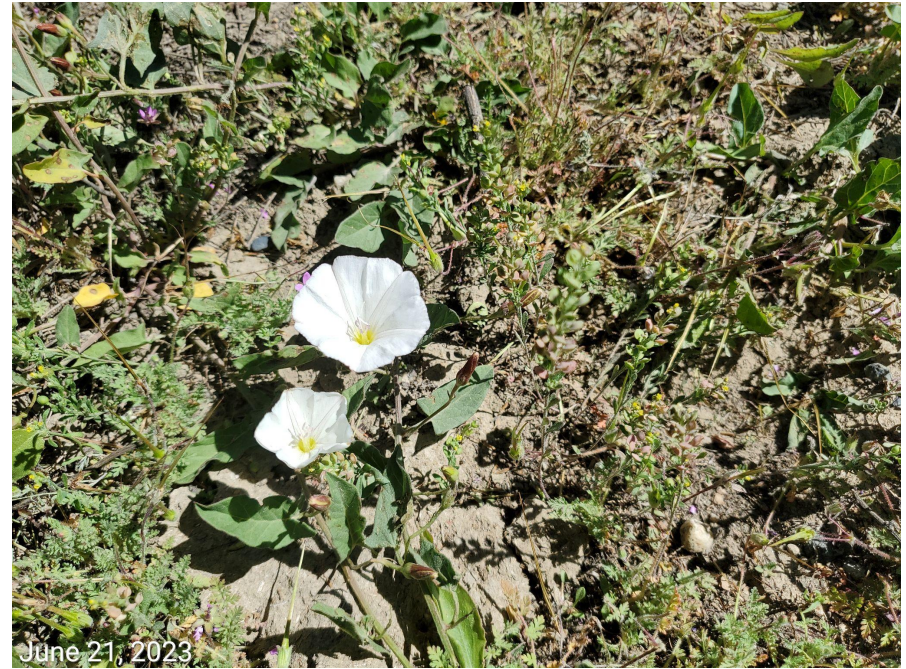
**Photo 8:** Photos 8-9 examples showing vegetation on the Location and access road. Vegetation observed on the Location is predominantly Undesirable and Noxious Plant species such as Redstem filaree, Field Bindweed, Hoary Cress, Curly cup Gumweed, etc... Unable to find evidence that ongoing weed management activities are being performed.

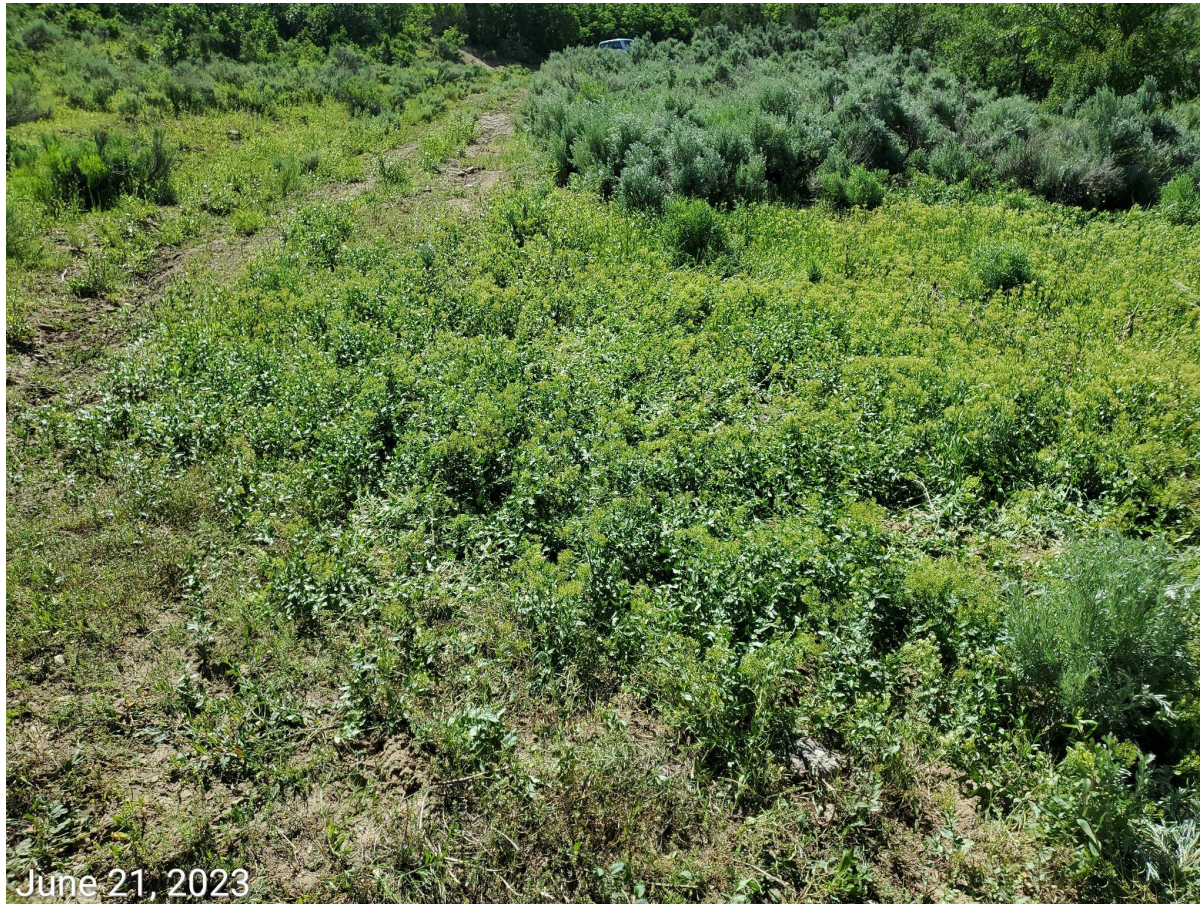
**Photo 9:** See comment under photo 8. Photo taken from the access road. Vegetation in photo Hoary Cress
