Inspection Photos
Location Name: CAERUS PICEANCE LLC B31 Pad
Location ID: 335307

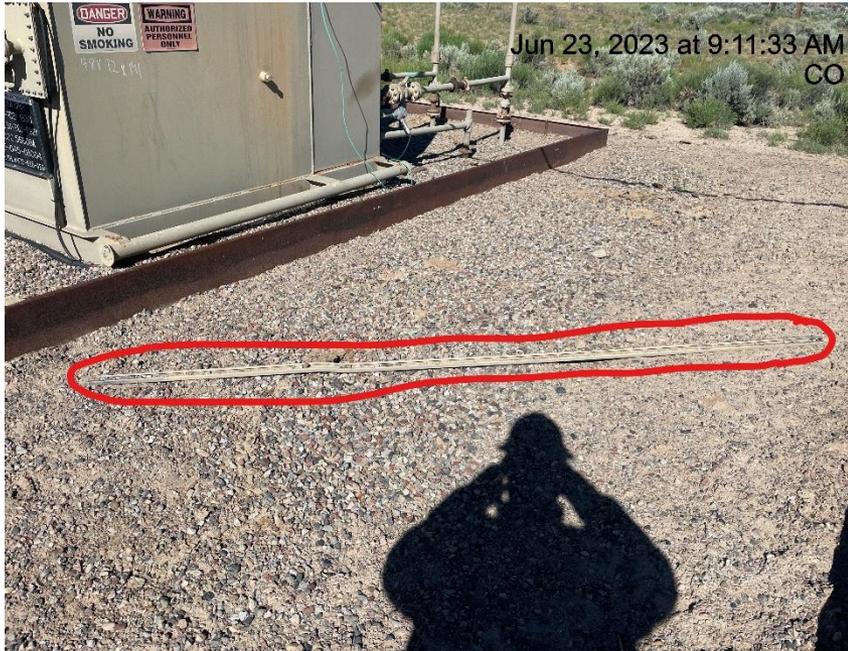
Photo # 1499 Debris

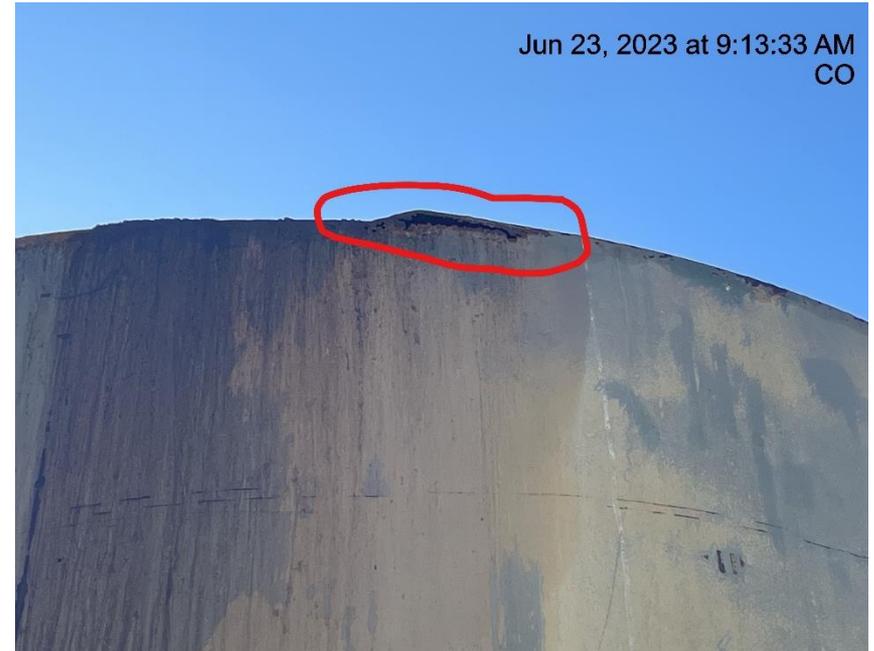
Photo # 1501 Hole in production tank/tank corrosion

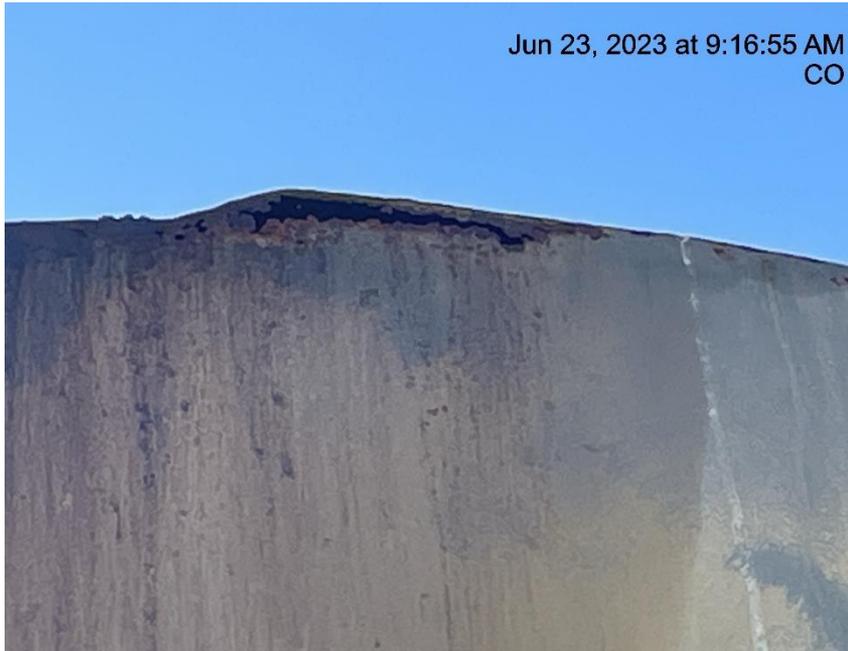
Photo # 1503 Hole in production tank/tank corrosion

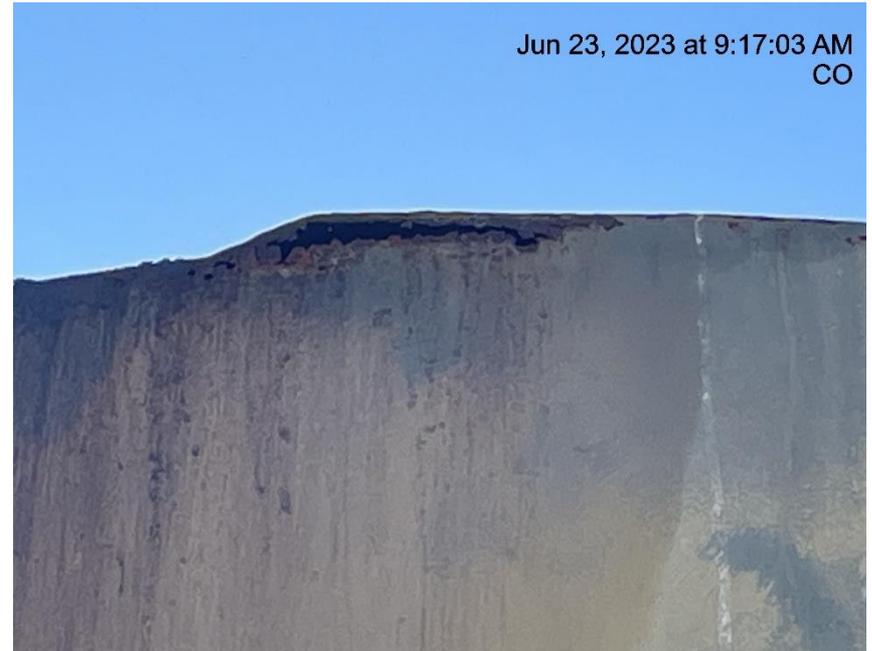
Photo # 1504 Hole in production tank/tank corrosion

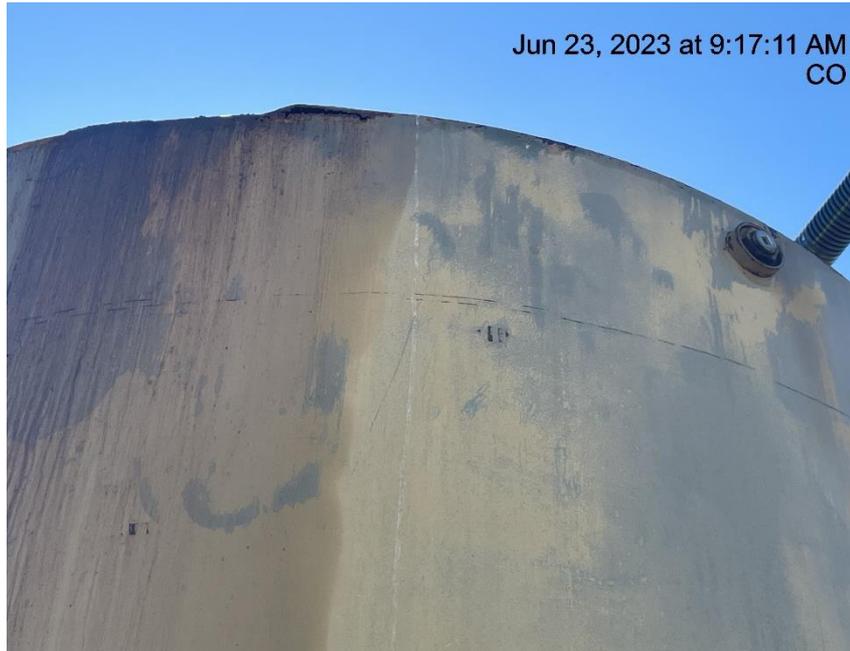
Photo # 1505 Hole in production tank/tank corrosion

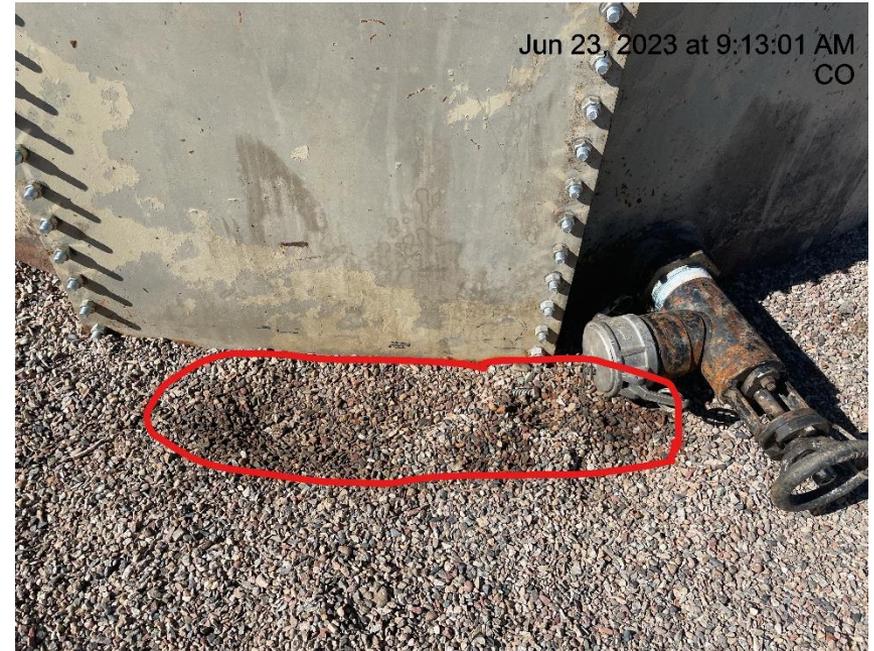
Photo # 1500 Stained gravel in secondary containment

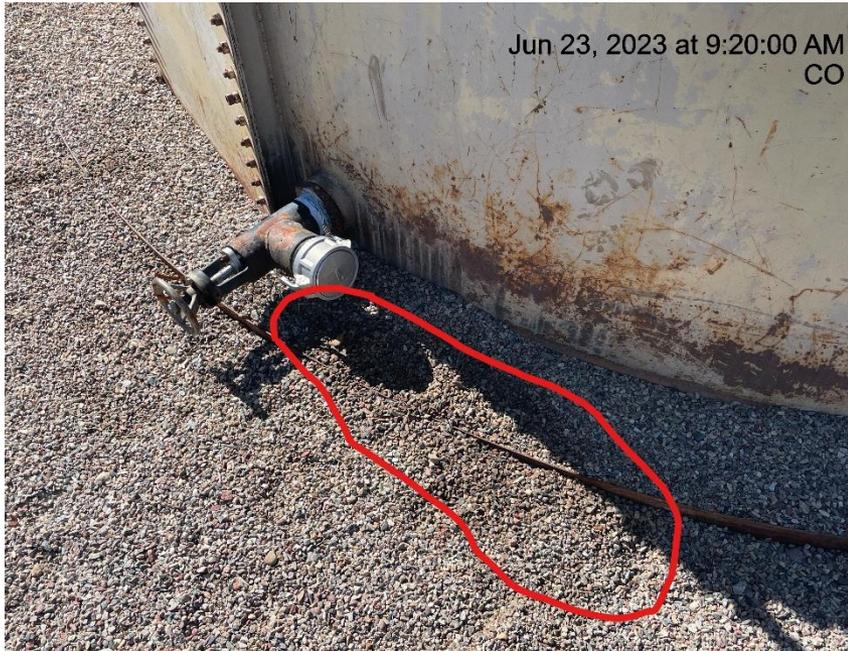
Photo # 1507 Stained gravel in secondary containment

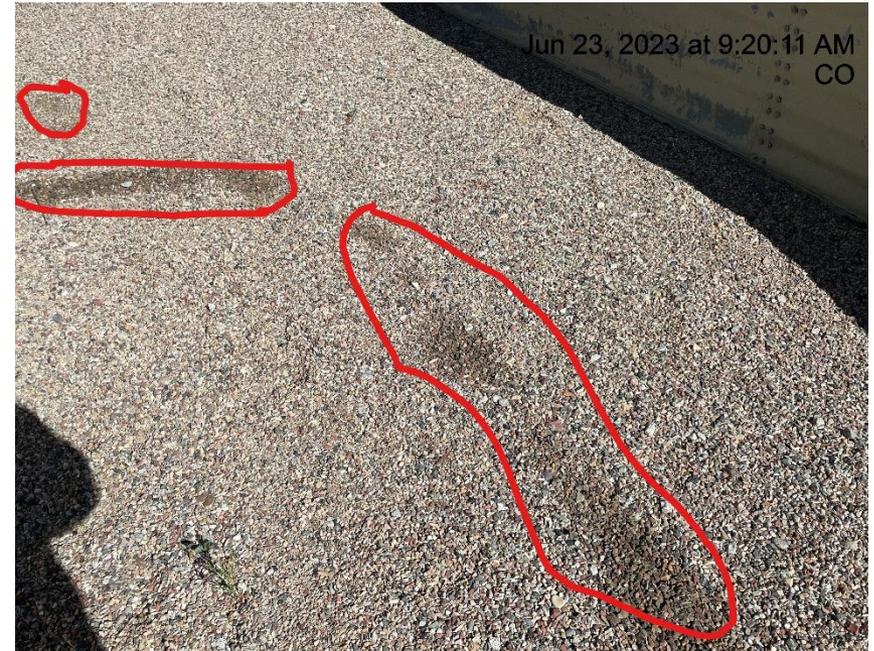
Photo # 1509 Stained gravel in secondary containment

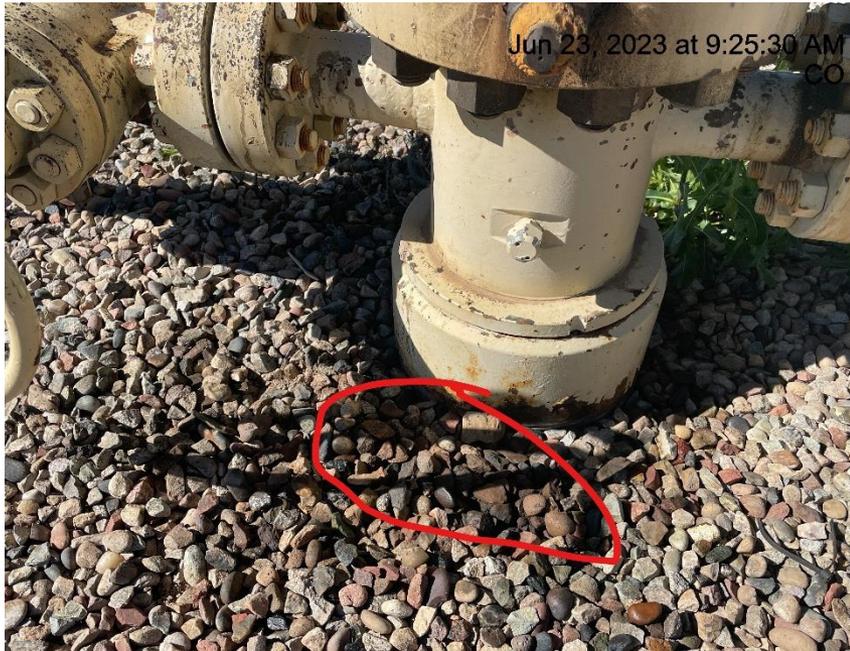
Photo # 1521 Stained soils & gravel (Couey 31-7 wellhead)

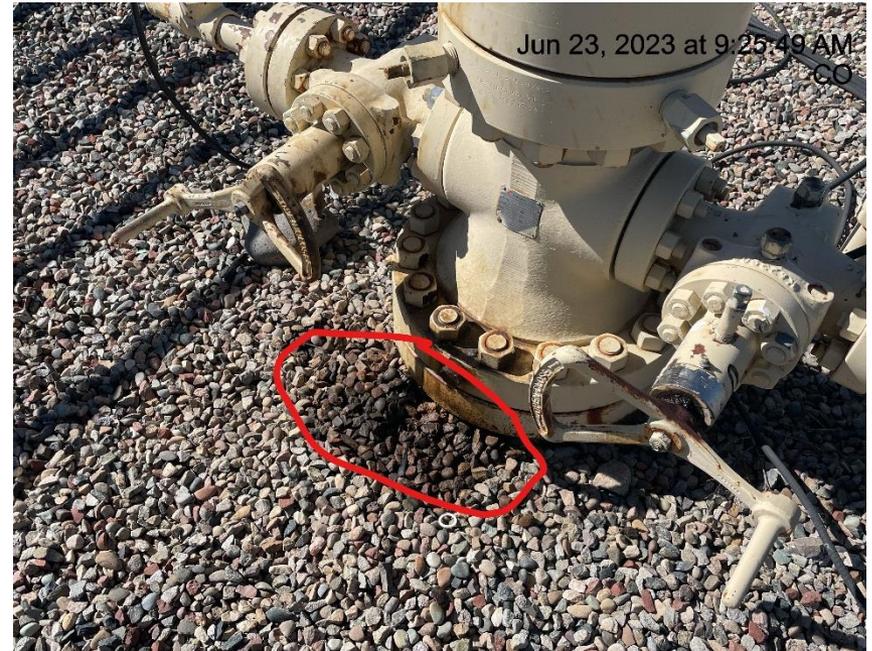
Photo # 1524 Stained soils & gravel (Couey 31-1C2 wellhead)

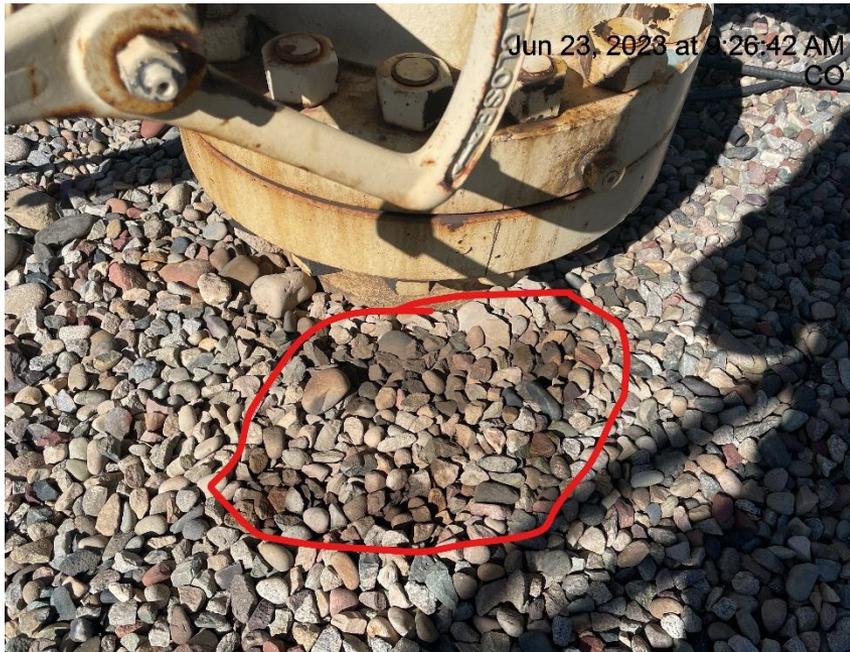
Photo # 1531 Stained soils & gravel (Couey 30-15 wellhead)

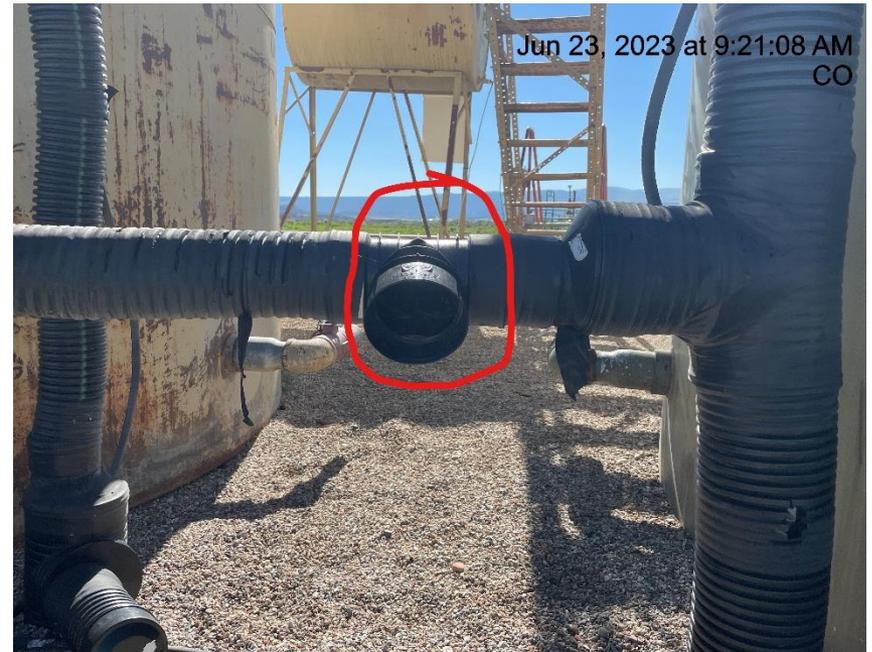
Photo # 1515 Flowline heating insulation open ended
