Interim Reclamation and Stormwater Inspection

Date: 06/28/2023

Operator: IMPETRO RESOURCES LLC - 10690

Location ID: 317118

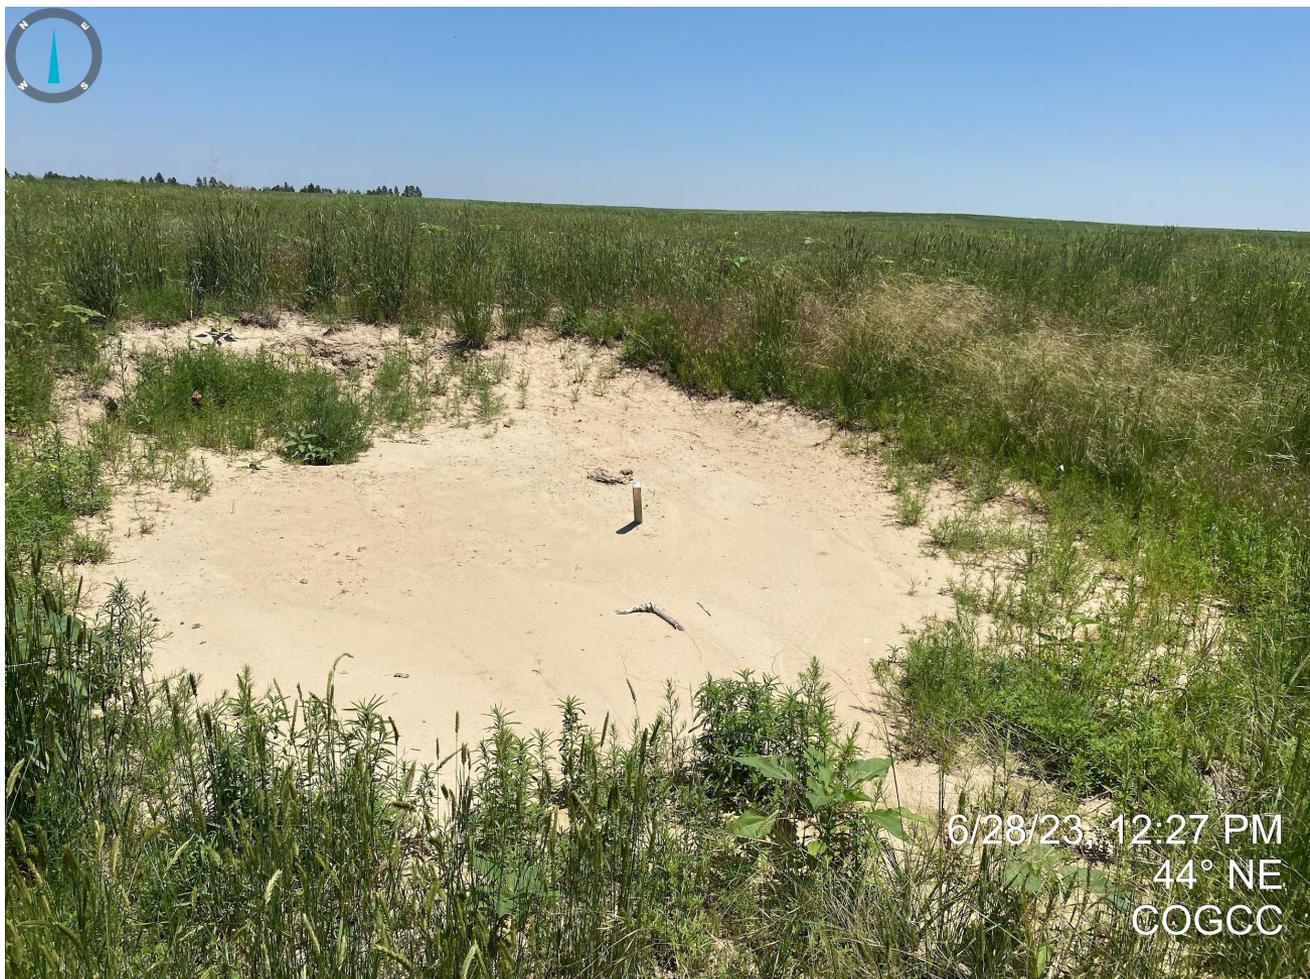
Photo 1. Guy line anchors not properly marked.

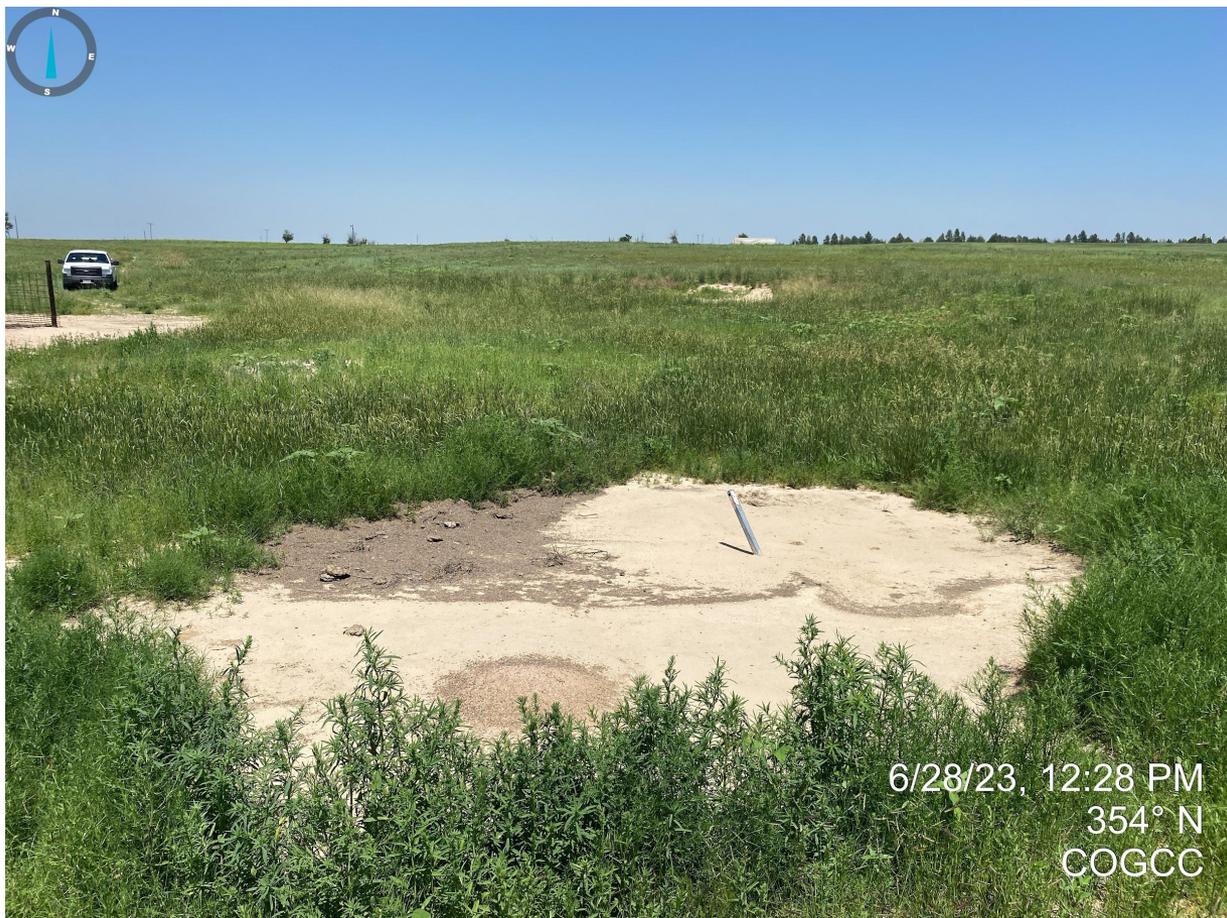
Photo 2. See comments in Photo 1.

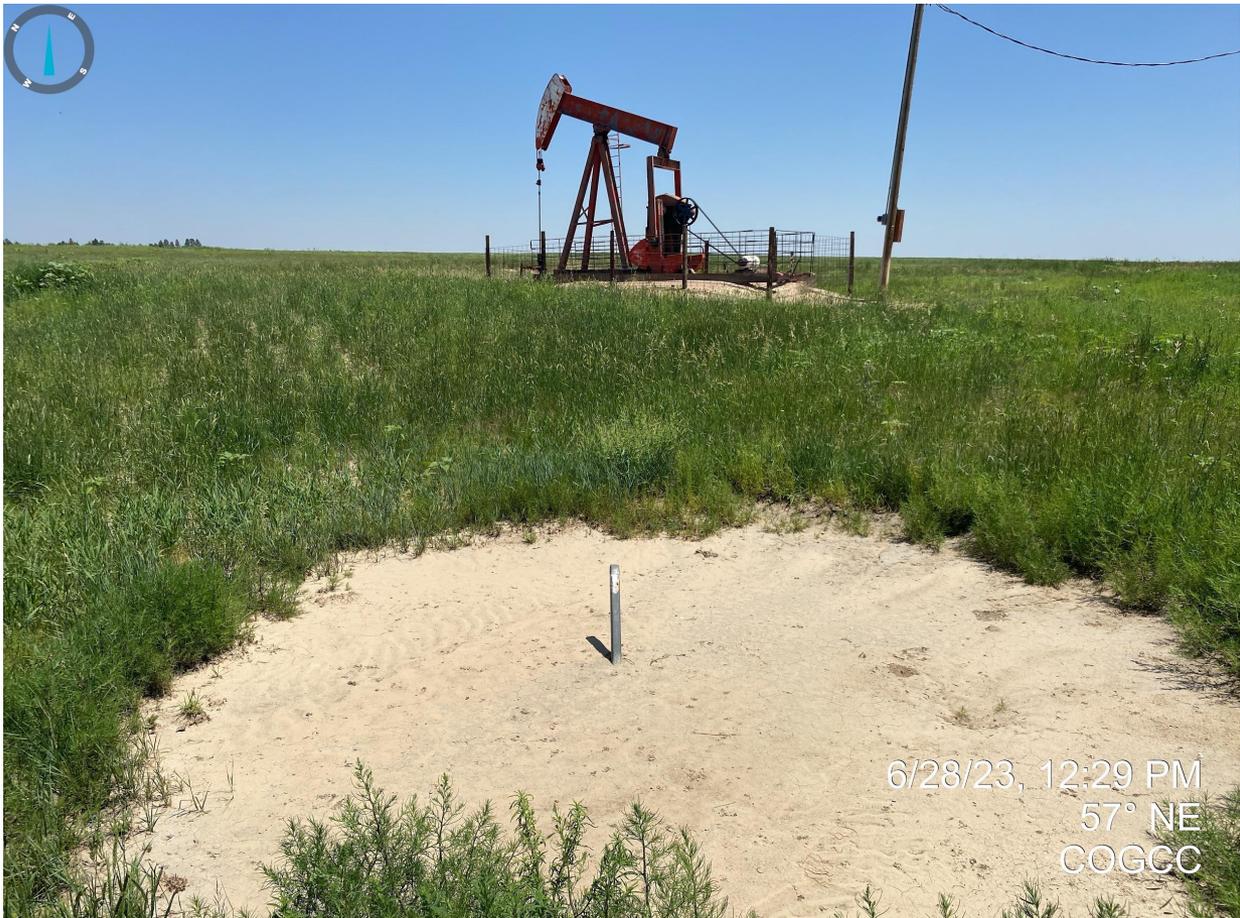
Photo 3. See comments in Photo 1.

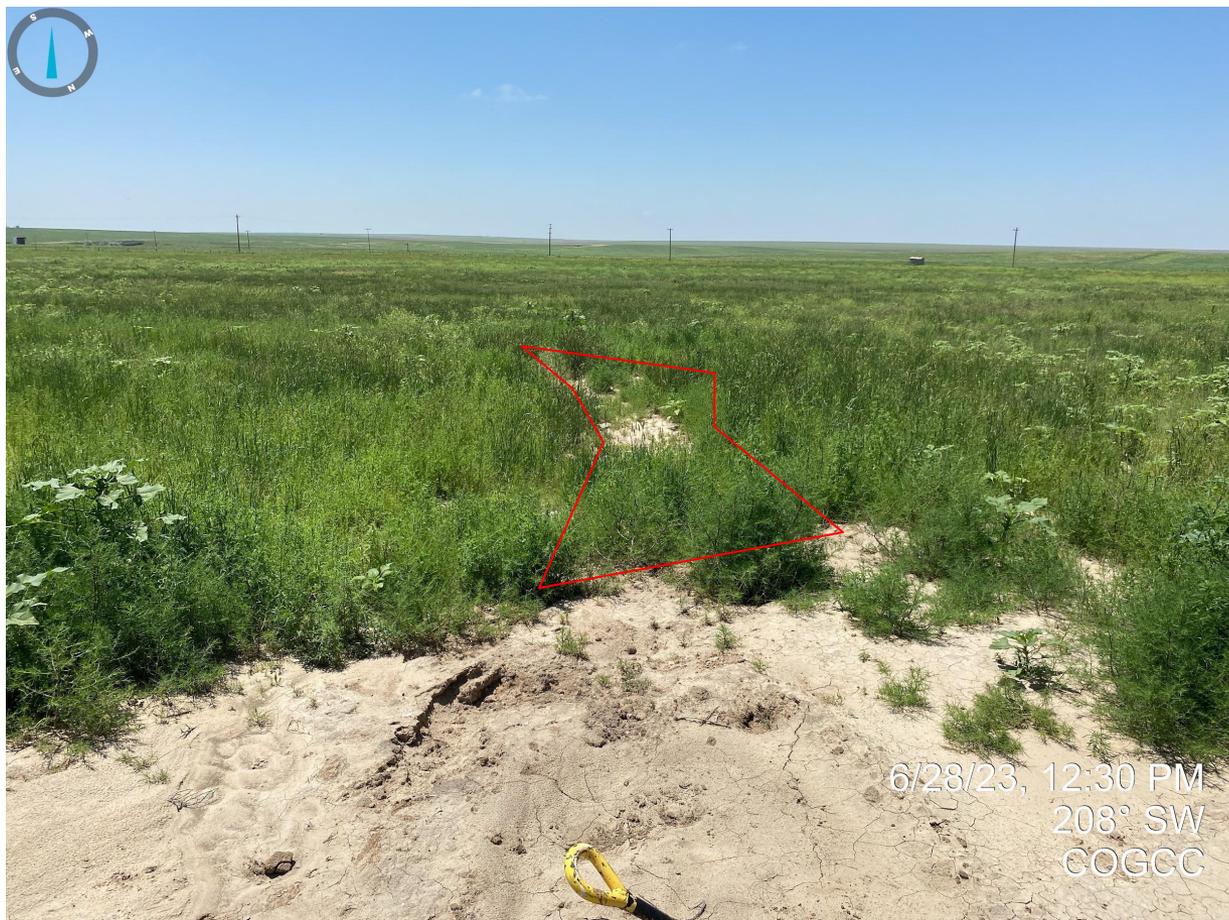
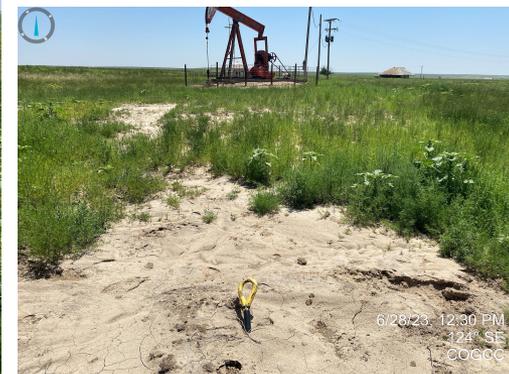
Photo 4. See comments in Photo 1. Additionally, rill erosion was observed on the northwest guy line anchor; soil do not appear to be properly stabilized.

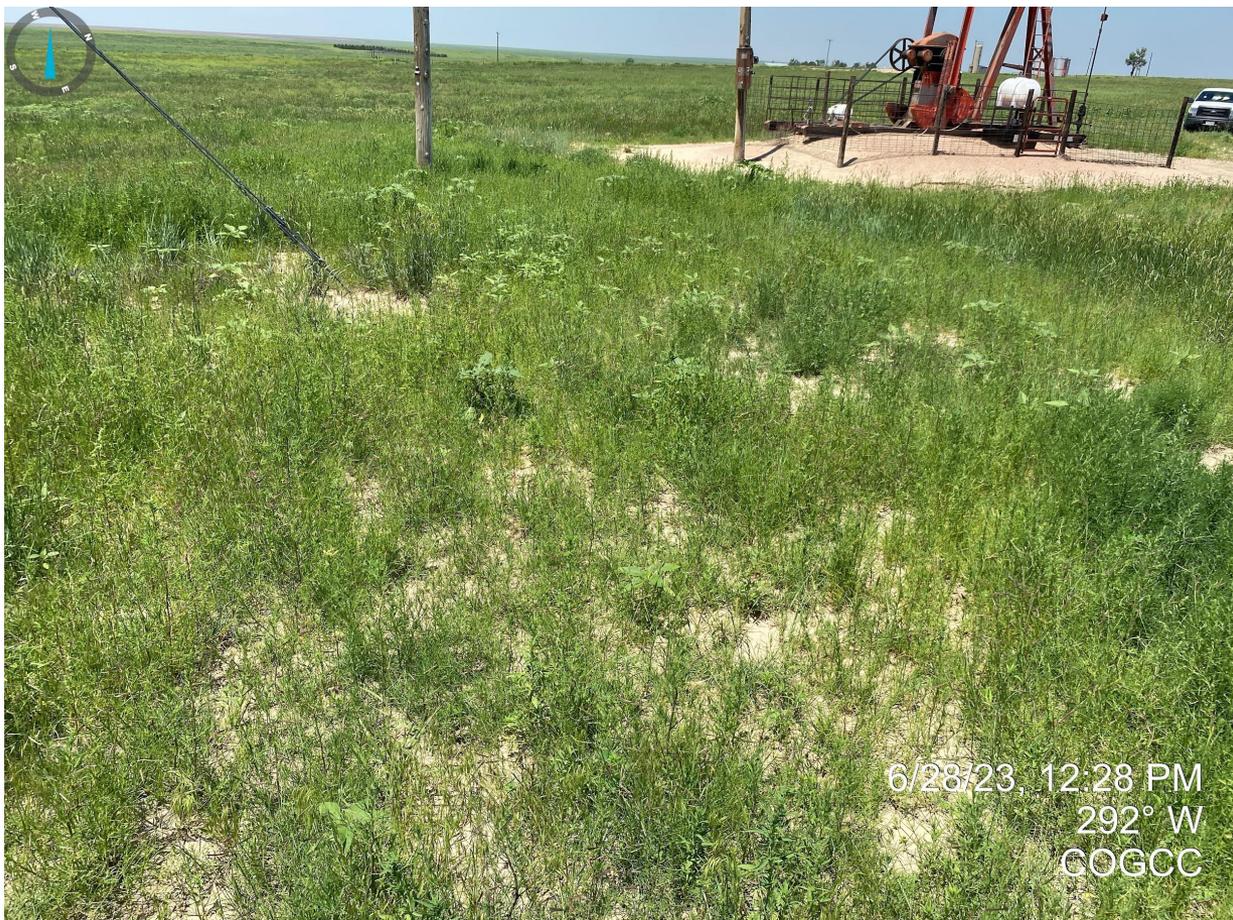
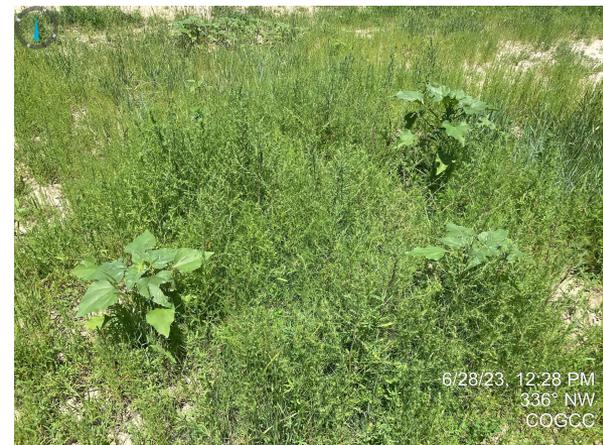
Photo 5. Undesirable vegetation (kochia and russian thistle pictured) will need to be actively managed for during this growing season.

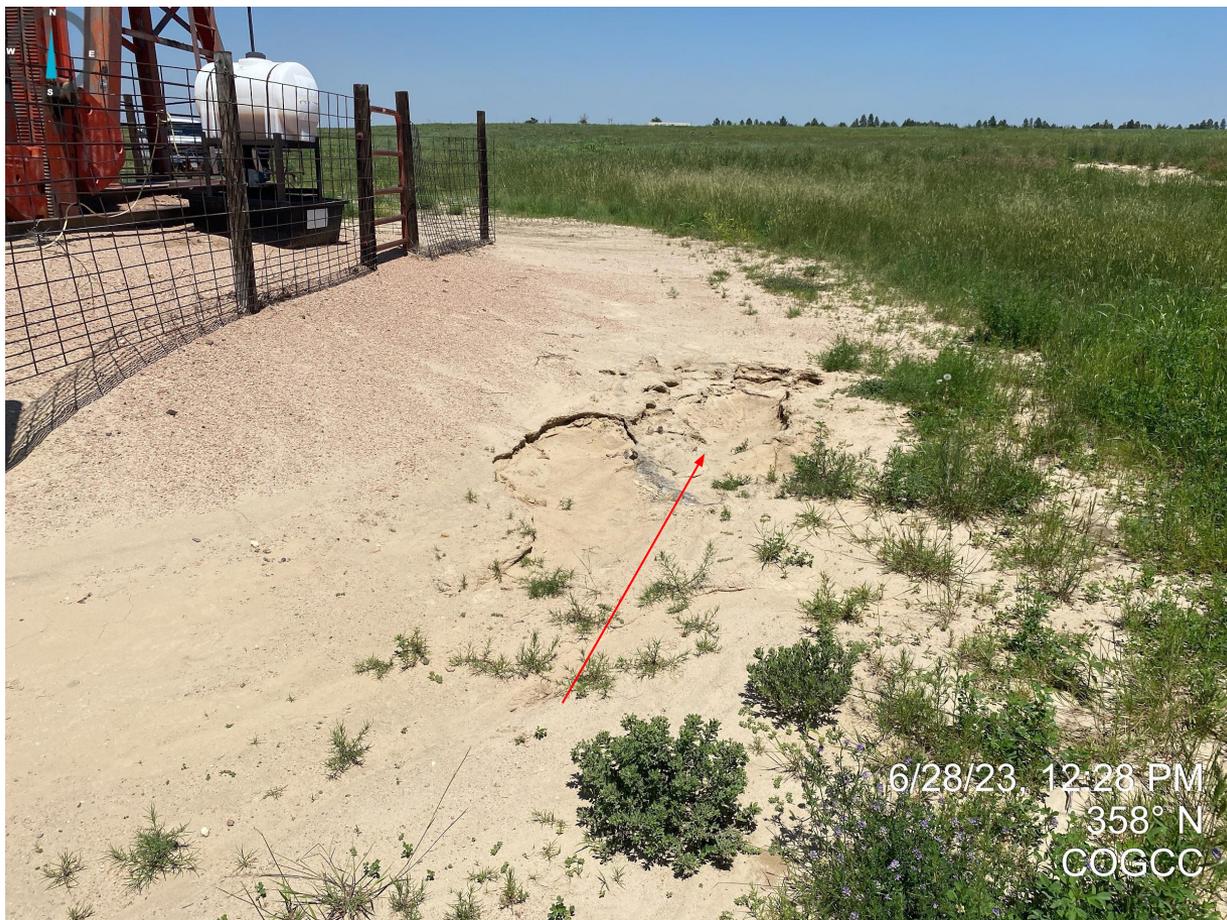
Photo 6. Unstabilized production areas will require maintenance and/or additional BMPs (roadbase, etc).

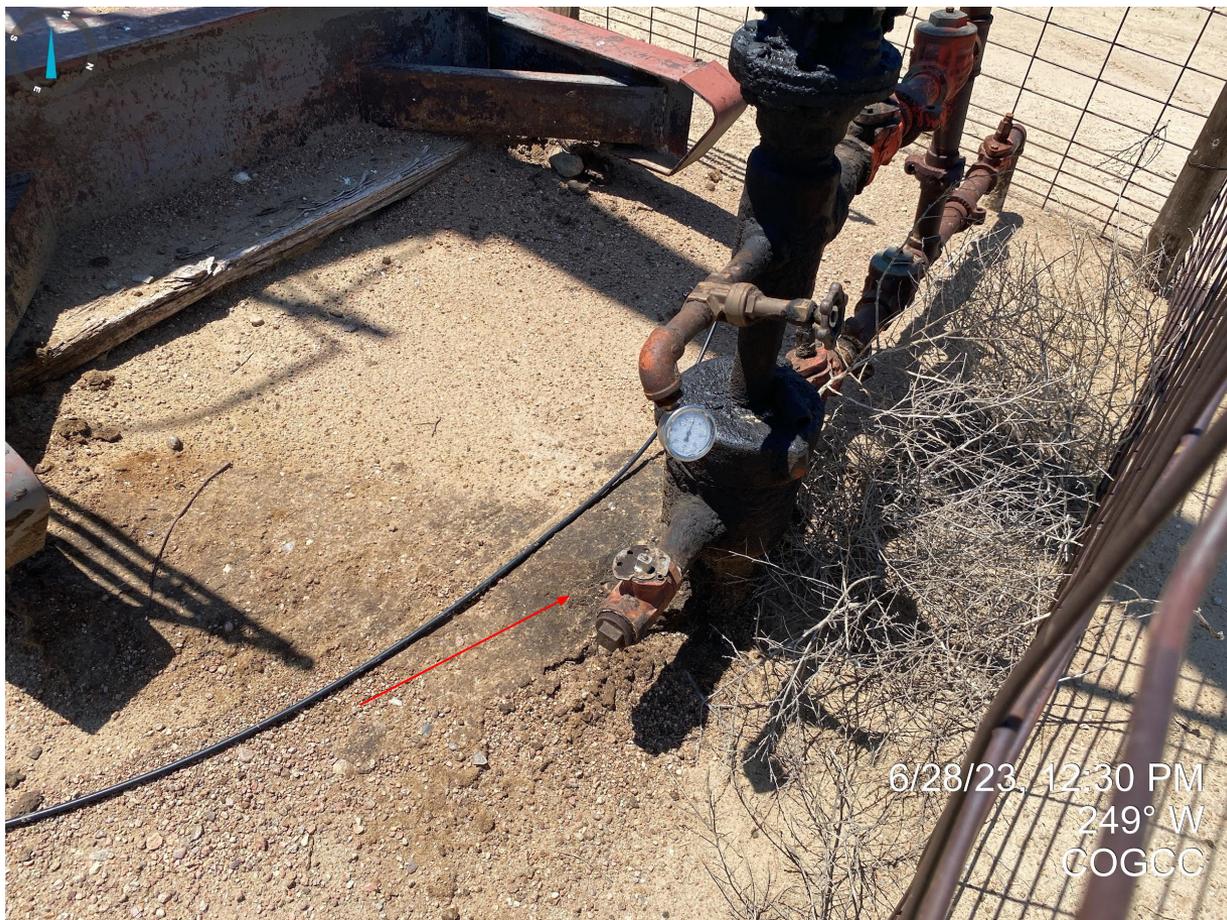
Photo 7. Stained soil around wellhead.

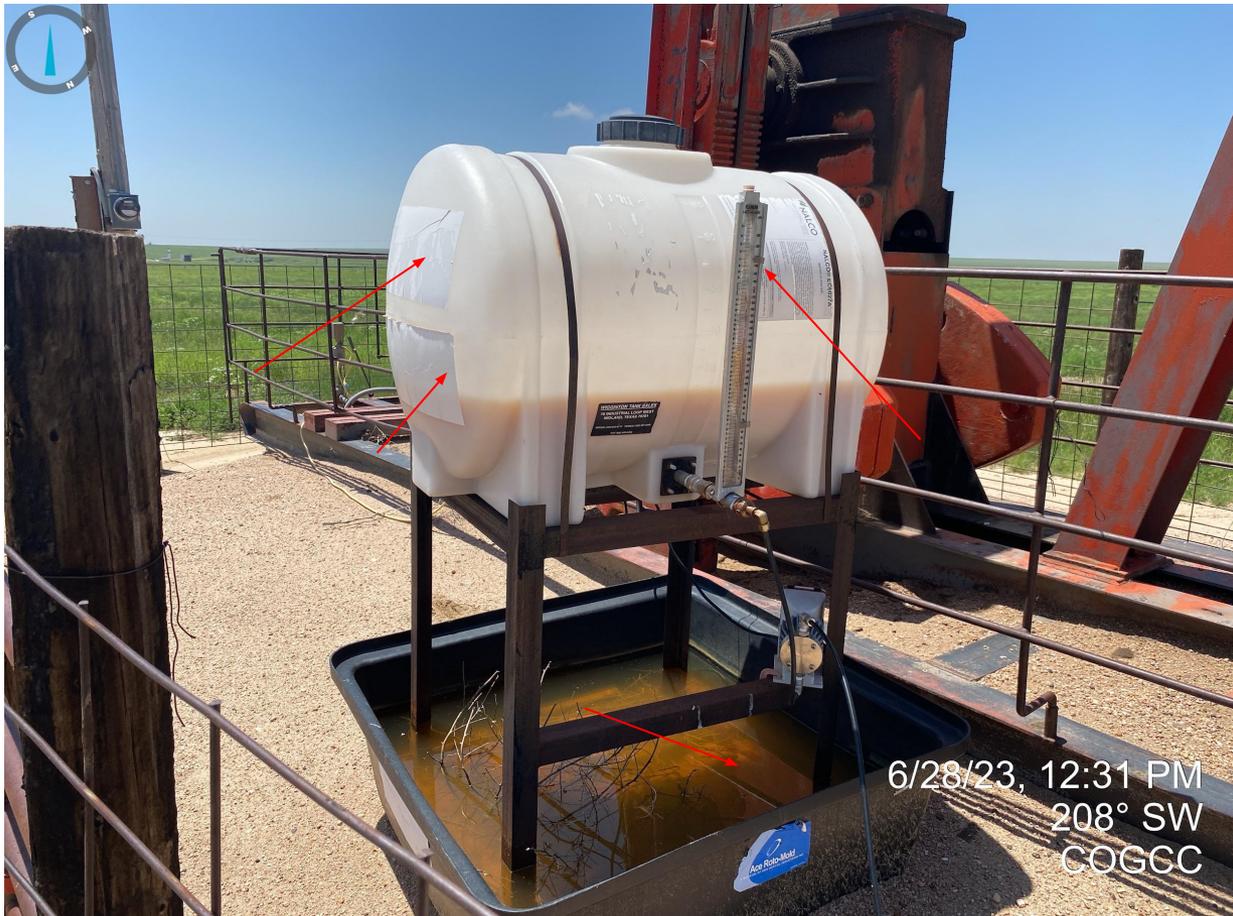
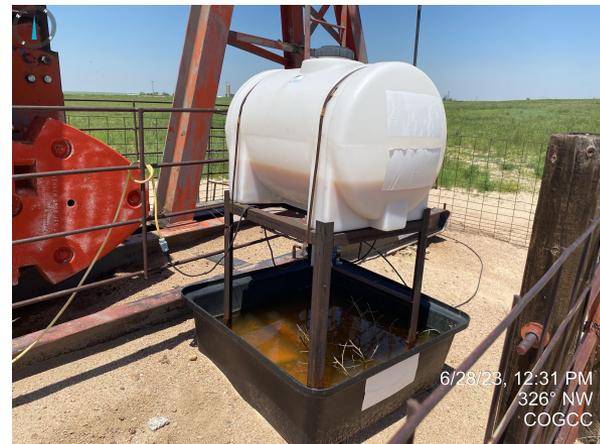
Photo 8. Day tank labels are not legible and missing wildlife protection equipment.

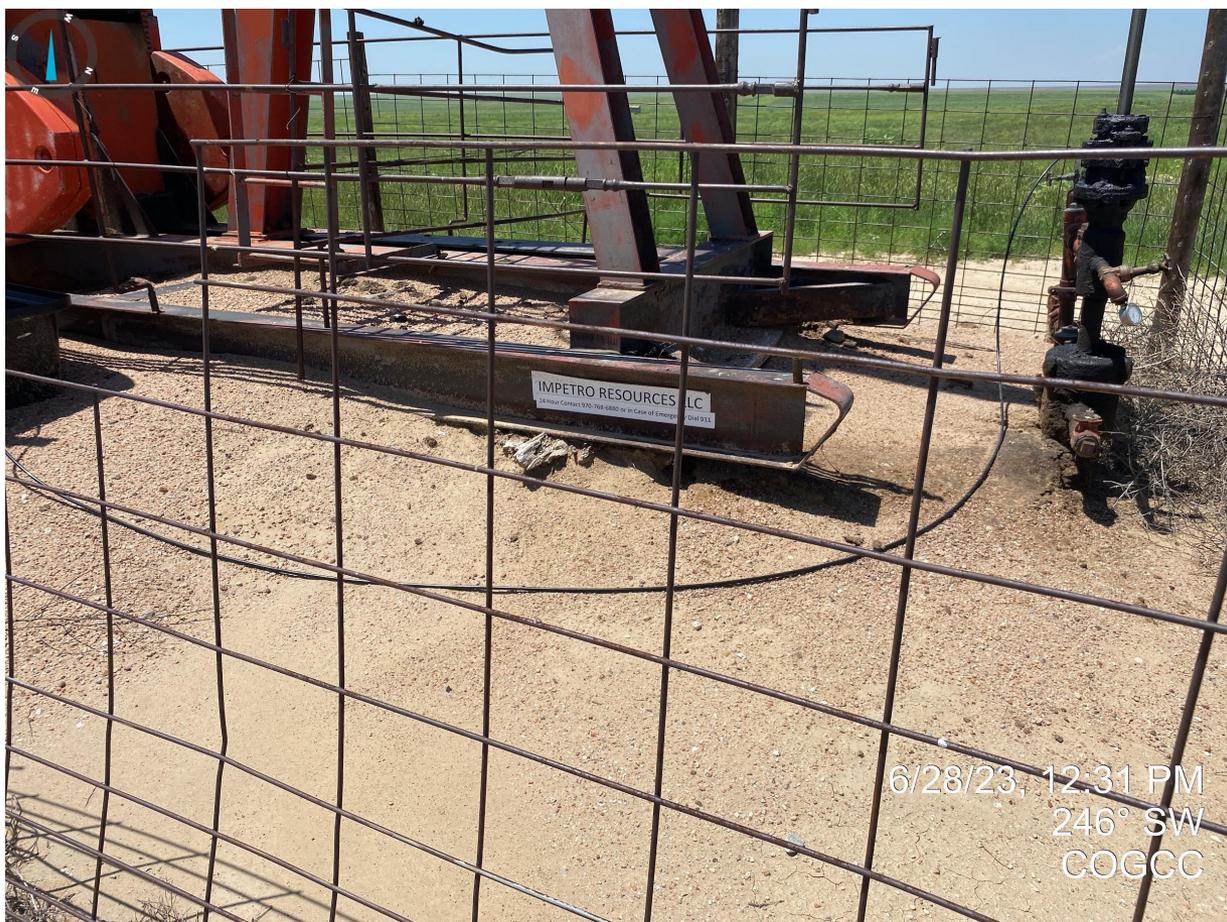
Photo 9. Well location requires additional signage to designate wellhead (e.g. API).

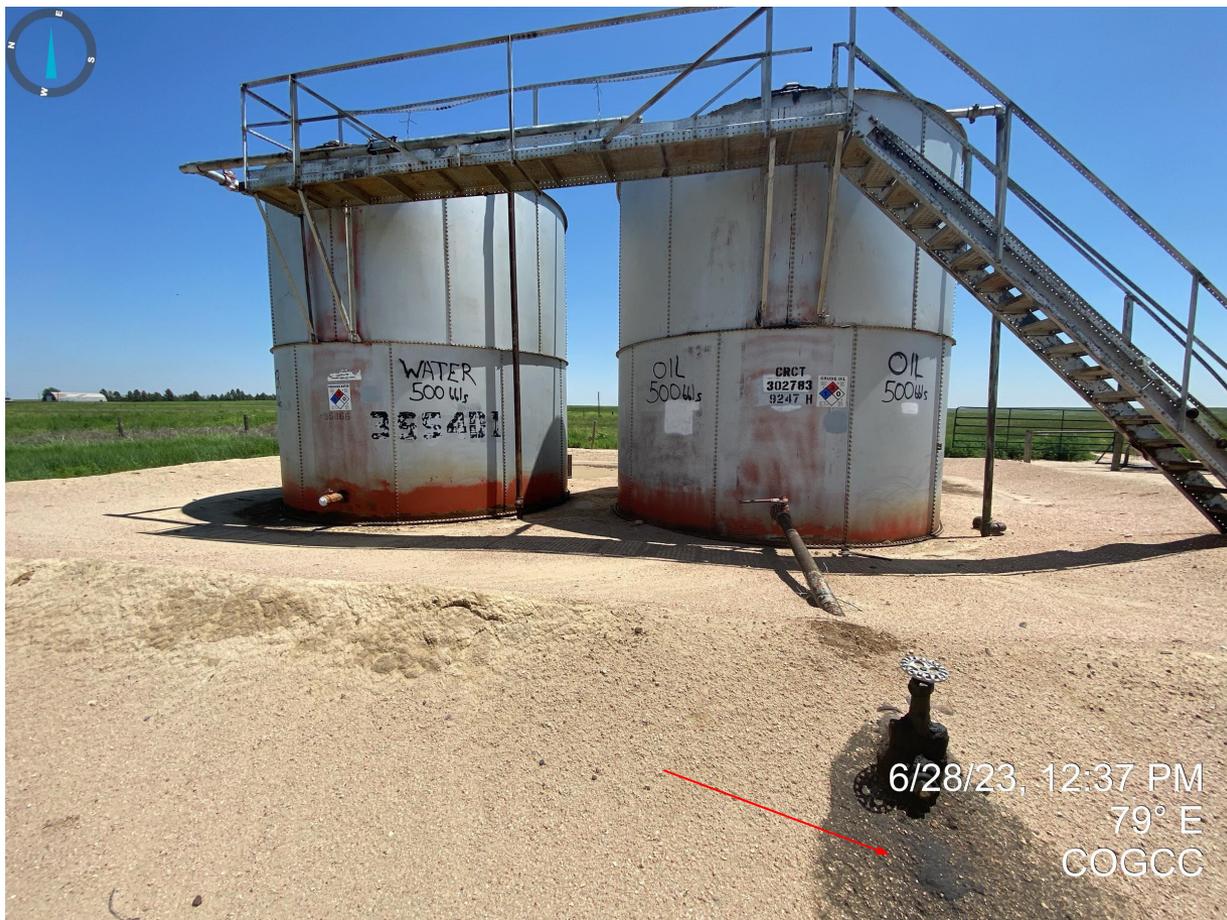
Photo 10. Stained soil around loadout line.

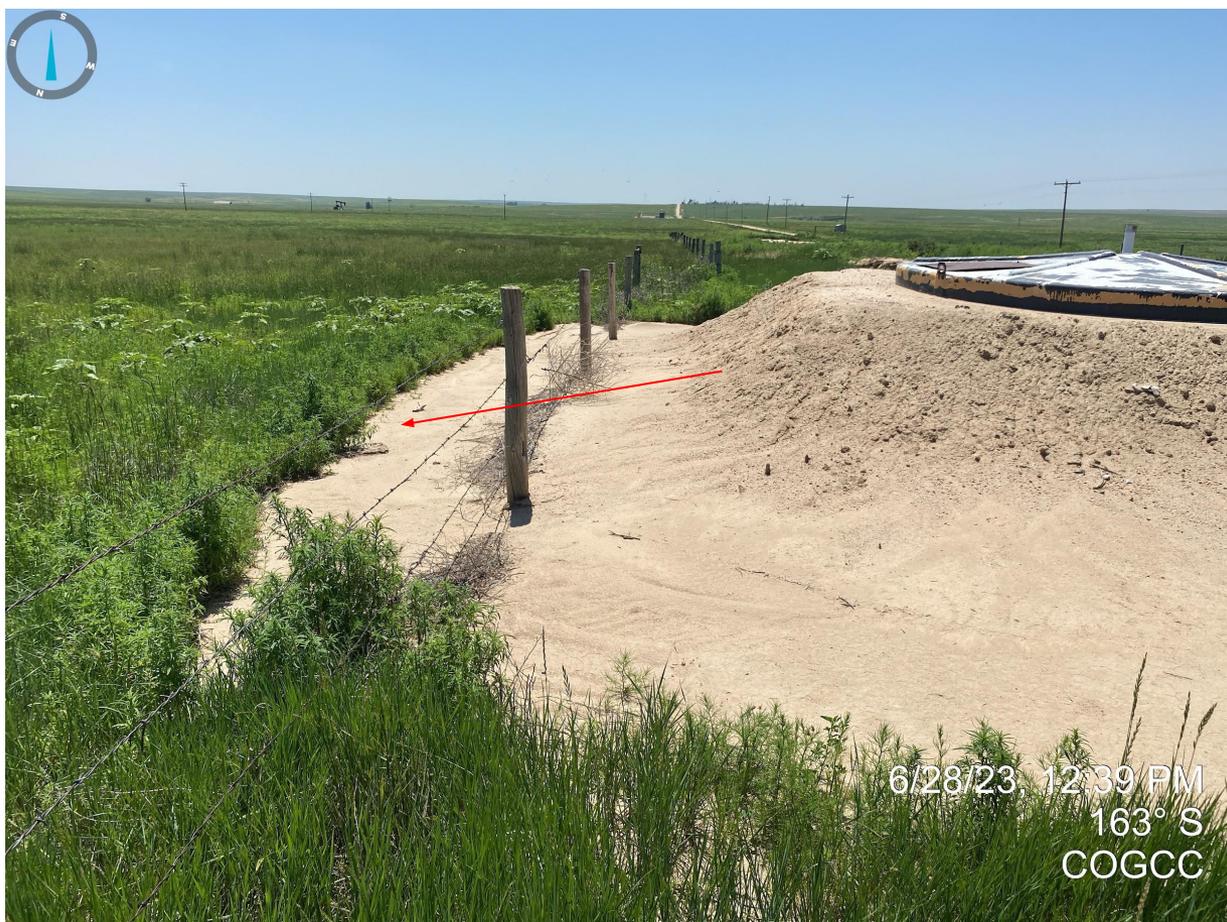
Photo 11. Soils around partially buried tank do not appear to be stabilized with evidence of off-location sediment transport. Additional maintenance or BMPs are required to come into compliance with Rule 1002.f.

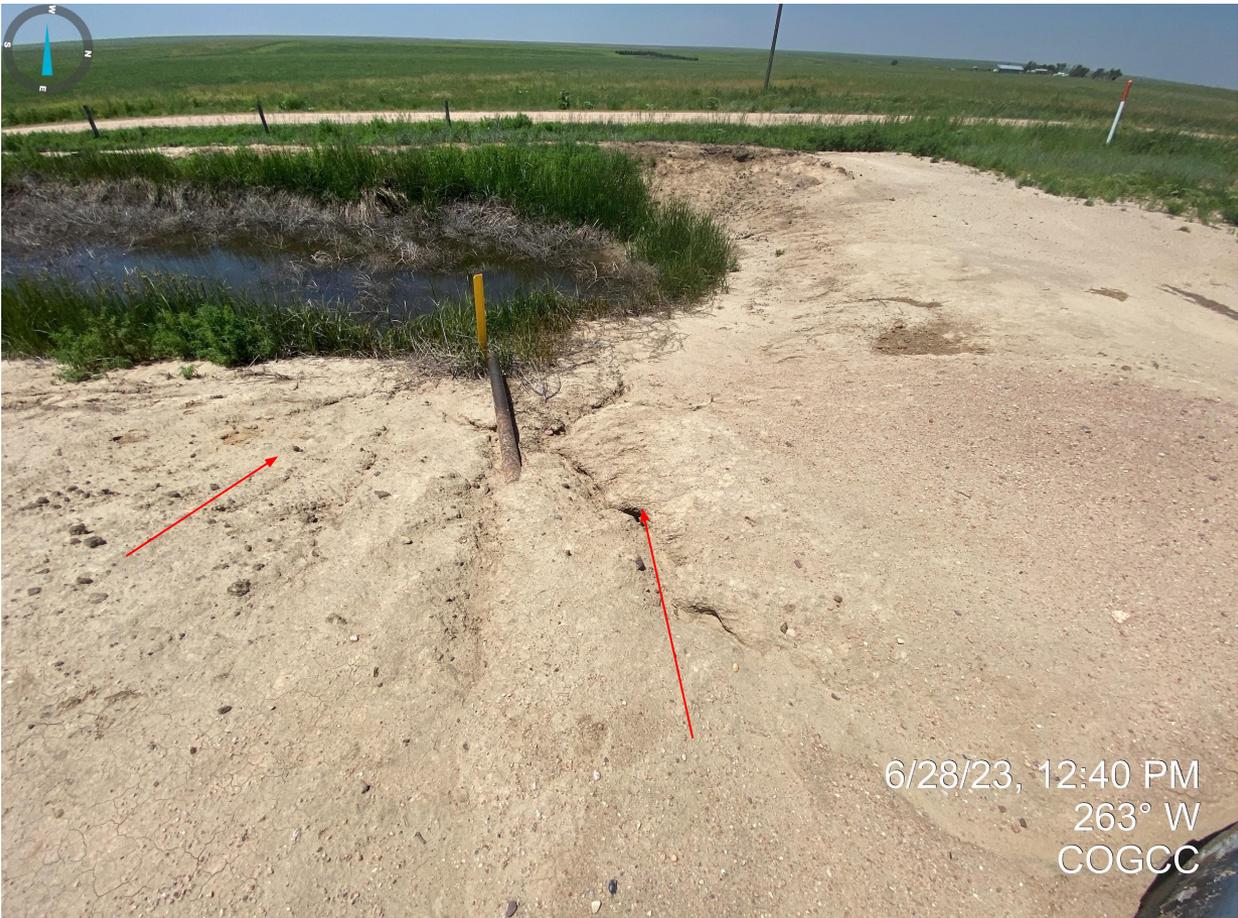
Photo 12. See comments in Photo 11.

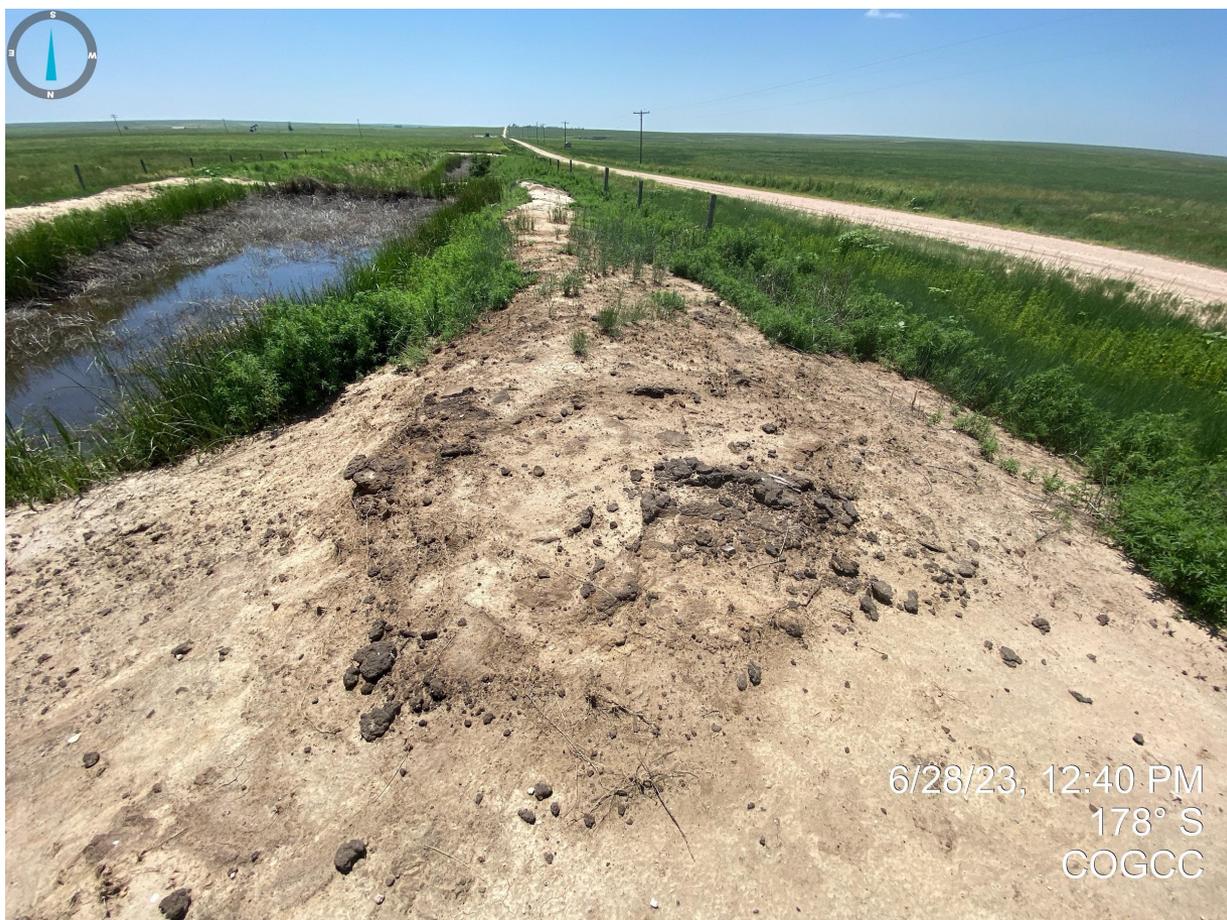
Photo 13. Stained soil observed on pit walls/berms will need to be properly cleaned up.

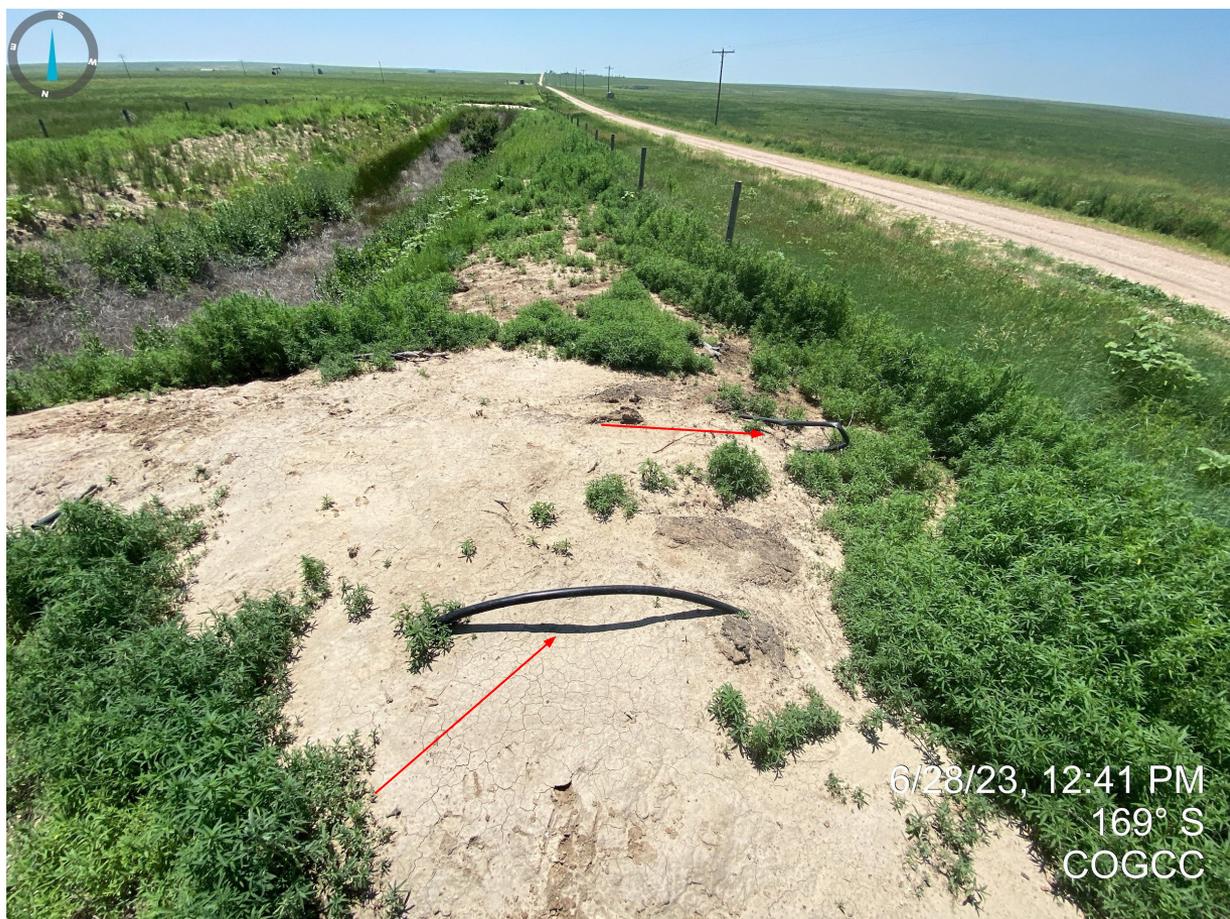
Photo 14. Debris within pit walls/berms.

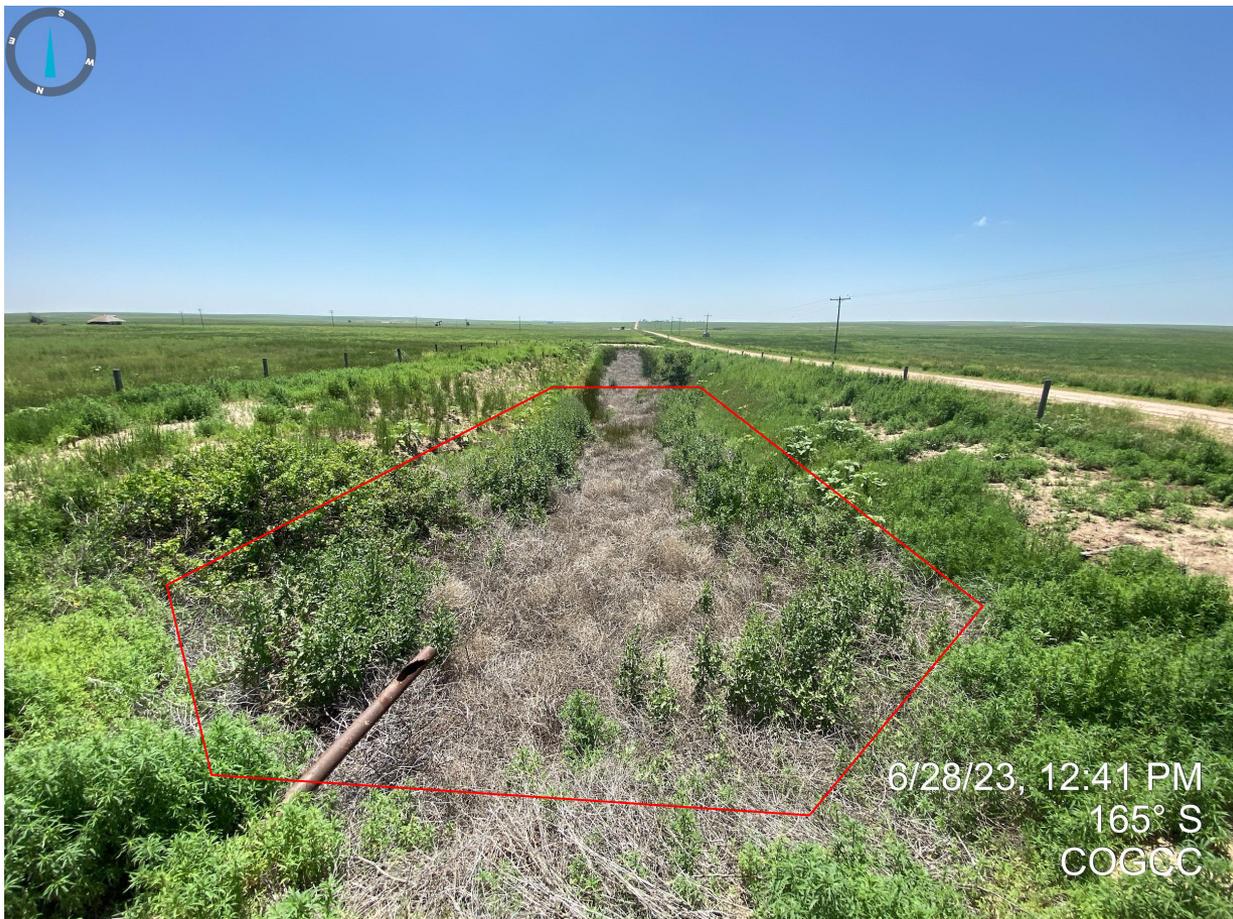
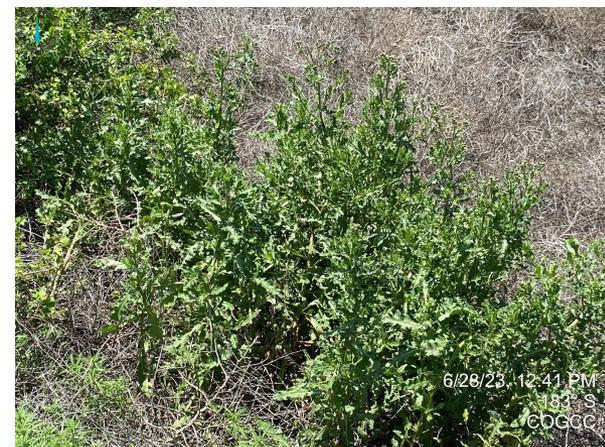
Photo 15. Colorado Noxious Weed List B (e.g. Canada thistle) observed within the southern pit will need to be managed for.

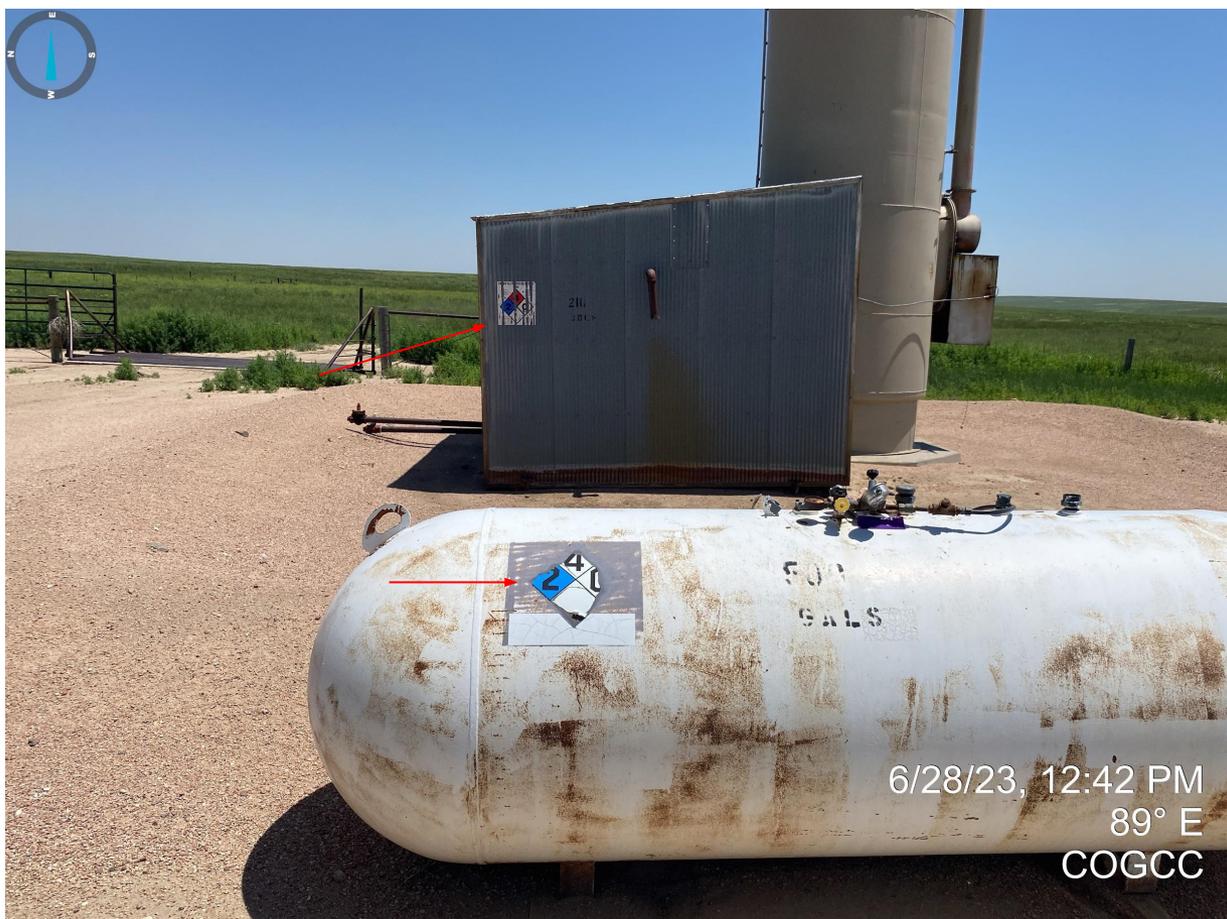
Photo 16. NFPA placards are peeling, faded, cracked, and/or not legible.

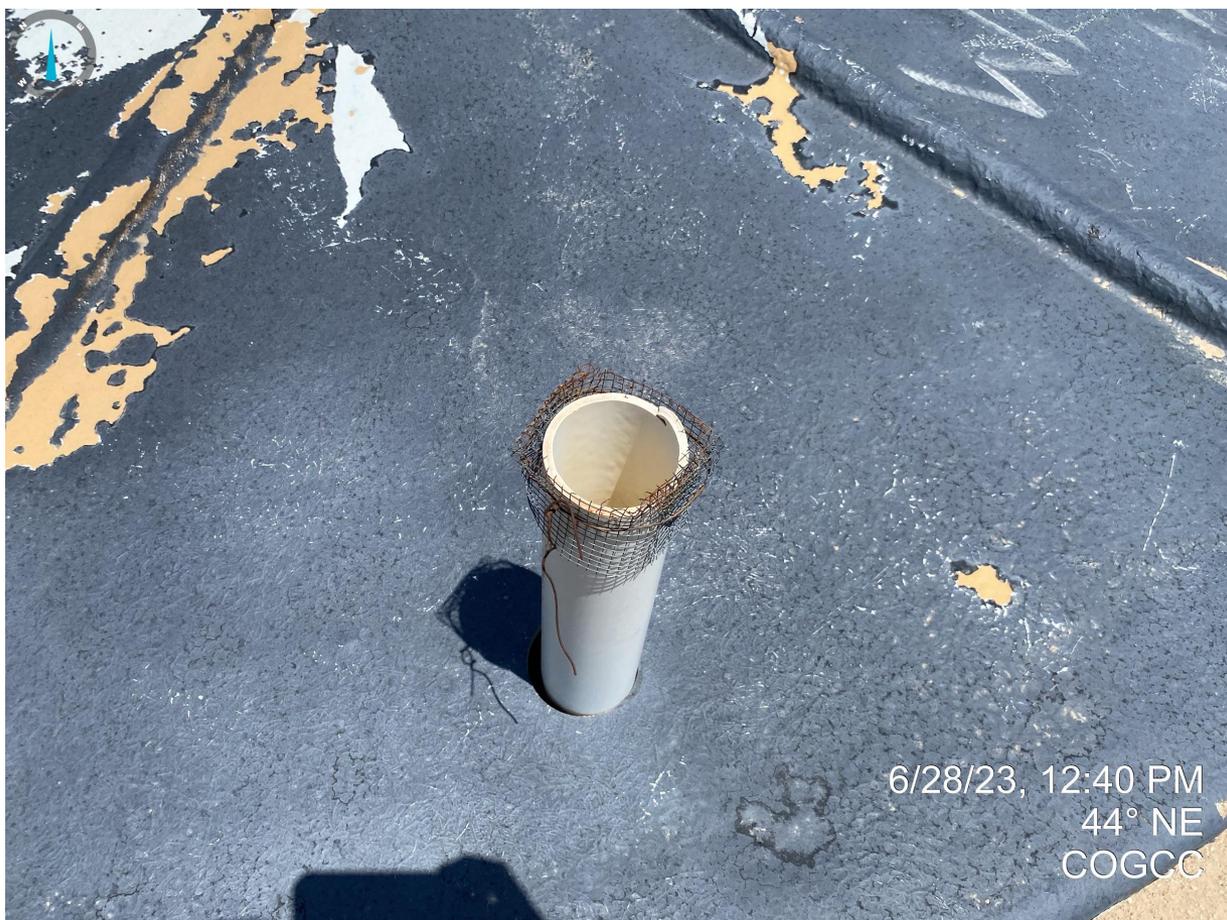
Photo 18. Wildlife protection equipment needs replacement/repair on partially buried tank.
