Interim Reclamation and Stormwater Inspection

Date: 06/28/2023

Operator: IMPETRO RESOURCES LLC - 10690

Location ID: 317058

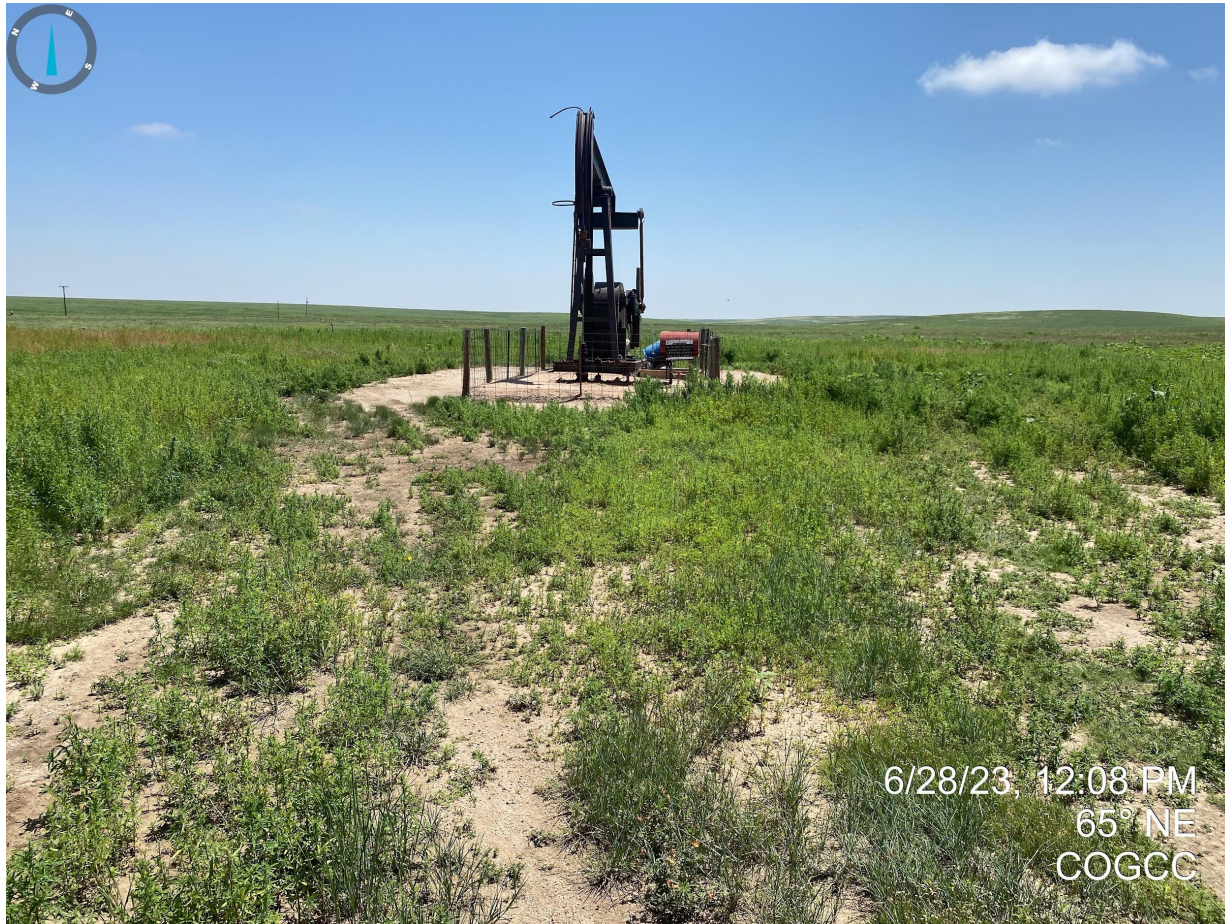
Photo 1. Well location is predominantly undesirable vegetation (e.g. kochia, russian thistle, CO List C Noxious Weed- cheatgrass) that will need to be managed for during this growing season.

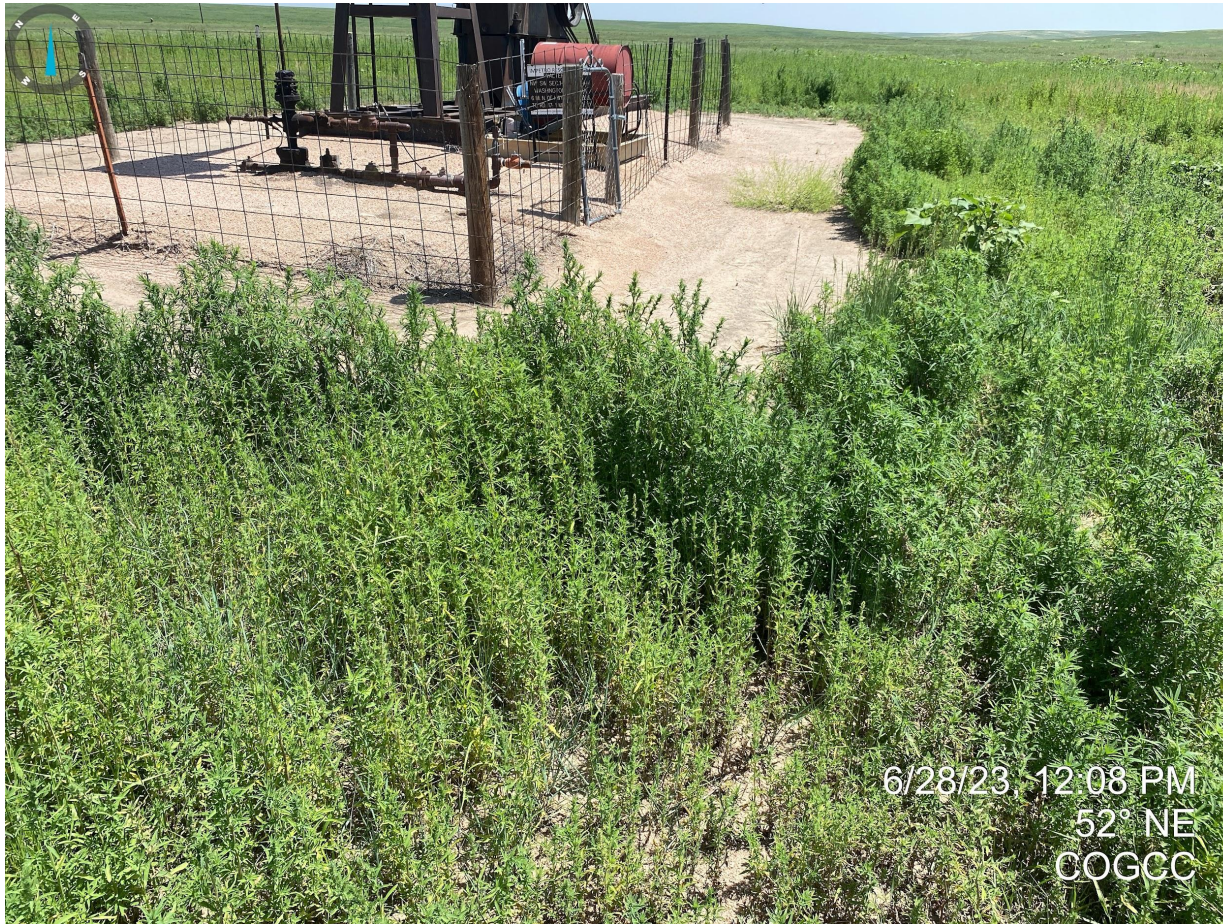
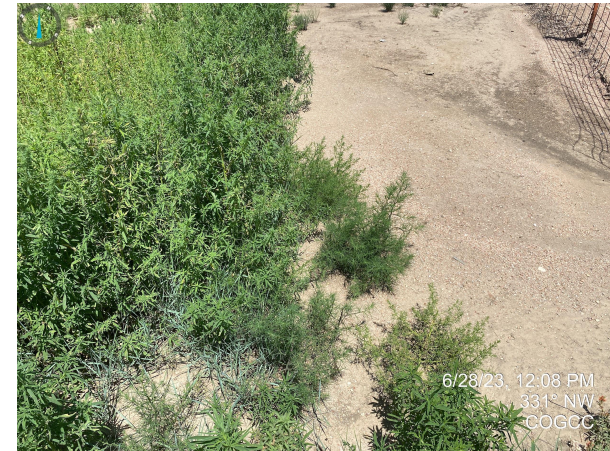
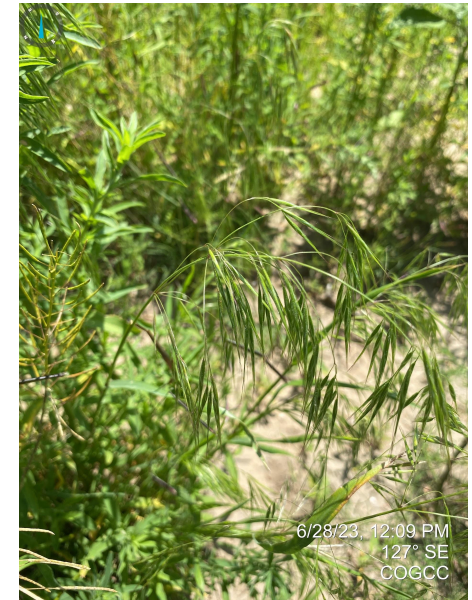
Photo 2. See comments in Photo 1.

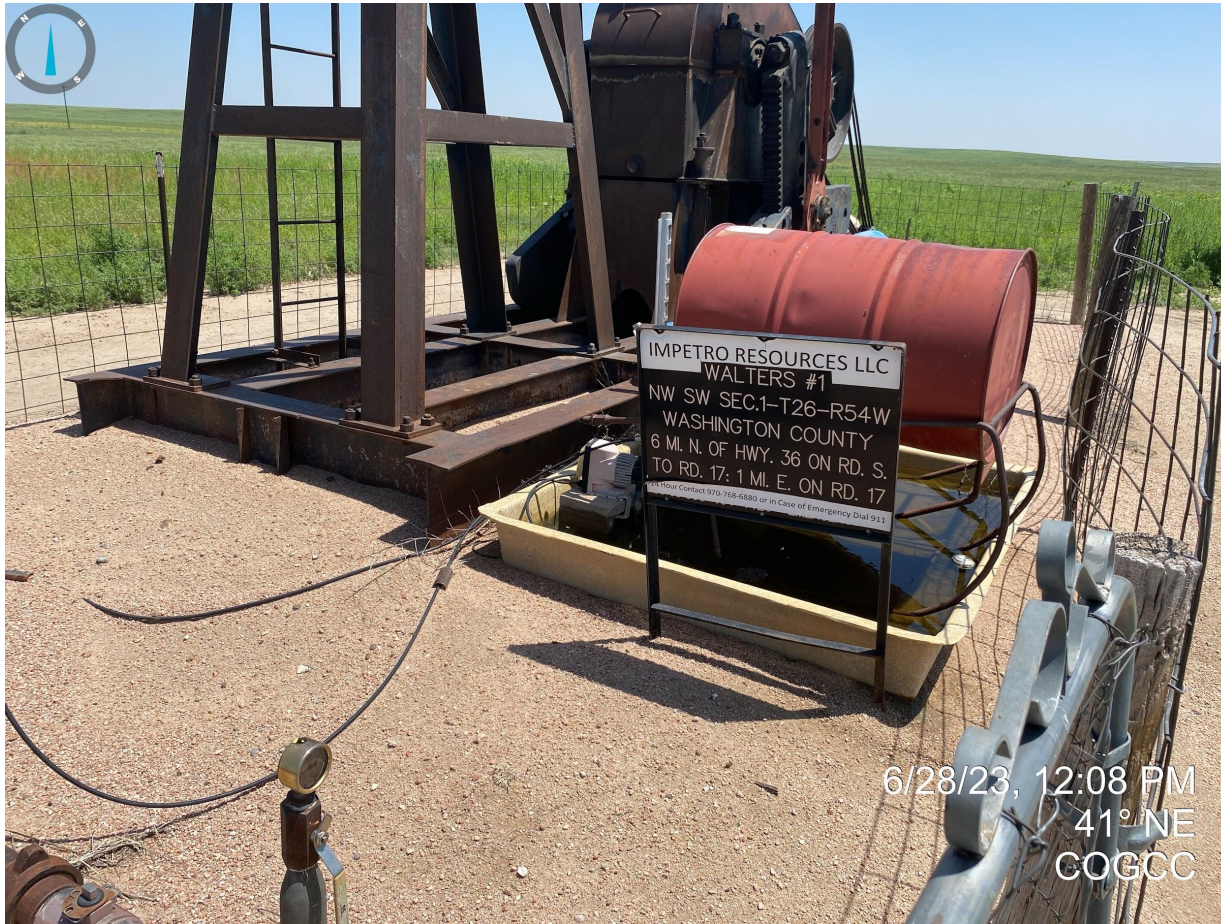
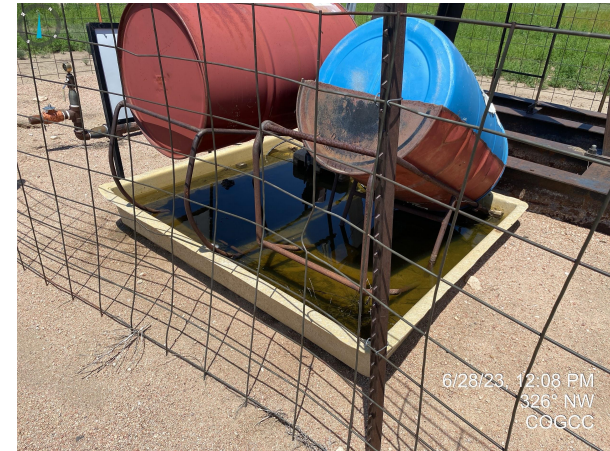
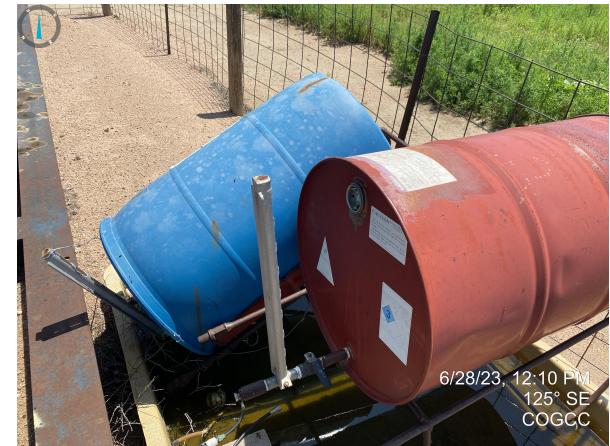
Photo 3. No wildlife protection equipment observed around secondary containment and tank labels are peeling, faded, cracked and/or not legible.

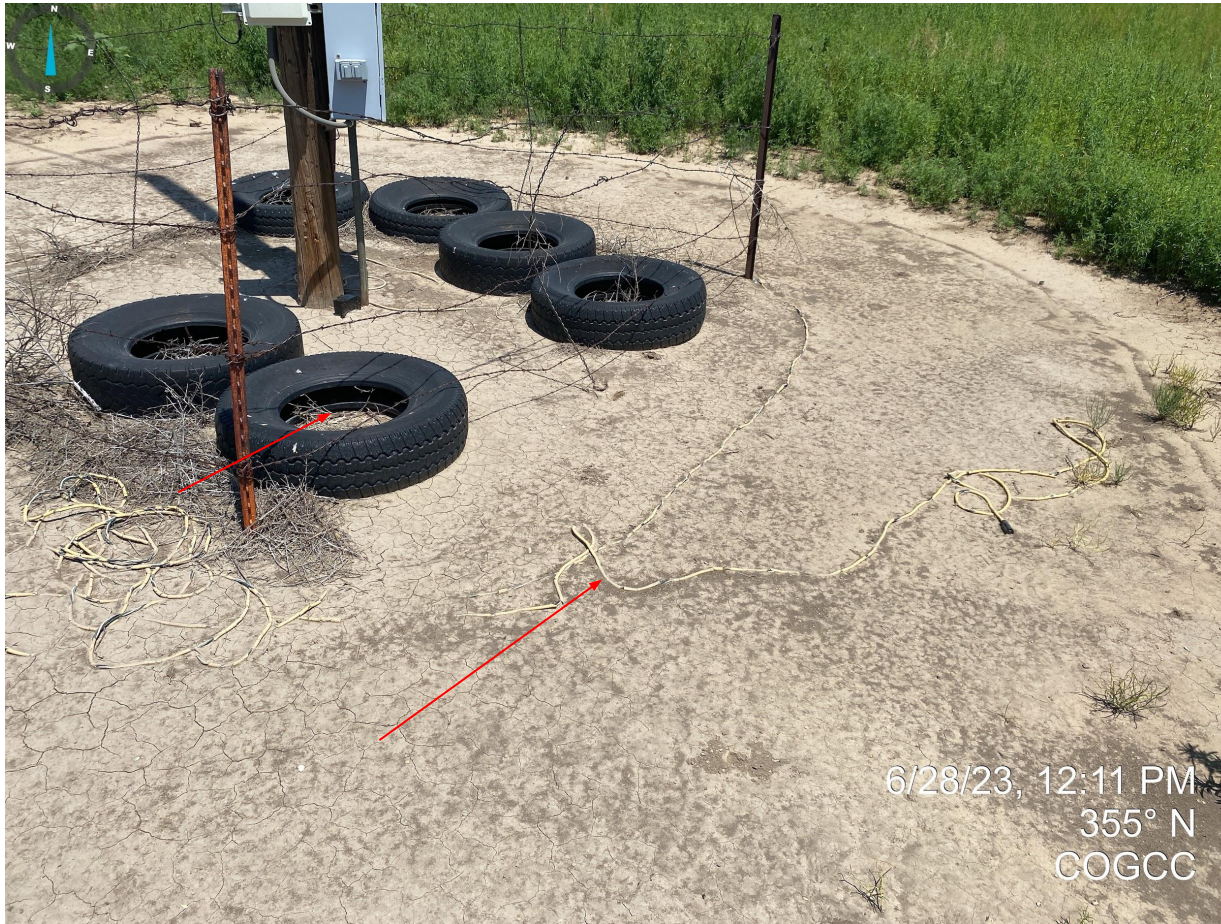
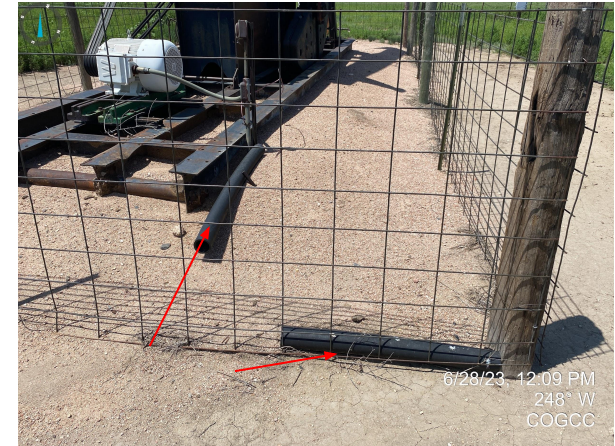
Photo 4. Unused equipment will need to be removed from the location.

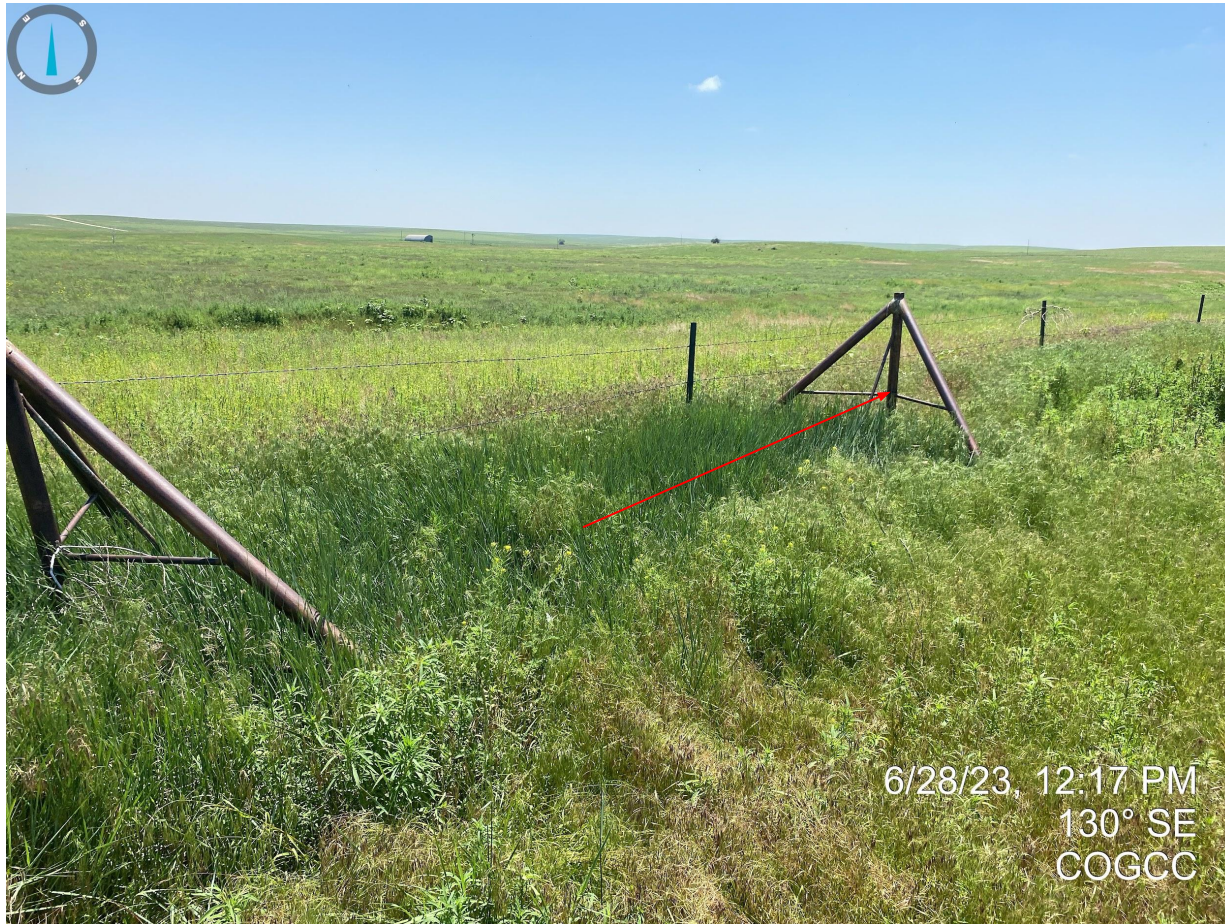
Photo 5. See comments in Photo 4.

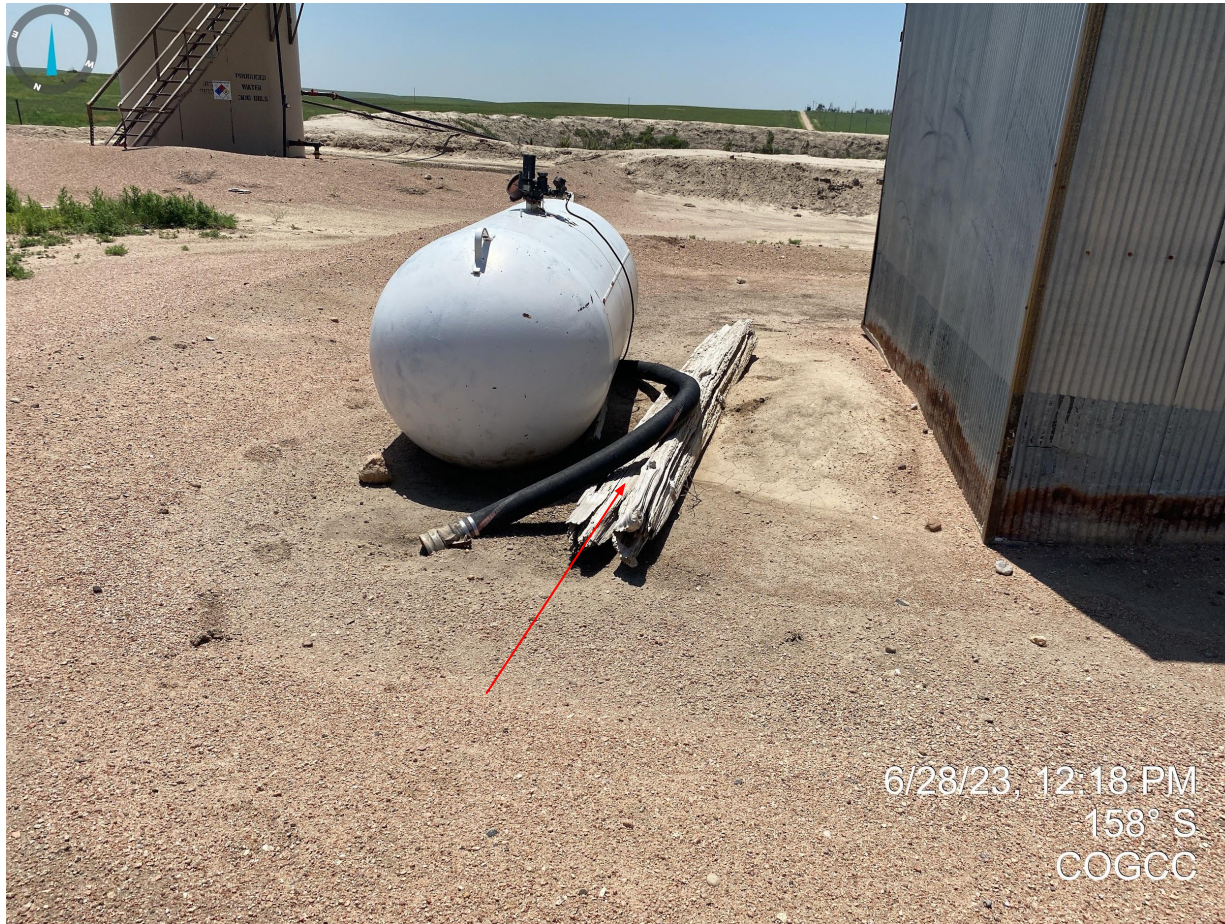
Photo 6. See comments in Photo 4.

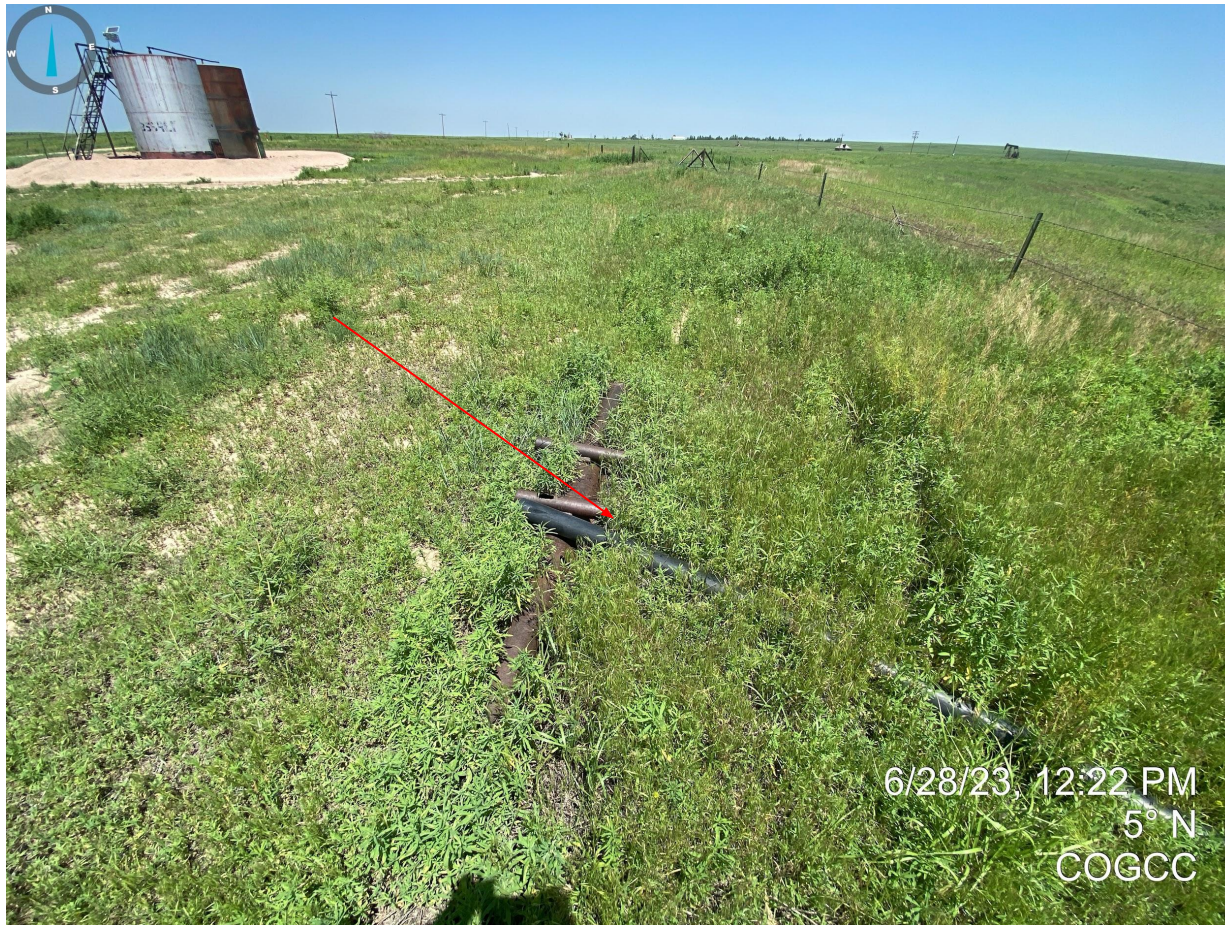
Photo 7. Road drag and piping; see comments in Photo 4.

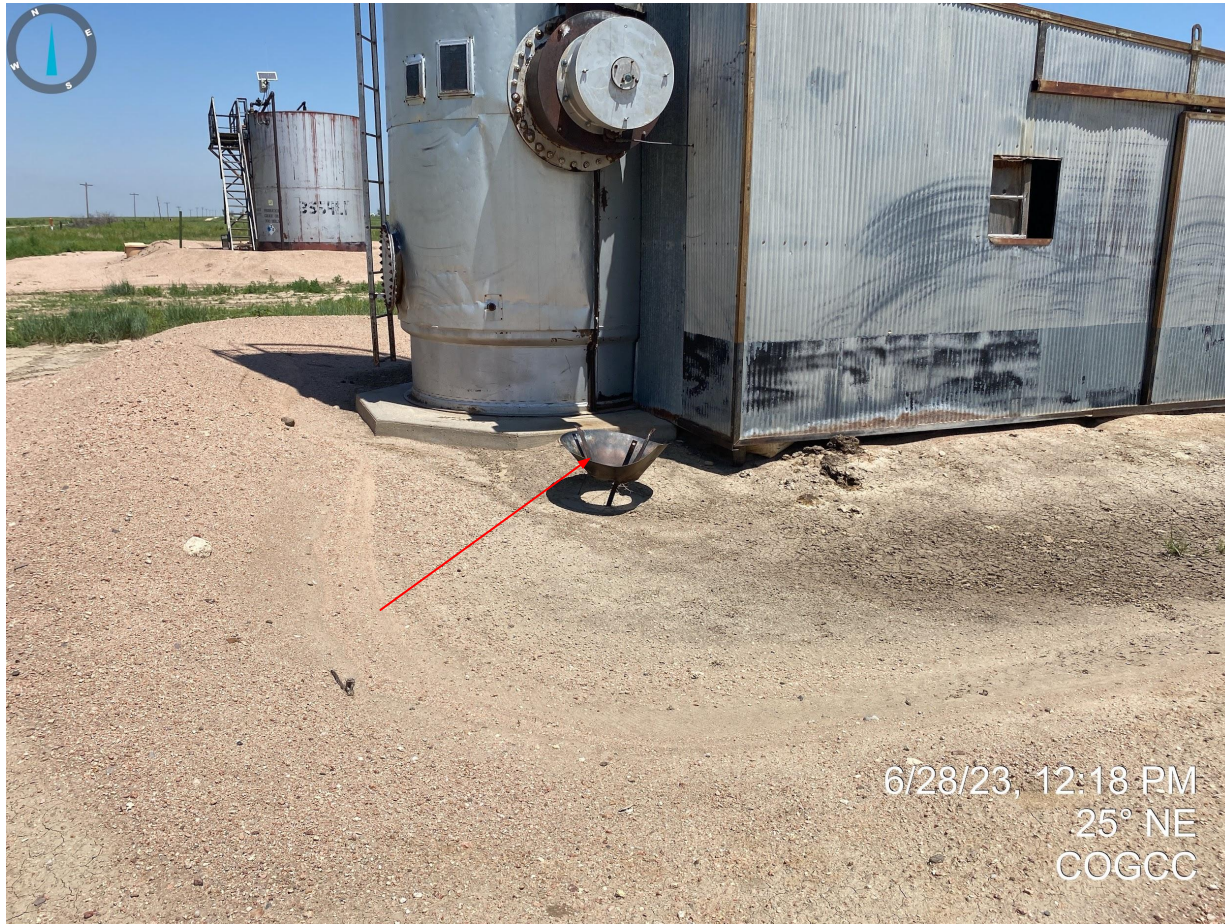
Photo 8. See comments in Photo 4.

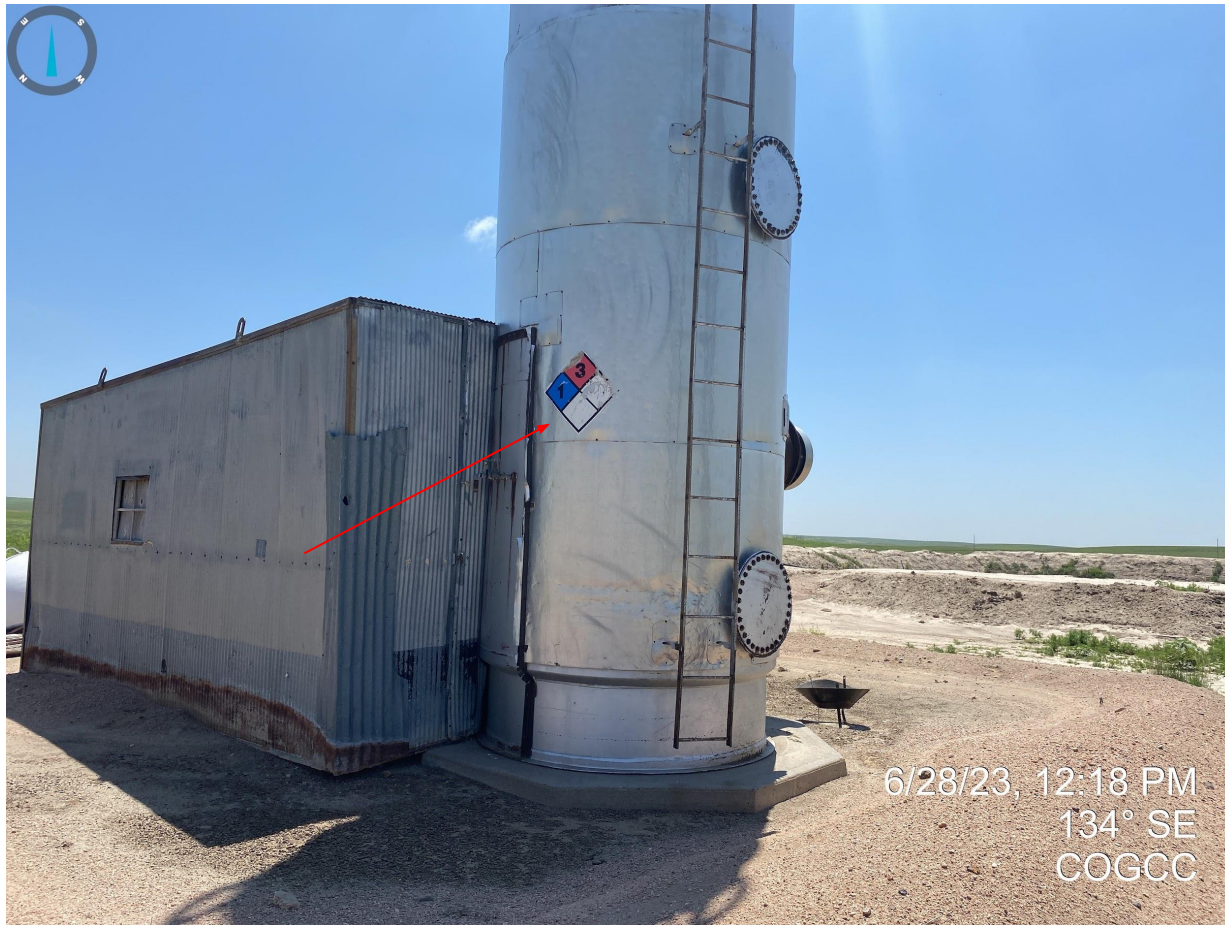
Photo 9. NFPA placard not legible and requires replacement.

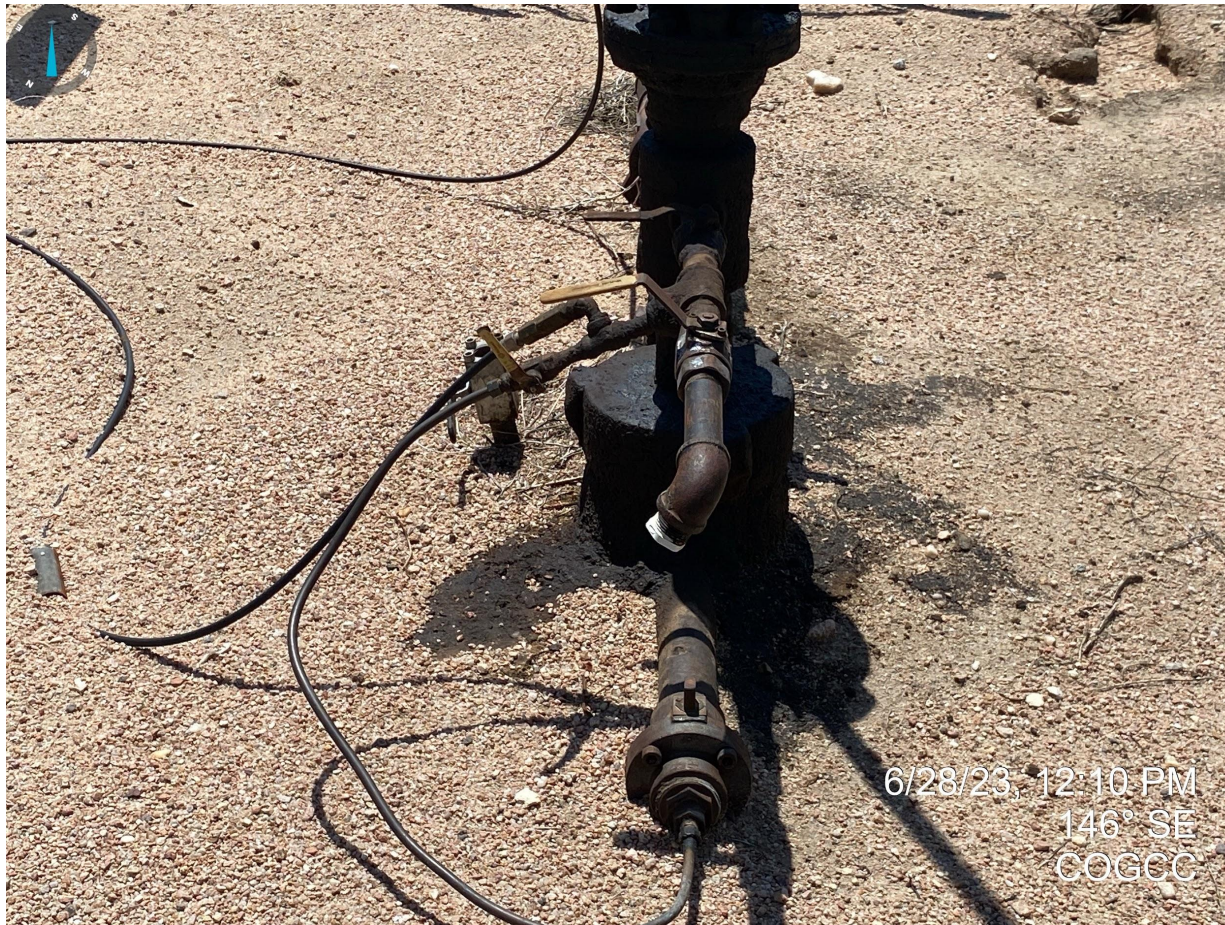
Photo 10. Stained soil at wellhead requires proper cleanup and disposal .

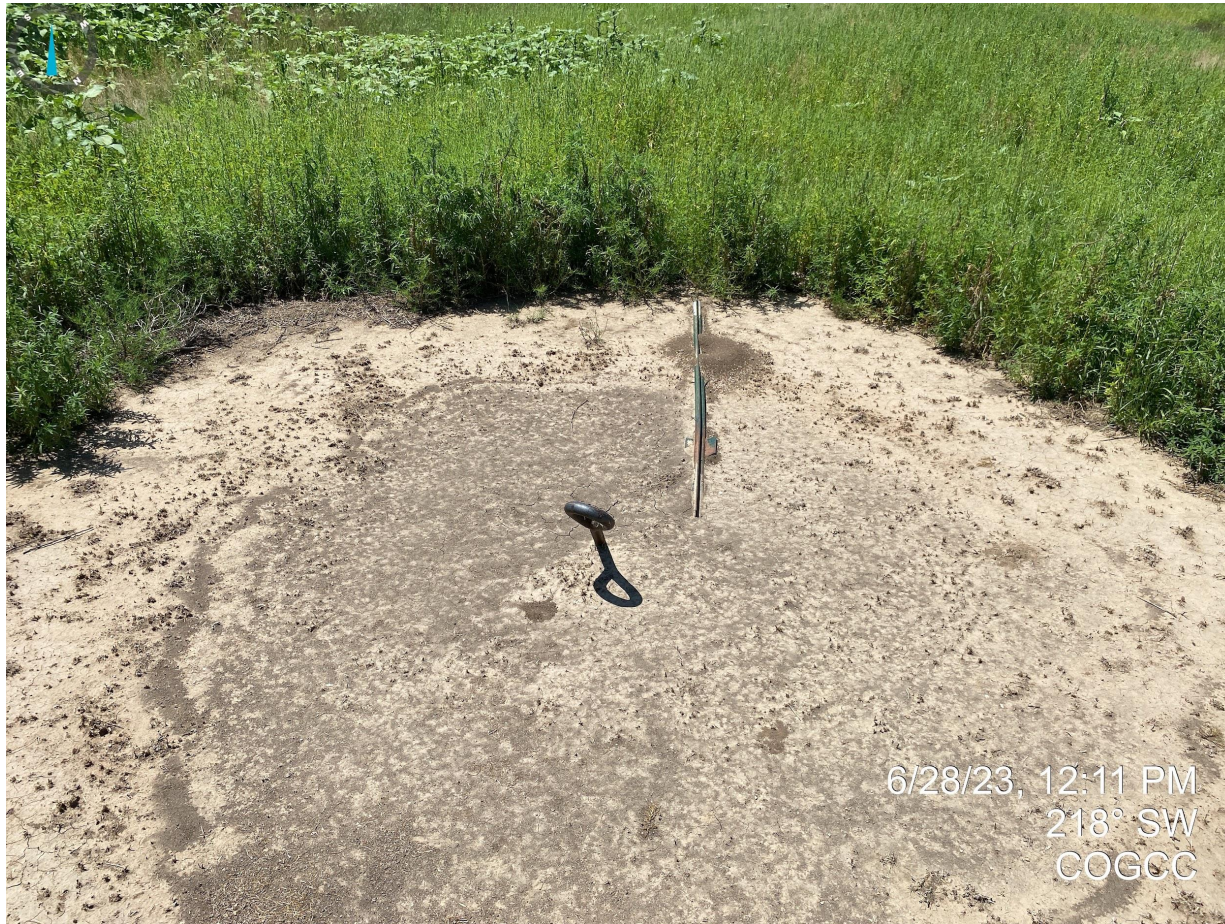
Photo 11. Guy line anchors not properly marked.

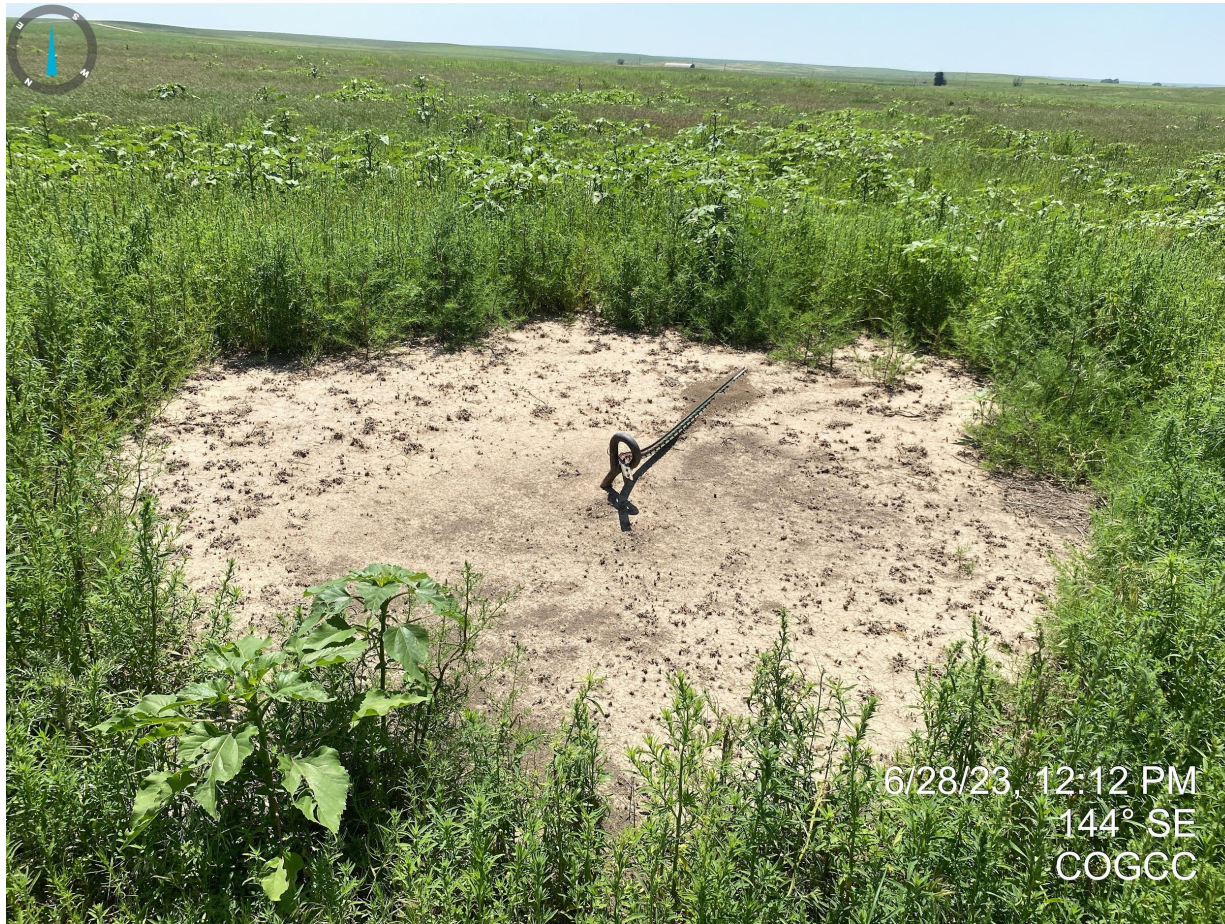
Photo 12. See comments in Photo 11.

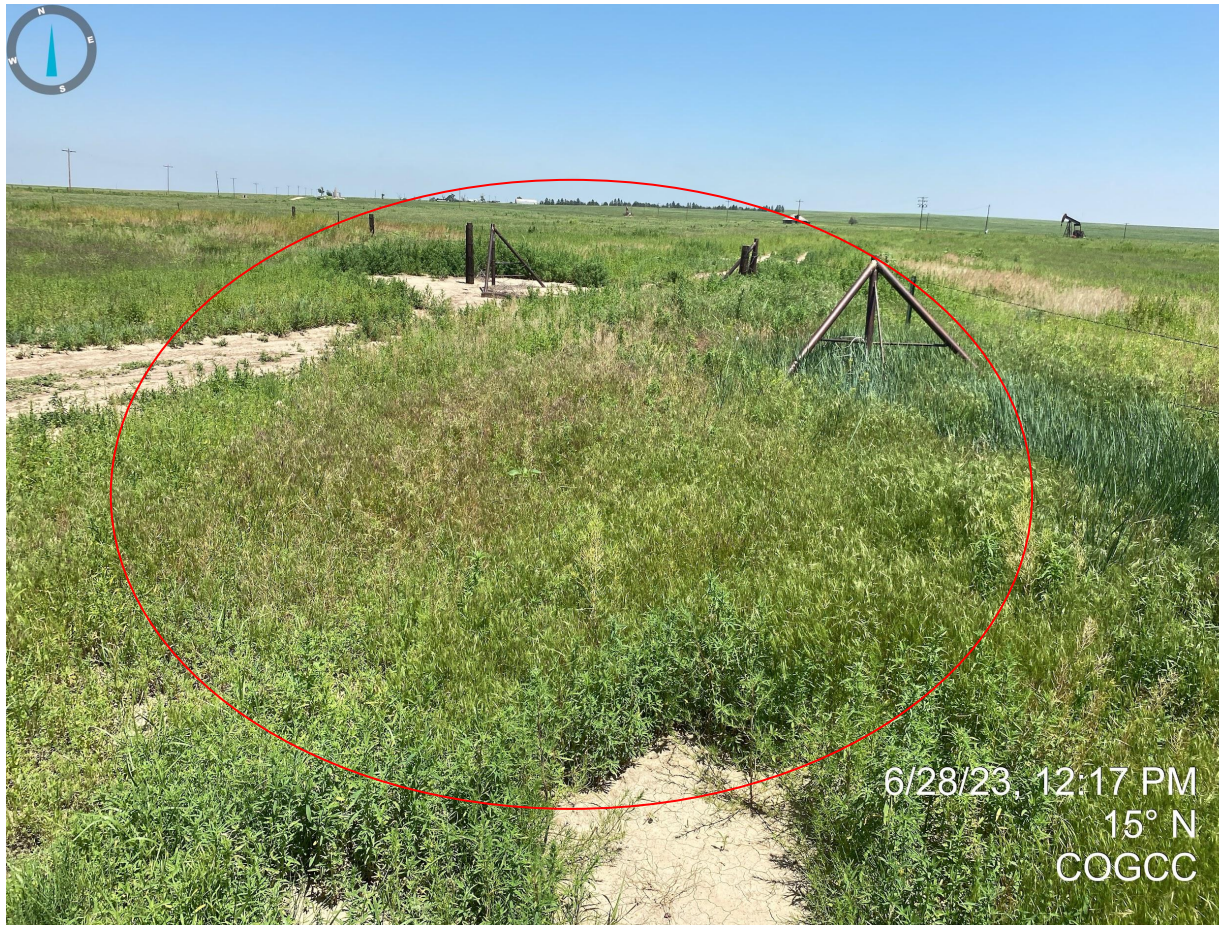
Photo 13. Undesirable vegetation within the production areas will require management during this growing season; cheatgrass infestation pictured.

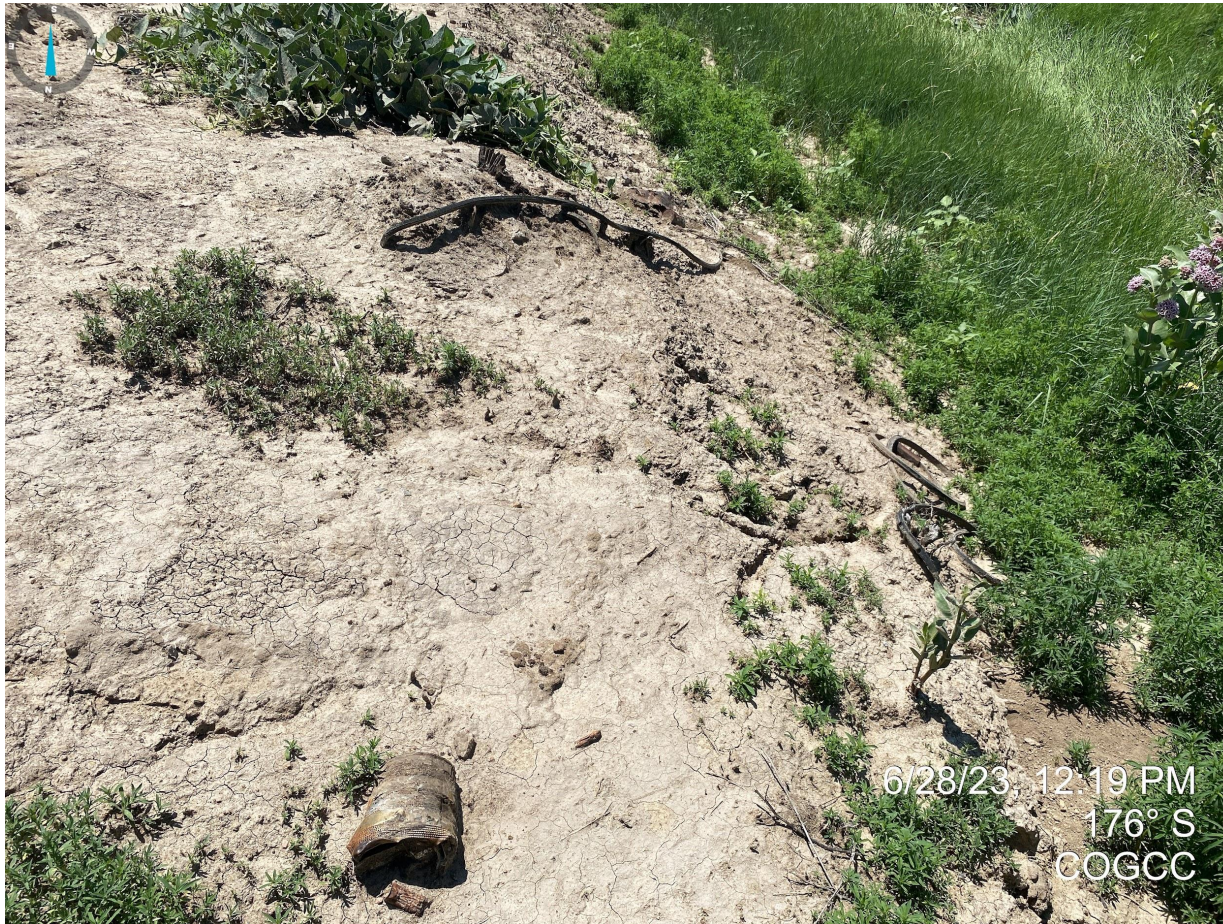
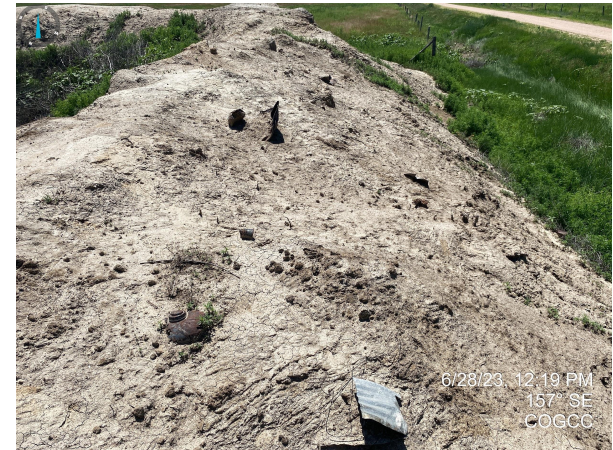
Photo 14. Debris within pit walls/berms will need to be removed and disposed of.

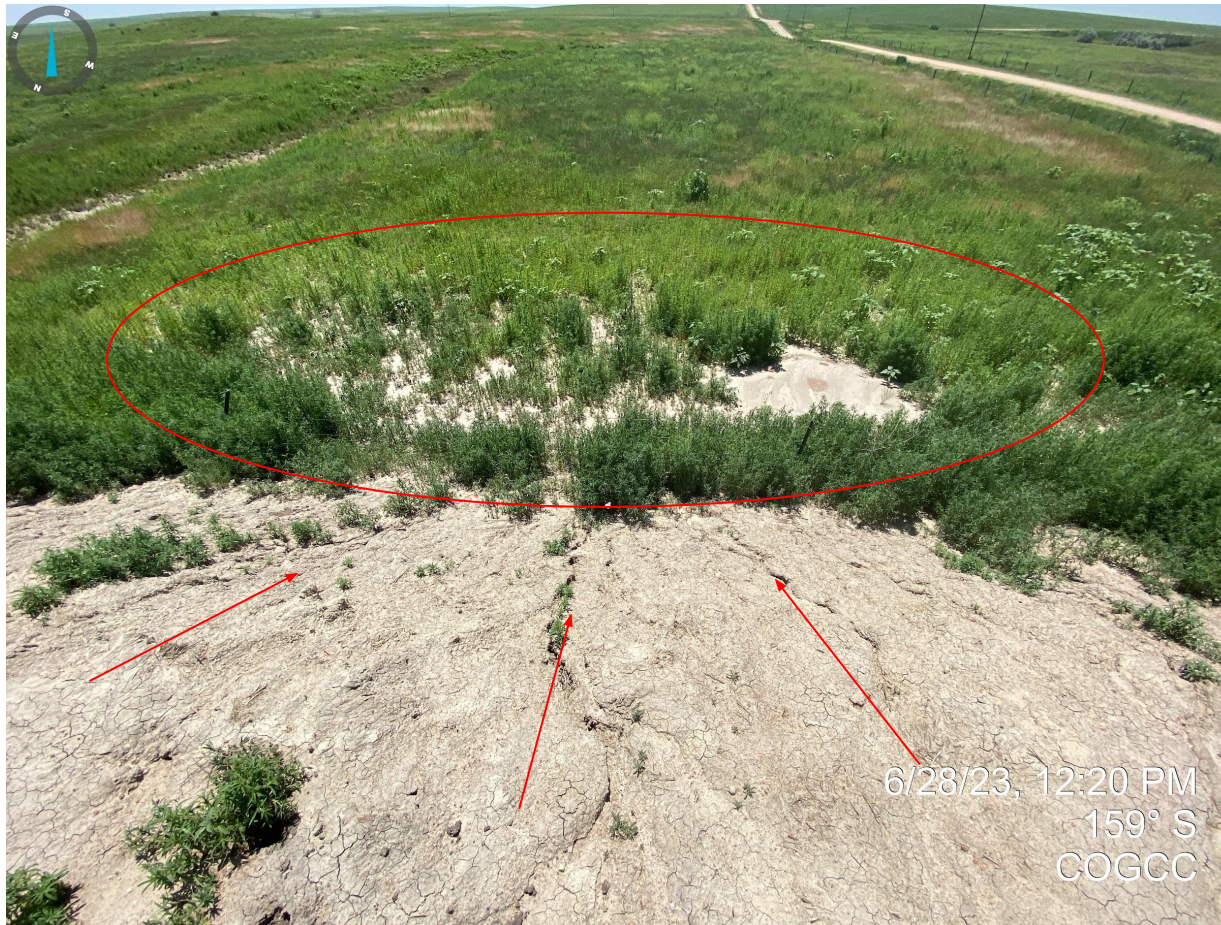
Photo 15. Southern pit wall. Evidence of rilling erosion and off-location sediment transport observed. Additional BMPs are required to stabilize the soils.

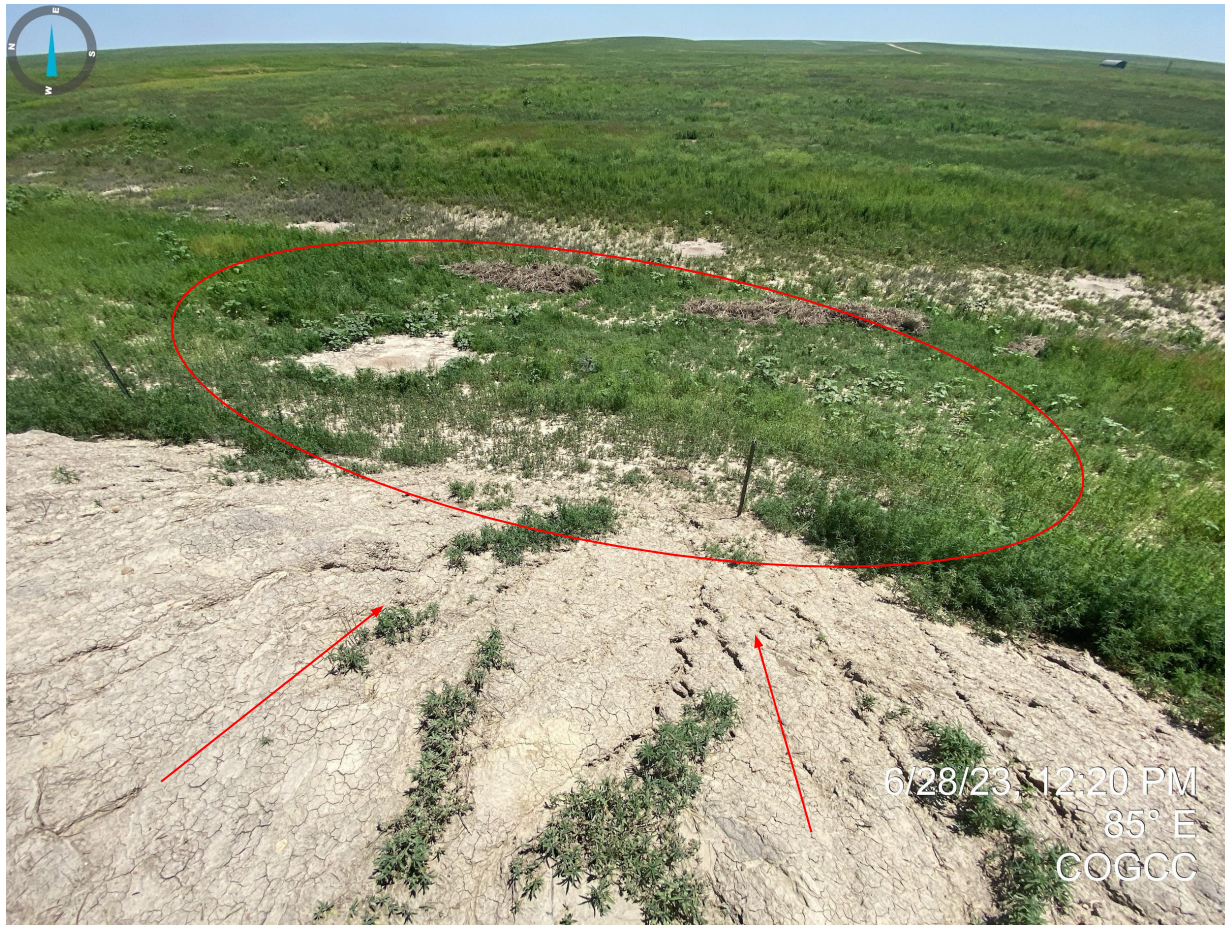
Photo 16. Eastern pit wall; see comments in Photo 15.

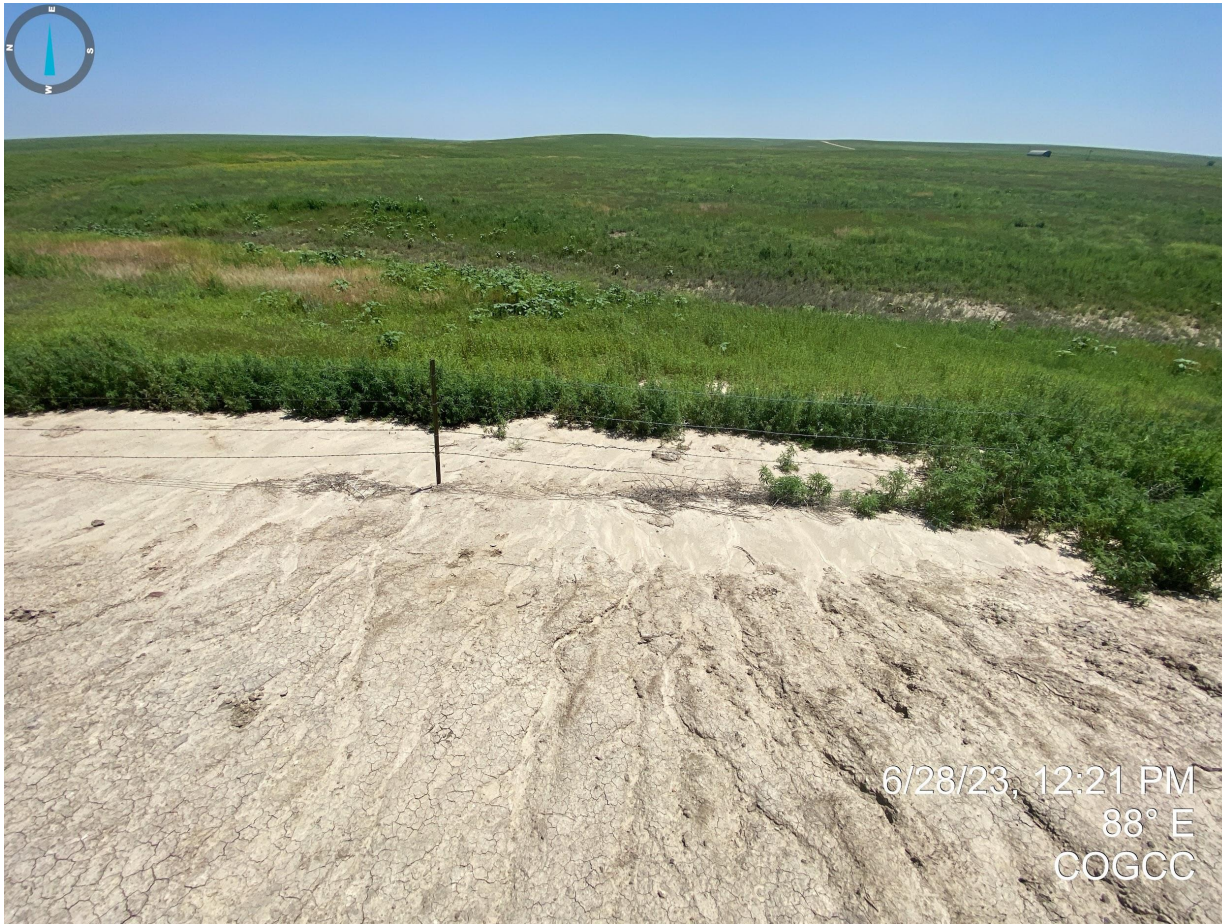
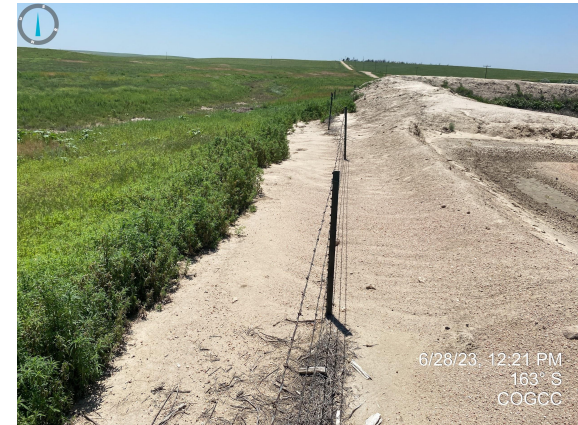
Photo 17. North and east of pit; see comments in Photo 15.
