Inspection Photos
Location Name: CAERUS PICEANCE LLC K17E Pad
Location #: 334791

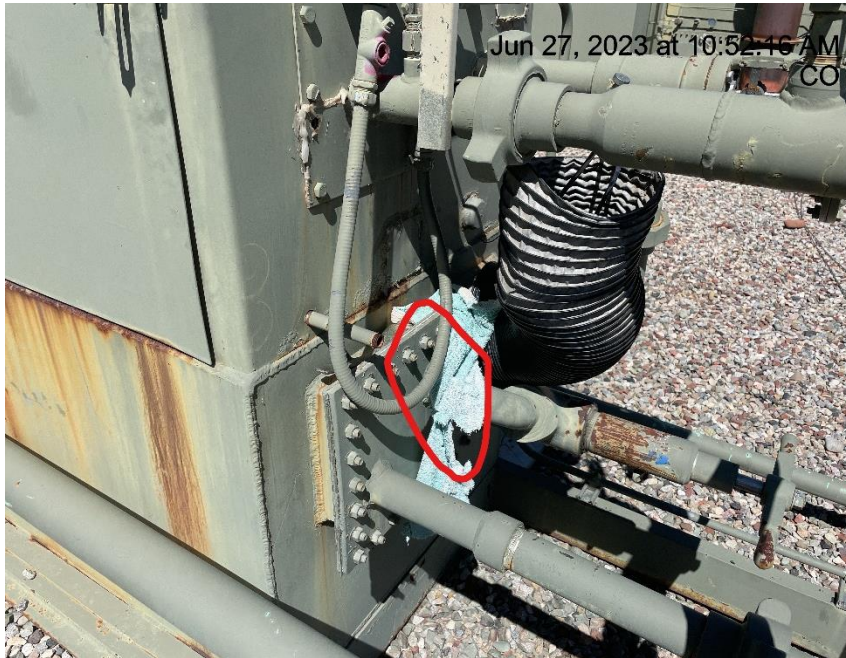
Photo # 2053 Debris

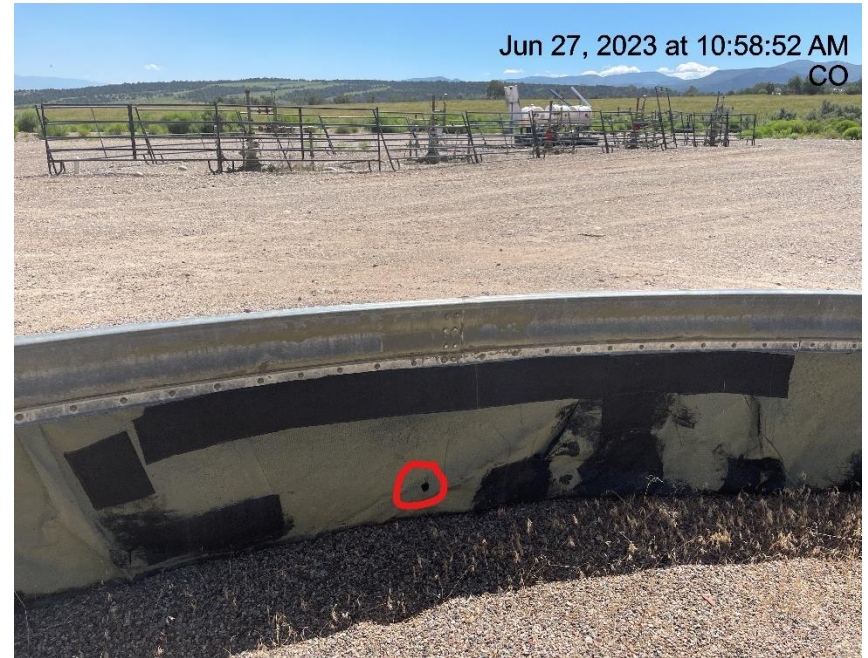
Photo # 2066 Hole in liner/liner needs maintenance

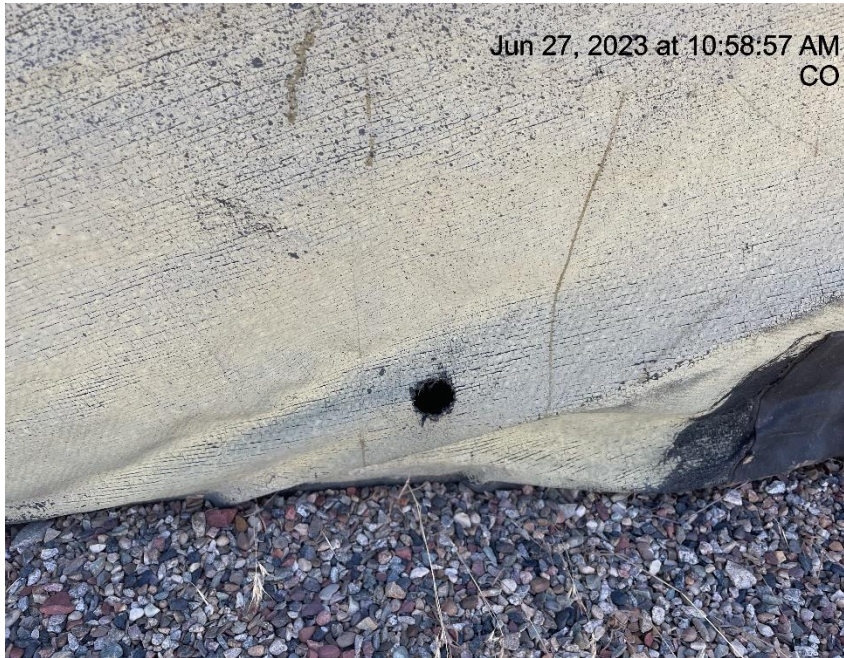
Photo # 2067 Hole in liner/liner needs maintenance

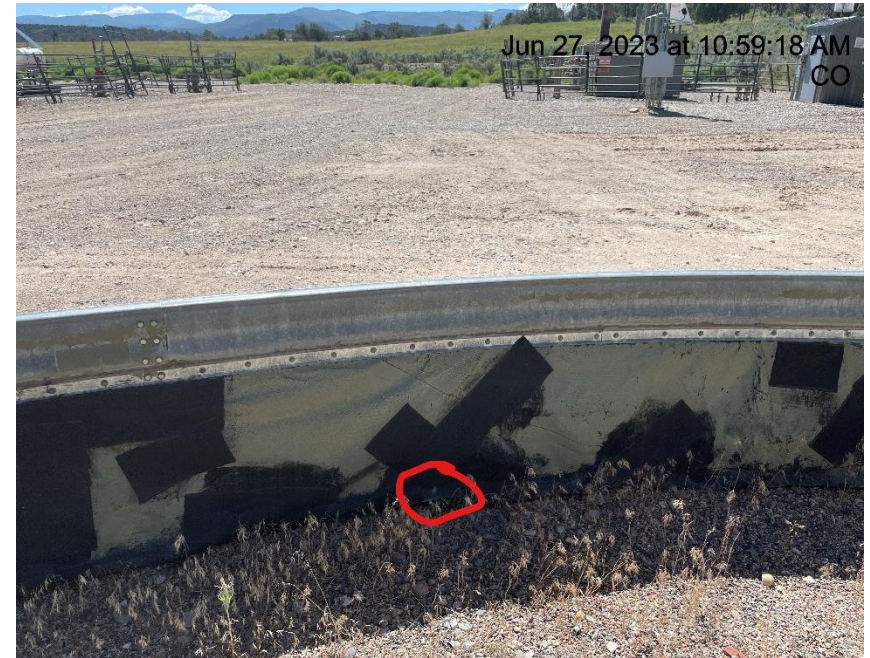
Photo # 2068 Hole in liner/liner needs maintenance

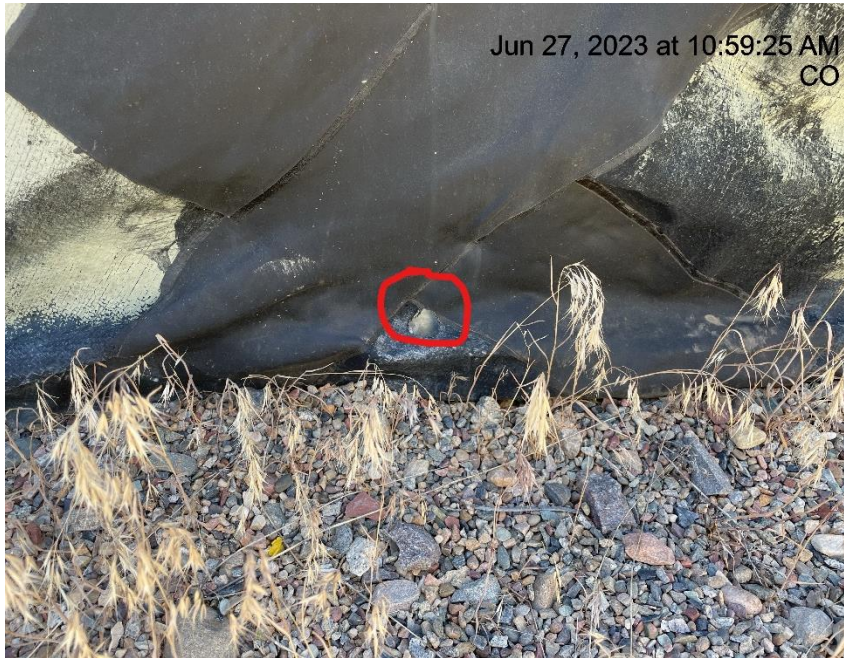
Photo # 2069 Hole in liner/liner needs maintenance

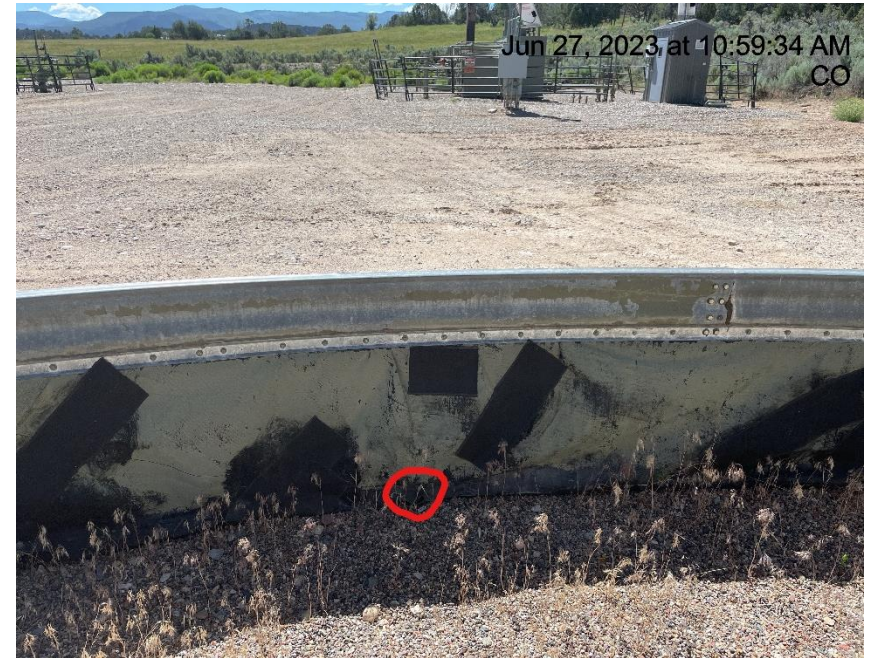
Photo # 2070 Hole in liner/liner needs maintenance

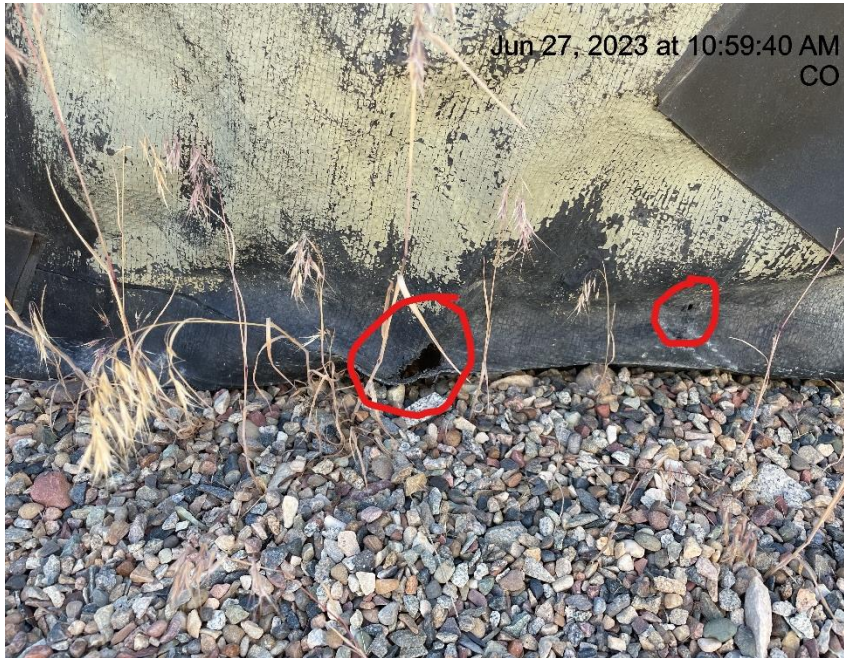
Photo # 2071 Hole in liner/liner needs maintenance

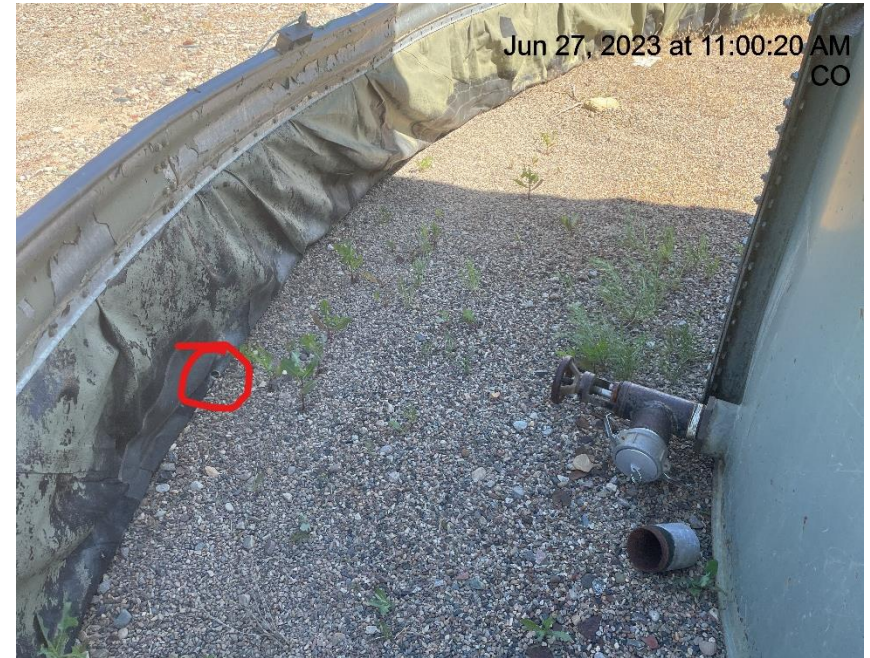
Photo # 2072 Hole in liner/liner needs maintenance

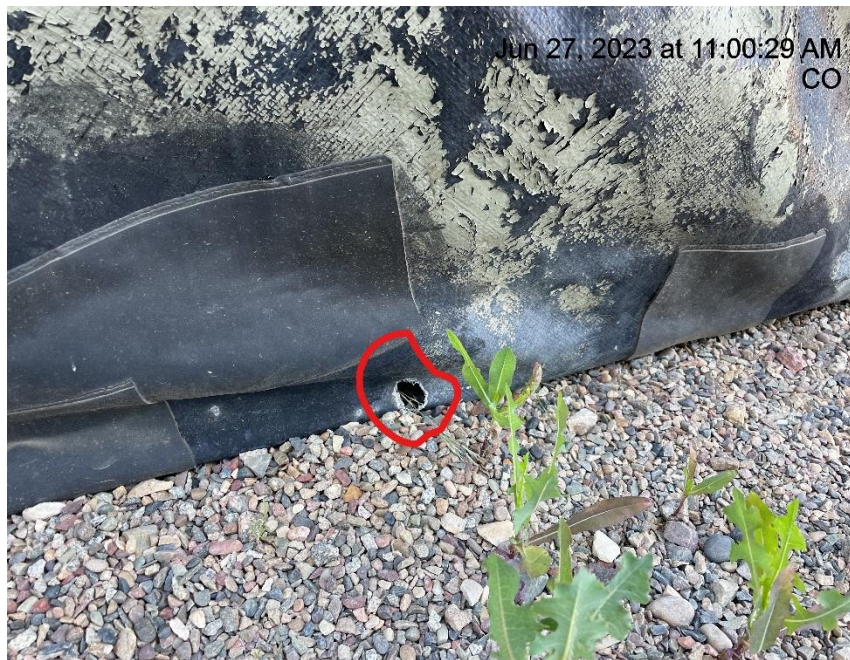
Photo # 2073 Hole in liner/liner needs maintenance

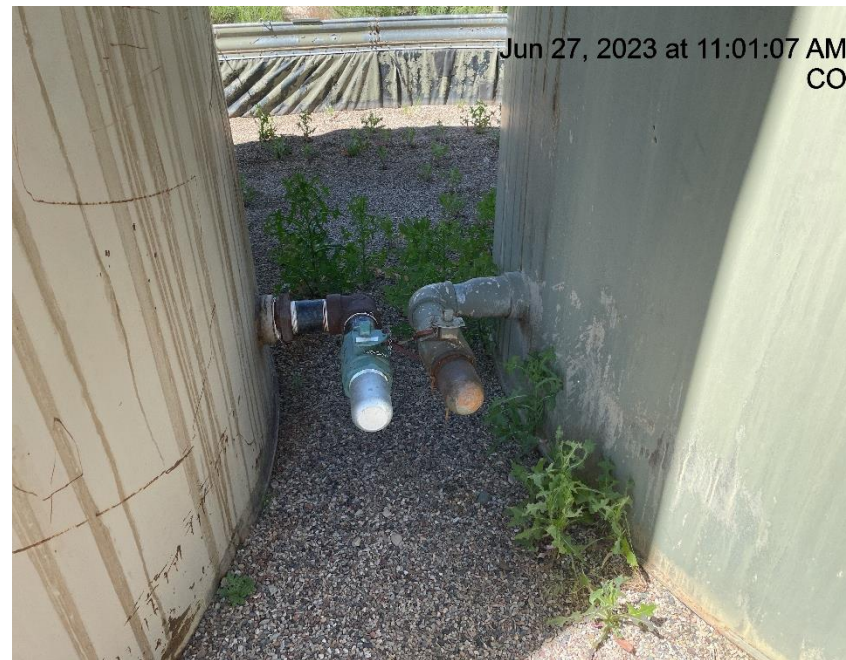
Photo # 2074 Weeds/undesirable plant species

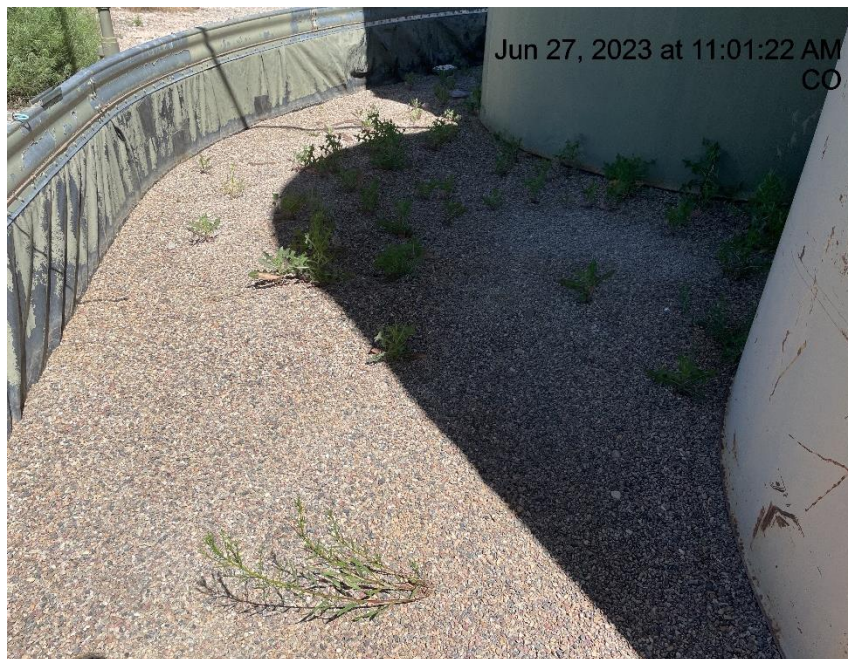
Photo # 2075 Weeds/undesirable plant species

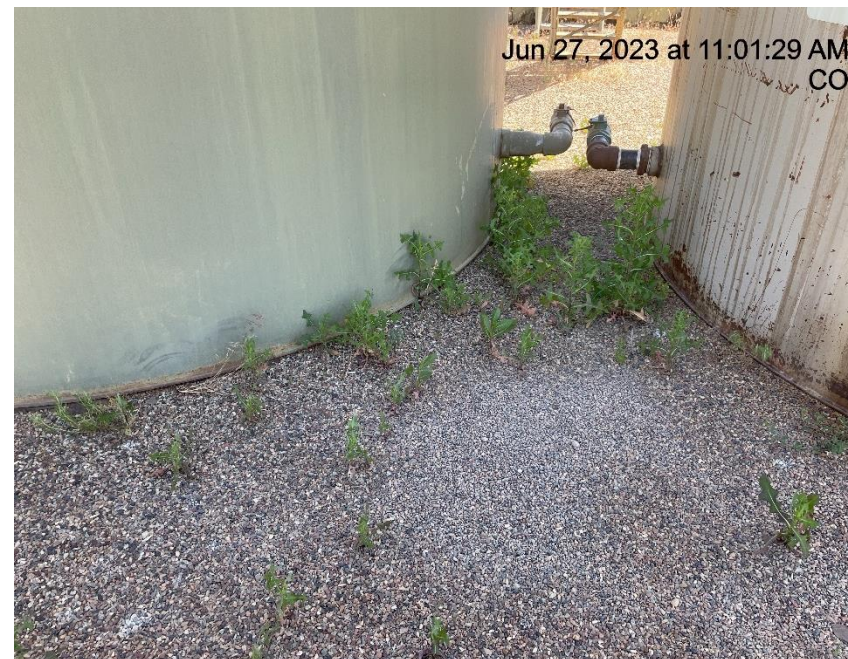
Photo # 2076 Weeds/undesirable plant species

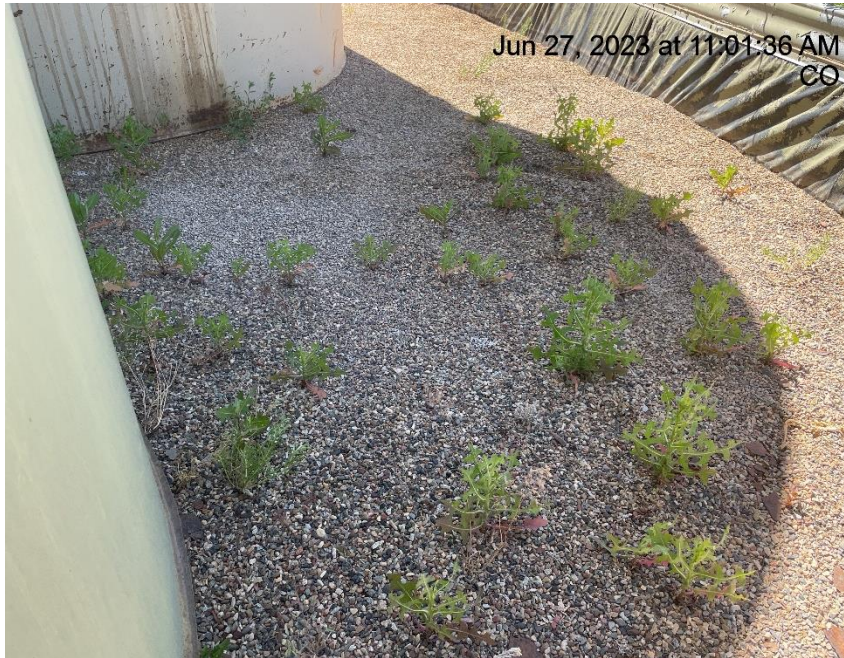
Photo # 2077 Weeds/undesirable plant species

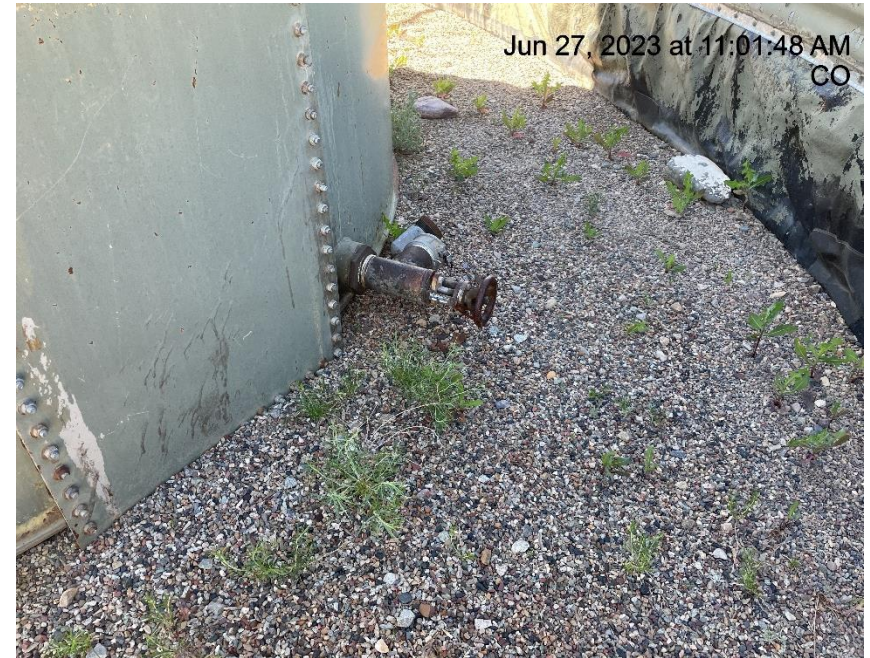
Photo # 2078 Weeds/undesirable plant species
