Inspection Photos
Location Name: CAERUS PICEANCE LLC N17E Pad
Location #: 334783

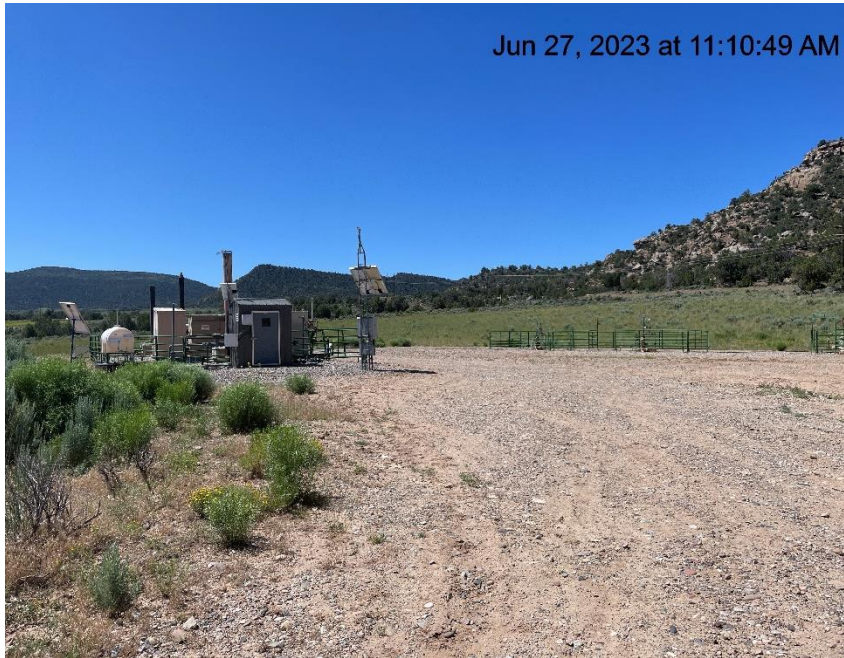
Photo # 2087 From entrance to location

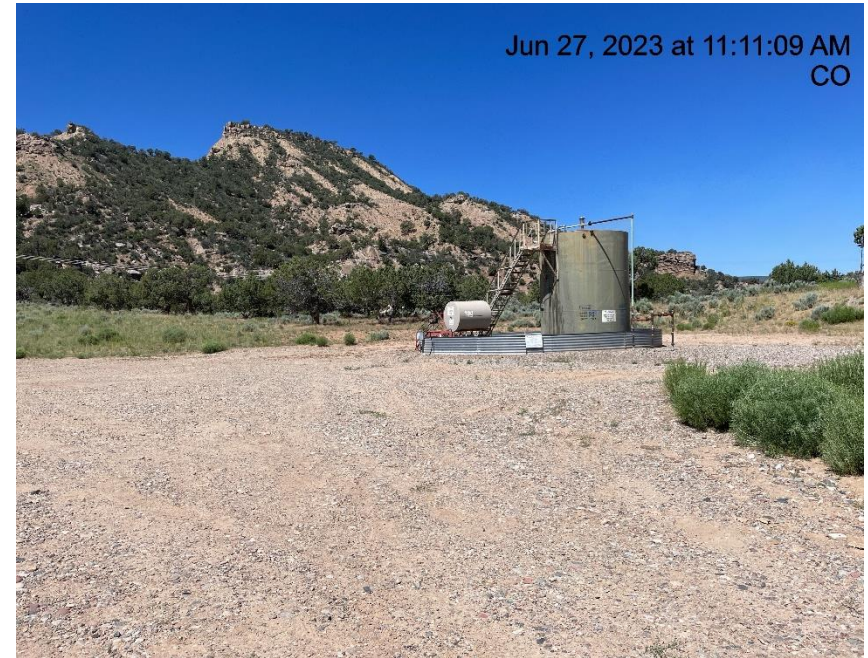
Photo # 2088 From entrance to location

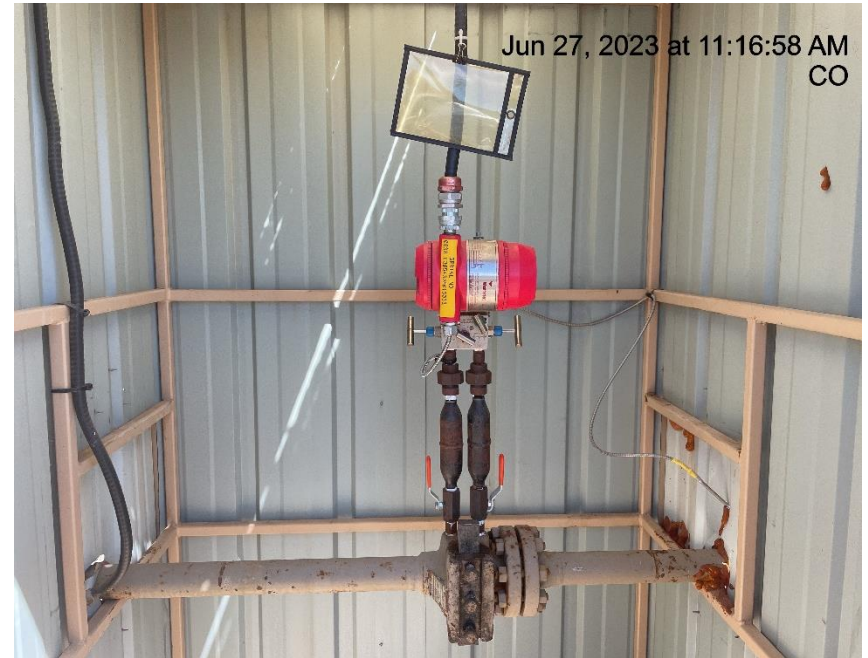
**Photo # 2093 COUEY 17-14 well missing calibration
info/Meter calibration info not conspicuously posted**

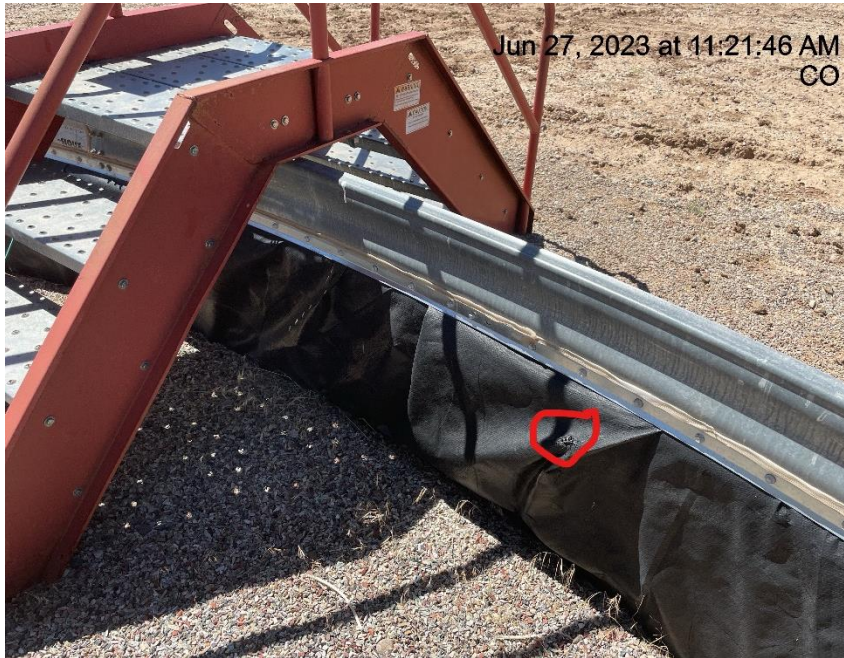
Photo # 2101 Hole in liner/liner needs maintenance

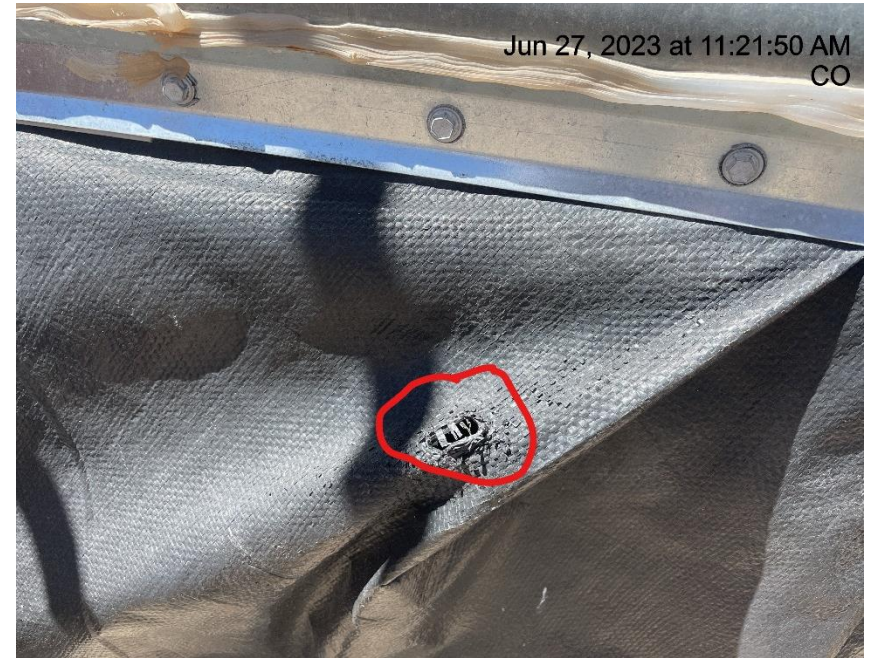
Photo # 2102 Hole in liner/liner needs maintenance

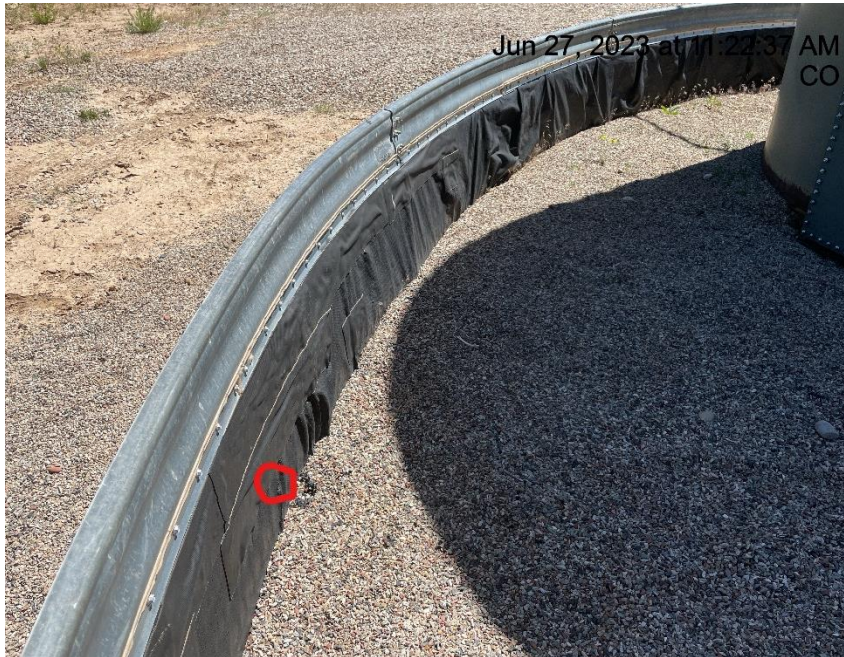
Photo # 2103 Hole in liner/liner needs maintenance

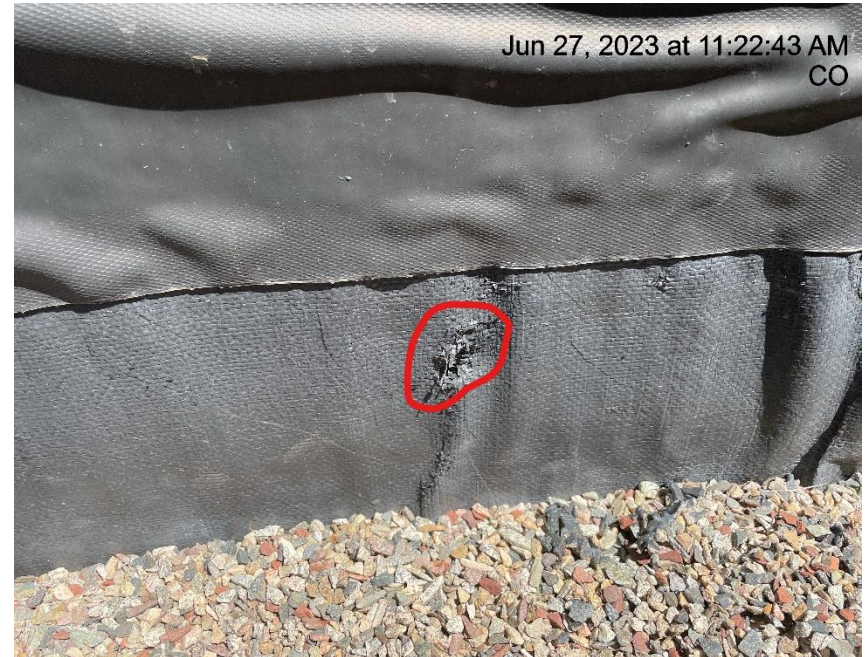
Photo # 2104 Hole in liner/liner needs maintenance

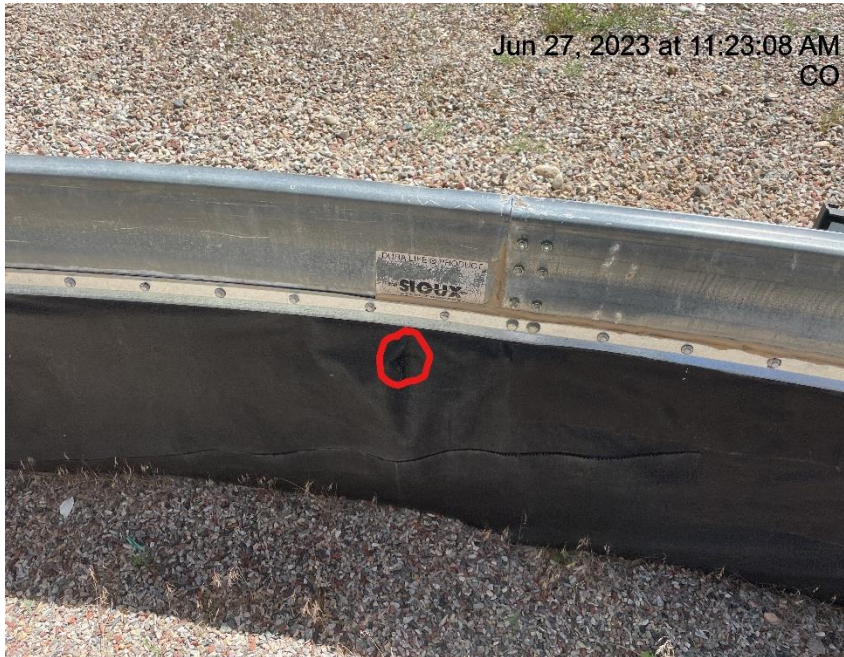
Photo # 2105 Hole in liner/liner needs maintenance

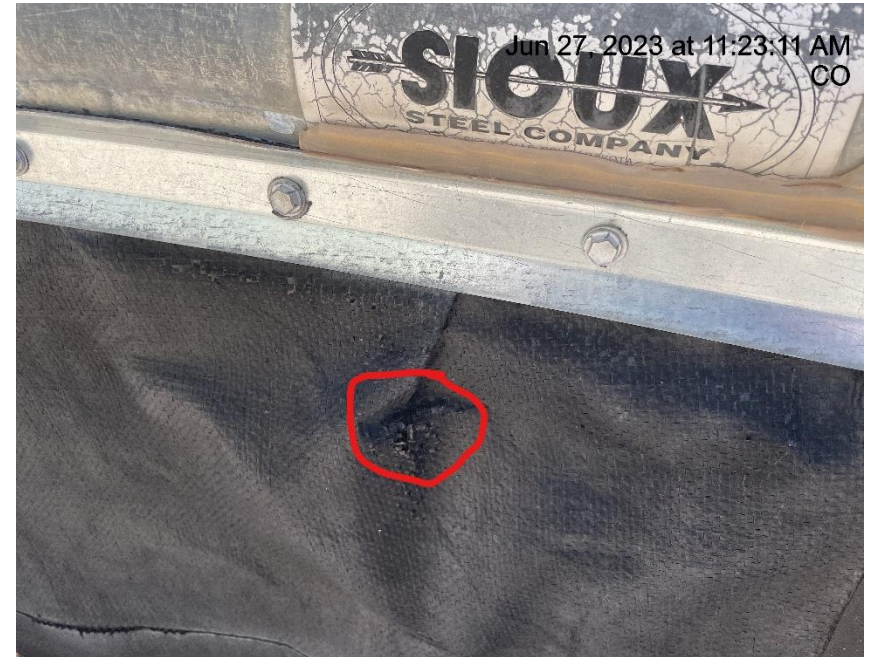
Photo # 2106 Hole in liner/liner needs maintenance
