Inspection Photos
Location Name: CAERUS PICEANCE LLC M34NE Pad
Location #: 334987

COLORADO
Oil & Gas Conservation
Commission
Department of Natural Resources

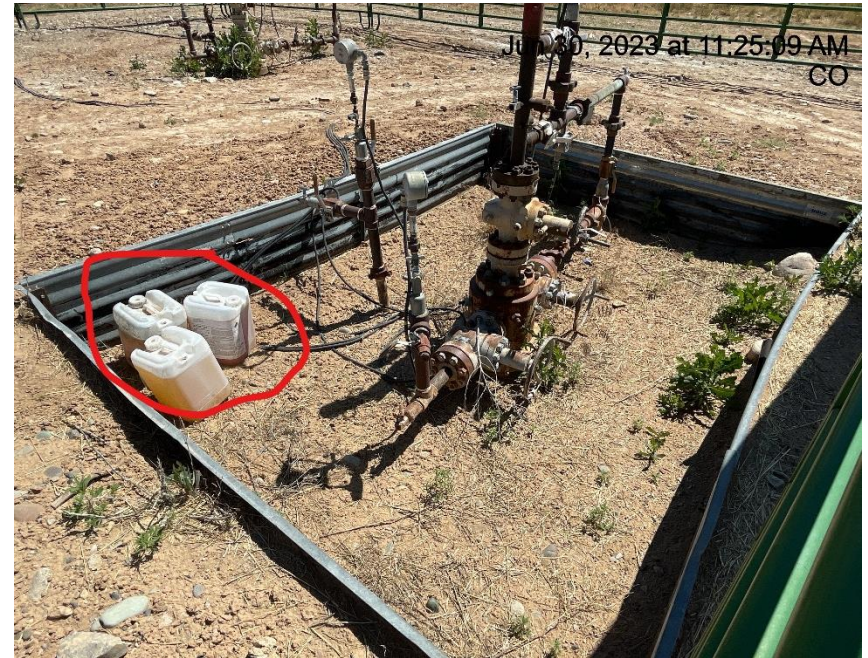
Photo # 2286 Storage of supplies & cellar lacks wildlife egress

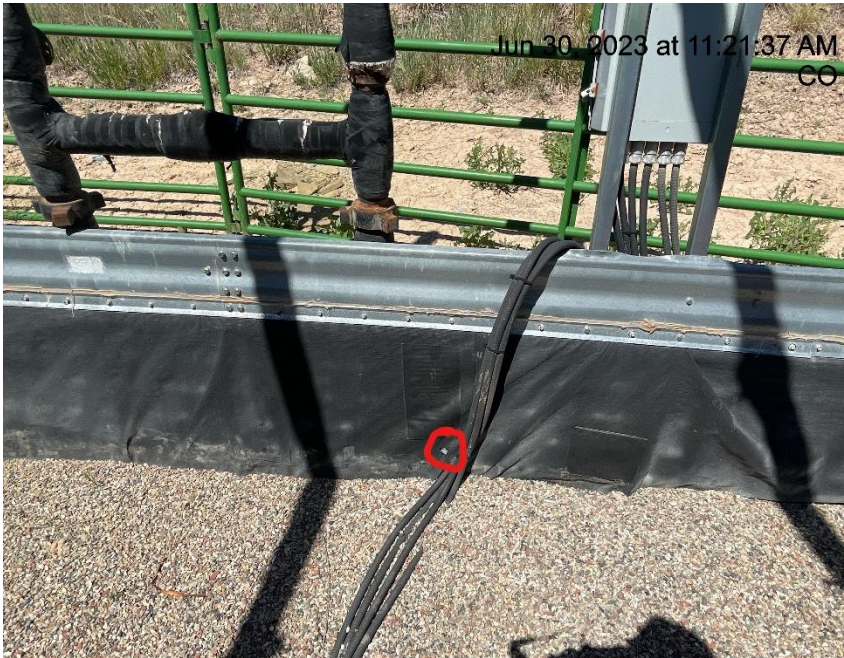
Photo # 2267 Hole in secondary containment liner/liner needs maintenance

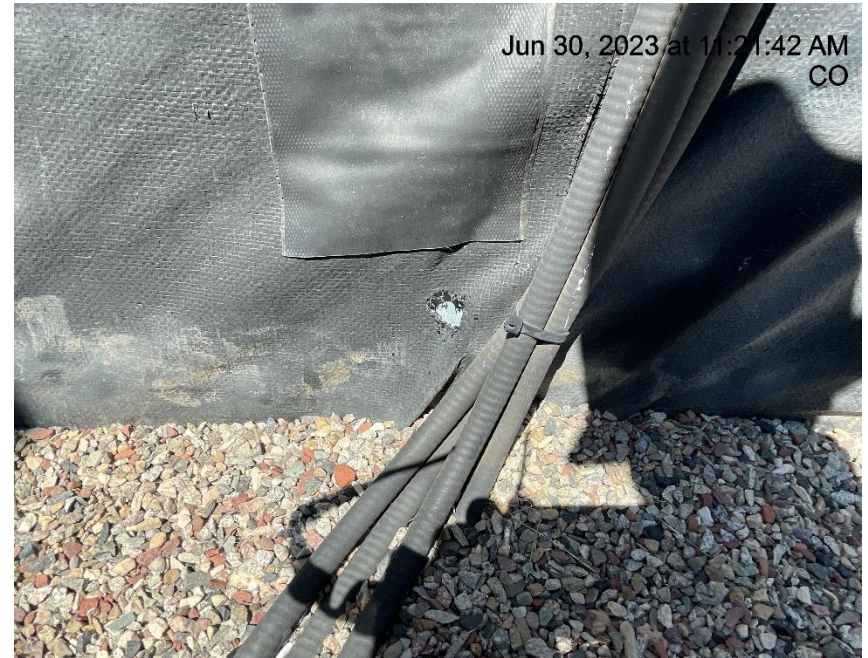
Photo # 2268 Hole in secondary containment liner/liner needs maintenance

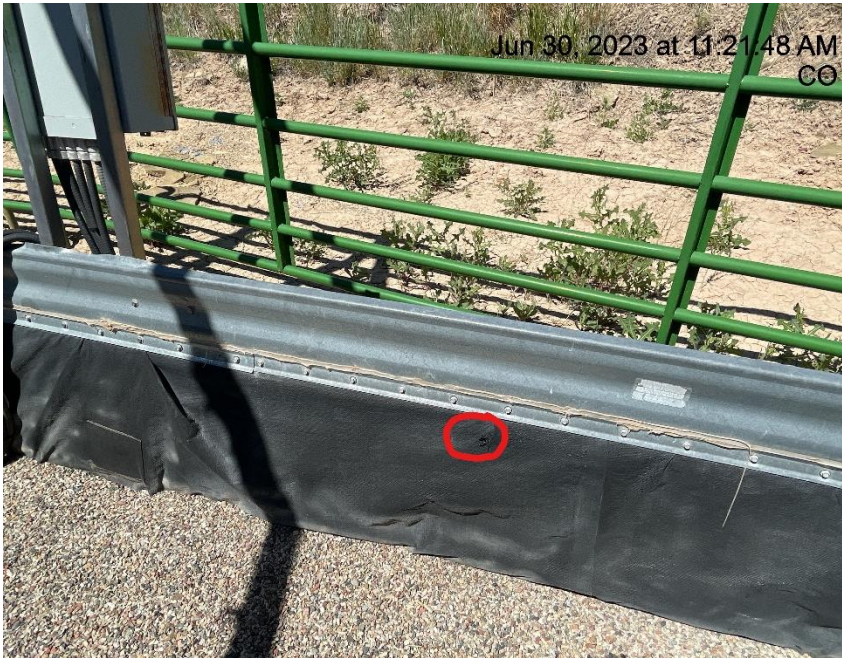
Photo # 2269 Hole in secondary containment liner/liner needs maintenance

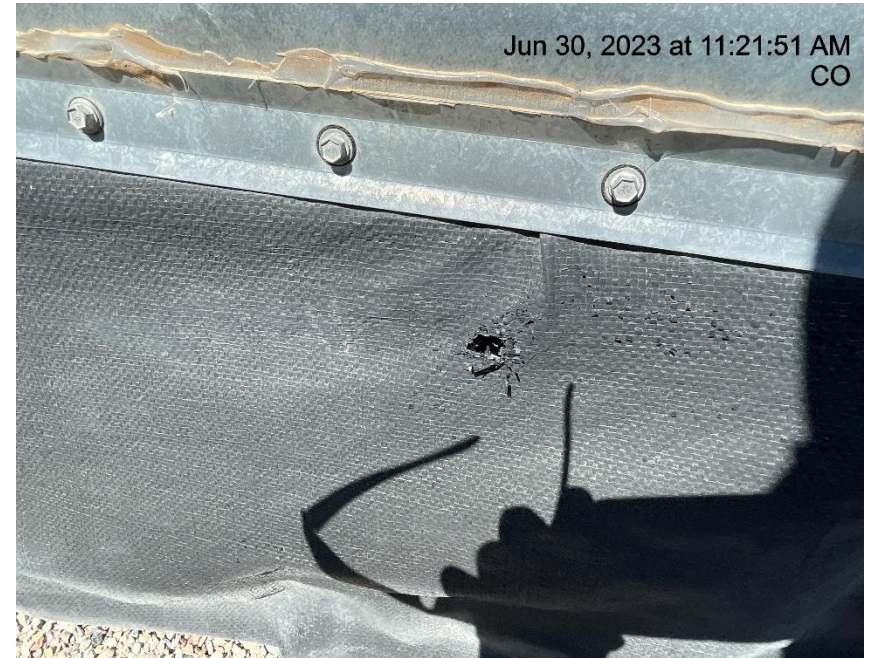
Photo # 2270 Hole in secondary containment liner/liner needs maintenance

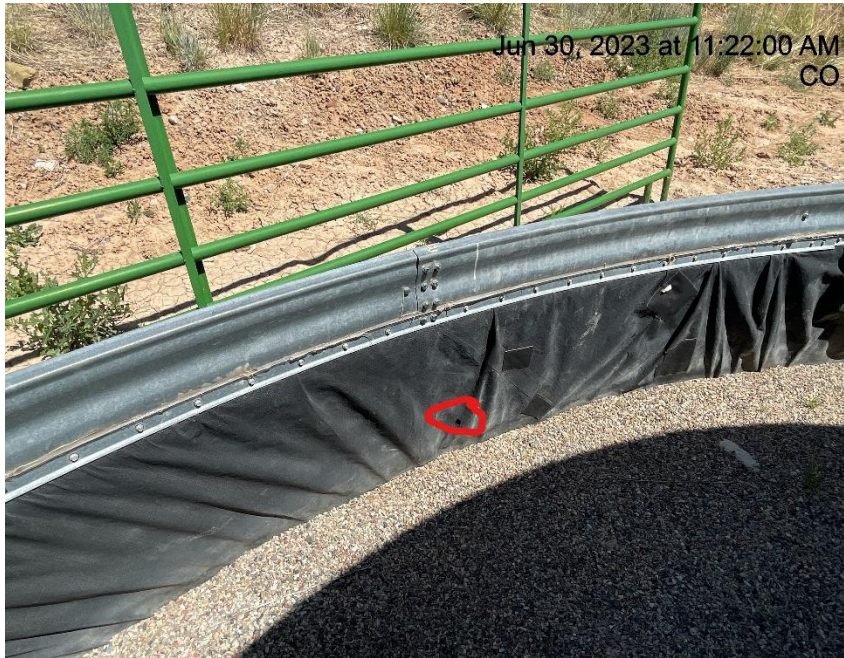
Photo # 2271 Hole in secondary containment liner/liner needs maintenance

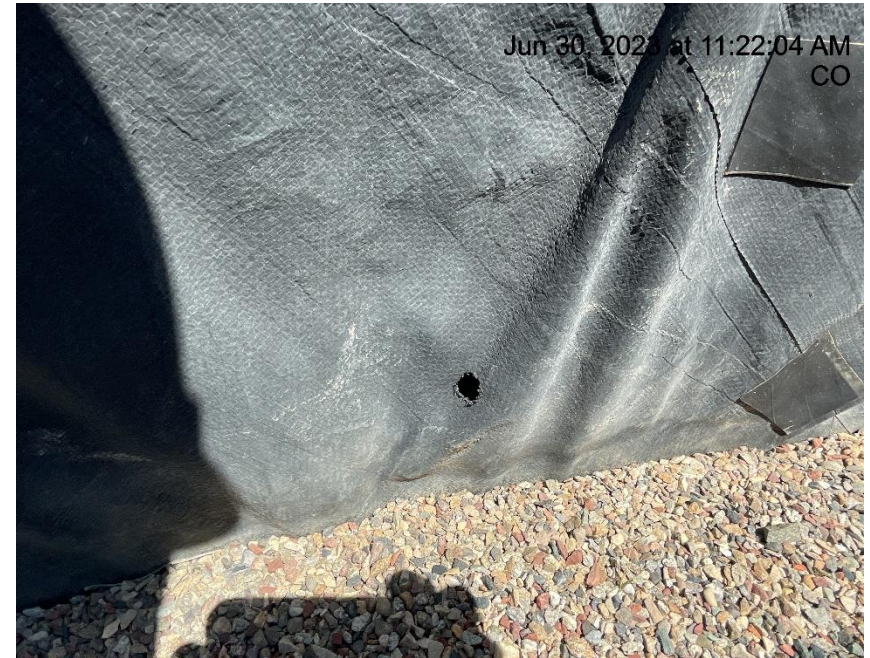
Photo # 2272 Hole in secondary containment liner/liner needs maintenance

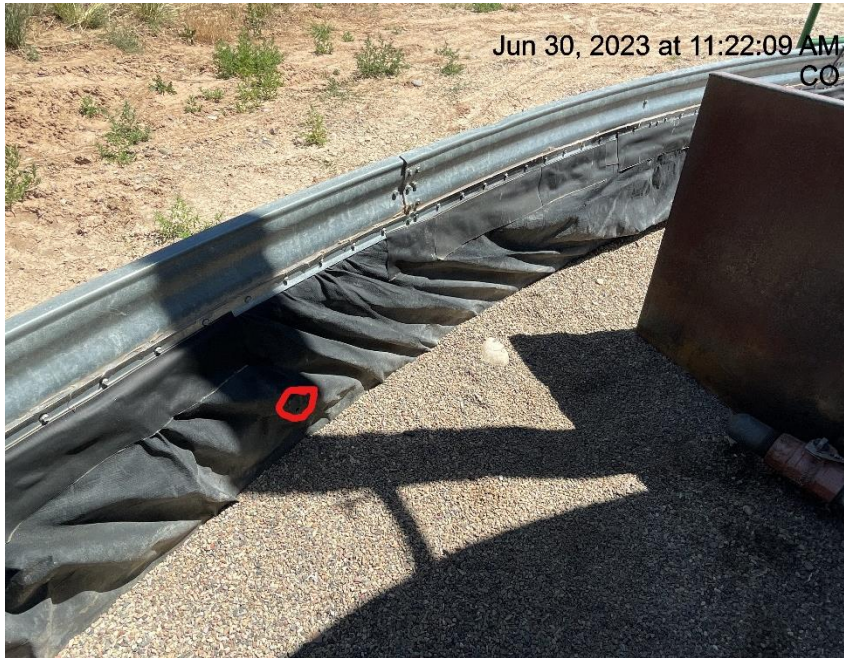
Photo # 2273 Hole in secondary containment liner/liner needs maintenance

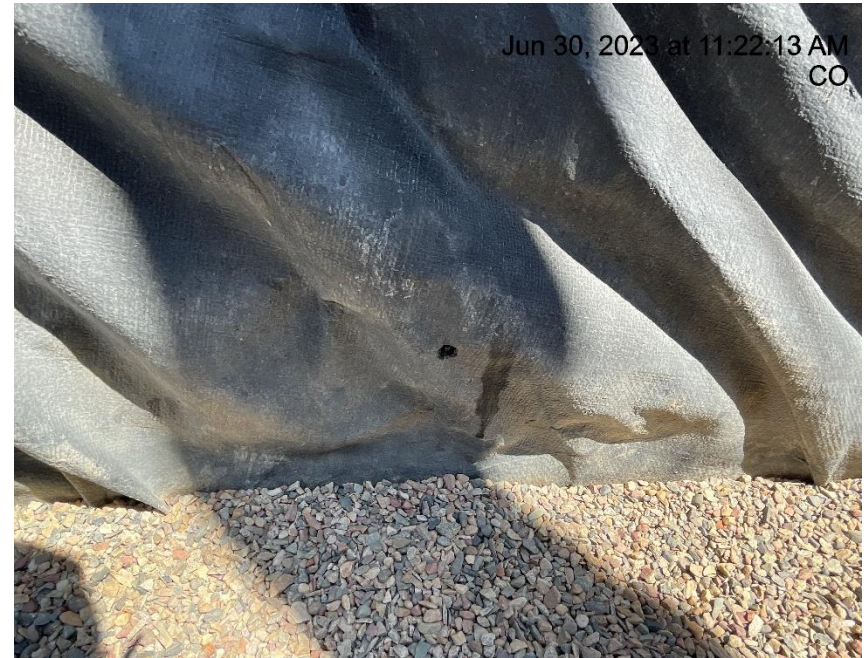
Photo # 2274 Hole in secondary containment liner/liner needs maintenance

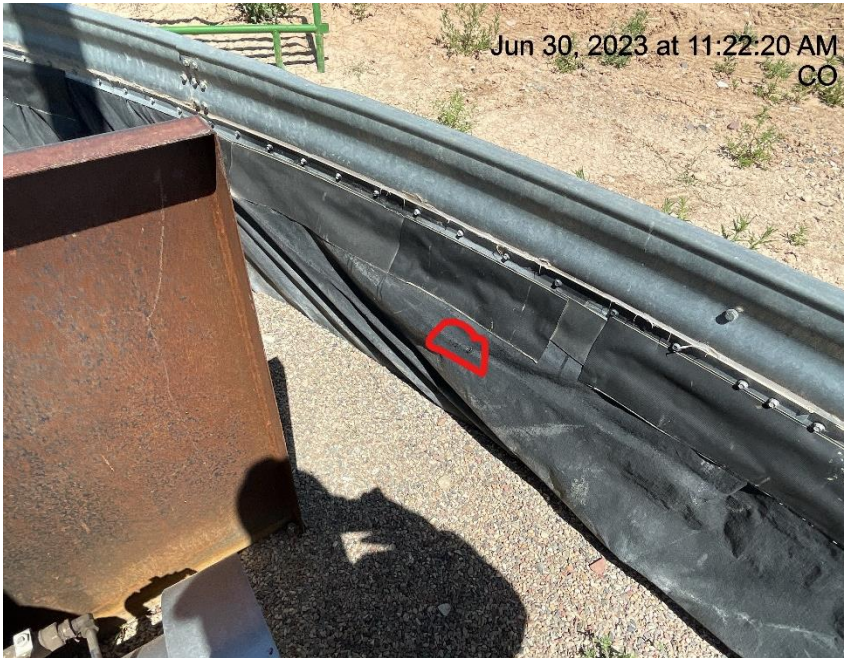
Photo # 2275 Hole in secondary containment liner/liner needs maintenance

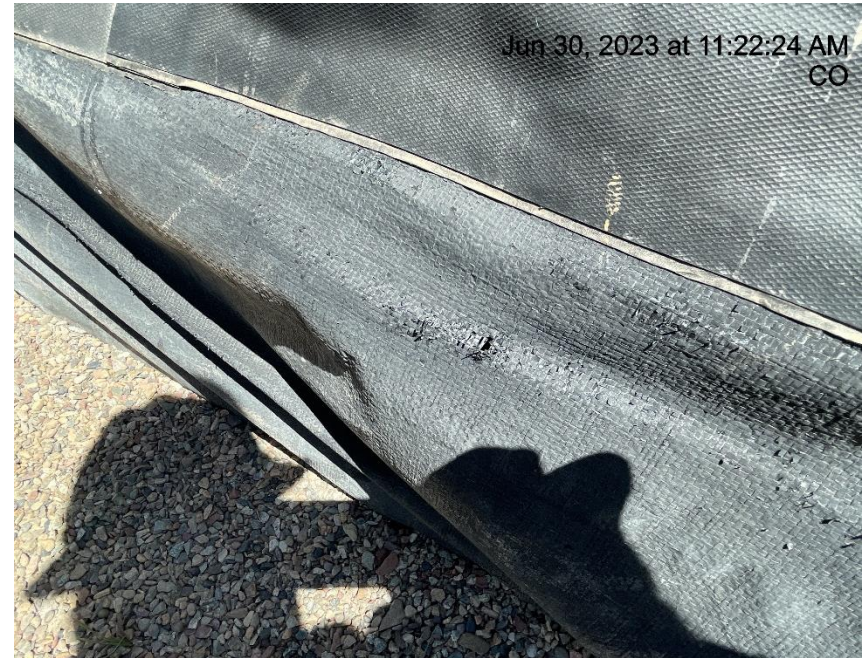
Photo # 2276 Hole in secondary containment liner/liner needs maintenance

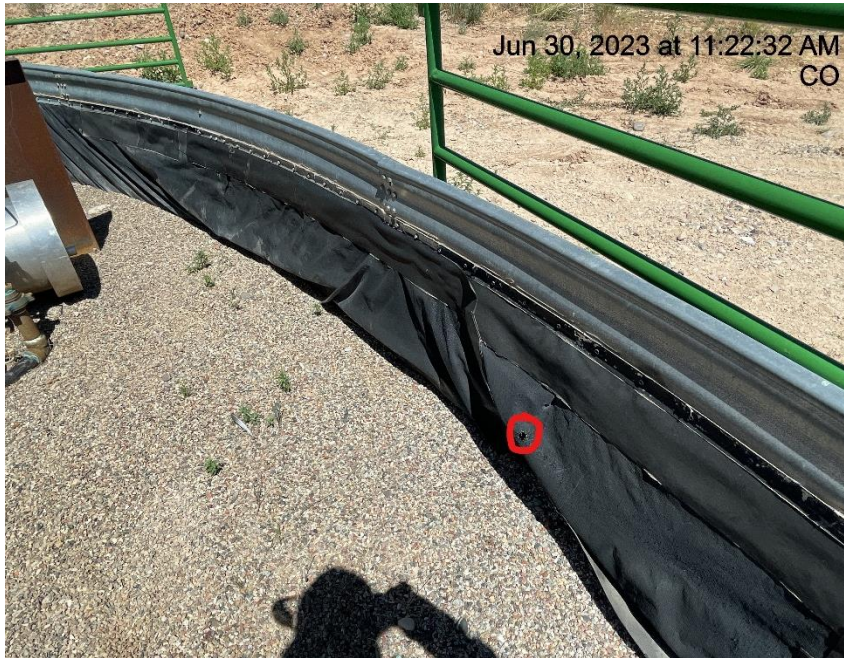
Photo # 2277 Hole in secondary containment liner/liner needs maintenance

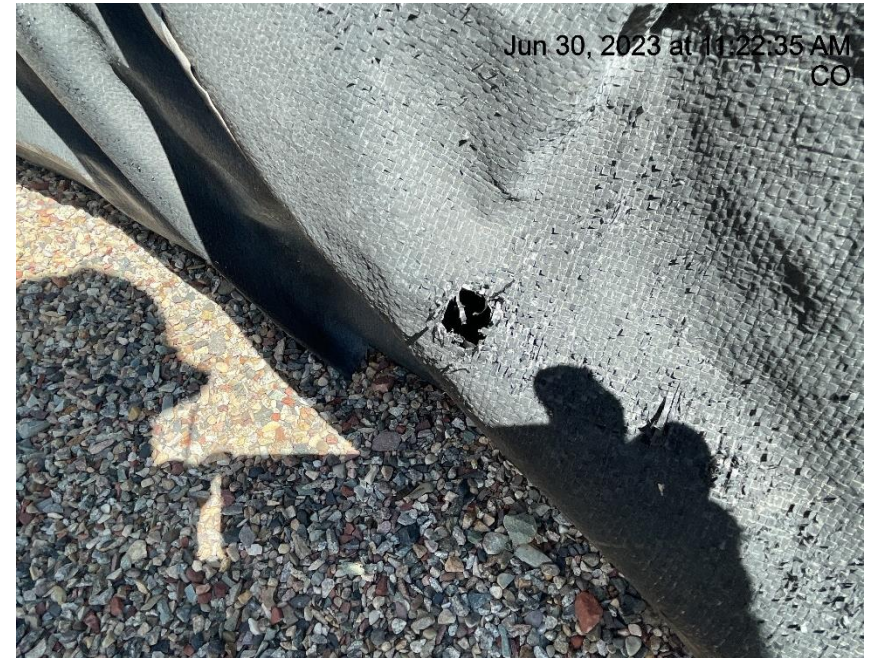
Photo # 2278 Hole in secondary containment liner/liner needs maintenance

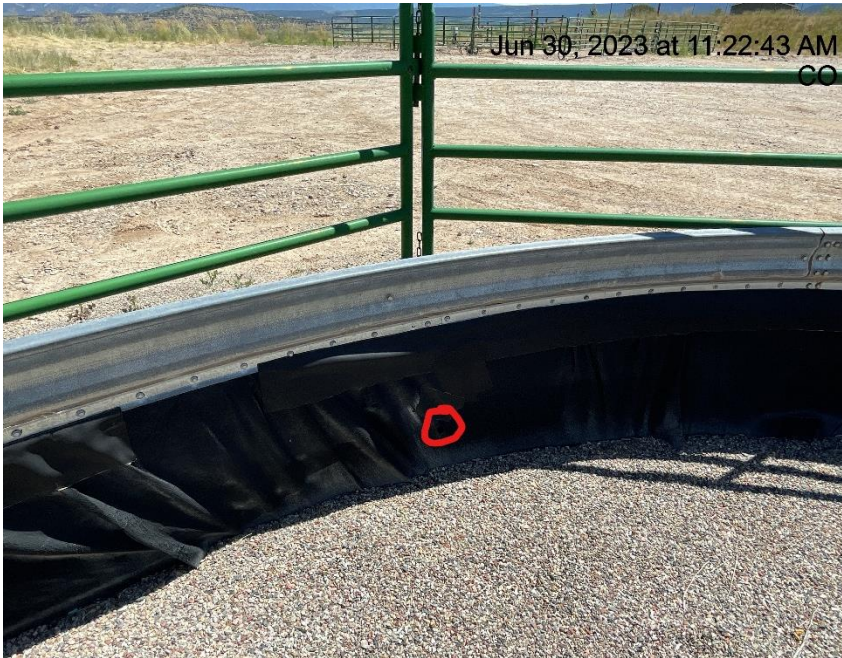
Photo # 2279 Hole in secondary containment liner/liner needs maintenance

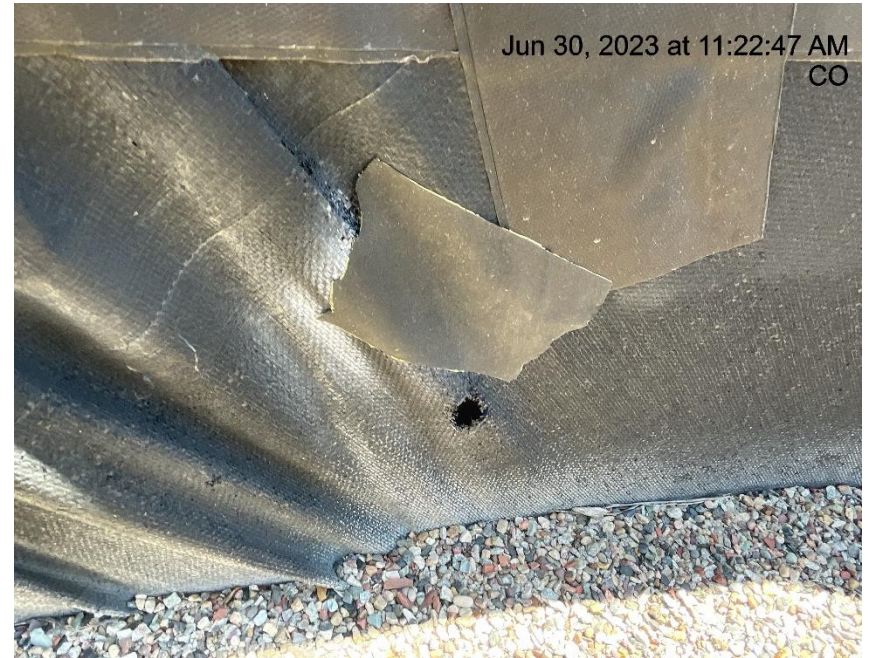
Photo # 2280 Hole in secondary containment liner/liner needs maintenance

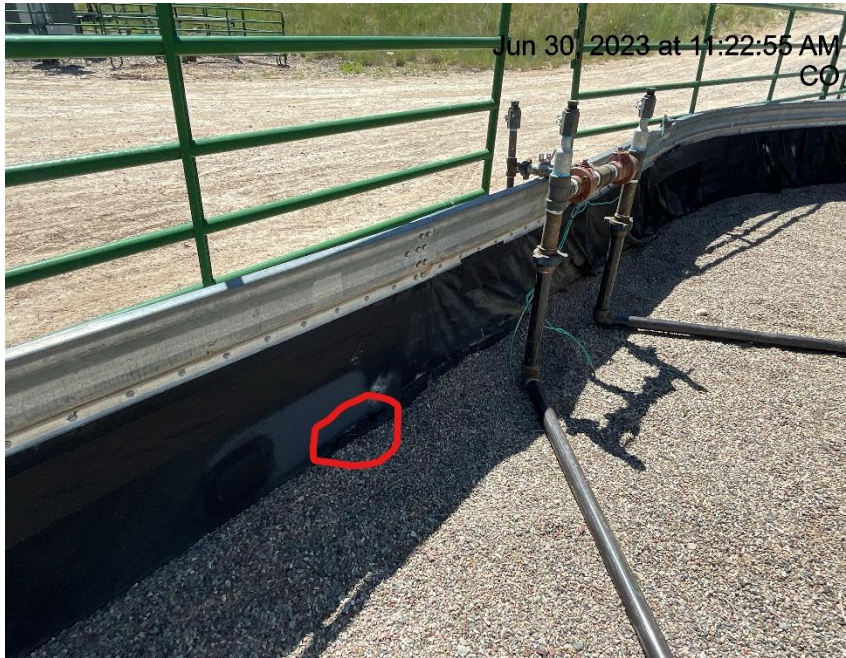
Photo # 2281 Hole in secondary containment liner/liner needs maintenance

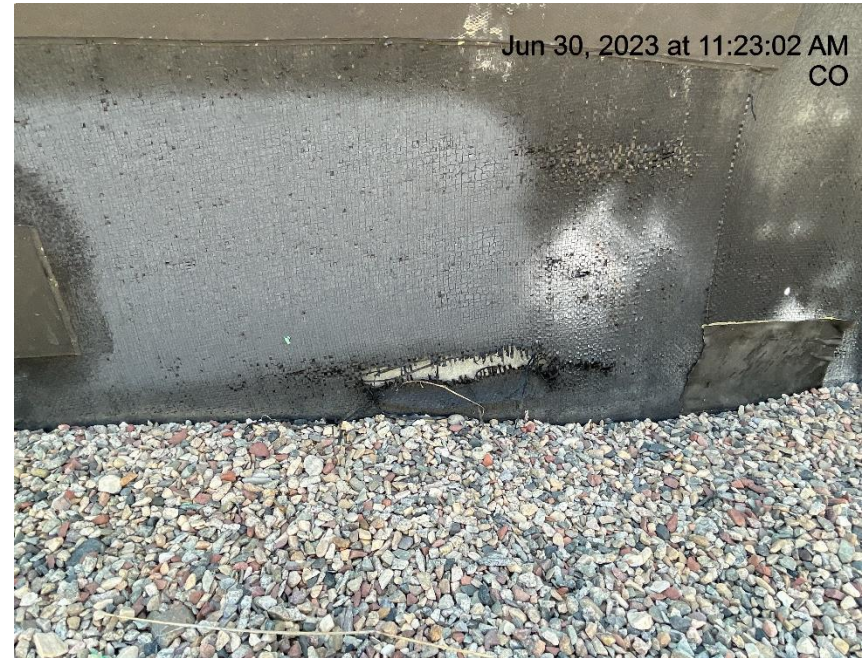
Photo # 2282 Hole in secondary containment liner/liner needs maintenance

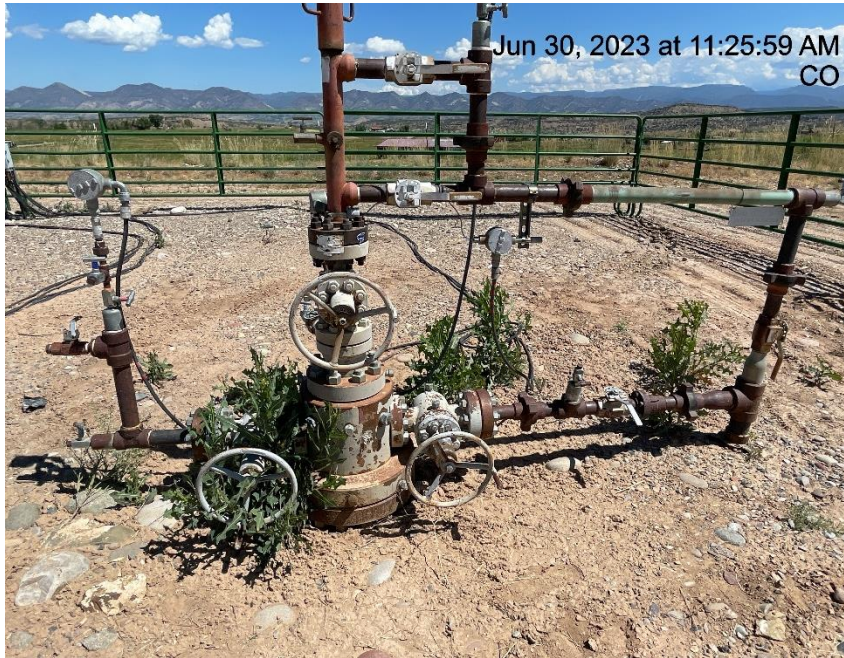
Photo # 2289 Weeds/undesirable plant species

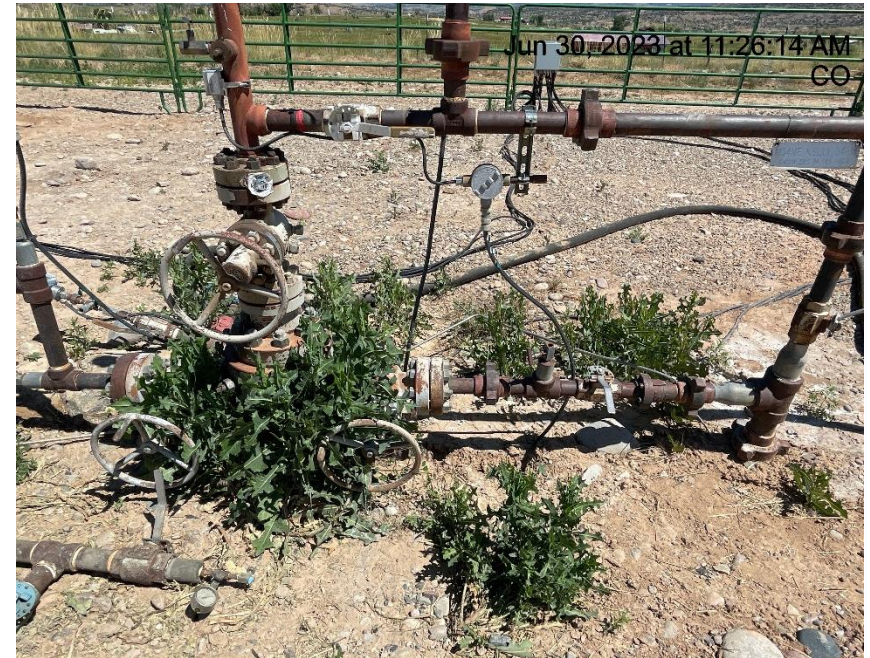
Photo # 2290 Weeds/undesirable plant species

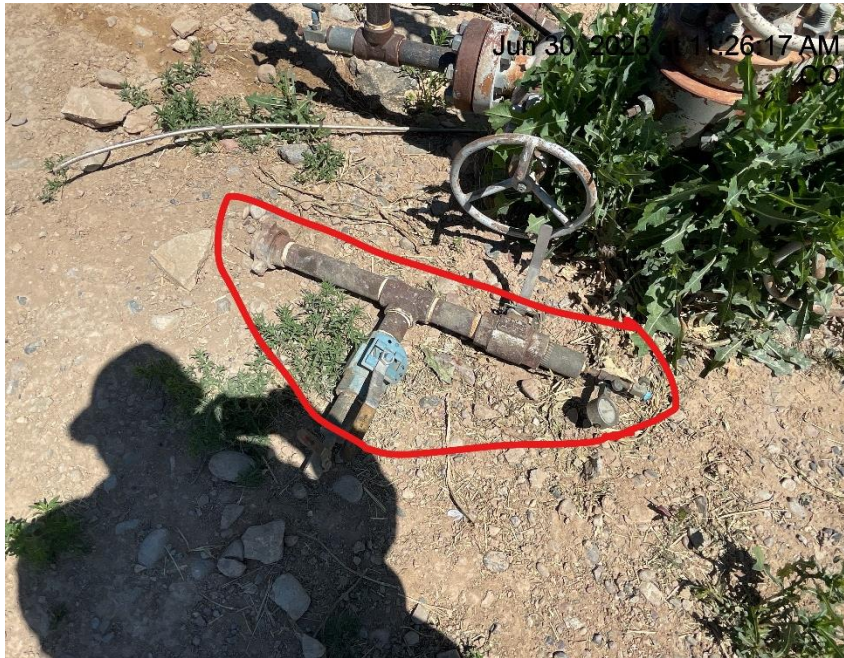
Photo # 2291 Debris & weeds/undesirable plant species

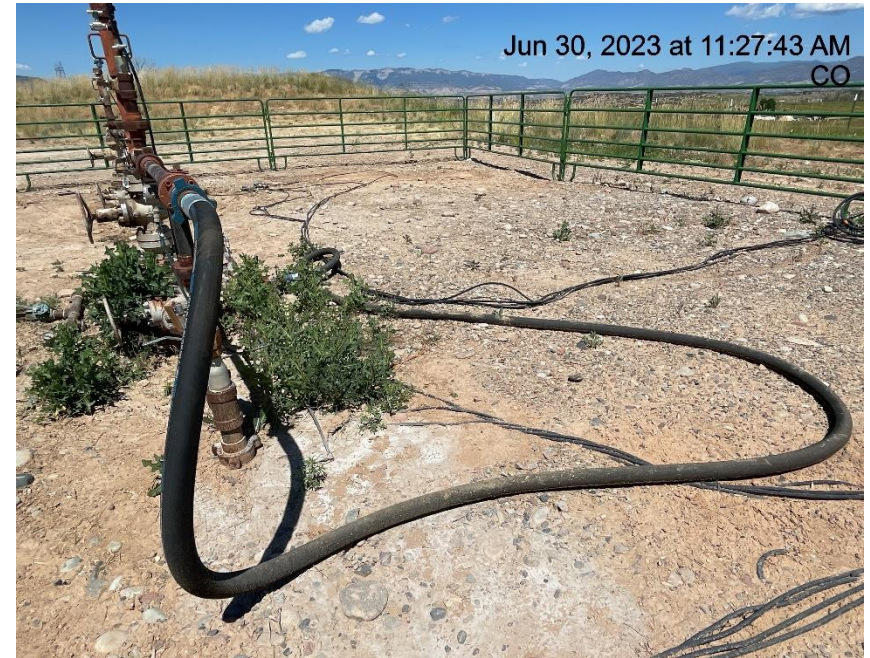
Photo # 2294 Weeds/undesirable plant species

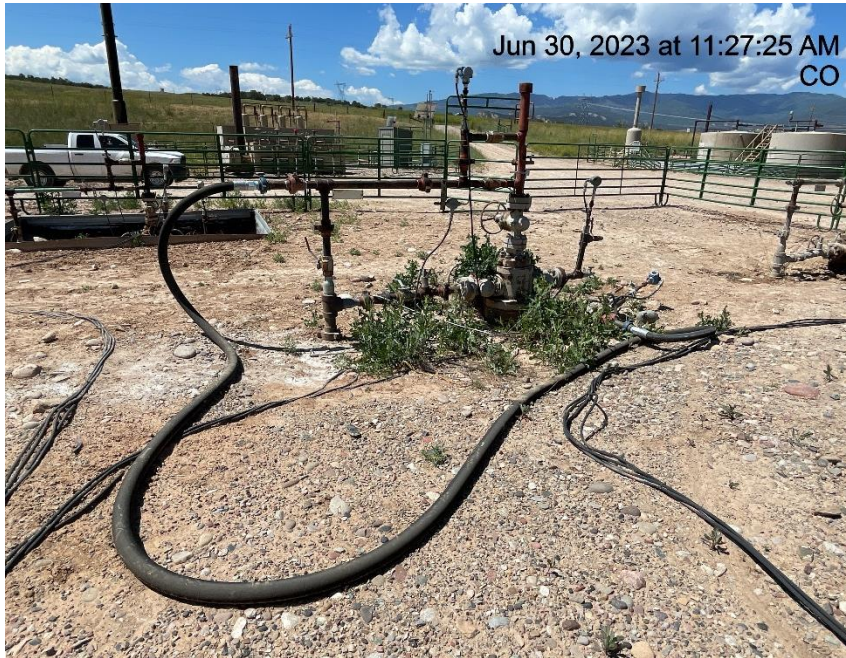
Photo # 2293 KELLY 34-13 well bradenhead connected to flowline, no check valve visible

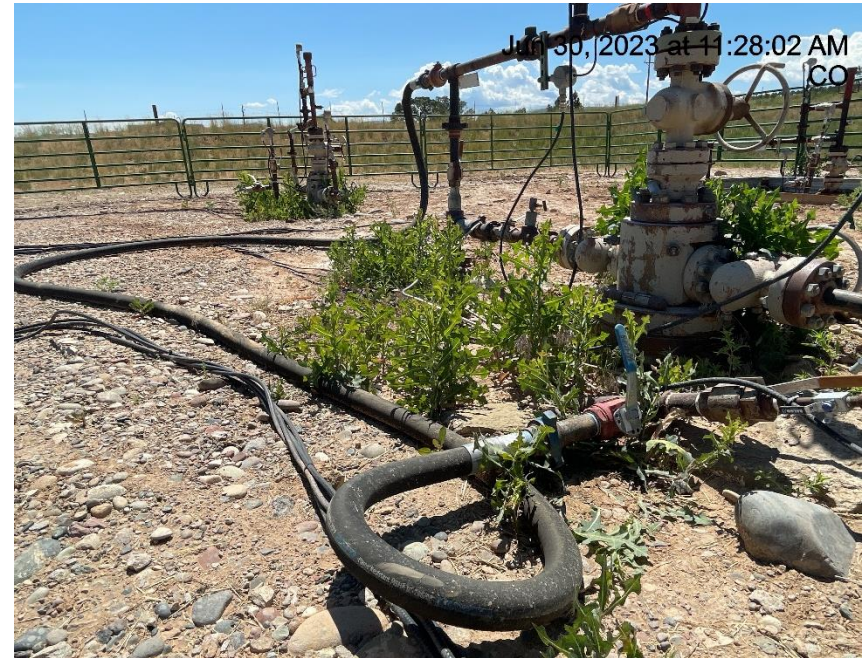
Photo # 2295 KELLY 34-13 well bradenhead connected to flowline, no check valve visible

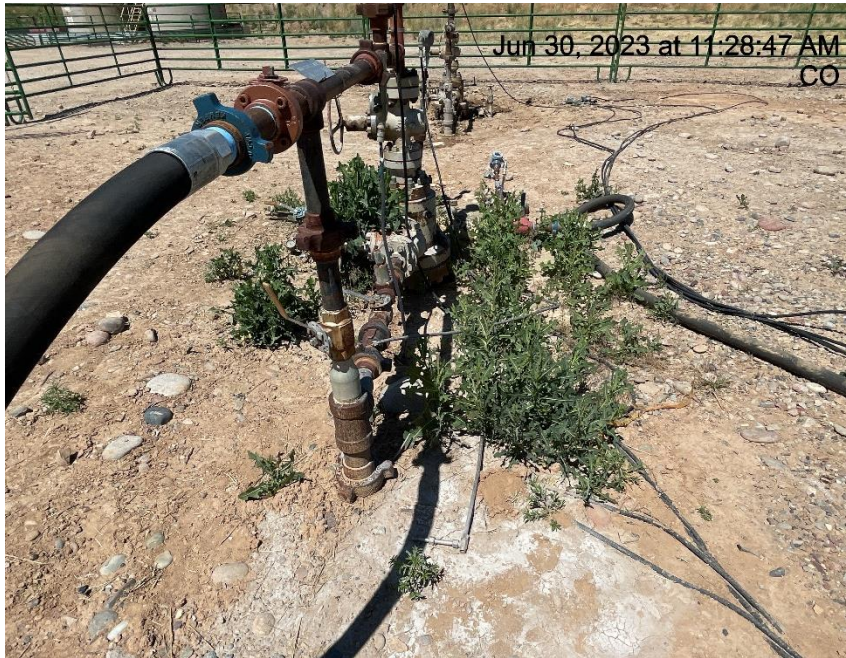
Photo # 2304 KELLY 34-13 well bradenhead connected to flowline, no check valve visible

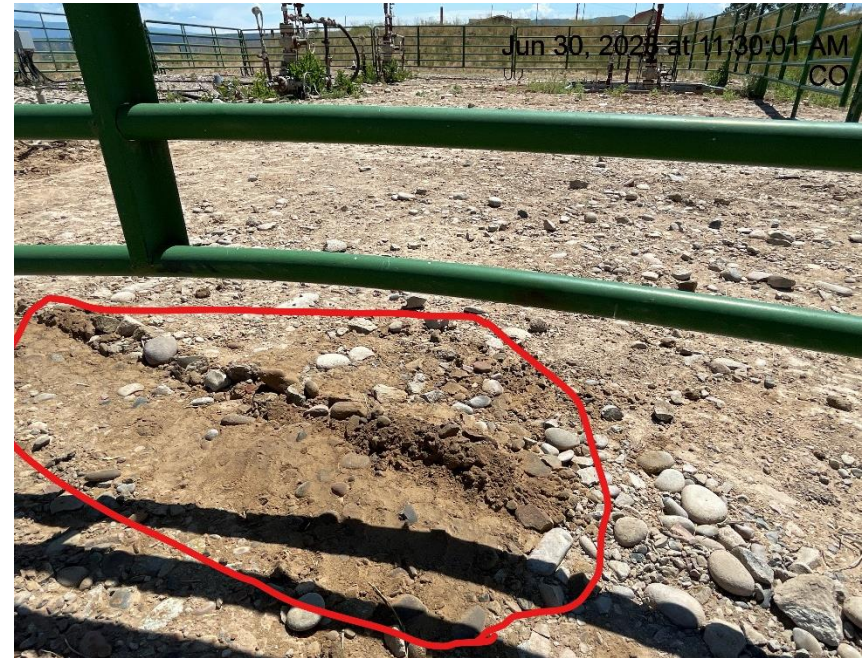
Photo # 2307 Stained soils & gravel on location

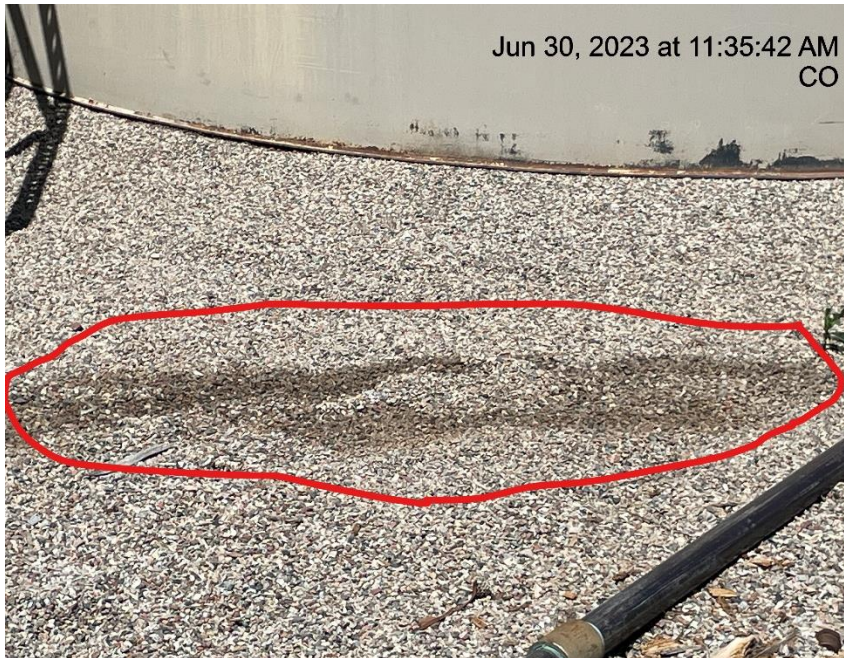
Photo # 2316 Stained gravel inside secondary containment
