Inspection Photos

API# 061-06023

Operator: WESTERN OPERATING COMPANY

Inspection Date: 7/6/2023

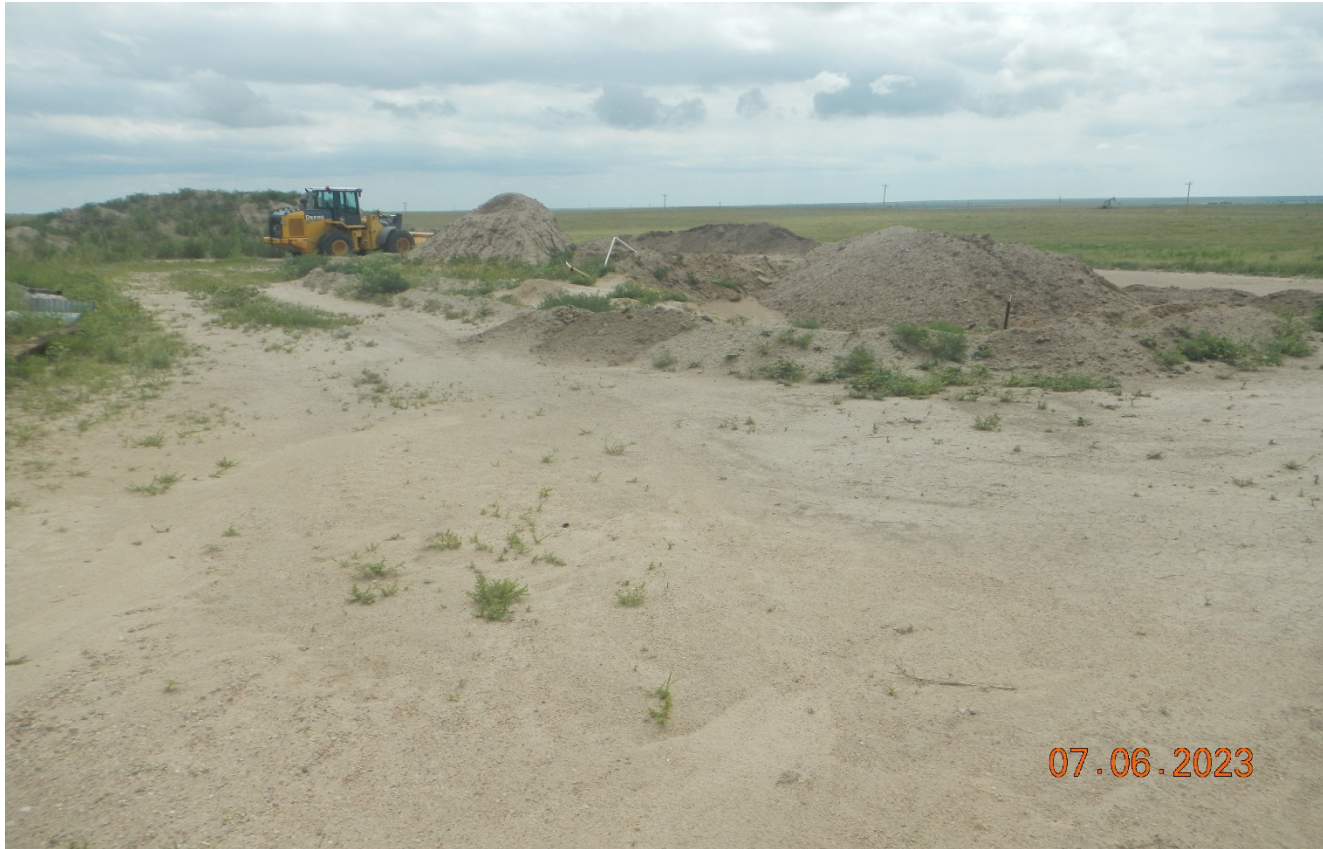
Photo 1. Facing southwest at the DAWSON A 1 tank battery facility. The tank was removed and soils have been excavated in this area. Remediation project: 20712

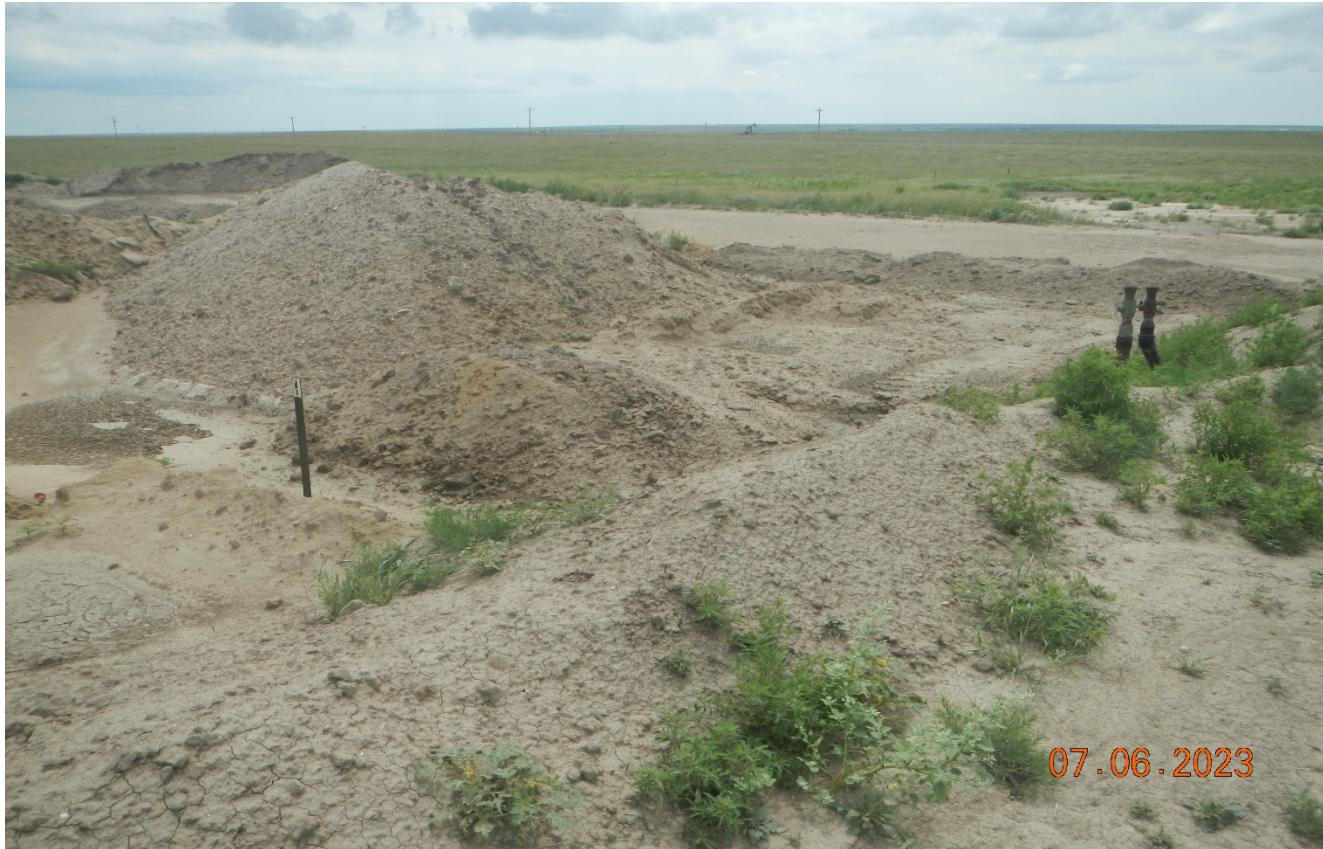
Photo 2. Facing southwest toward the tank battery facility. The tank was removed and soils were excavated in this area. It appears soils have been backfilled into the excavated area where tanks were located. There is still a pile of contaminated material improperly stored at the location.

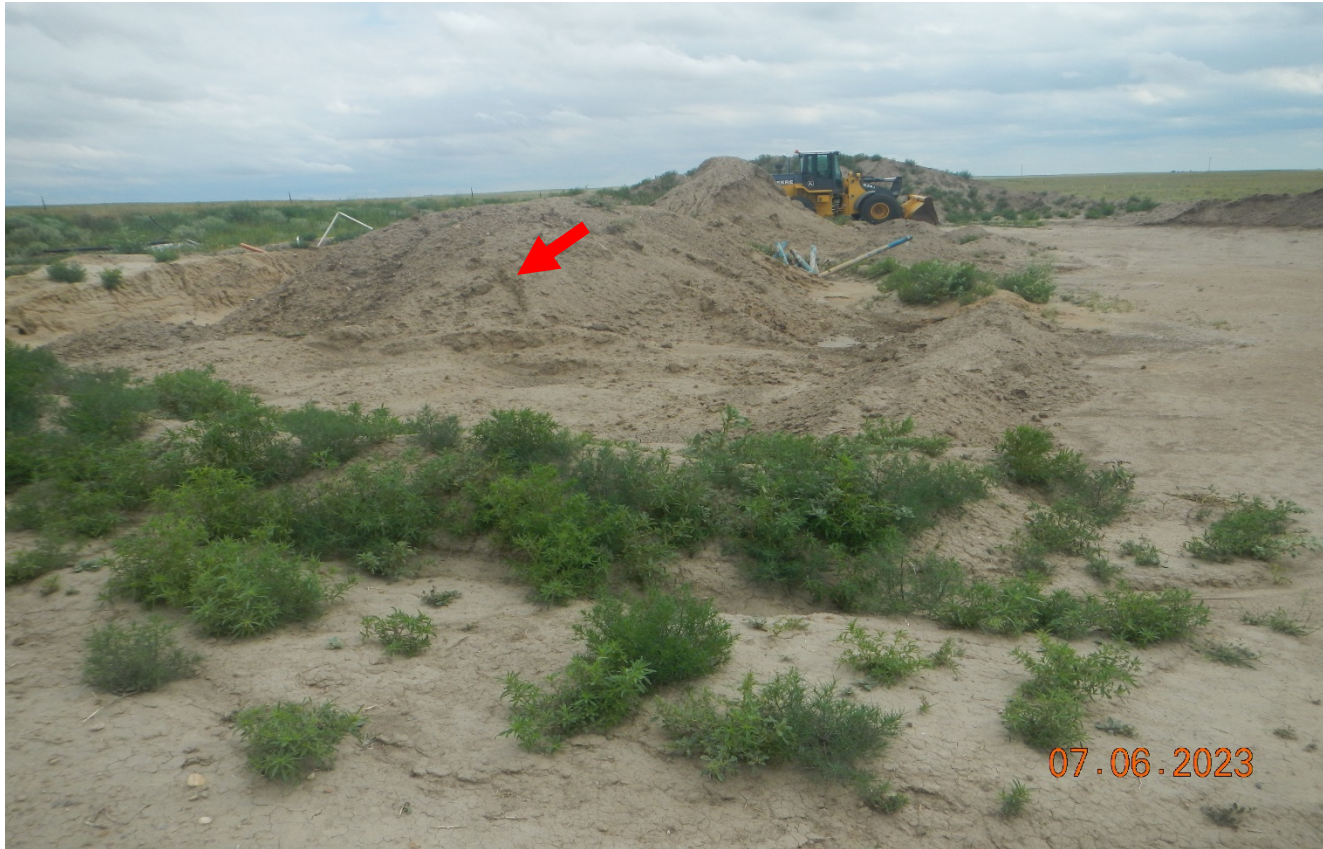
Photo 3. There is no liner observed under the contaminated soils which are not being properly stored. The berms around the material are not compacted or adequately constructed. Contaminated soils need to be removed and properly disposed. Red arrow points to black hydrocarbon soils.

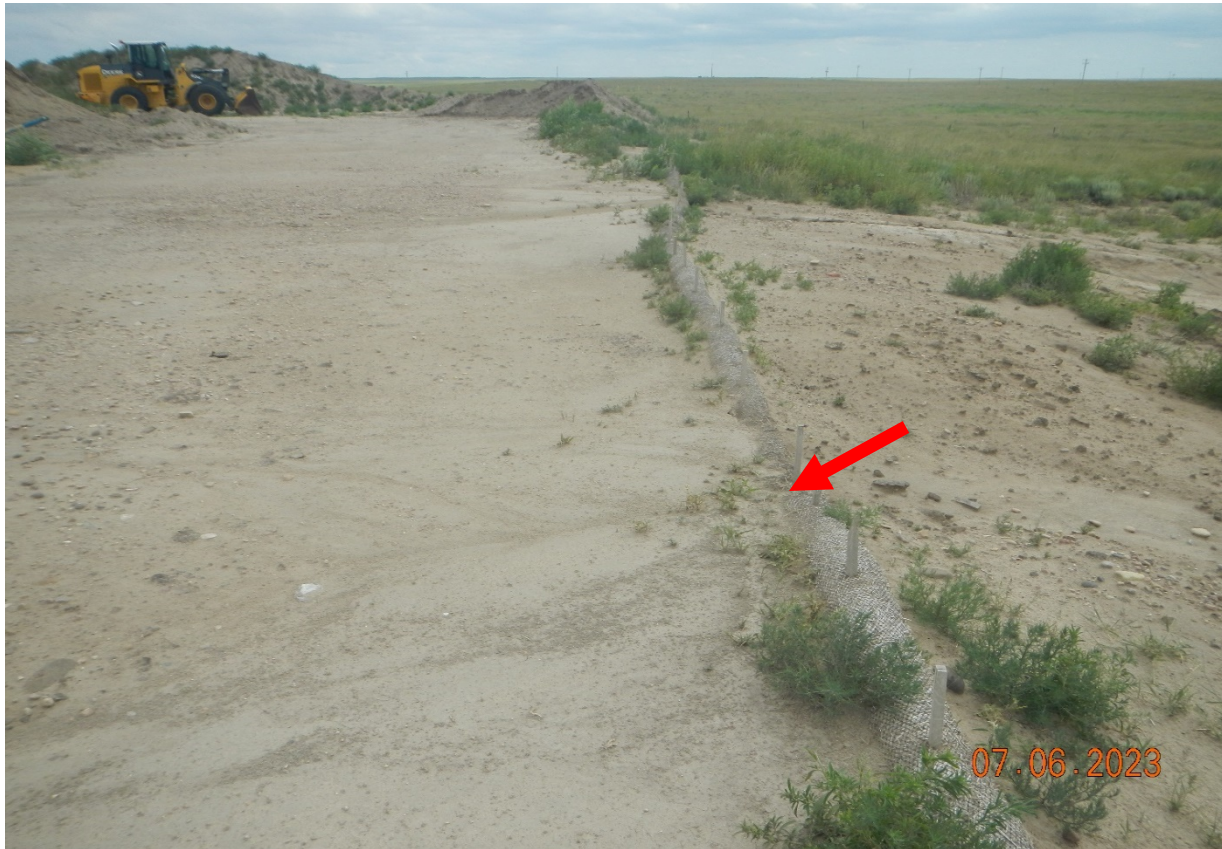
Photo 4. Facing south at the tank battery facility. There is insufficient stormwater controls in this area and the wattles at red arrow have filled with sediment which has overtopped the wattles.

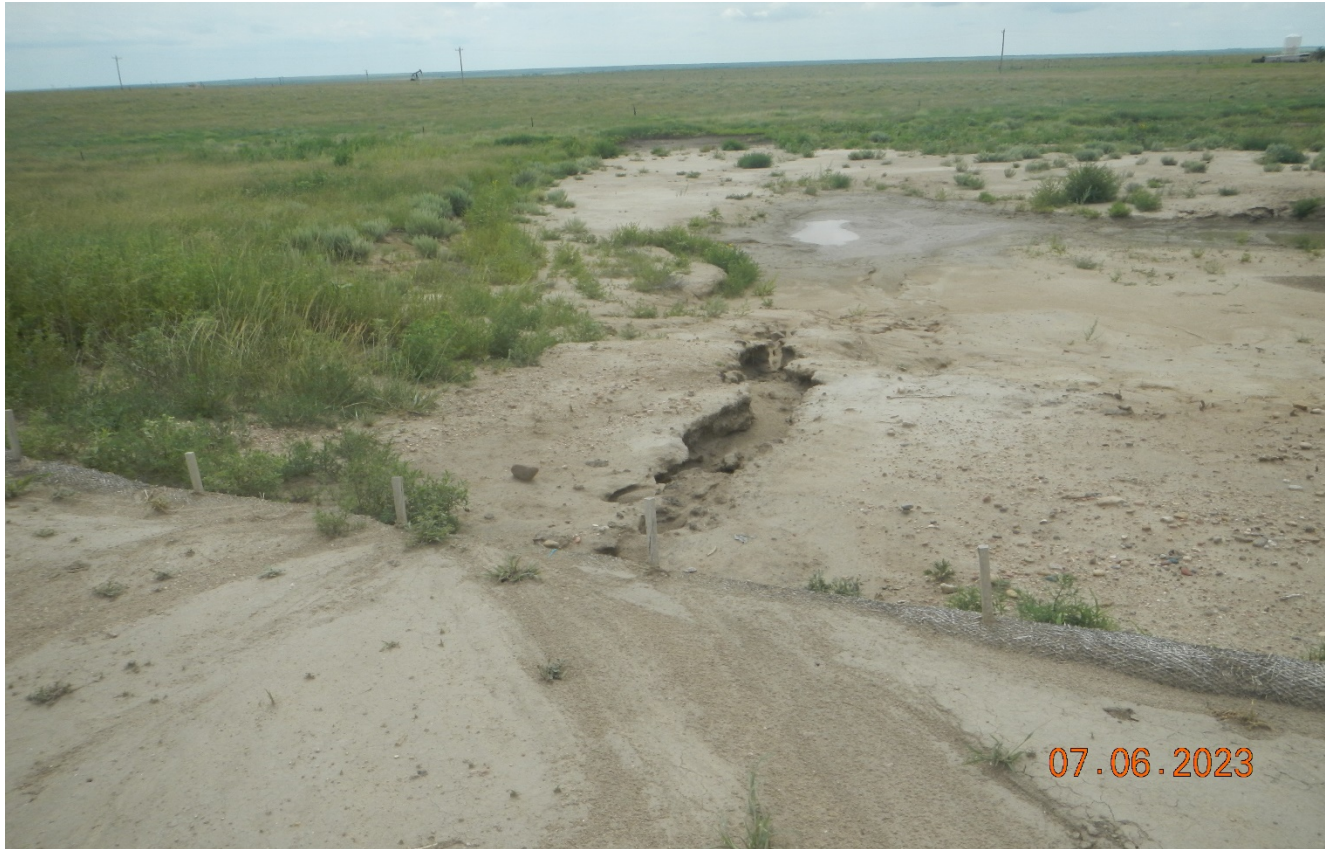
Photo 5. View of wattles which sediment has filled in and overtopped moving sediment offsite causing additional erosion.

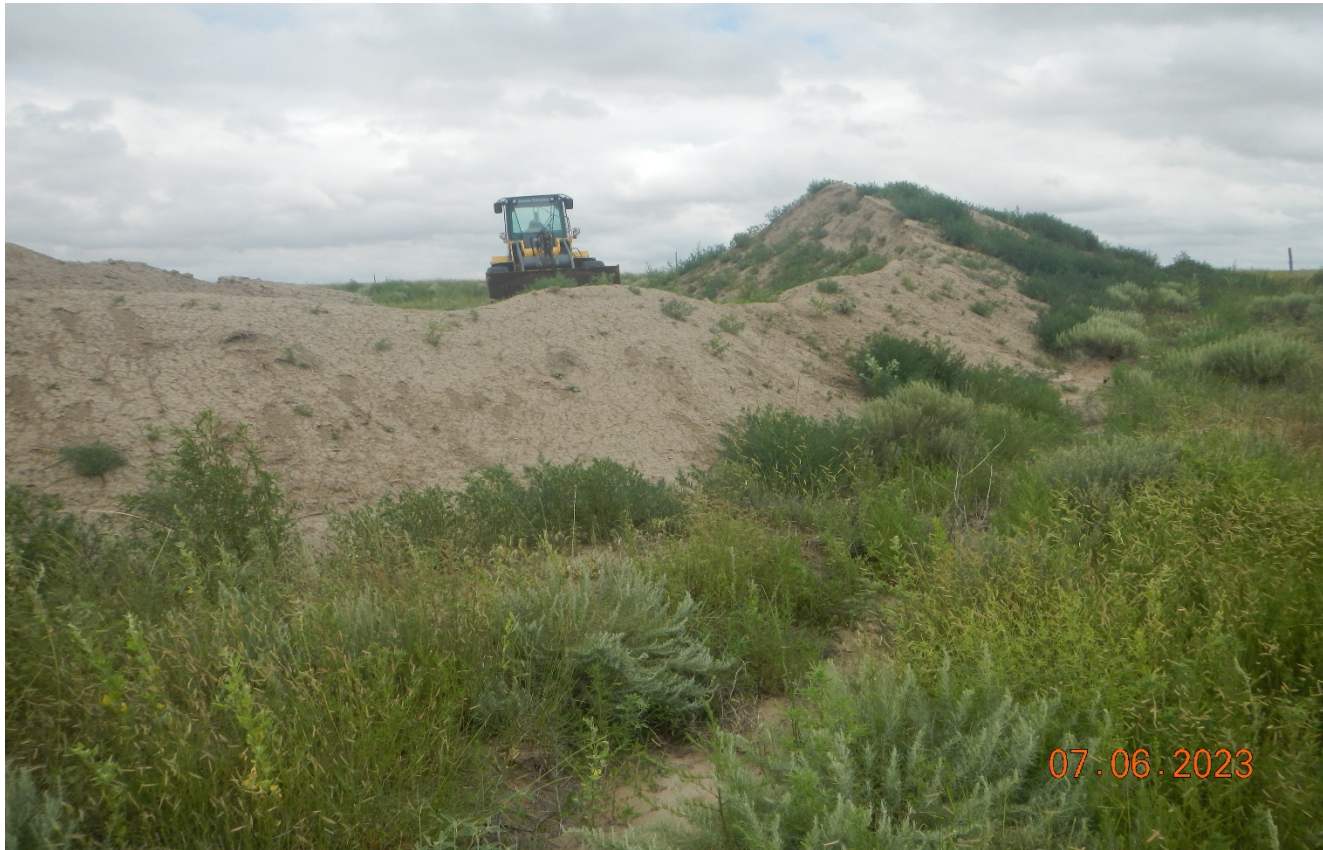
Photo 6. There have been soils brought in and stockpiled at the south side of the location. There is inadequate stormwater BMP's to prevent erosion of the stock piled soil. Previous corrective action was not completed.

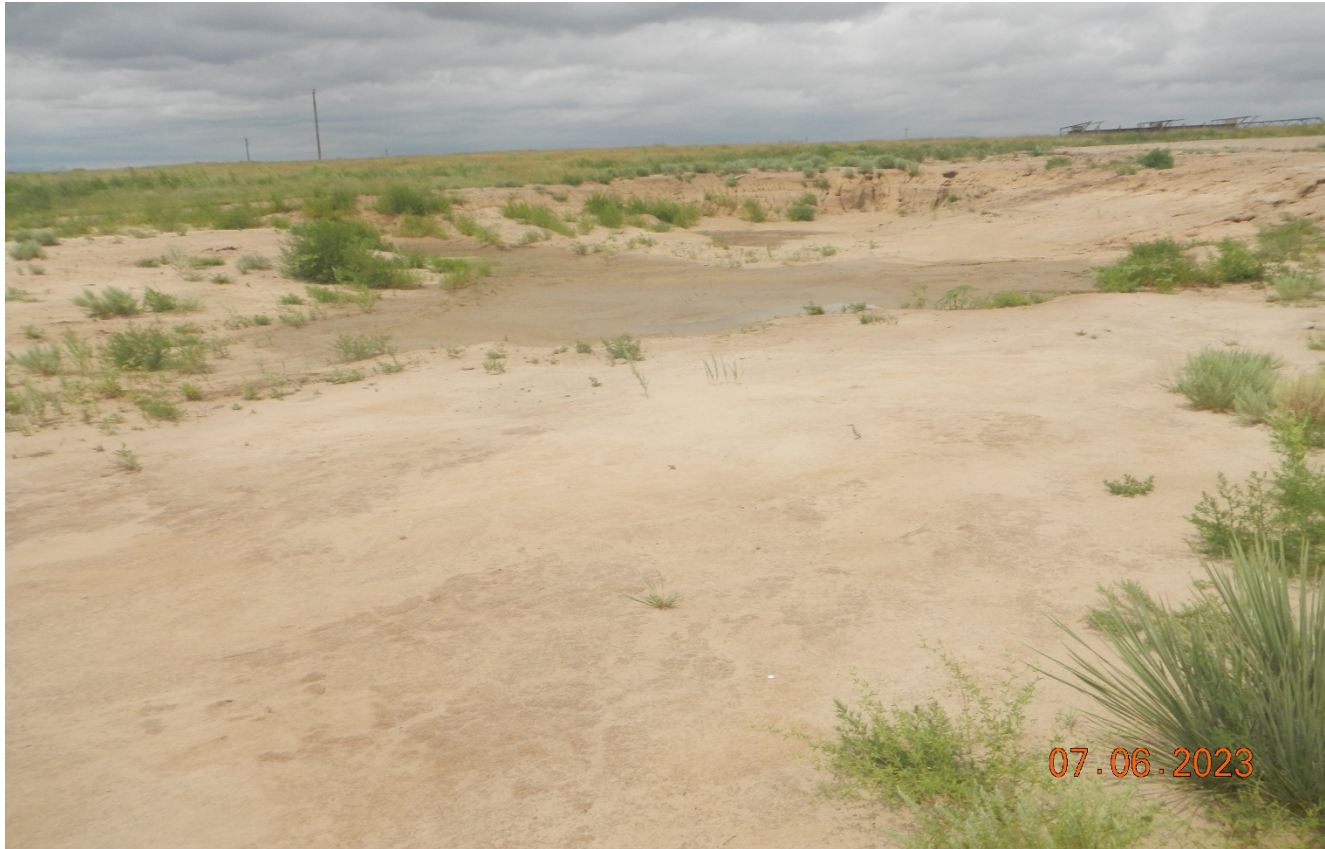
Photo 7. Facing west of the battery site toward the area where the spill occurred February of 2022, Remediation project: 20712.

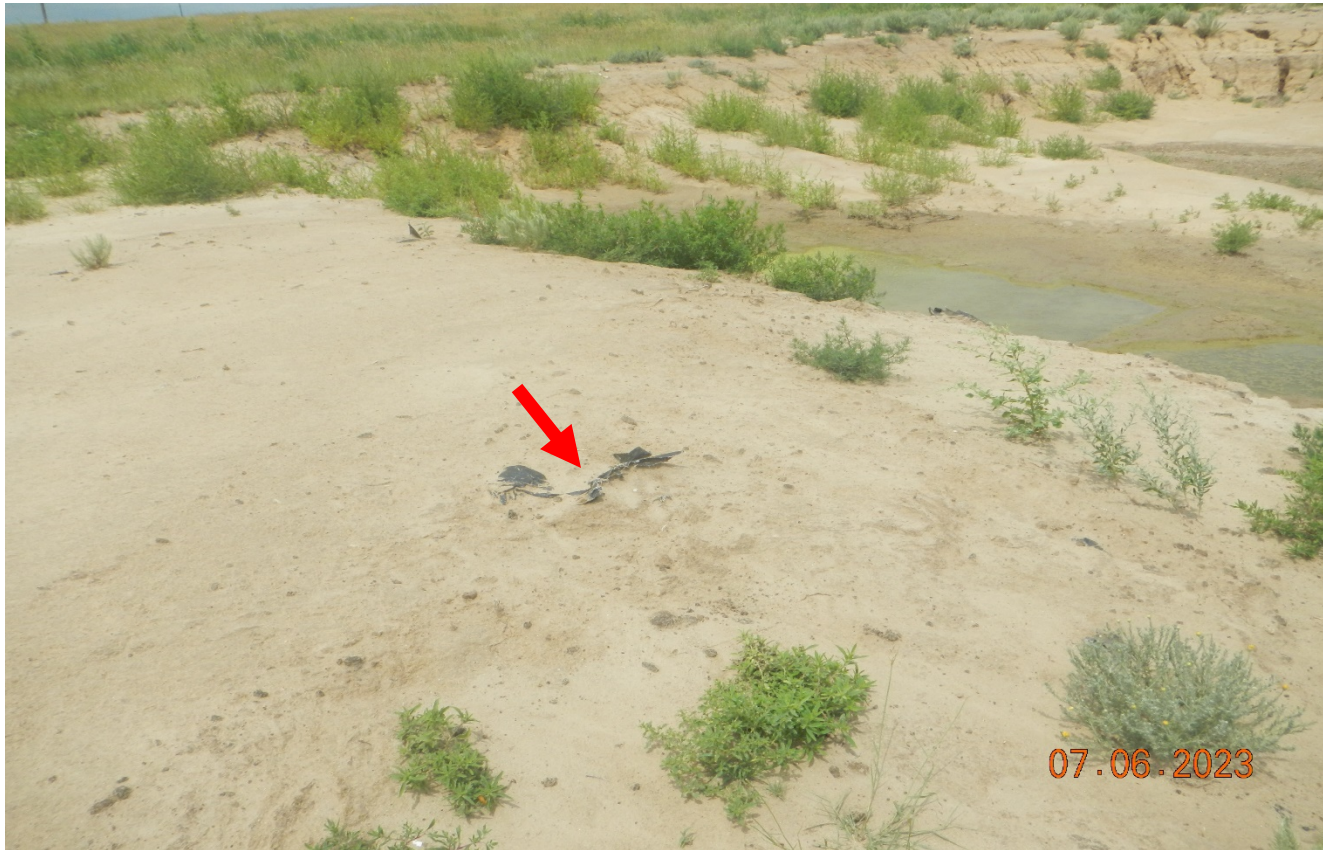
Photo 8. Facing southwest toward the area where the spill occurred. Remediation project: 20712. Some areas have been excavated more than other areas. There are still areas of impacted soils observed. Red arrow points to liner material and stained soil.

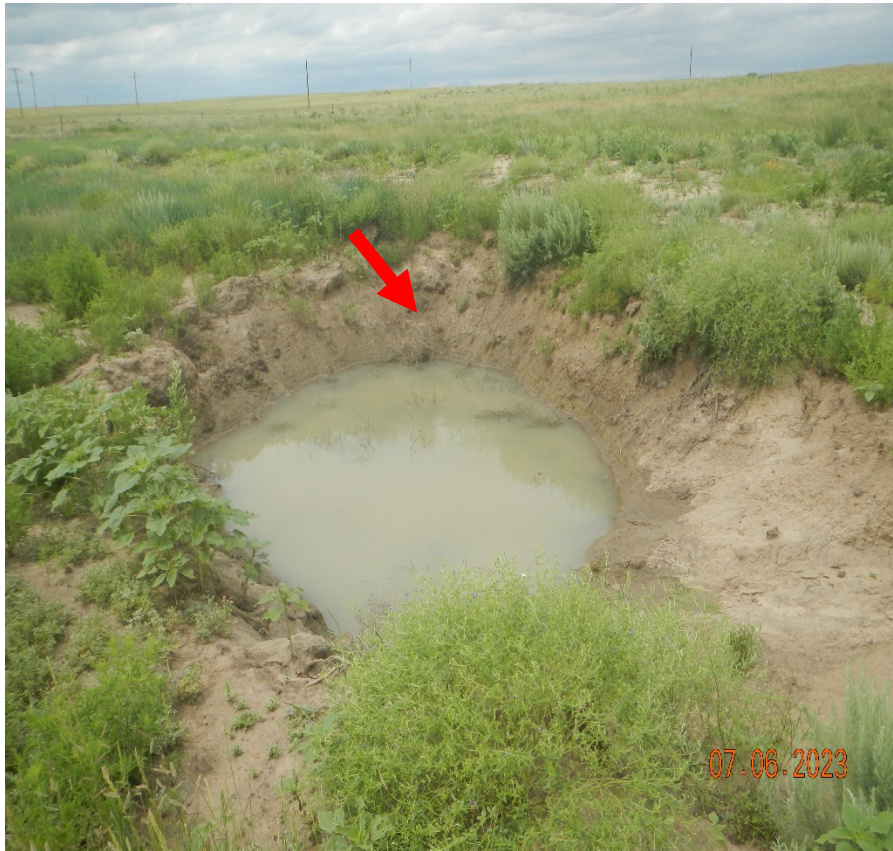
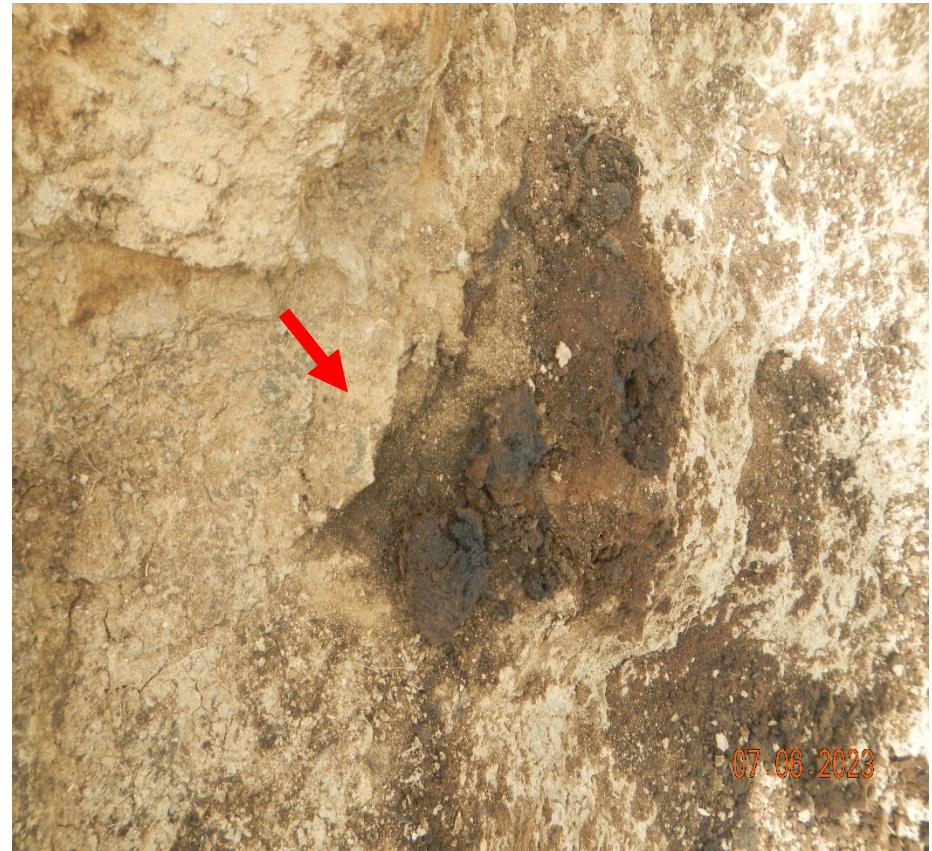
Photo 9. Located at the western side of the spill area. There is an excavated hole at this area approximately 12'x12'6'. There are still areas of oil stained soils at the surface (Bottom left) and 2ft. Down into the excavation area (right photo). Further excavation is needed.

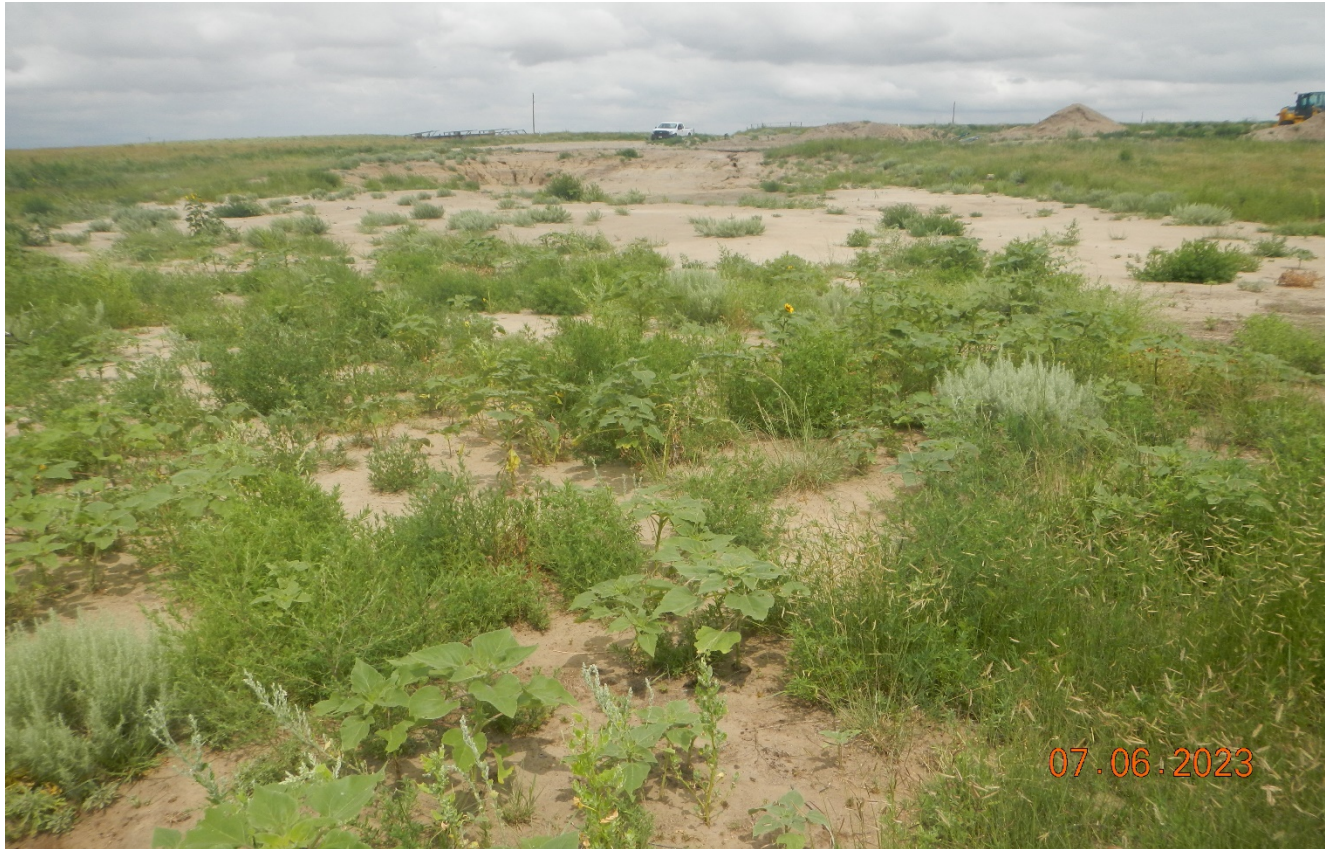
Photo 10. Facing east toward the area where the spill occurred February of 2022, Remediation project: 20712.

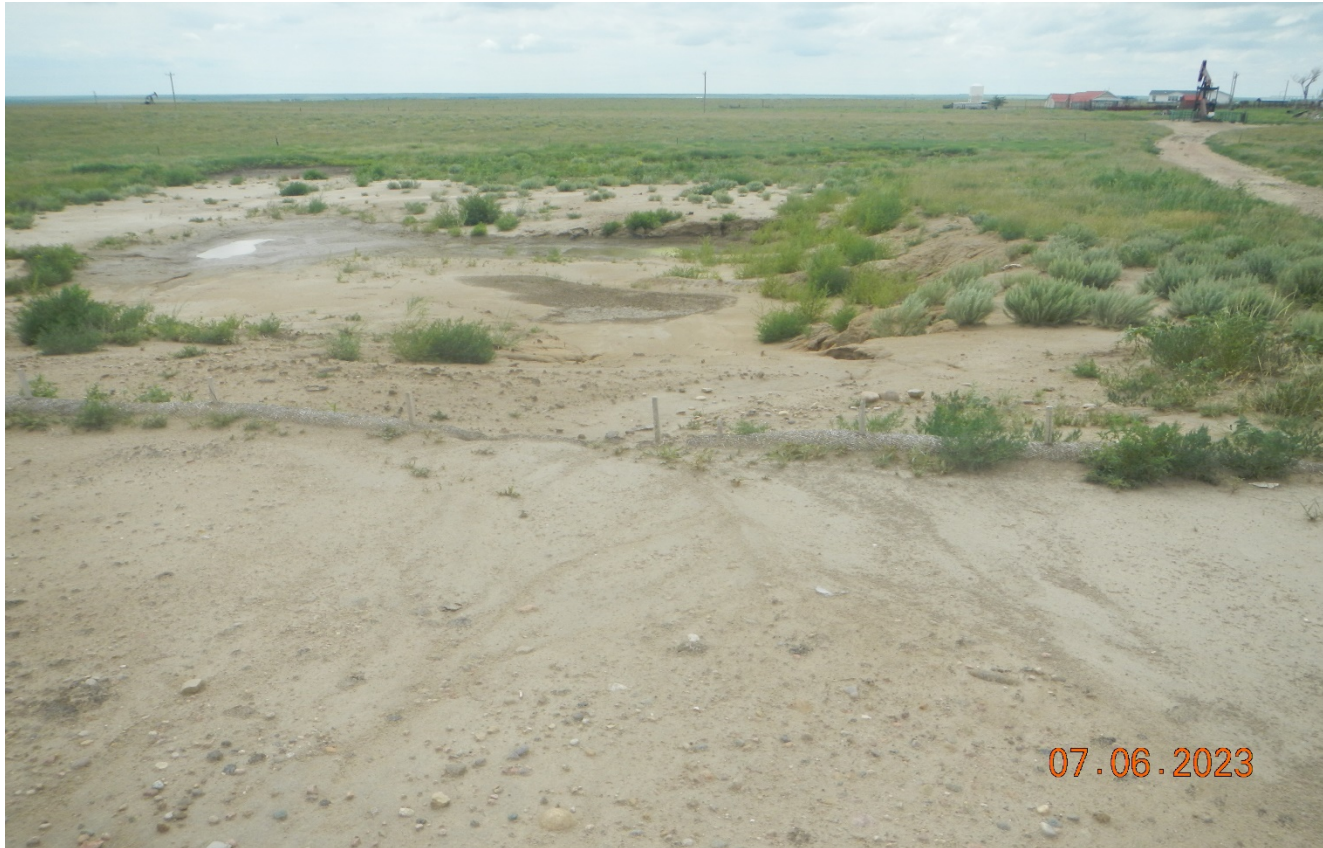
Photo 11. Facing southwest toward the area where the spill occurred. Remediation project: 20712. Some areas have been excavated more than other areas.

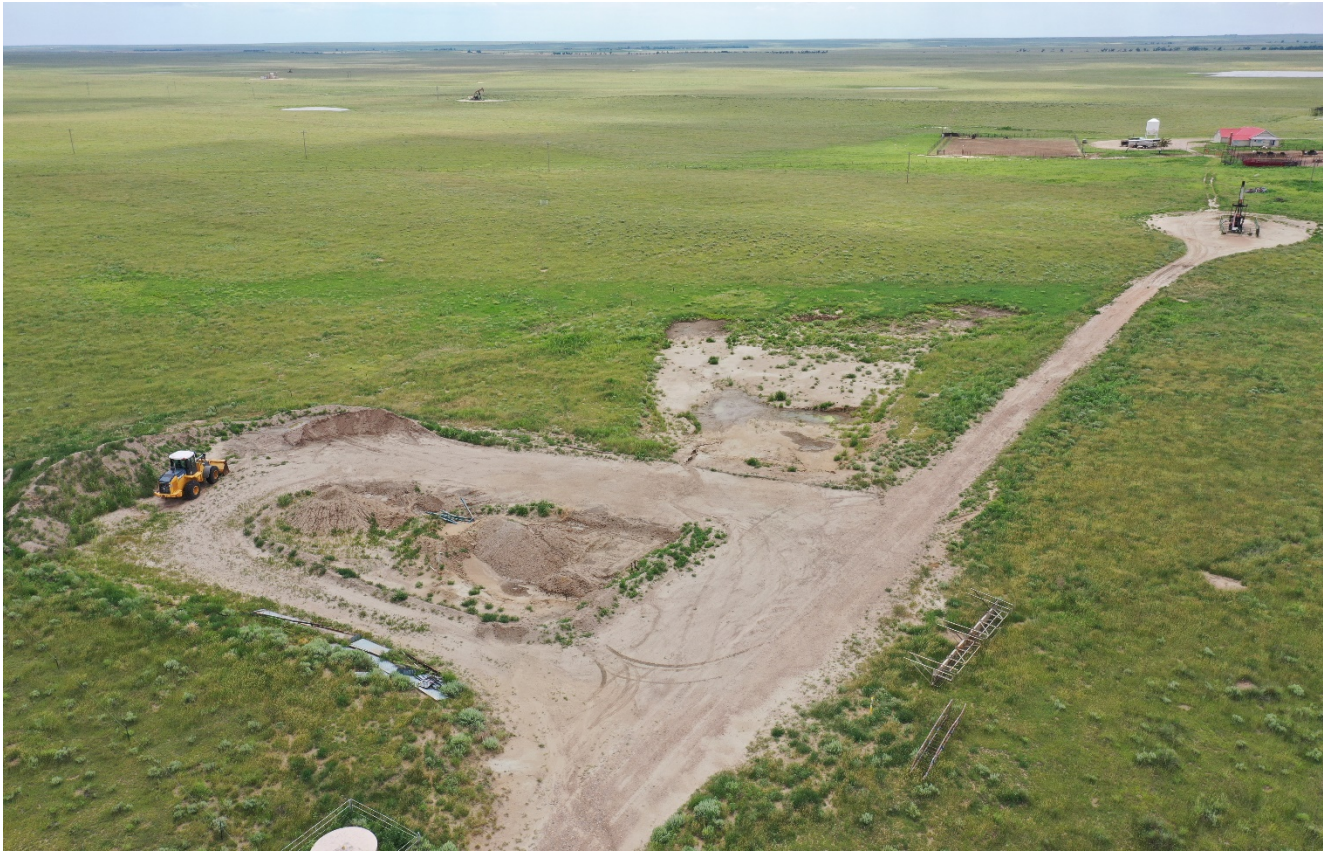
Photo 12. Drone aerial photo facing southwest toward the battery and wellsite. Remediation Project #20712 remains ongoing and excavation has been open for more than 12 months.

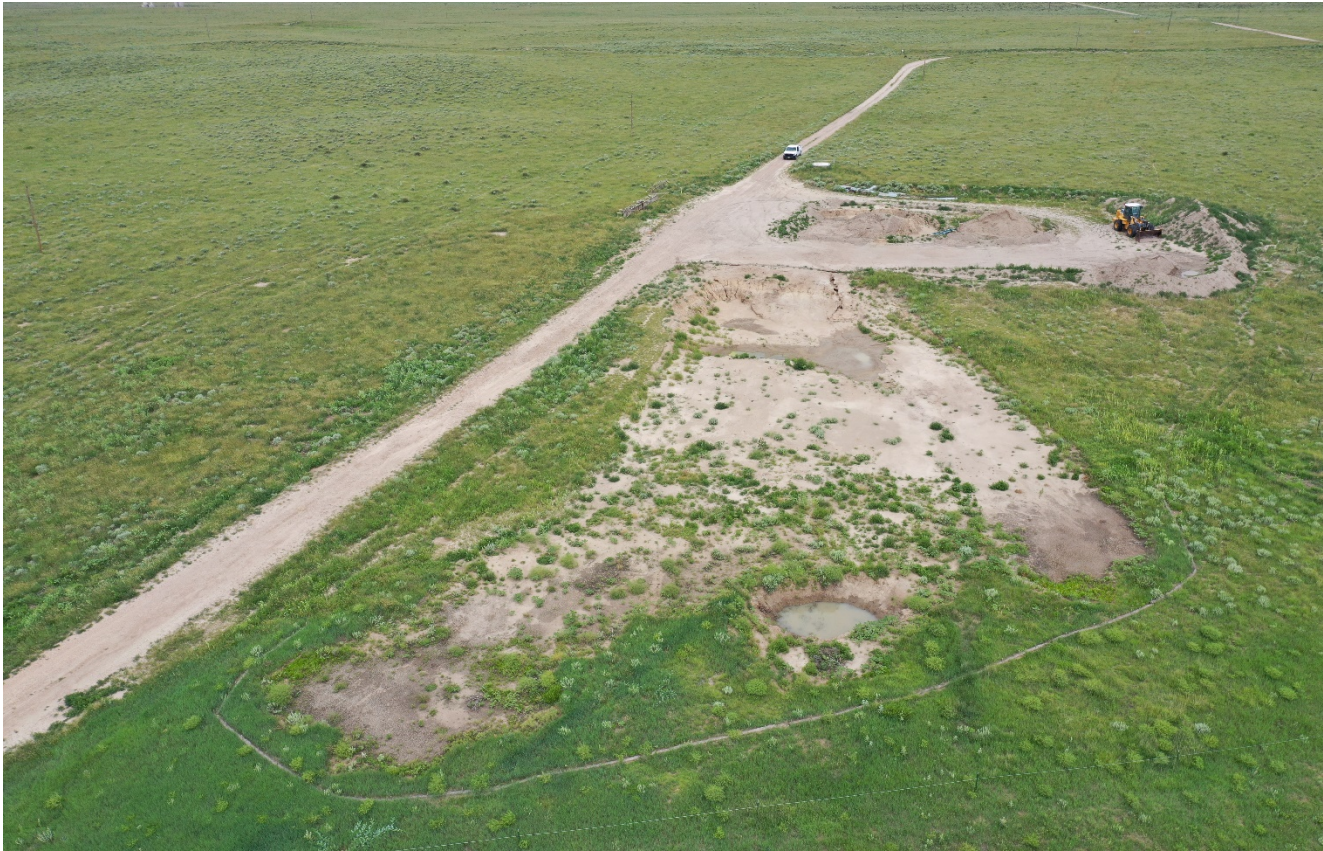
Photo 13. Drone aerial photo facing northeast toward the tank battery site. Remediation Project #20712 remains ongoing and excavation has been open for more than 12 months.
