# Interim Reclamation and Stormwater Inspection

July 5, 2023

Operator: KERR MCGEE OIL & GAS ONSHORE LP - #47120

Location ID: 336152

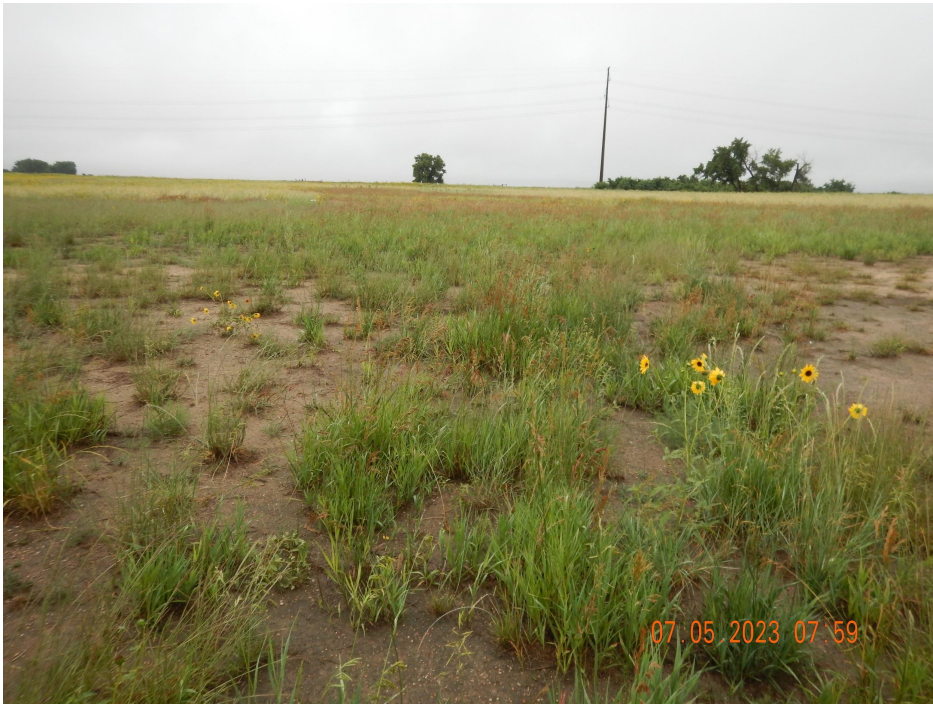
**Photo 1.** Photo taken east of the wellhead, facing South. Photo illustrates an area that is being actively managed for weeds and native perennial vegetation establishment.

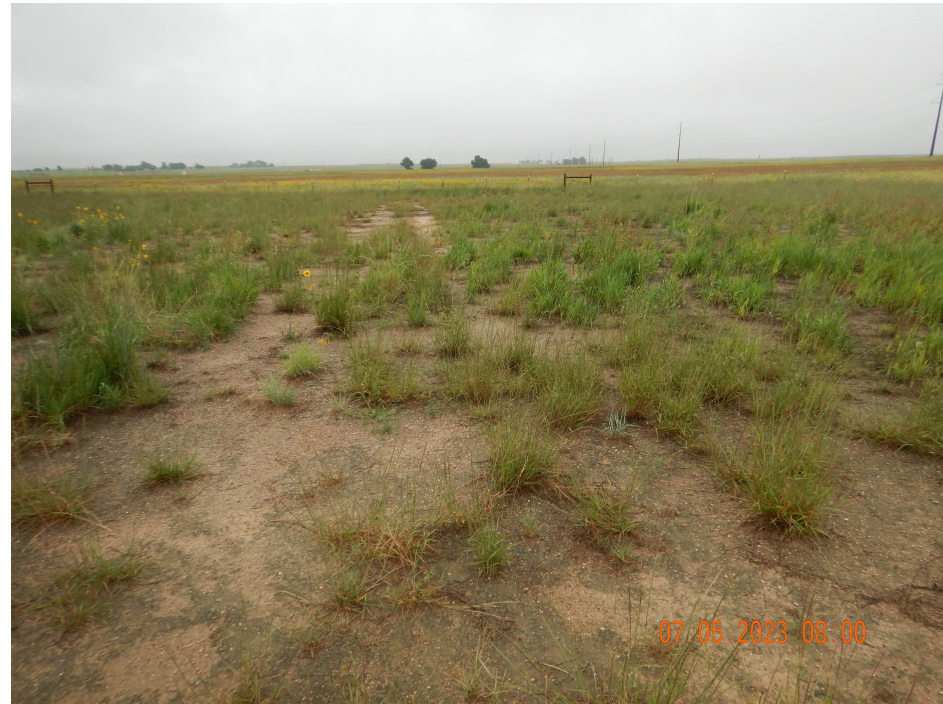
**Photo 2.** Photo taken east of the wellhead, facing East. See comments under Photo 1.

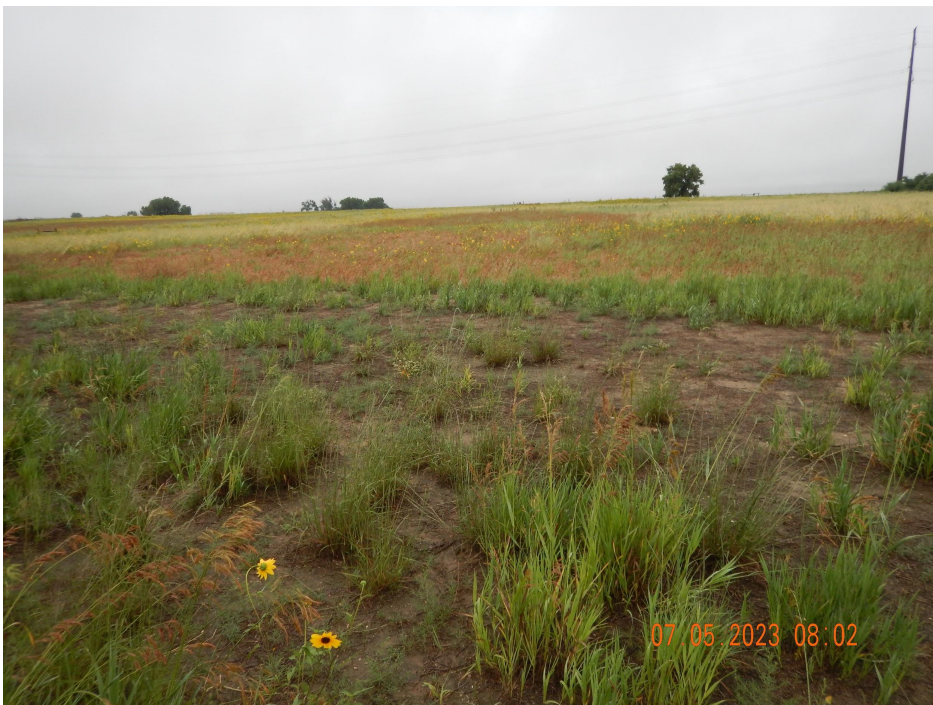
**Photo 3.** Photo taken south of the wellhead, facing South. Photo illustrates an area of Smooth brome establishment (brownish color) with Common rye establishment (yellowish color) to the outer extent.

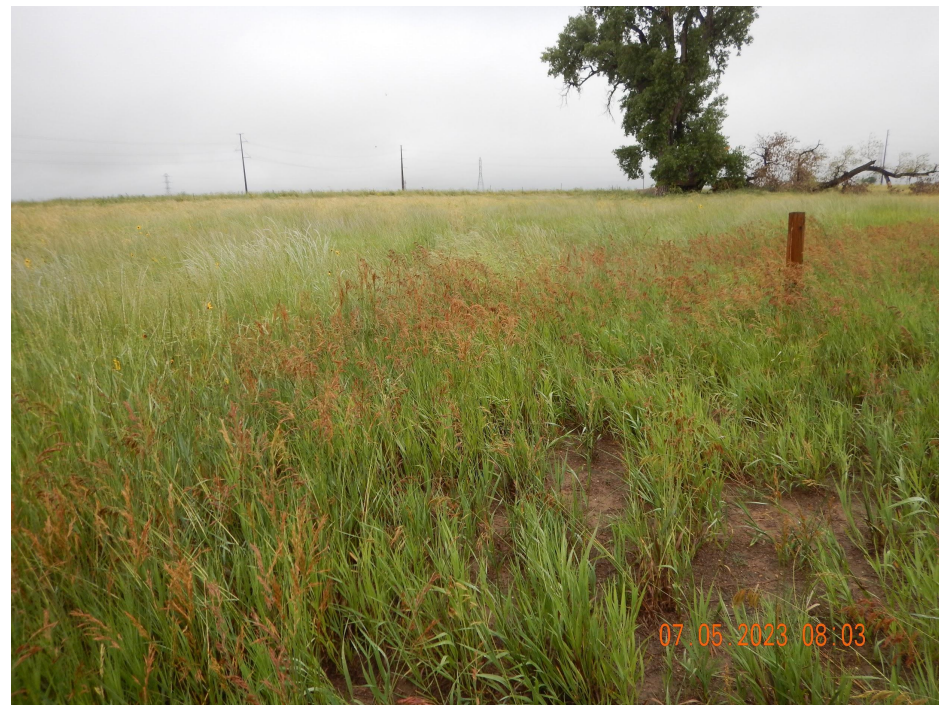
**Photo 4.** Photo taken west of the wellhead, facing West. Photo illustrates an area of Smooth brome establishment (brownish color), wheatgrass establishment (blueish green color), and Common rye establishment (yellowish color) in the background.

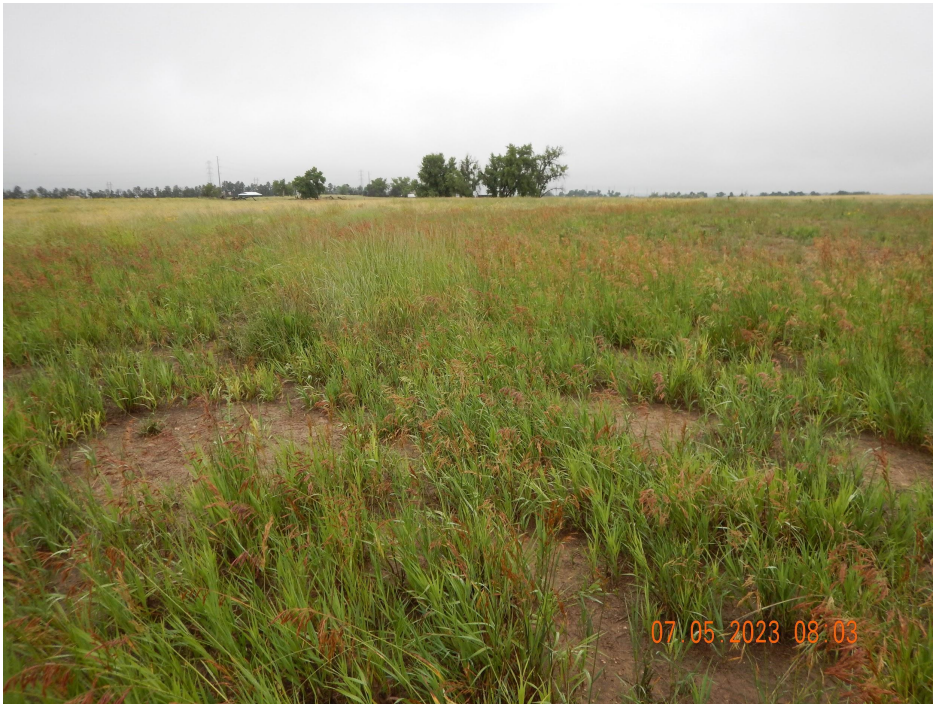
**Photo 5.** Photo taken west of the wellhead, facing North. See comments under Photo 3.

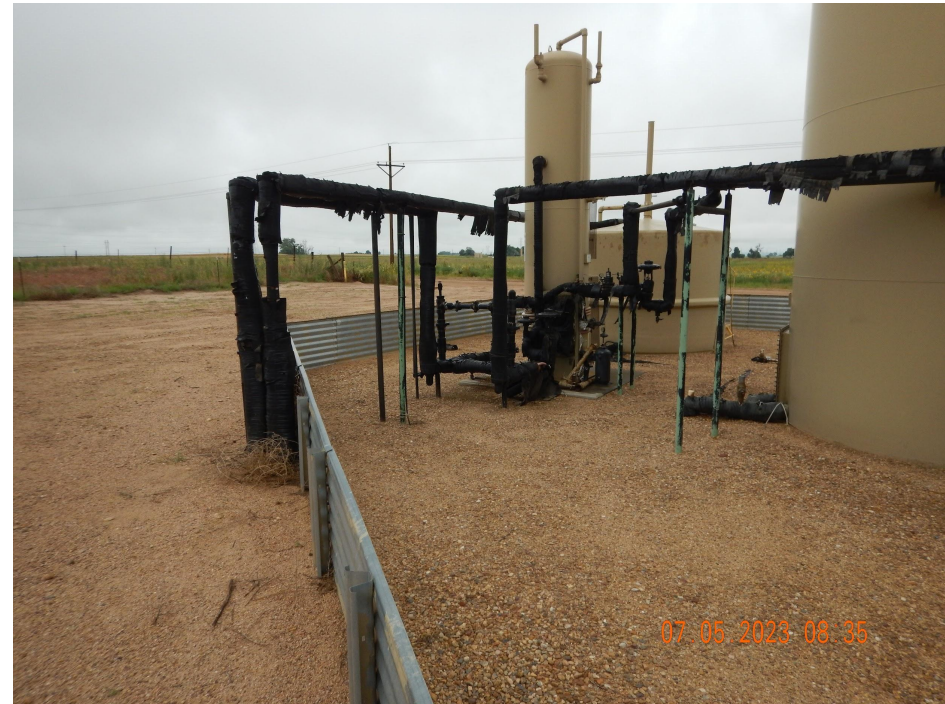
**Photo 6.** Photo taken from the associated offsite tank battery. Photo illustrates tape that is degrading. Tape and foam coming off piping, which is contributing to trash around the location.

This remains out of compliance and scheduled for repairs.

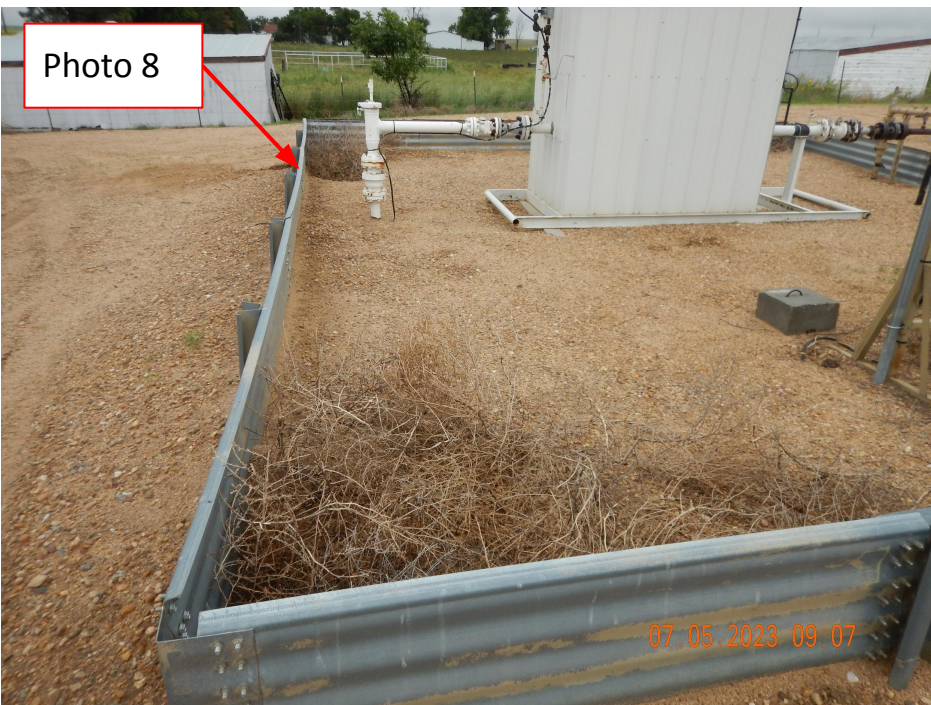
**Photo 7.** Photo taken from the associated offsite tank battery. Photo illustrates weed debris around equipment that appears to have blown in from the surrounding area.

This remains out of compliance and scheduled for repairs.

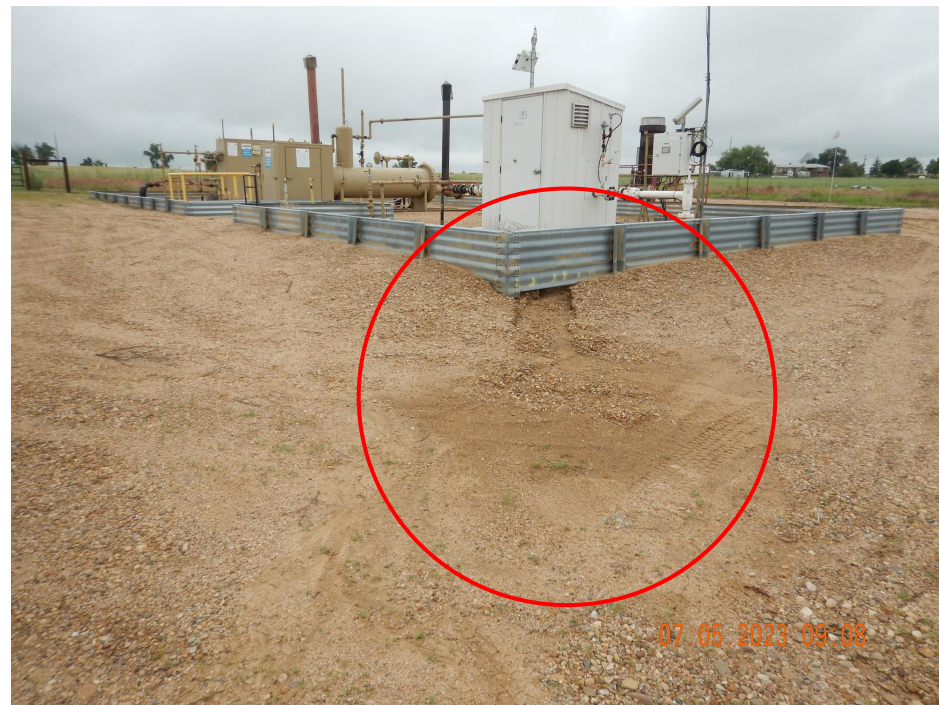
Photo 8

**Photo 8.** Photo taken from the associated offsite tank battery, facing South. Photo illustrates stormwater erosion that is compromising secondary containment.
