## Inspection Photos

Location Name: UPRC-65N64W/23NESE

Location ID: 336587

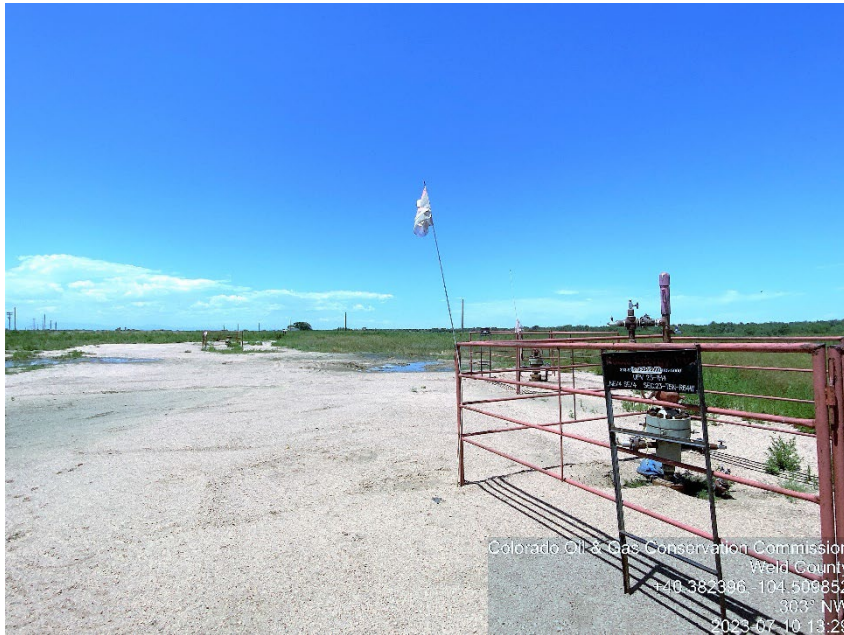
**Photo #1**

**UPRC-65N64W/23NESE pad 7: Wellsites**

**3: Temporarily Abandoned | TA**

**4: Plugged & Abandoned | PA**

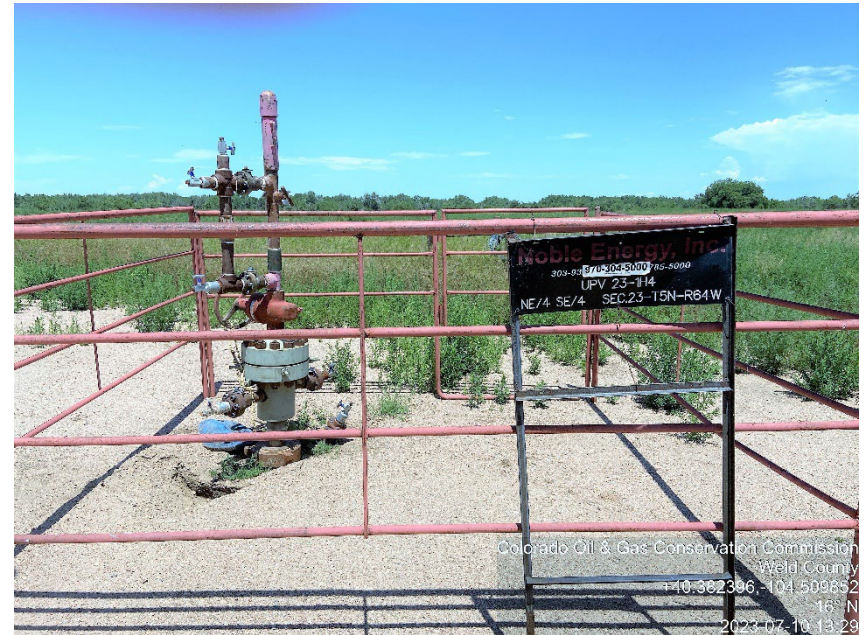
**Photo #2**

**UPV 23-1H4 (123-18886) Wellsite**

**Temporarily Abandoned | TA**

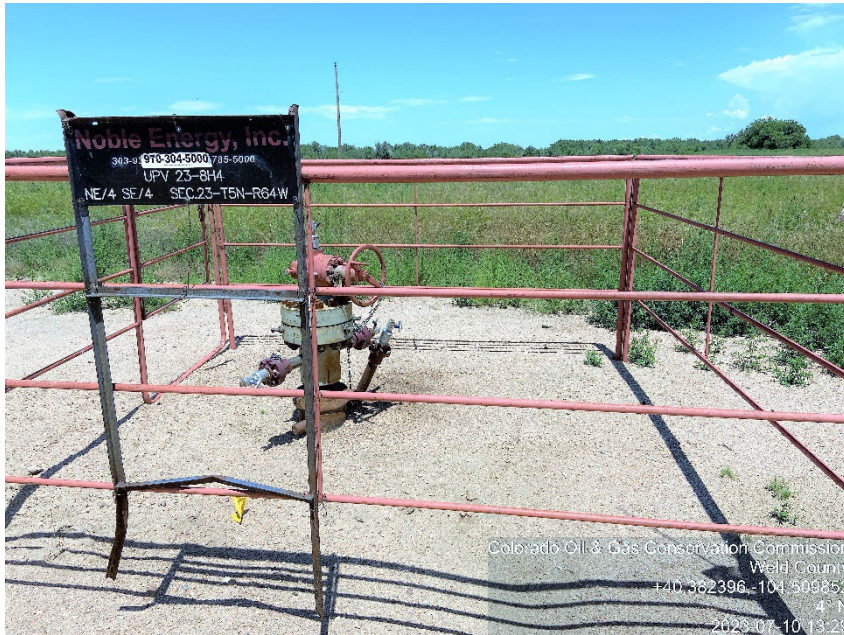
**Photo #3**  
**UPRV 23-8H4 (123-18887) Wellsite**  
**Temporarily Abandoned | TA**

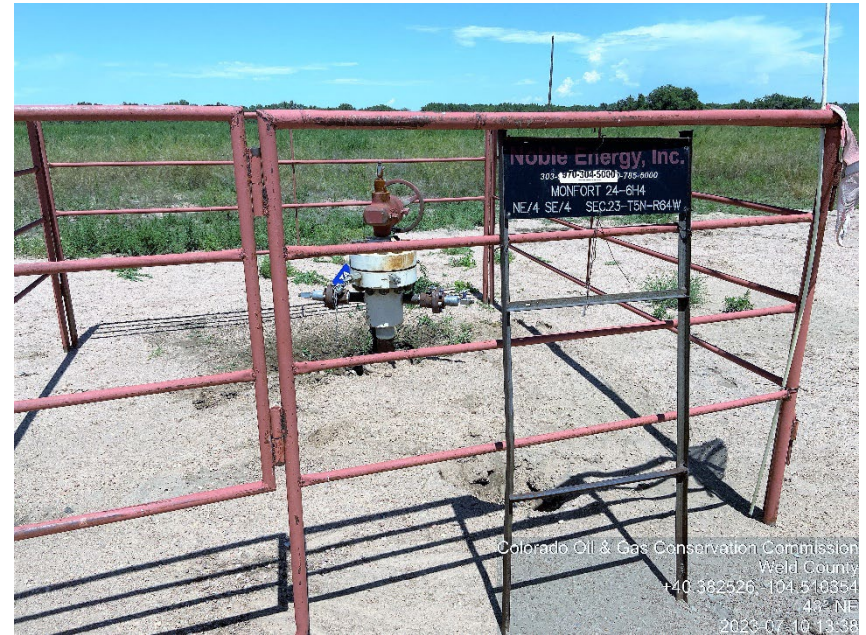
**Photo #4**  
**Monfort 24-6H4 (123-18167) Wellsite**  
**Temporarily Abandoned | TA**

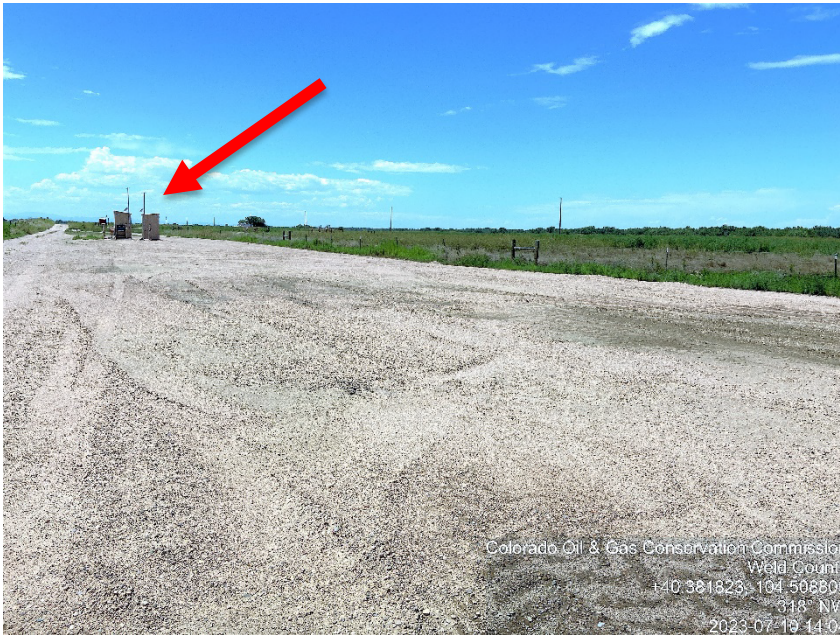
**Photo #5**

**UPV 23-1H4, 23-8H4, Monfort 24-6H4** Battery site

**Abandoned: MOST Equipment Removed**

*Formerly served:*

*UPRC 23-9H4, 23-16H4, Chewy B 23-23,*

*Ferguson 24-5H4 ;*

*Plugged & Abandoned | PA*

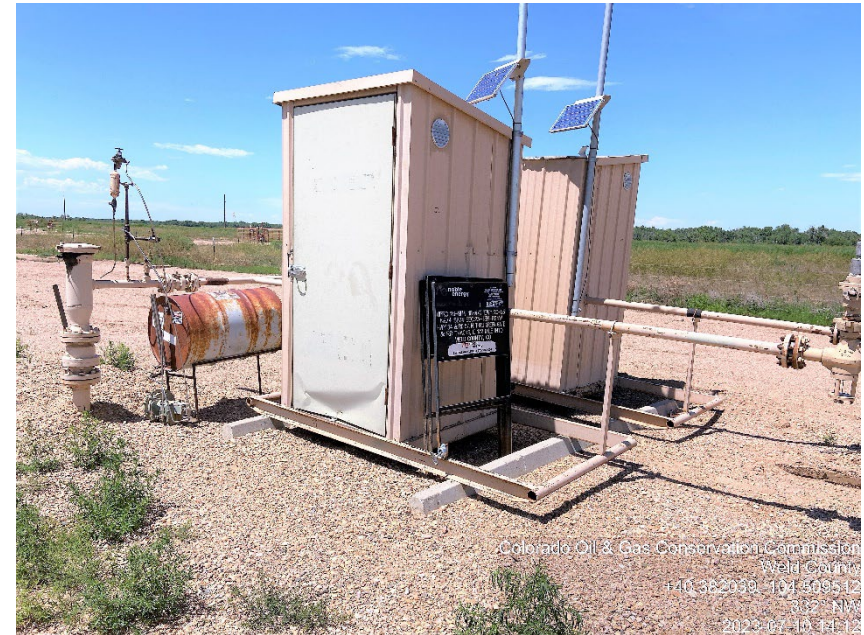
**Photo #6**

**UPV 23-1H4, 23-8H4, Monfort 24-6H4** Battery site

**Abandoned: MOST Equipment Removed**

**2-gas mtr runs, pig station, methanol pump, tank, battery  
signage.**

**CA: Unnecessary Equipment.**

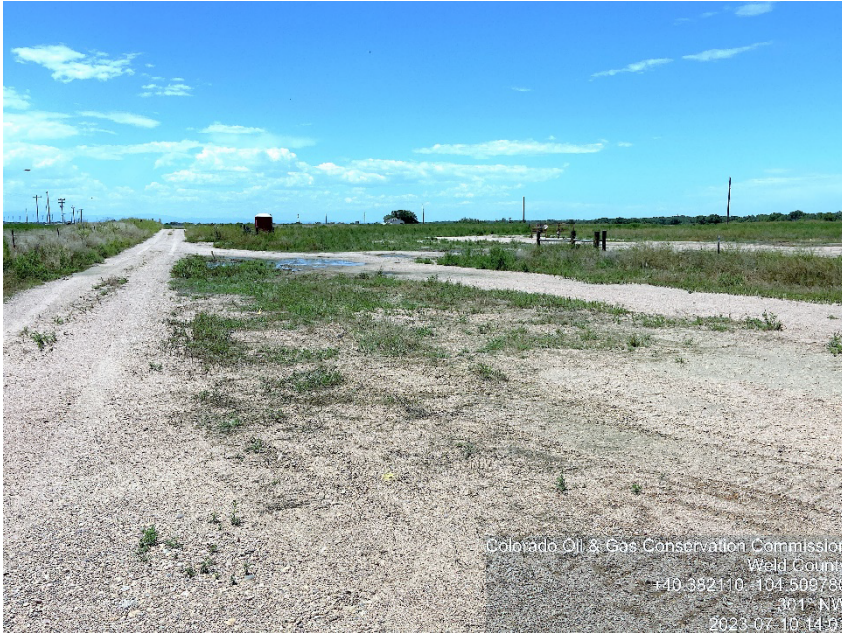
**Photo #7**

**UPV 23-1H4, 23-8H4** Battery site-Prior

**Abandoned: ALL Equipment Removed**
