Inspection Photos

7/10/2023

Operator: GUNNISON ENERGY LLC - 10515

Location Number: 324485

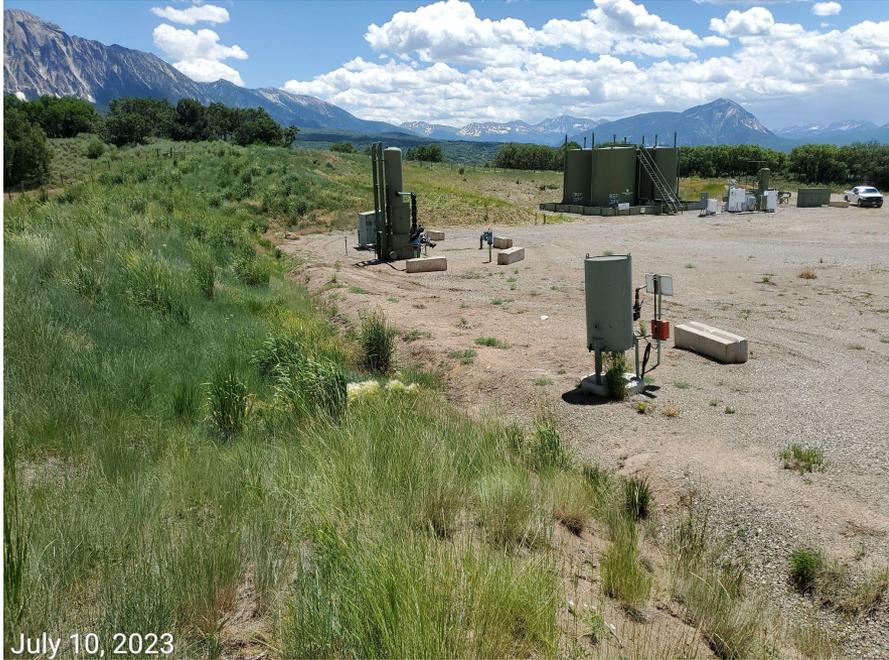
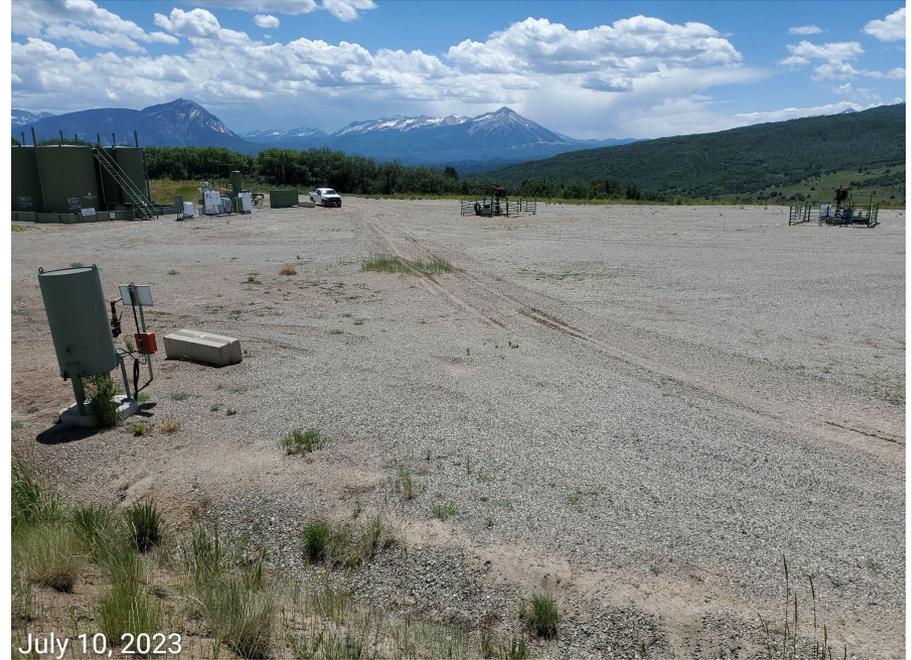
Photo 1: Photos 1-2 taken from the North end of the Location. Photos provide an overview of the Location from east, southeast, southwest to west.

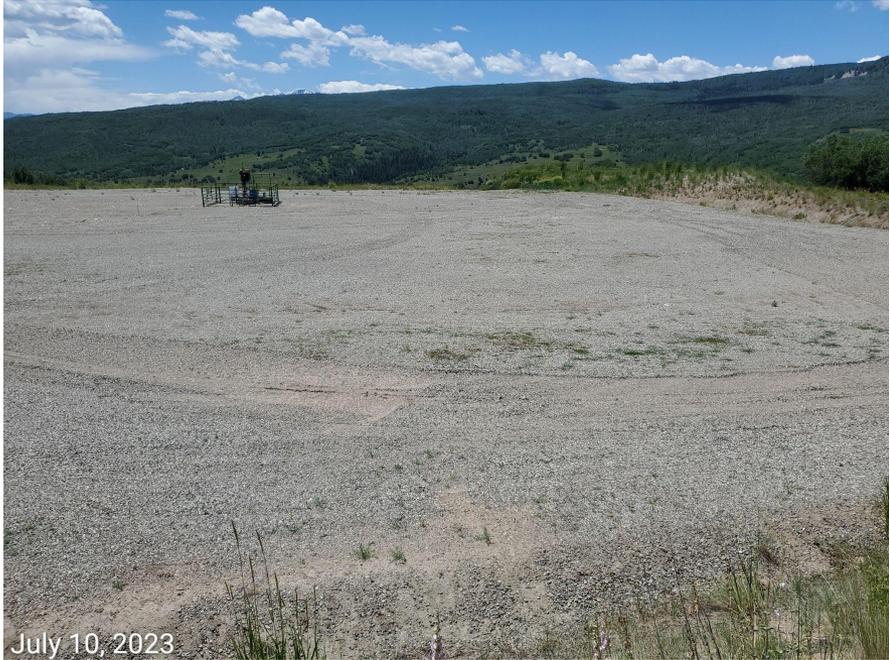
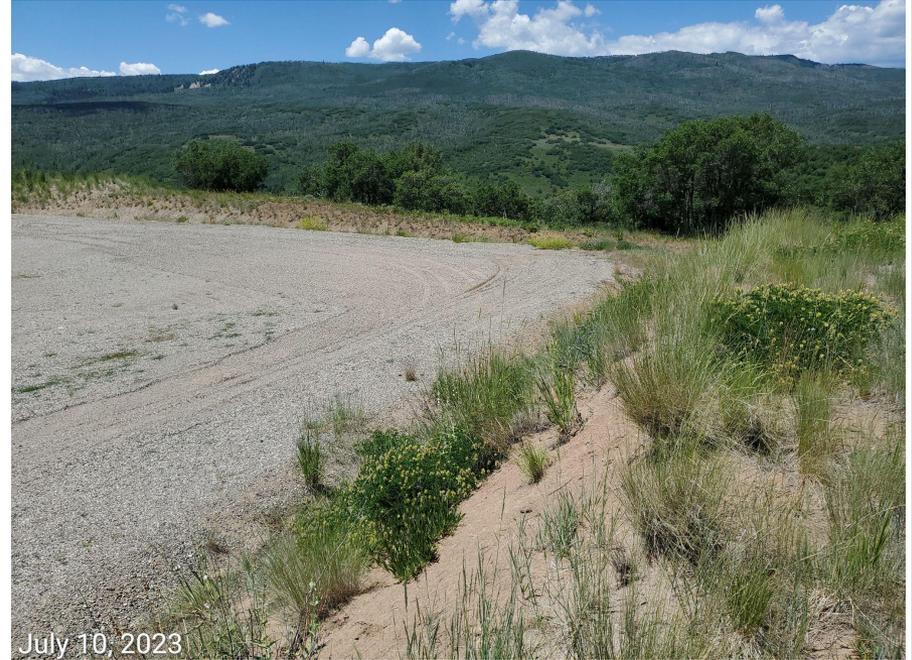
Photo 2: See comments under photo 1. Photos also show areas on the west end of the Location, not needed for production, have not been reclaimed in accordance with 1003 Rules.

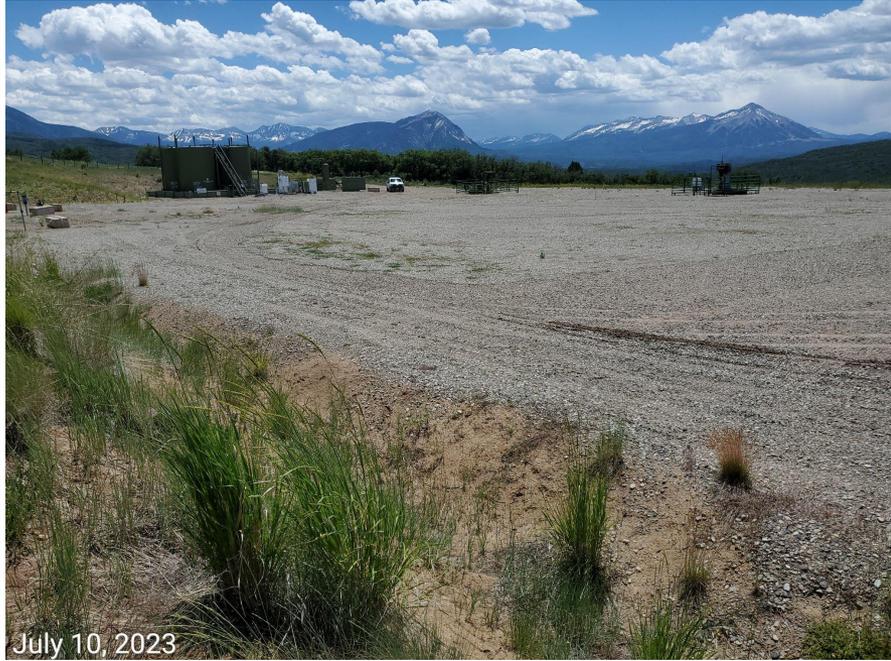
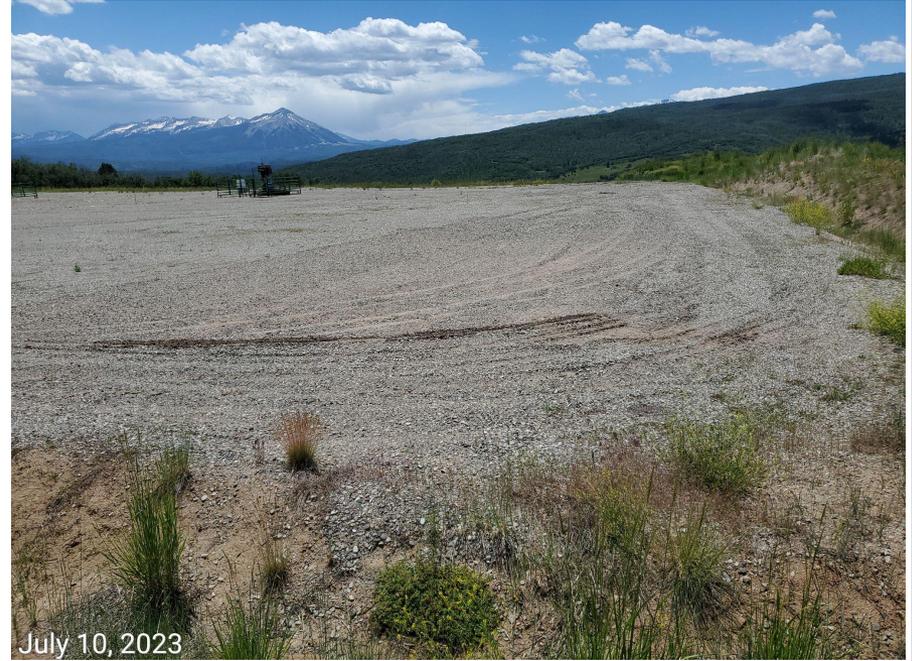
Photo 3: Photos taken from the northwest corner of the Location, facing east and south. Photos show areas on the west end of the Location, not needed for production, have not been reclaimed in accordance with 1003 Rules.

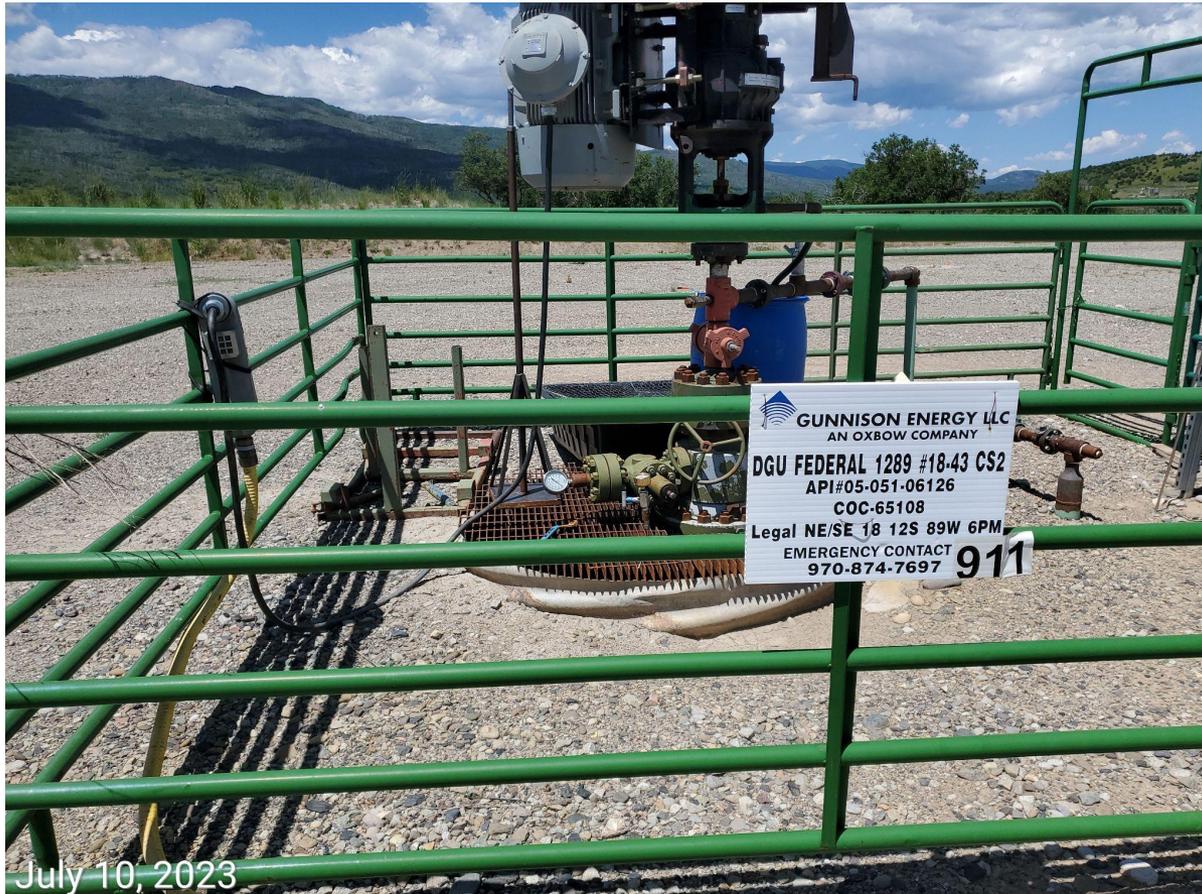
Photo 4: Photo shows Well API #051-06126. Well is the easternmost producing well on the Location.

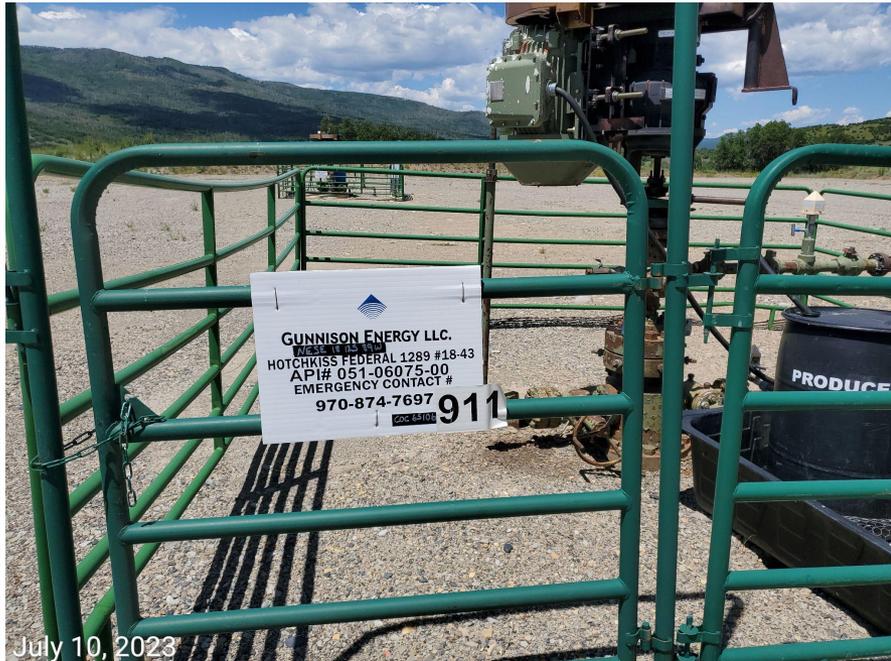
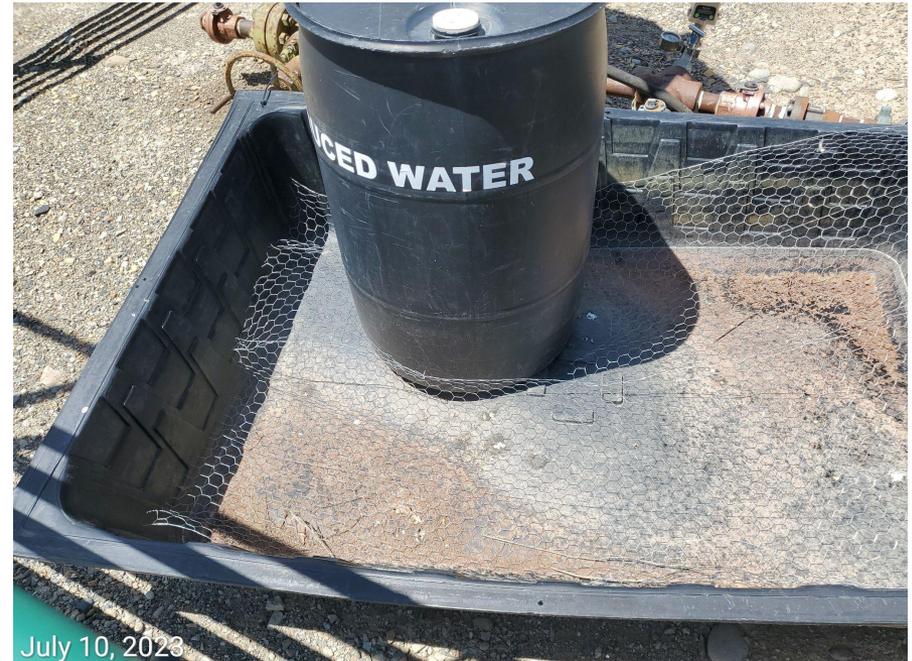
Photo 5: Photo shows Well API #051-06075. Well is the westernmost producing well on the Location; “As Drilled” coordinates within scout card incorrect. Photo right shows wildlife protection BMP (chicken wire/netting) is no longer in proper functioning condition.

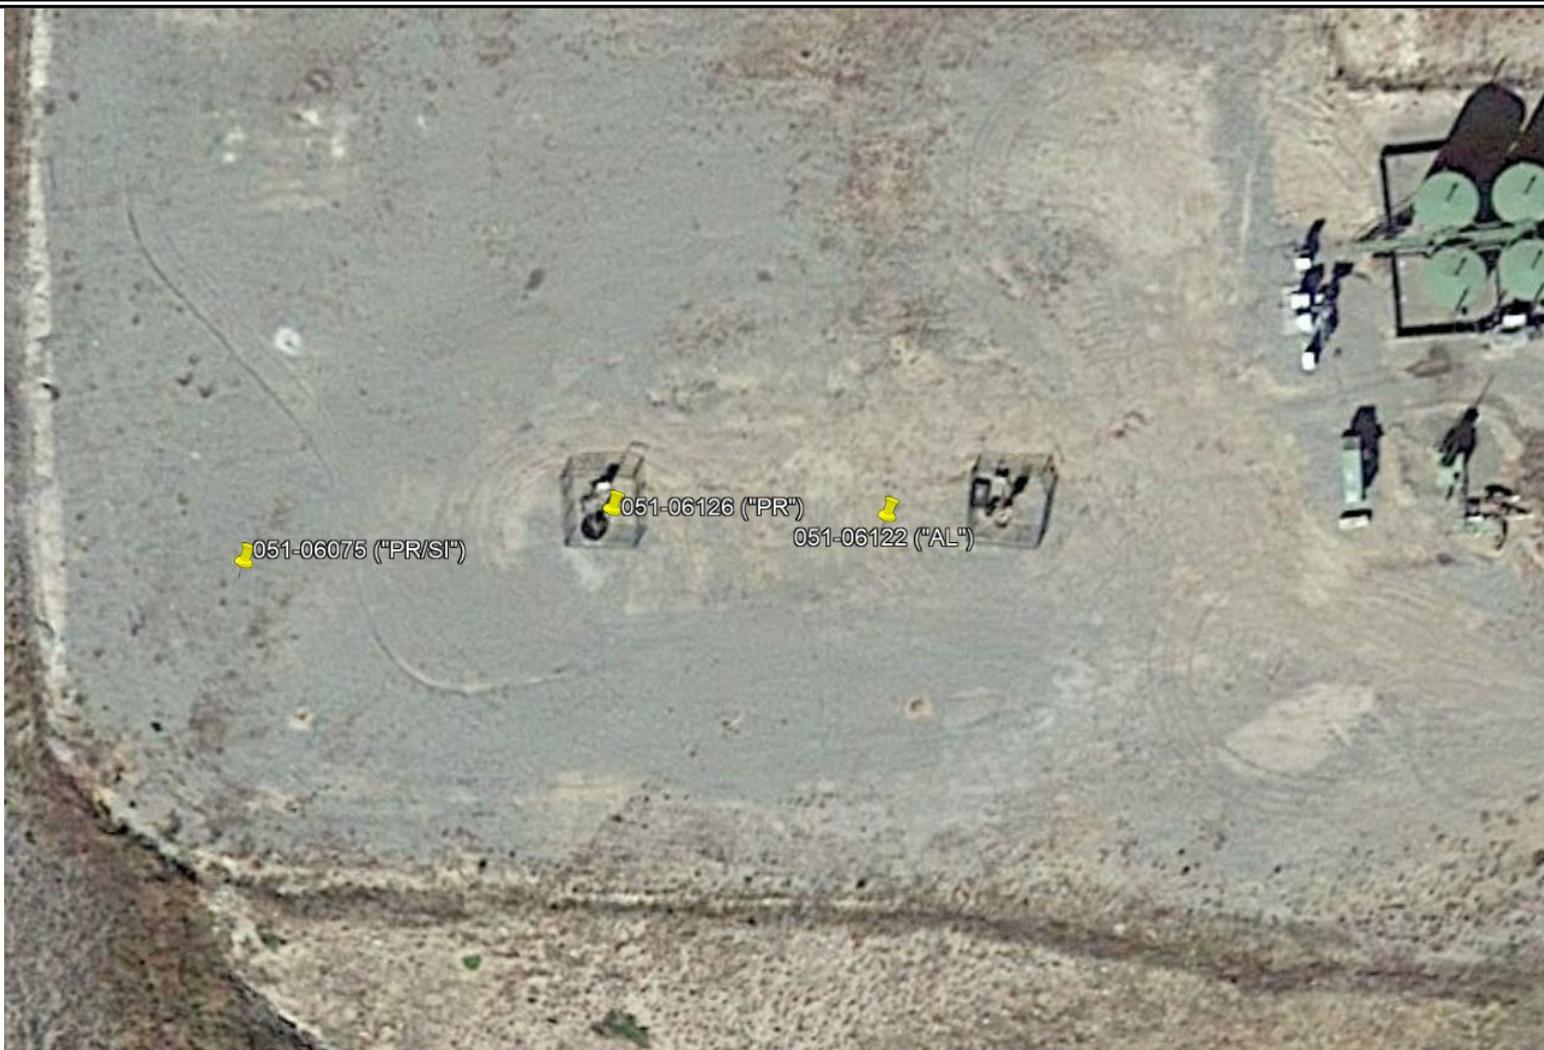
Photo 6: Continue from photo 5. Photo a Google Earth aerial image of the Location. Photo shows well coordinates from the Scout Cards; as drilled coordinates for Well API 051-06075 incorrect; coordinates for the abandoned Well API 051-06122 also incorrect.

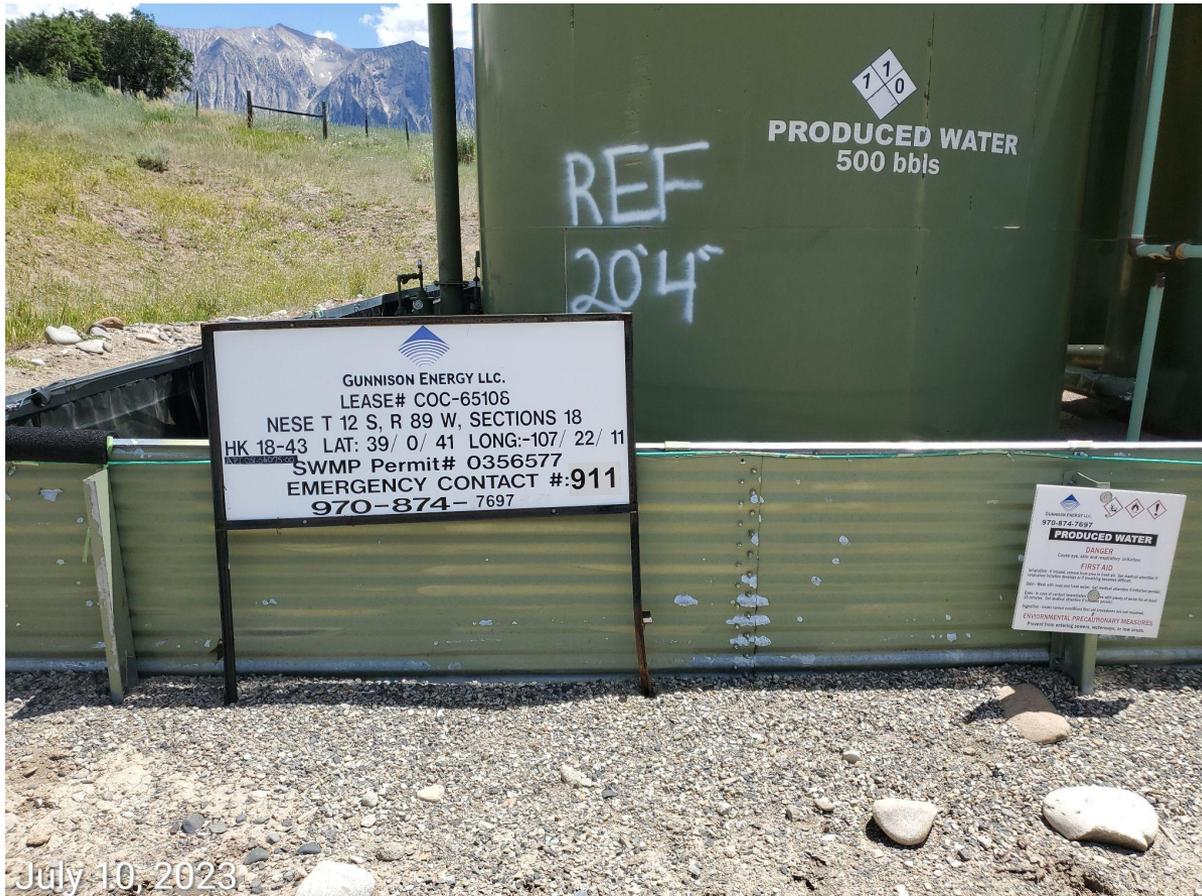
Photo 6: Photo taken from the tank battery facility on the east end of the Location. Photo shows tank battery signage missing required information in accordance with Rule 605.e; The four tanks at the battery facility observed missing required information in accordance with Rule 605.h.

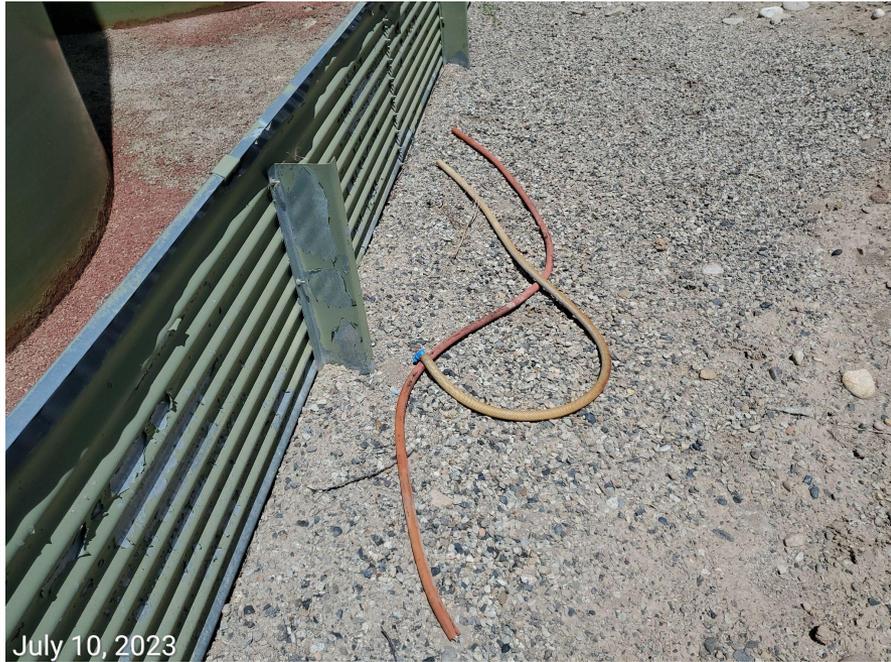
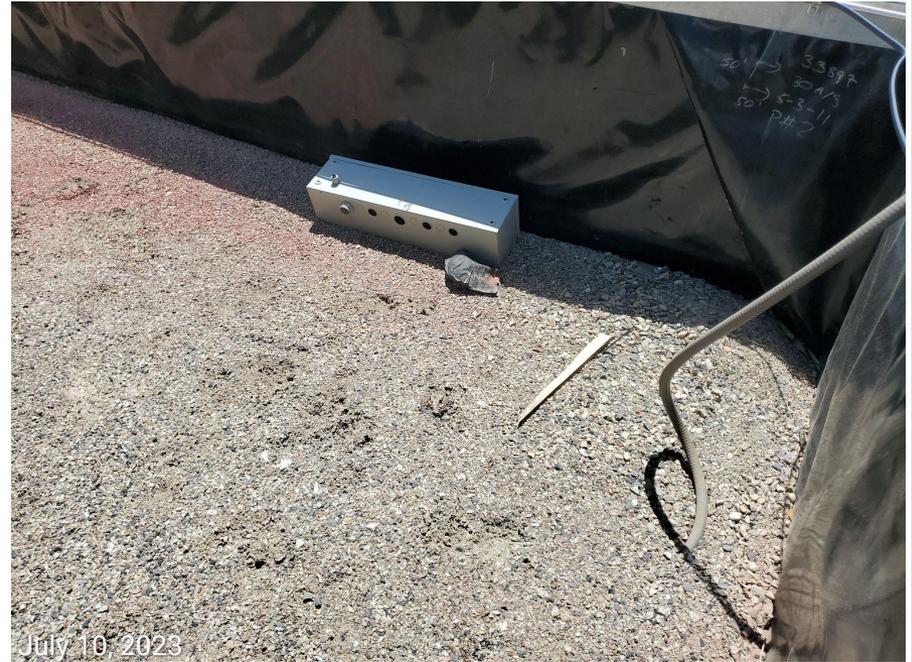
Photo 8: Photos 8-7 show various unused equipment/trash/debris observed improperly stored within the battery's containment BMP.

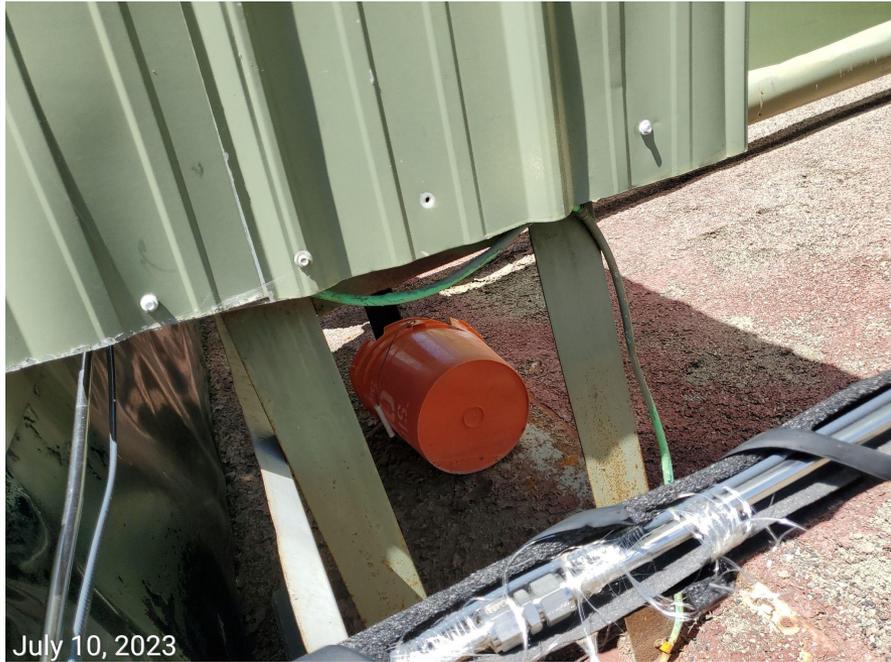
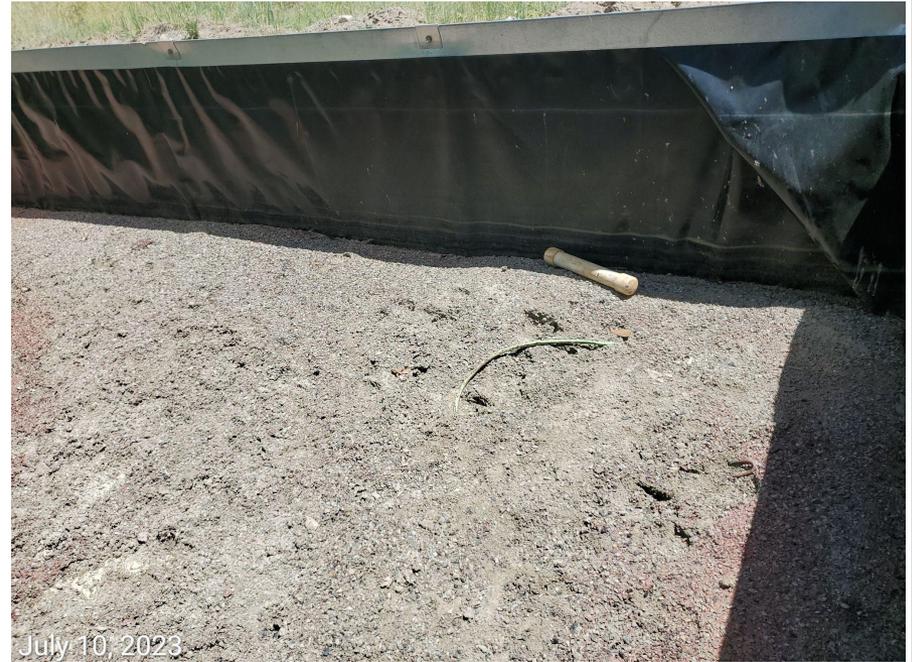
Photo 9: See comments under photo 7.

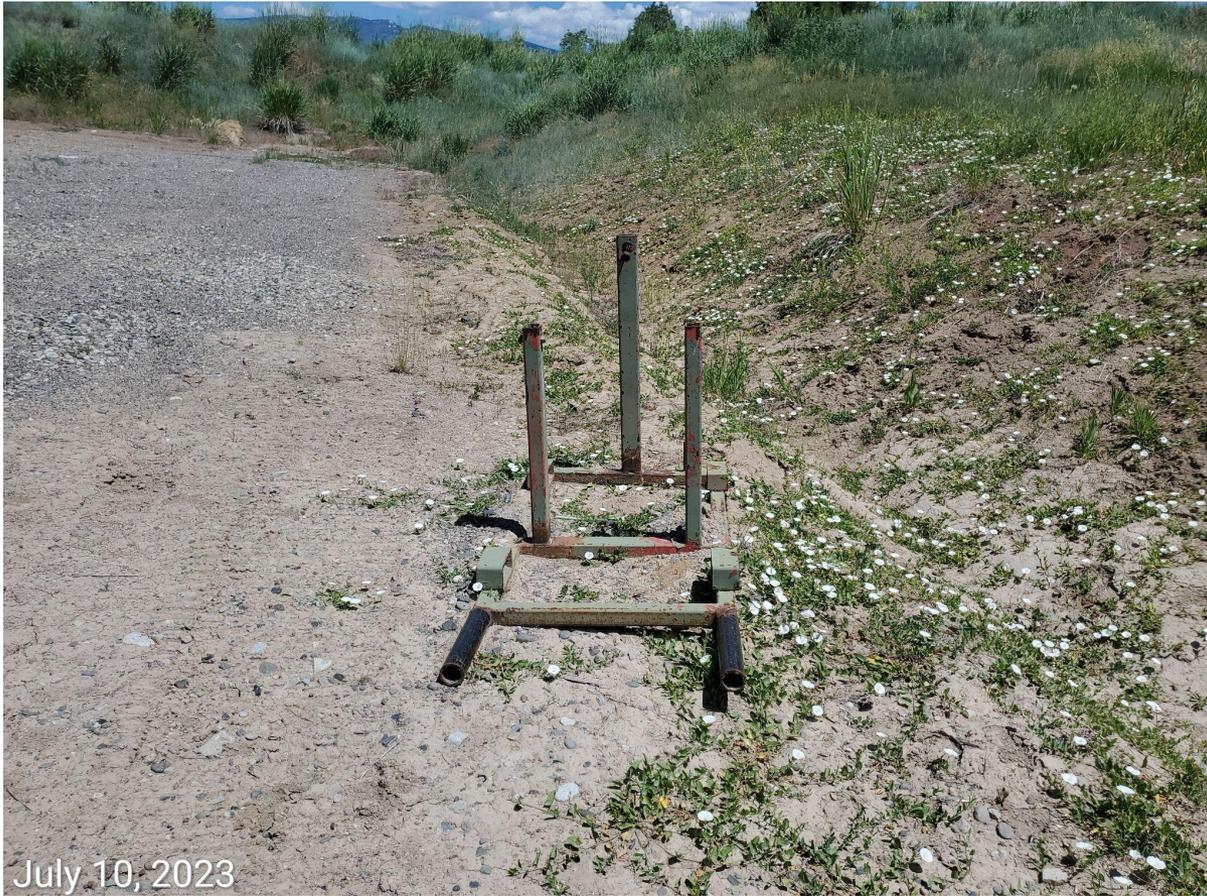
Photo 10: Photo taken from the east end of the Location. Photo shows Unused equipment stored on Location.

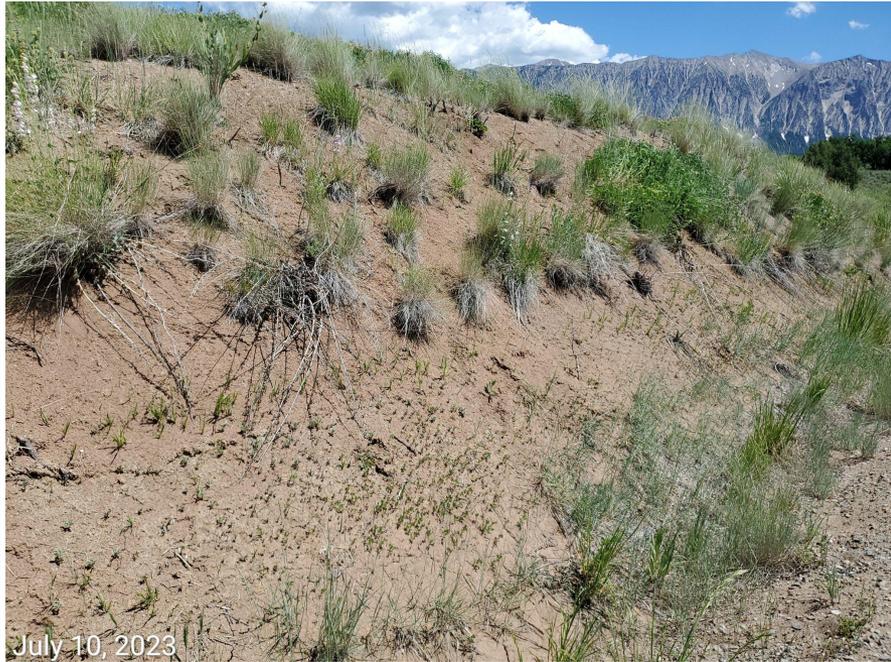
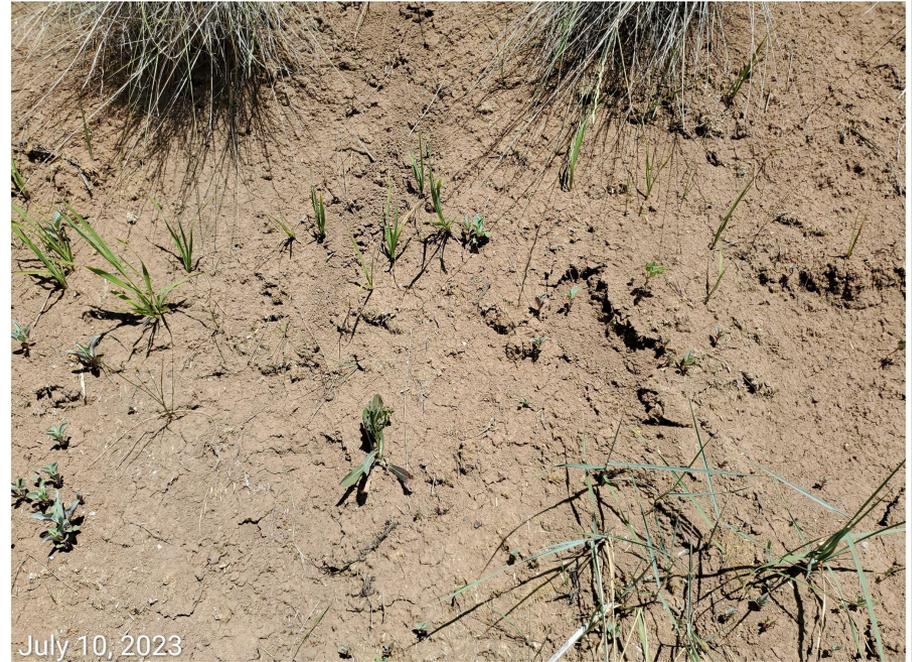
Photo 11: Photos taken from the slopes on the north end of the Location. Hydromulch observed on slopes, though degradation of the BMP is beginning to occur. Maintenance advised prior to failure of the control.

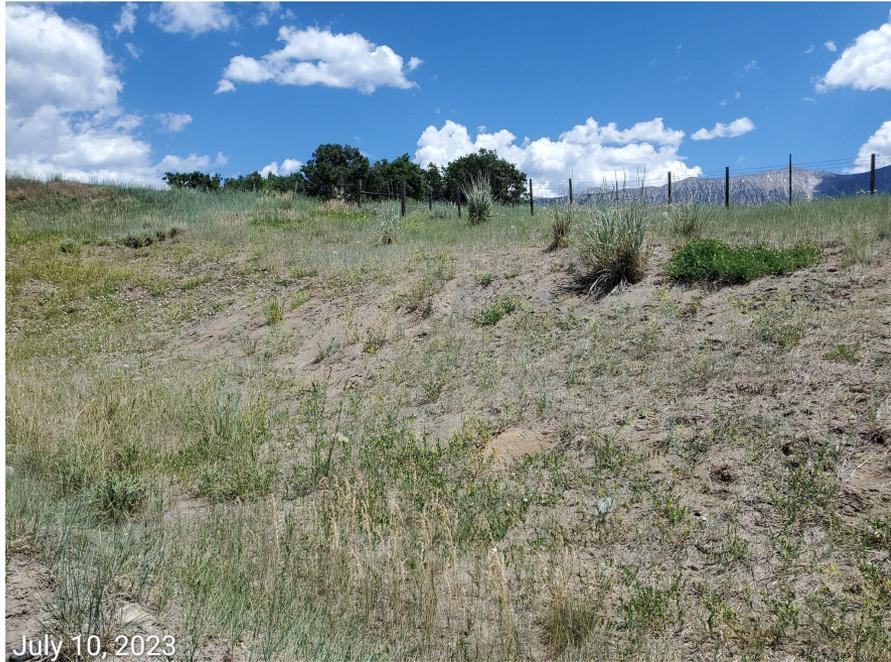
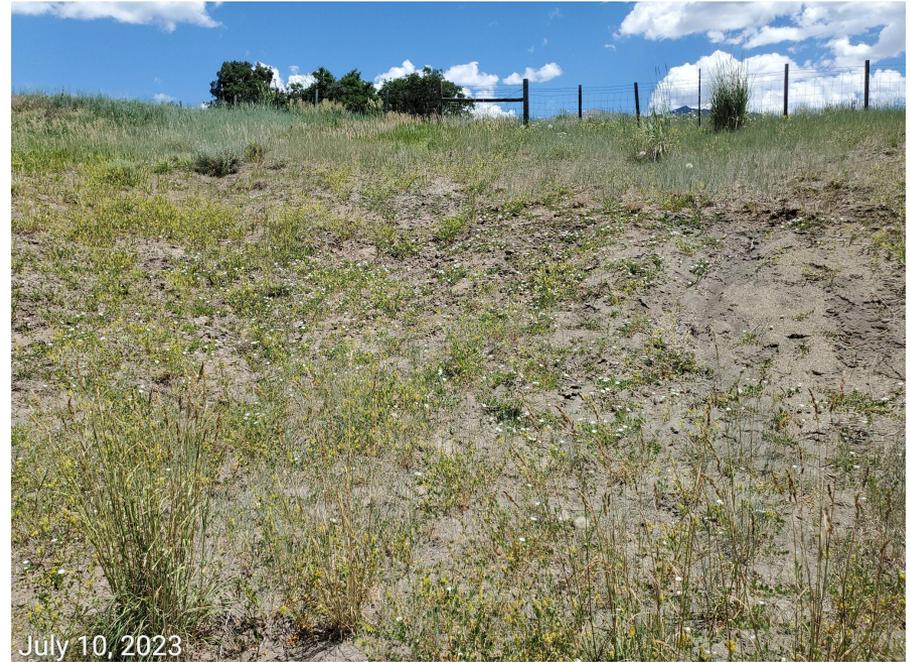
Photo 12: Photos taken from cut slopes on the east end of the Location. Hydromulch observed on slopes, though degradation of the BMP is beginning to occur. Maintenance advised prior to failure of the control. Photo right also shows Undesirable/Noxious Plant Species (Bindweed, white flowers) established on the Location.

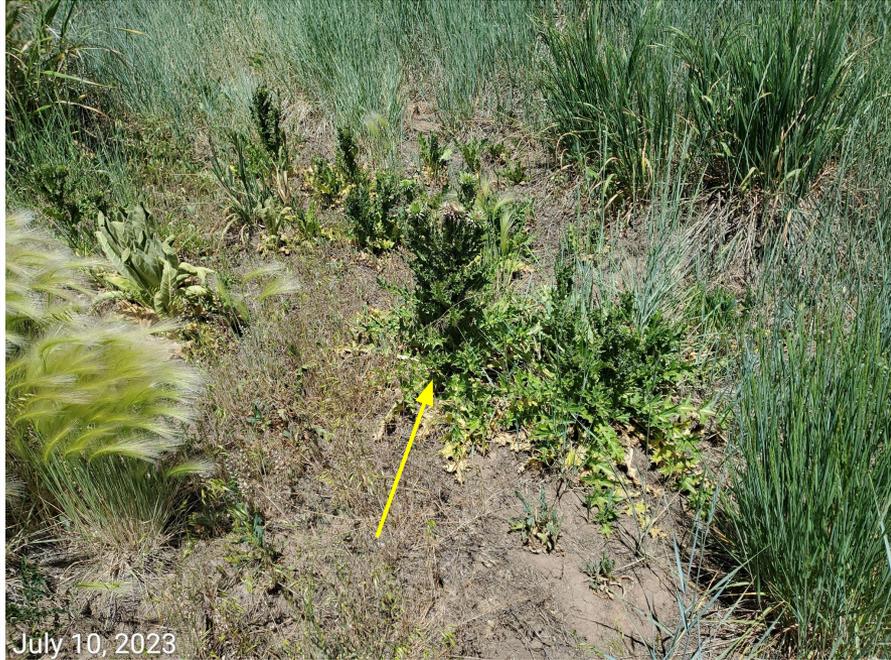
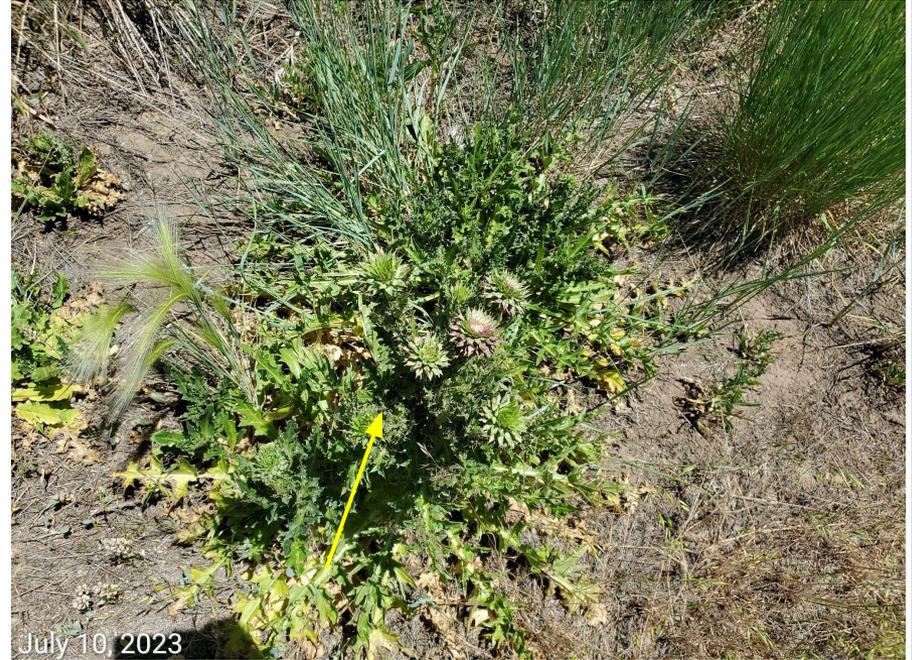
Photo 13: Photos 13-16 show Undesirable and Noxious Plant Species observed established on the vegetated areas along the perimeter of the Location, and the working pad surface.

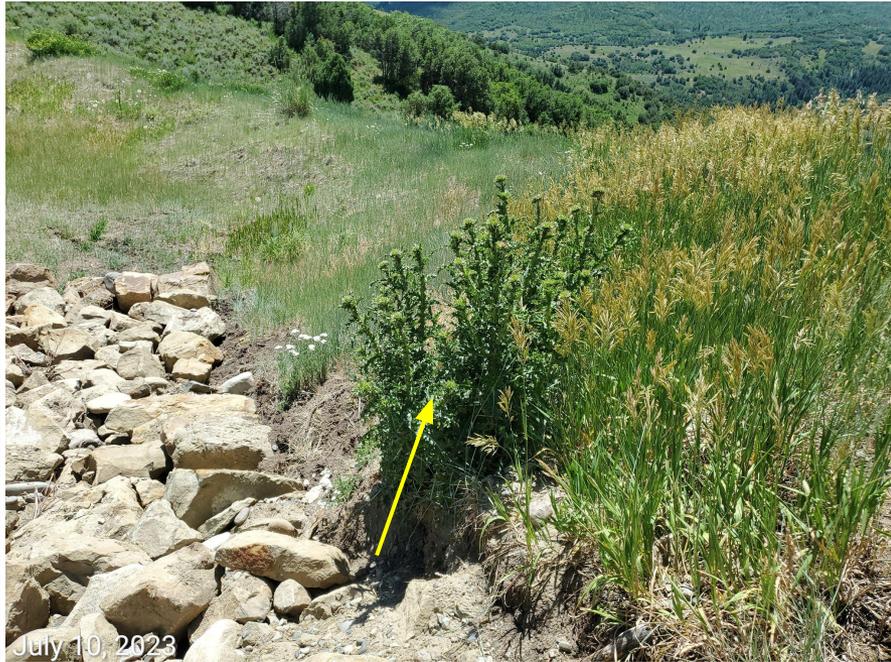
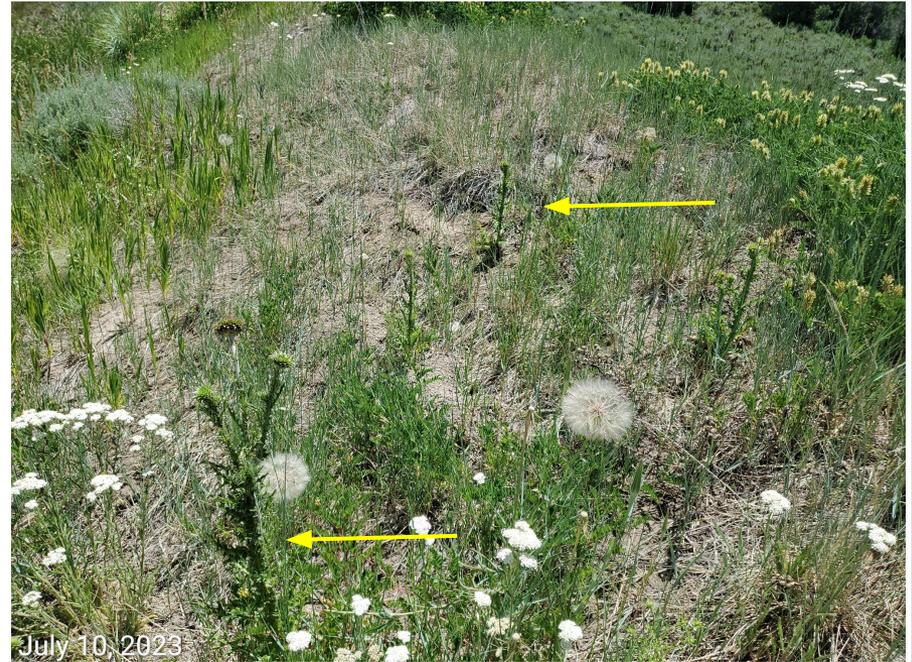
Photo 14: See comments under photo 13.

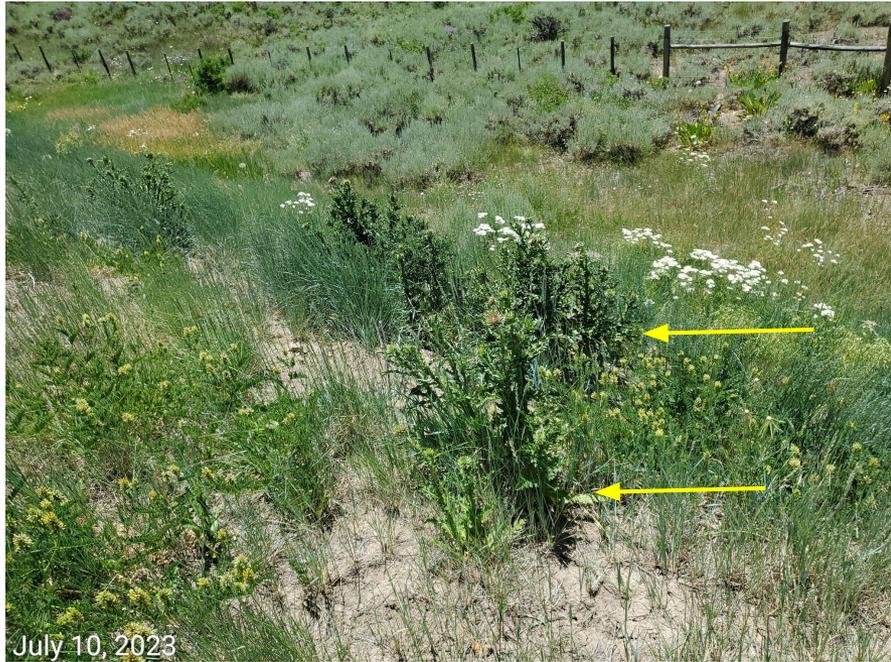
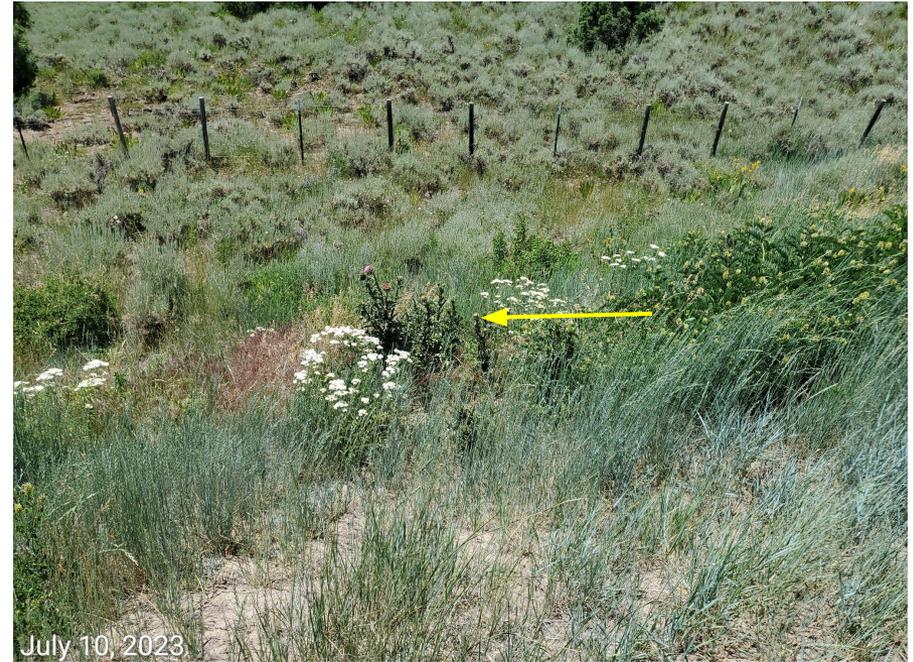
Photo 15: See comments under photo 15.

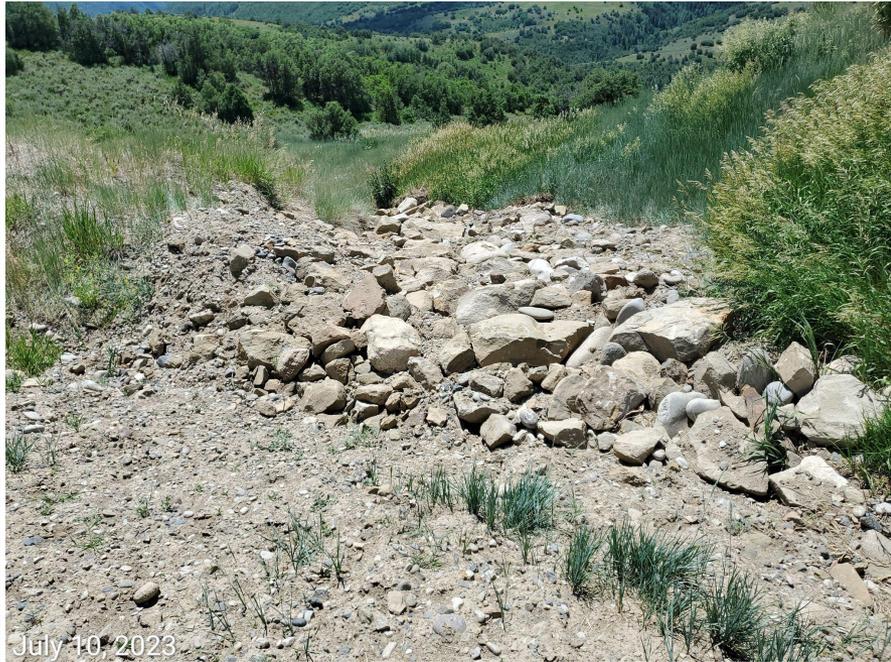
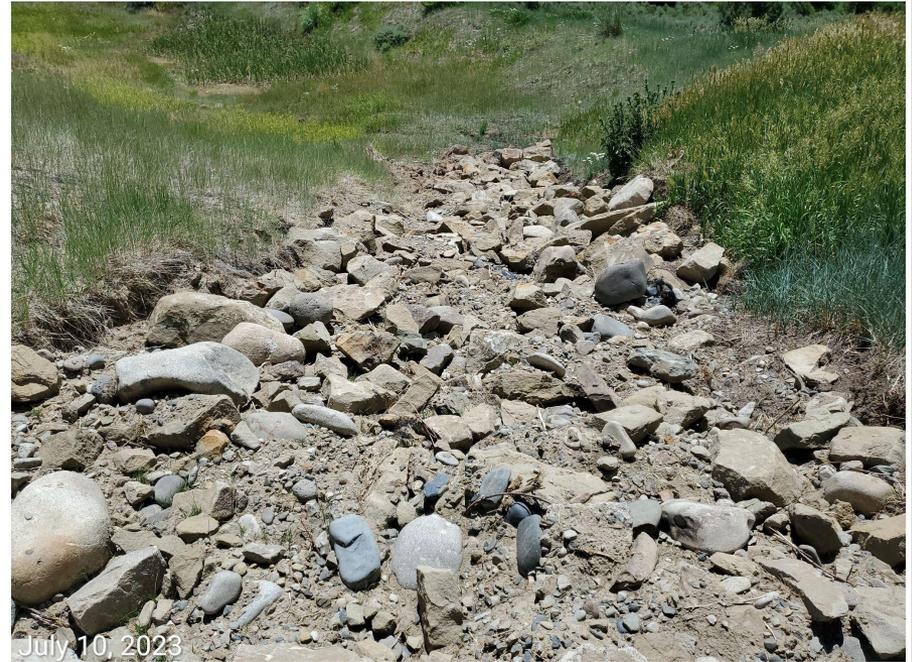
Photo 17: Photos taken from the sediment trap inlet on the southwest end of the Location. Photo shows the gully erosion has been repaired, and the inlet armored with riprap material; liner appears to have been placed beneath the rock material.
