Inspection Photos
Location Name: Just Unit 2
Location ID: 318486

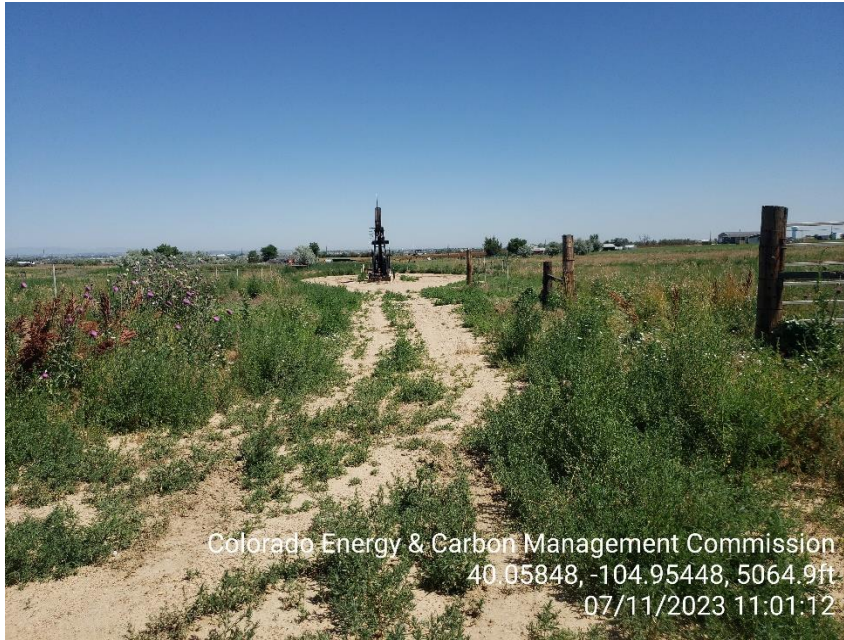
Photo 1 Location entrance

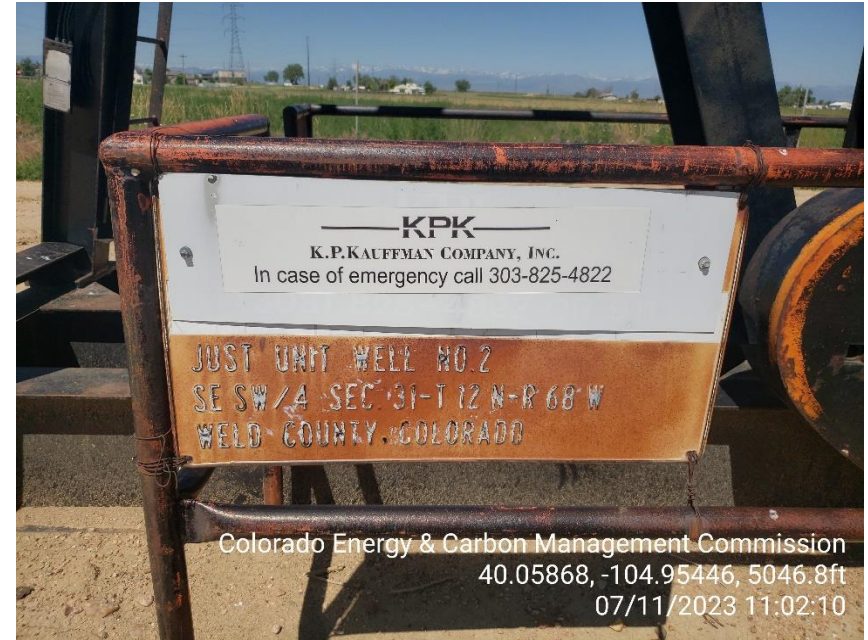
Photo 2 WH sign

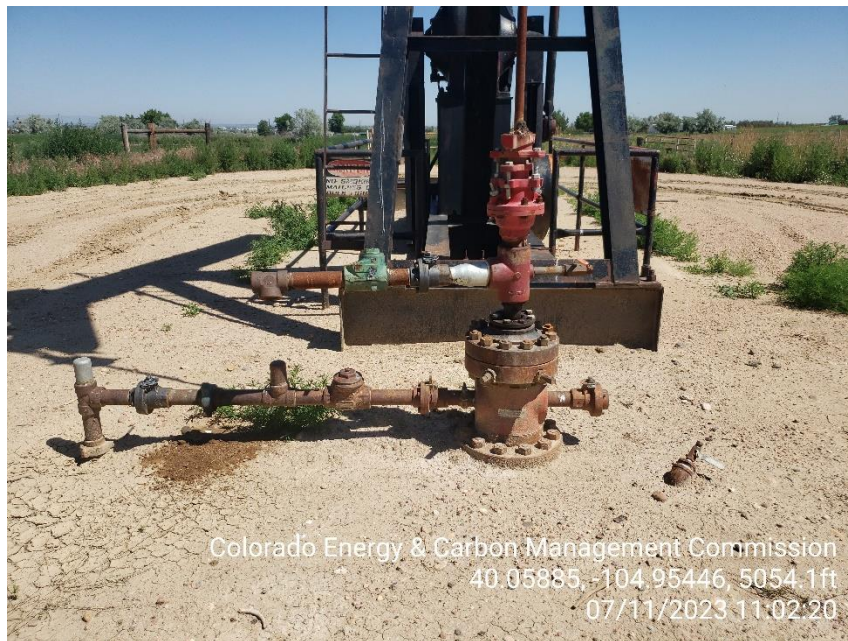
Photo 3 WH, Stained soil under flow line

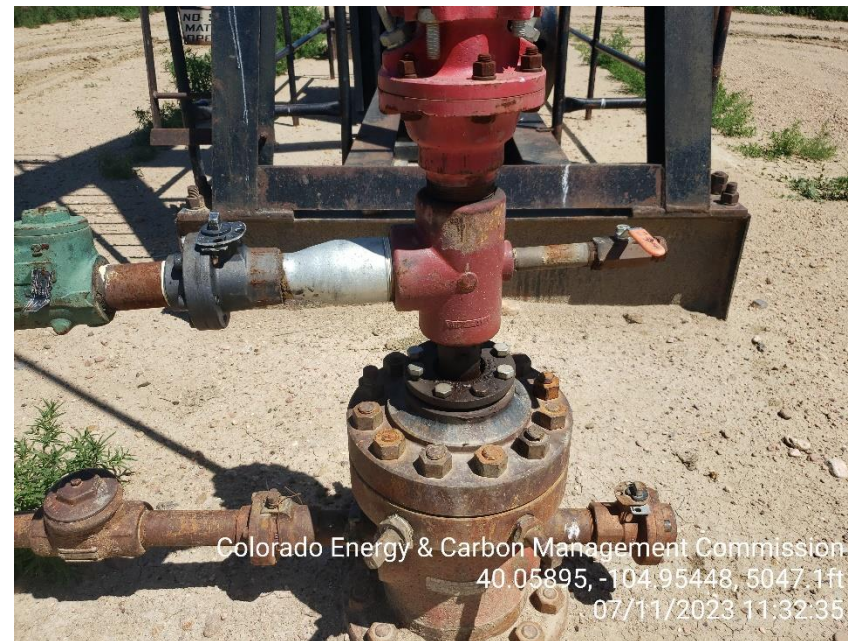
Photo 4 WH is SI.

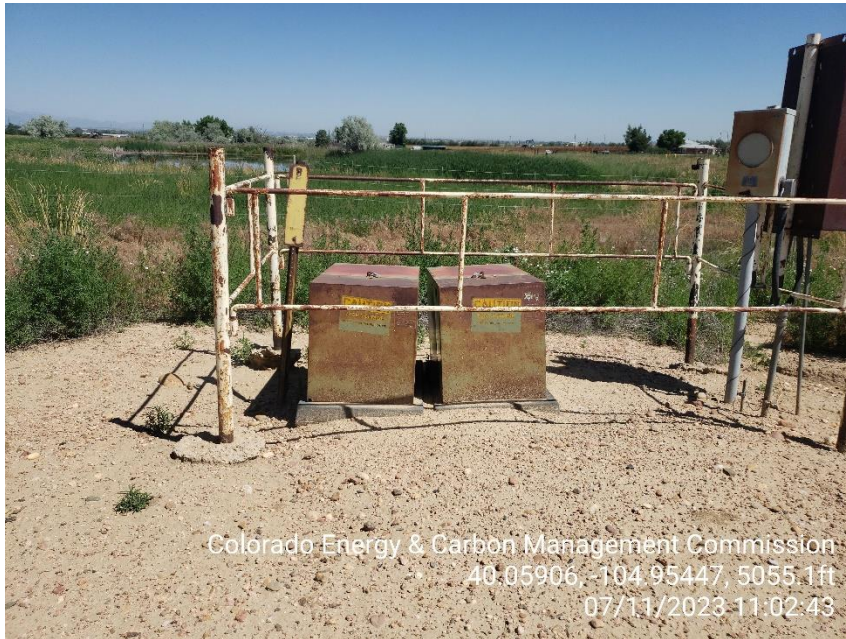
Photo 5 Ancillary Equip.

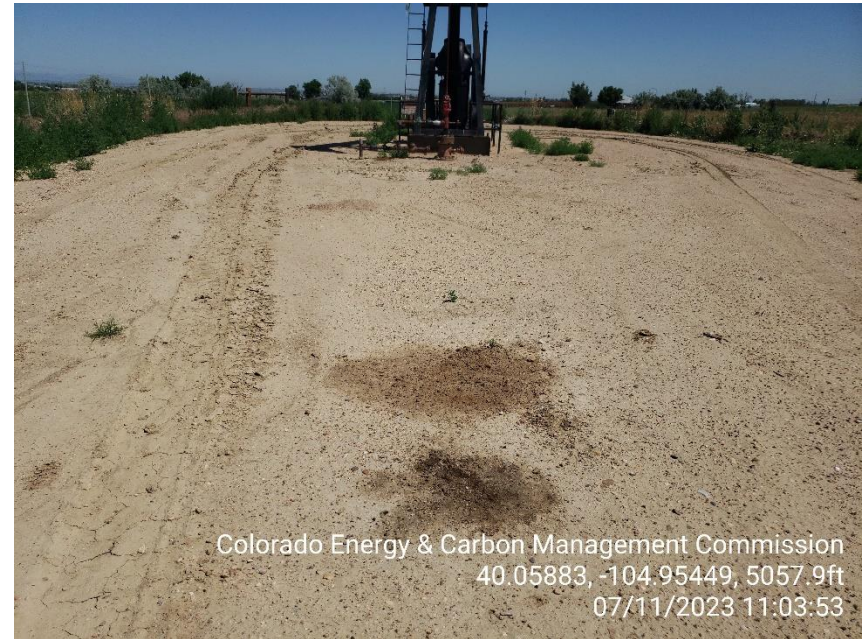
Photo 6 Spotty stained soil .

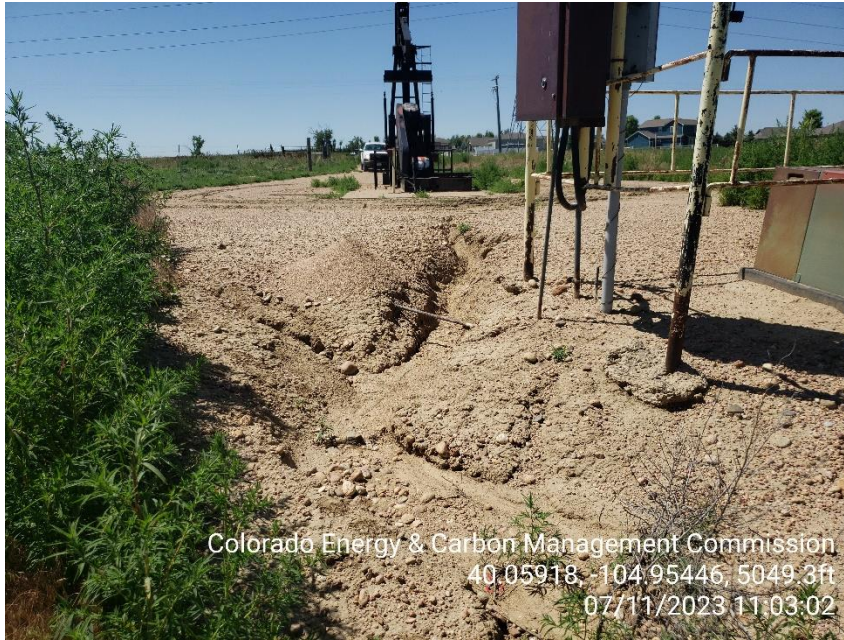
Photo 7 Sediment laden storm water has discharged sediment off location by the ancillary equipment.
