**Inspection Photos**  
**Location Name: Brophy J 26-15**  
**Location ID: 125-07570**

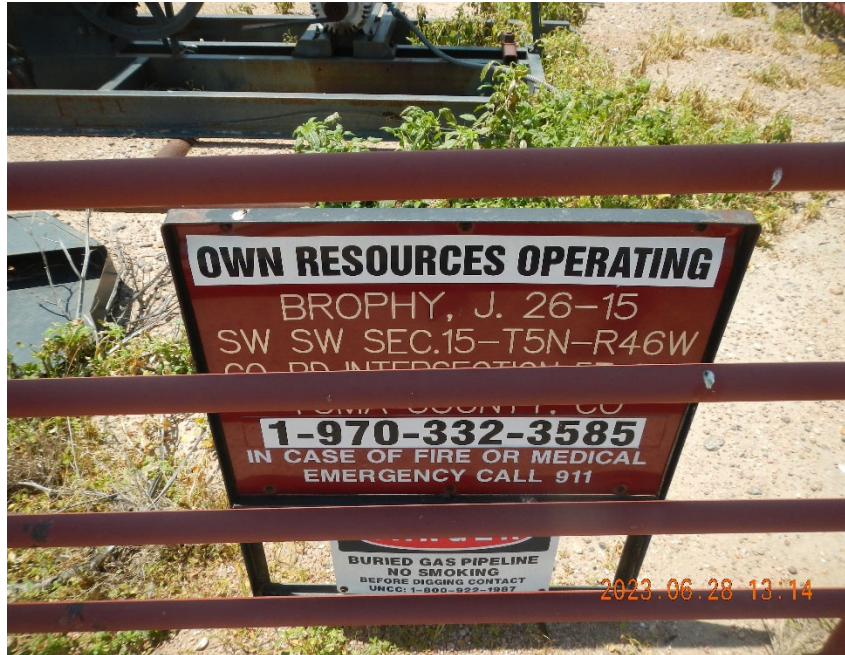
**1. Well sign at well site.**

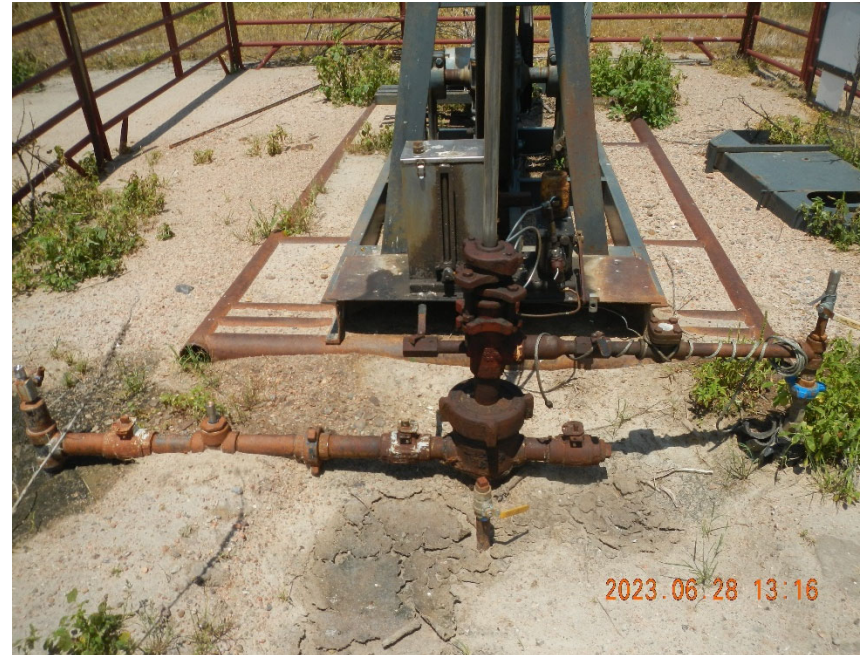
**2. View of wellhead. Note stained soils in lower left of picture.**

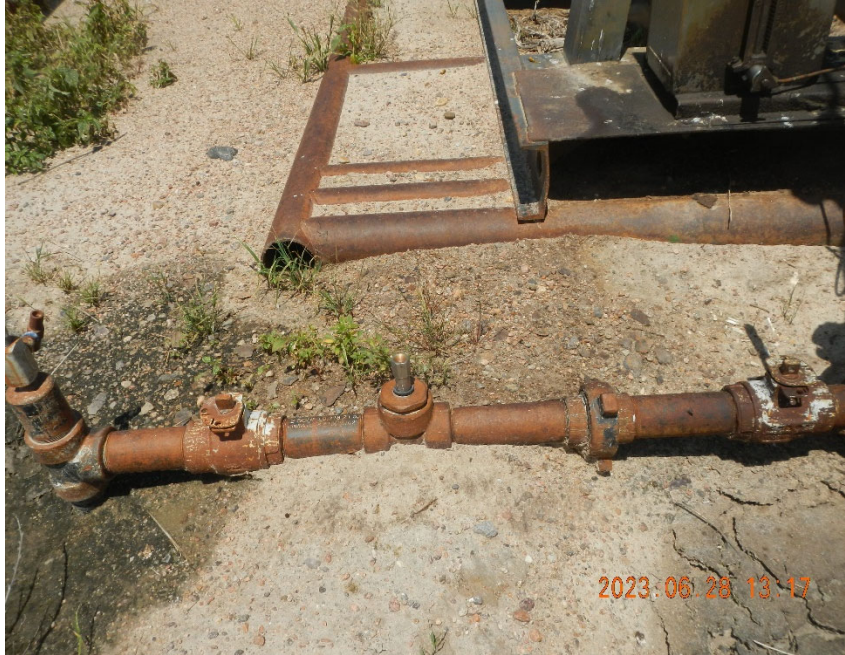
**3. Casing flowline off west side of wellhead with visible soil staining.**

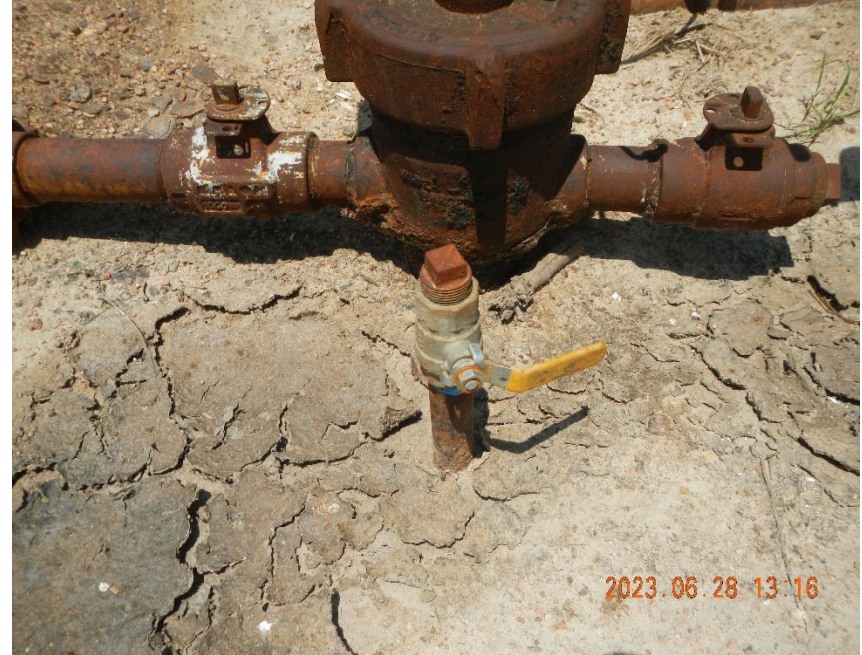
**4. Soils areas that are dry with visible cracks and what appears to be unstained soil below.**

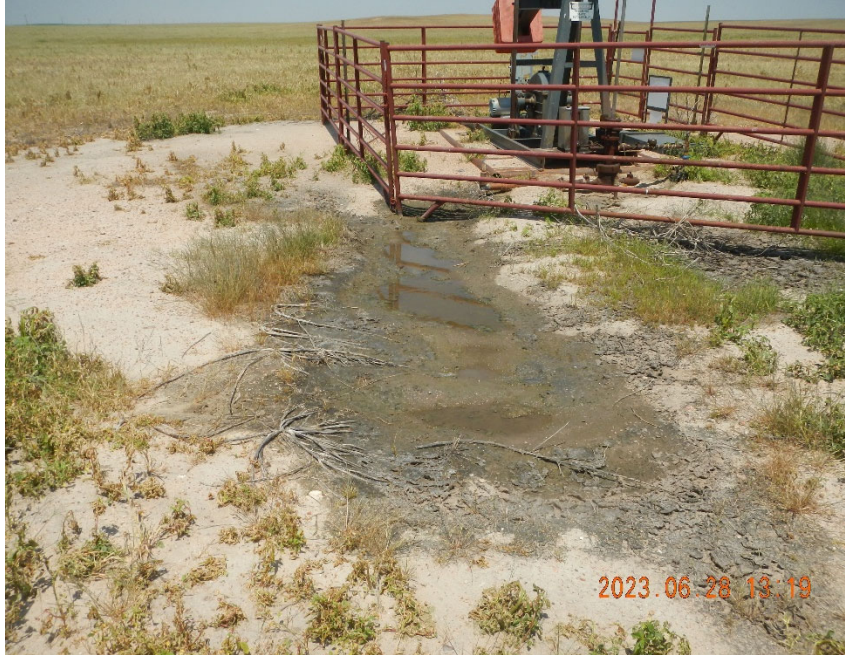
**5. Overview of stained soil to the south and west outside the stock panel fencing that surrounds the well site.**

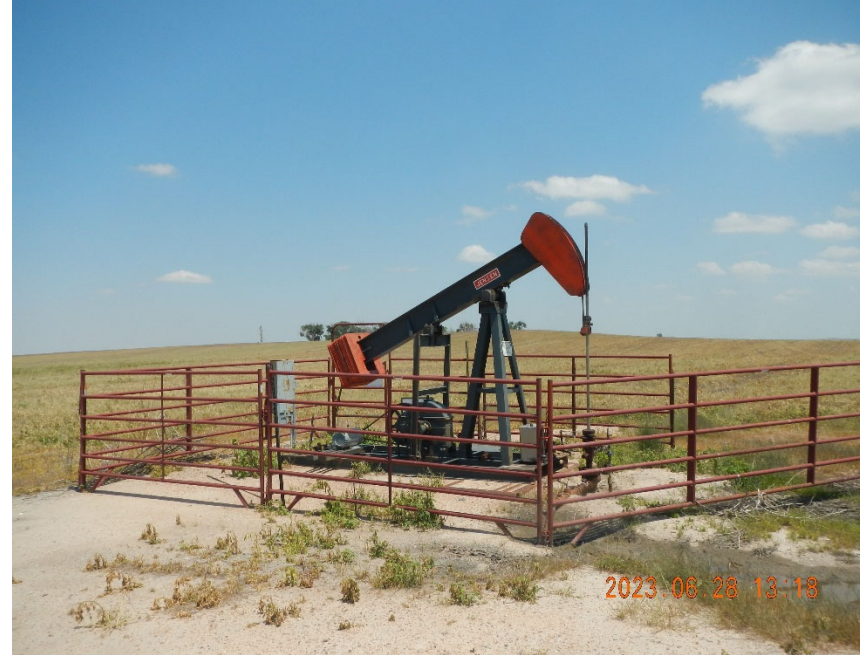
**6. View of Pump Jack. Note staining in lower right portion of picture.**

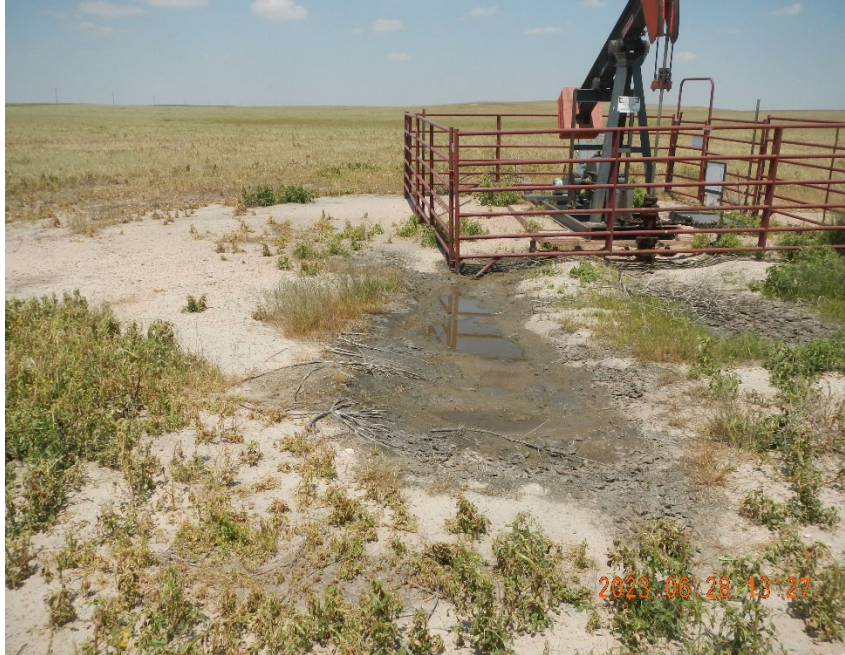
**7. Overview of well site looking North. Staining visible at center of photo.**

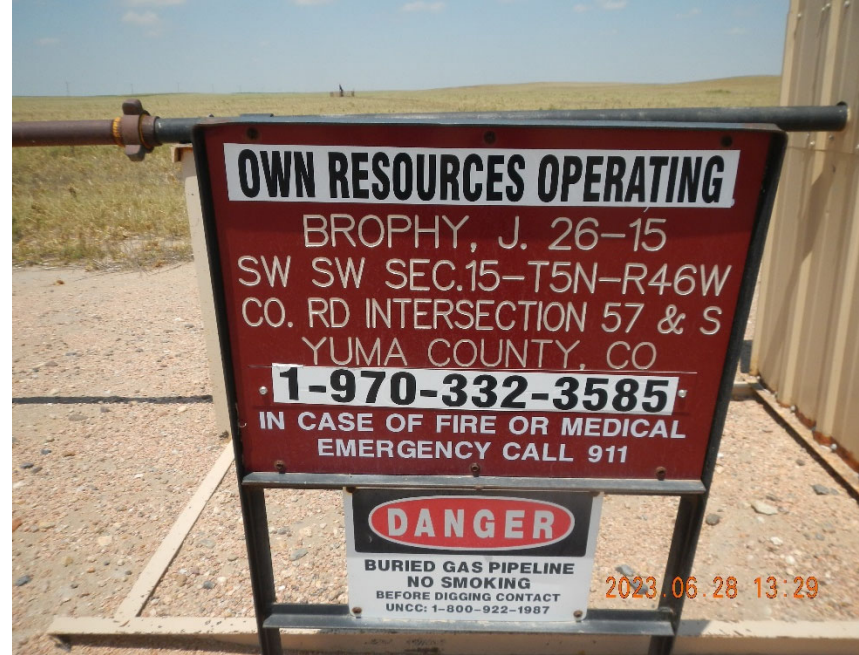
**8. Well sign at remote Gas Meter Run.**

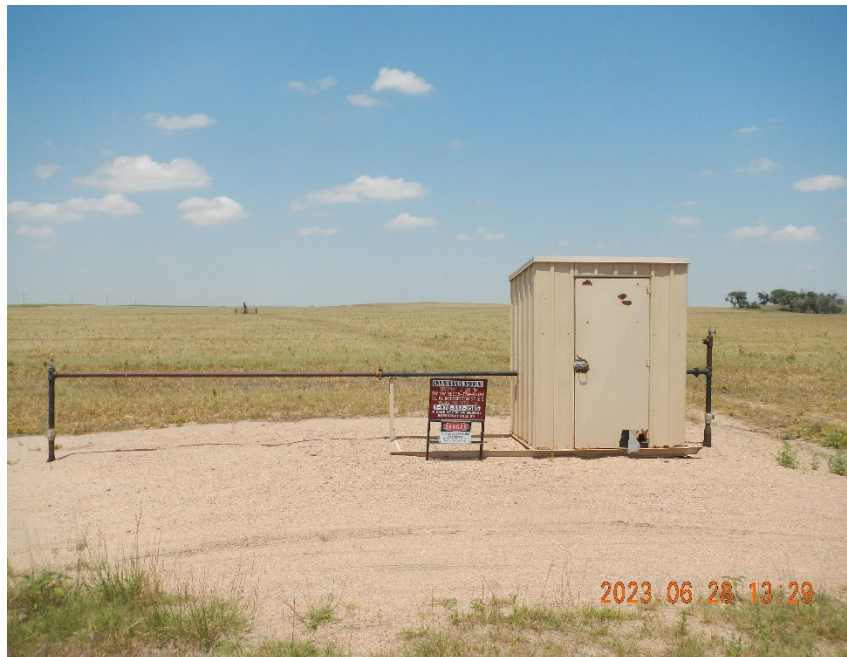
**9. View of remote meter site off CR 57.**

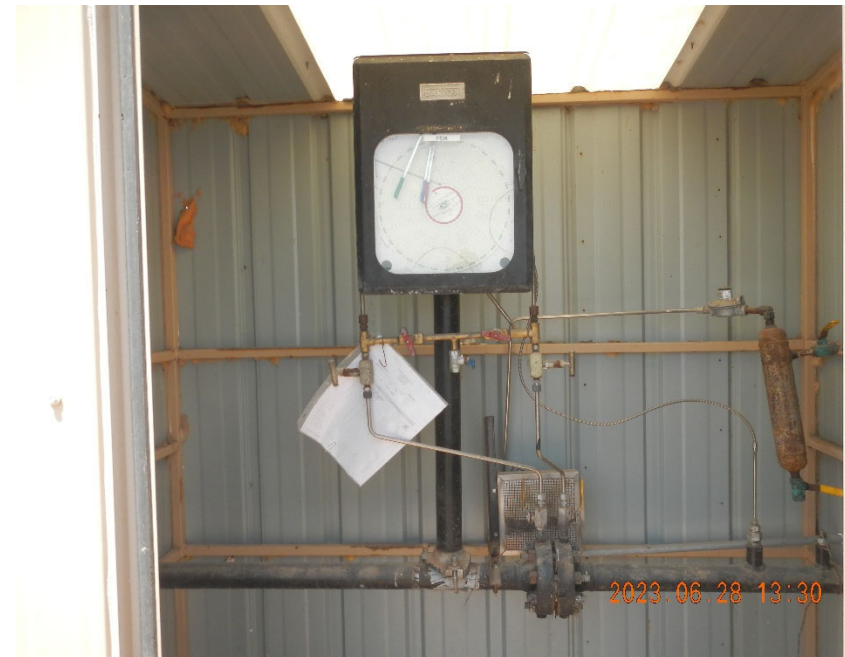
**10. View of gas meter run inside meter shed.**
