Inspection Photos

Location Name: TEP ROCKY MOUNTAIN LLC FEDERAL RWF 13-19 Pad

Location ID: 335434

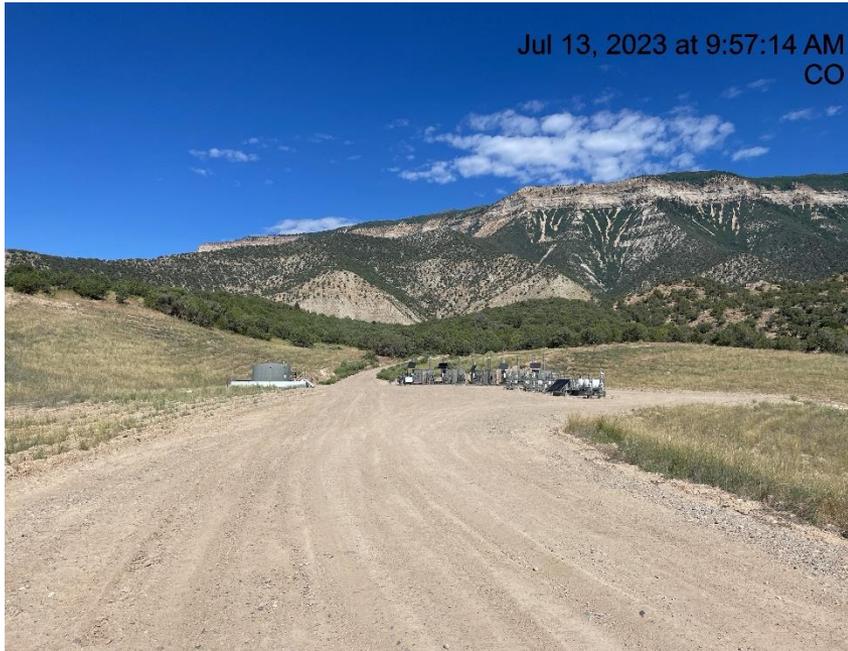
Photo # 2905 From entrance to location

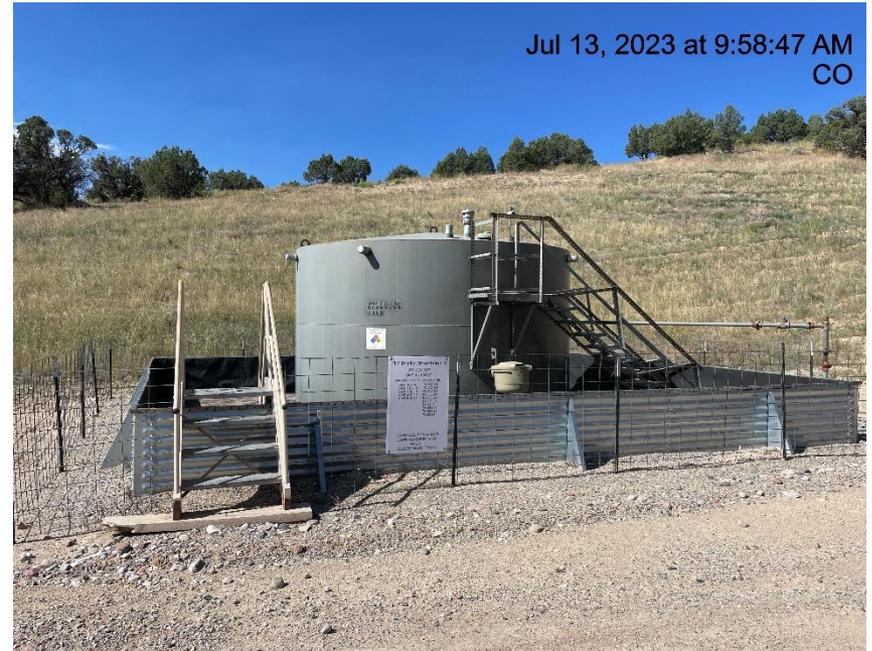
Photo # 2906 Location

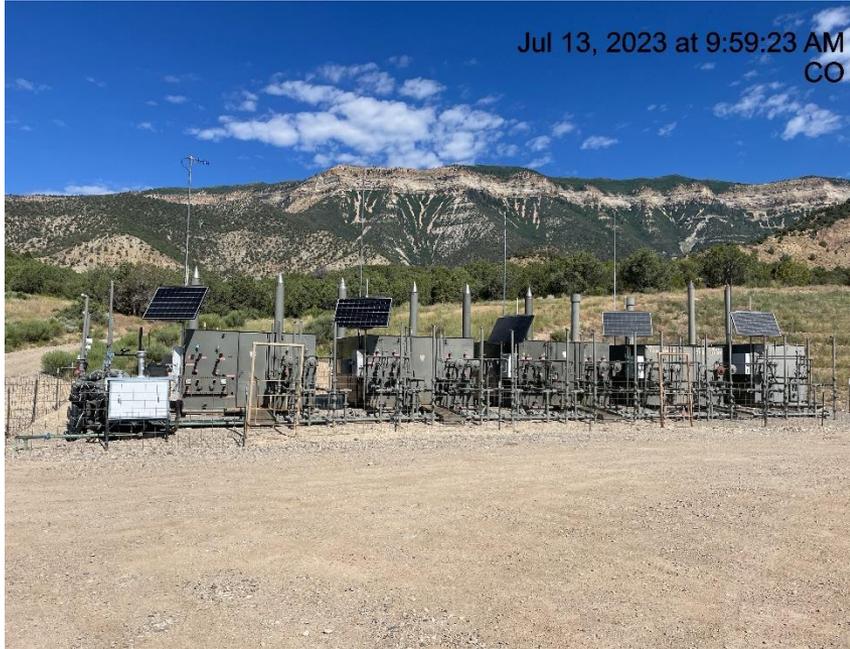
Photo # 2907 Location

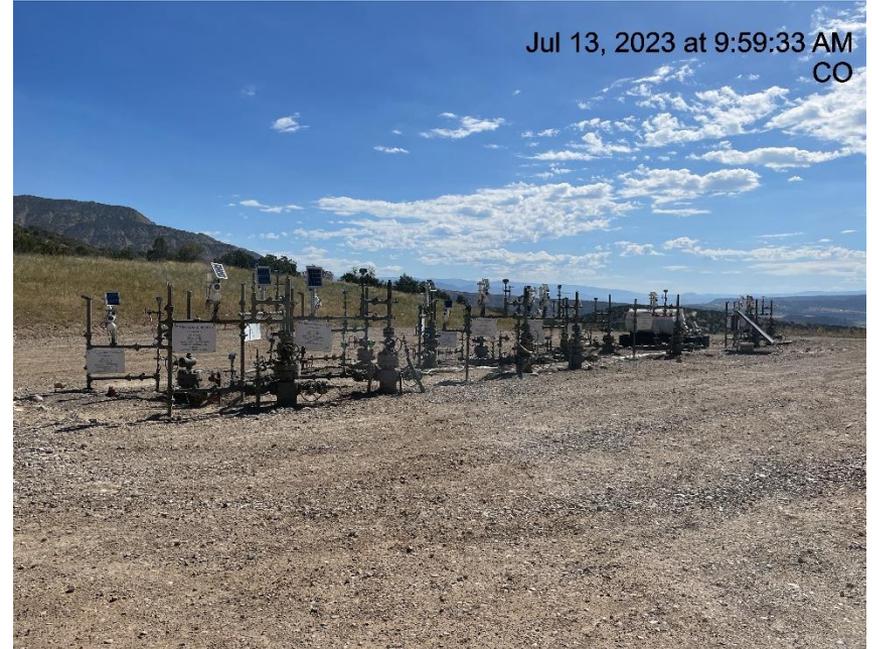
Photo # 2908 Location

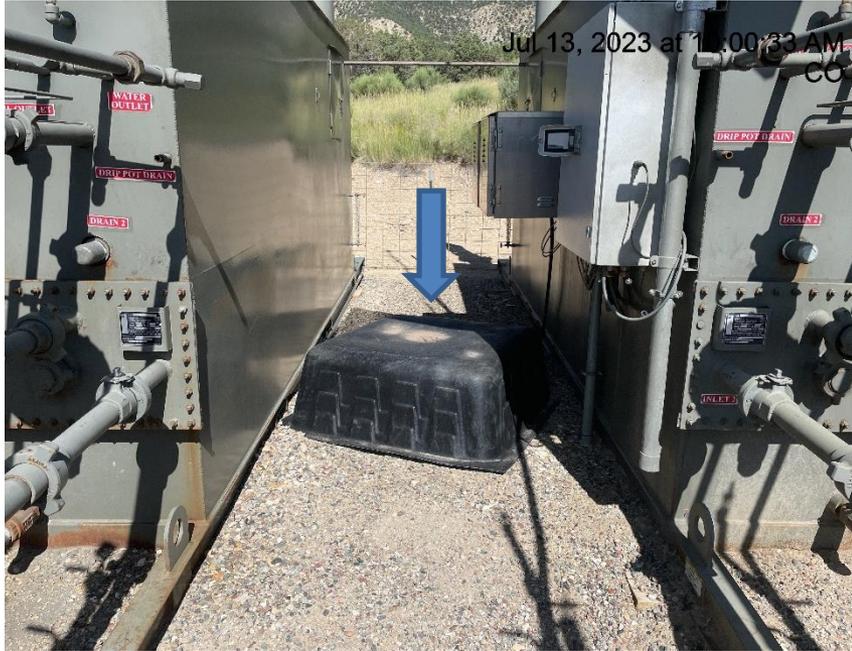
Photo # 2911 Debris

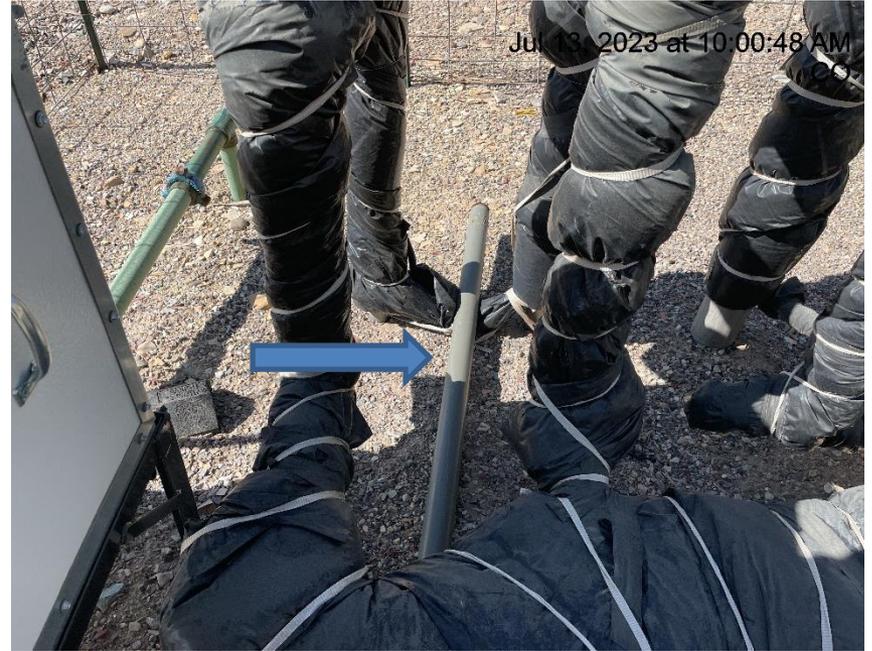
Photo # 2912 Debris

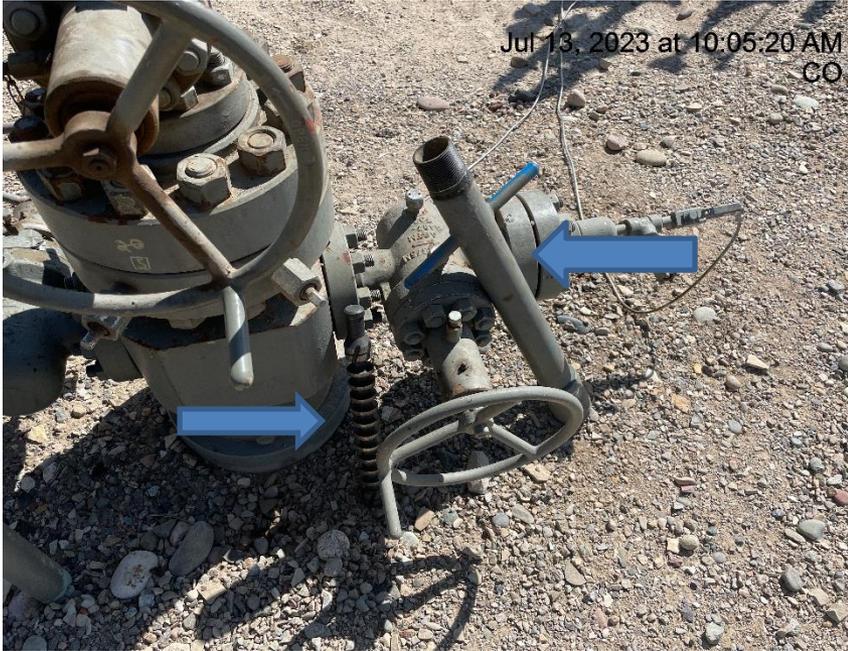
Photo # 2915 Debris

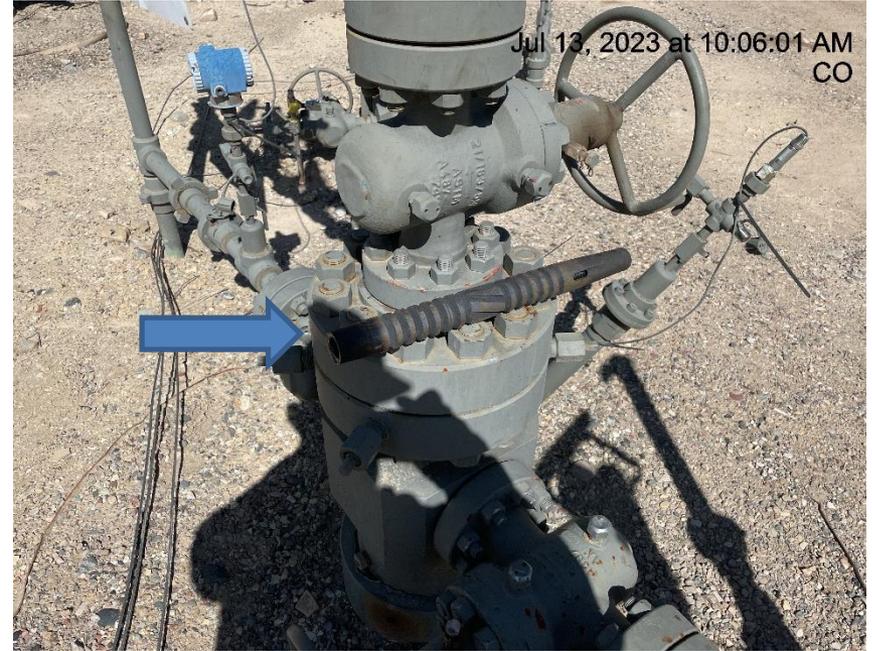
Photo # 2917 Debris

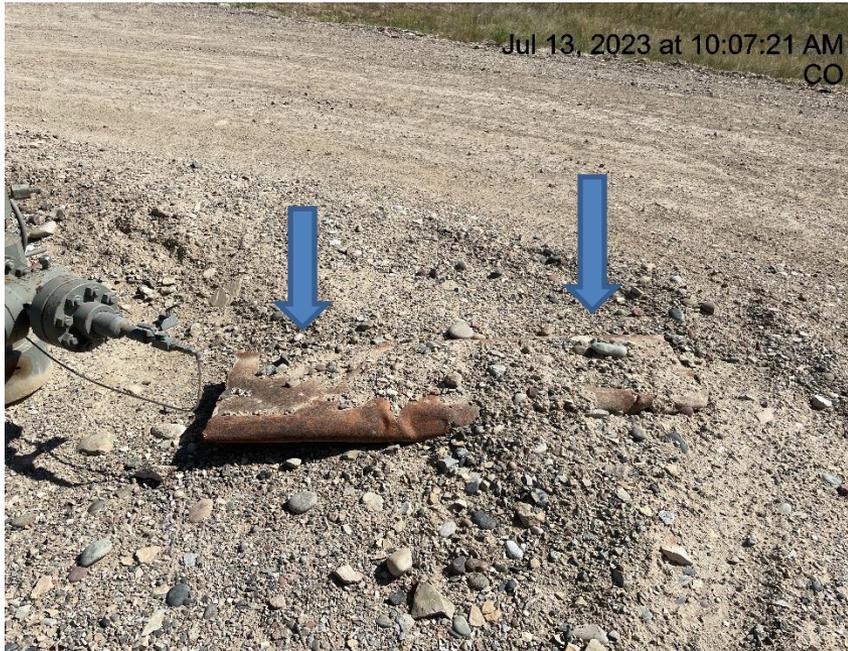
Photo # 2918 Debris

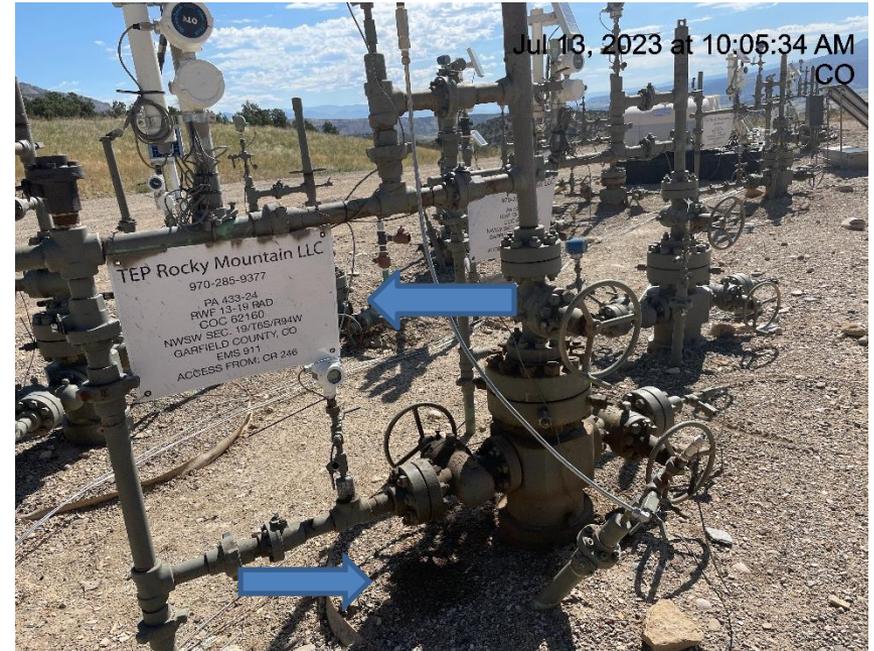
Photo # 2916 Wellhead sign missing API # & Stained soils & gravel near wellhead

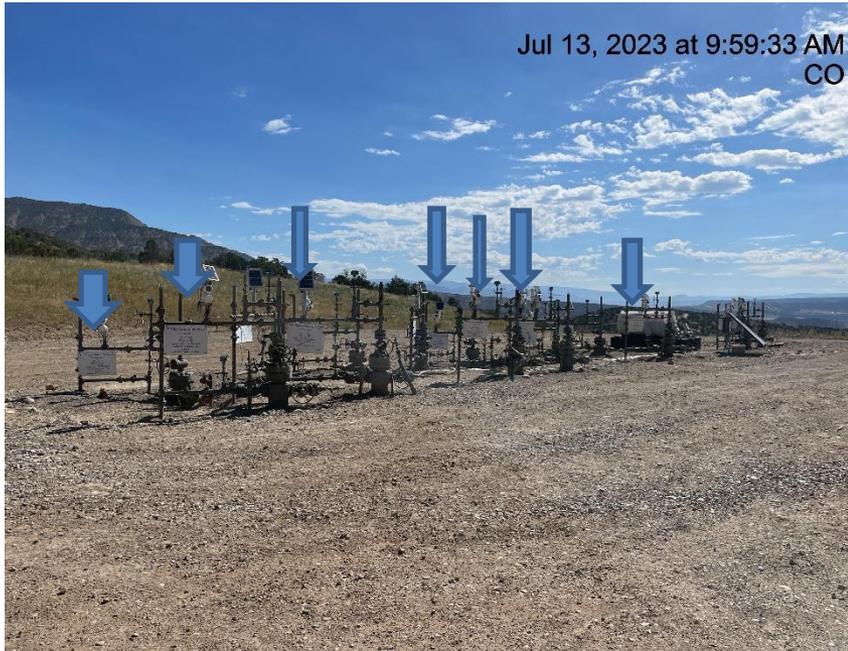
Photo # 2908 Multiple wellhead signs missing API #

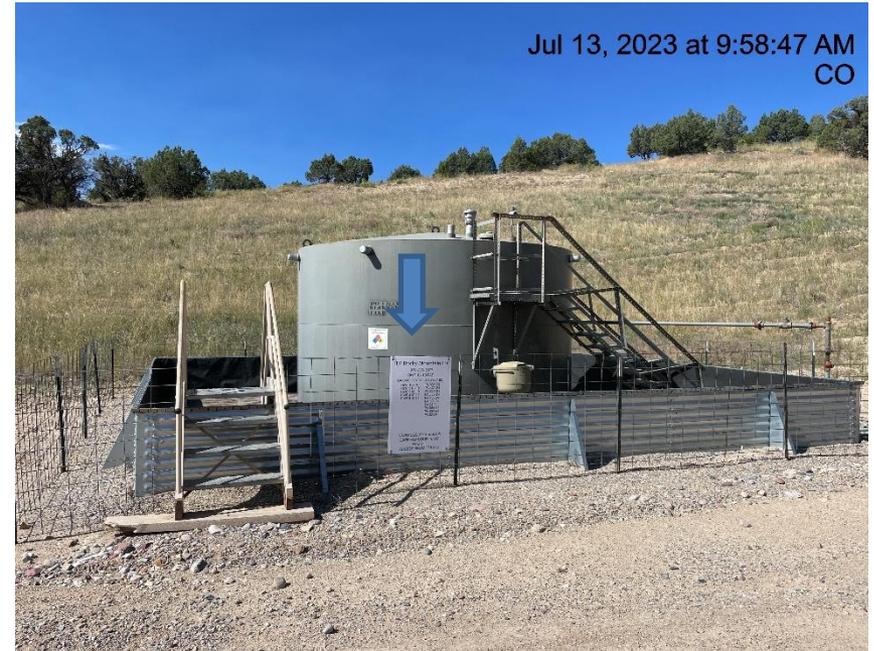
Photo # 2906 Battery sign missing well API #'s

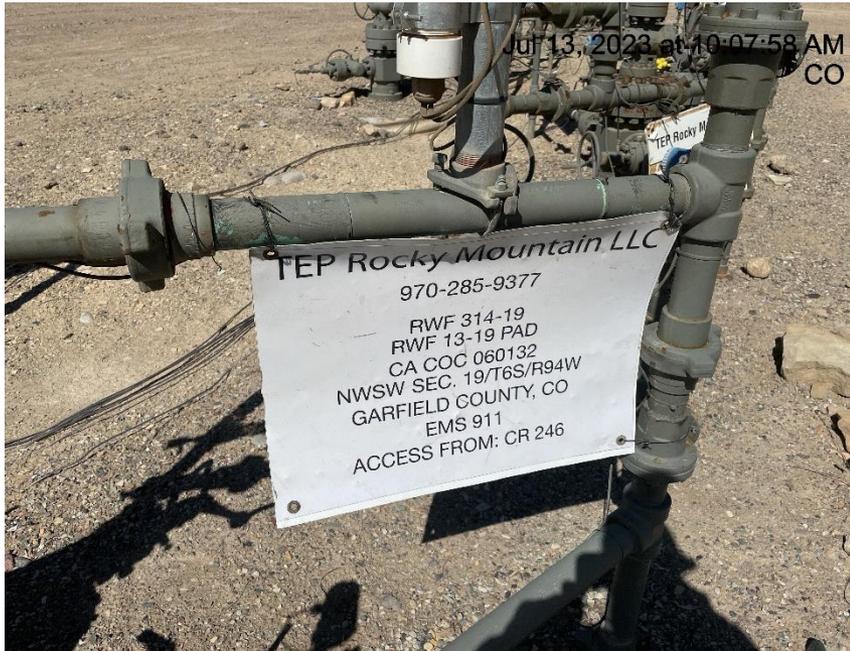
Photo # 2920 Wellhead sign missing API #

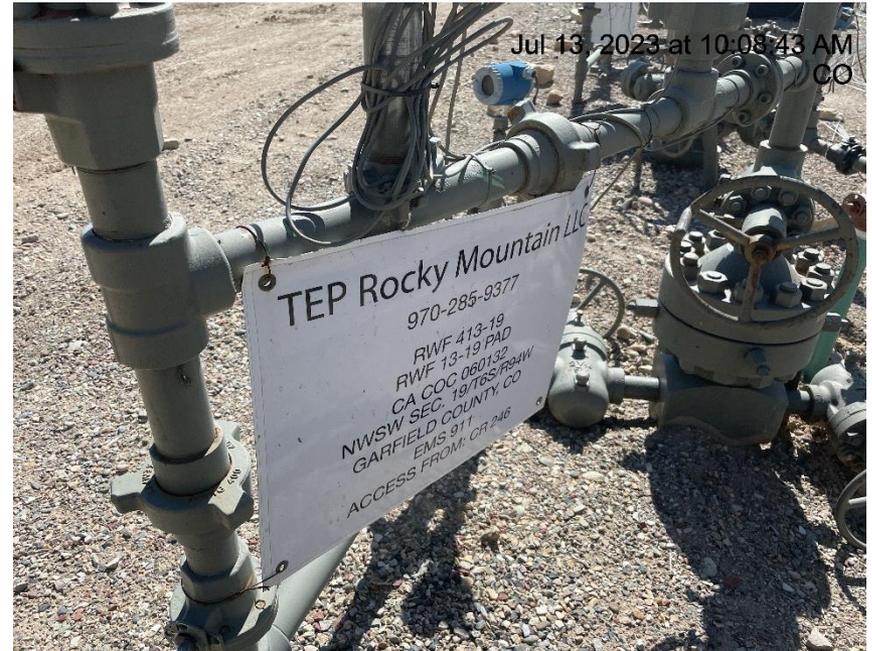
Photo # 2922 Wellhead sign missing API #

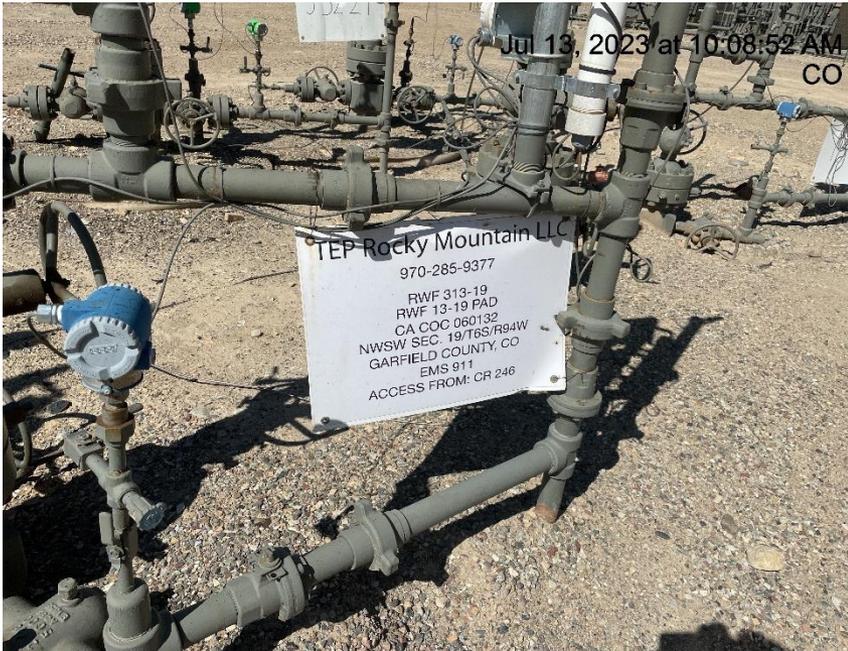
Photo # 2923 Wellhead sign missing API #

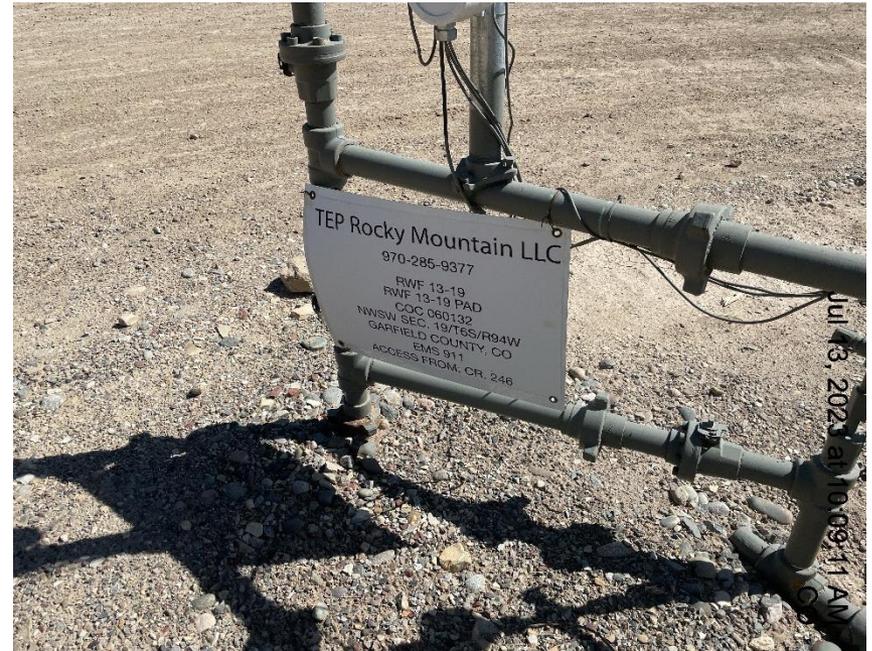
Photo # 2924 Wellhead sign missing API #
