## Inspection Photos

Location Name: TEP ROCKY MOUNTAIN LLC FEDERAL RMV 171-19 Pad

Location ID: 335382

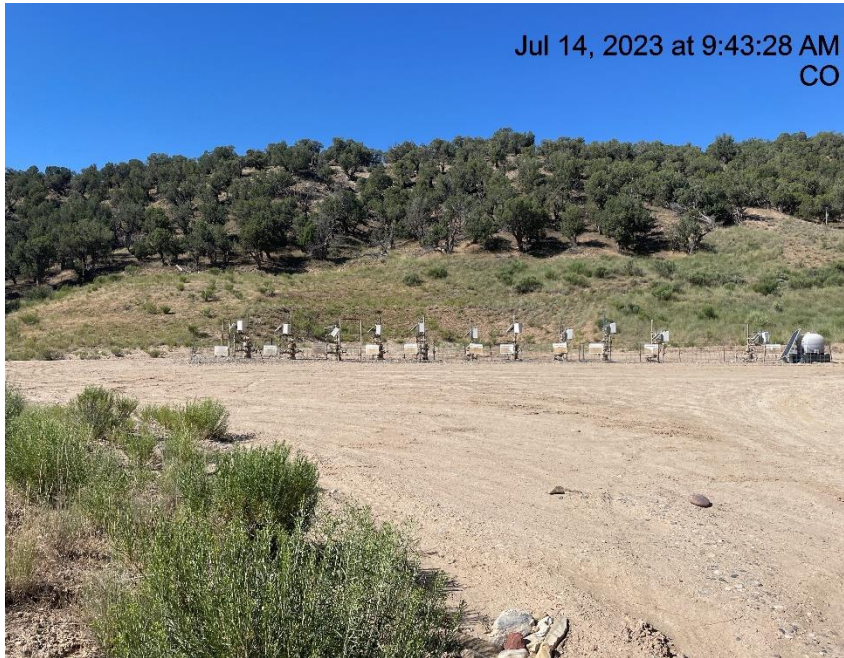
Photo # 3021 From entrance to location

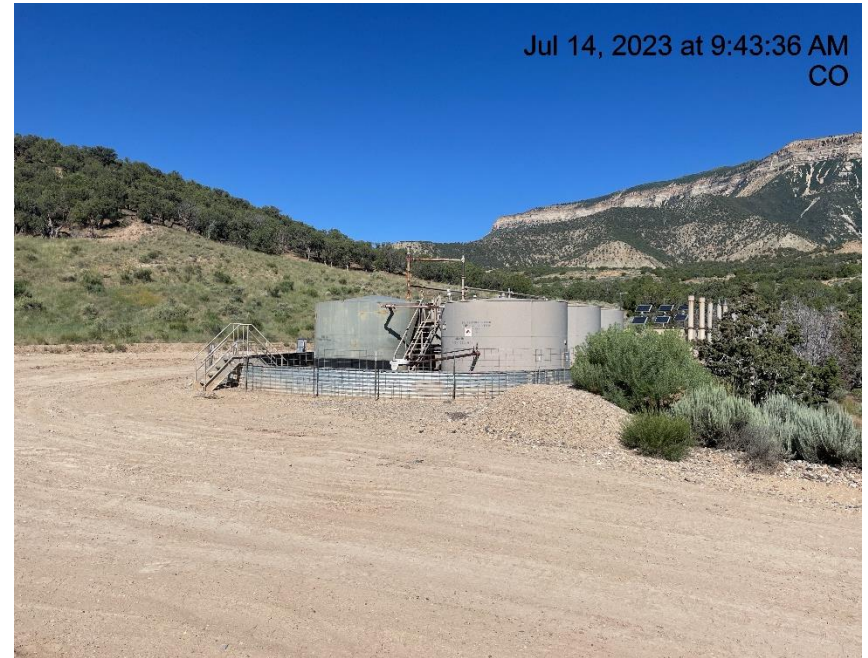
Photo # 3022 From entrance to location

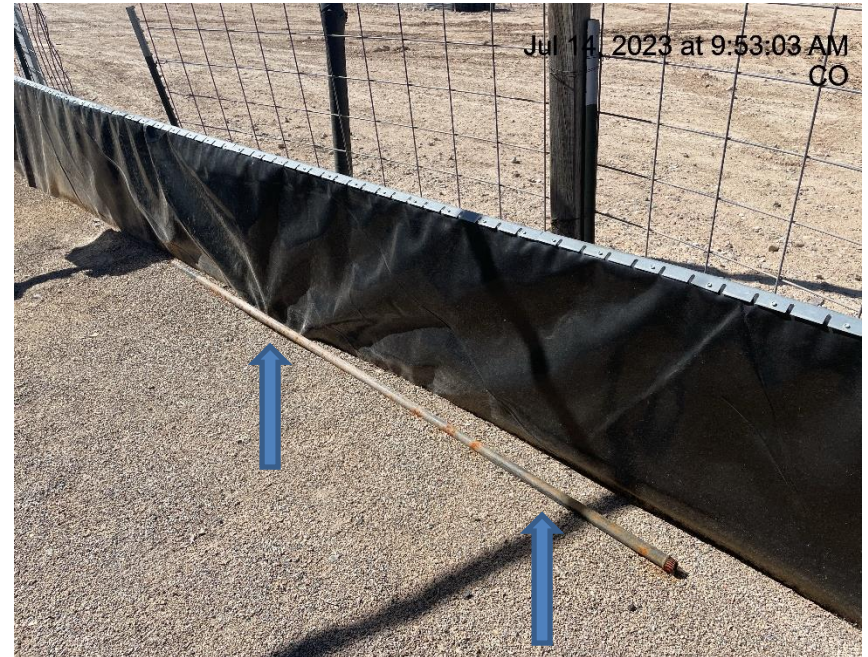
Photo # 3035 Debris

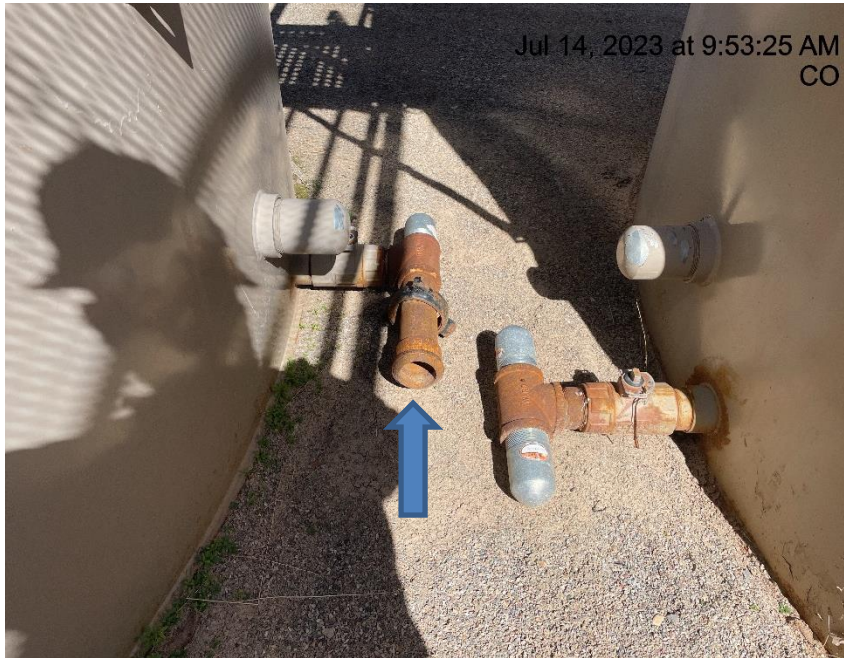
Photo # 3036 Open ended load line

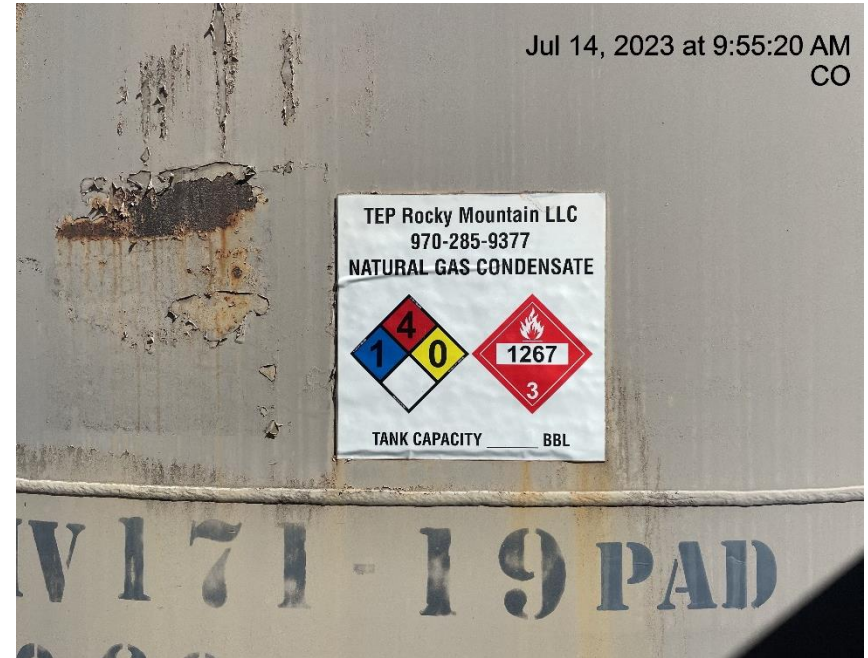
Photo # 3041 Tank label missing required information

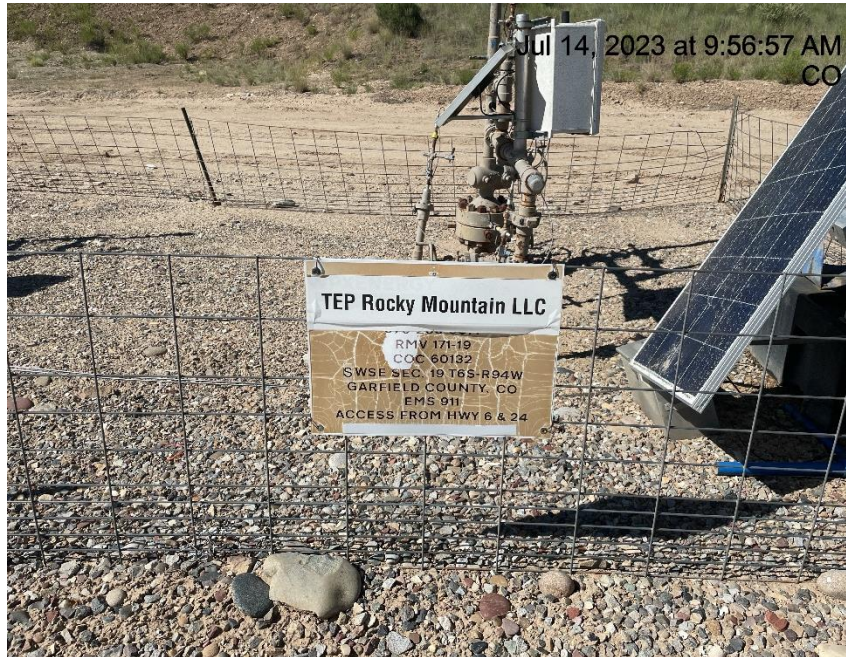
Photo # 3042 Wellhead sign missing API #

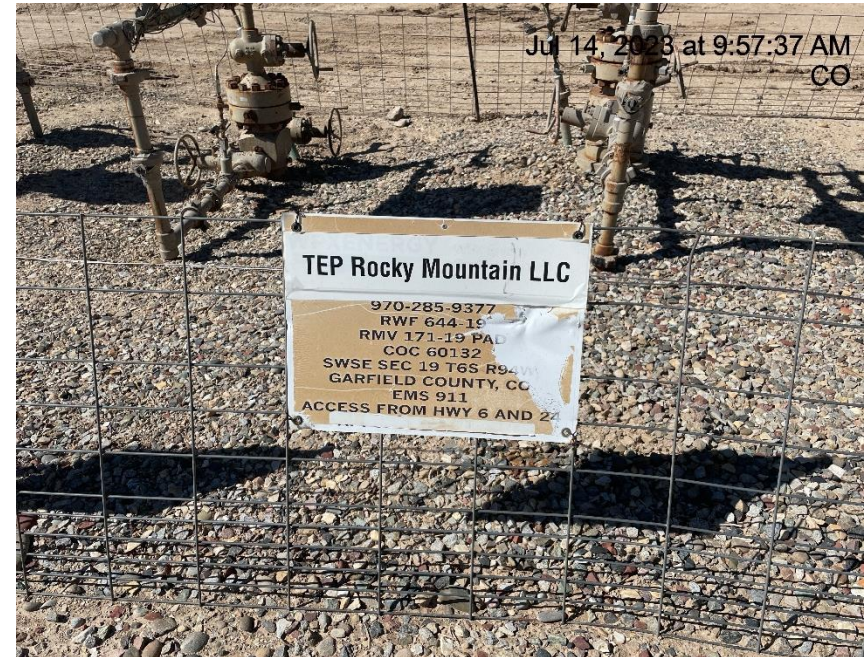
Photo # 3043 Wellhead sign missing API #

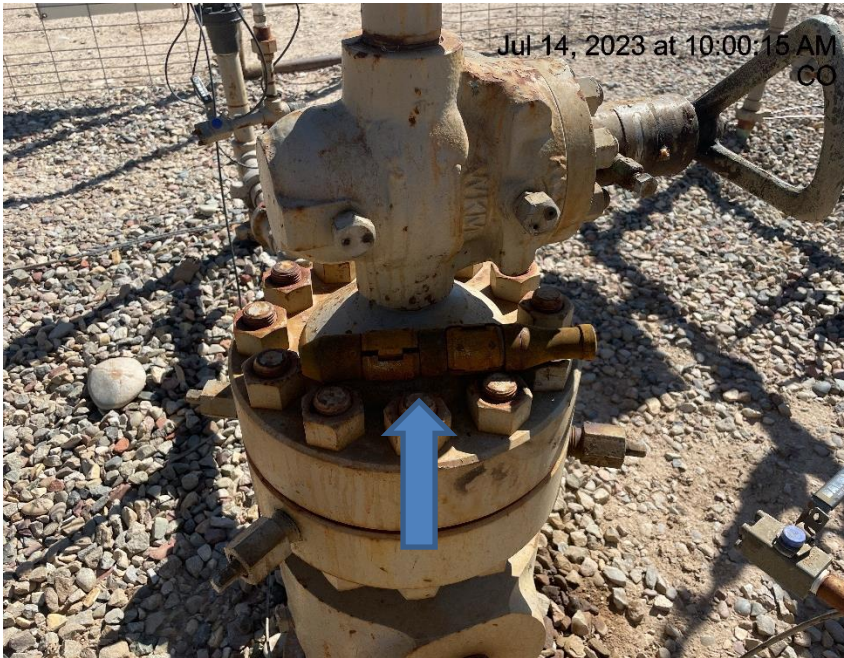
Photo # 3046 Debris

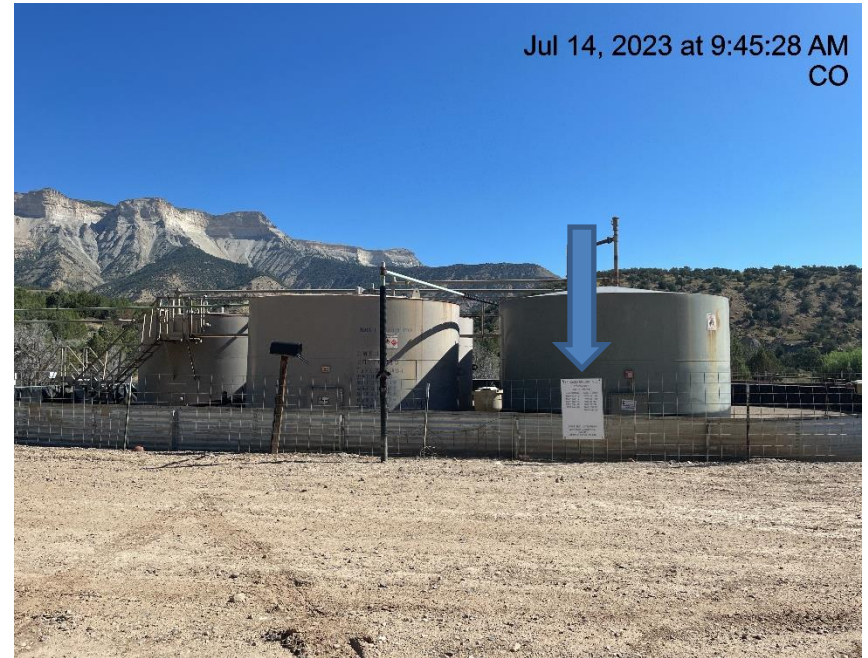
Photo # 3024 Battery sign missing API #'s
