**Inspection Photos**  
**Location Name: Bledsoe 15-7-3-43**  
**Location ID: 125-09117**

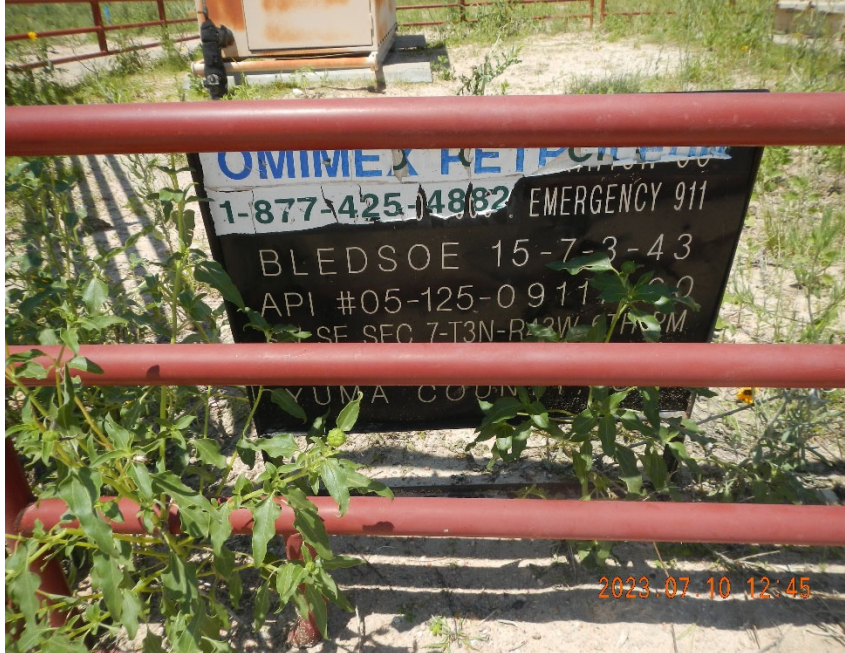
**1. Well sign at well site located inside stock panel fencing.  
Noted vegetation growth inside fenced area.**

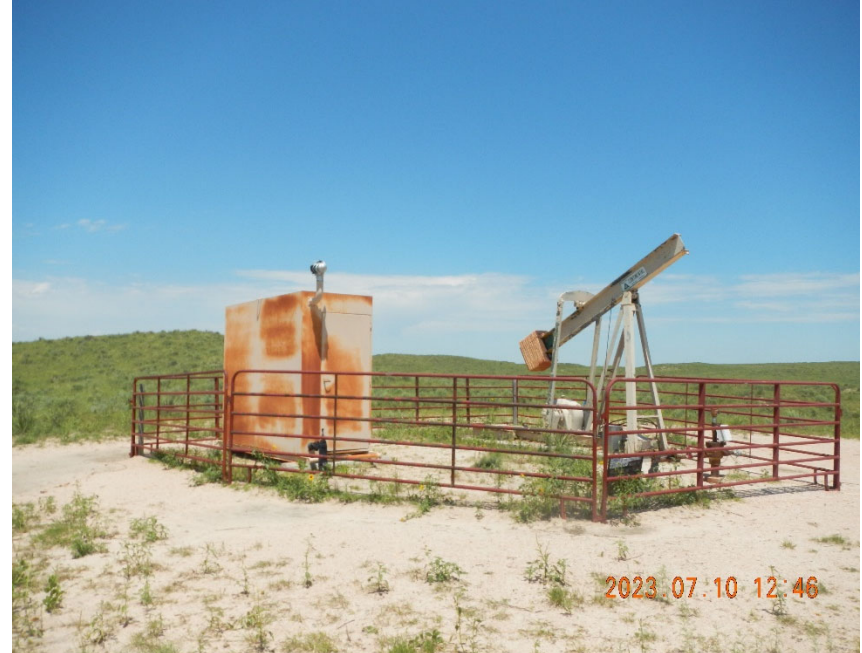
**2. Overview of well site.**

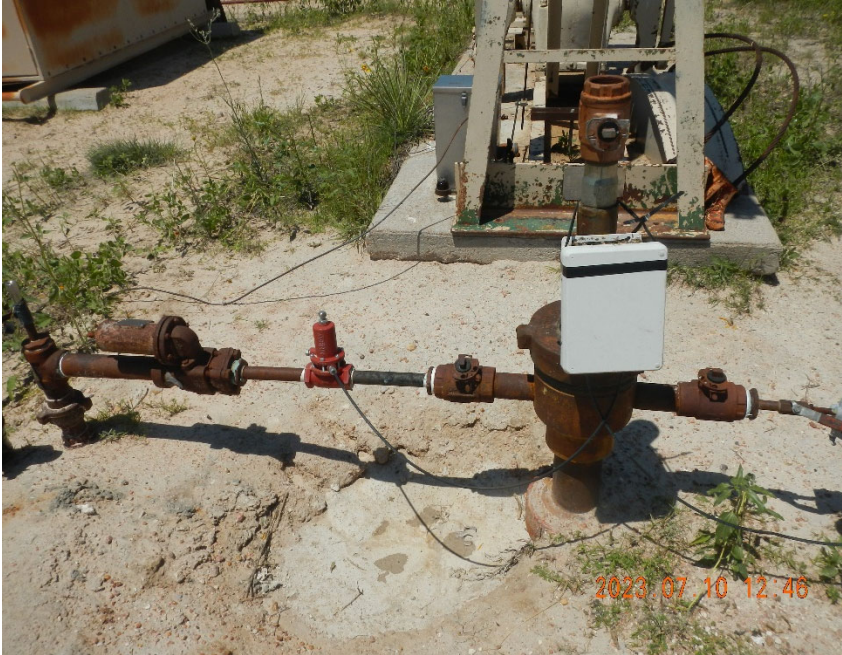
**3. Wellhead.**

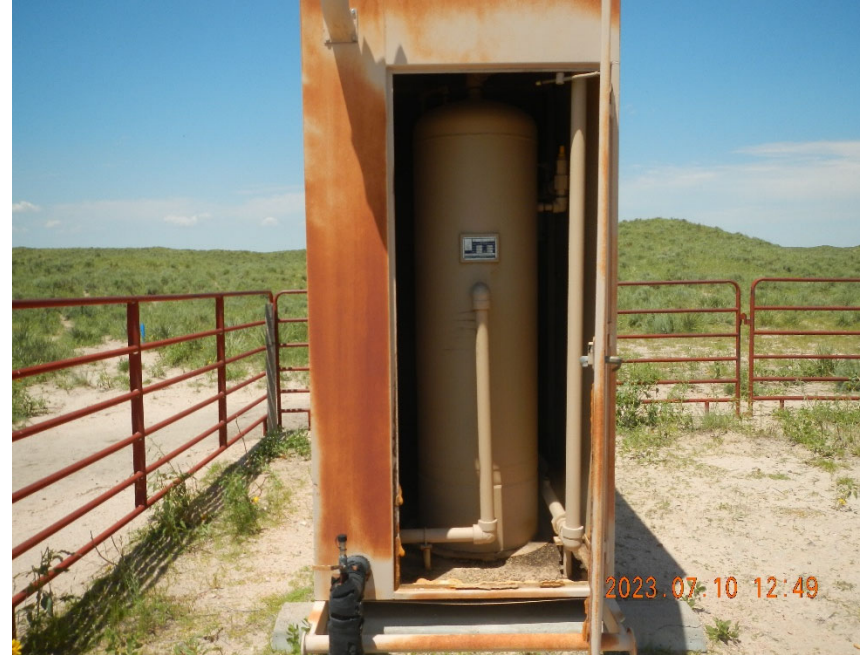
**4. Meter/Separator building with door open and Vertical Separator visible.**

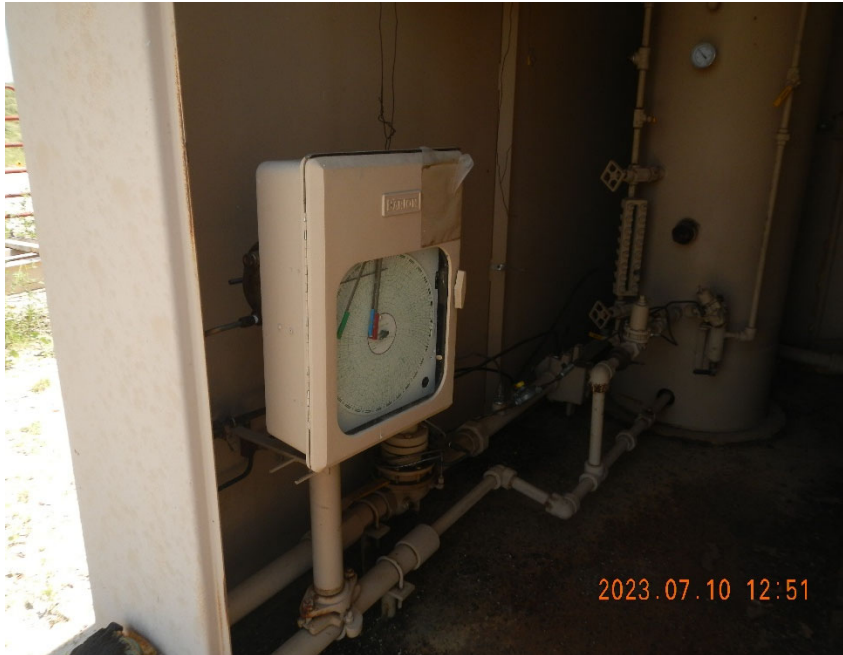
**5. Meter/Separator building with door open and Gas Meter Run visible.**

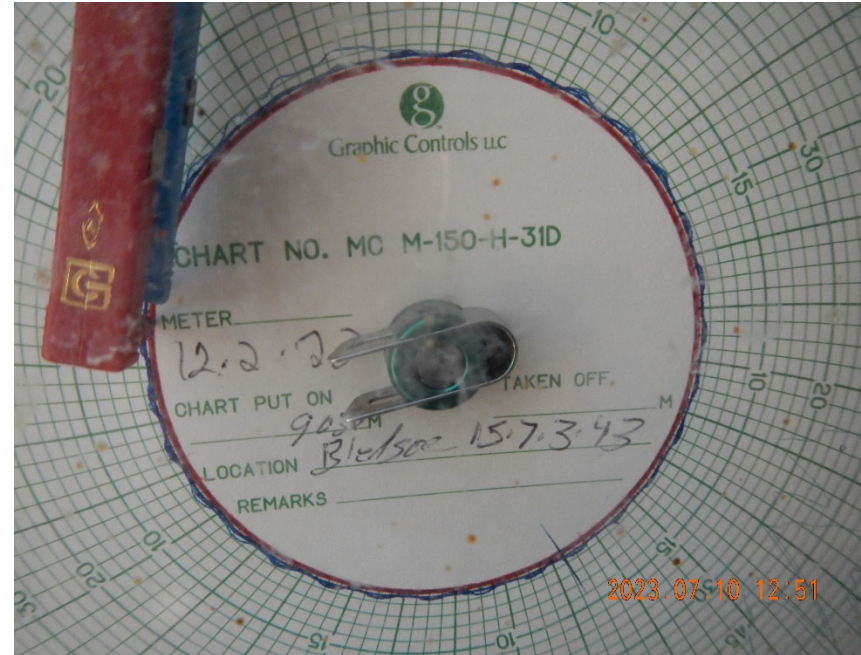
**6. Chart inside meter box dated 12-2-22 at time of inspection.**

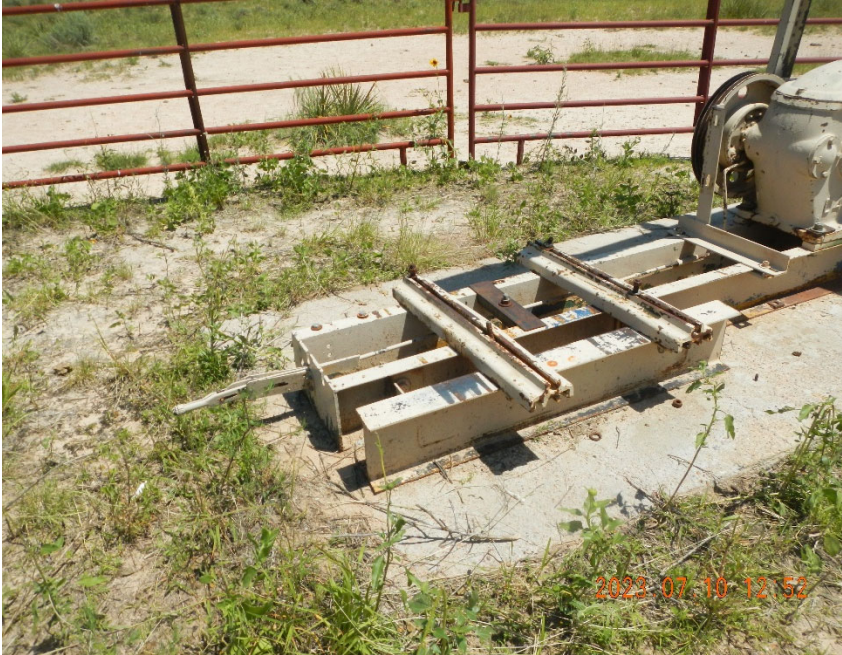
**7. Prime Mover has been removed from Pump Jack. Note surrounding vegetation growth.**

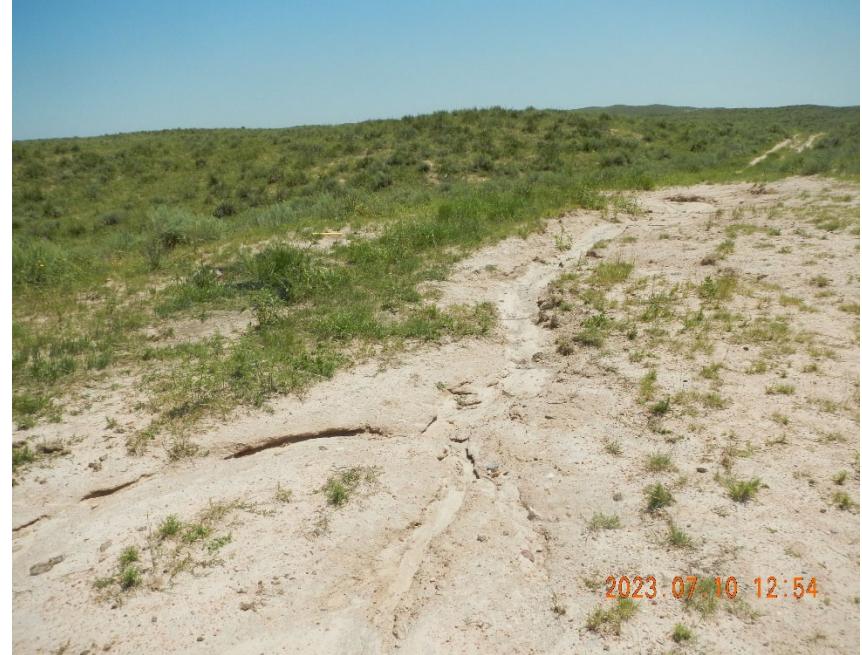
**8. View of erosion channel looking from location entry area to the SE down access road.**

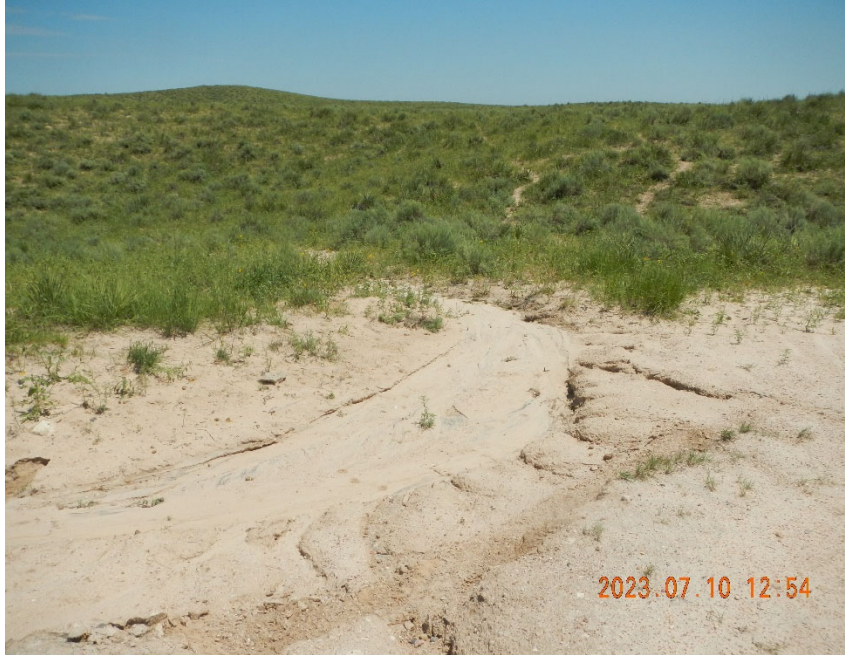
**9. Closer view of erosion channel looking from location entry area to the SE down access road.**

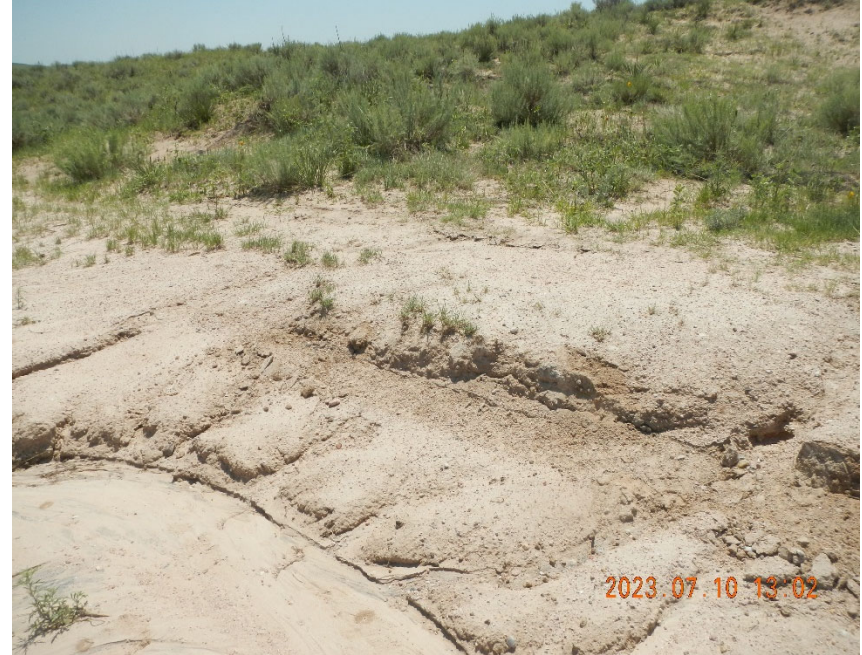
**10. View of area where access road has washed out and erosion channel turns in more E direction carrying sediment down the sloping grade.**

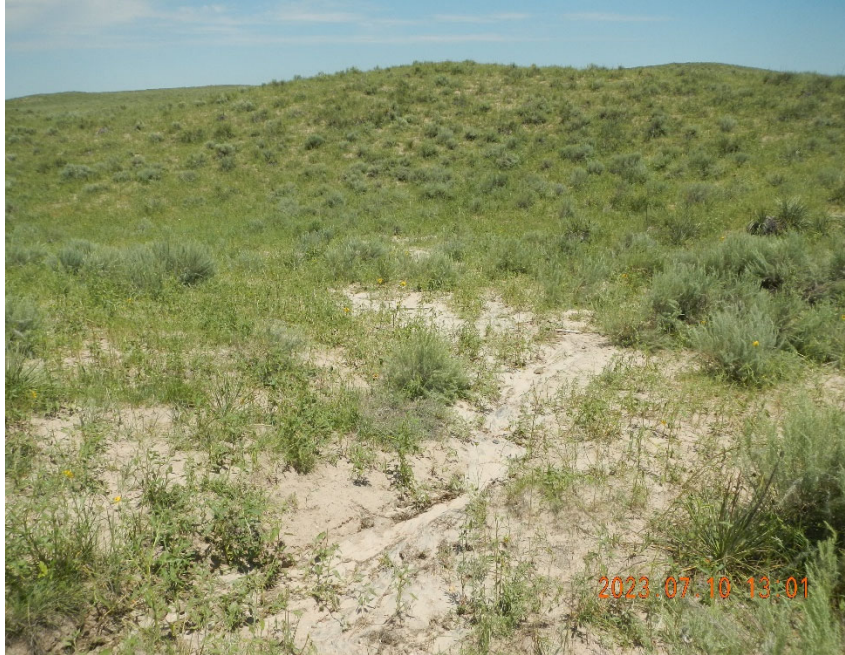
**11. View of erosion channel flowing east down grade.**

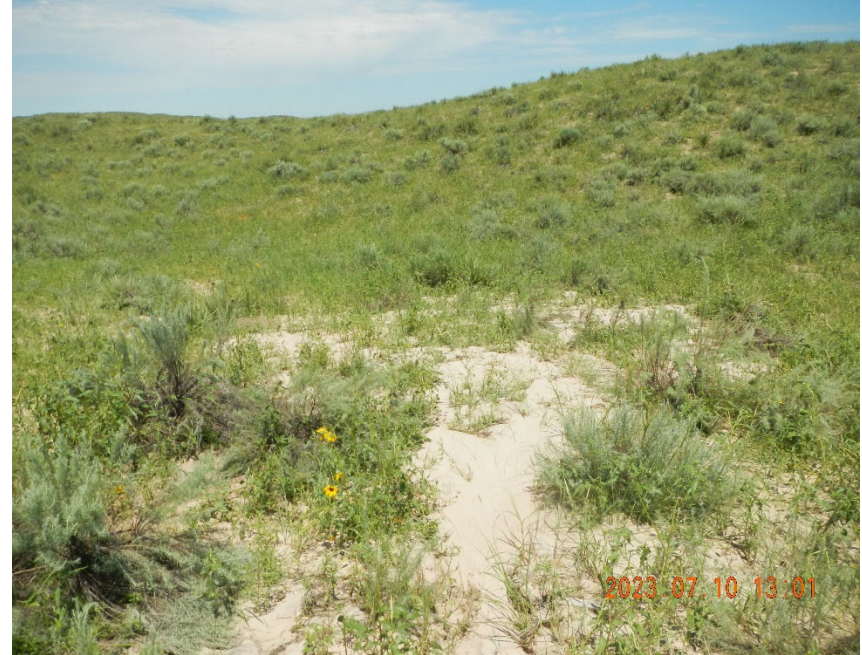
**12. View of sediment plume as flow reaches bottom of sloping grade.**
