Inspection Photos  
Location Name: Bledsoe 15-18-3-43  
Location ID: 125-09004

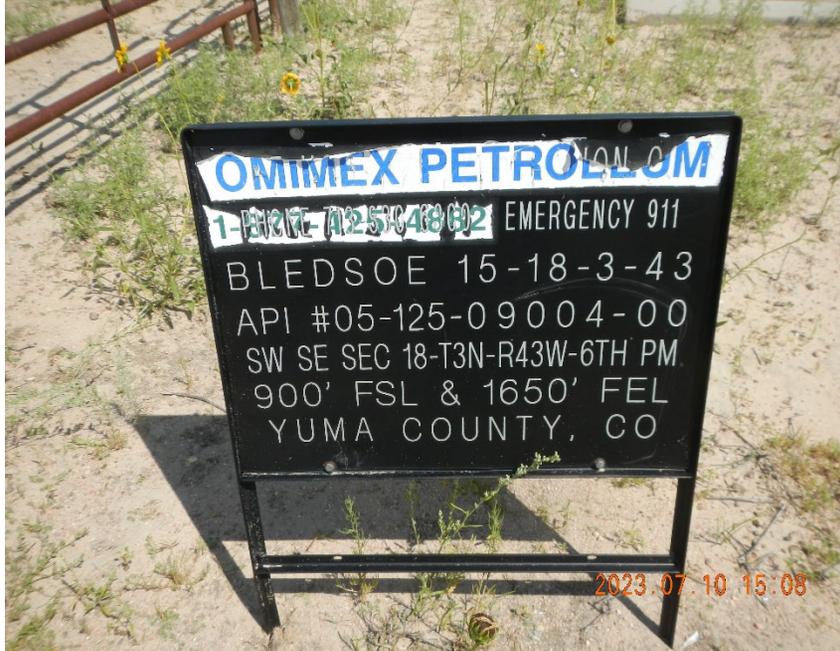
1. Wellhead sign inside fencing.

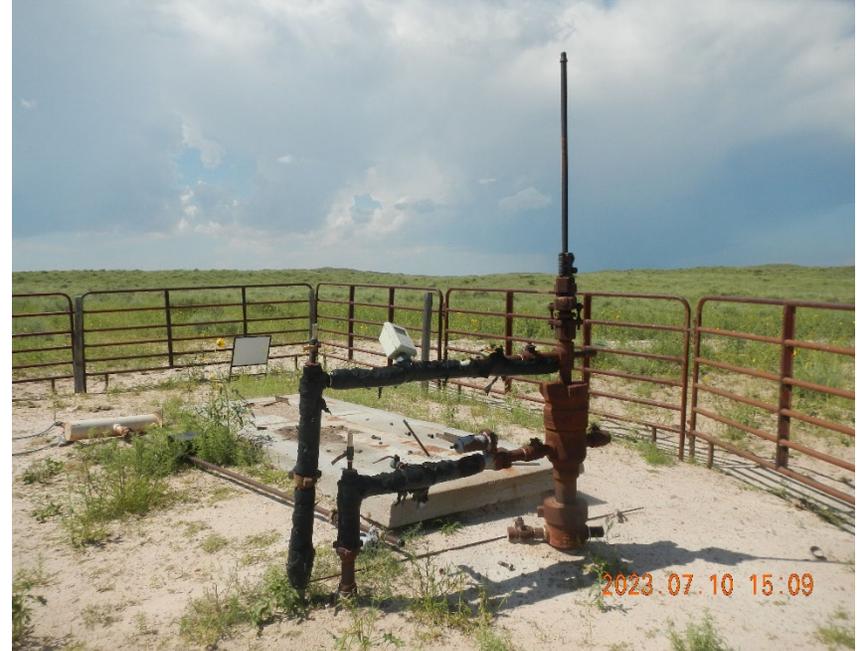
2. View of wellhead with polish rod visible.

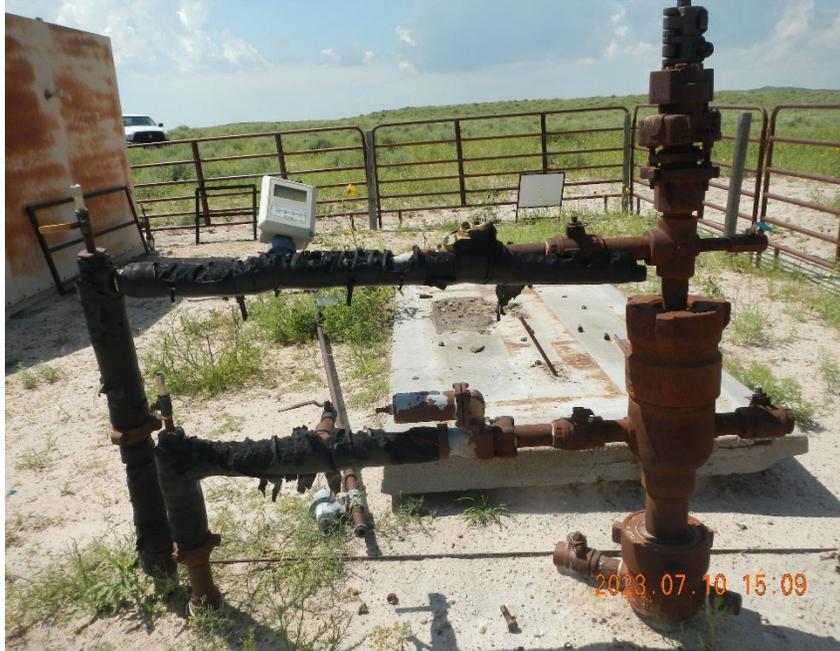
**3. Closer view of wellhead. Concrete Pumping Unit Slab in the background.**

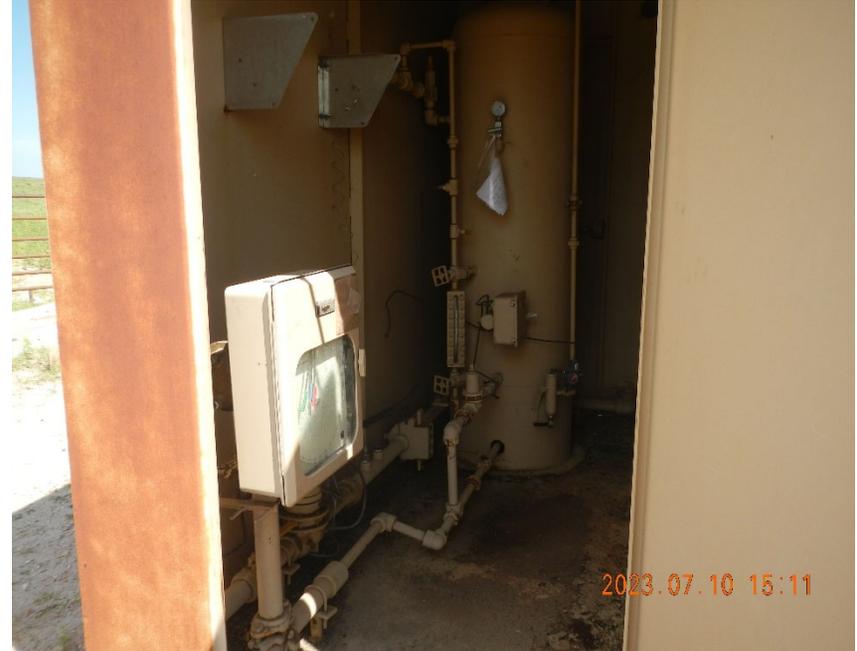
**4. View of Gas Meter Run and Vertical Separator shed.**

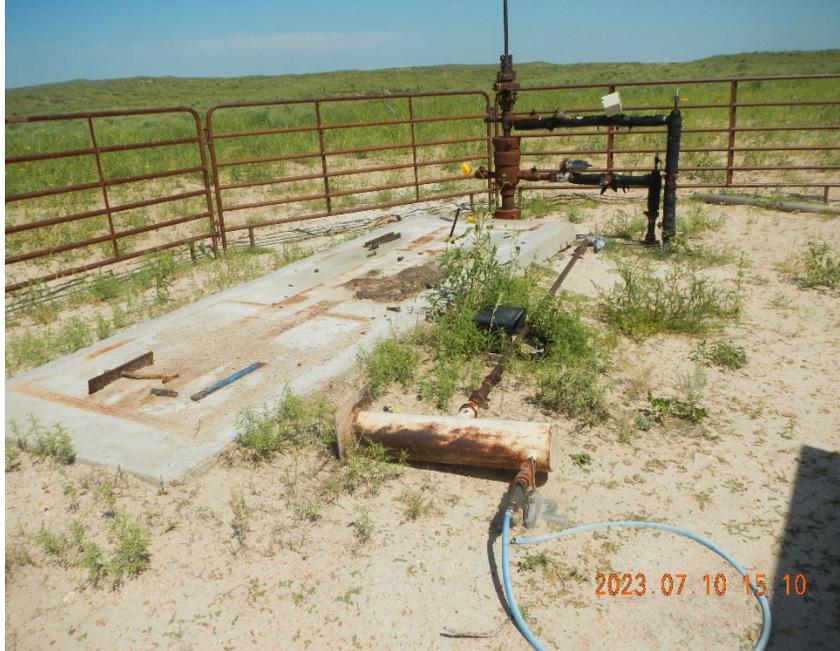
**5. View of Concrete Pad, Dryer Vessel, Pipe Section, and Debris inside fencing.**

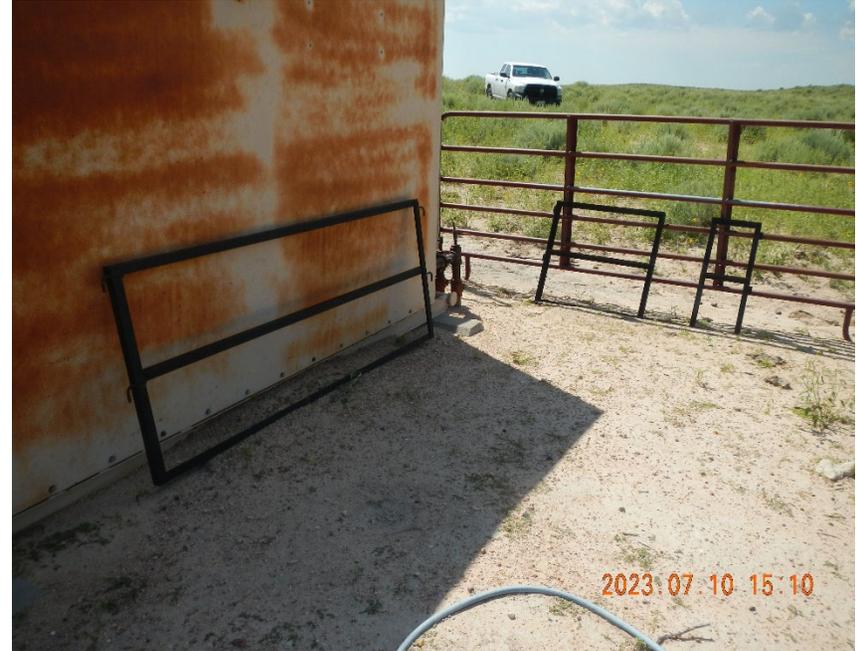
**6. Pump Jack Rail propped up at Gas Meter/Separator Shed.**

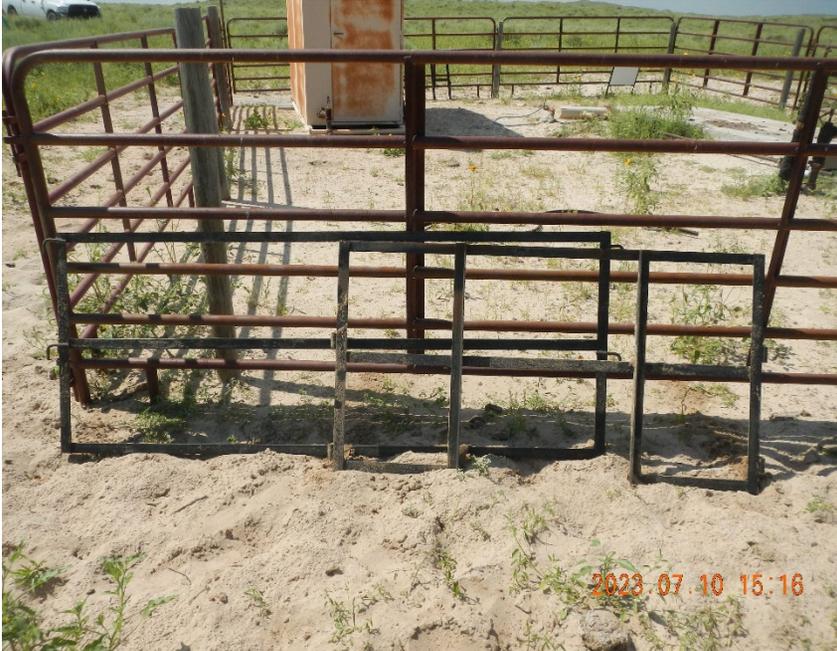
**7. Pumping Unit rails and guards inspector picked up outside the fencing and propped up against panel fencing.**

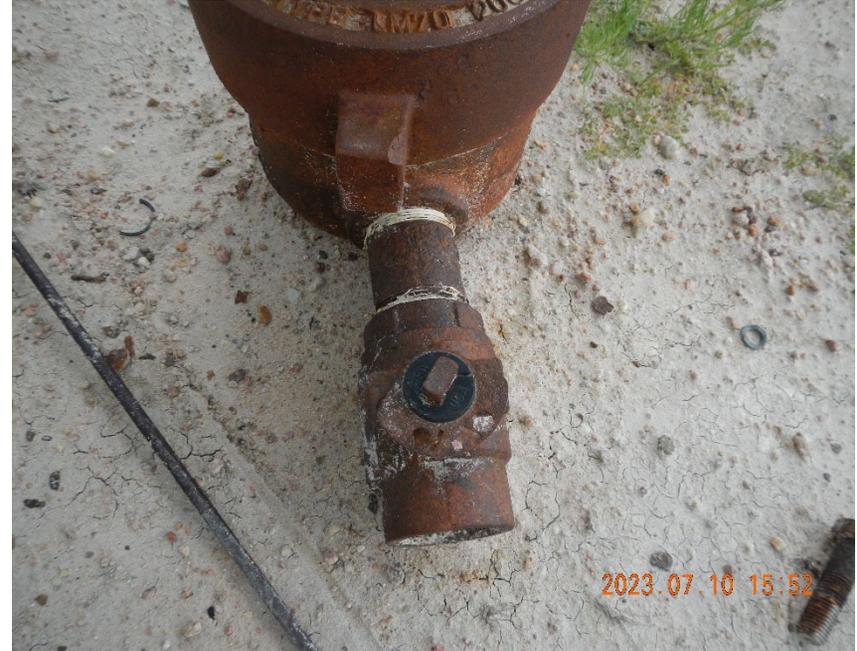
**8. Surface casing valve open to atmosphere.**

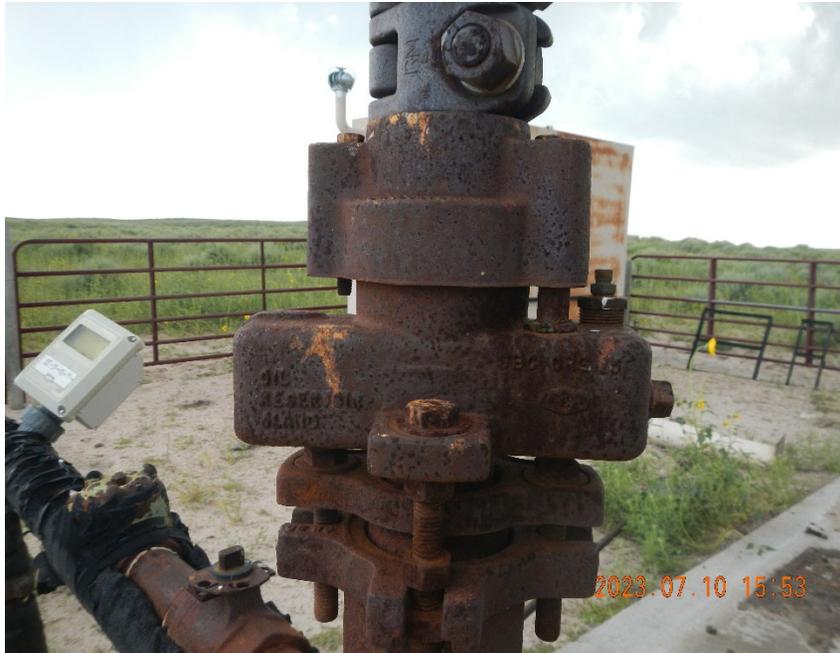
9. View of Stuffing Box.

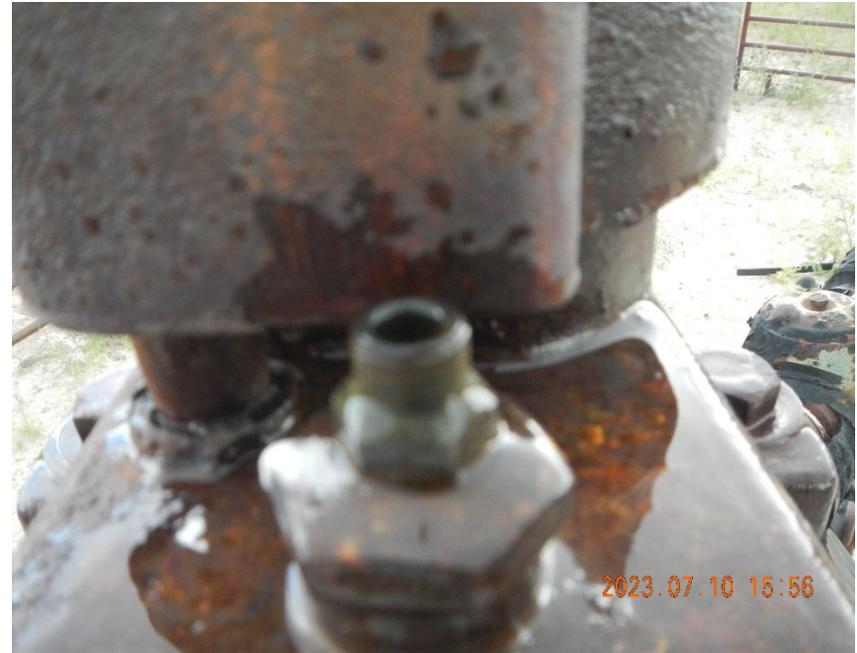
10. Gas is venting through Compression Bolt.

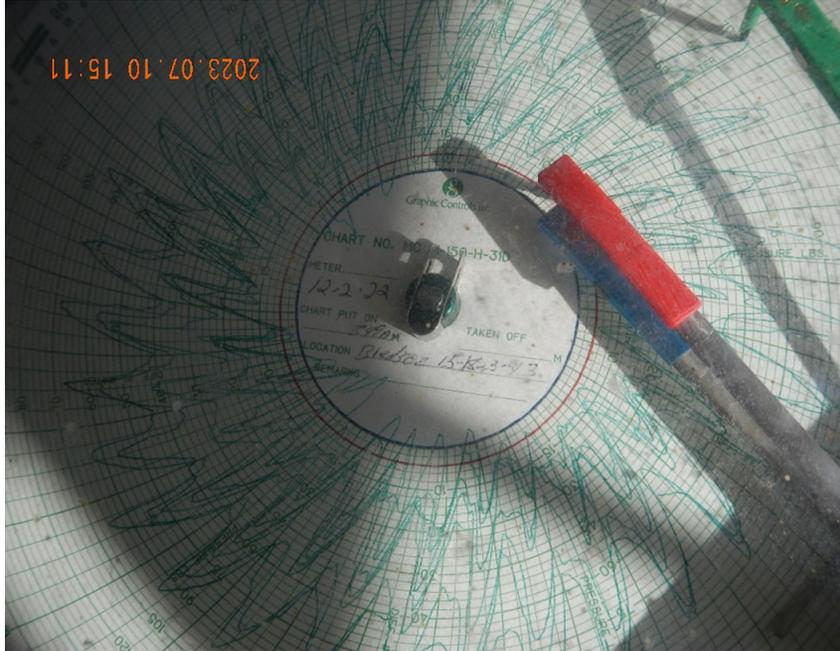
**11. View of Chart dated 12-2-22 that was in Meter Box at time of inspection.**

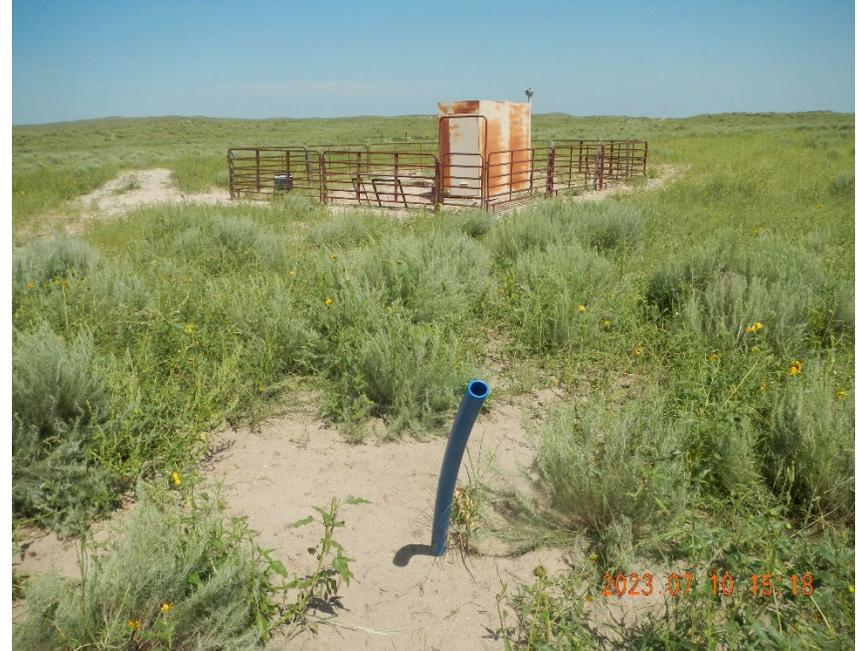
**12. View of 1 of 4 anchors and marker.**
