Final Reclamation Inspection

Operator: PDC ENERGY INC - 69175

Location ID: 306542

Inspection Photos
Location Name: Becker 12-10i
Location ID: 306542

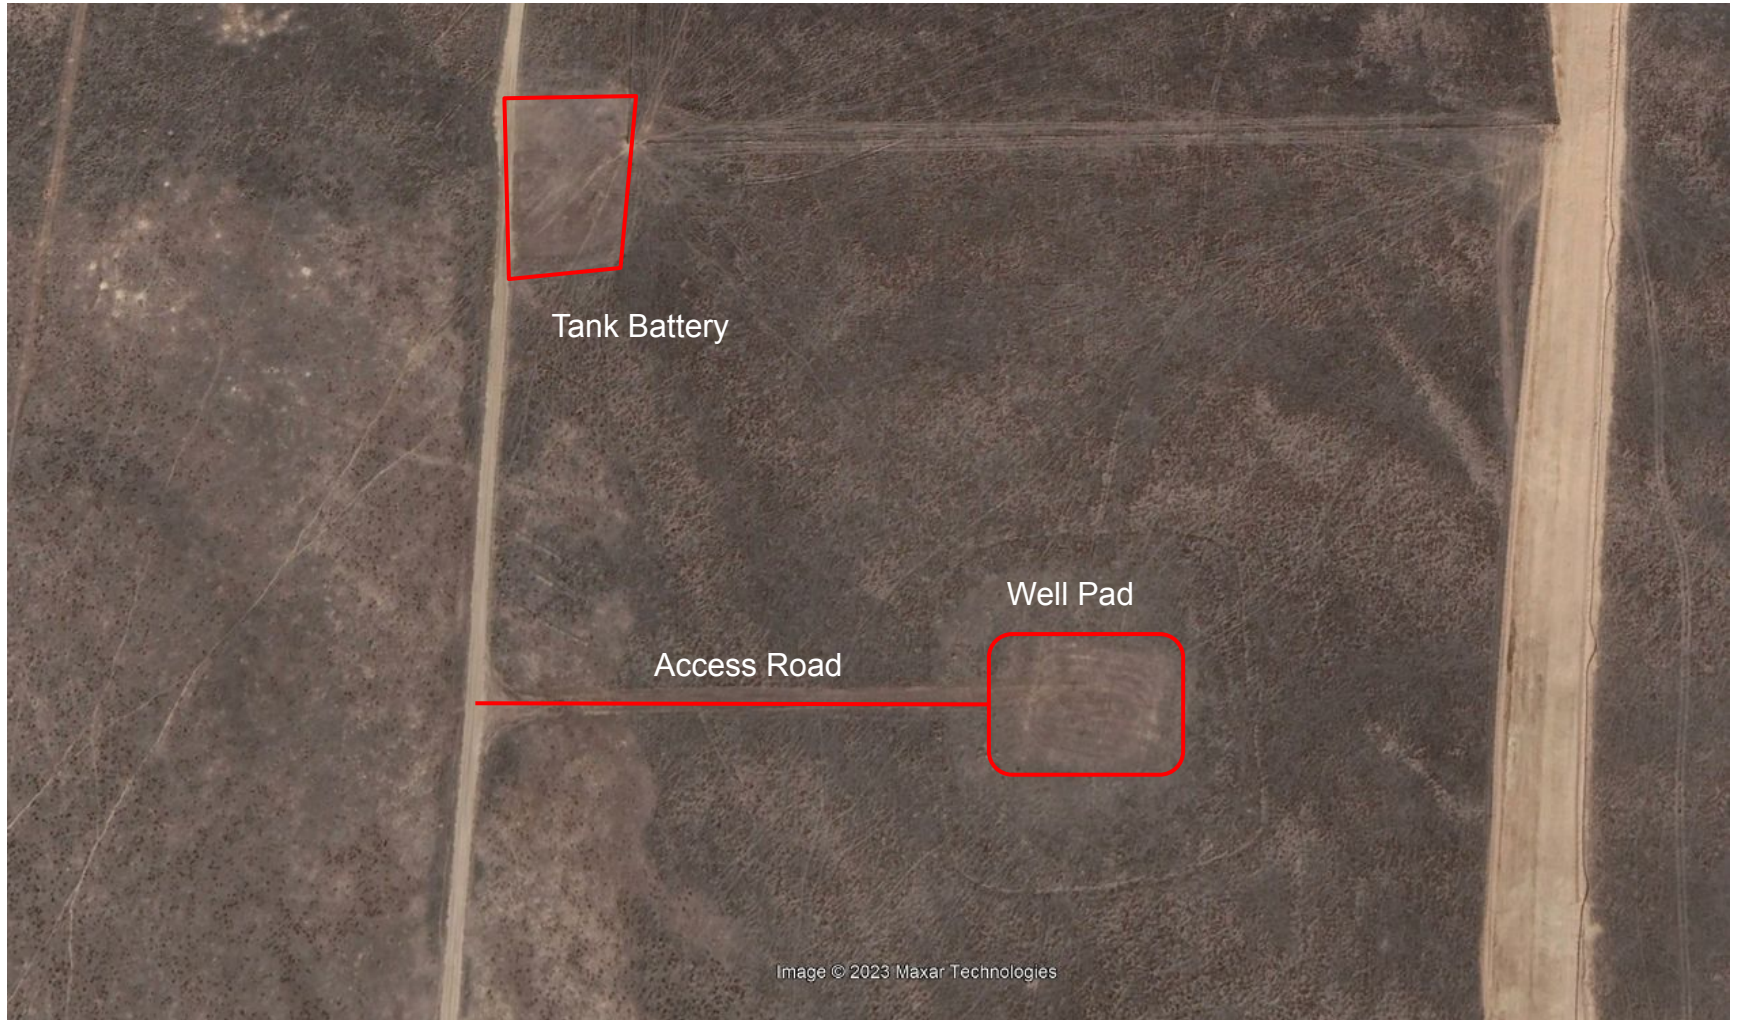
Photo 1. 2022 aerial imagery of the well pad, access road and associated tank battery (north is up).

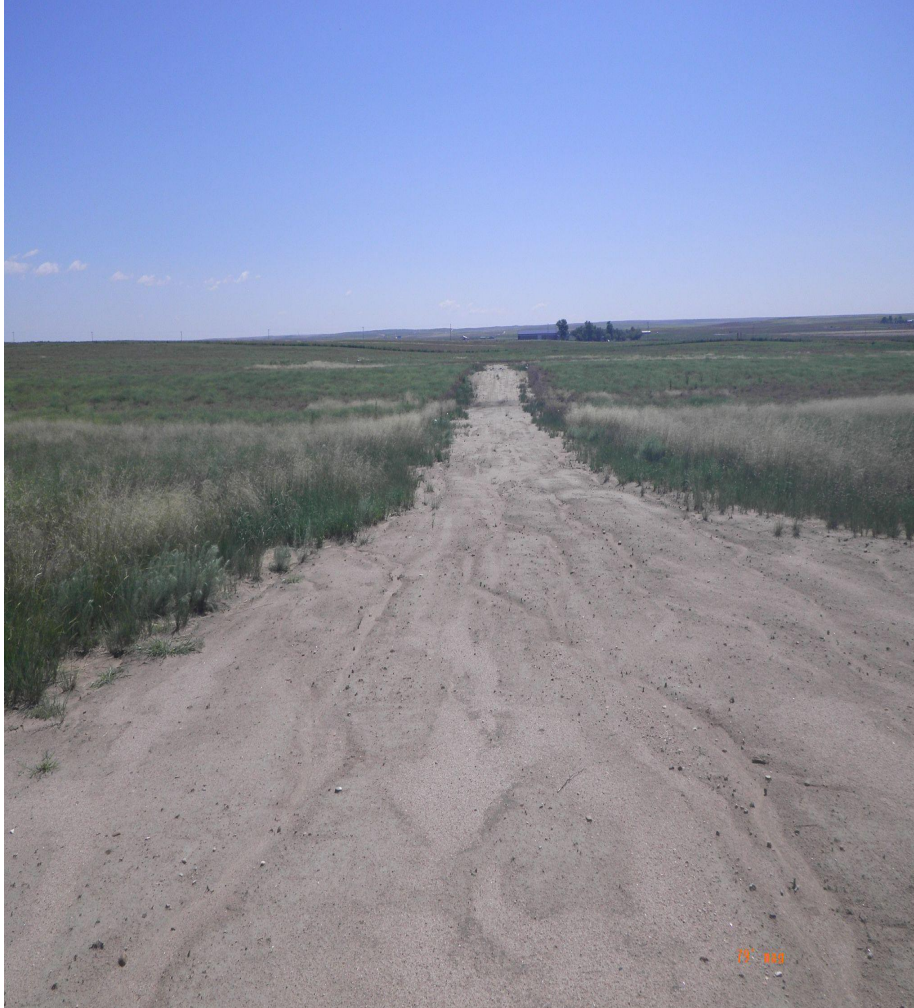
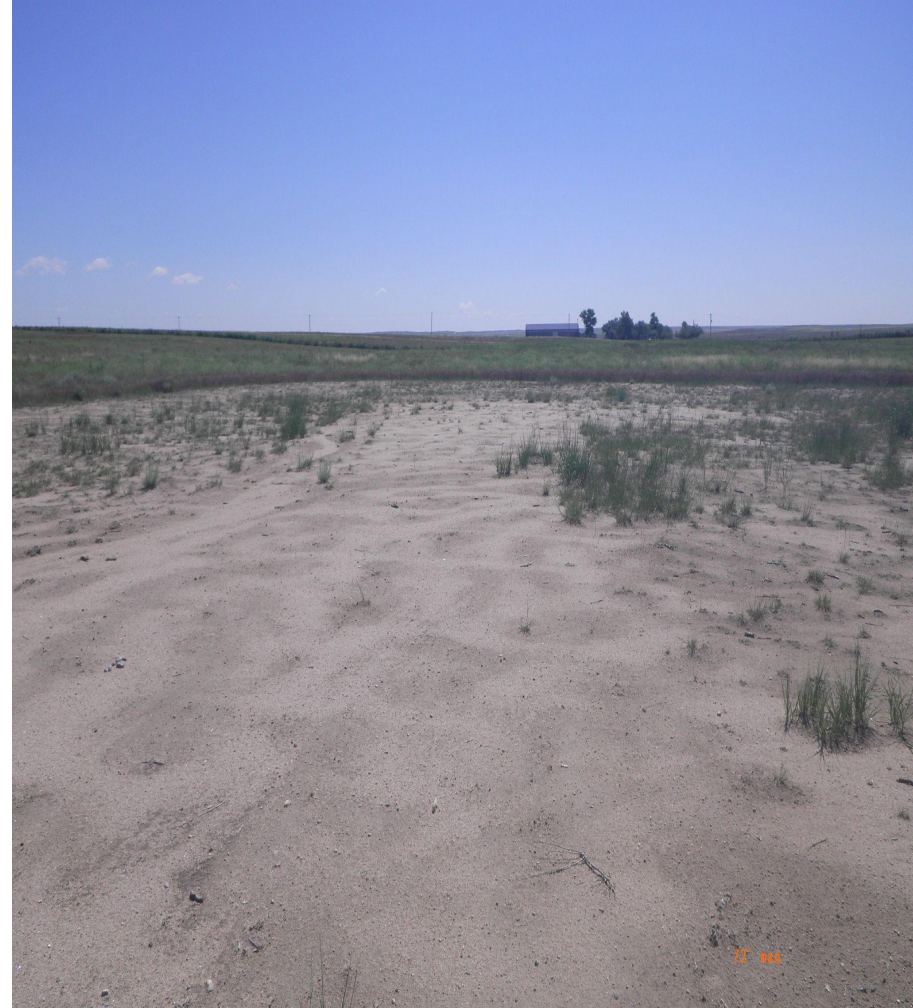
Photo 2. Overview photos of the well pad access road (left) and well pad (right) taken at ground level from the western edge facing east.

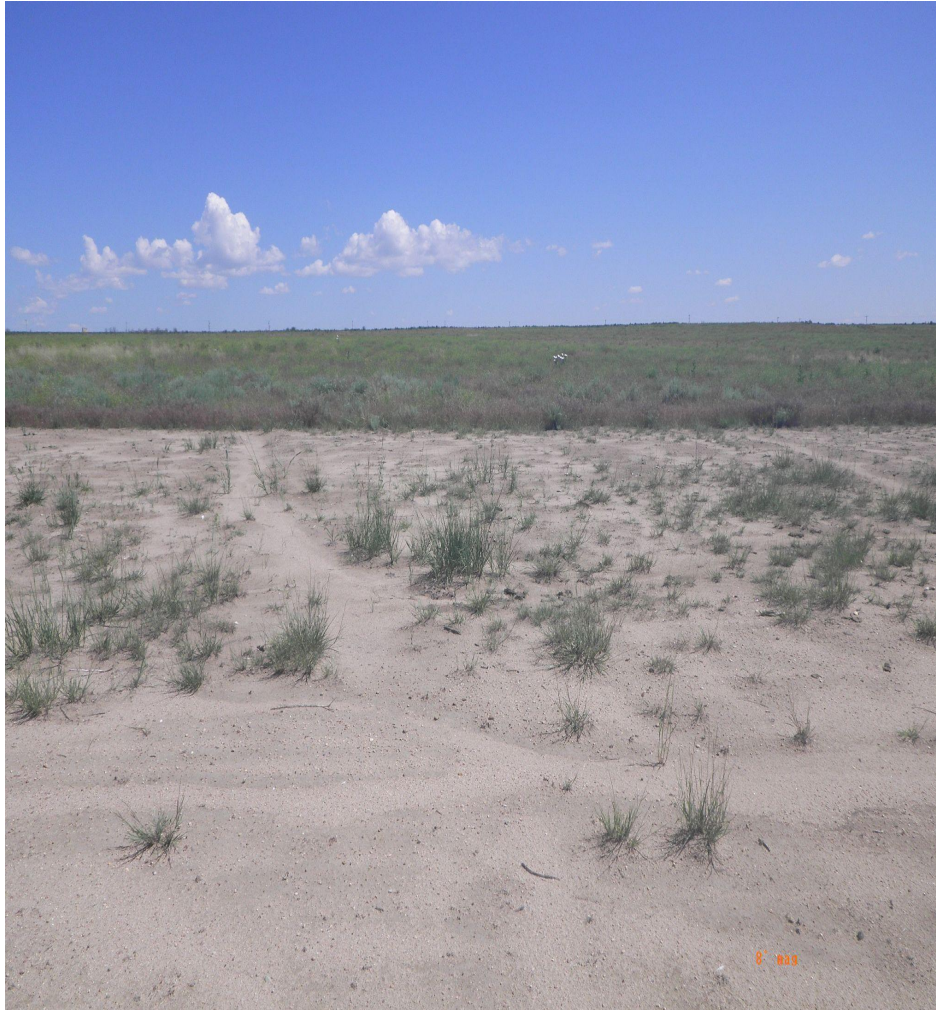
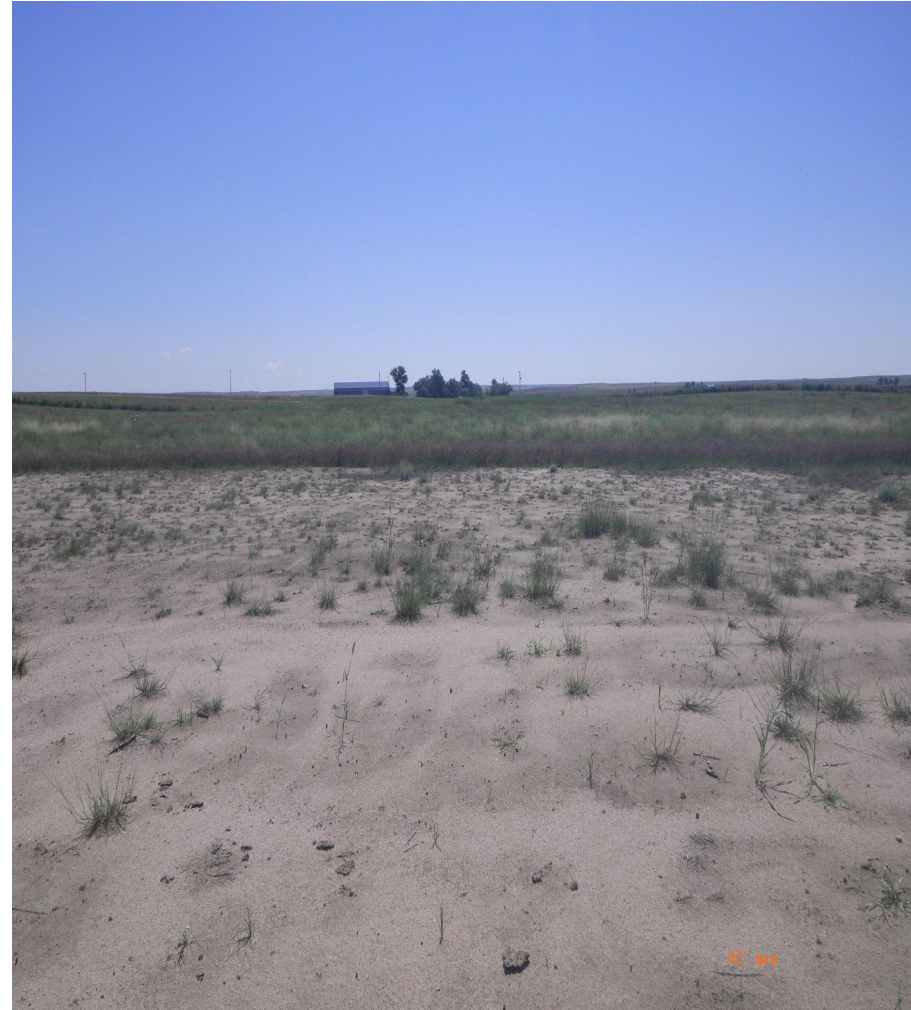
Photo 3. Cardinal photos taken from the middle of the well pad. Left photo facing north, right photo facing east.

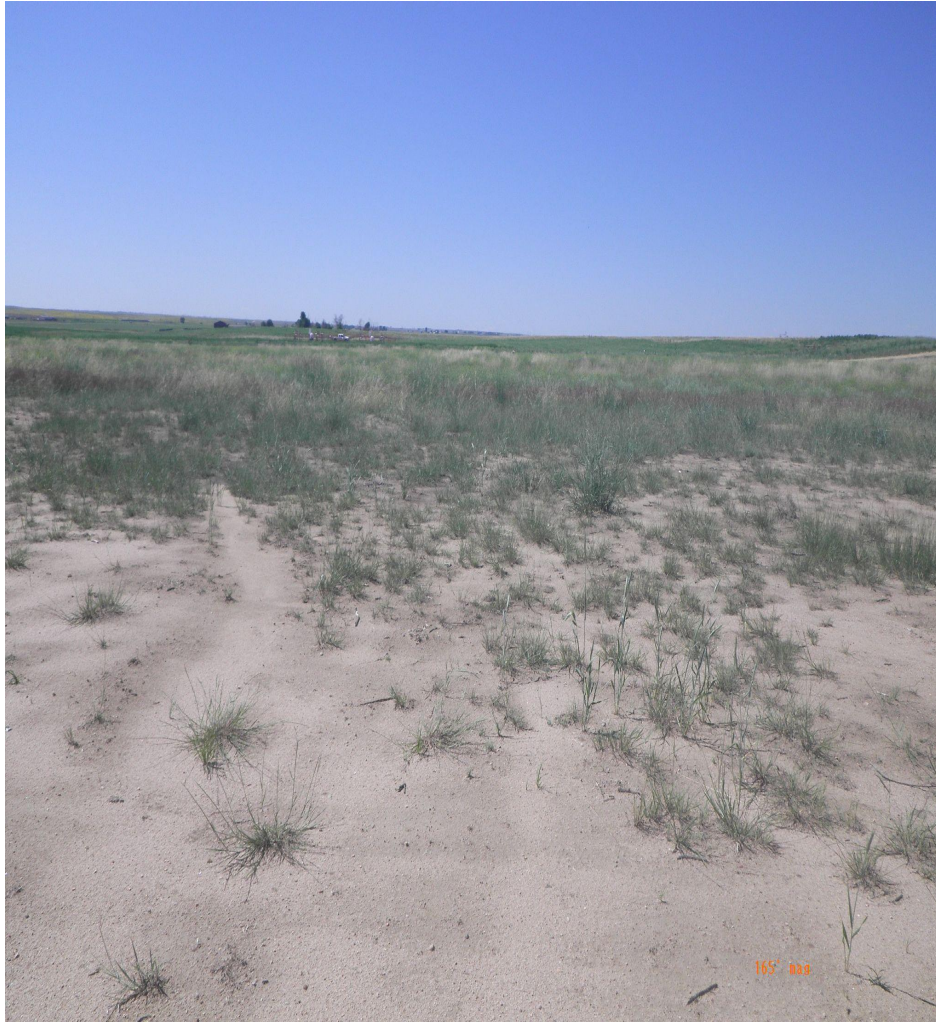
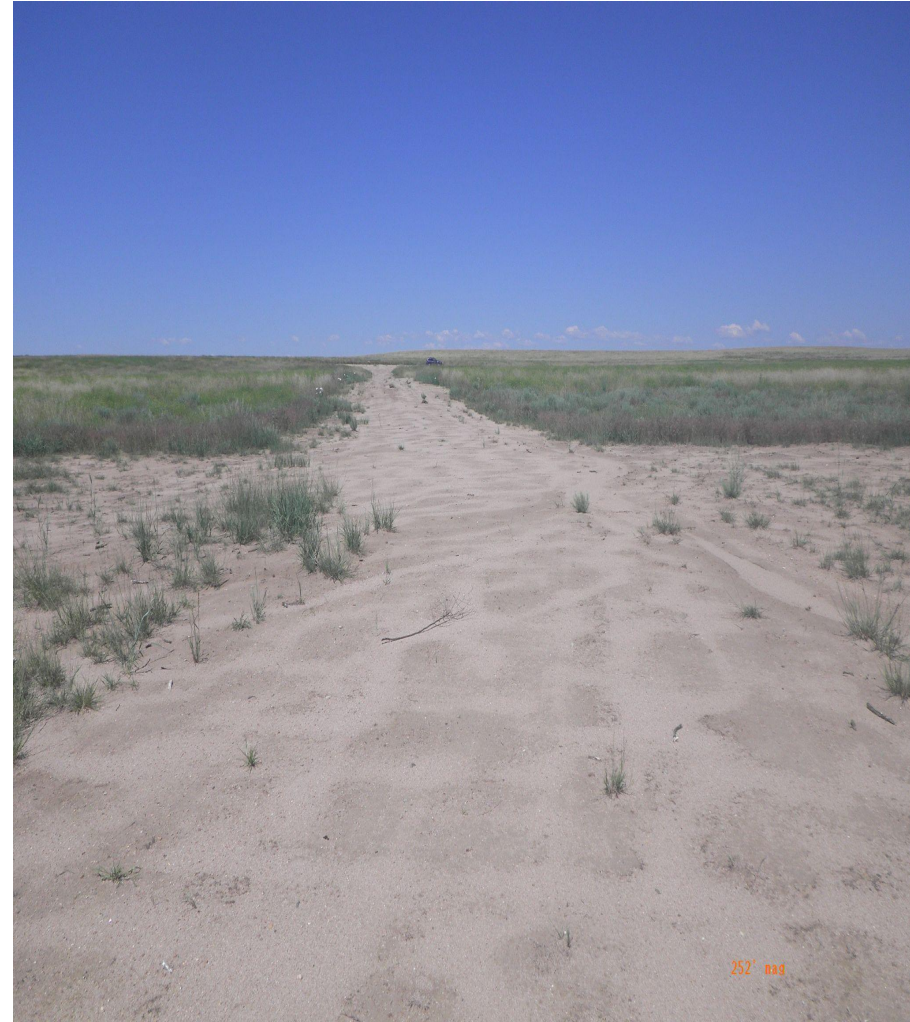
Photo 4. Cardinal photos taken from the middle of the well pad. Left photo facing south, right photo facing west. Note: well pad and access show significant bare ground and do not appear consistent with adjacent reference area (see photo #5).

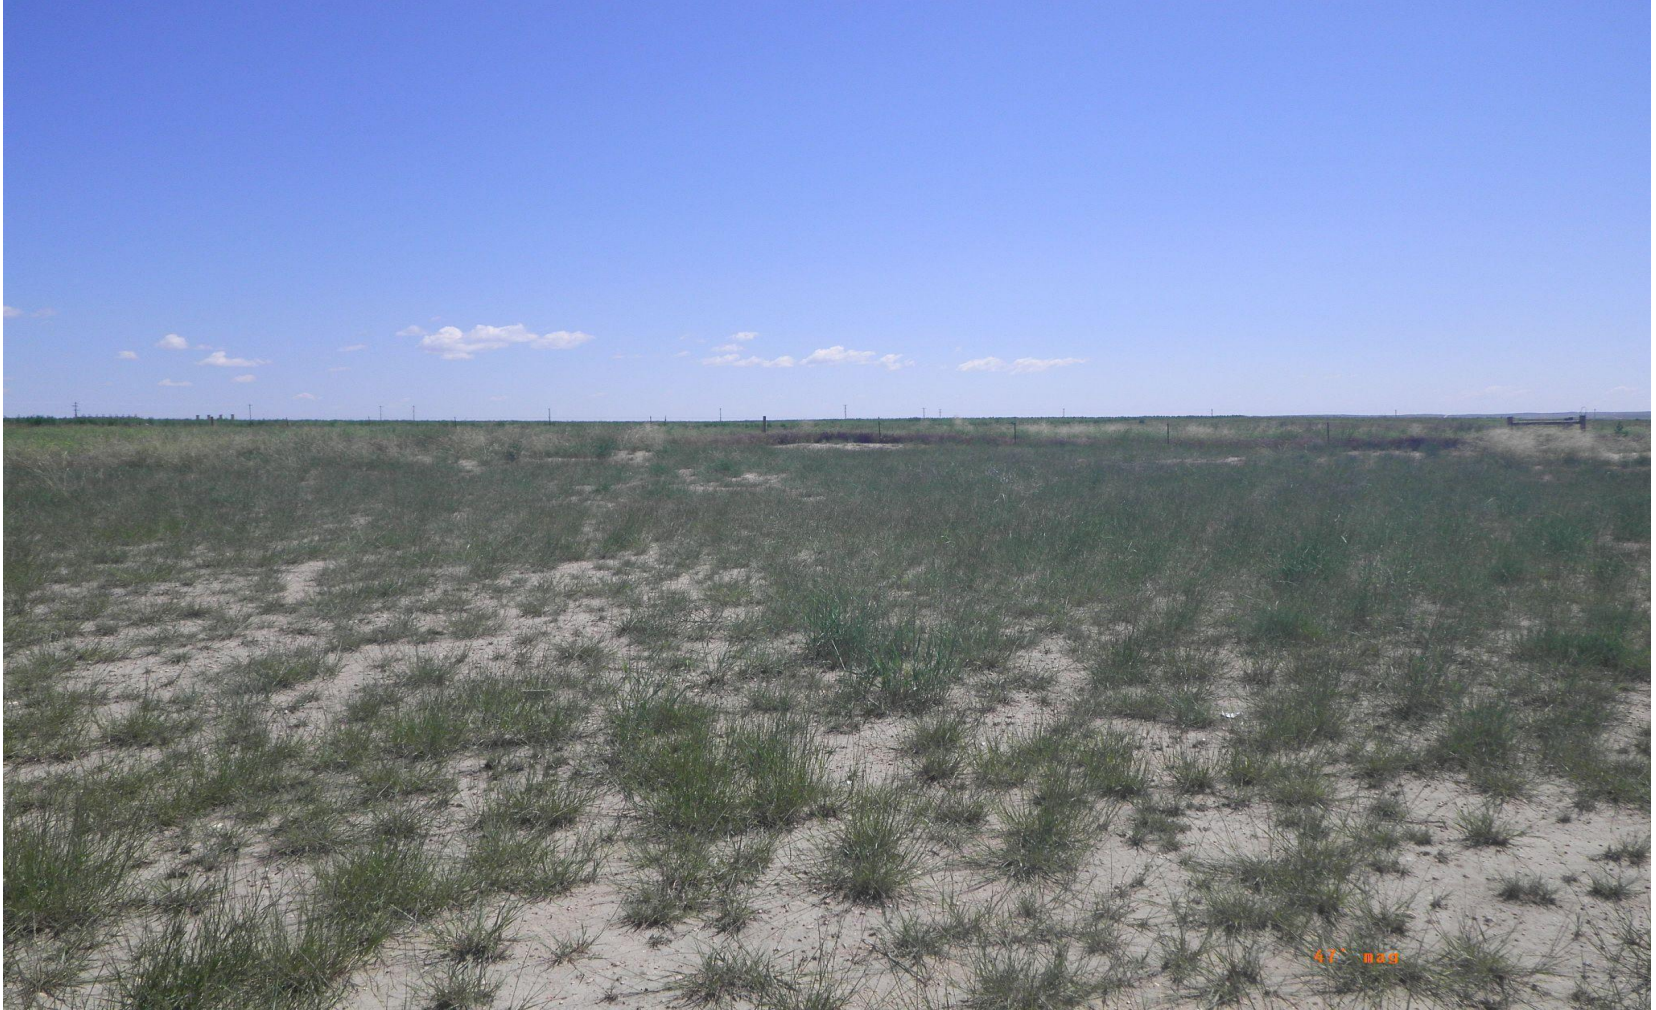
Photo 6. Overview photo of the tank battery taken from the western edge facing east.

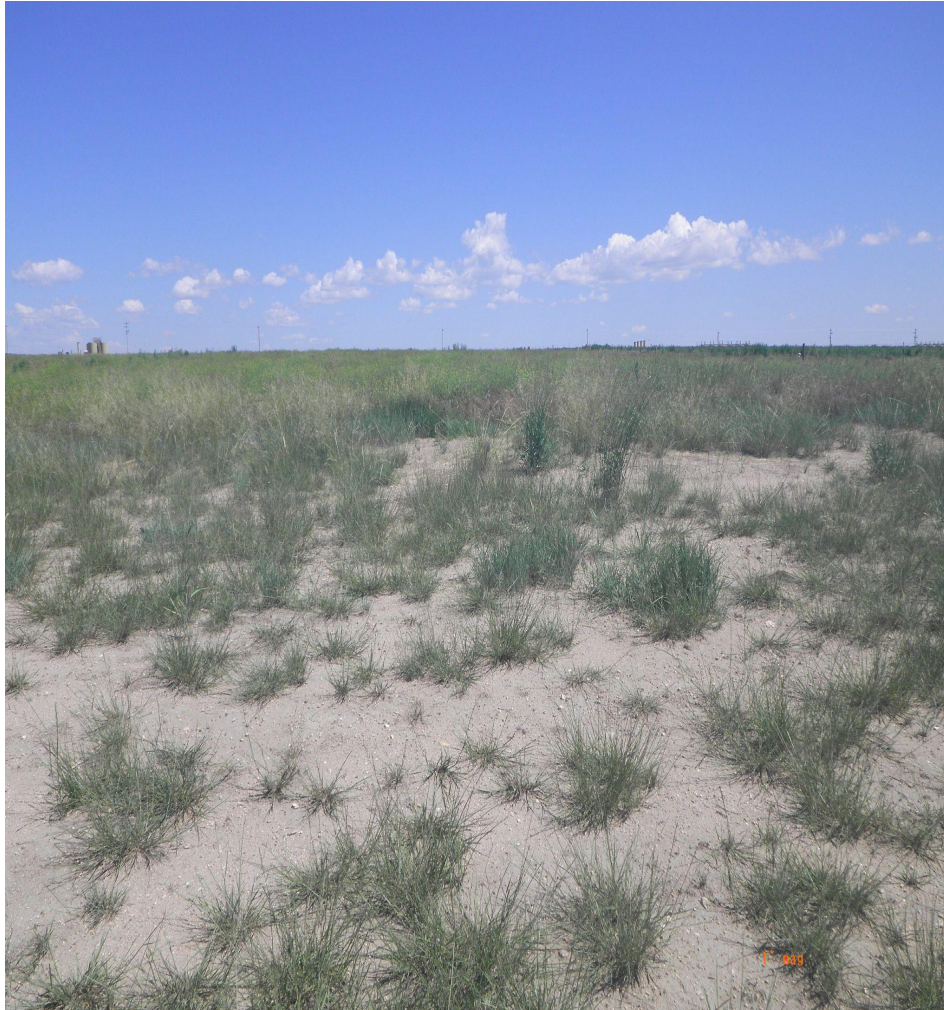
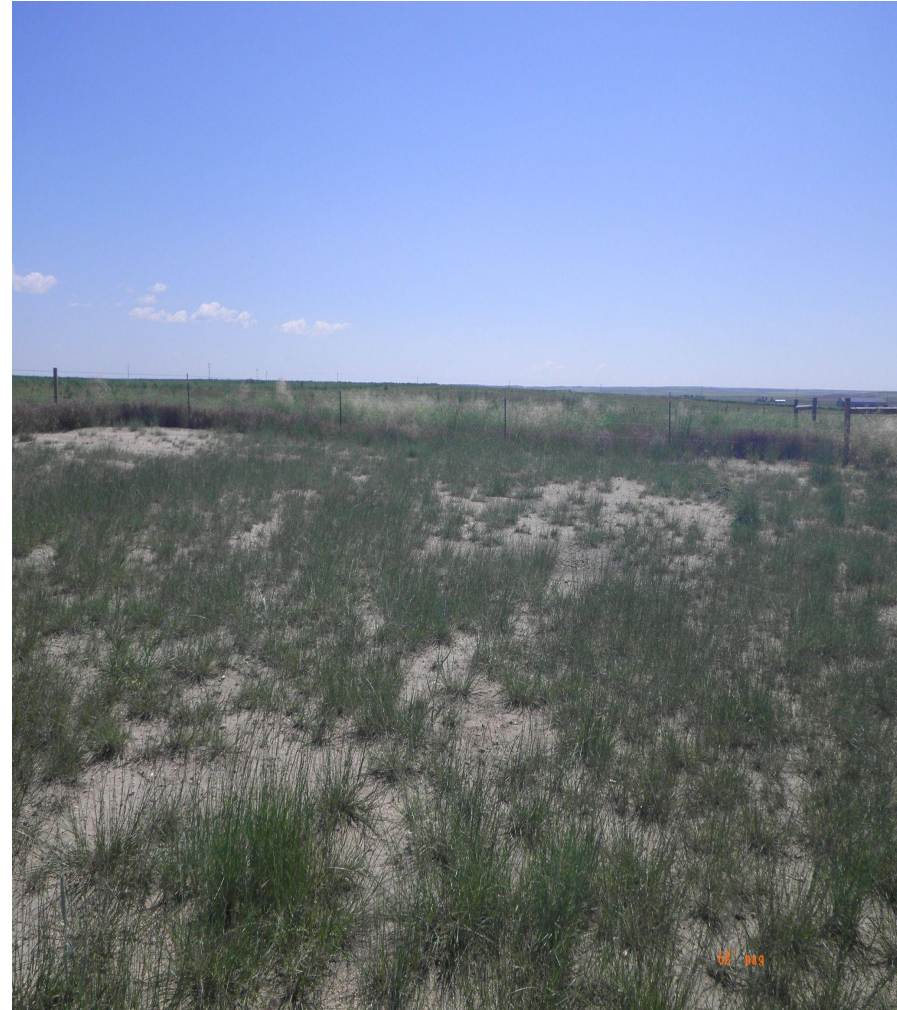
Photo 7. Cardinal photos taken from the middle of the tank battery.
Left photo facing north, right photo facing east.

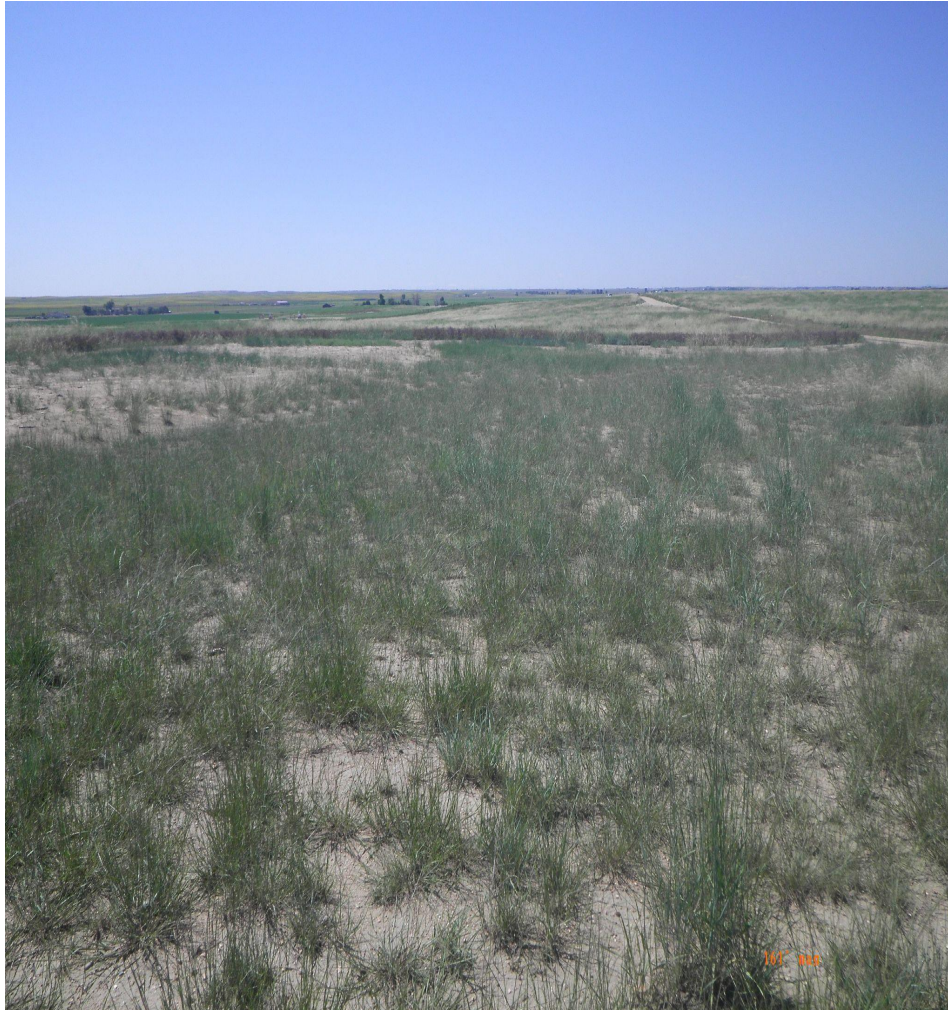
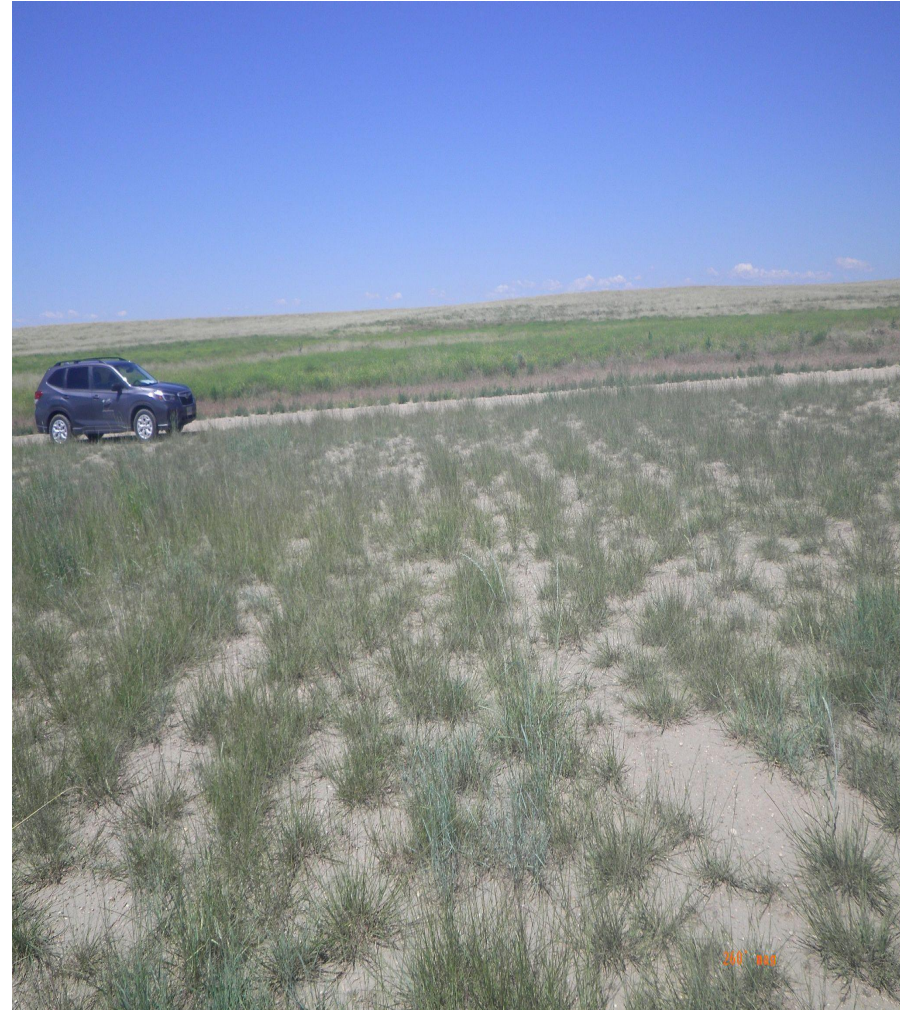
Photo 8. Cardinal photos taken from the middle of the tank battery. Left photo facing south, right photo facing west. Note: germination of desirable species observed at location. 80% vegetation cover has not yet been achieved, site will remain in-process until rule 1004 standards are met.
