## Inspection Photos

Location Name: TEP ROCKY MOUNTAIN LLC, AMERICAN SODA-67S96W/3NENE

Location ID: 334596

Date: 7/6/2023

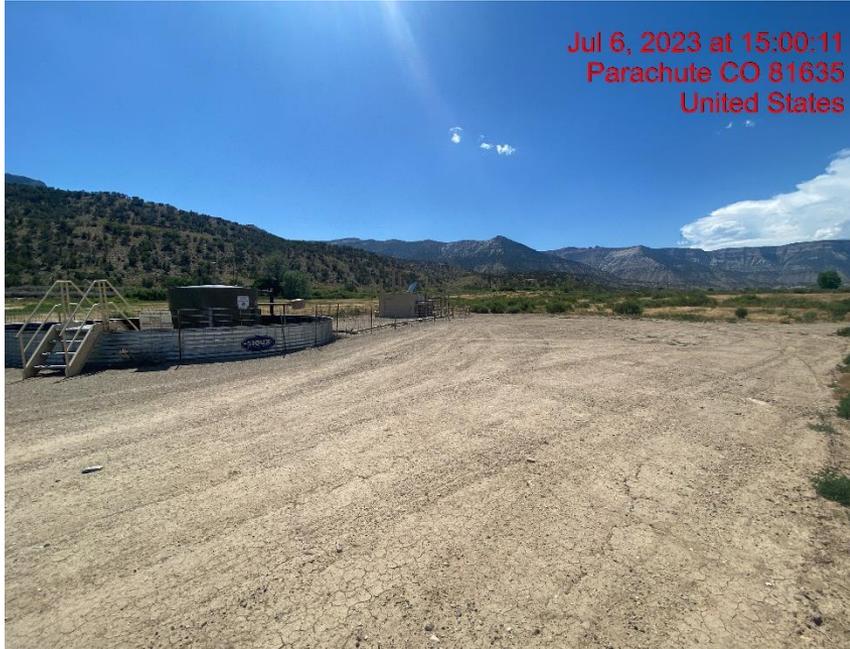
Location Entrance – Photo #05036

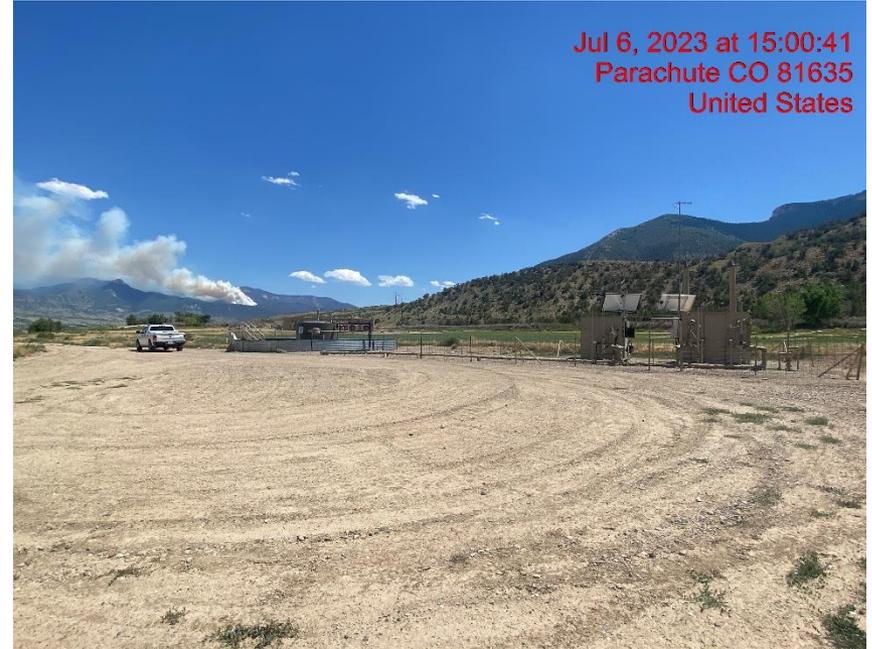
North Side of Location – Photo #05037

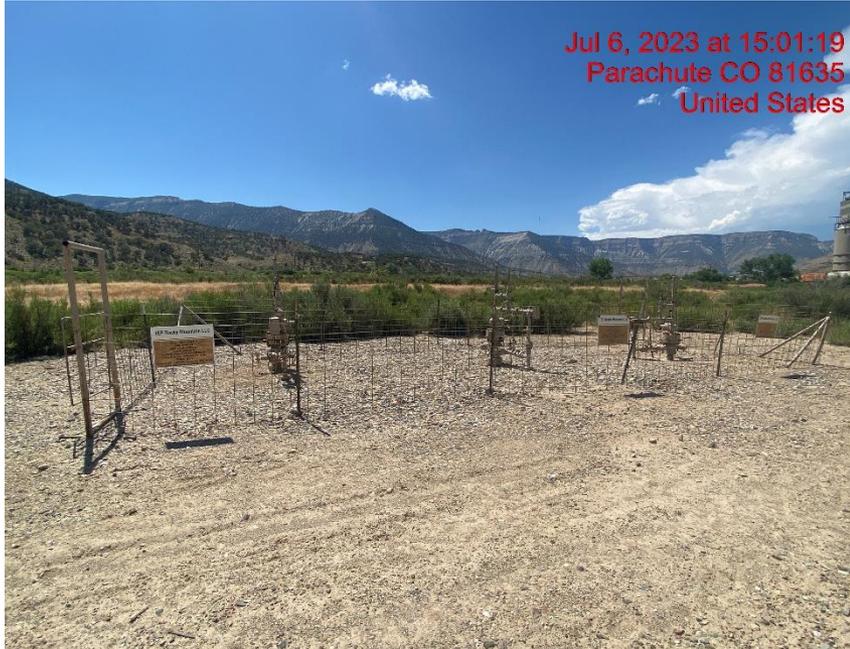
Wellheads – Photo #05038

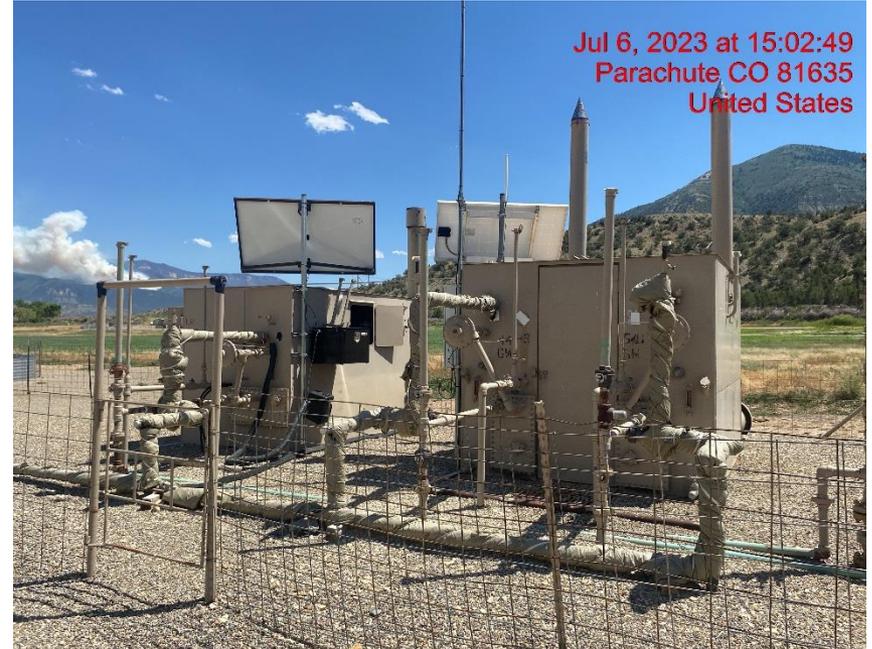
Separators – Photo #05041

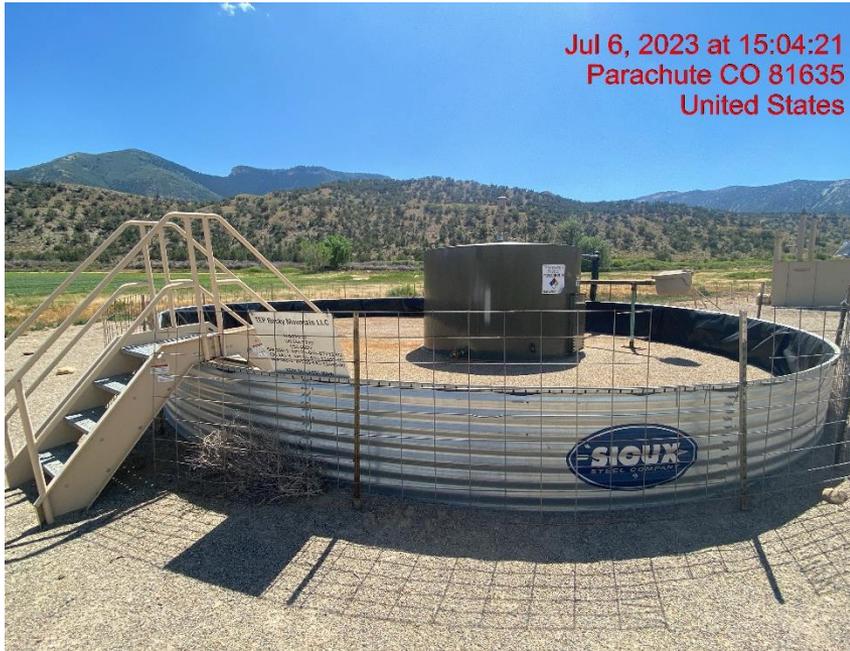
Tank Battery – Photo #05045

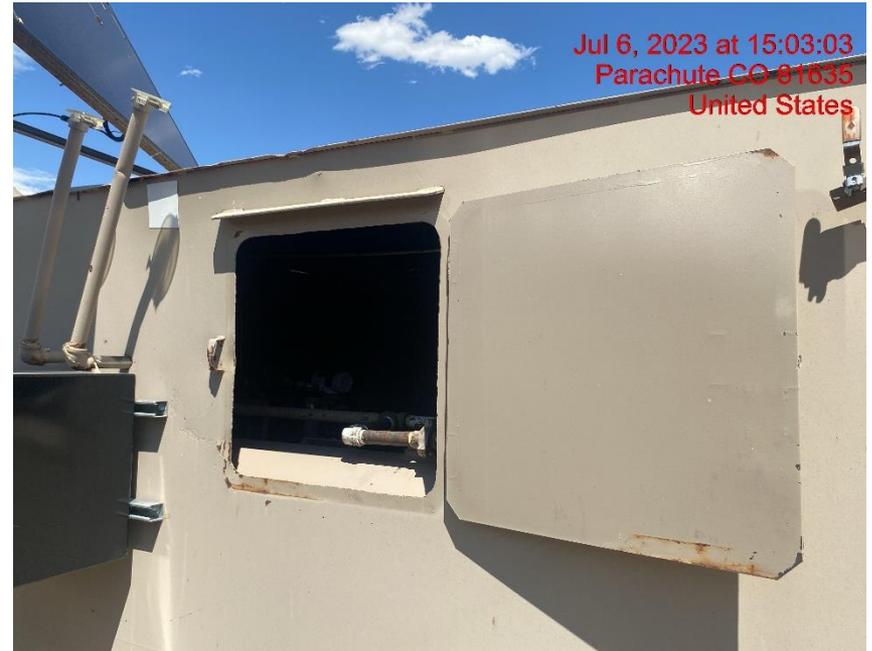
Unsecured Hatch on Separator – Photo #05042

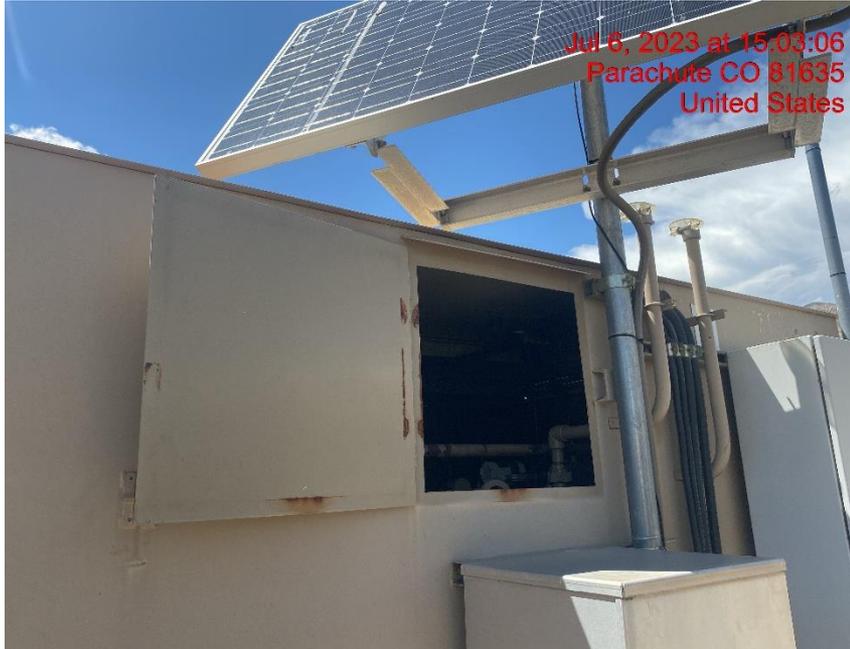
**Unsecured Hatch on Separator – Photo #05043**

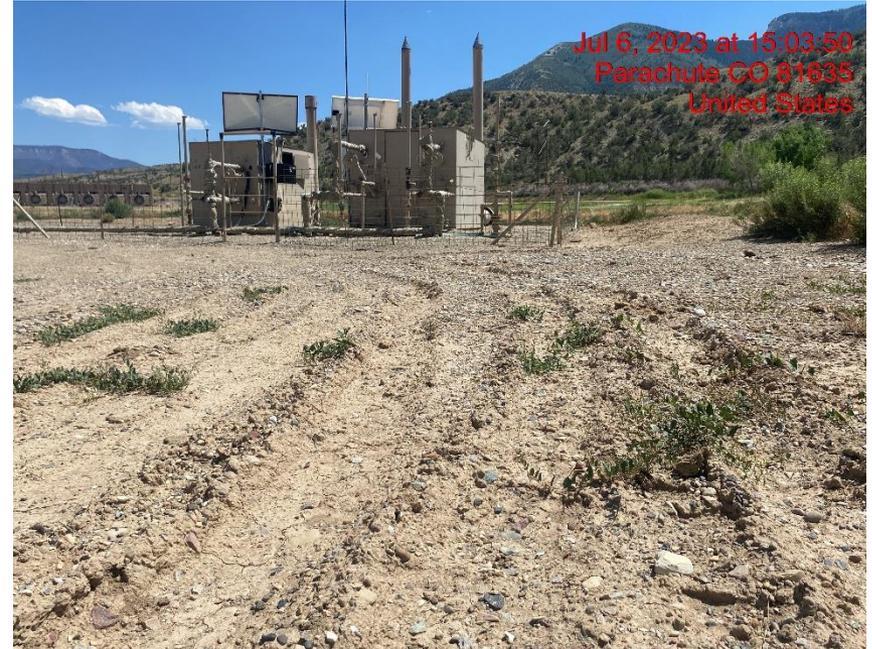
**Lack of Stabilization – Photo #05044**

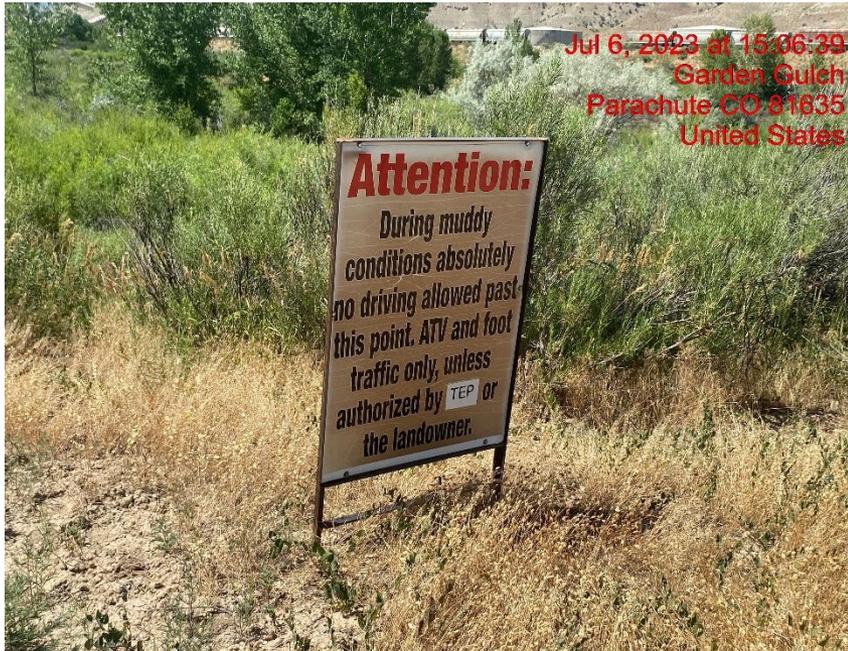
Administrative BMP – Photo #05048

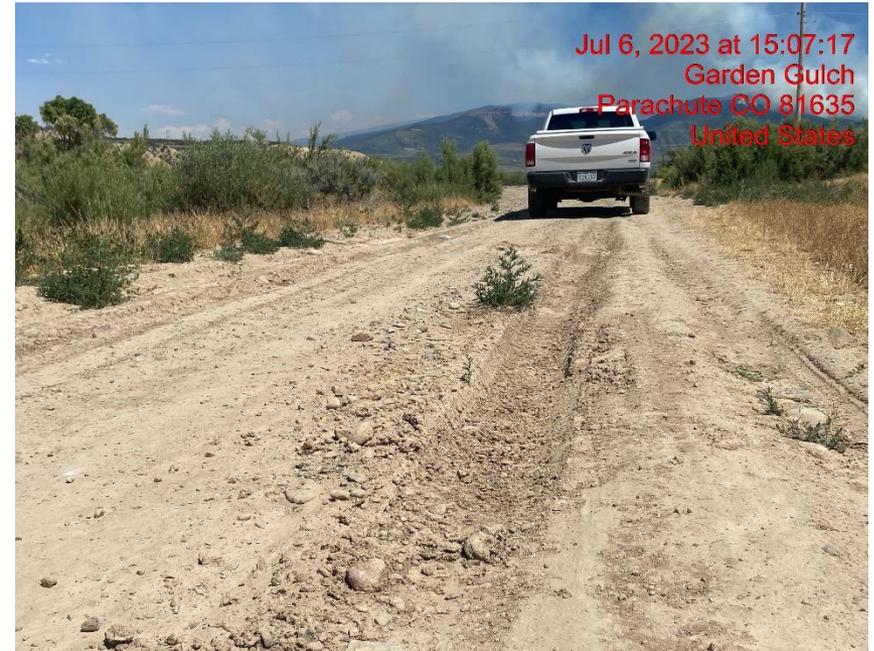
Lack of Stabilization on Access Road – Photo #05049

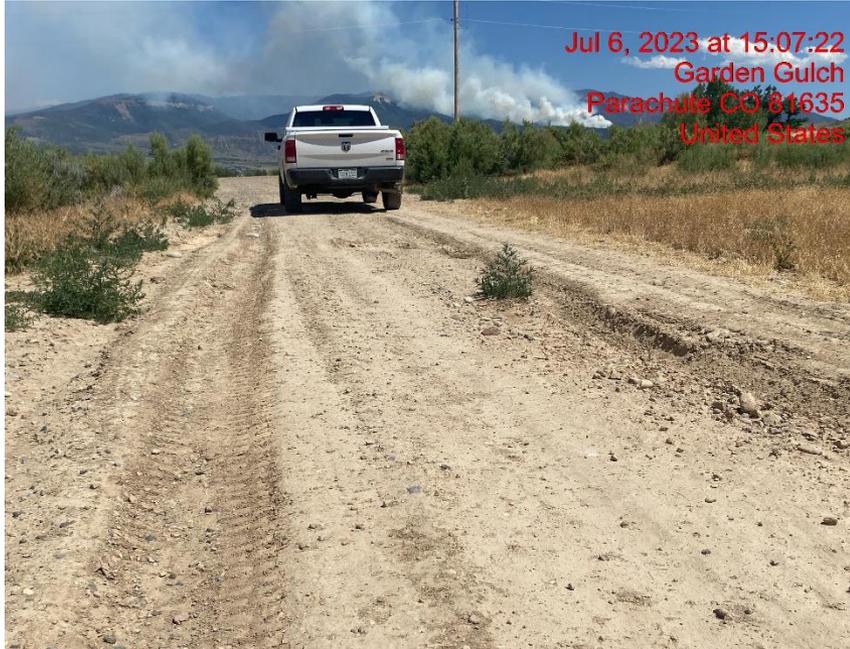
**Lack of Stabilization on Access Road – Photo #05050**

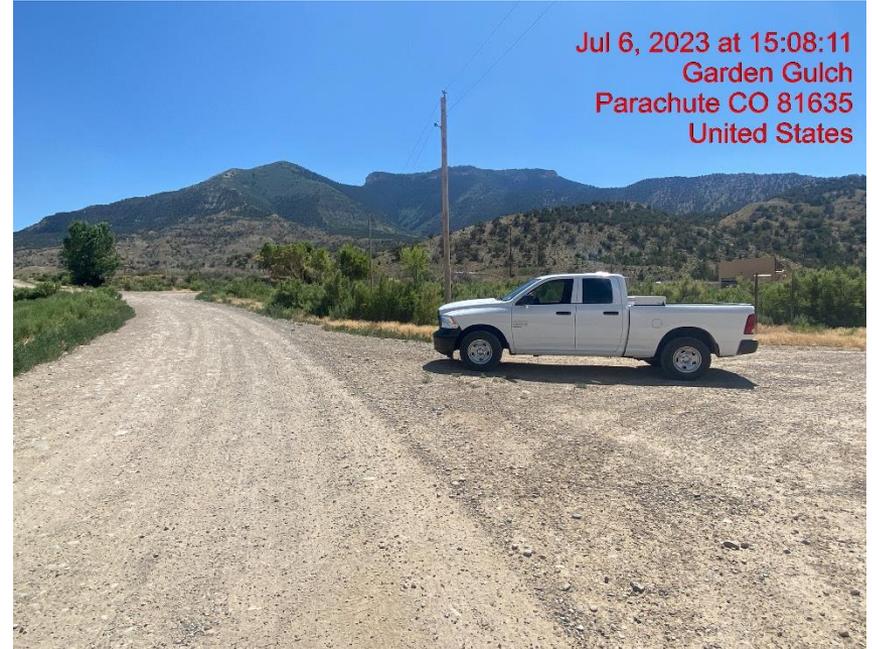
**Insufficient Vehicle Tracking BMPs at Location Entrance/Exit  
– Photo #05051**
