Inspection Photos
UPRR 43 PAN AM I 33 & 27
Spill ID 481679
Remediation Project Nos 26277, 23488

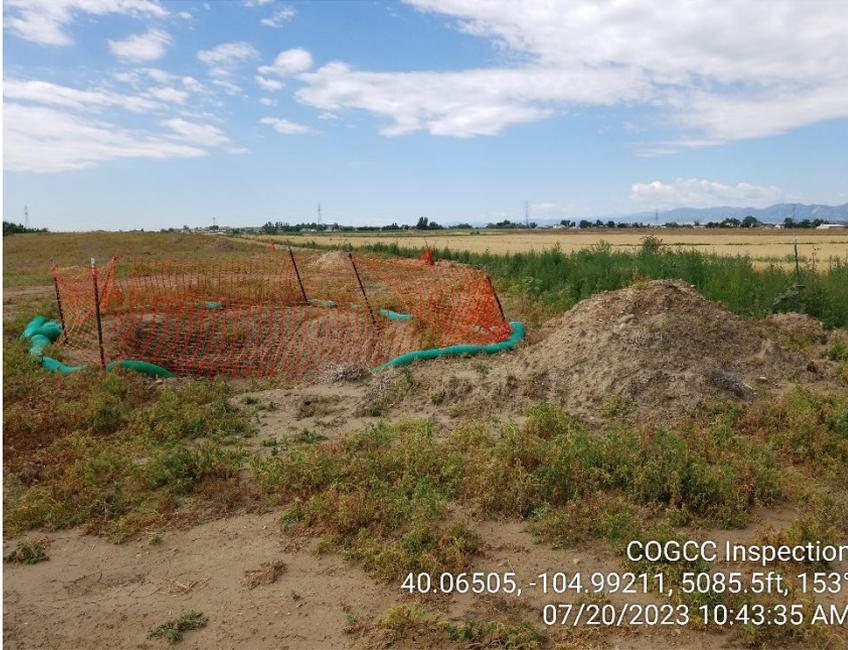
Photo 1 – Spill ID 481679 excavation. Fencing is falling down around open excavation. Soil stored on location with inadequate BMPs.

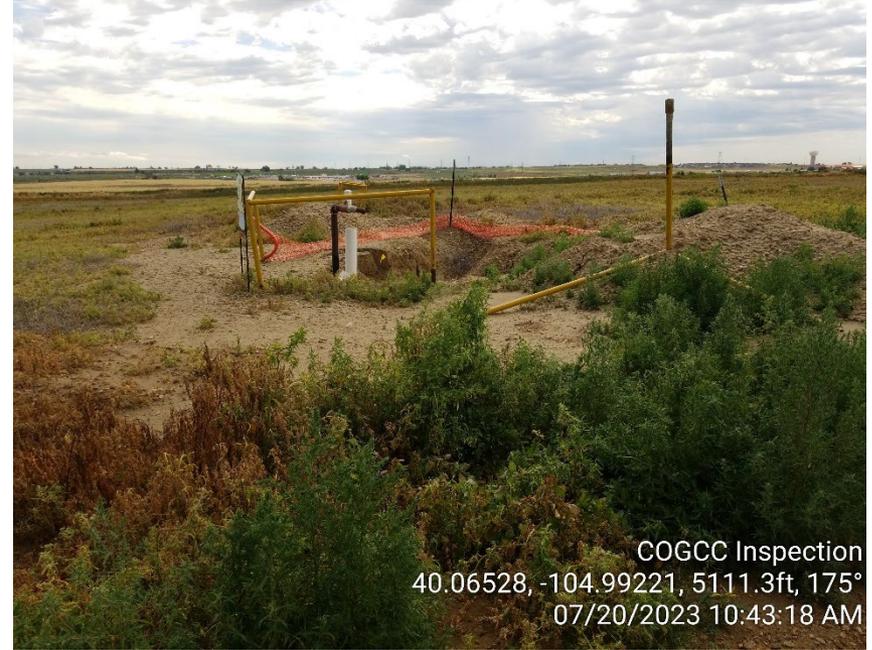
Photo 2 – Flowline excavation for Rem 26277. Fencing is down around open excavation. Soil stockpile has missing/inadequate BMPs.

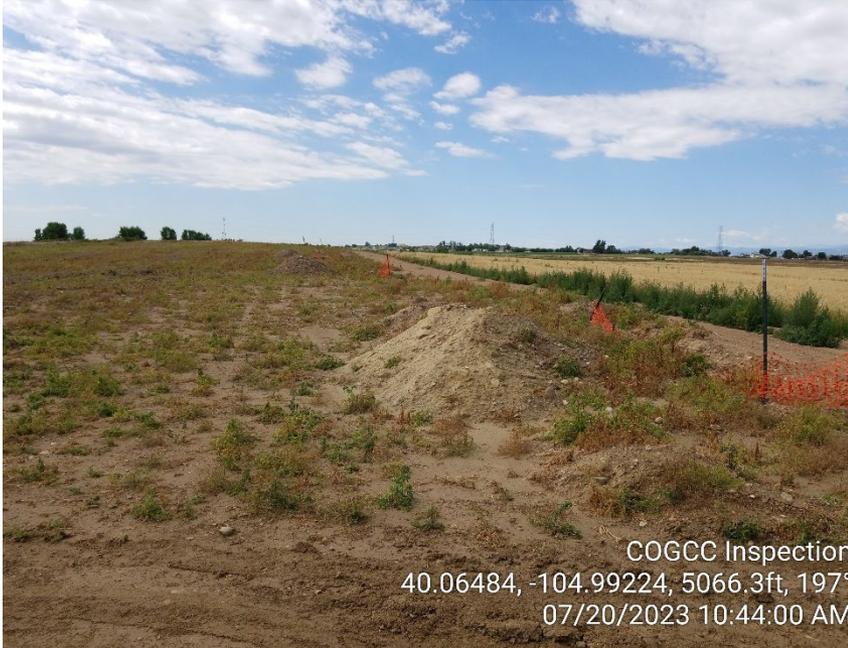
Photo 3 – Flowline excavation for Rem 26277. Fencing is down around open excavation. Soil stockpile has missing/inadequate BMPs.

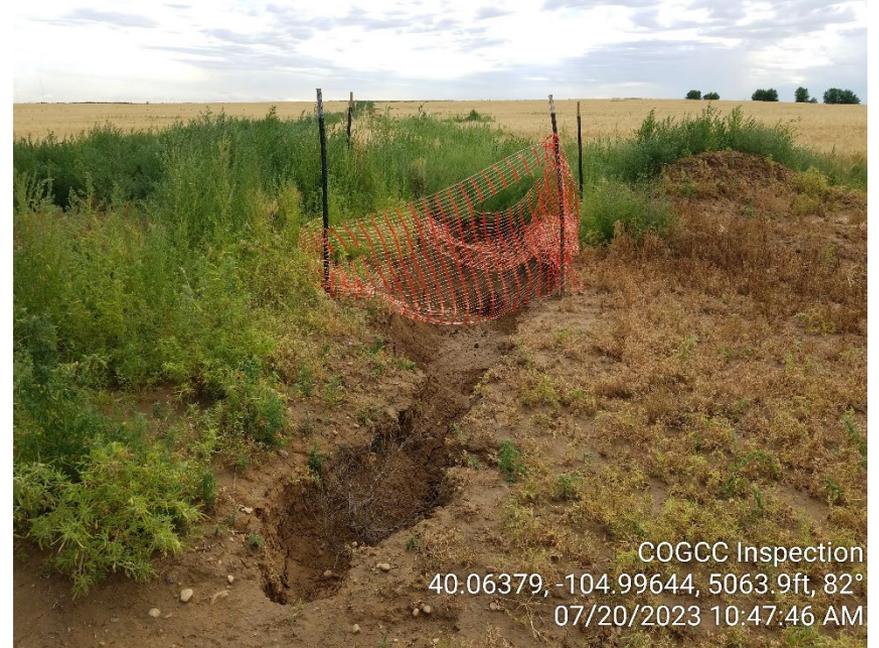
Photo 4 – Flowline excavation for Rem 26277. Fencing is down around open excavation. Soil stockpile has missing/inadequate BMPs. Weeds on access road for API 05-123-09913.

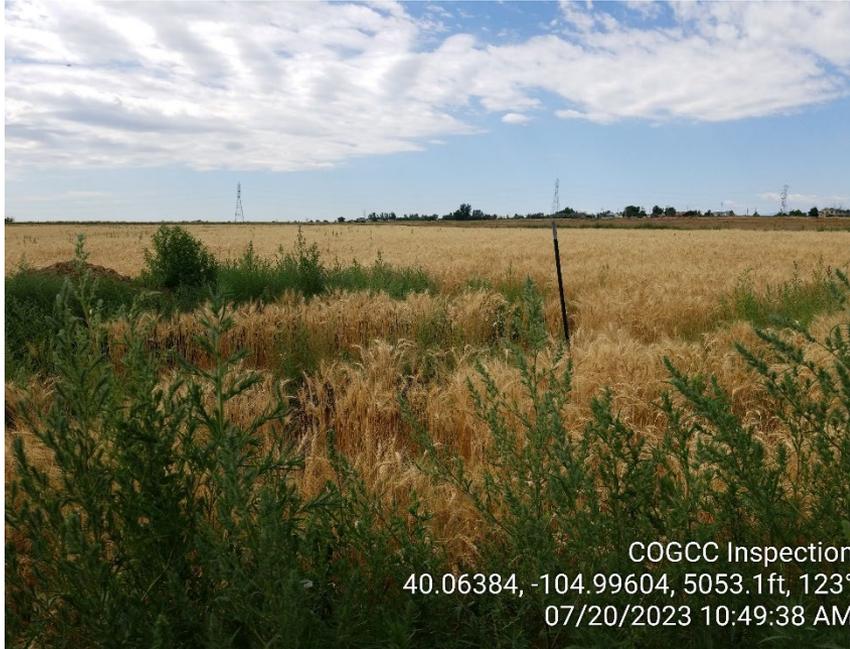
**Photo 5 – Flowline excavation for Rem 26277.
Fencing is down around open excavation.**

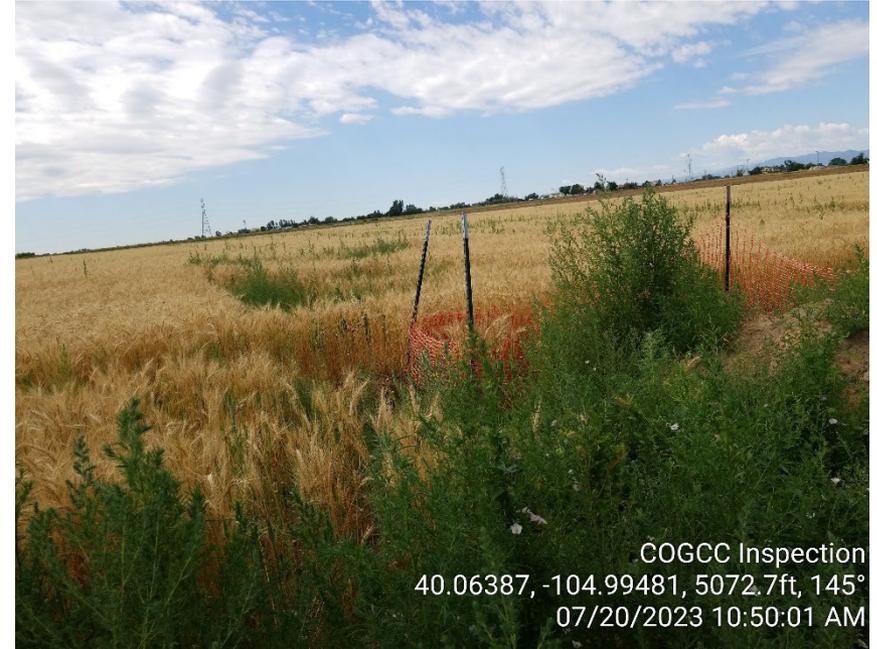
**Photo 6 – Flowline excavation for Rem 26277.
Fencing is down around open excavation.**

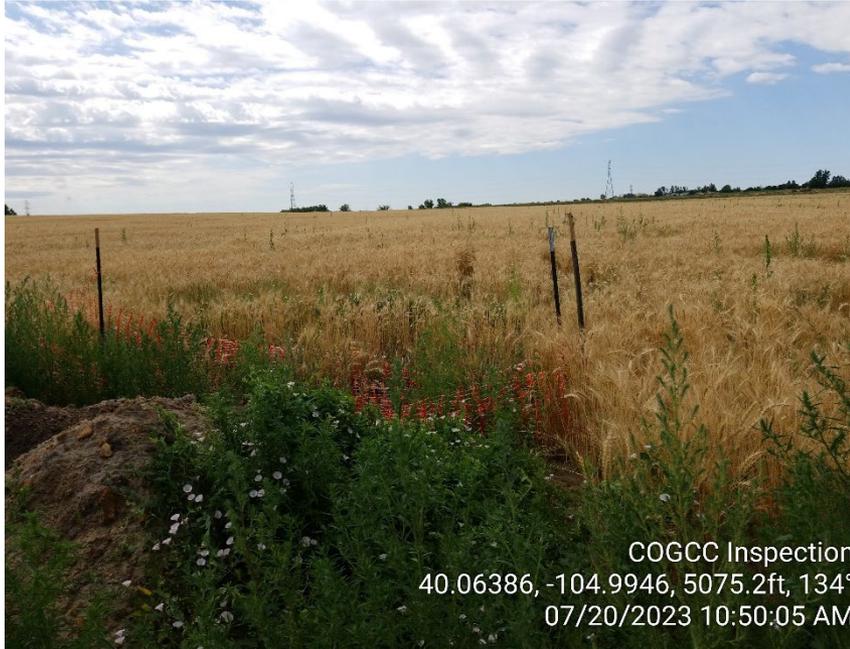
Photo 7 – Flowline excavation for Rem 26277. Fencing is down around open excavation. Soil stockpile has missing/inadequate BMPs.

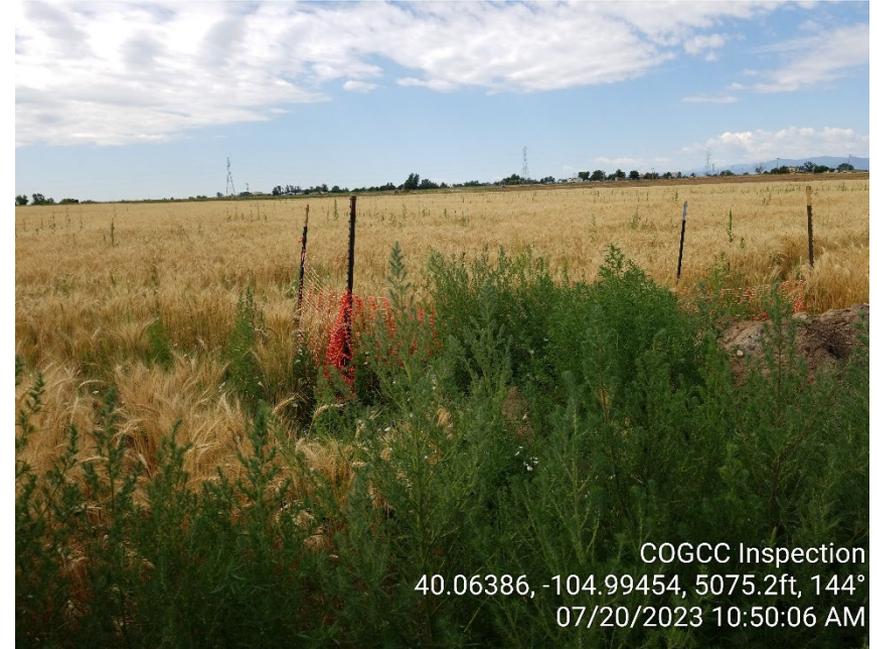
Photo 8 – Flowline excavation for Rem 26277. Fencing is down around open excavation. Soil stockpile has missing/inadequate BMPs.

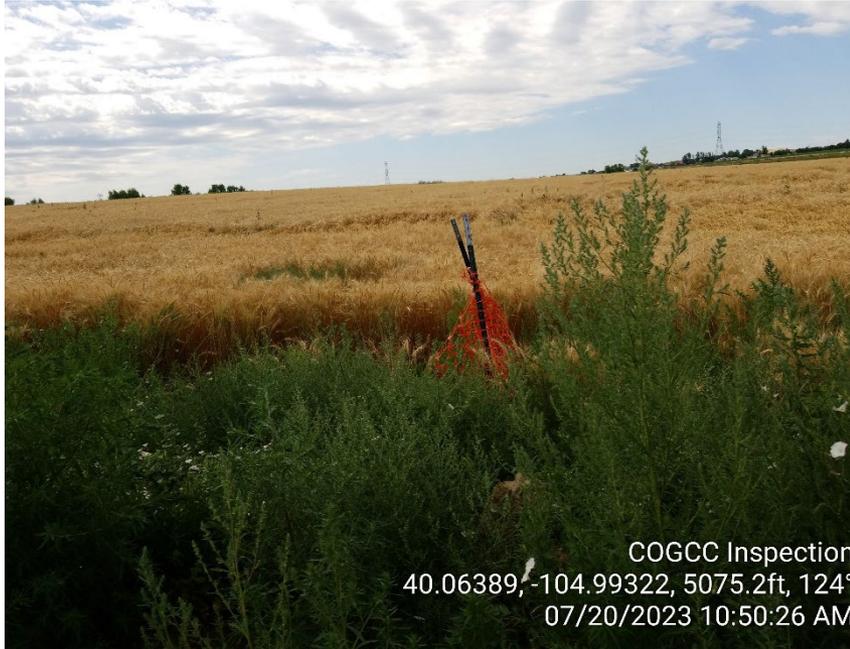
**Photo 9 – Flowline excavation for Rem 26277.
Fencing is down around open excavation.**

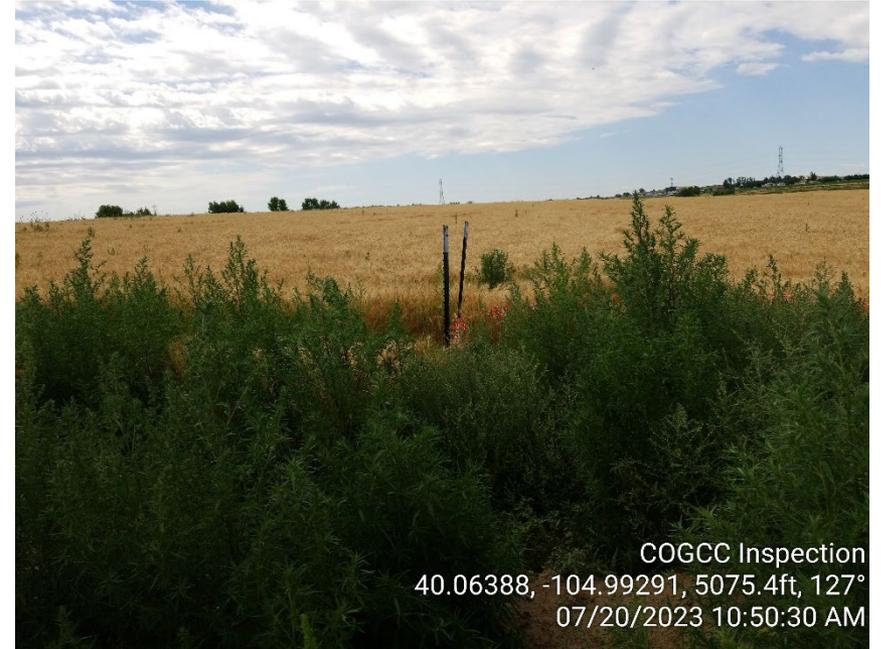
**Photo 10 – Flowline excavation for Rem 26277.
Fencing is down around open excavation.**

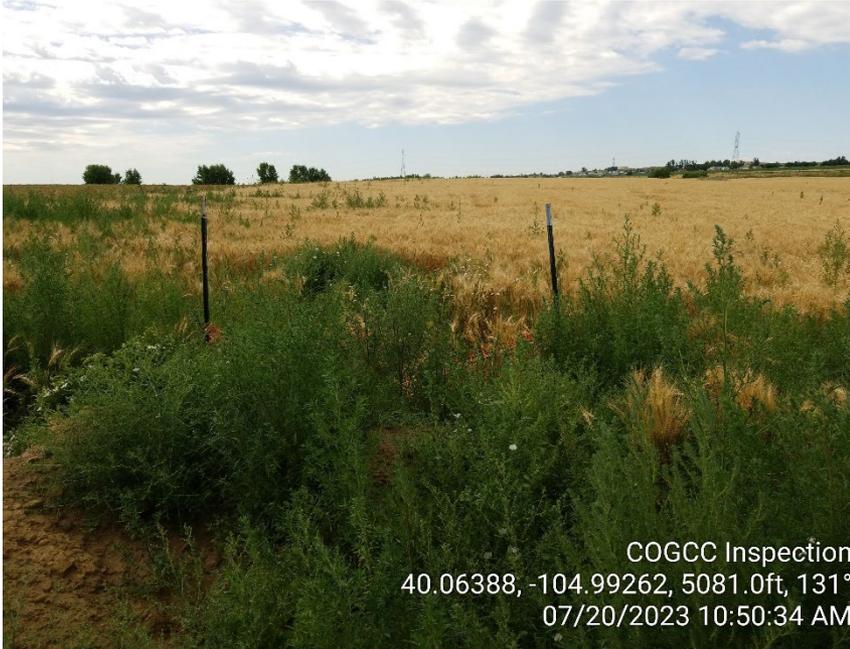
**Photo 11 – Flowline excavation for Rem 26277.
Fencing is down around open excavation.**

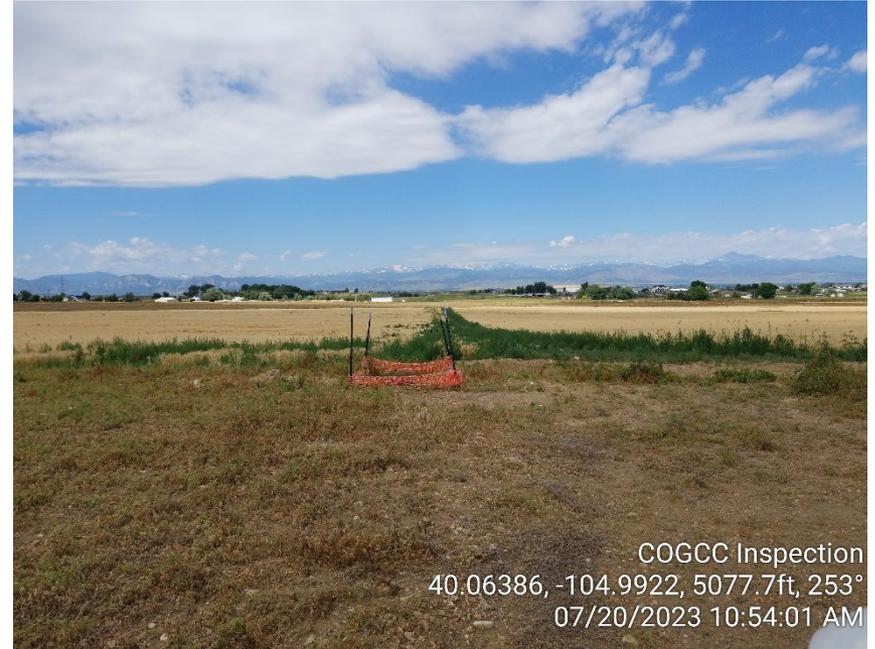
**Photo 12 – Flowline excavation for Rem 26277.
Fencing is down around open excavation. Weeds on
access road for API 05-123-09913.**

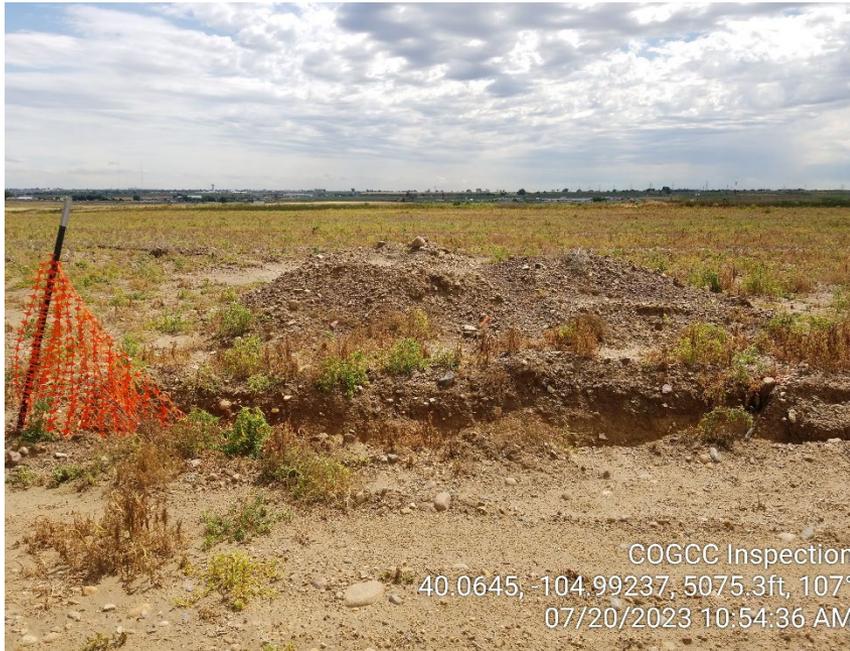
**Photo 13 – Flowline excavation for Rem 26277.
Fencing is down around open excavation. Soil
stockpile has missing/inadequate BMPs.**

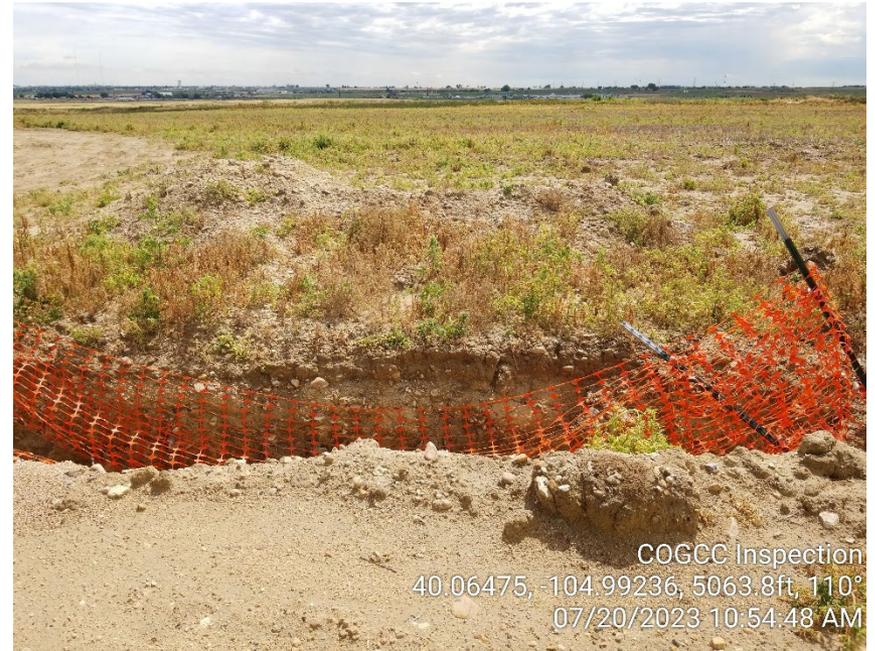
**Photo 14 – Flowline excavation for Rem 26277.
Fencing is down around open excavation.**

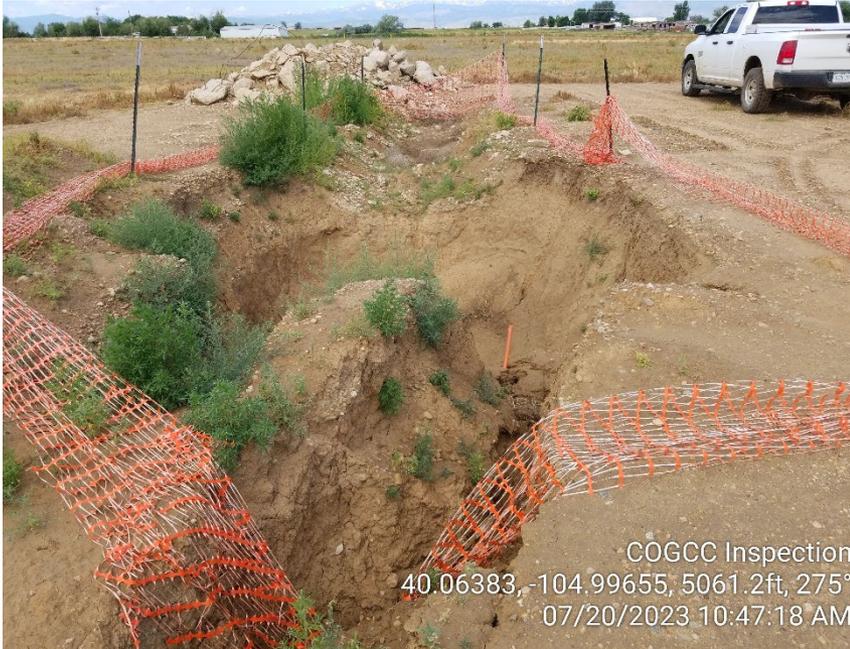
Photo 15 – Wellhead (API 05-123-09913) excavation for Rem 26277. Fencing is down around open excavation. Trash and debris (concrete, rebar, etc.) piled near open excavation.

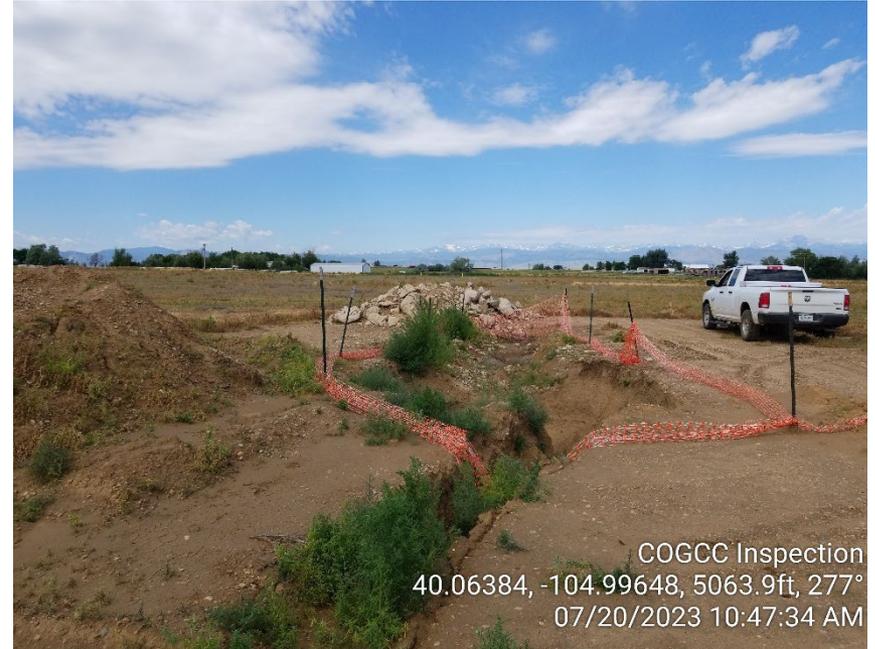
Photo 16 – Wellhead (API 05-123-09913) excavation for Rem 26277. Fencing is down around open excavation. Trash and debris (concrete, rebar, etc.) piled near open excavation. Weeds growing in open excavation. Soils pile with no BMPs present next to open excavation.

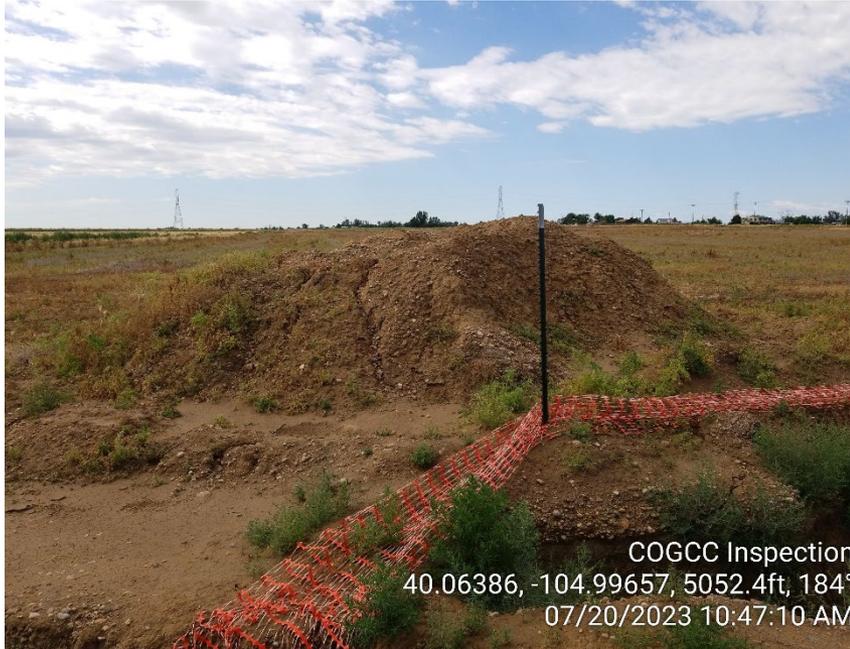
Photo 17 – Soils pile with no BMPs present next to open wellhead excavation.

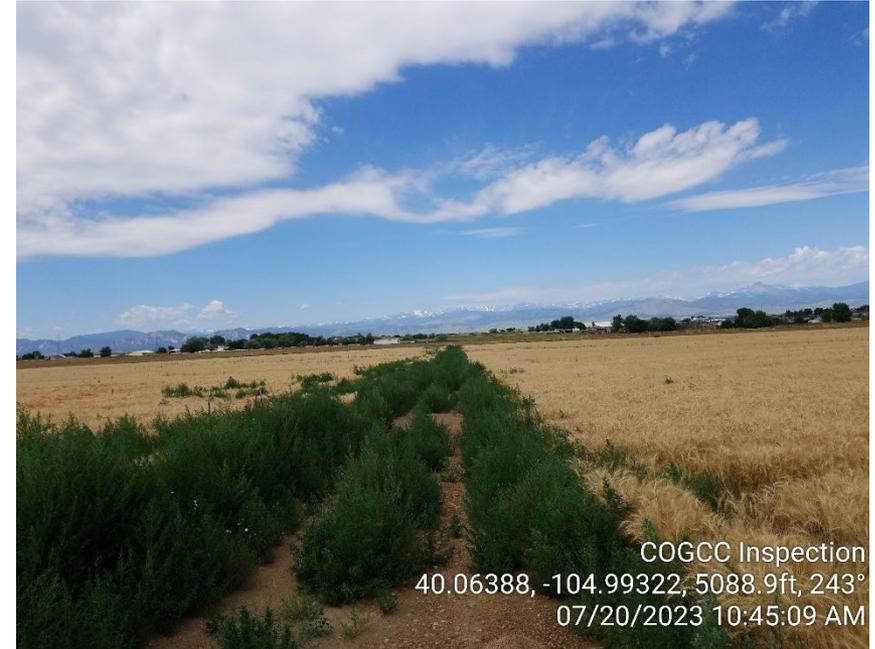
Photo 18 – Weeds on access road for API 05-123-09913.

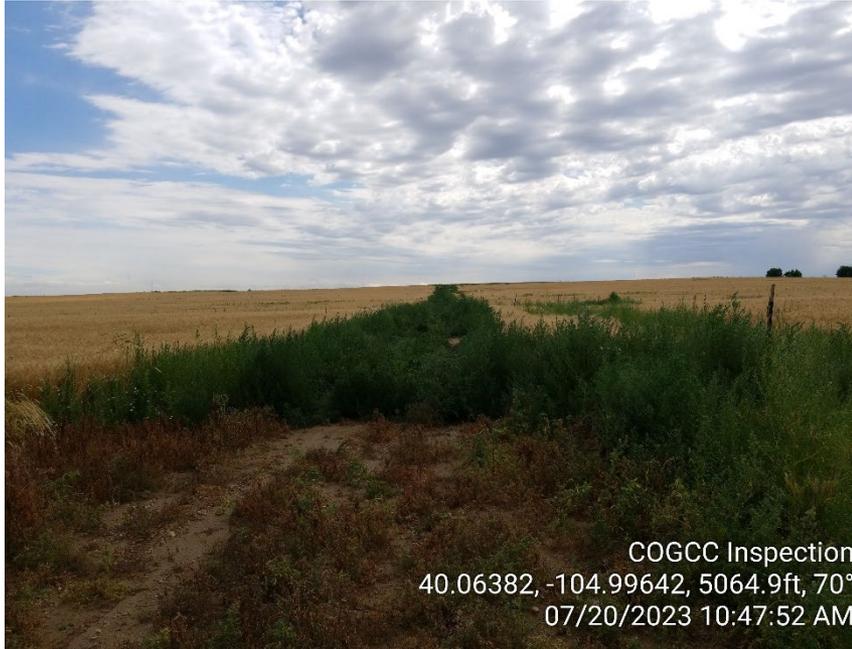
Photo 19 – Weeds on access road for API 05-123-09913.

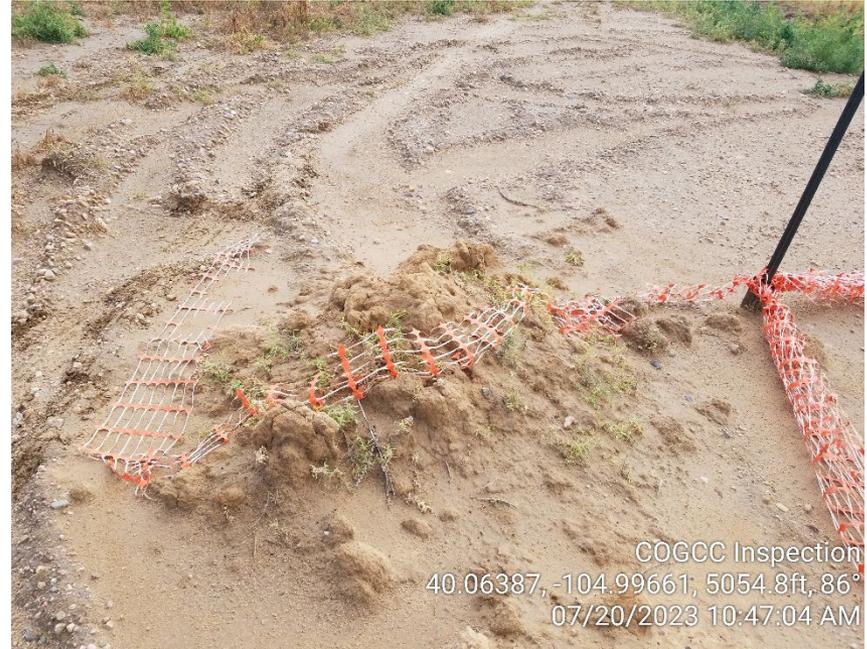
Photo 20 – Orange excavation fencing has become trash.
