**Storm Water Management and Erosion control**  
**Location Name: TEP ROCKY MOUNTAIN LLC RMV 32-21 pad**  
**Location ID: 323916**

**Location Overview: Location is within High Priority/Density  
Habitat areas & within close proximity to Bald Eagle Roost  
site. Drainage contributes to the Colorado River.**

**Section/Township/Range: 21 6S94W**

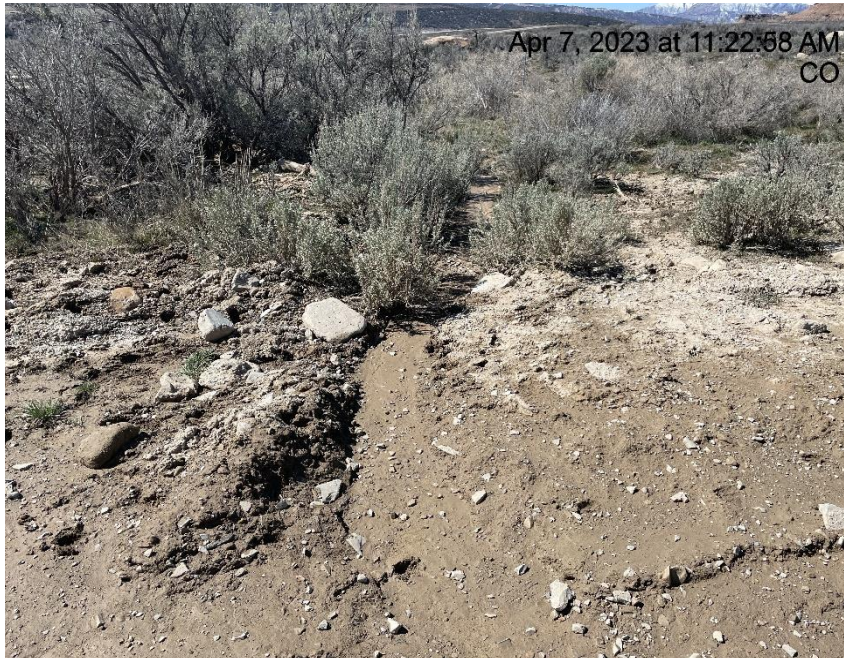
**Photo # 4639 From Inspection 708900241 conducted on 04/07/2023 Erosion & transport of sediment off lease road/insufficient BMP's**

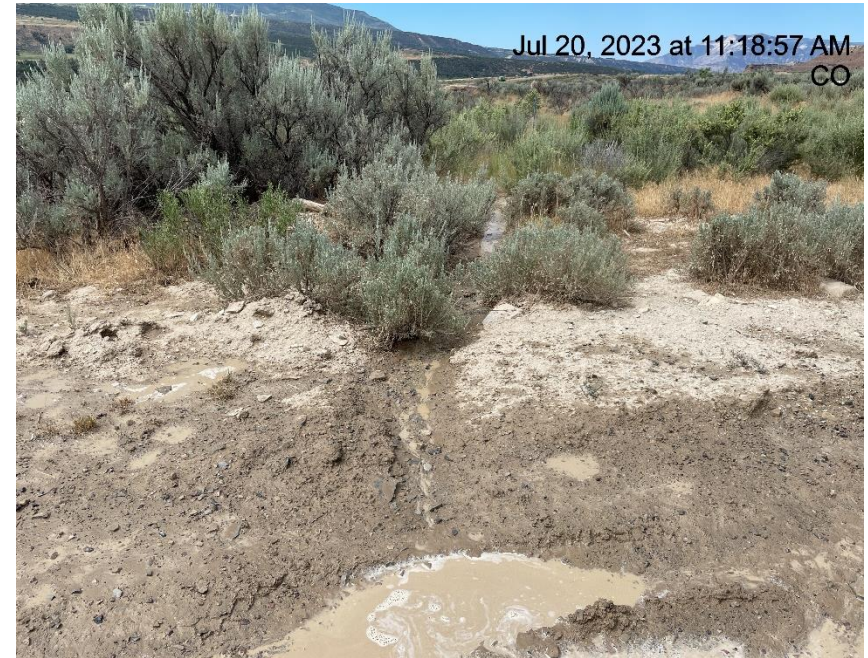
**Photo # 3488 Erosion & transport of sediment off lease road/insufficient BMP's**

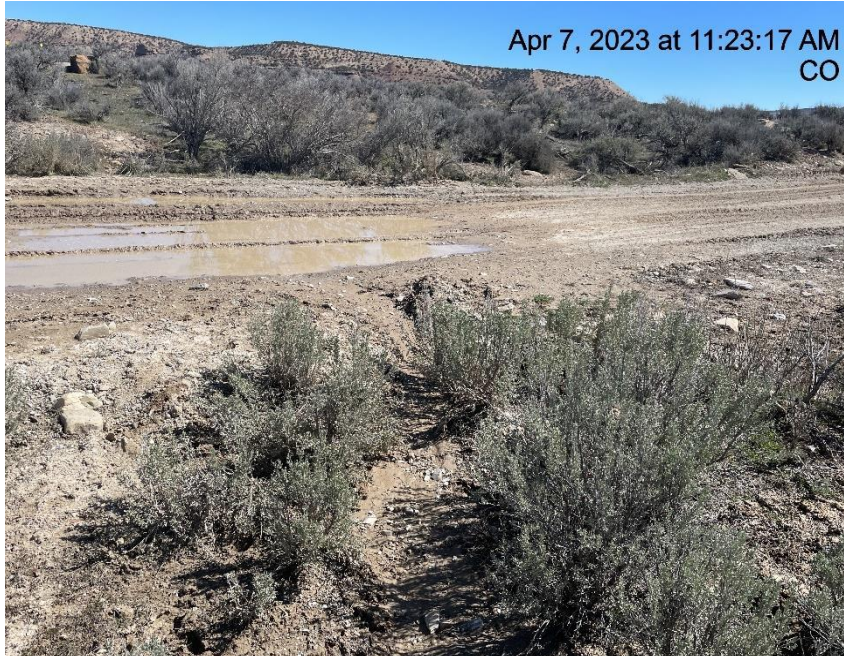
**Photo # 4640 From Inspection 708900241 conducted on 04/07/2023 Erosion & transport of sediment off lease road/insufficient BMP's**

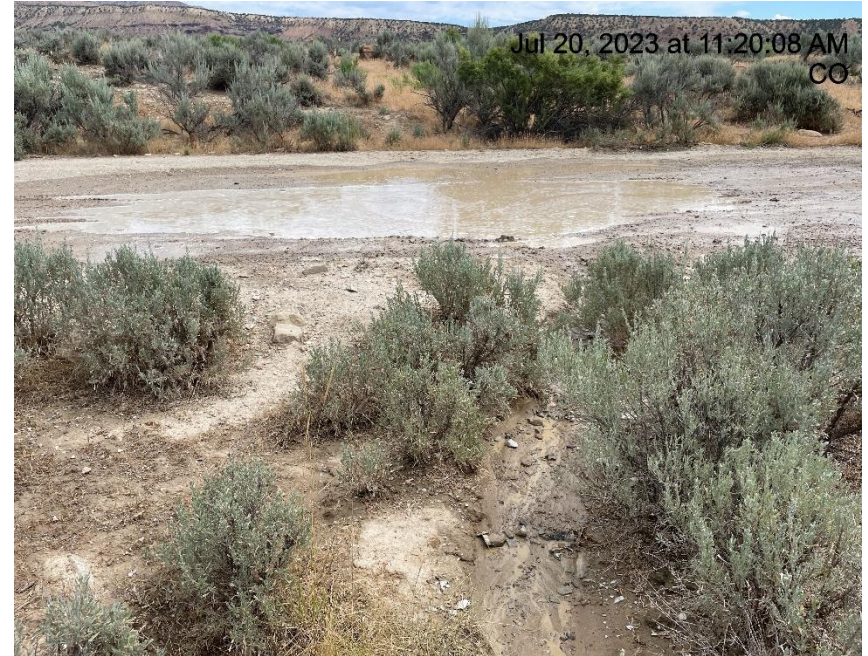
**Photo # 3495 Erosion & transport of sediment off lease road/insufficient BMP's**

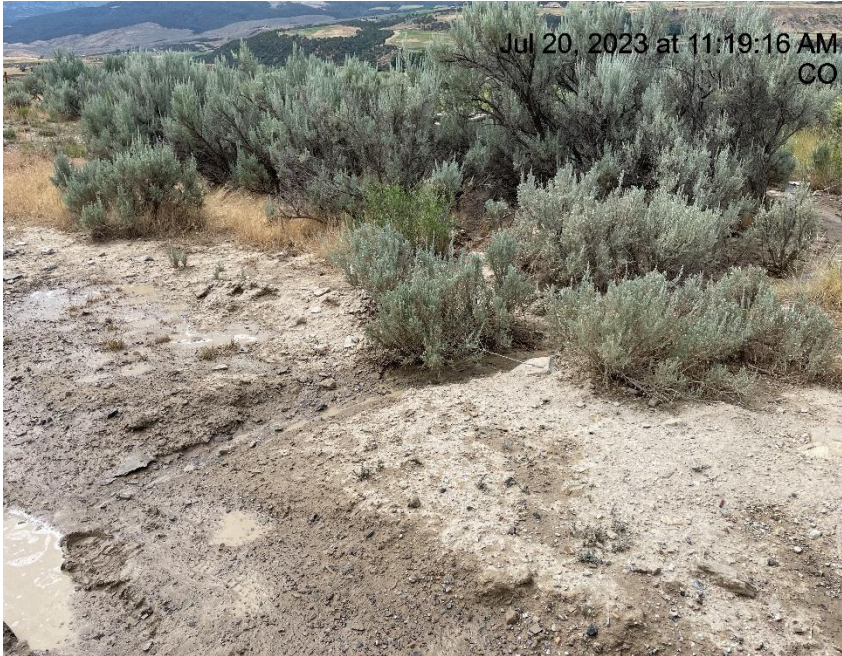
**Photo # 3490 Erosion & transport of sediment off lease road/insufficient BMP's**

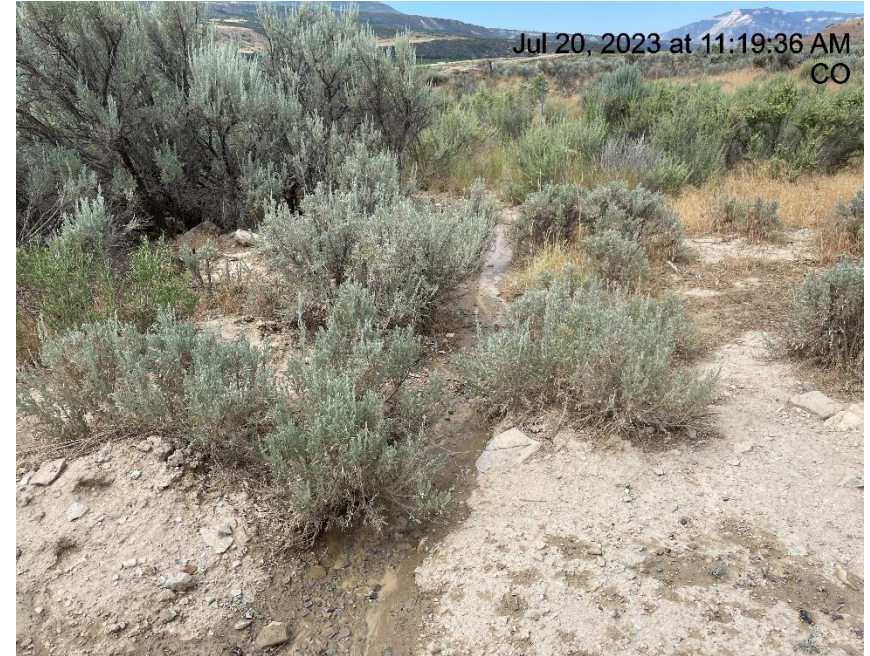
**Photo # 3492 Erosion & transport of sediment off lease road/insufficient BMP's**

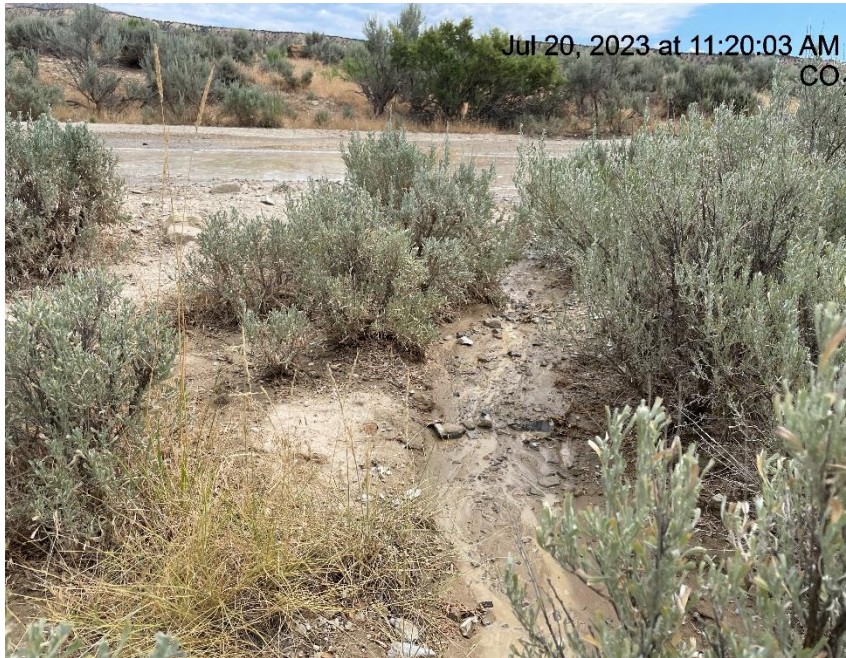
**Photo # 3493 Erosion & transport of sediment off lease road/insufficient BMP's – sediment is being transported into a vegetated area & choking off vegetation.**

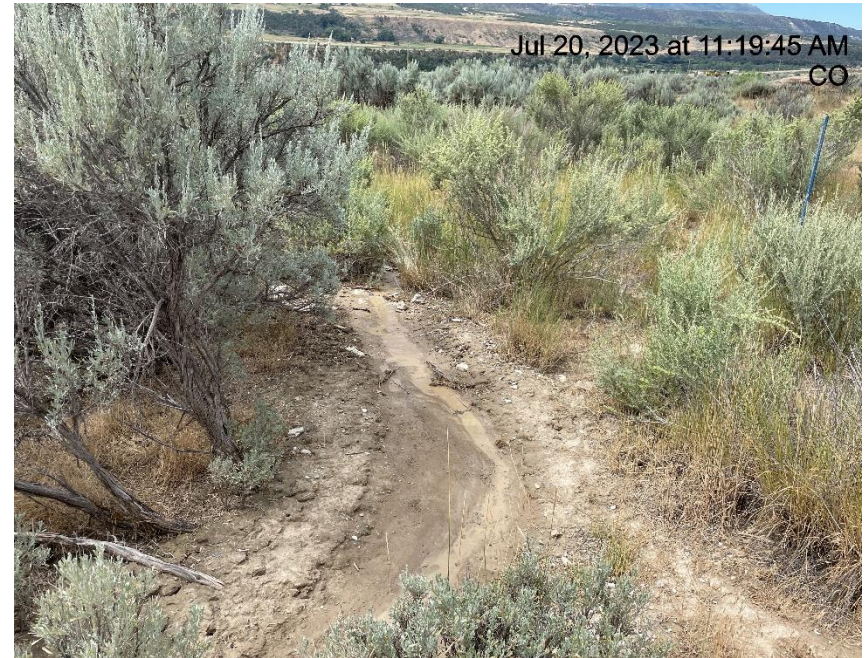
**Photo # 3494 Erosion & transport of sediment off lease road/insufficient BMP's – sediment is being transported into a vegetated area & choking off vegetation.**

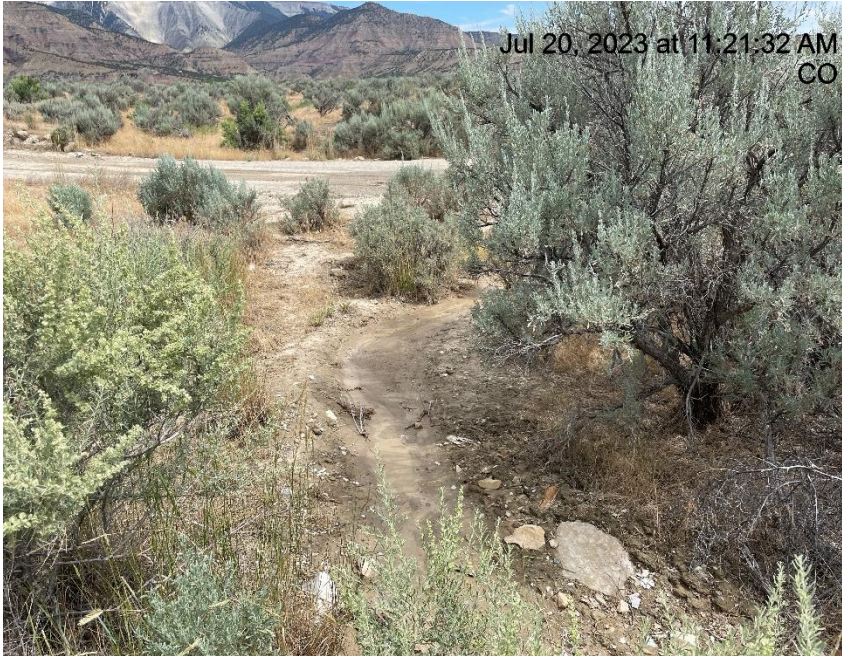
**Photo # 3502 Erosion & transport of sediment off lease road/insufficient BMP's – sediment is being transported into a vegetated area & choking off vegetation.**

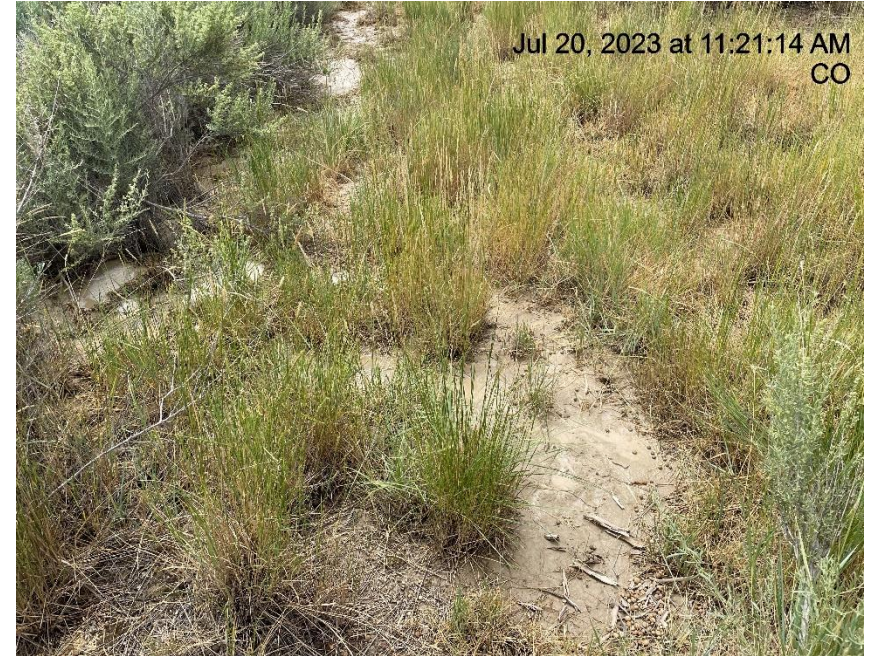
**Photo # 3500 Erosion & transport of sediment off lease road/insufficient BMP's – sediment is being transported into a vegetated area & choking off vegetation.**

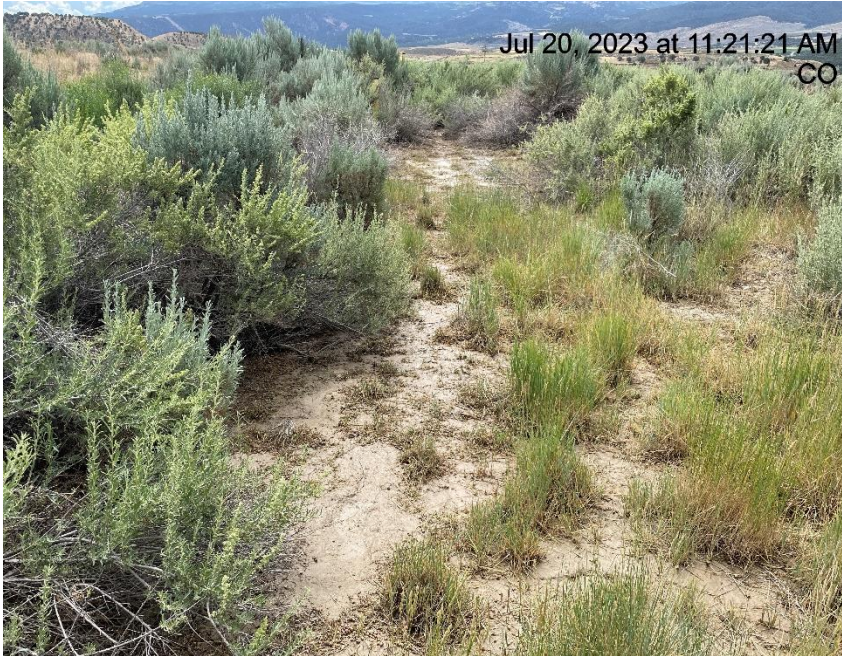
**Photo # 3501 Erosion & transport of sediment off lease road/insufficient BMP's – sediment is being transported into a vegetated area & choking off vegetation.**
