Inspection Photos
Location Name: Bledsoe 1-25-3-44
API Number: 125-09083

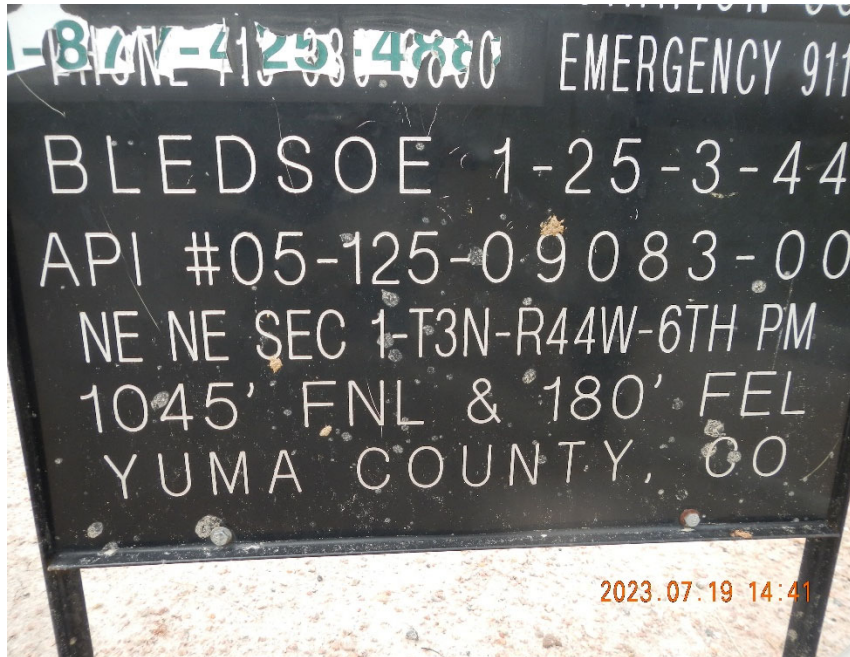
1. Well sign.

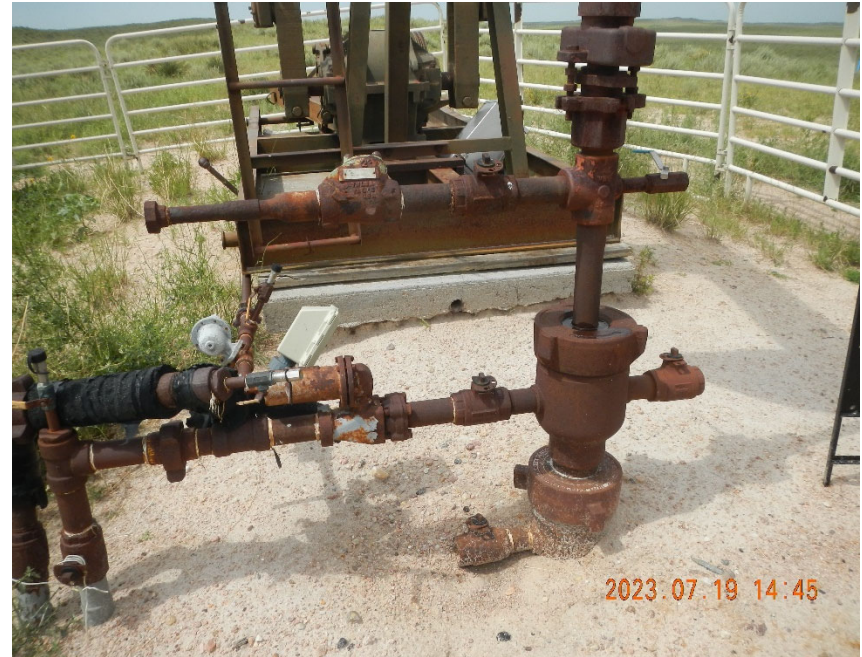
2. View of wellhead.

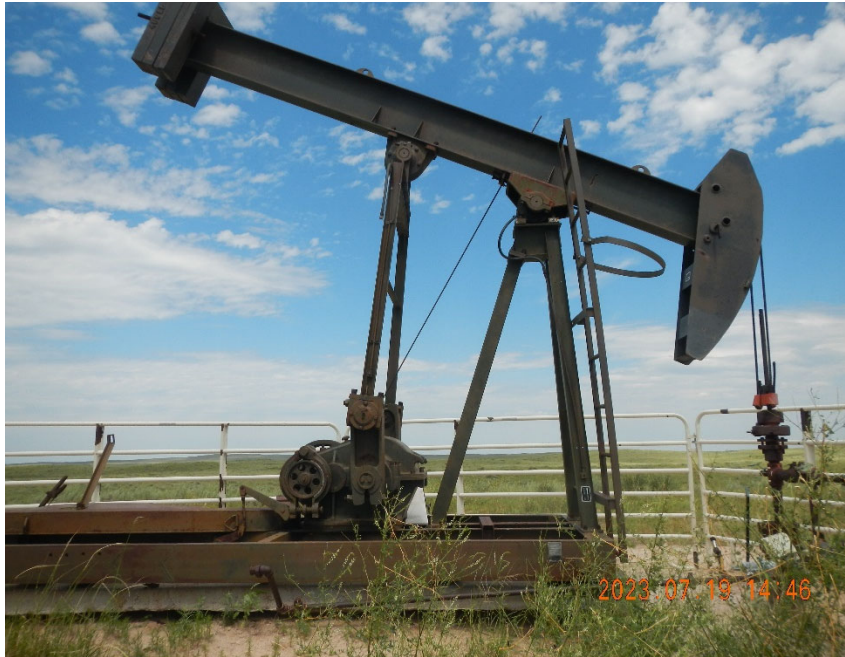
3. Pump Jack with motor removed.

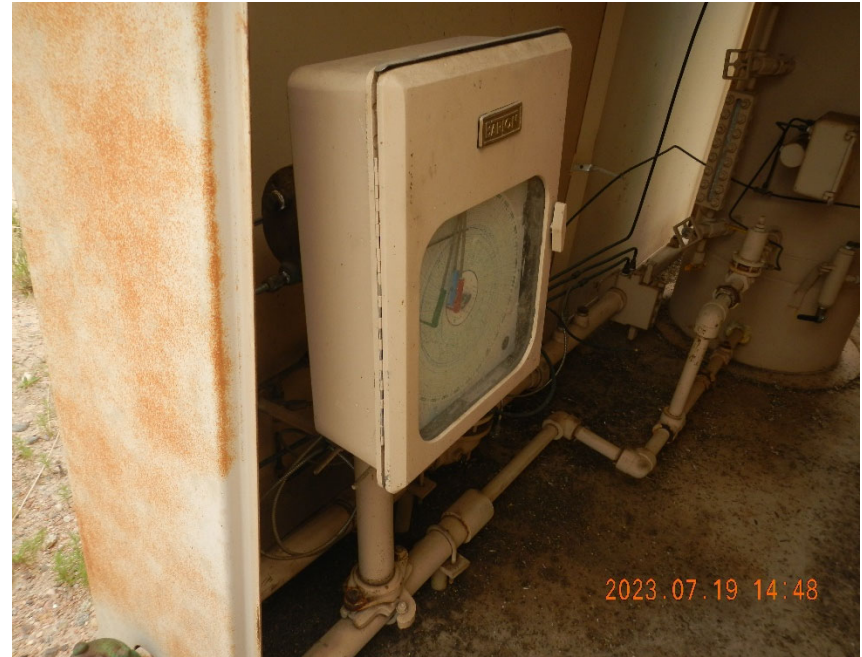
4. View of gas meter run inside meter shed.

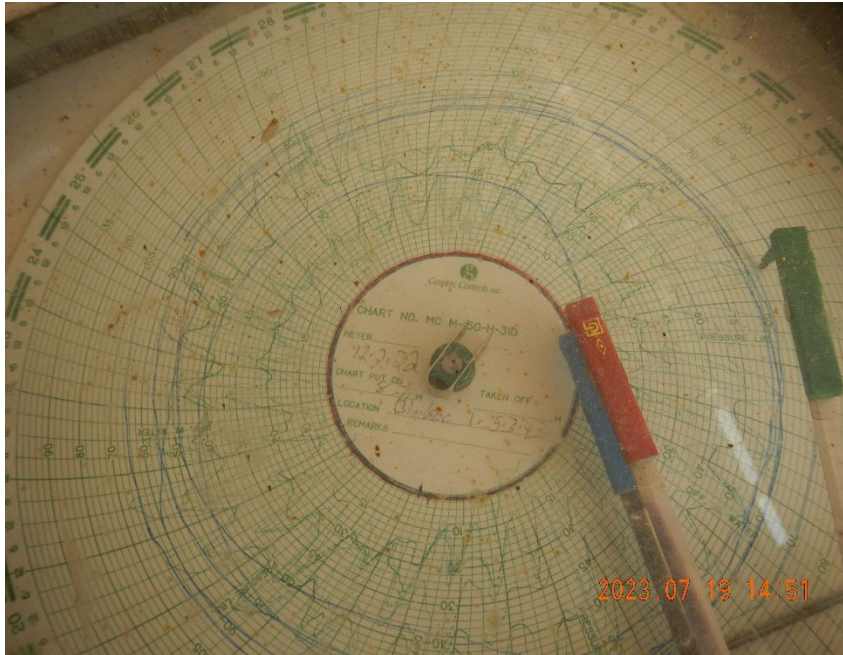
5. View of recording chart inside meter box dated 12-2-22.

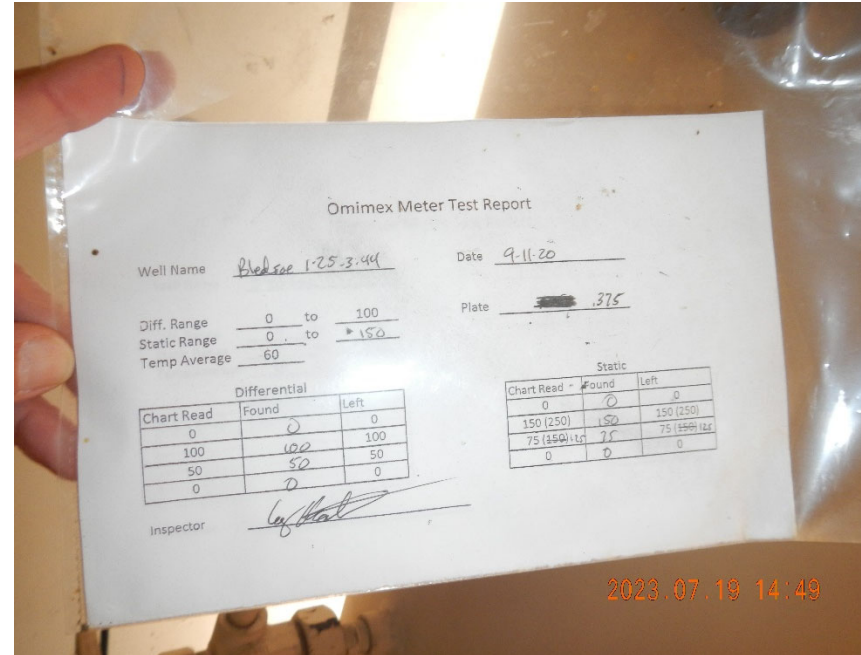
6. View of meter test report attached to gas meter run dated 9-11-20.

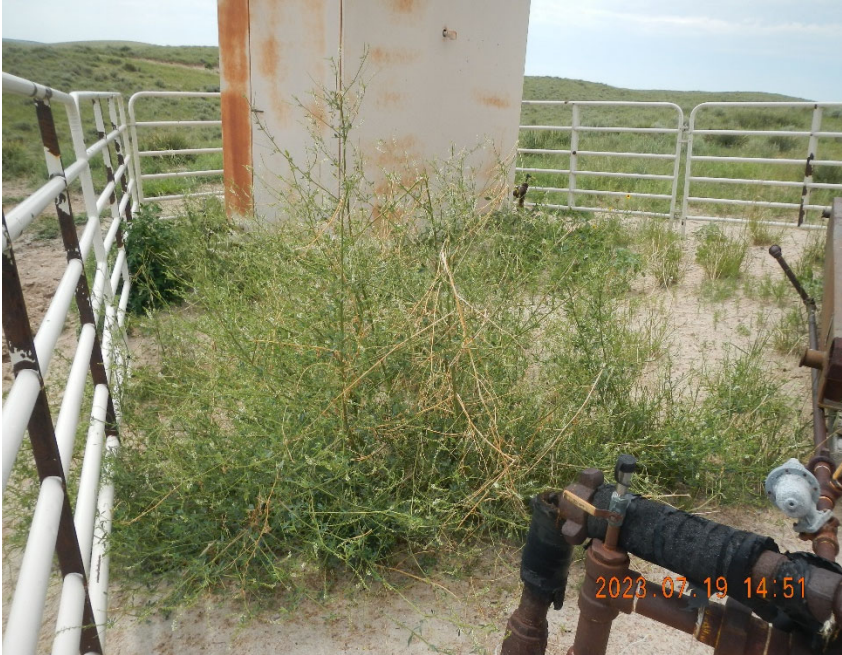
7. View of weed/vegetation growth inside fencing.

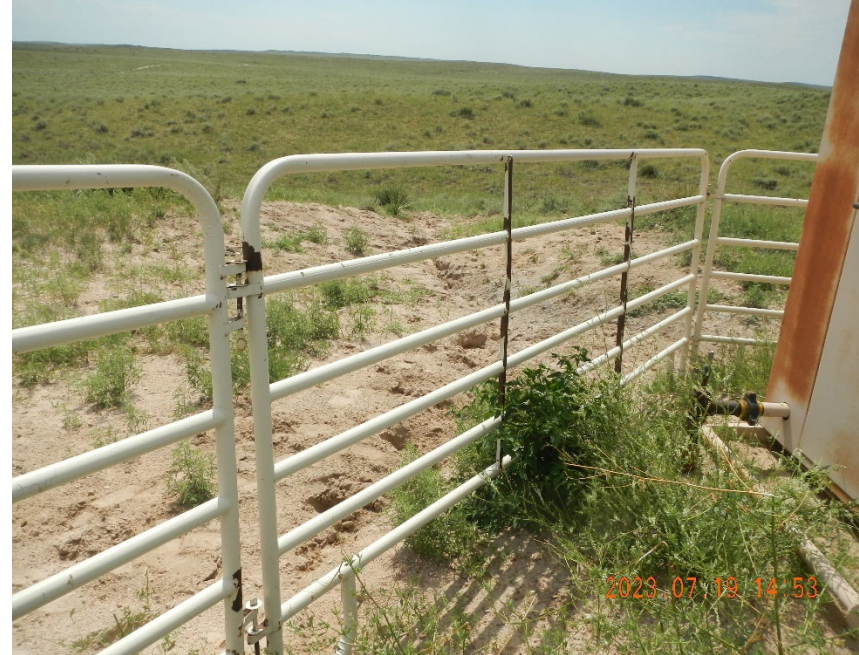
8. View looking SW from inside fencing at erosion channel that starts on the S end of panel fencing.

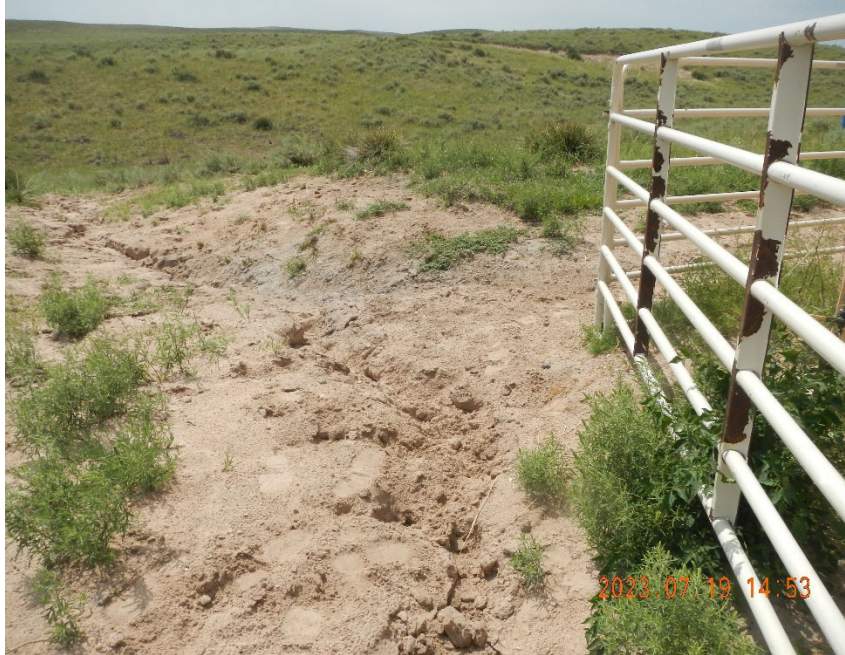
9. View of erosion channel from outside fencing looking W.

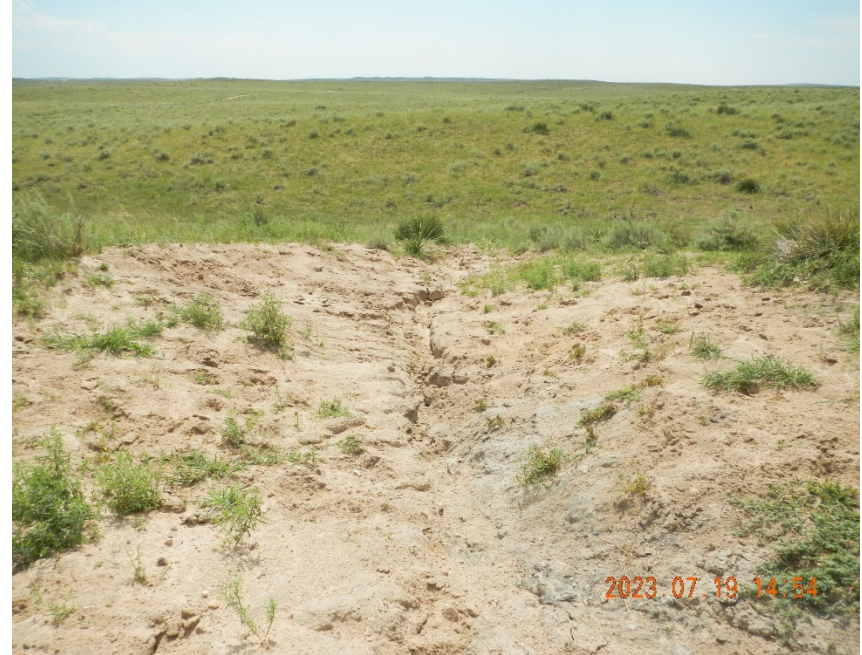
10. View of erosion channel looking W/SW at edge of location and top edge of slope.

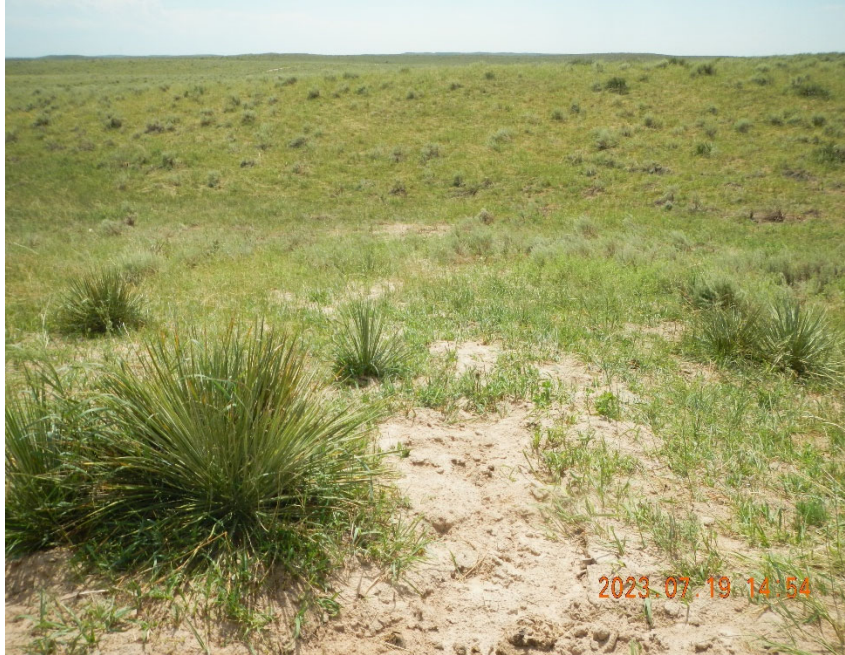
11. View of erosion channel looking SW downgrade of slope.

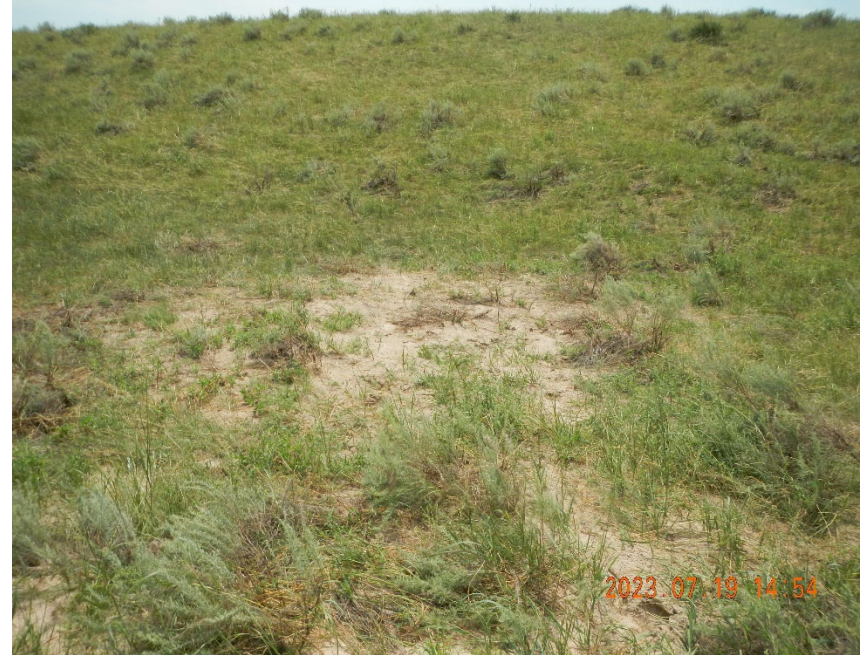
12. View of sediment deposit from erosion channel at base of slope.

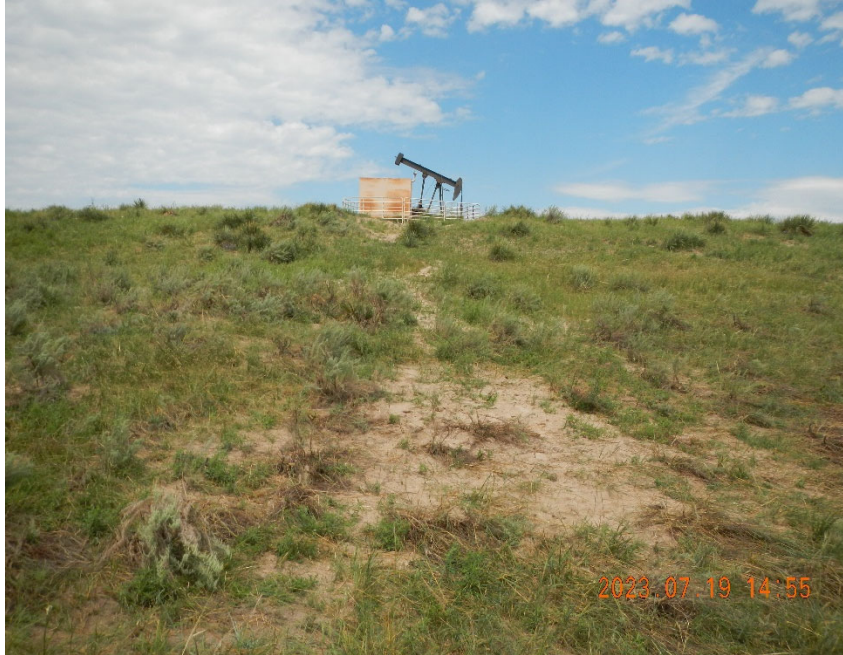
13. View at base of slope looking NE towards well location.

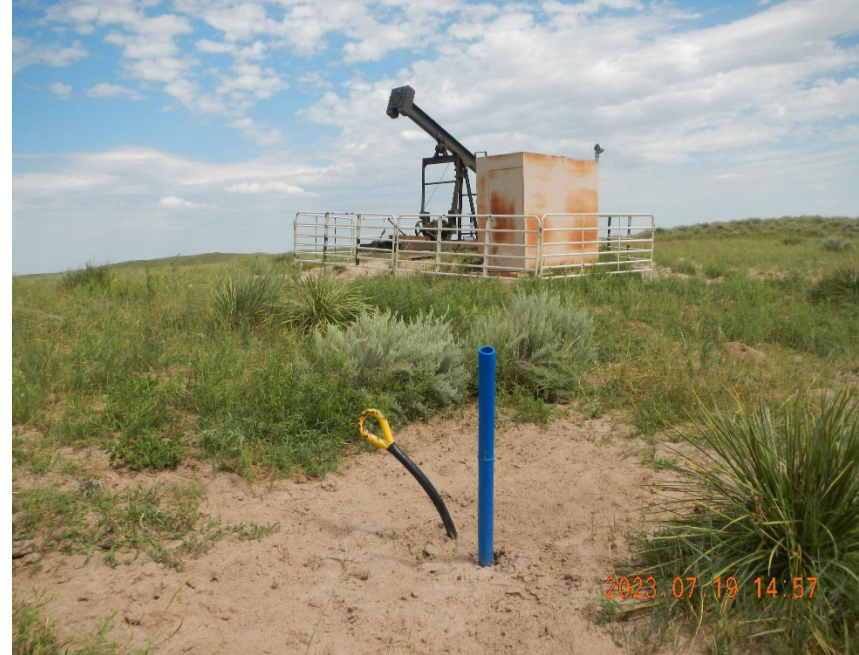
14. One of four marked deadmen.
