Inspection Photos
Location Name: CAERUS PICEANCE LLC O29NE Pad
Location #: 335085

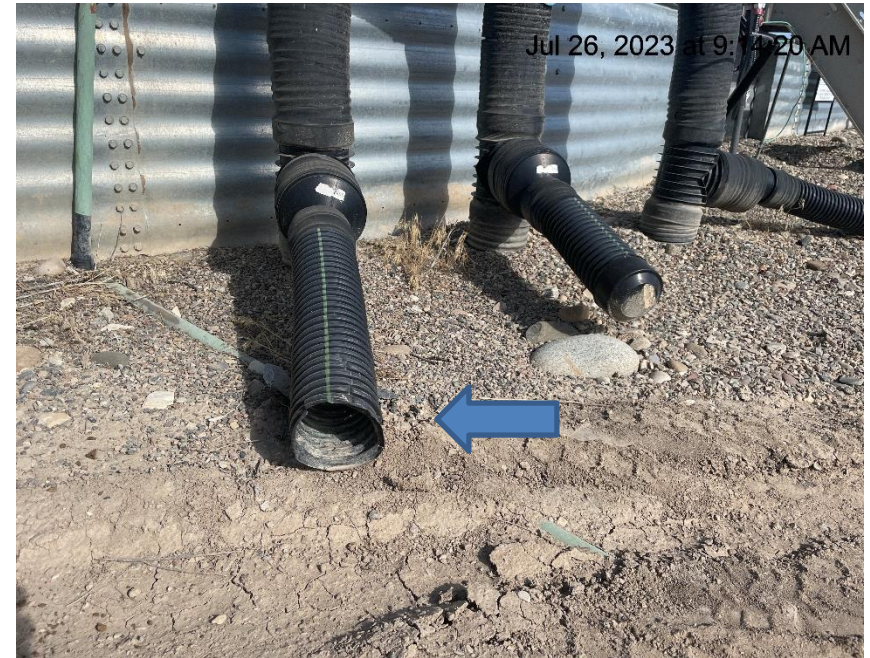
Photo # 3726 Flowline heating insulation open ended

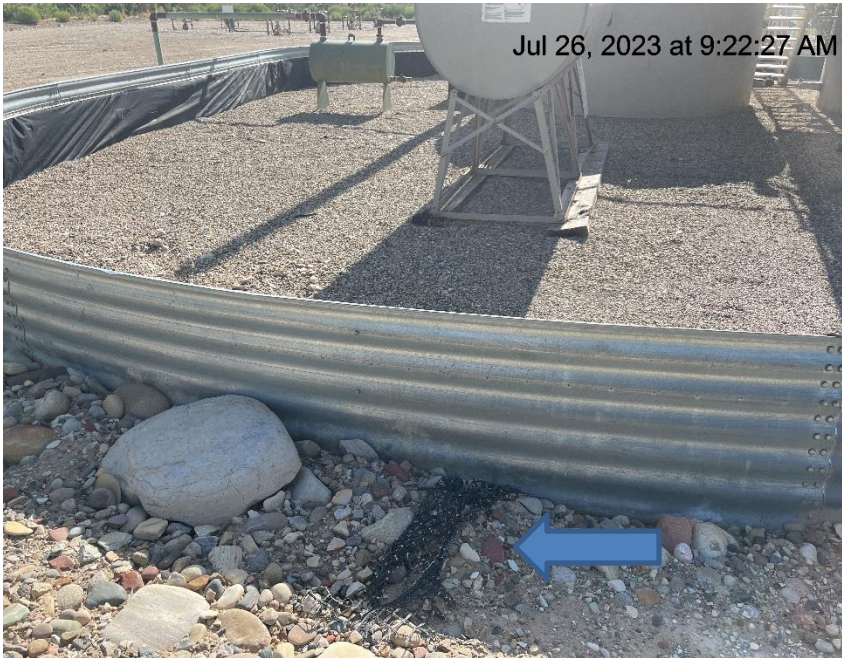
Photo # 3732 Debris

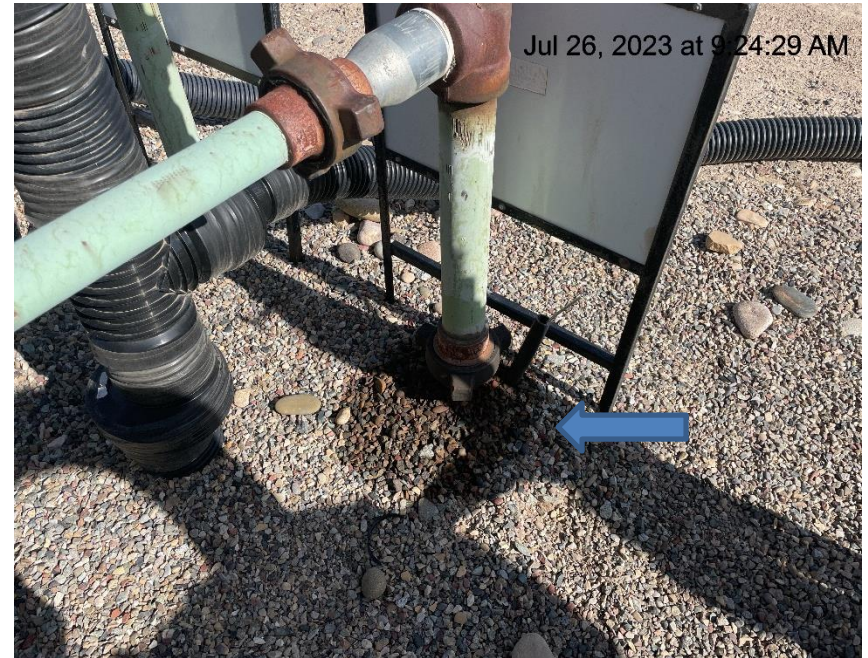
Photo # 3734 Stained soils & gravel
