Inspection Photos
Location Name: CAERUS PICEANCE LLC P32 Pad
Location #: 334836

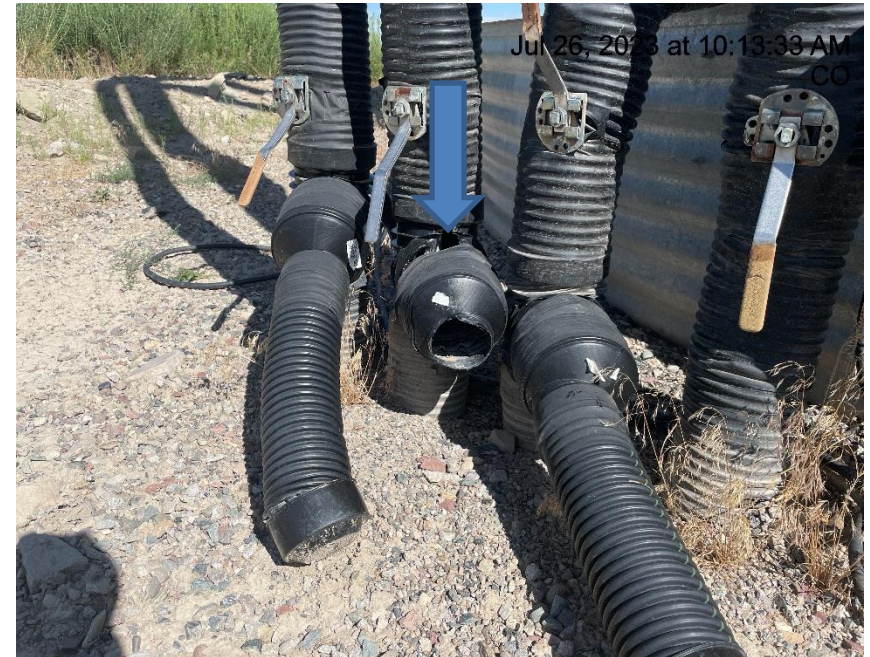
Photo # 3762 Flowline heating insulation open ended

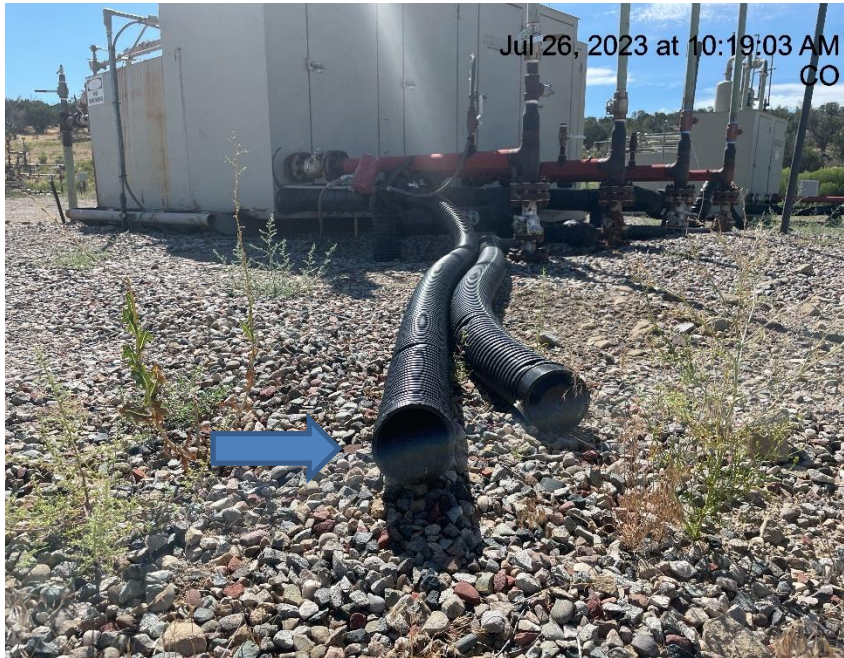
Photo # 3774 Flowline heating insulation open ended

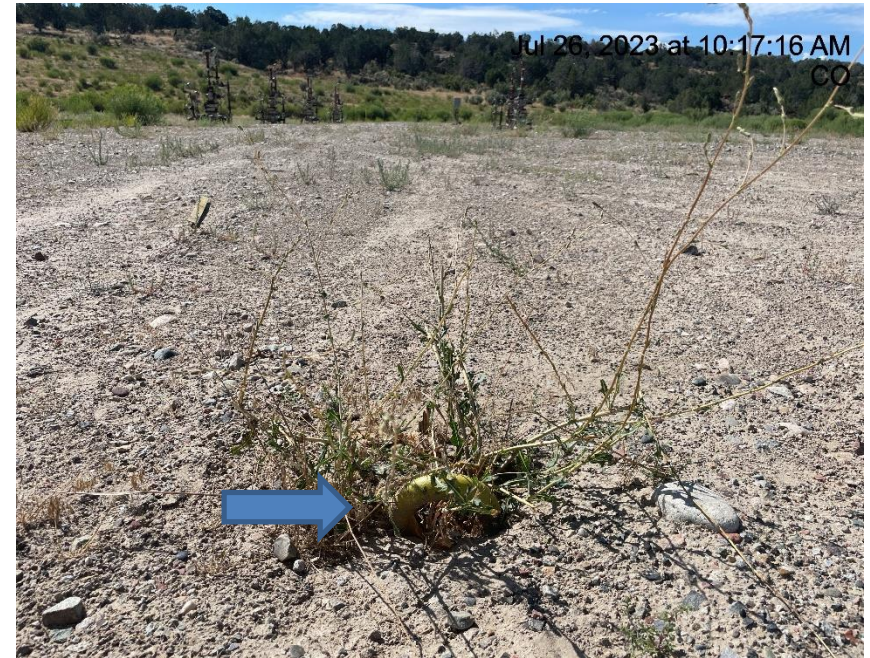
Photo # 3769 Unmarked deadman #1

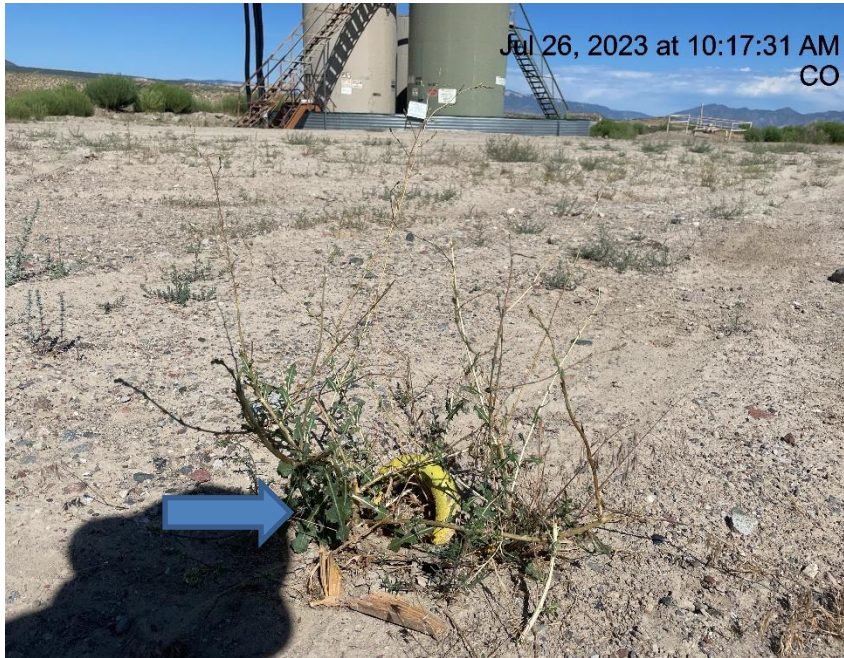
Photo # 3770 Same unmarked deadman from a different angle

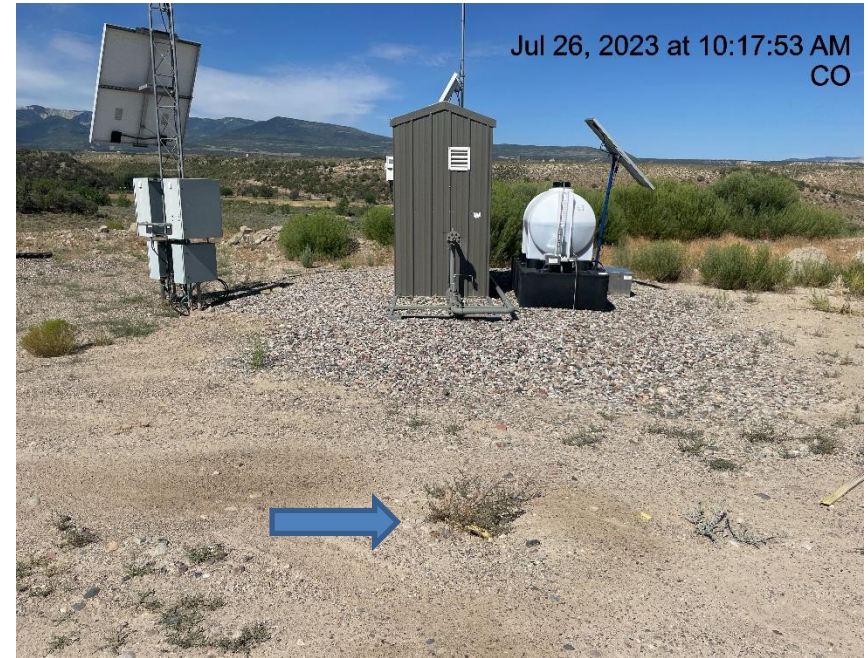
Photo # 3771 Unmarked deadman #2

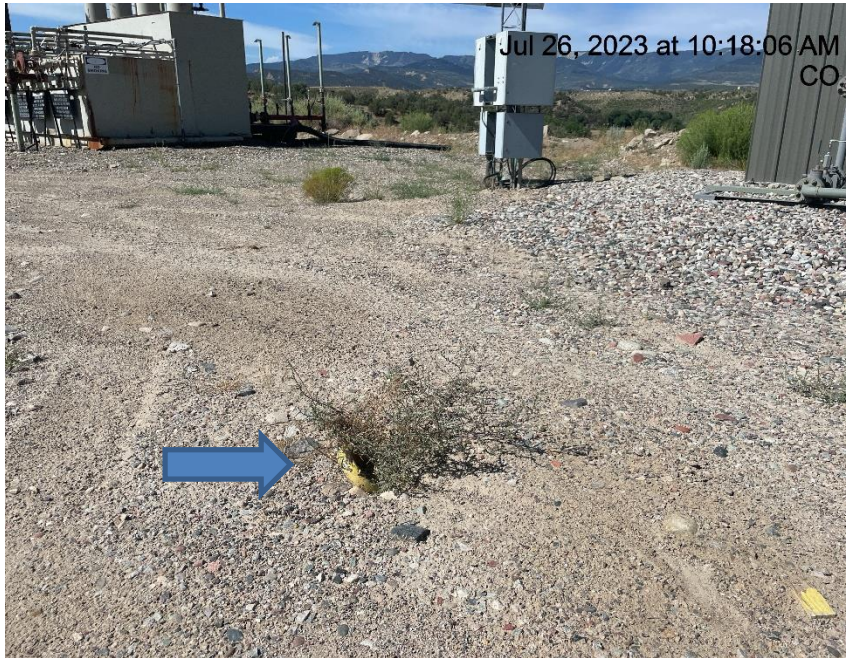
Photo # 3772 Same unmarked deadman from a different angle

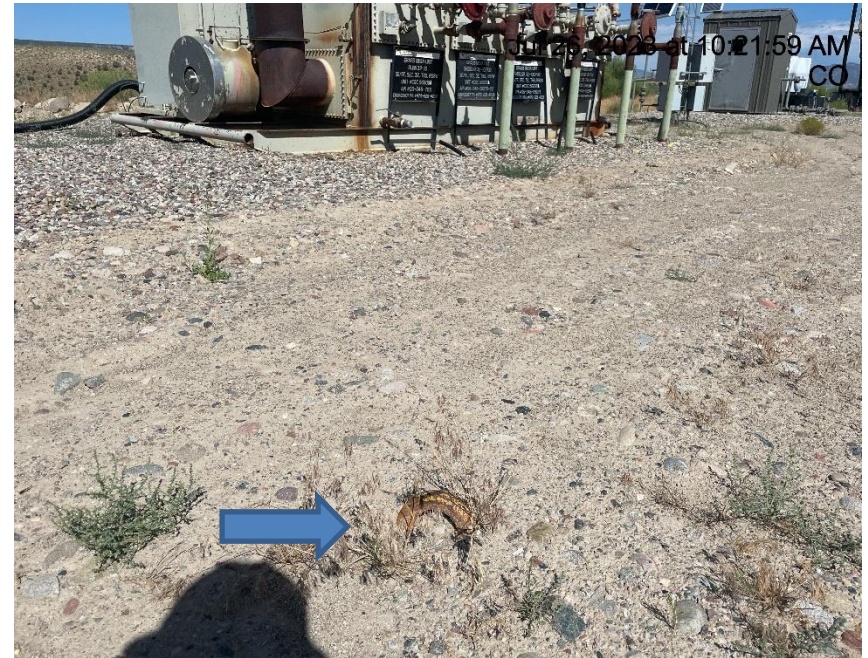
Photo # 3775 Unmarked deadman #3

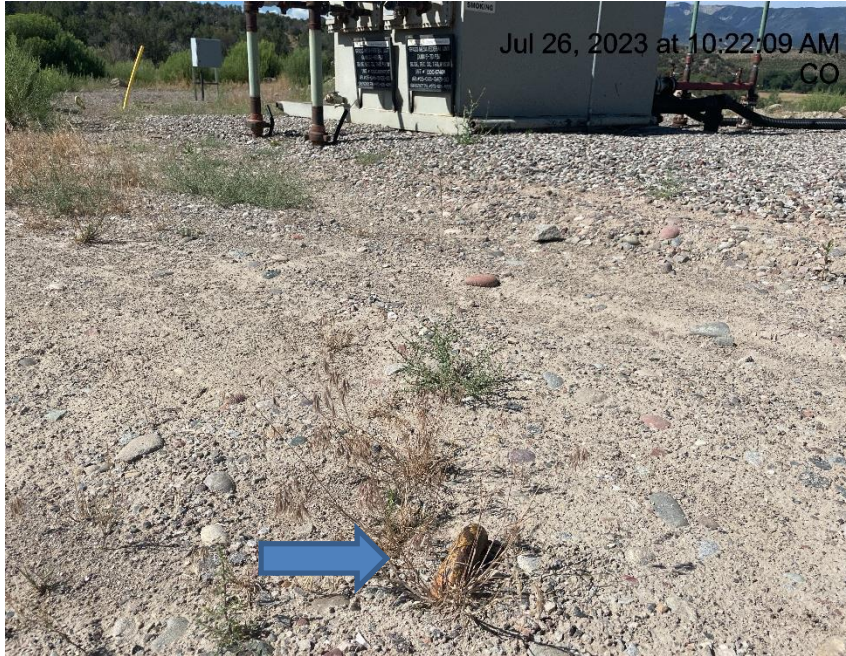
Photo # 3776 Same unmarked deadman from a different angle
