Inspection Photos
Location Name: CAERUS PICEANCE LLC F19 Pad
Location #: 311615

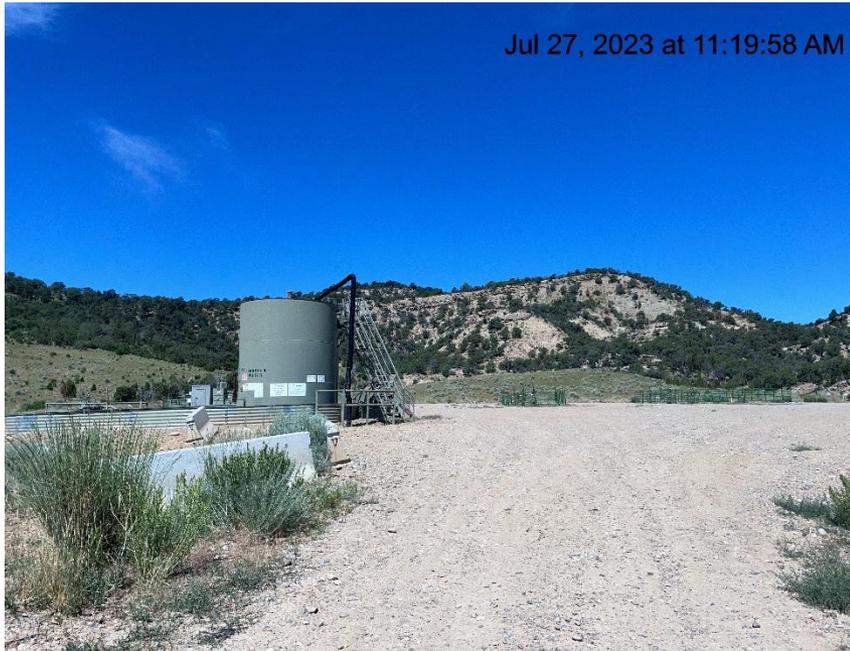
Photo # 3997 From entrance to location

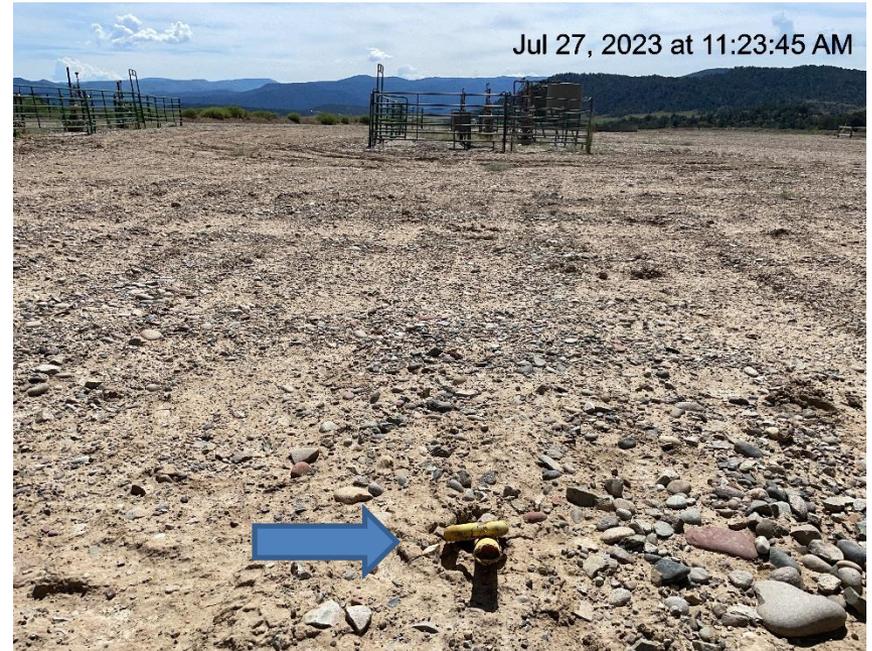
Photo # 4004 Unmarked deadman #1

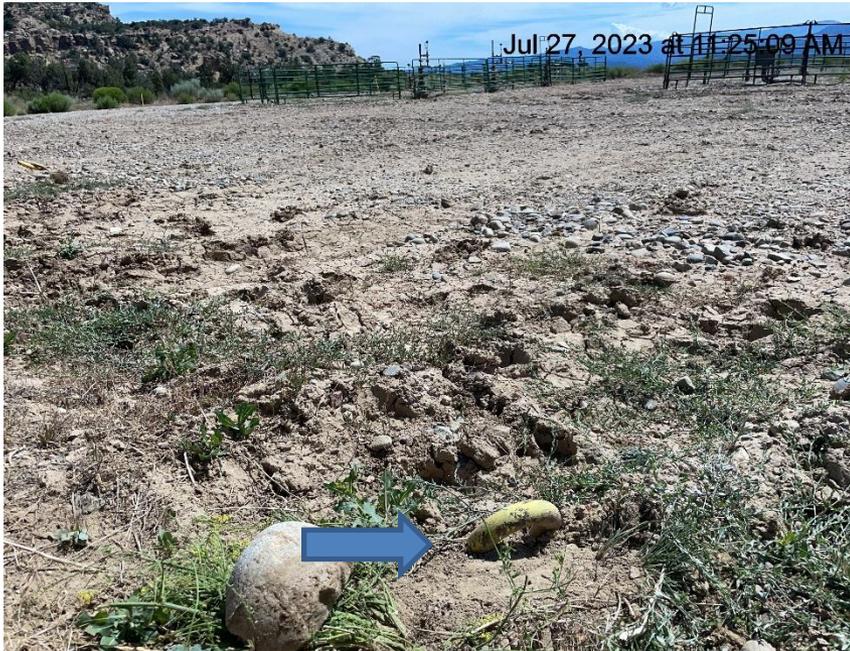
Photo # 4005 Unmarked deadman #2

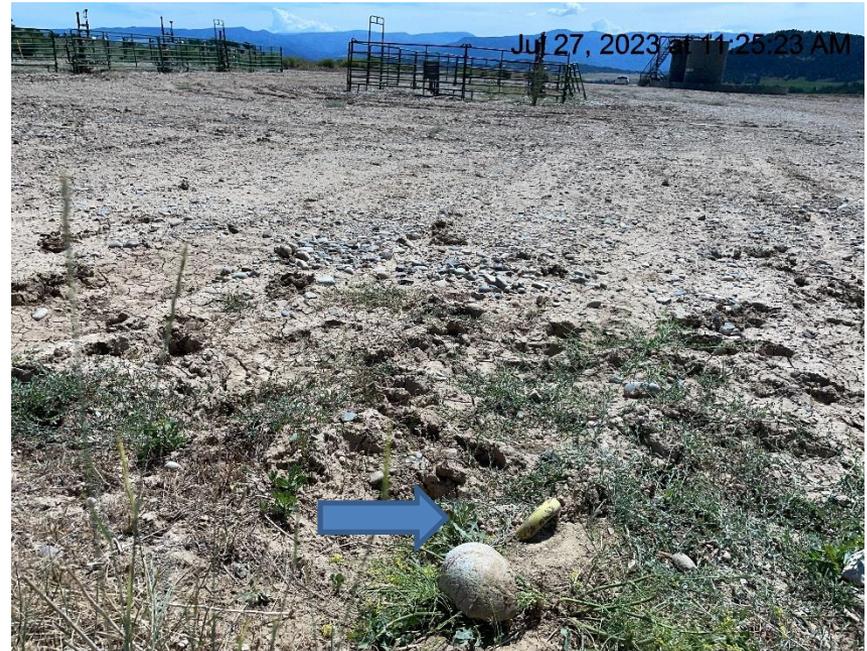
Photo # 4006 Same unmarked deadman from different angle

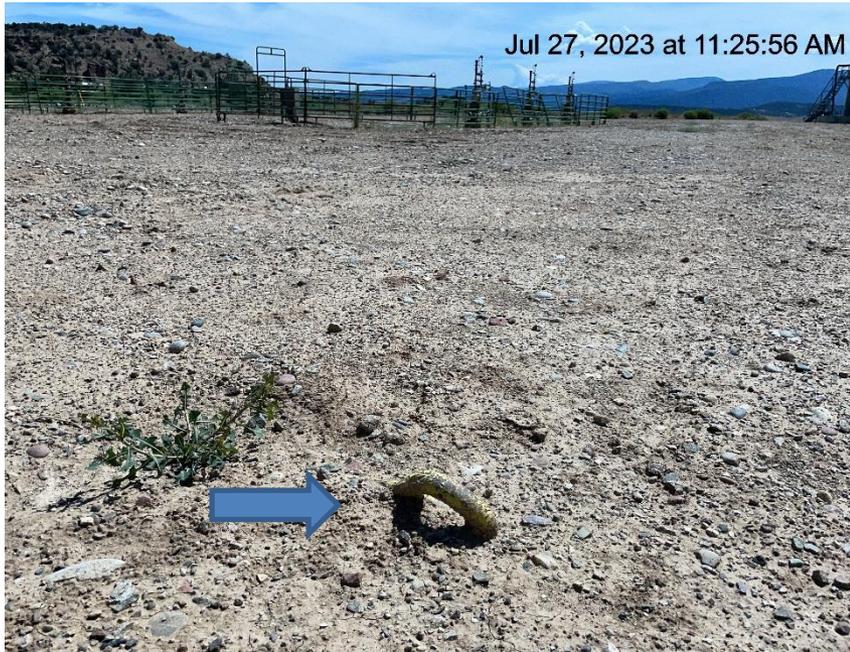
Photo # 4007 Unmarked deadman #3

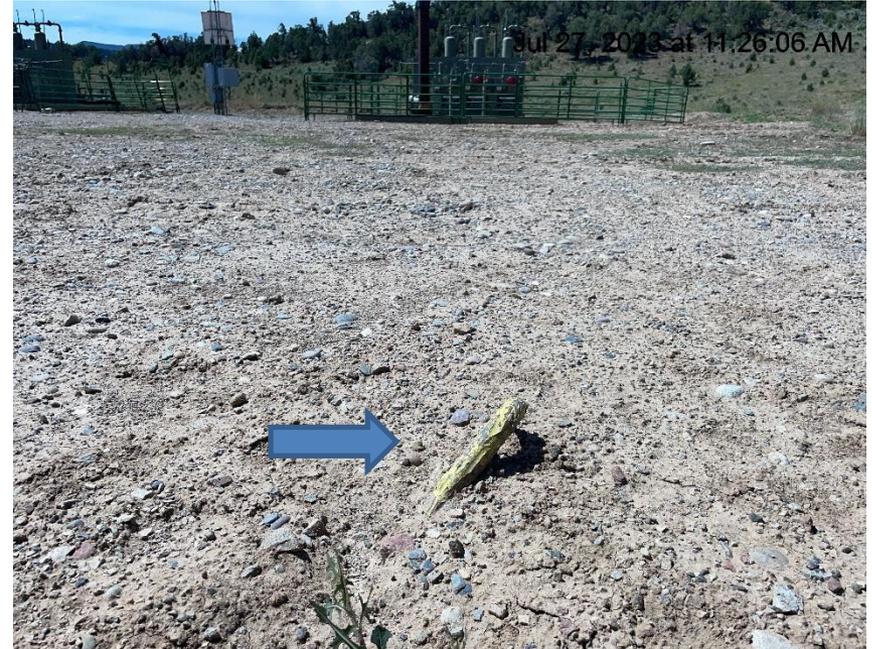
Photo # 4008 Same unmarked deadman from different angle

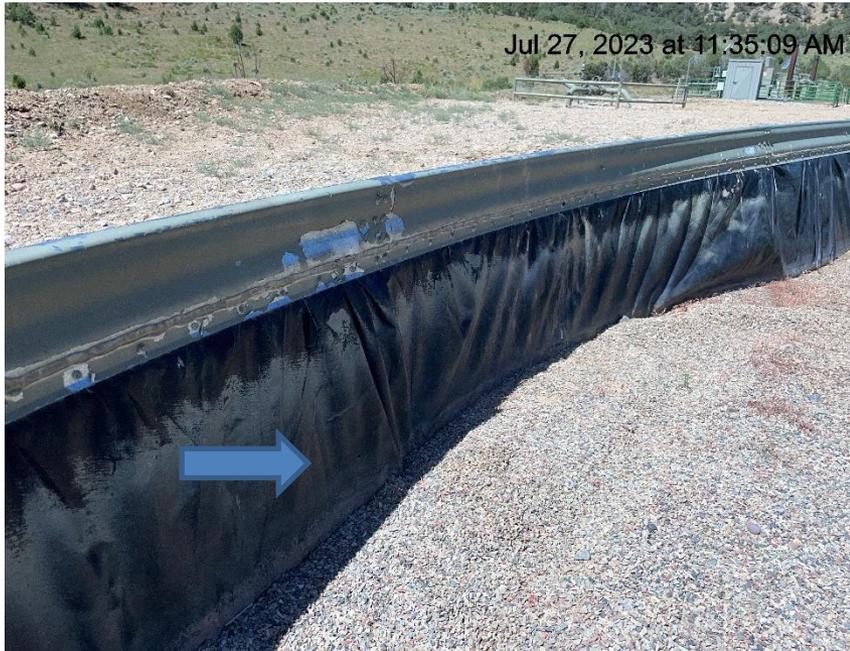
Photo # 4025 Secondary containment liner needs maintenance

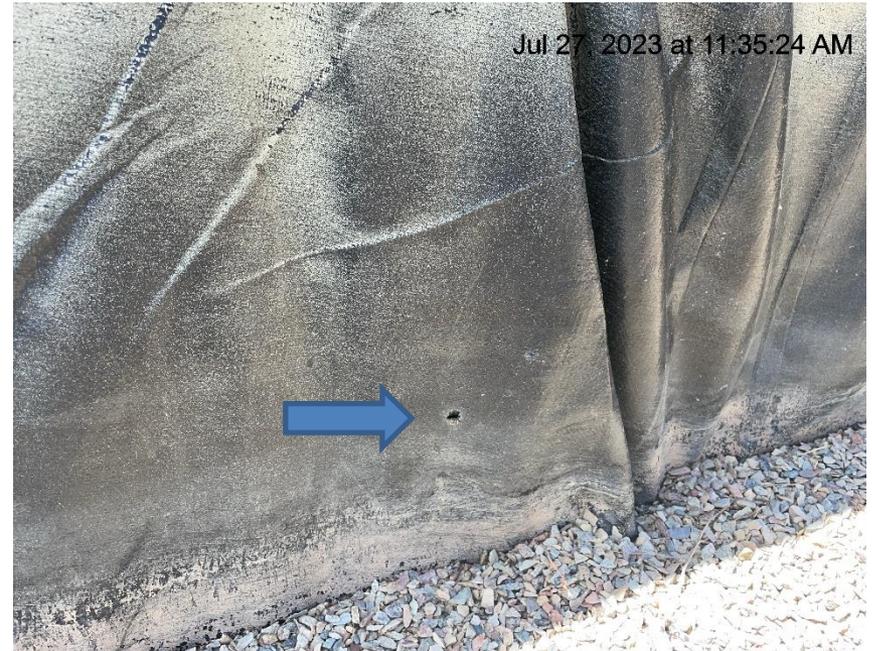
Photo # 4026 Secondary containment liner needs maintenance

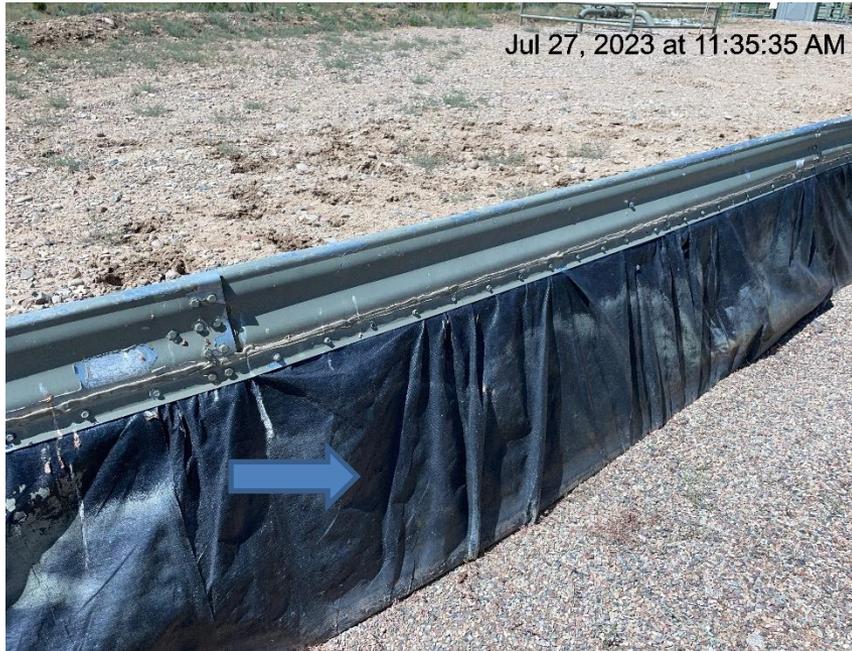
Photo # 4027 Secondary containment liner needs maintenance

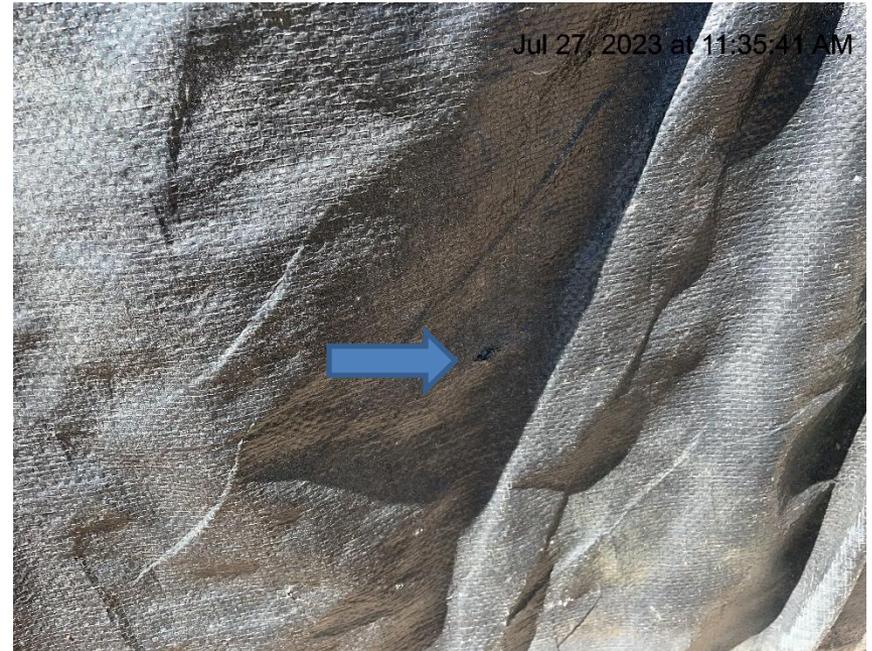
Photo # 4028 Secondary containment liner needs maintenance

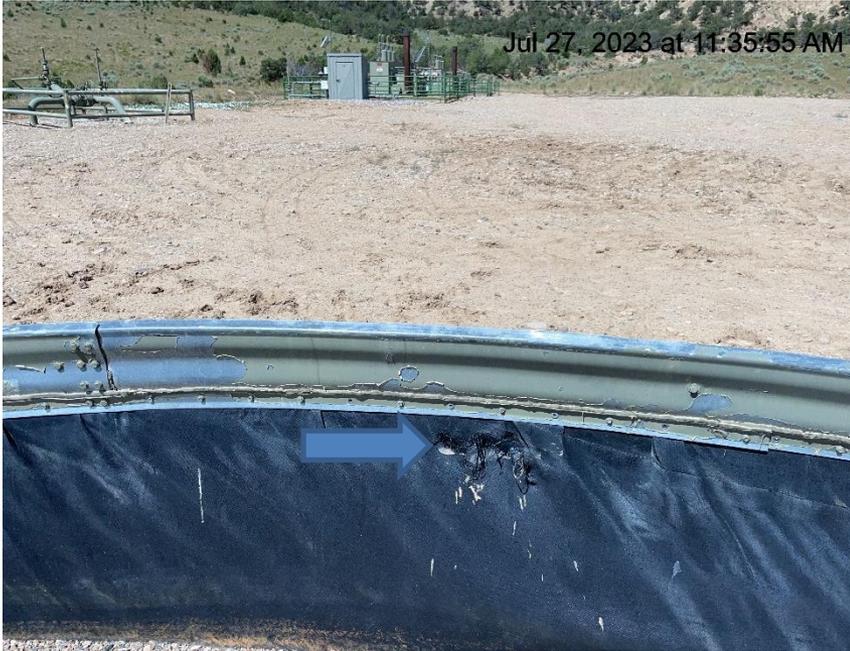
Photo # 4025 Secondary containment liner needs maintenance

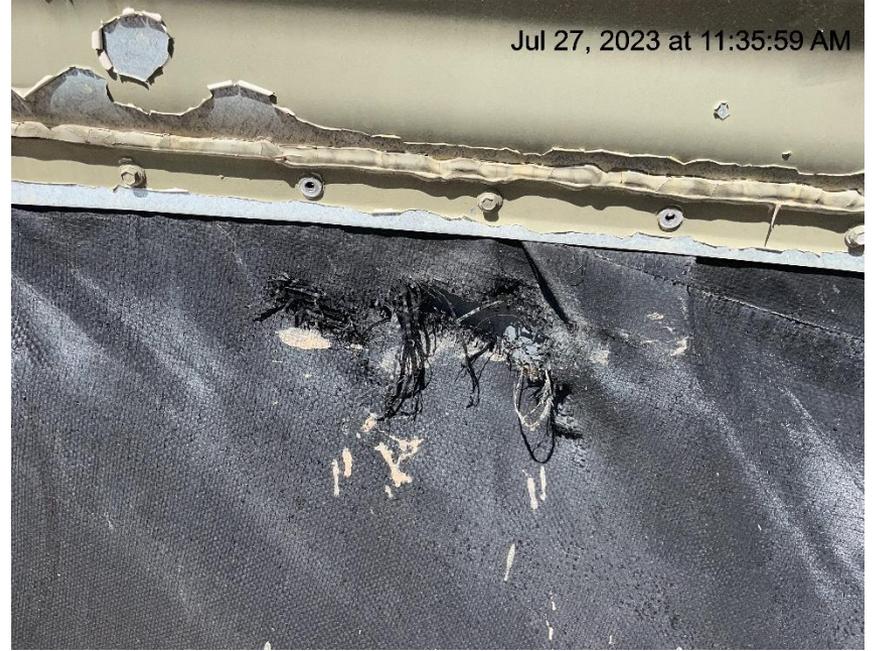
Photo # 4026 Secondary containment liner needs maintenance

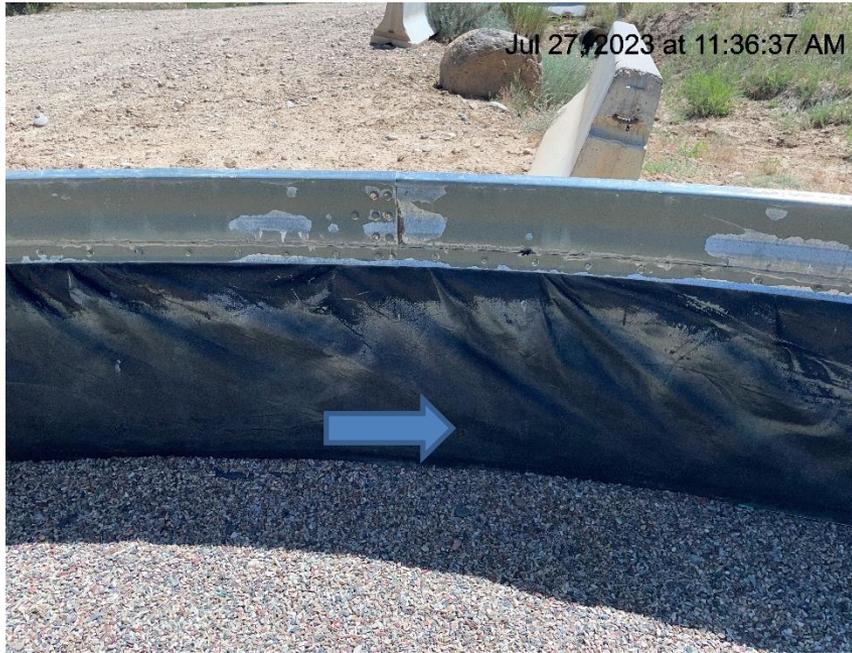
Photo # 4025 Secondary containment liner needs maintenance

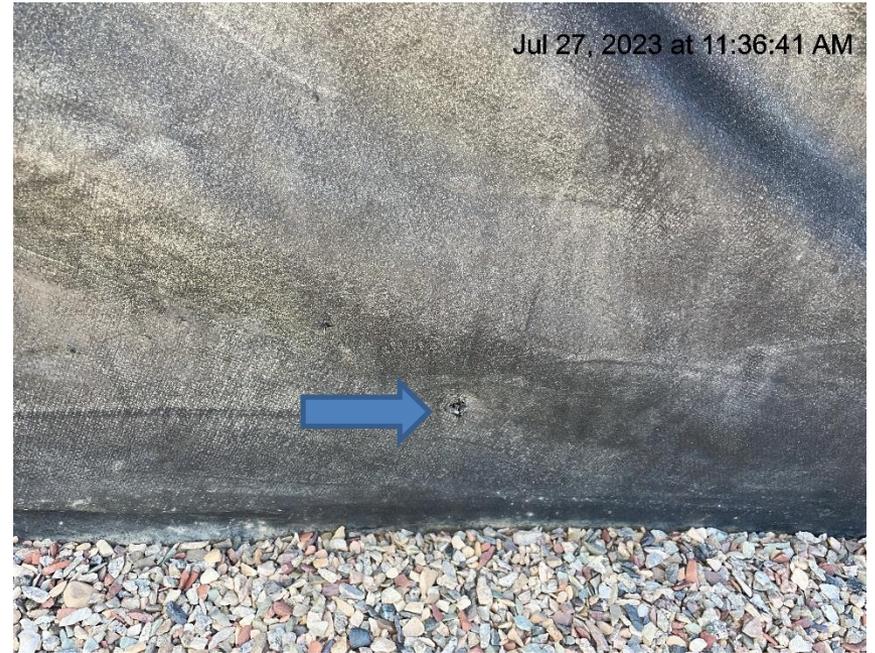
Photo # 4026 Secondary containment liner needs maintenance

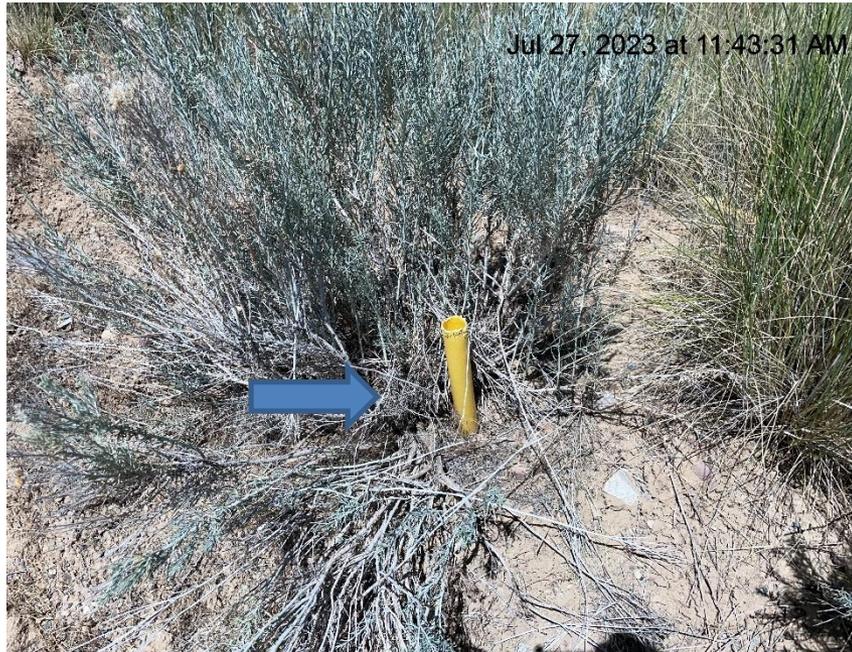
Photo # 4053 Improperly marked deadman
