**Inspection Photos**  
**Location Name: C Korf 2-19**  
**API Number: 125-06977**

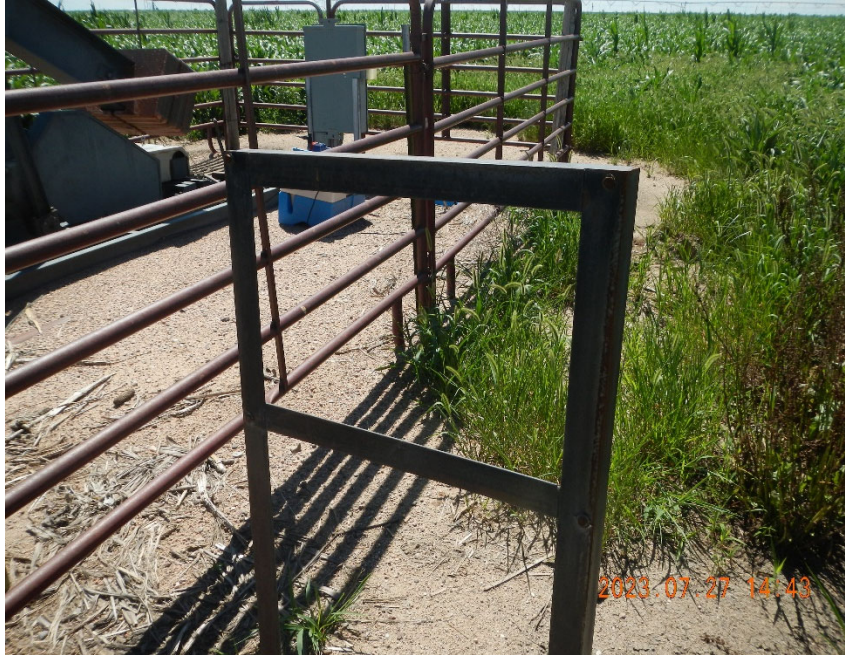
**1. Well sign bracket missing well sign.**

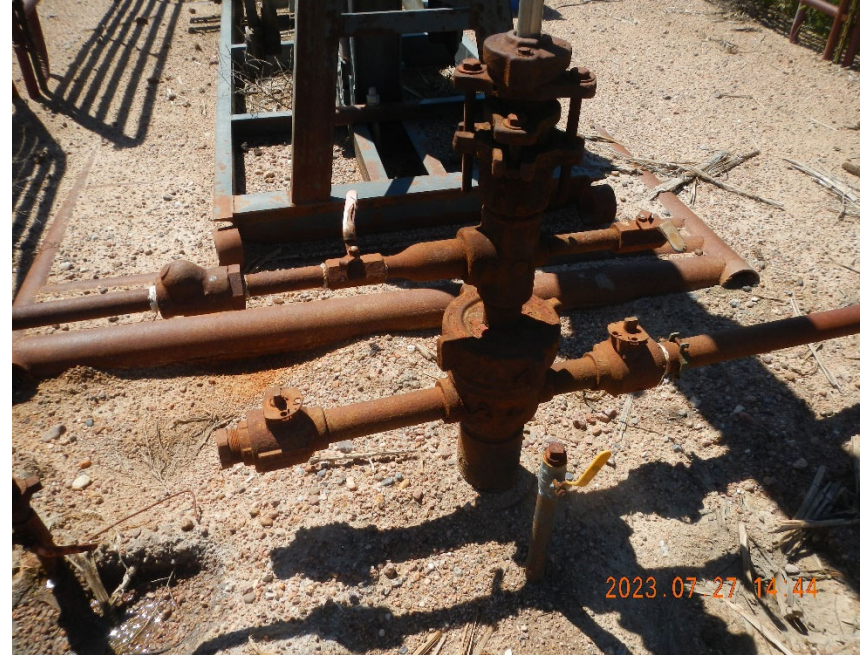
**2. View of Wellhead.**

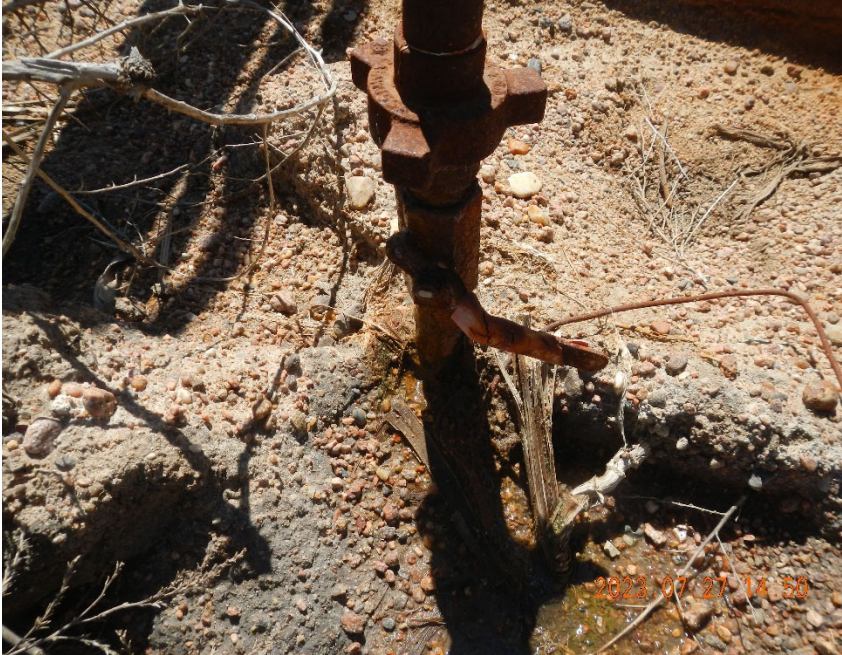
**3. View of tubing produced water flowline with seep at hammer union threads.**

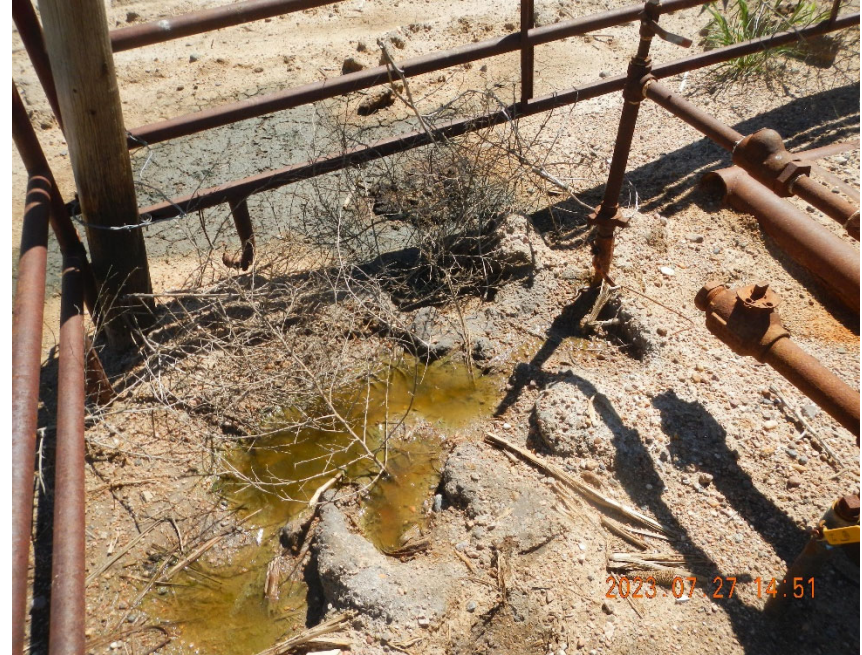
**4. View of fluids inside SE corner of fencing. Soil is wet and saturated. Well is in active Pivot Irrigated Corn Field adding to moisture around well location.**

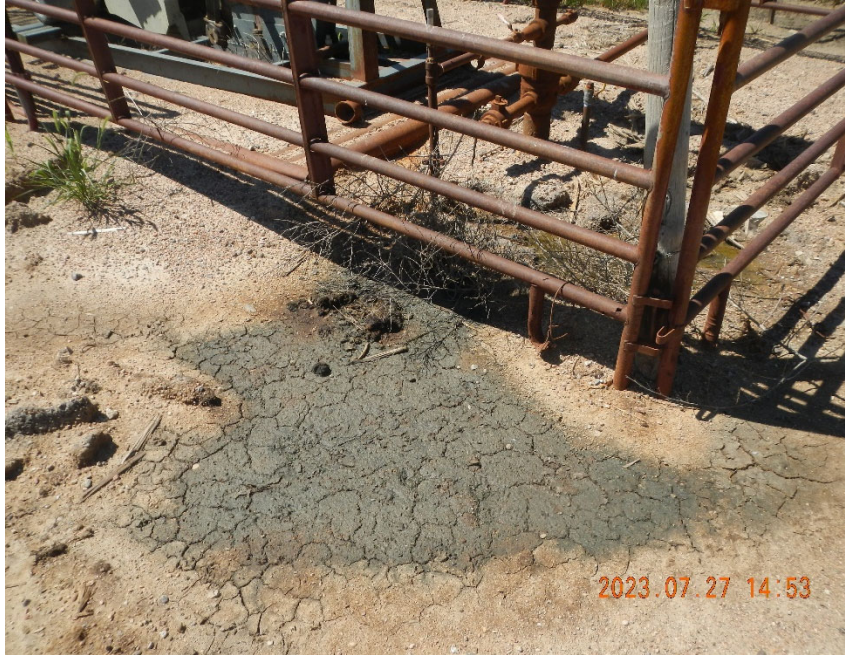
**5. View of SE corner of well location fencing.**

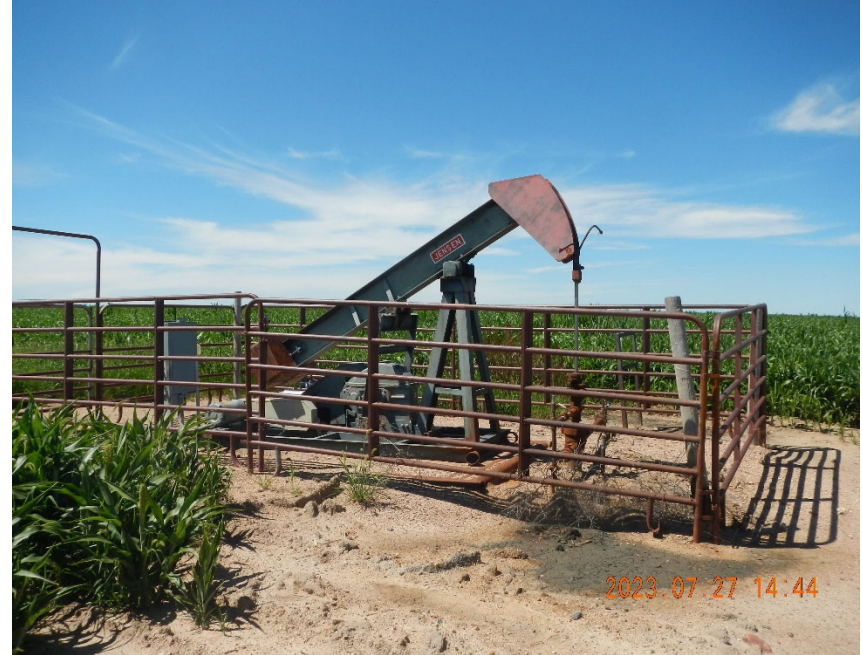
**6. Well location overview. Center pivot pipe can be seen in background left side of photo just above fencing.**

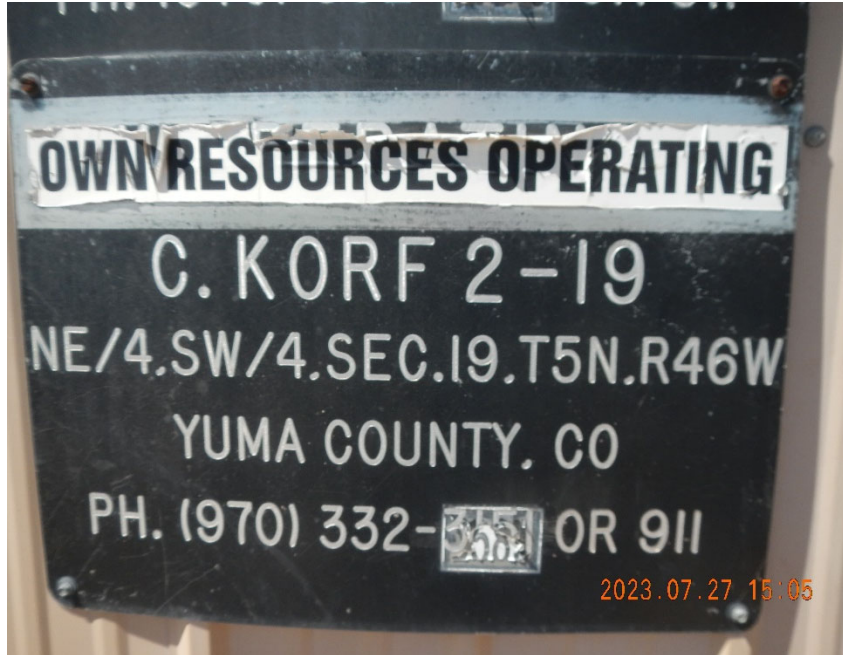
7. Well sign at remote Gas Meter Run.

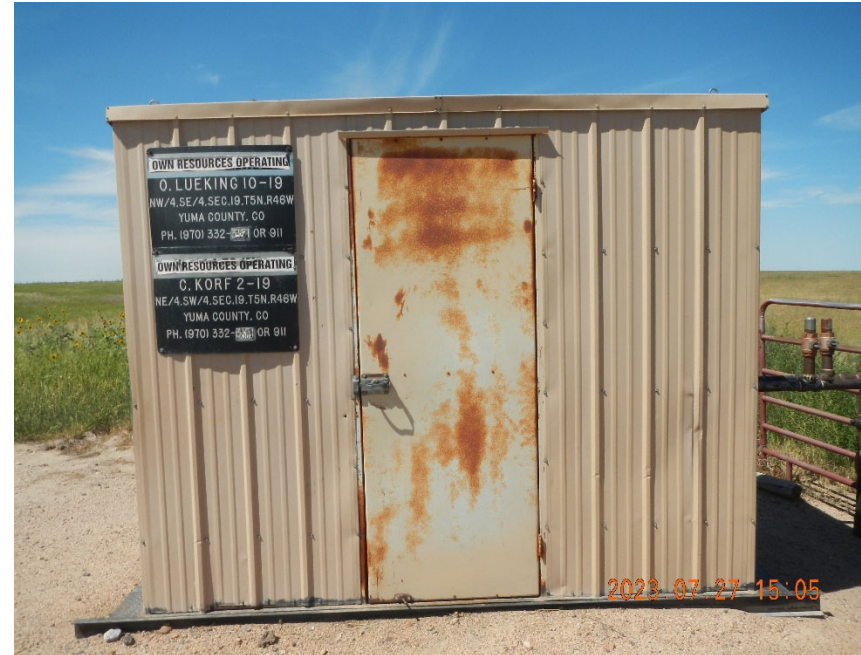
8. Remote Meter Shed.

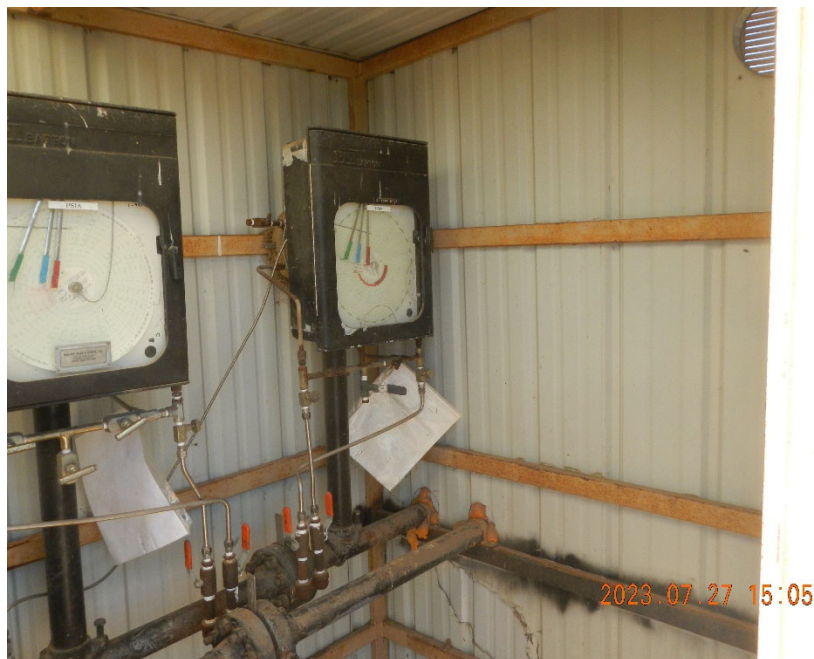
**9. Remote Gas Meter Run inside Meter Shed.**

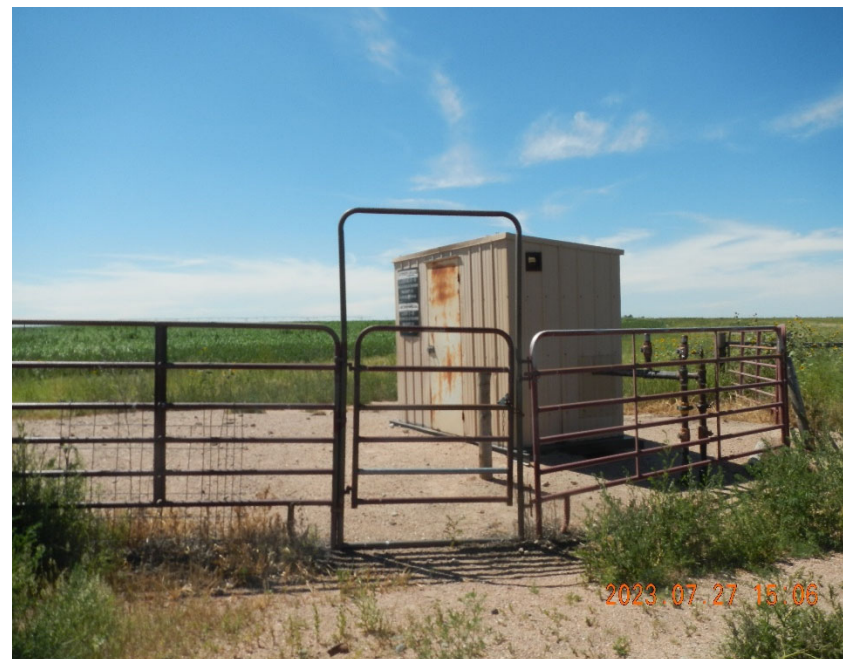
**10. Remote Gas Meter location overview.**
