Inspection Photos
Location Name: CAERUS PICEANCE LLC N32 Pad
Location #: 334856

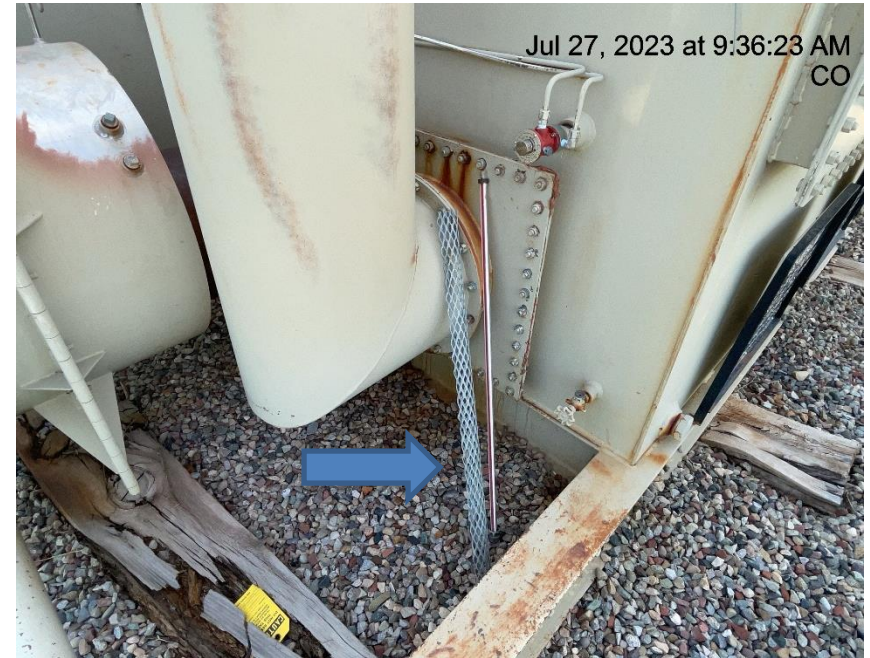
Photo # 3870 Debris

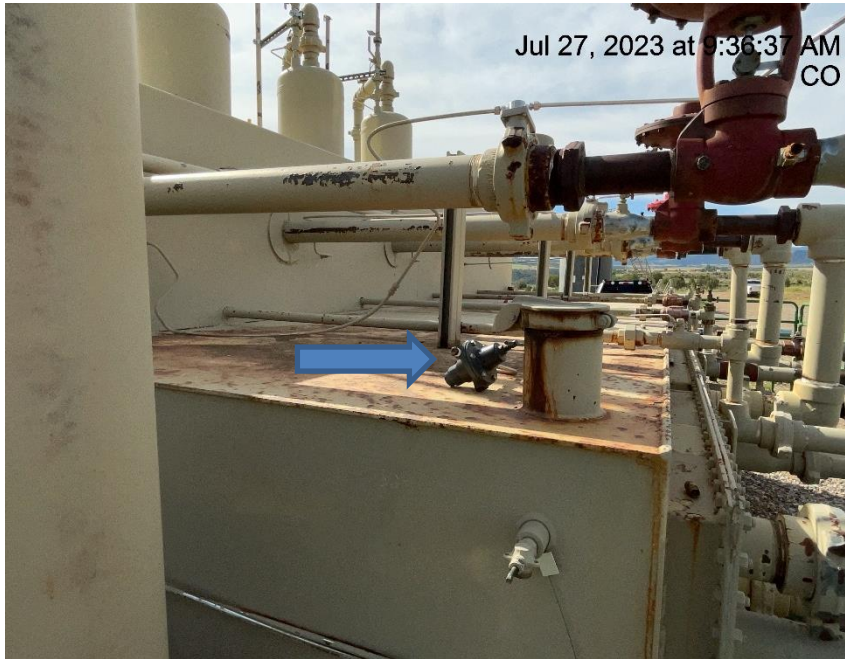
Photo # 3871 Debris

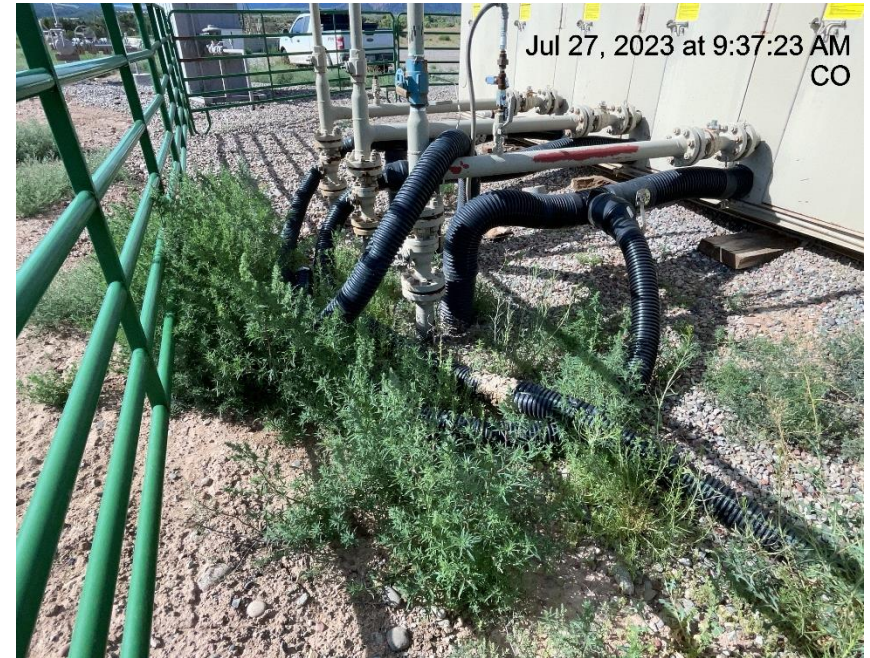
Photo # 3872 Weeds/Undesirable plant species

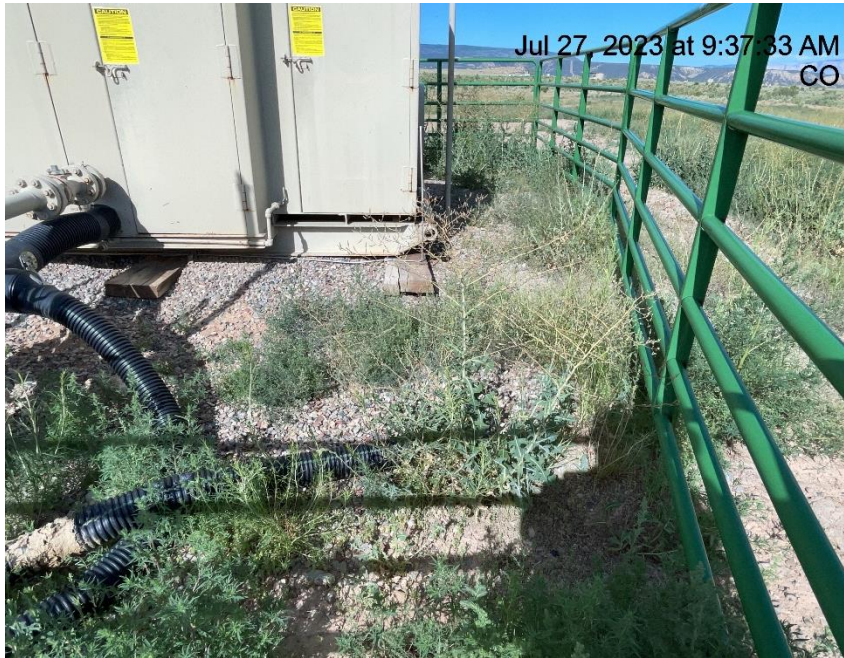
Photo # 3873 Weeds/Undesirable plant species

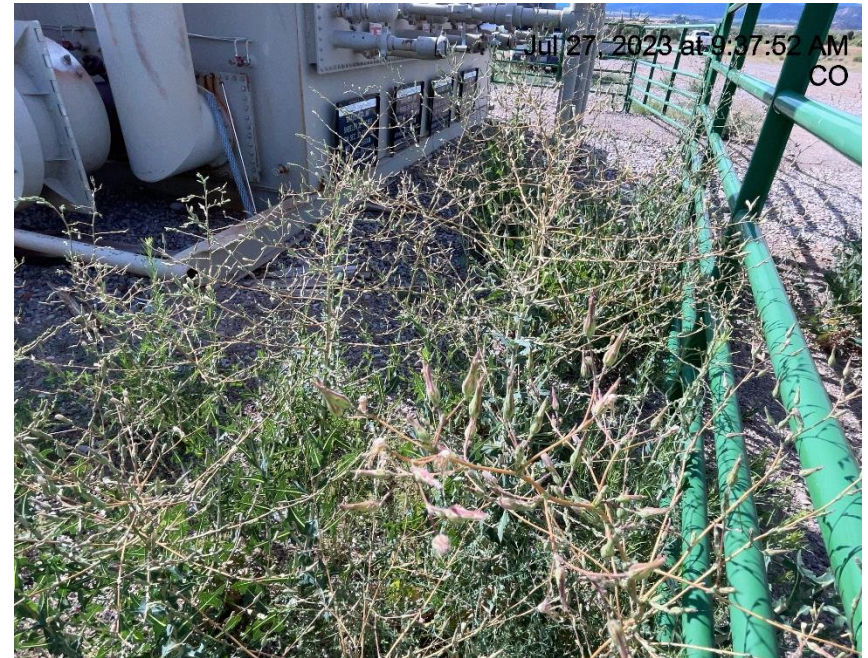
Photo # 3874 Weeds/Undesirable plant species

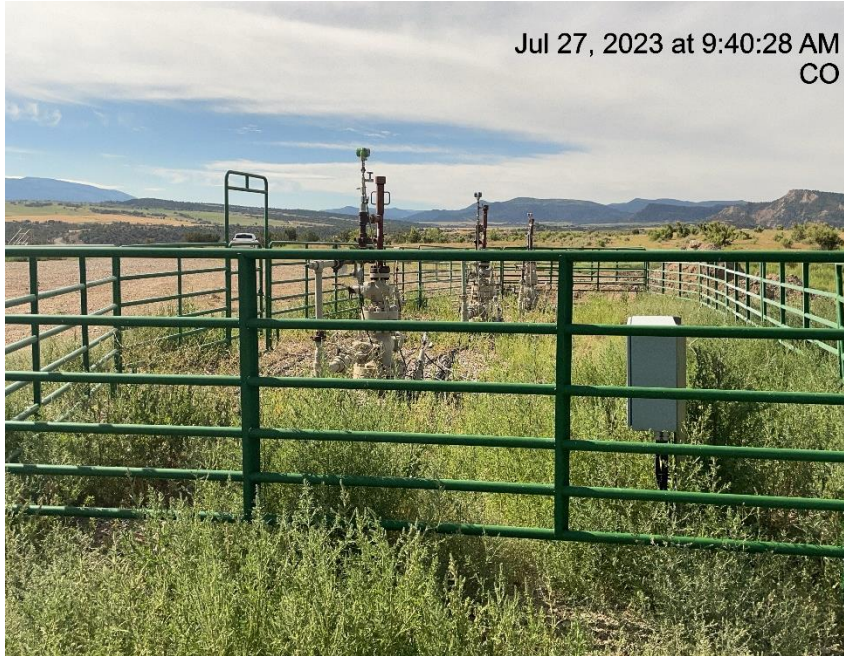
Photo # 3879 Weeds/Undesirable plant species

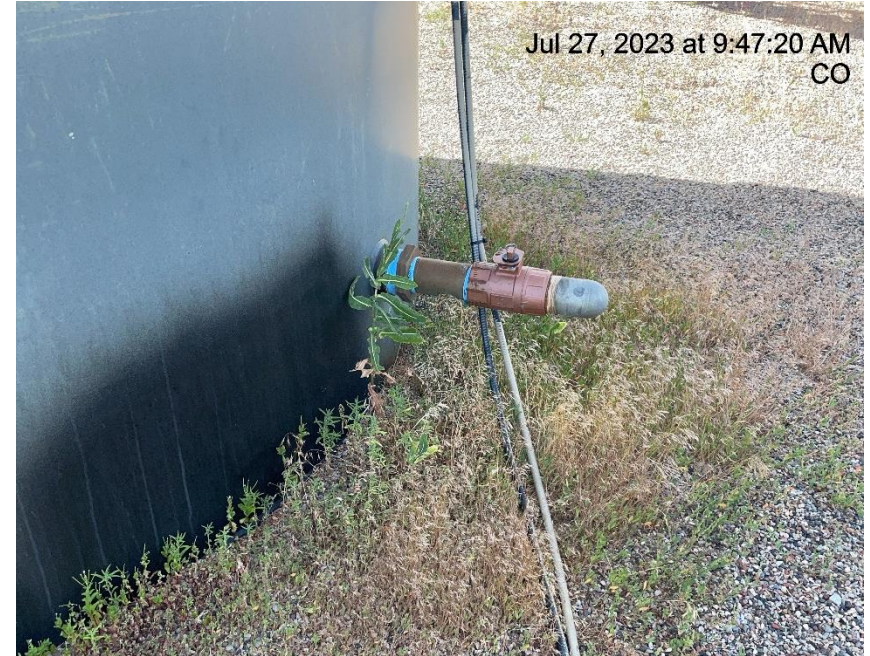
Photo # 3891 Weeds/Undesirable plant species (secondary containment)

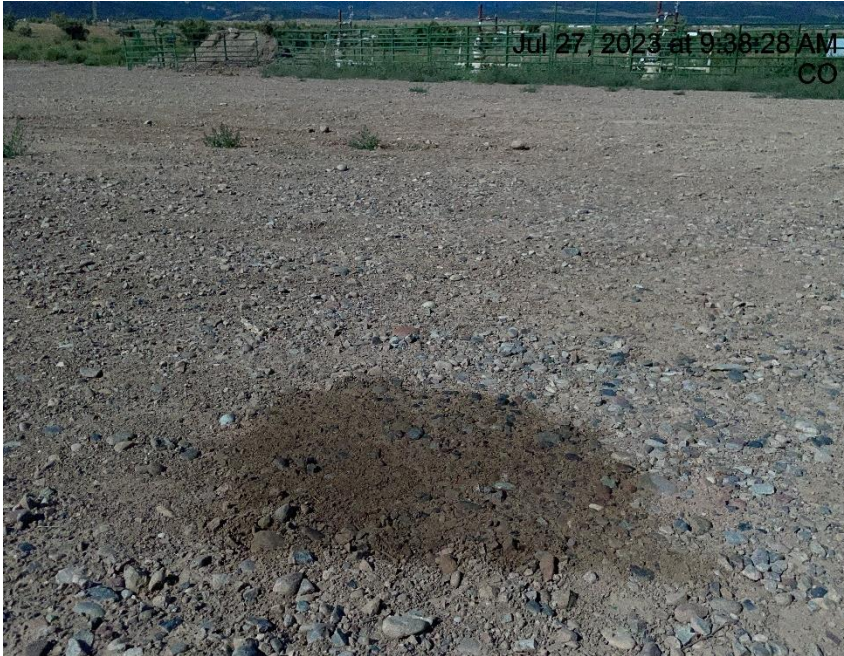
Photo # 3876 Stained soils & gravel on location

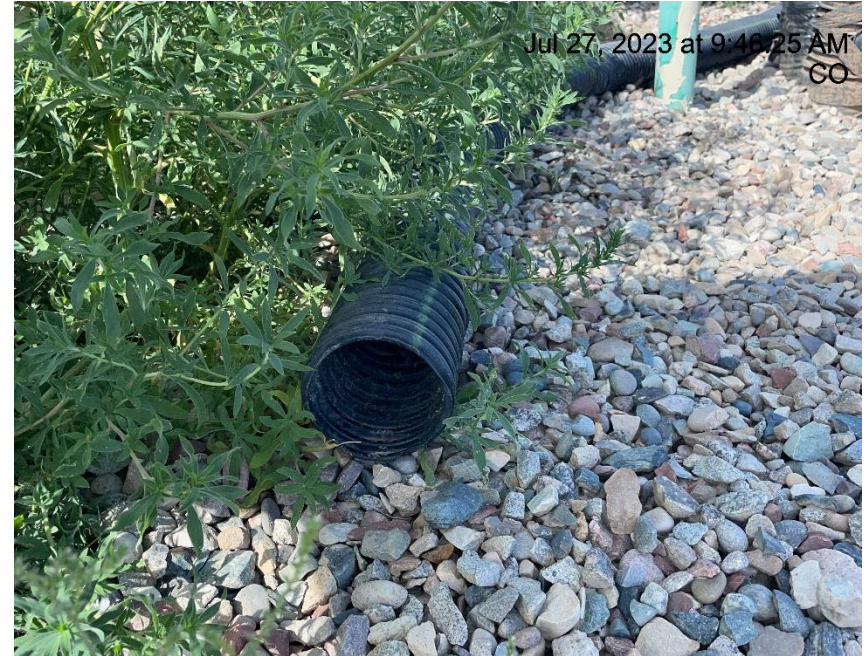
Photo # 3888 Flowline heating insulation open ended

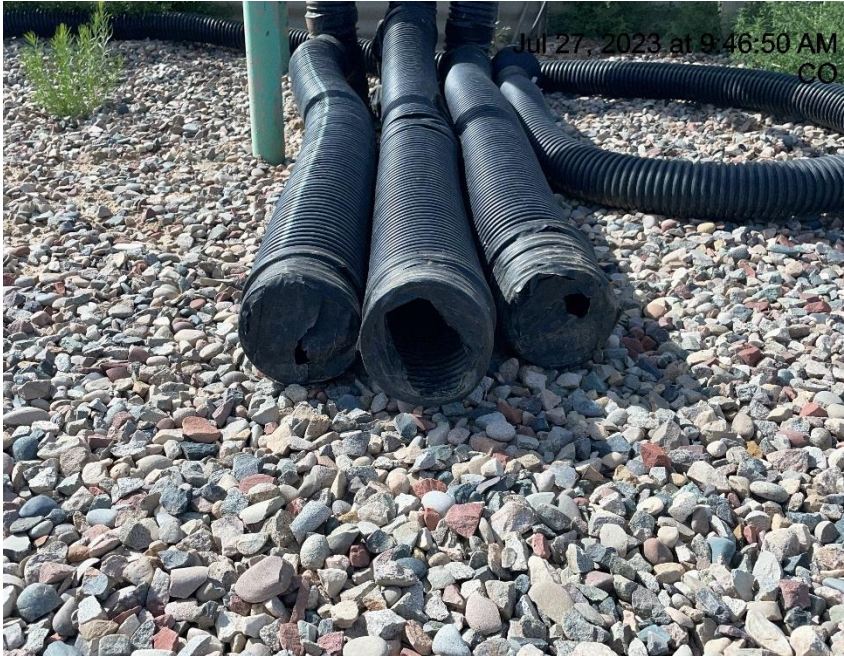
Photo # 3889 Flowline heating insulation open ended

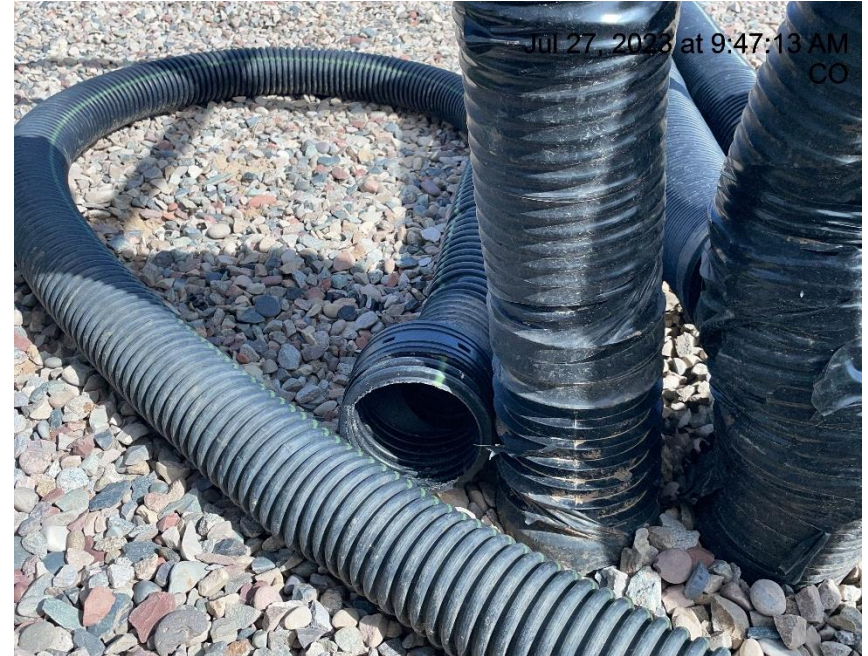
Photo # 3890 Flowline heating insulation open ended

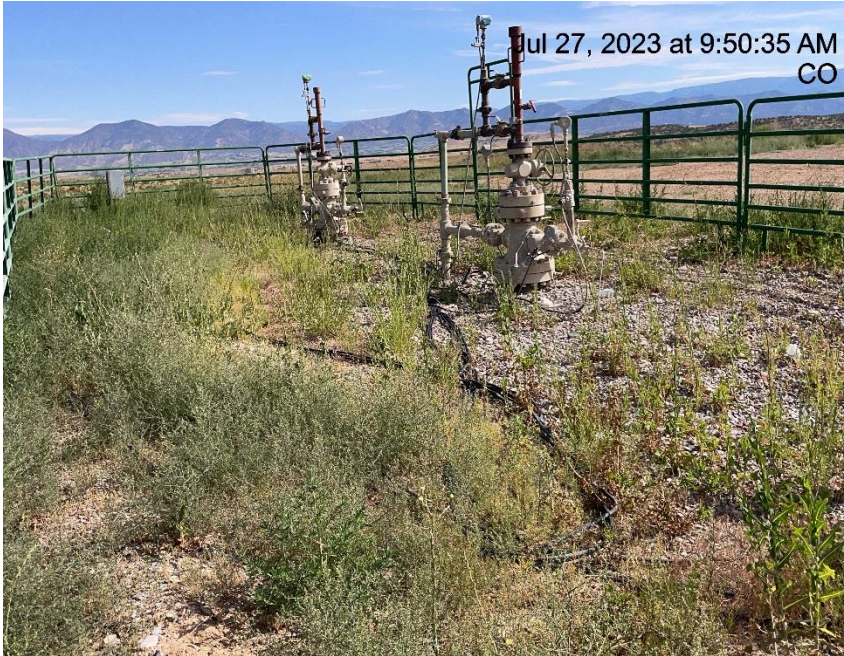
Photo # 3898 Weeds/Undesirable plant species
