Inspection Photos

7/31/2023

Operator: CAERUS PICEANCE LLC #10456

Location Number: 334927

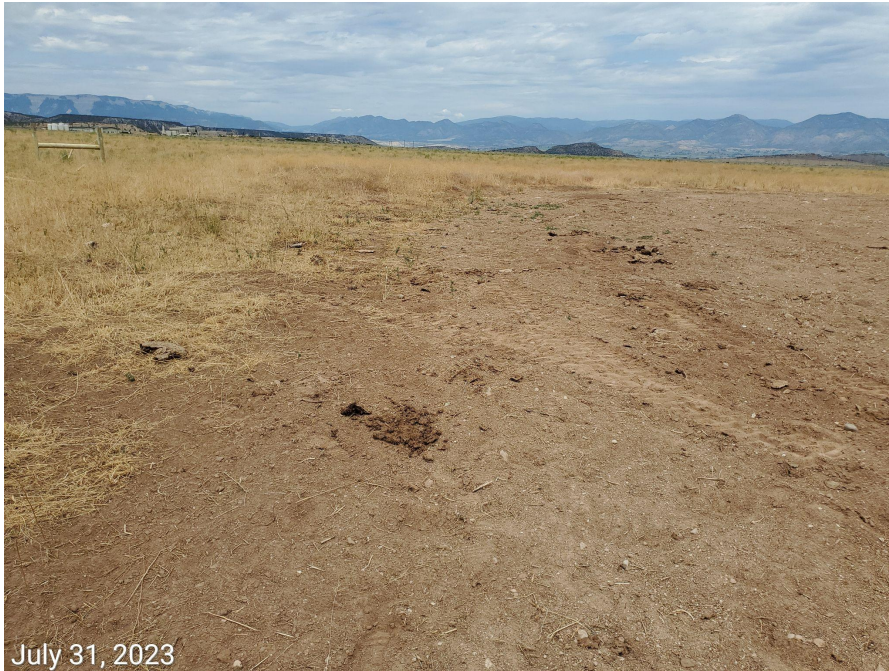
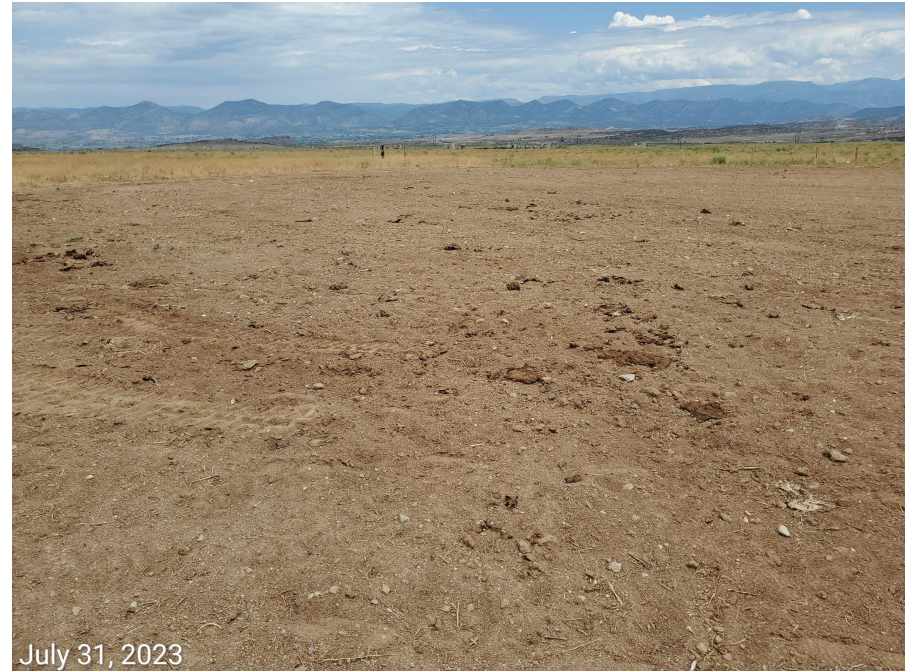
Photo 1: Photos 1-2 taken from the west end of the Location. Photos provide an overview of the location from north, northeast, southeast to south. Photos also show stormwater and erosion control measures to manage stormwater runoff have not been installed prior to, or during dirt-work construction/reclamation activities.

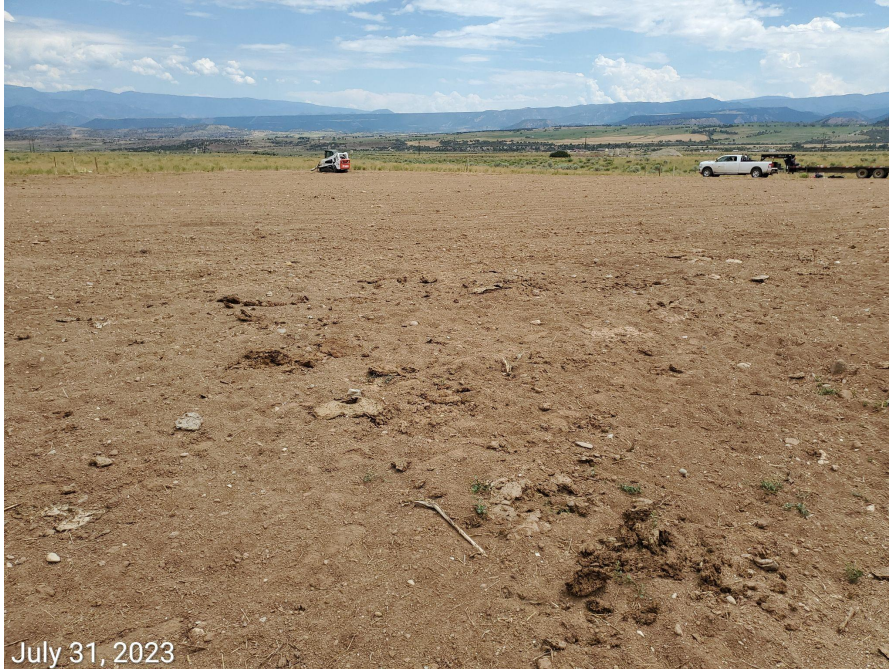
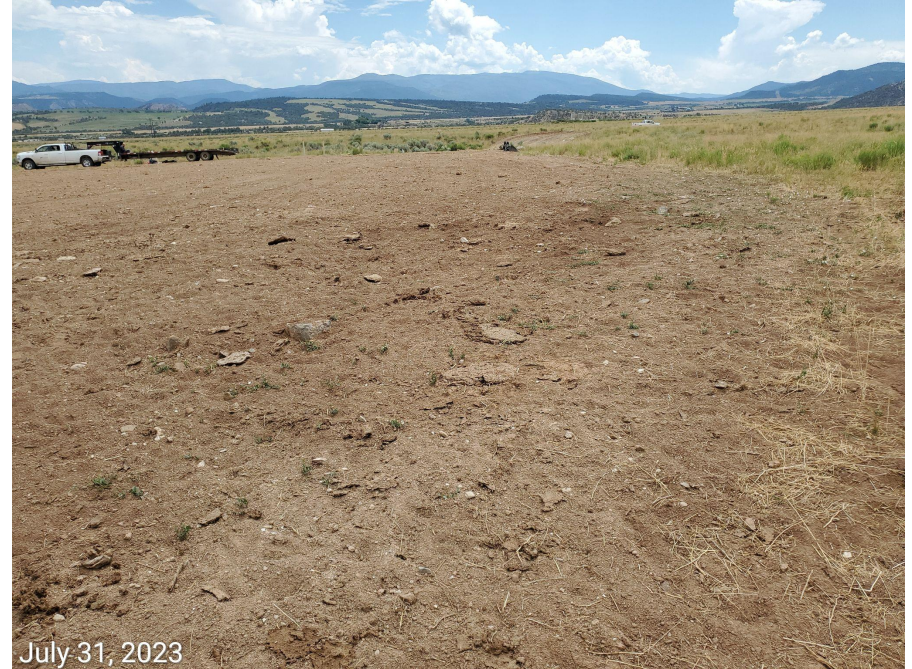
Photo 2: See comments under photo 1.

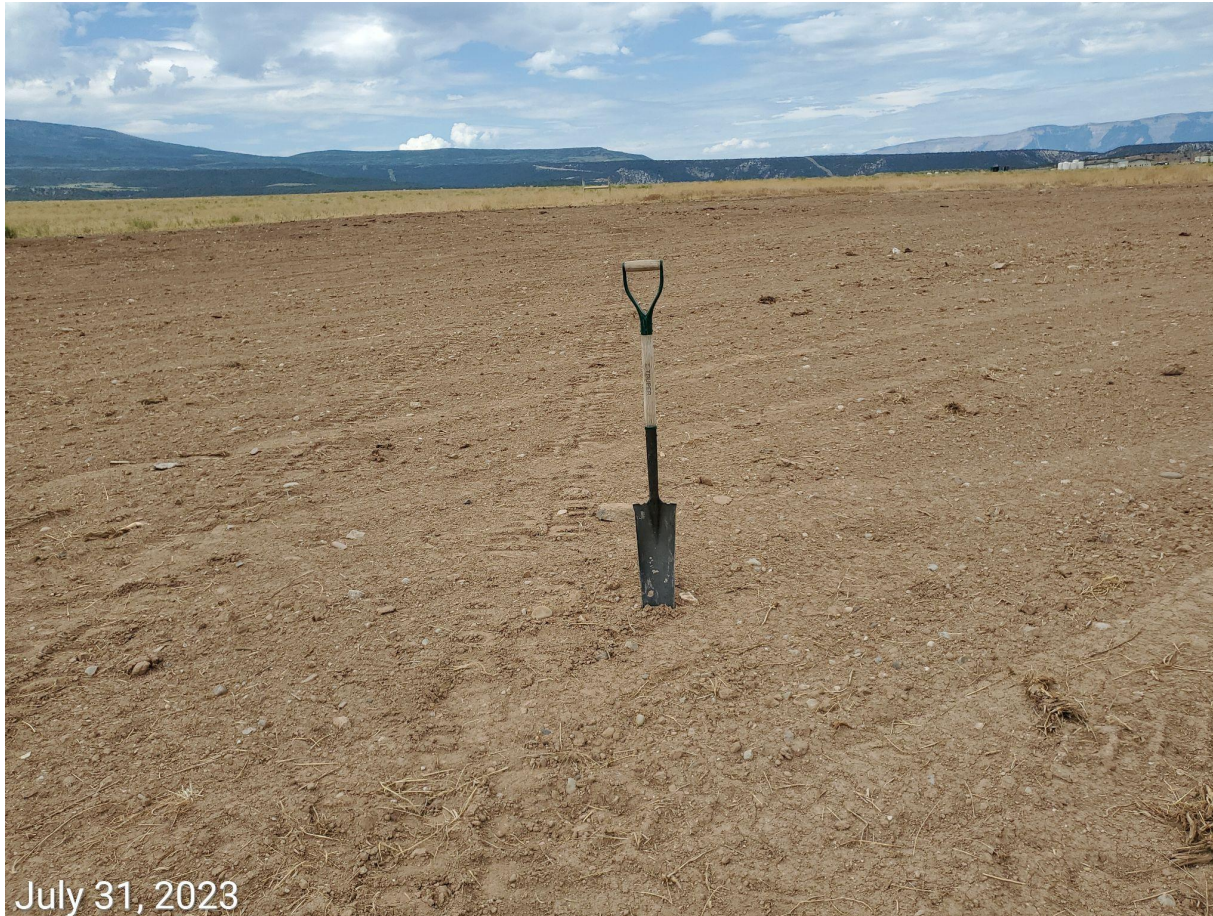
Photo 3: Photo taken from central areas of the Location. Photo shows reclamation specialist was only able to easily penetrate top couple of inches; compaction issues apparent; Location has not been cross-ripped to a minimum depth of 18 inches.

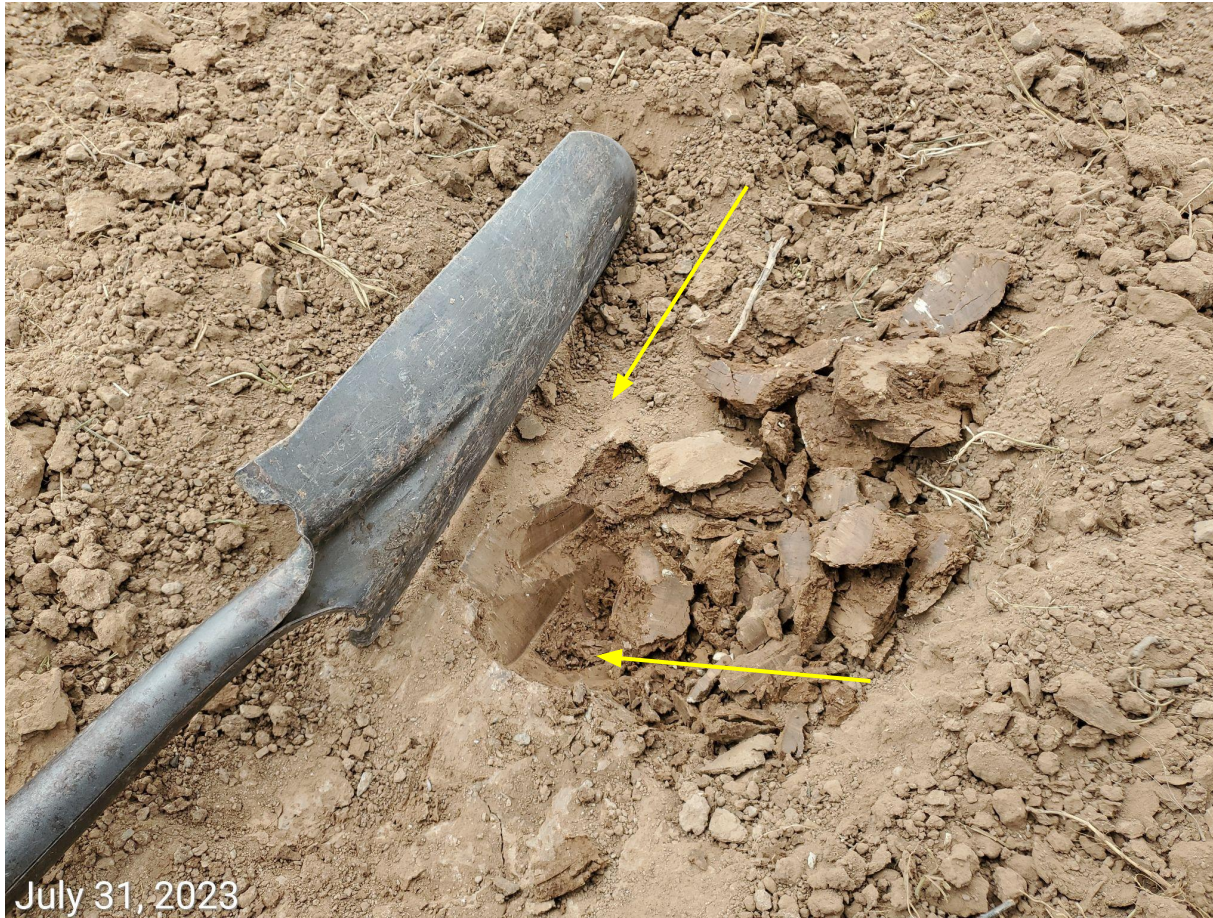
Photo 4: Photo shows compaction alleviation test-pit performed by Reclamation Specialist on the Location. Photo shows an apparent zone of compaction ~2-4 inches below the soil surface.

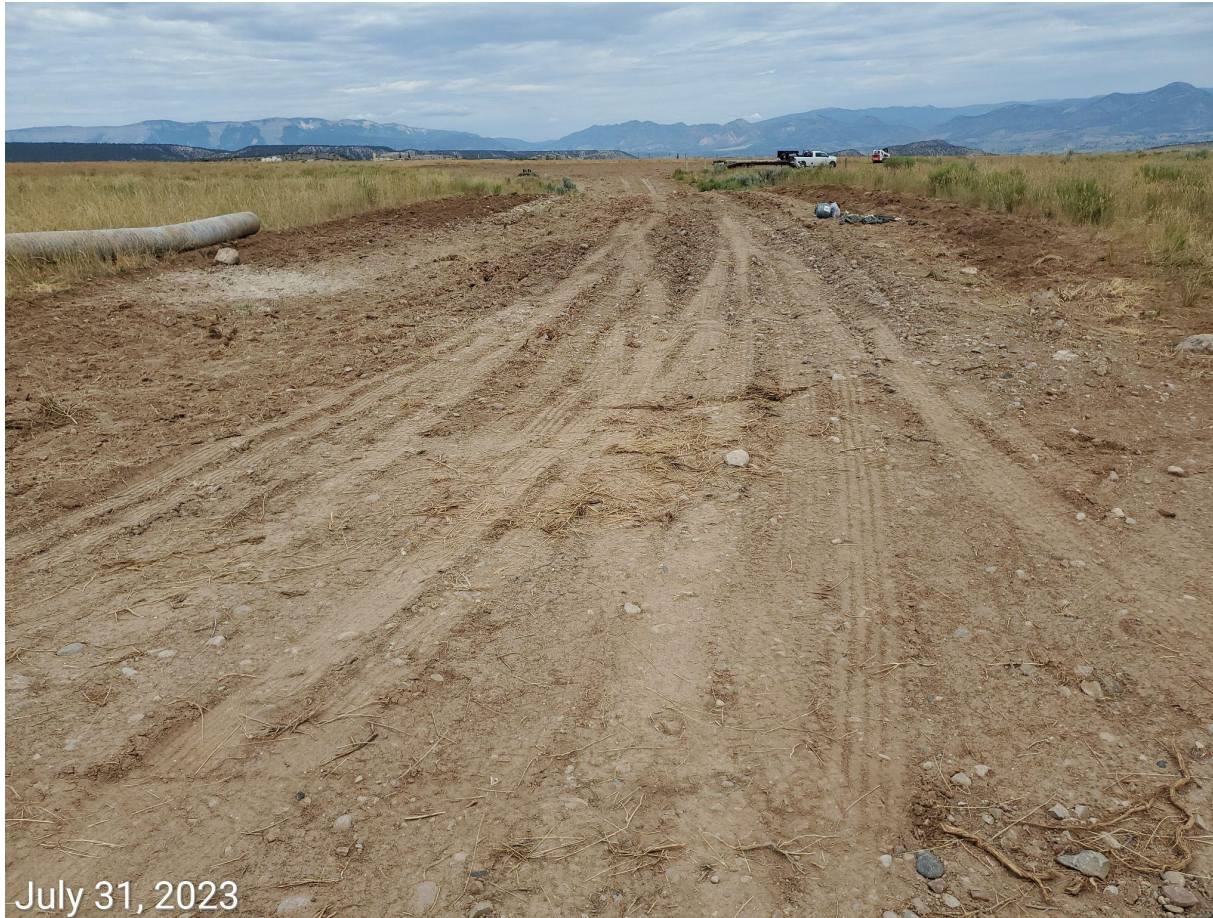
Photo 5: Photo taken from the access road, facing north. Operator appears to have ripped only a portion of the access road in one direction. Areas have not been cross-ripped and compaction issues remain apparent. Photo also shows stormwater and erosion control measures to manage stormwater runoff have not been installed prior to, or during dirt-work construction/reclamation activities.

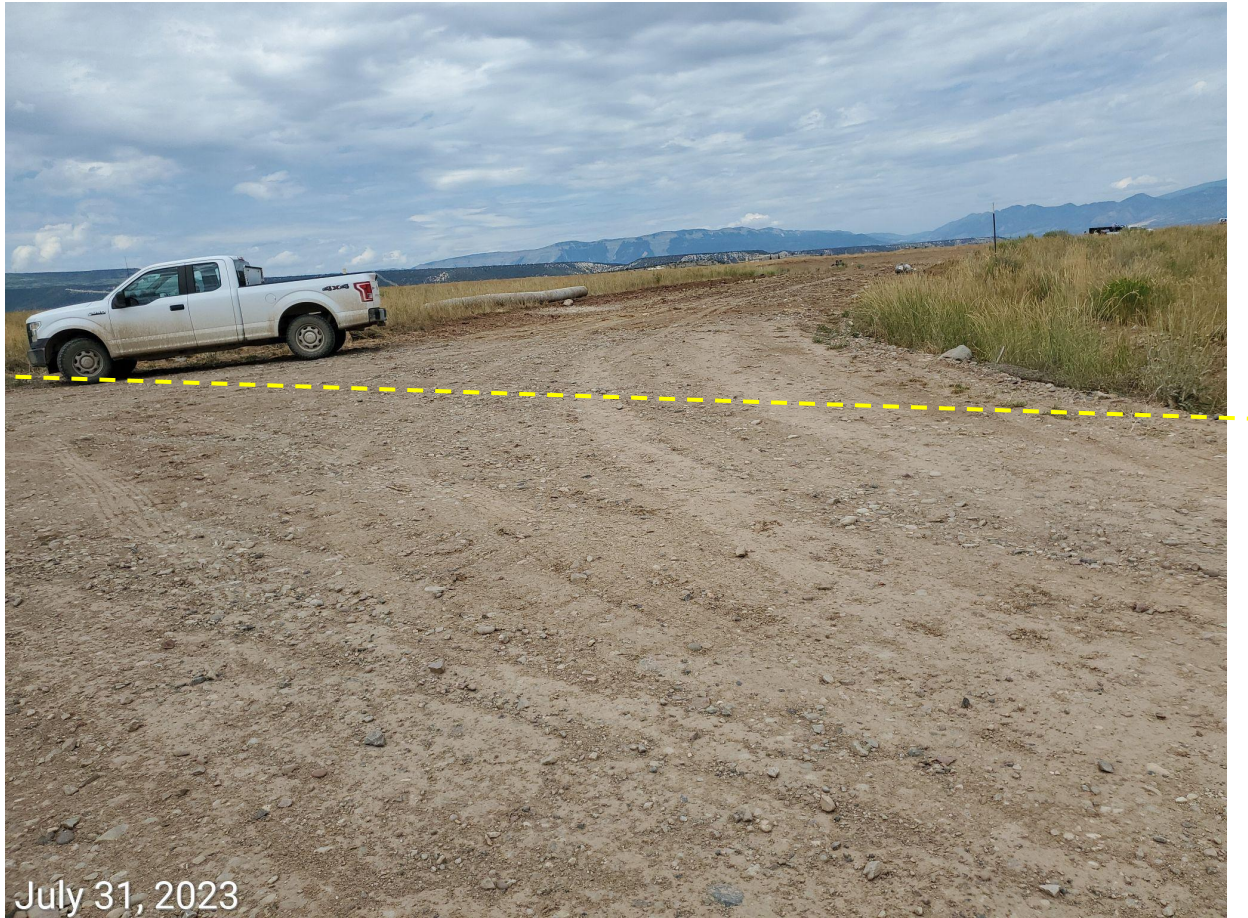
Photo 6: Photo taken from the access road entrance, facing north. Photo shows section of the access road that has not been reclaimed (above yellow line)

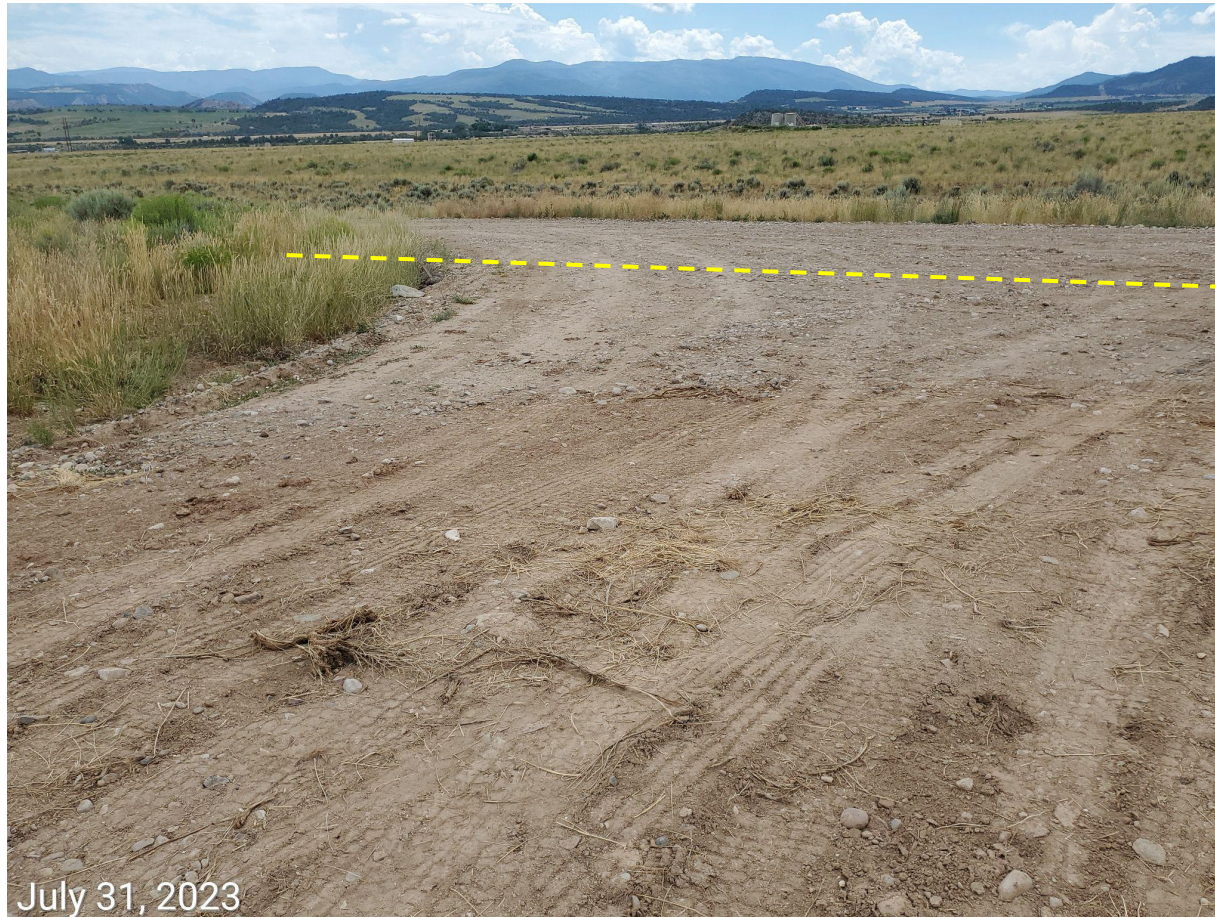
Photo 7: Photo taken from the access road entrance, facing south. Photo shows section of the access road that has not been reclaimed (below yellow line).

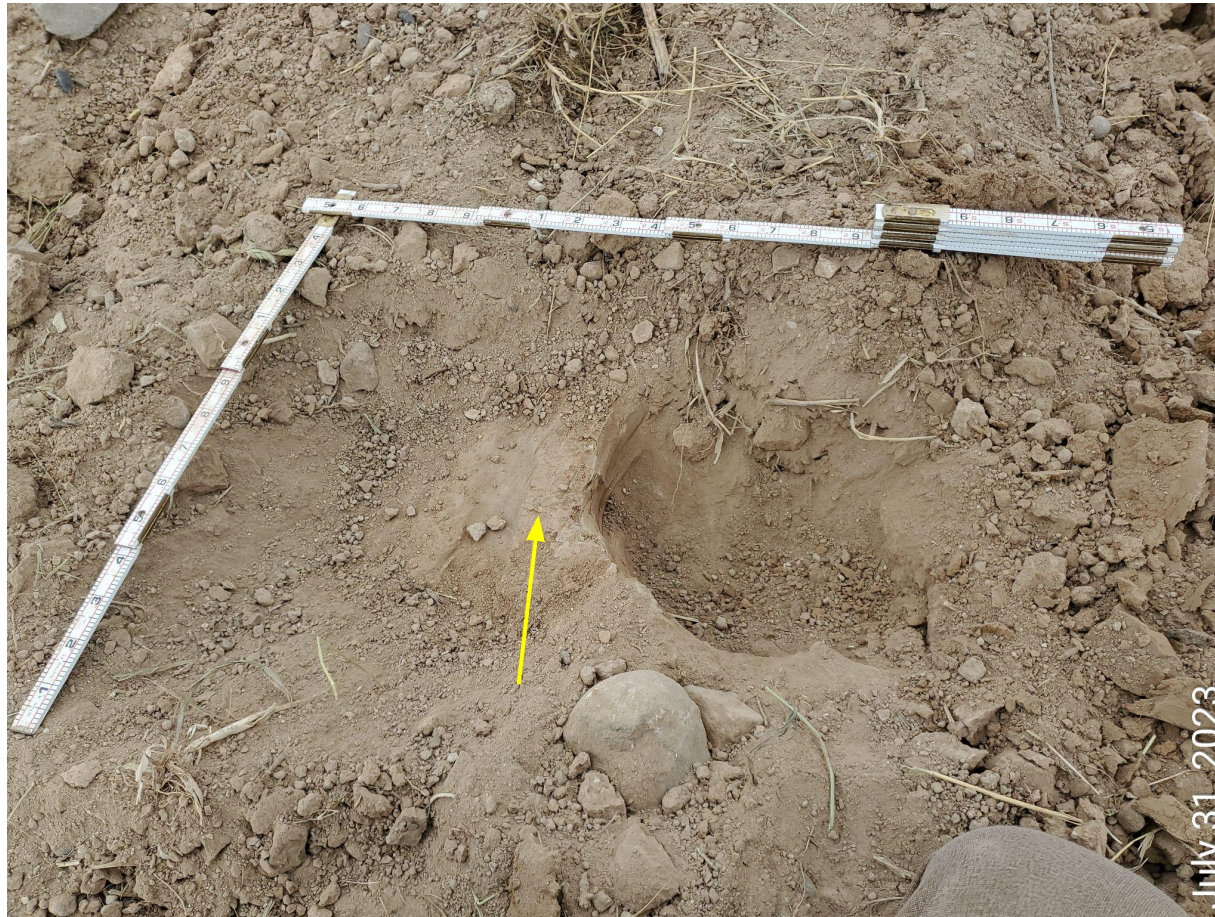
Photo 8: Photo shows compaction alleviation test-pit performed by Reclamation Specialist on the access road. Operator appears to have ripped a section of the access road in one direction. Photo shows an apparent zone of compaction remaining at road

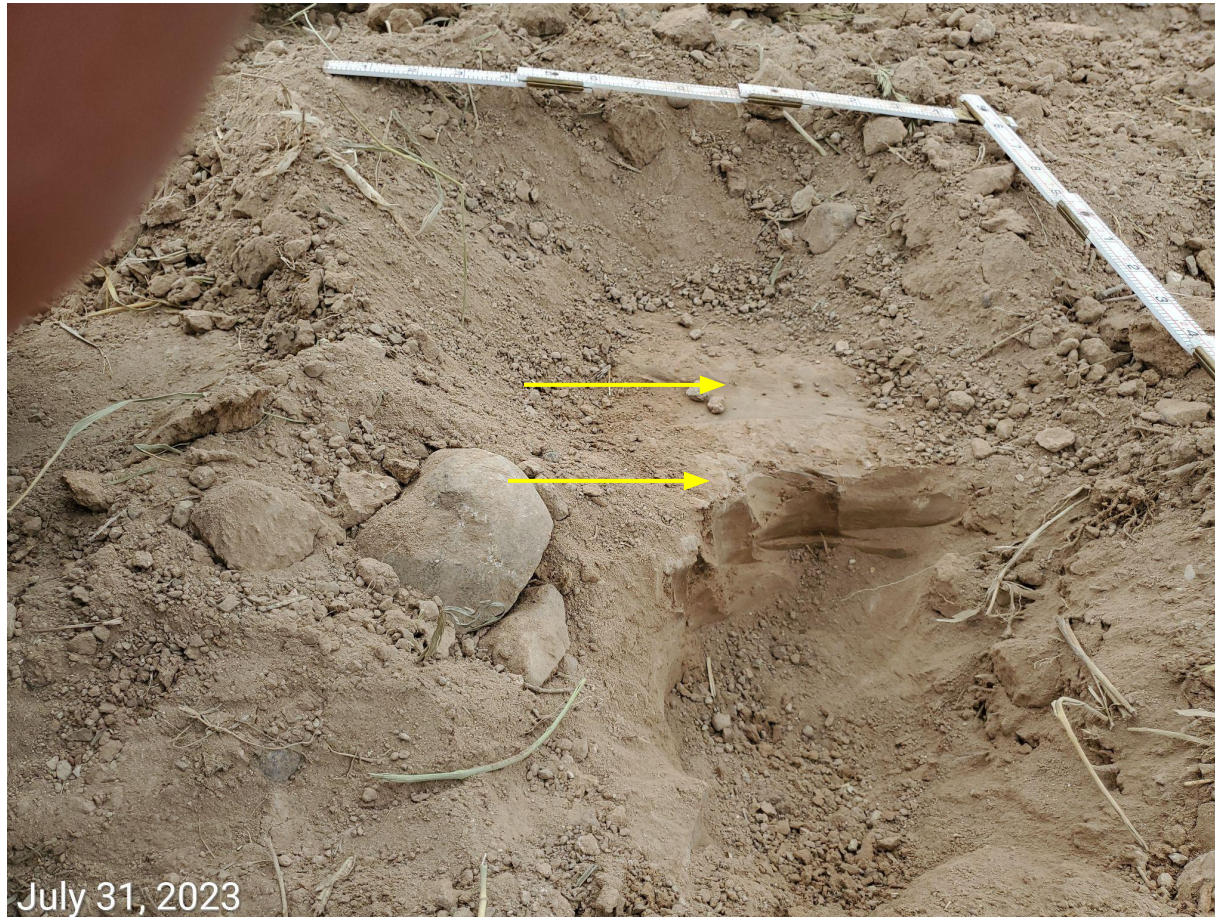
Photo 9: See comments under photo 8.

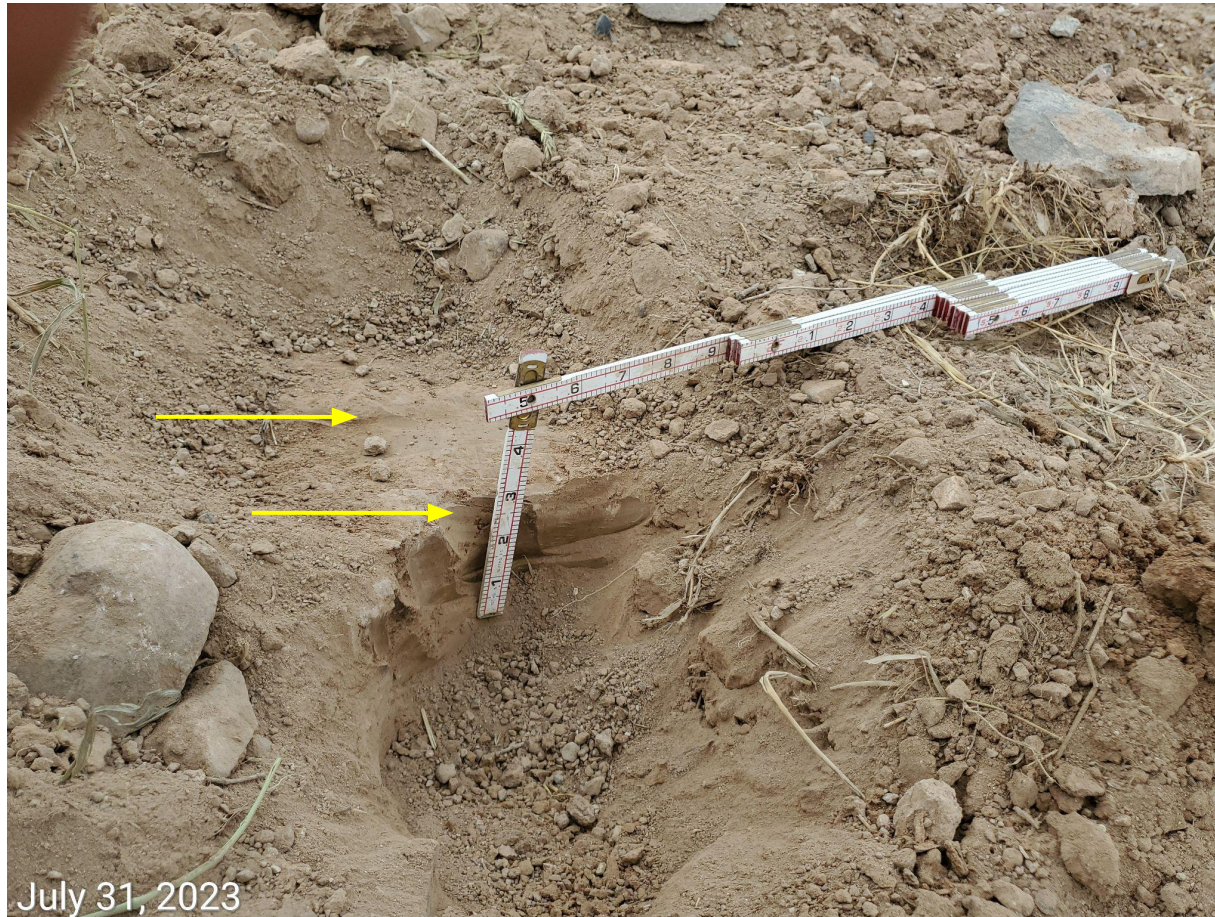
Photo 10: See comments under photo 8.

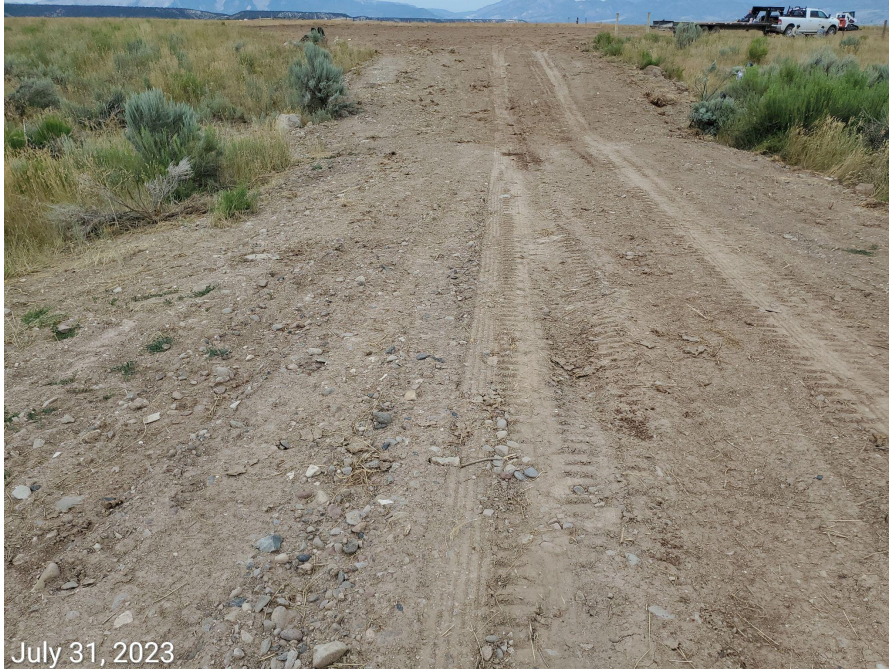
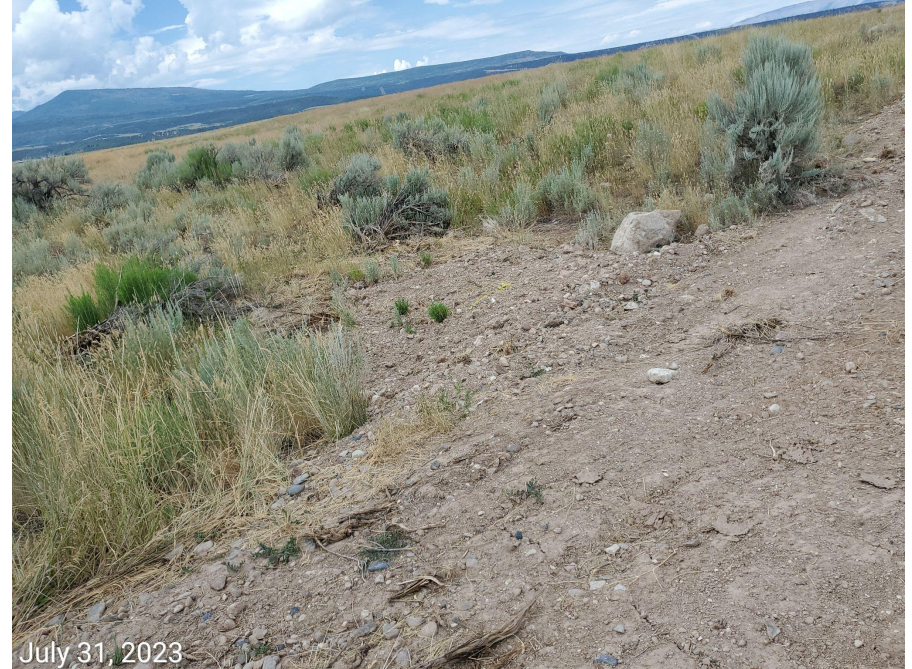
Photo 11: Photo shows stormwater and erosion control measures to manage stormwater runoff have not been installed prior to, or during dirt-work construction/reclamation activities.

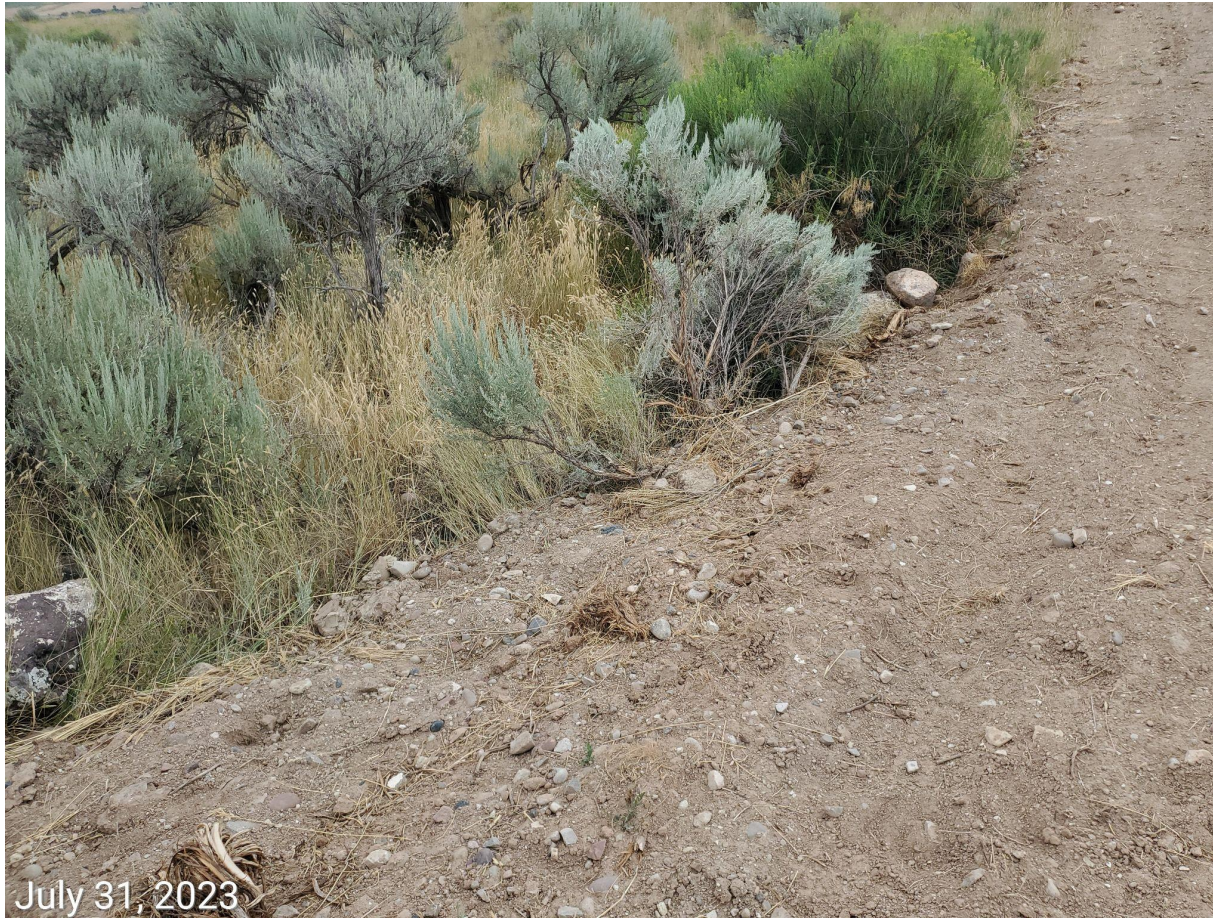
Photo 12: Photo shows stormwater and erosion control measures to manage stormwater runoff have not been installed prior to, or during dirt-work construction/reclamation activities.

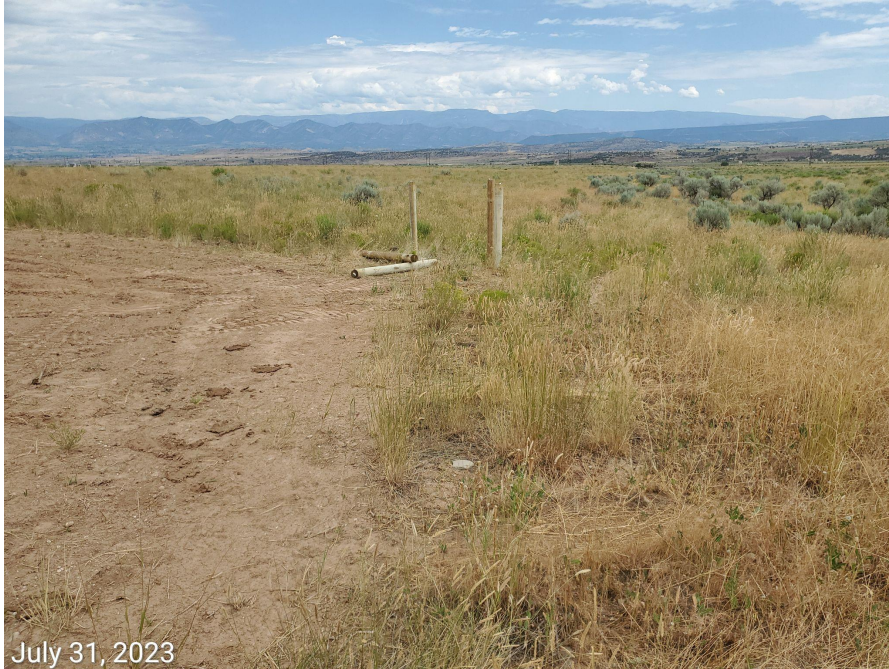
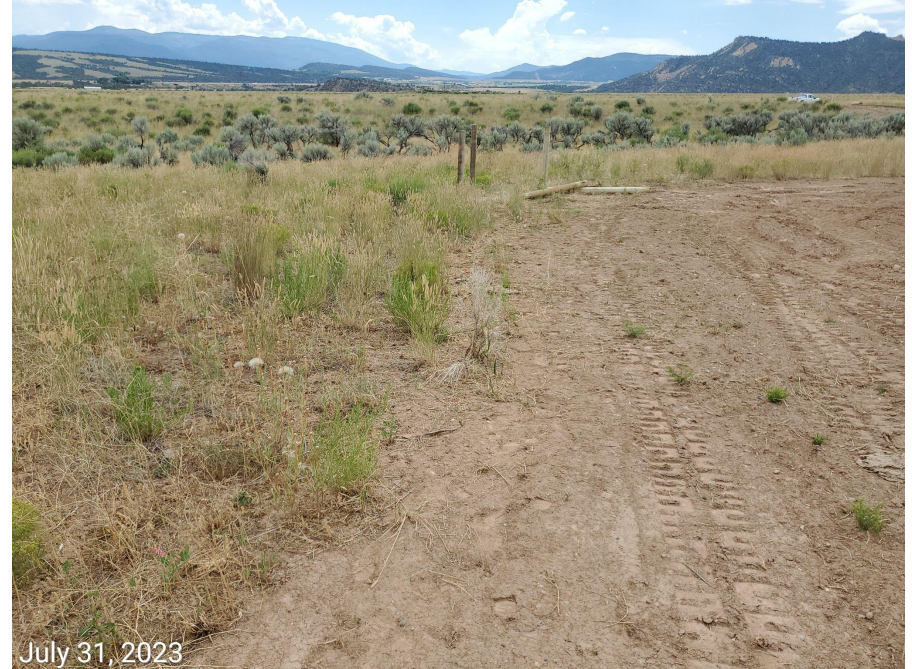
Photo 13: Photo shows stormwater and erosion control measures to manage stormwater runoff have not been installed prior to, or during dirt-work construction/reclamation activities.
