Inspection Photos

Location Name: LARAMIE ENERGY LLC, Blackman/14-12 Pad

Location ID: 334544

Date: 8/1/2023

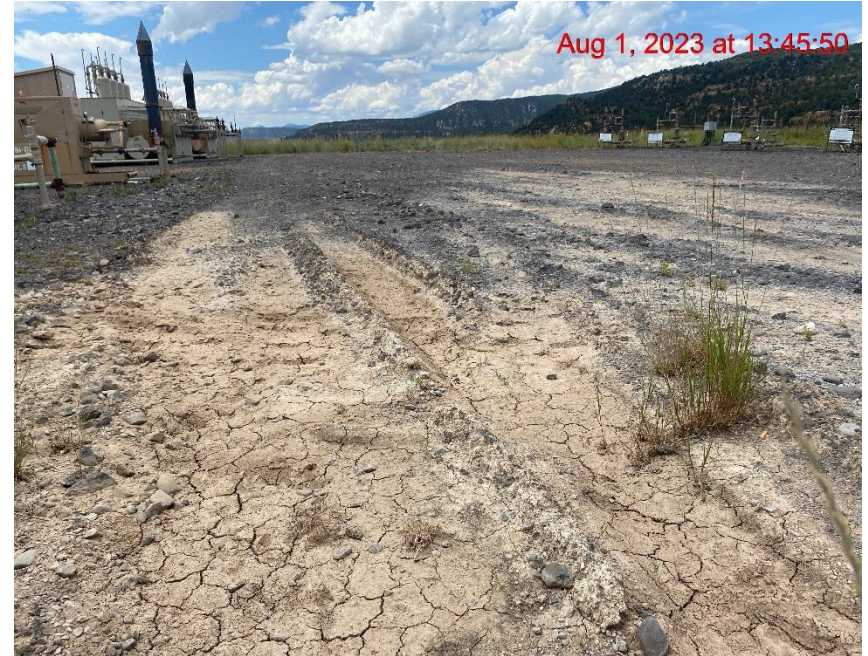
Location Lacks Stabilization – Photo #05300

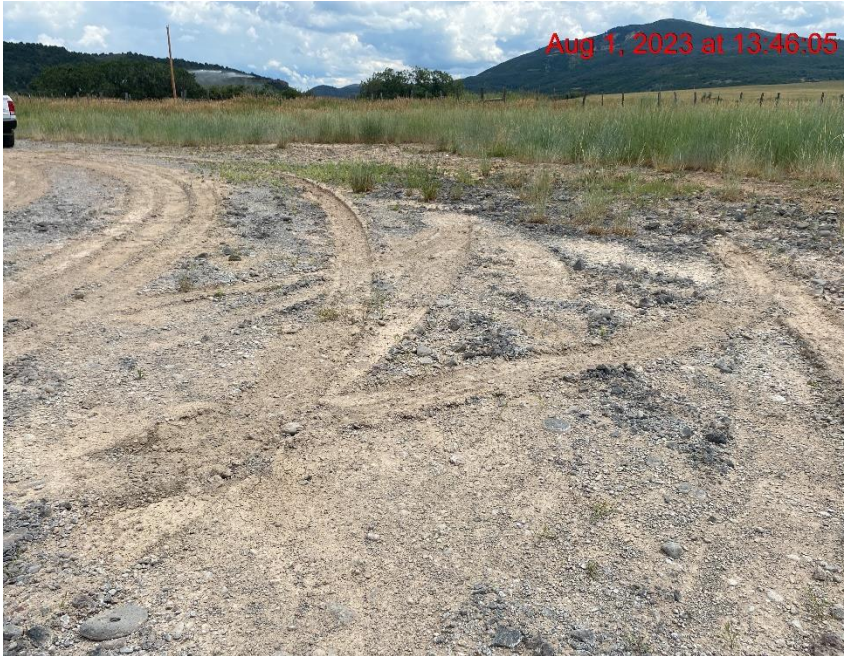
Location Lacks Stabilization – Photo #05301

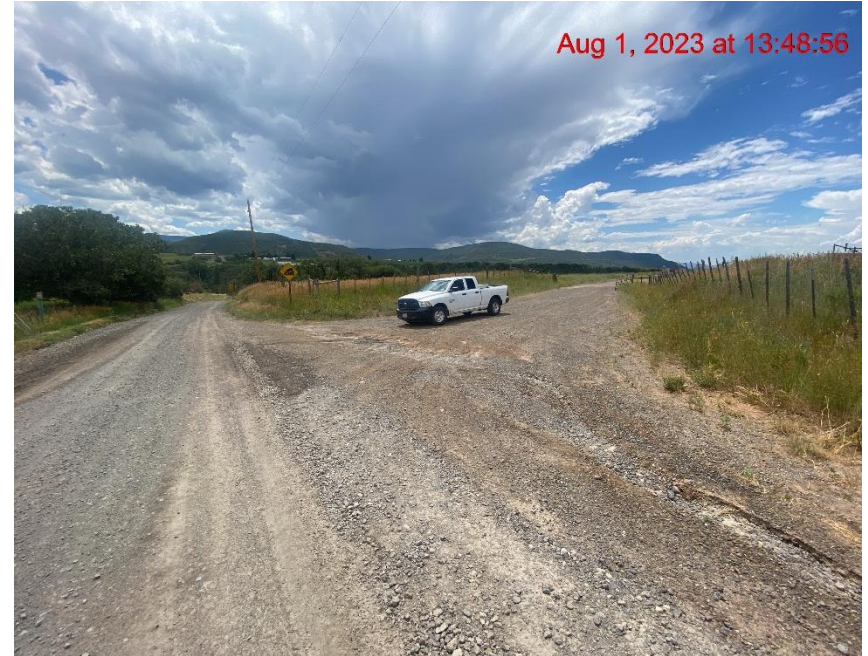
Insufficient Vehicle Tracking BMPs at Location Entrance/Exit – Photo #05304

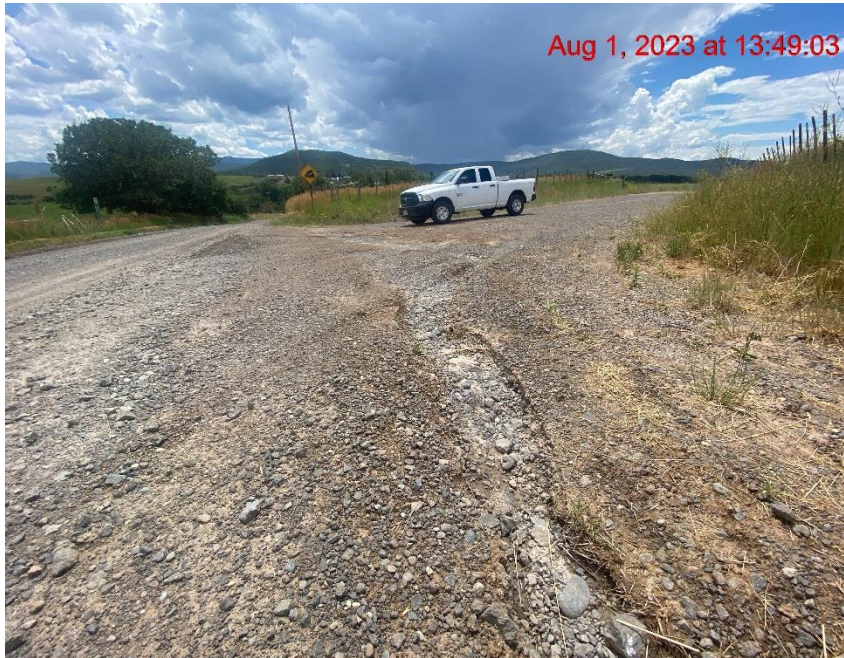
Rill Erosion Running Across Access Road – Photo #05305
