TEP
DOE 2-W-21
Location ID:
335256

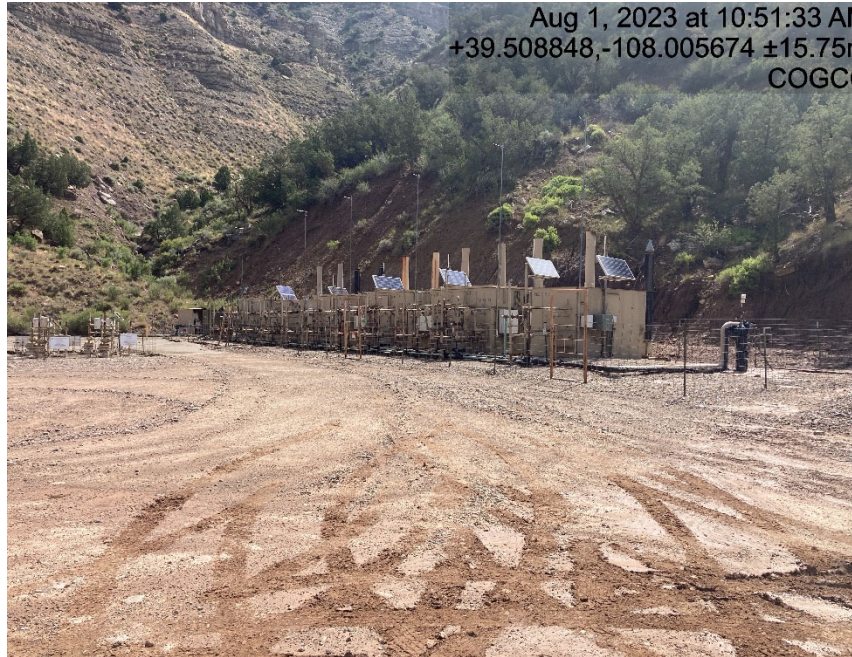
Separators

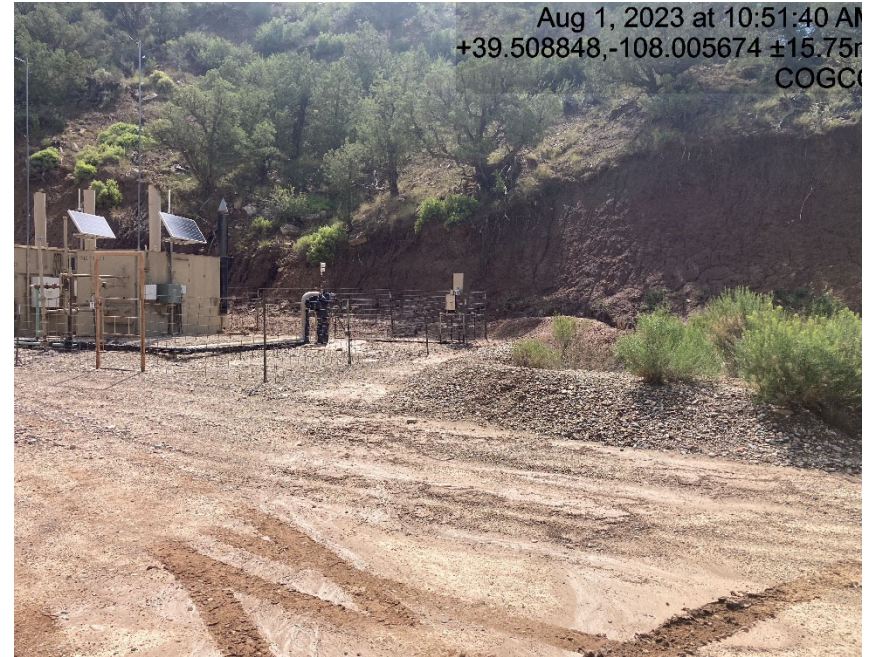
Cut slope sluffing off. Roots of vegetation is exposed.

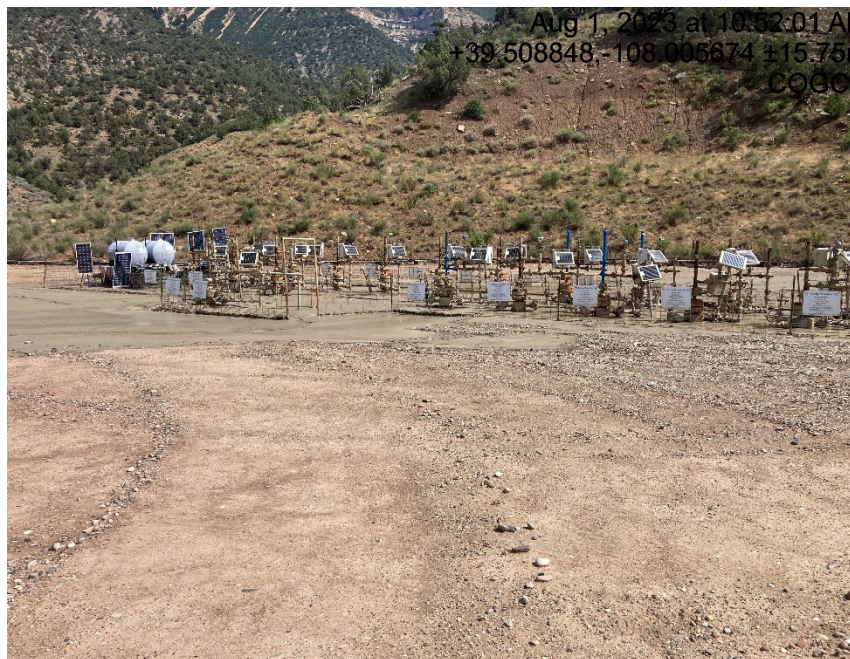
Location covered with mud. BMP's failing. Well heads.

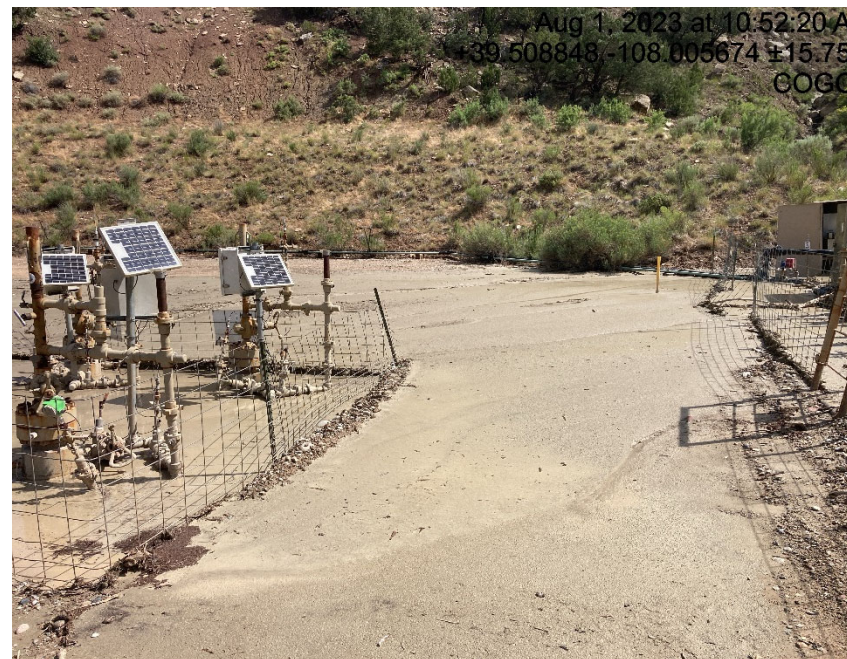
Location covered with mud. BMP's failing

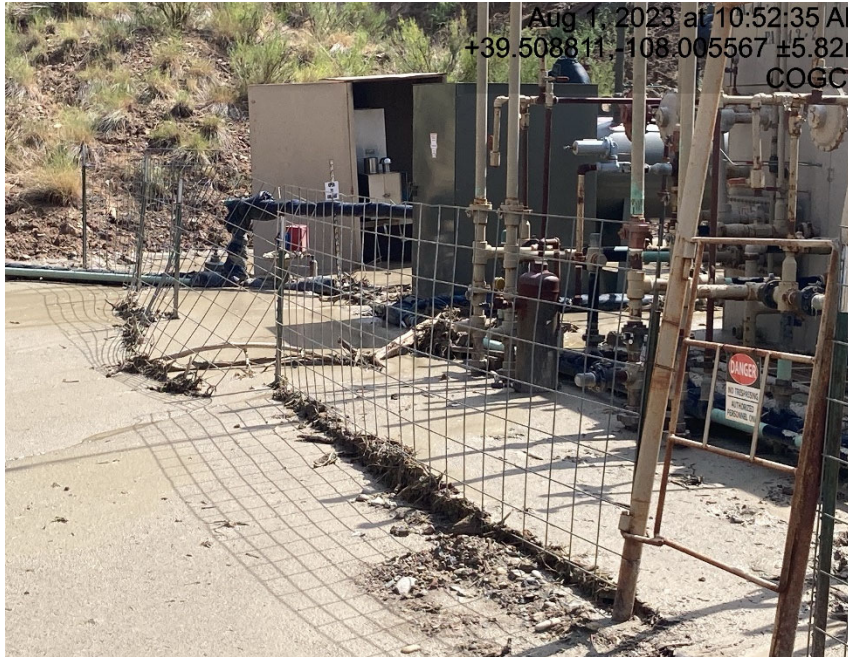
Location covered with mud. BMP's failing

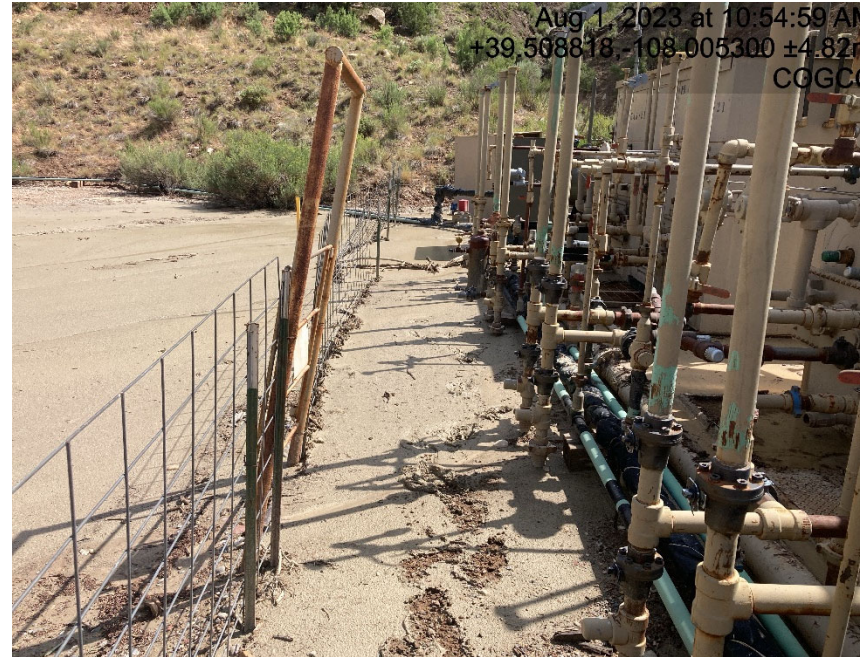
Location covered with mud. BMP's failing

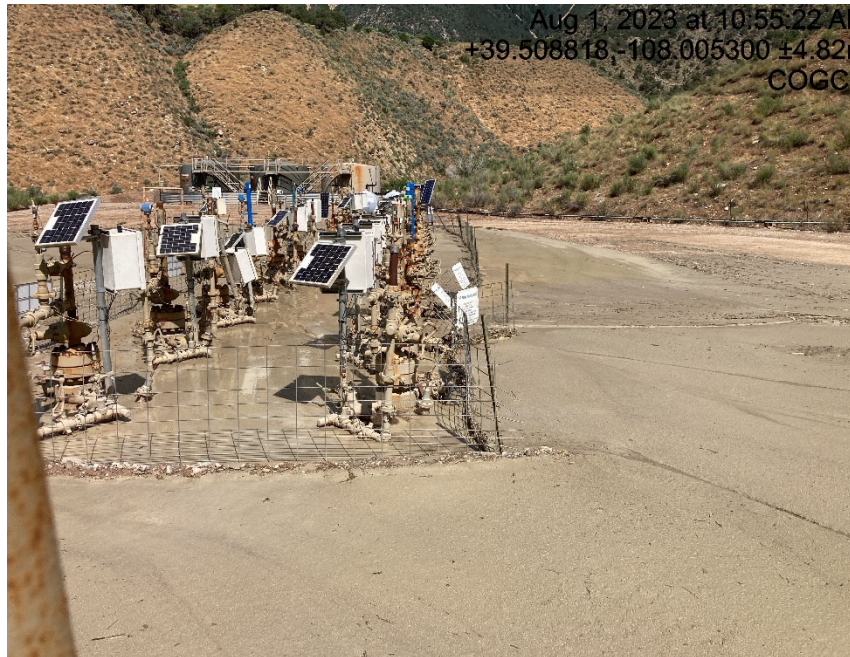
Location covered with mud. BMP's failing

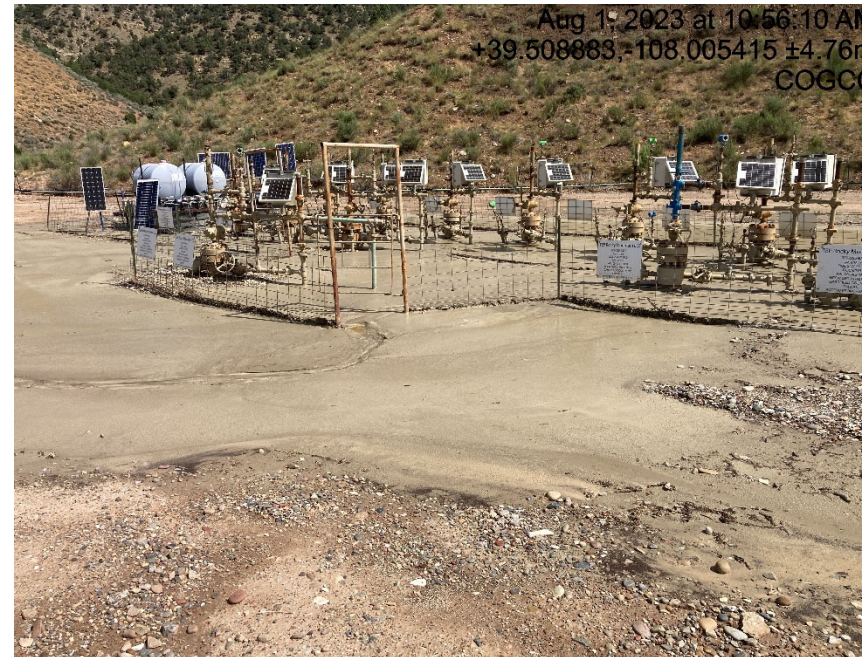
Location covered with mud. BMP's failing

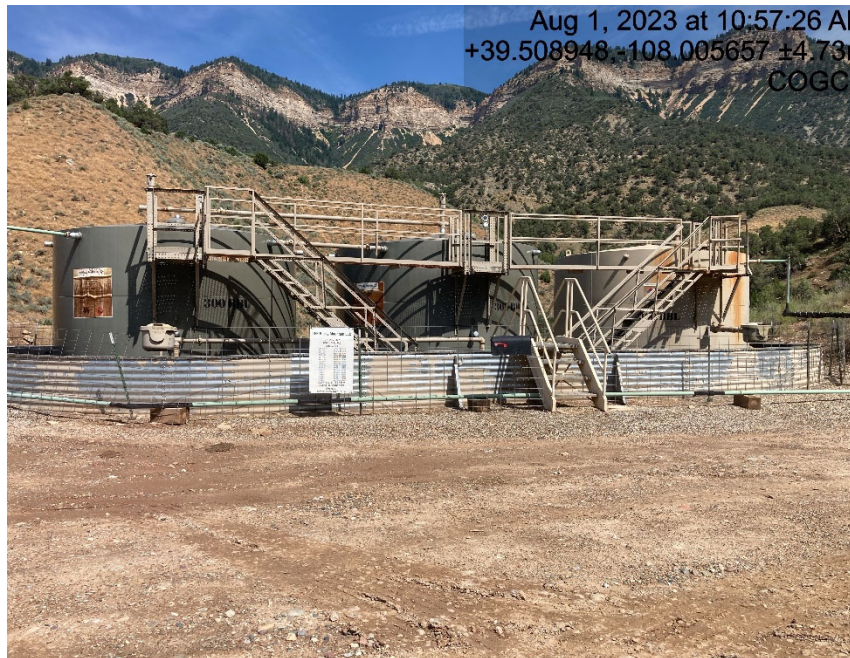
Tank battery

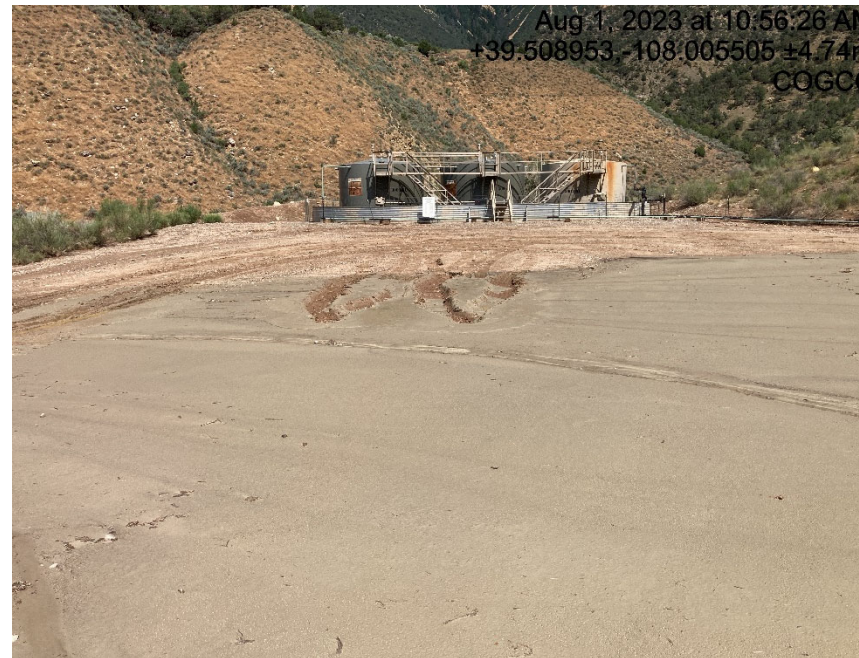
Vehicle has driven into mud which could lead to tracking issues

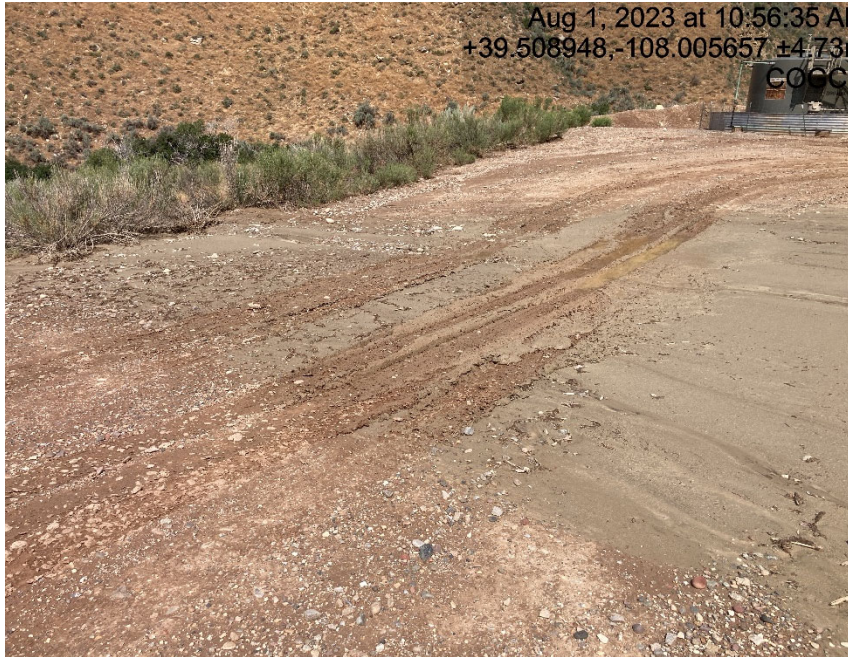
Vehicle has driven into mud which could lead to tracking issues

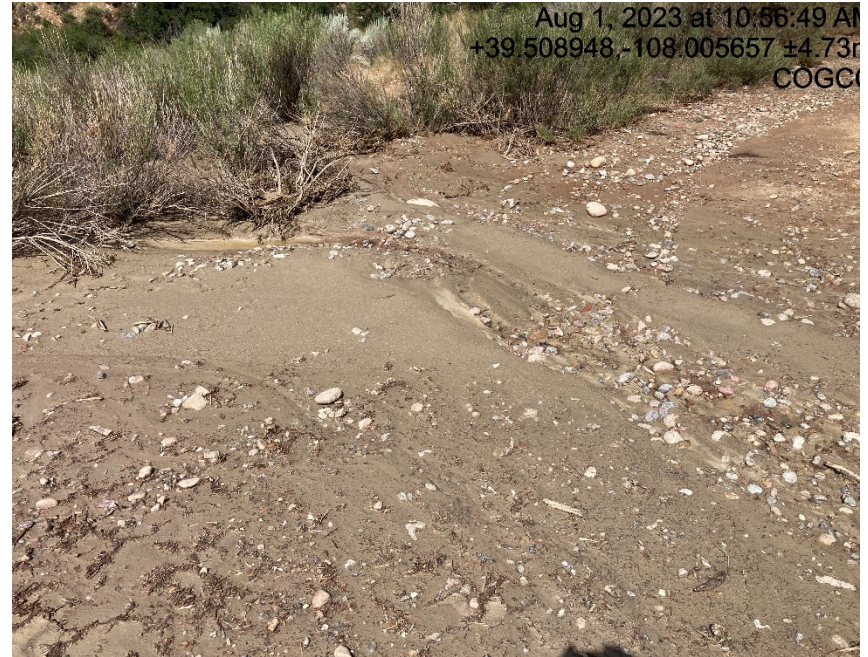
Run off

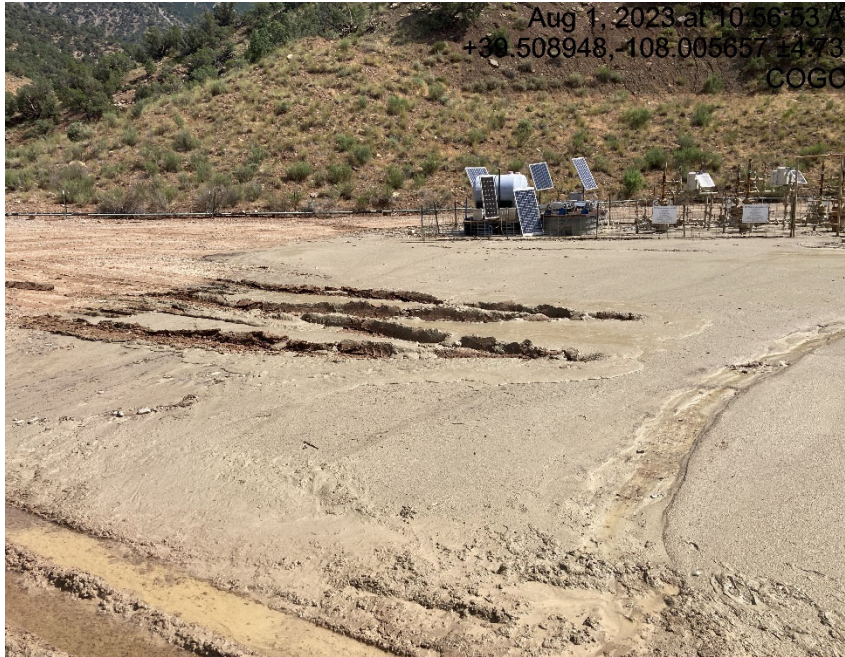
Vehicle has driven into mud which could lead to tracking issues

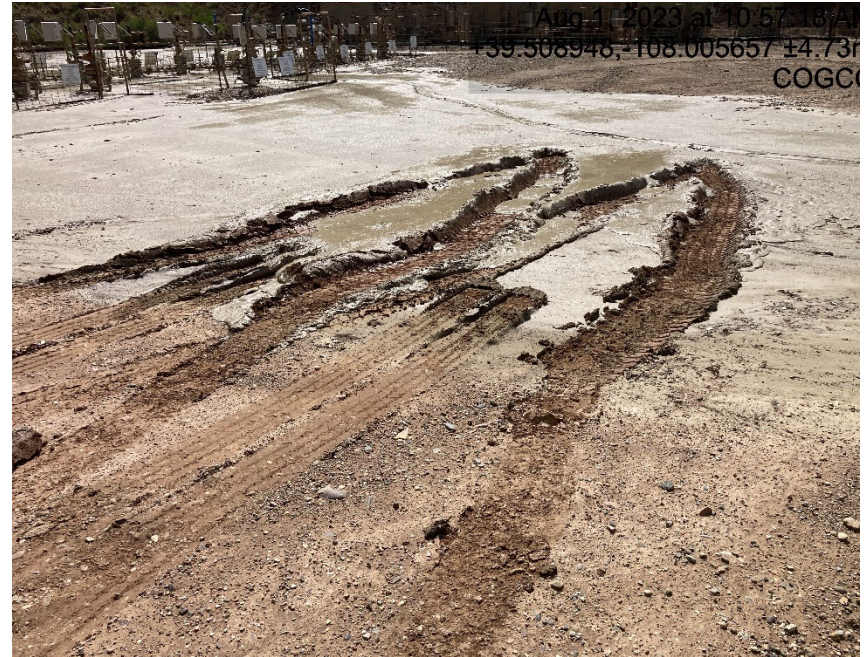
Vehicle has driven into mud which could lead to tracking issues

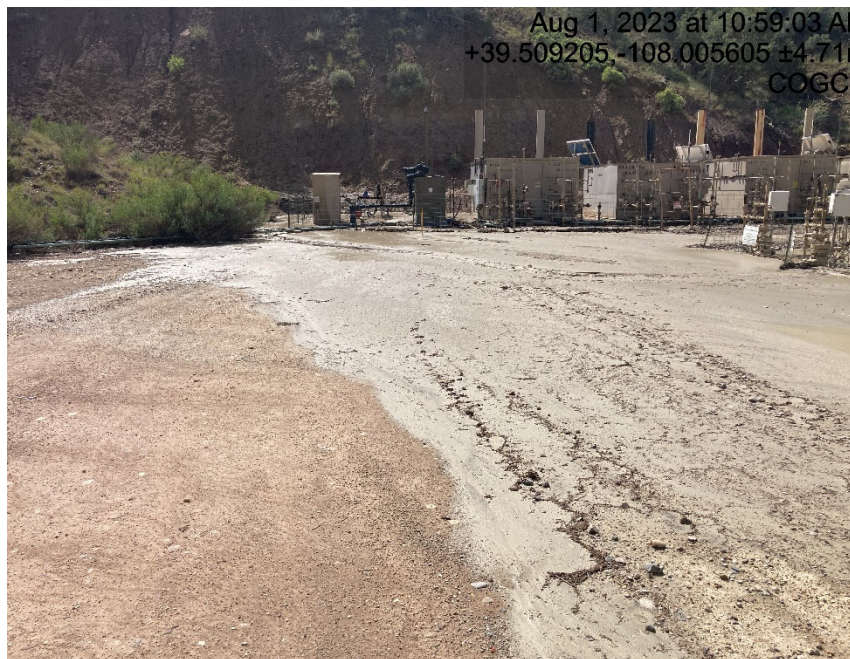
Location covered with mud

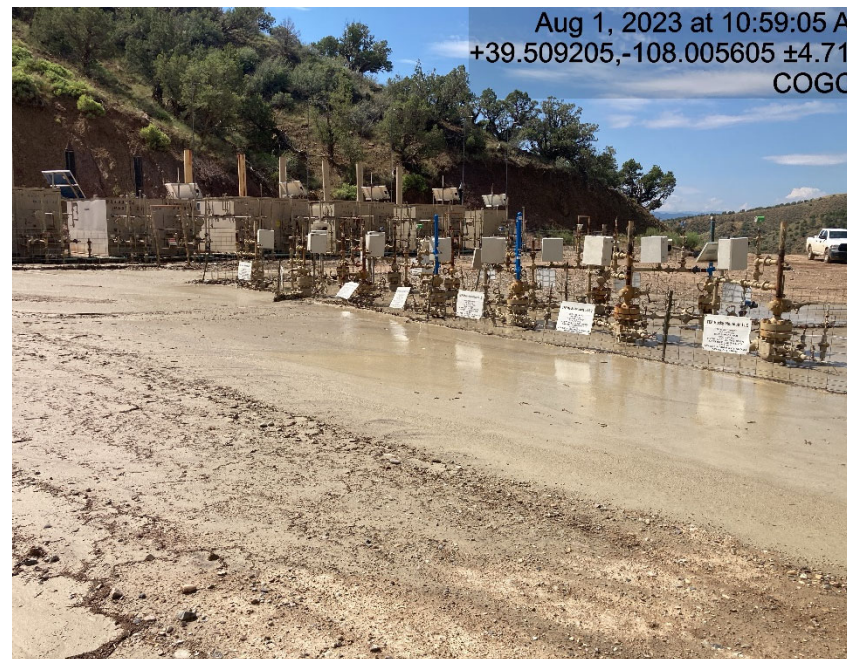
Location covered with mud

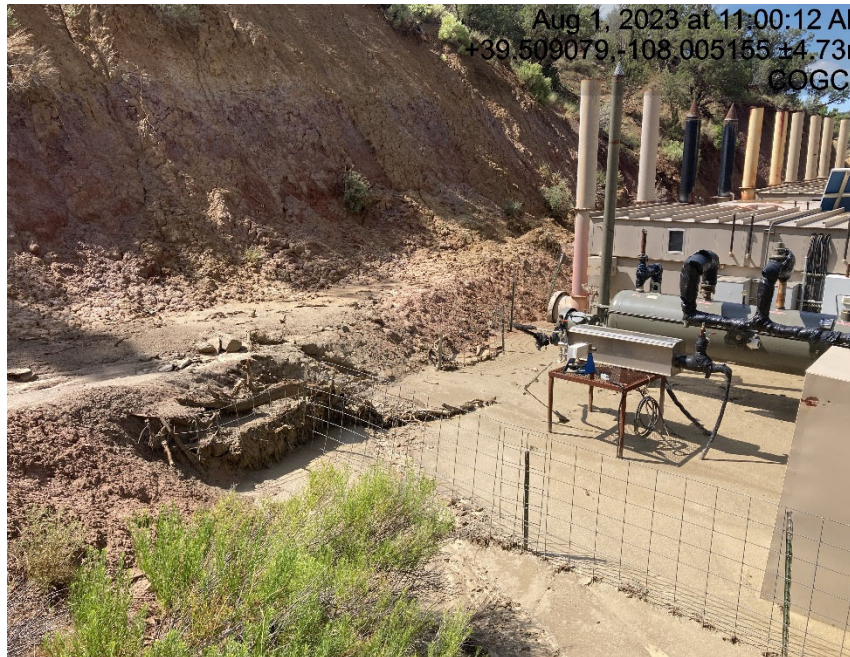
**Cut slope lacks stabilization, riling and erosion.
BMP's failing**

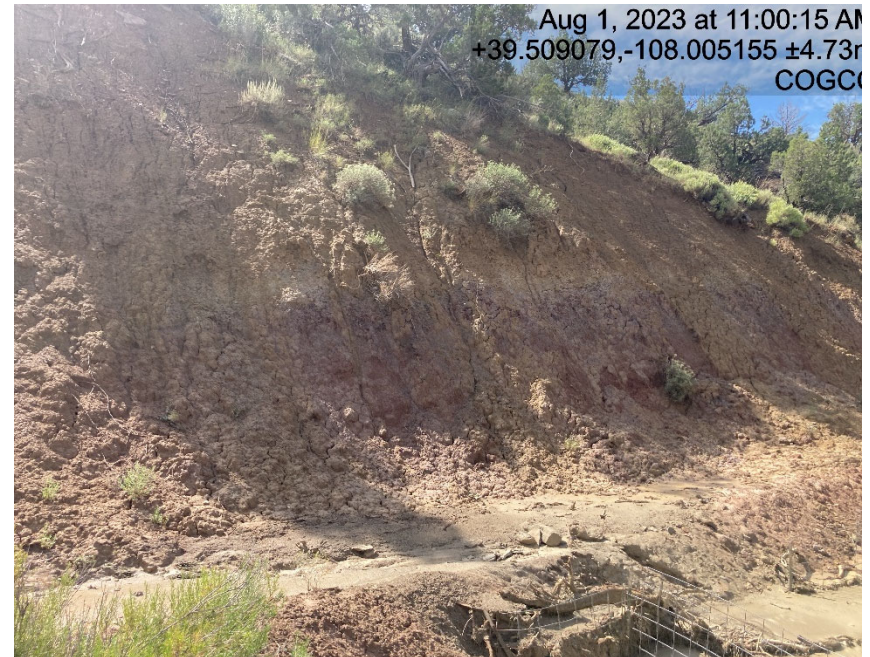
Cut slope lacks stabilization, riling and erosion

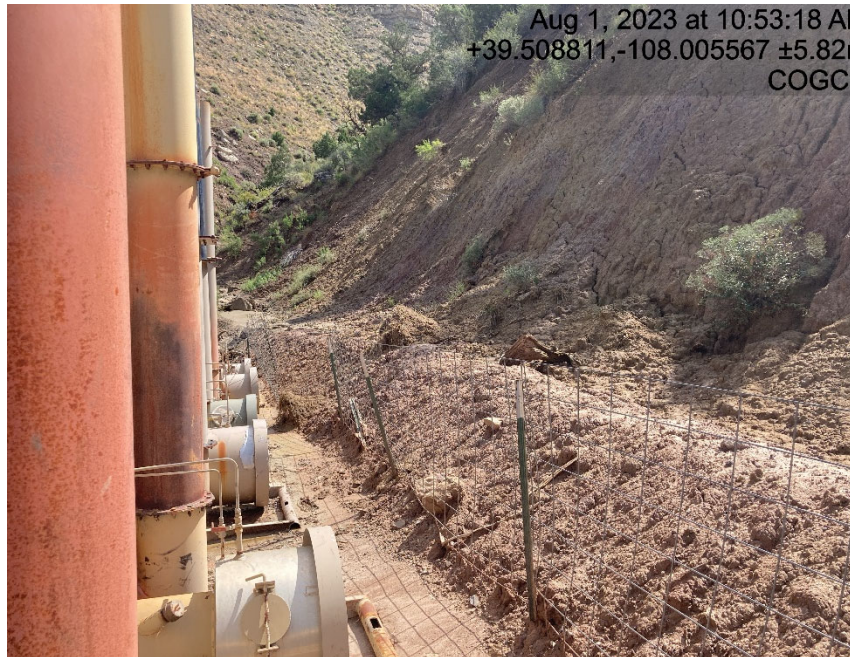
Cut slope lacks stabilization, riling and erosion

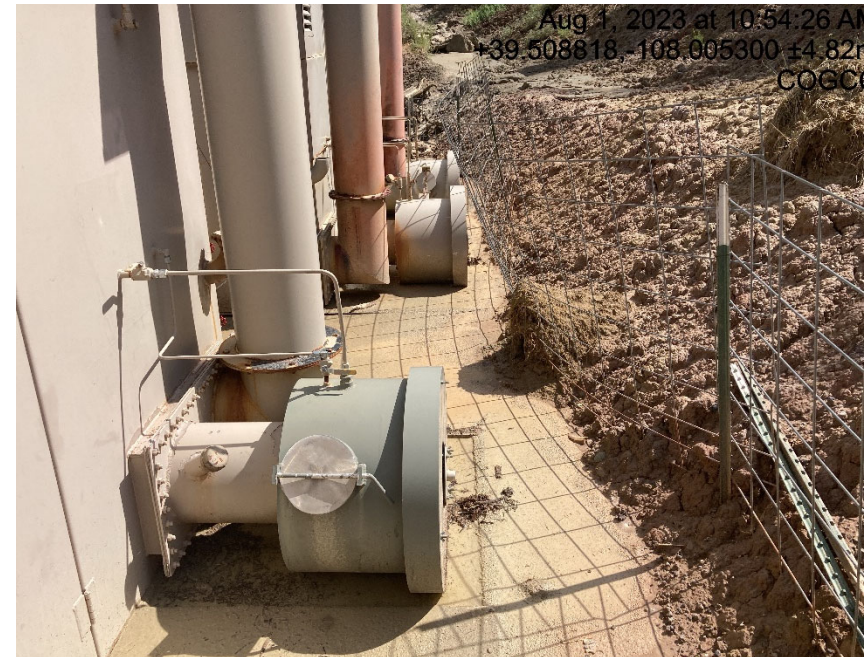
BMP's failing

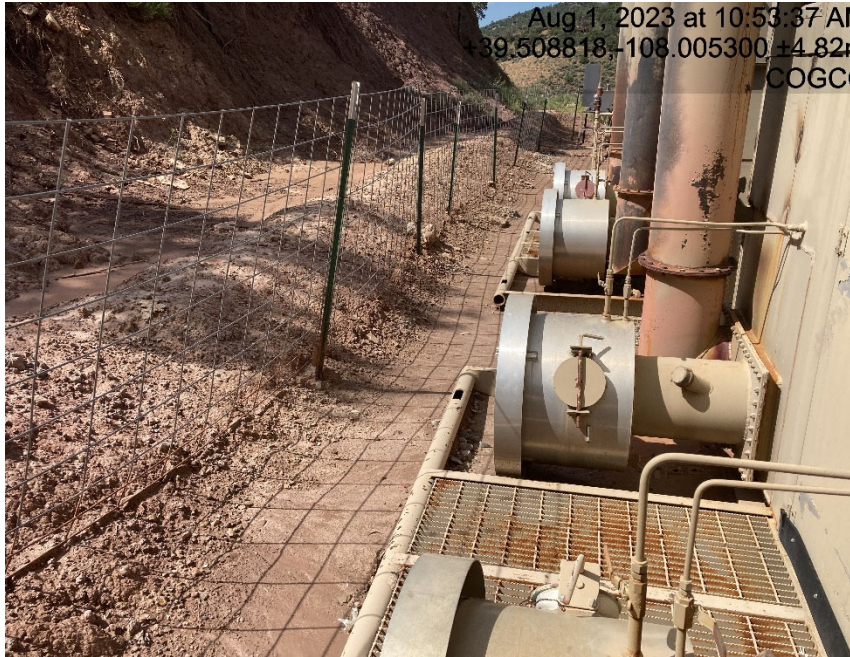
BMP's failing

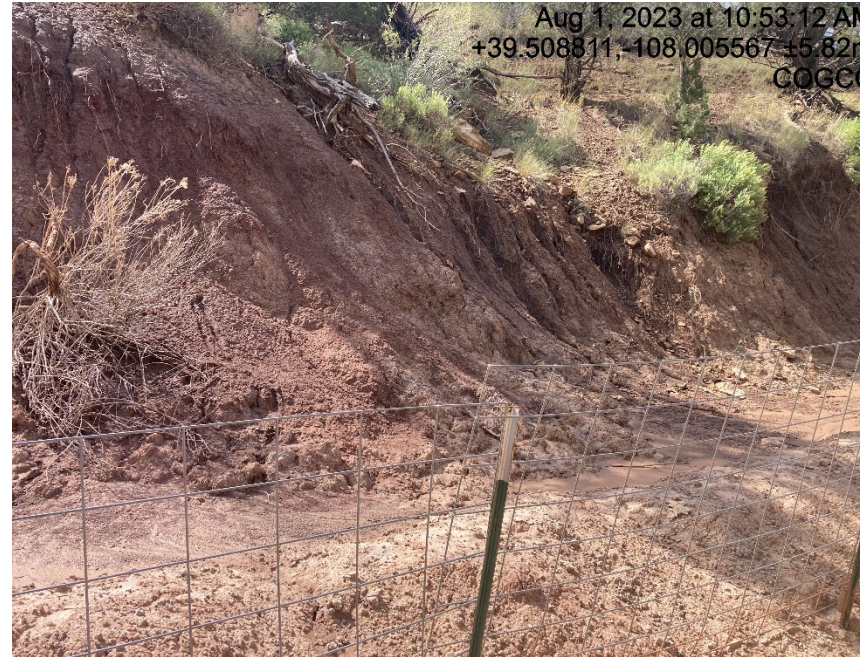
Cut slope lacks stabilization, riling and erosion

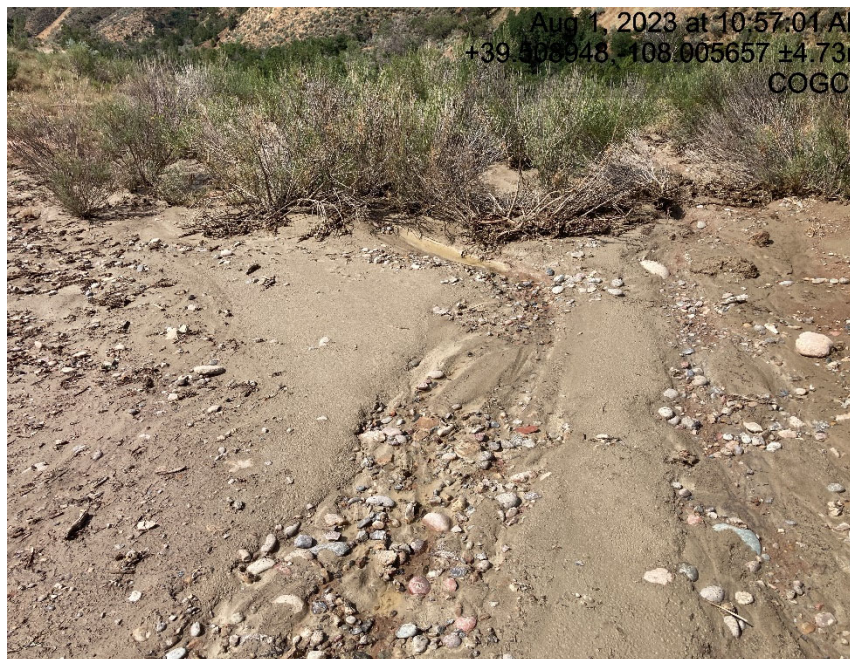
Run off

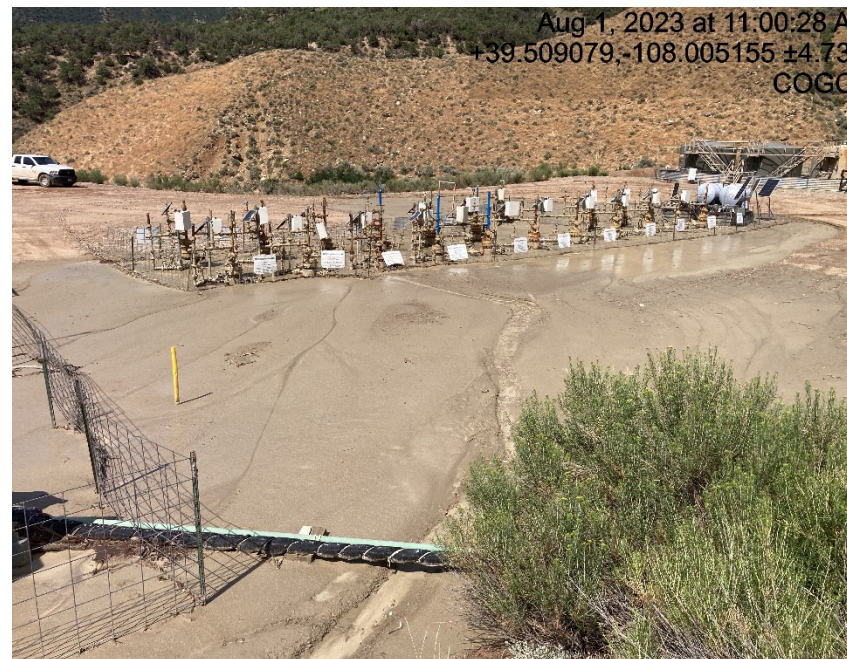
Location covered with mud. Storm water BMP's failing
