Inspection Photos

Location Name: LARAMIE ENERGY LLC, Piceance/28-05 Pad

Location ID: 334427

Date: 8/3/2023

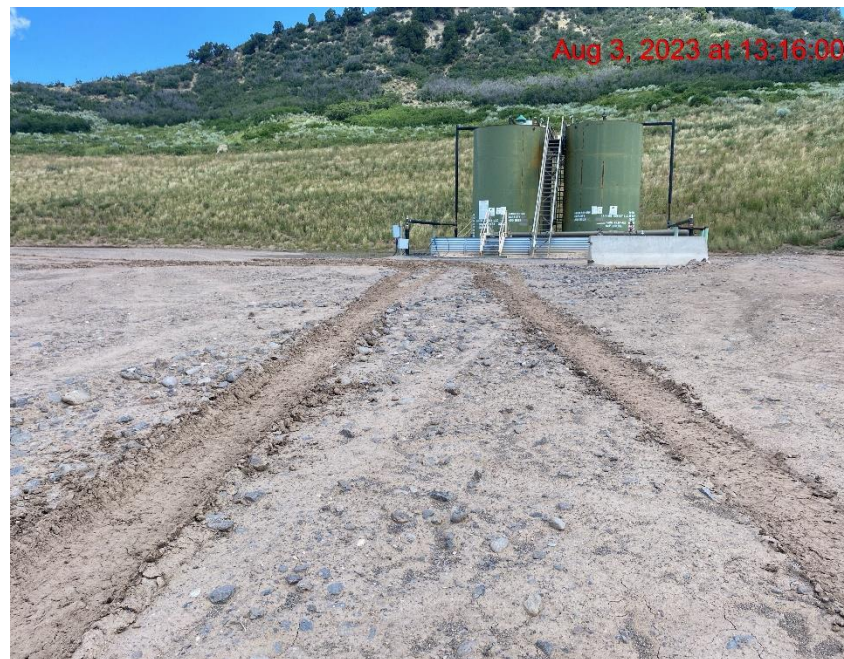
Location Lacks Stabilization – Photo #05438

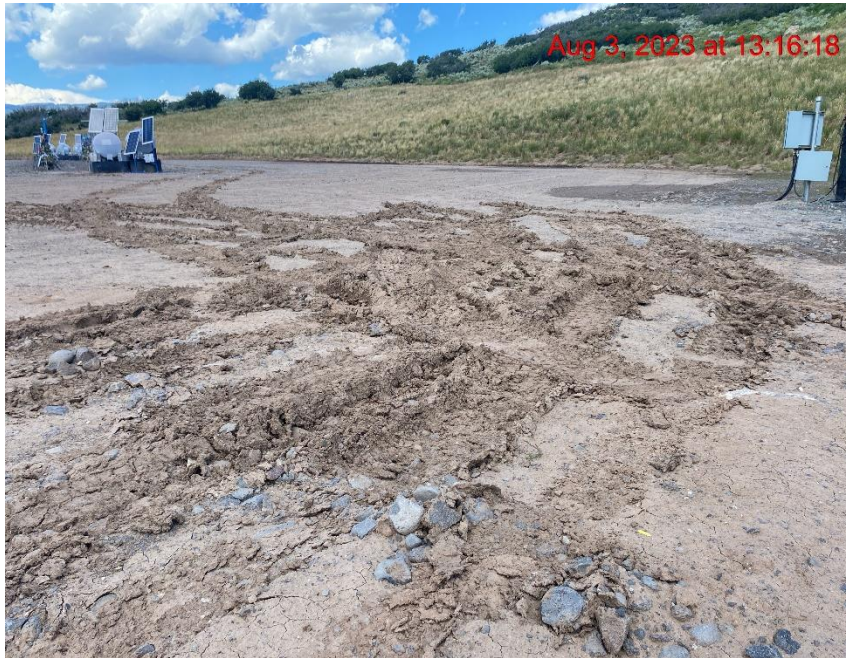
Location Lacks Stabilization – Photo #05439

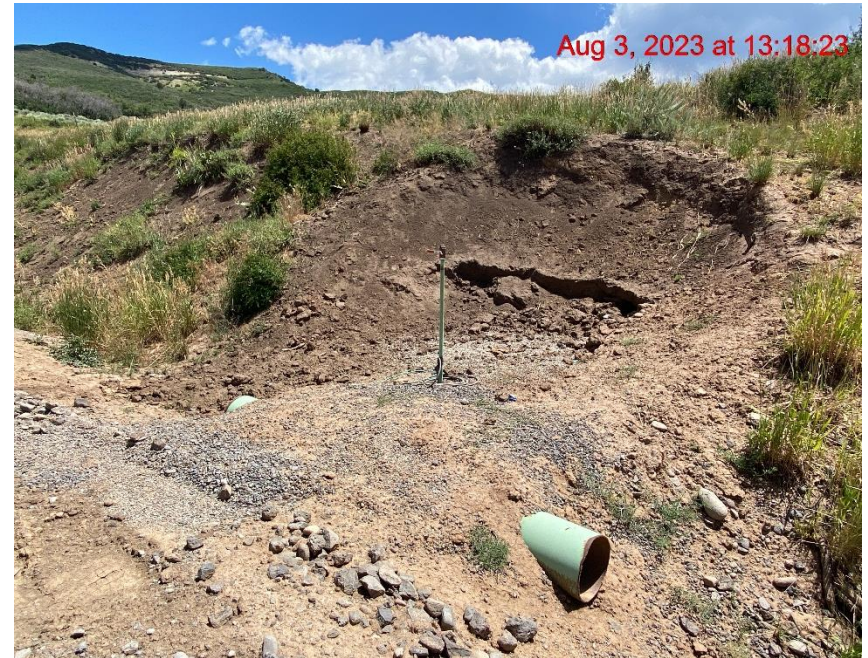
Insufficient Cut Slope Erosion Control – Photo #05442

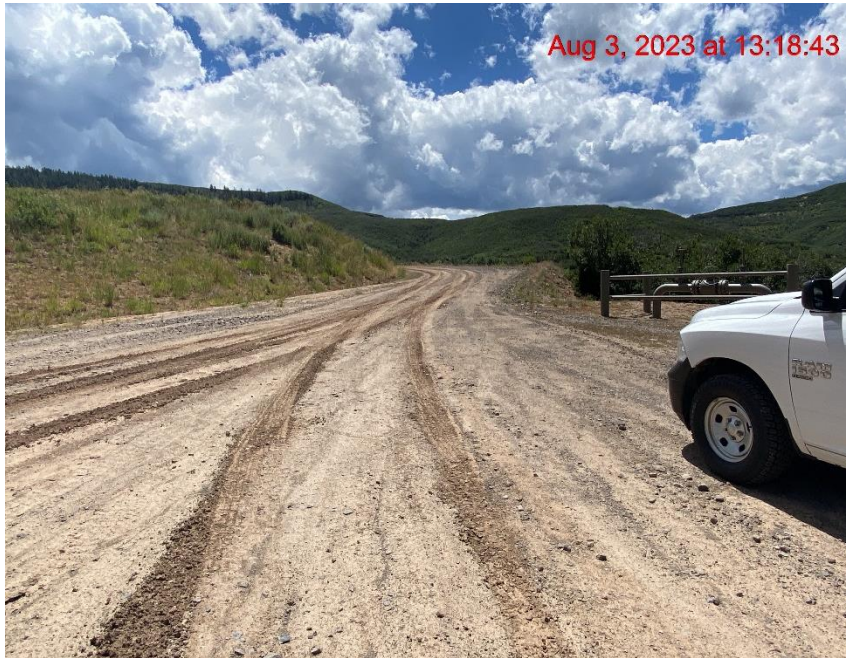
**Insufficient Vehicle Tracking BMPs at Location Entrance/Exit
– Photo #05443**

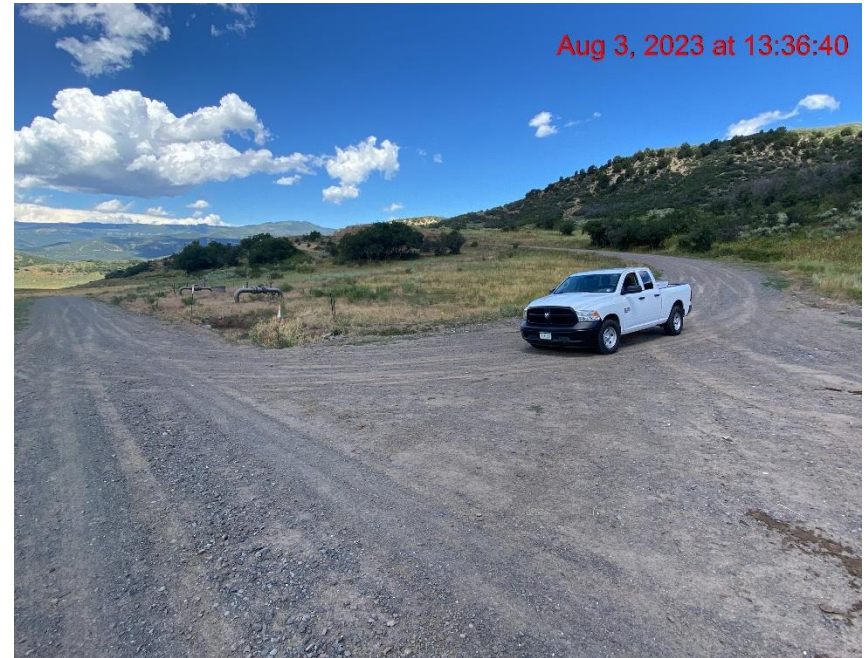
**Insufficient Vehicle Tracking BMPs at Access Road
Entrance/Exit – Photo #05445**
